CORPORATE OF THE TOWN OF TECUMSEH
2016 Culvert Needs Study

Structures with Spans $\leq 3.0\text{m}$ – Final Report

Our File: 15-2977

October 28, 2016

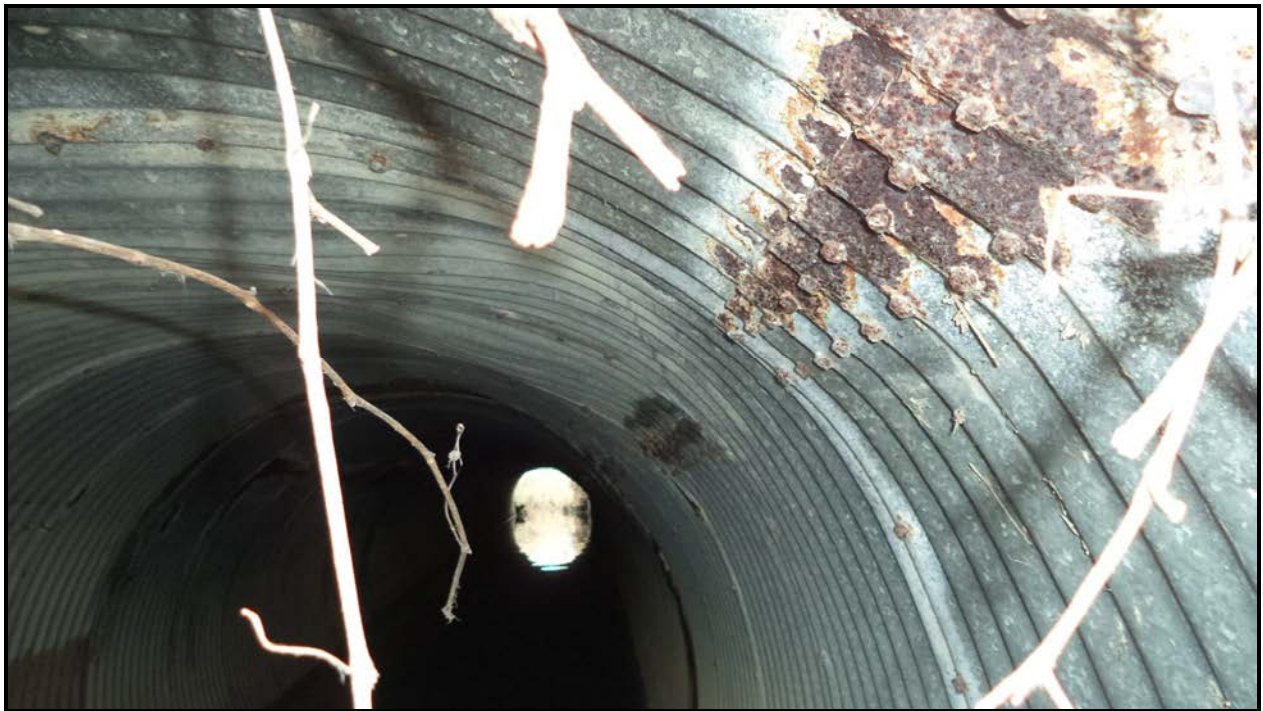
Photograph 3 – Bending and Settlement at the Barrel Top

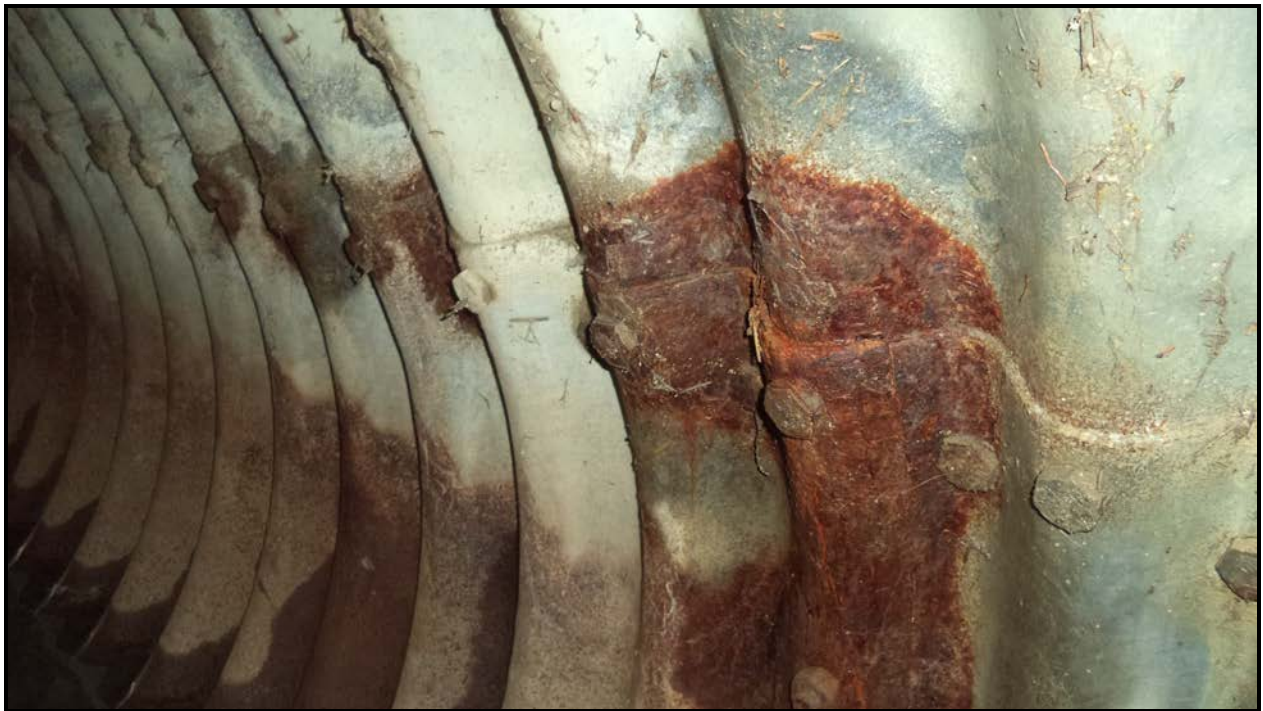
Photograph 3 – Bolts Corrosion at Culvert Soffit
