CORPORATION OF THE TOWN OF TECUMSEH
2020 Bridge and Culvert Needs Study
Structures with Spans > 3.0 m

March 30, 2021

Town of Tecumseh
2020 Bridge and Culvert Needs Study
Structures with Spans > 3.0 m

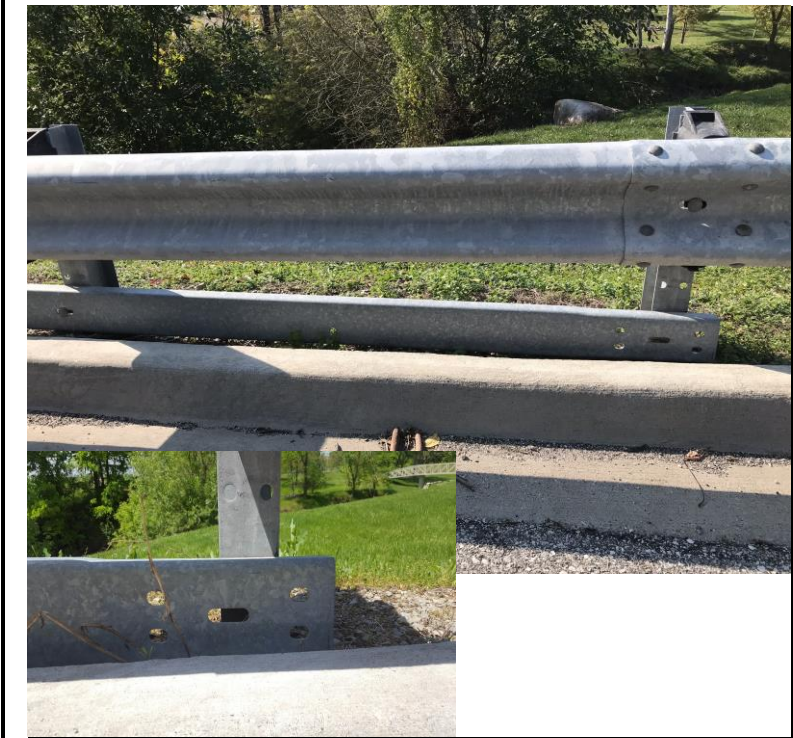
Description
Missing bolt(s) for bottom of northwest guardrail.

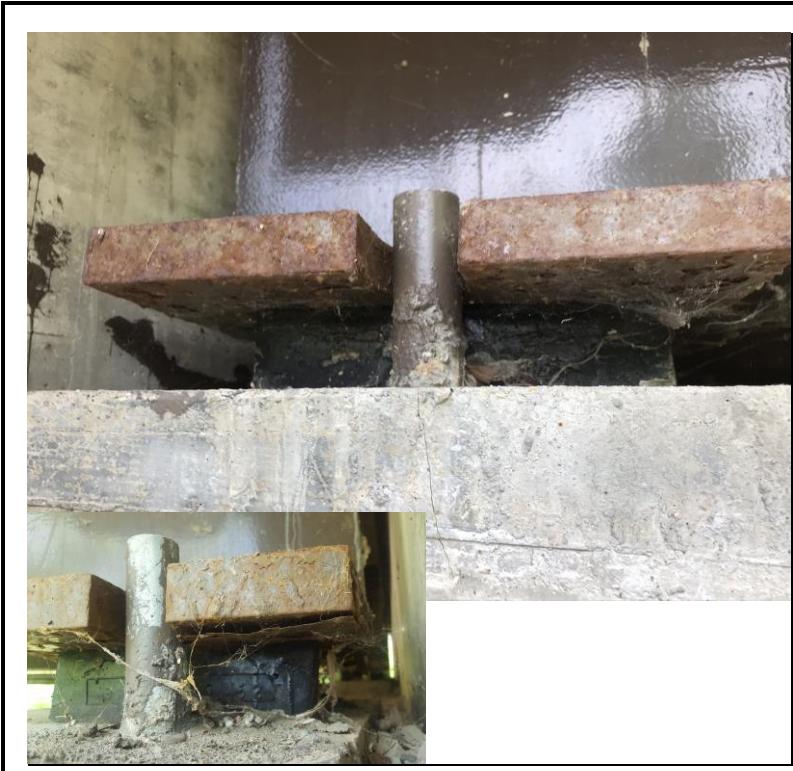
Description
Medium corrosion observed at bearing shoe plate (Typ.)

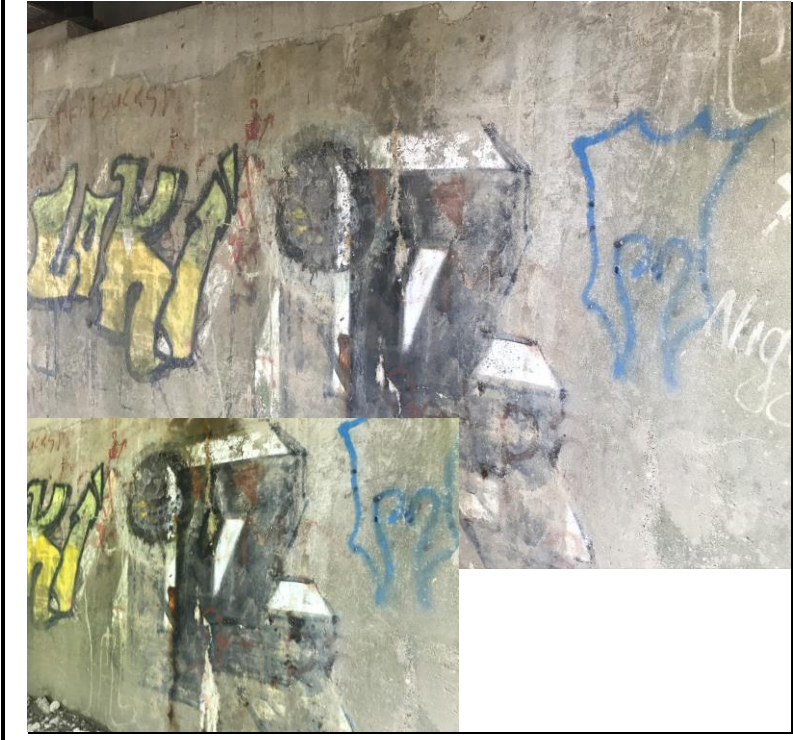
Description
Medium crack with active wet areas and efflorescence at North abutment wall.

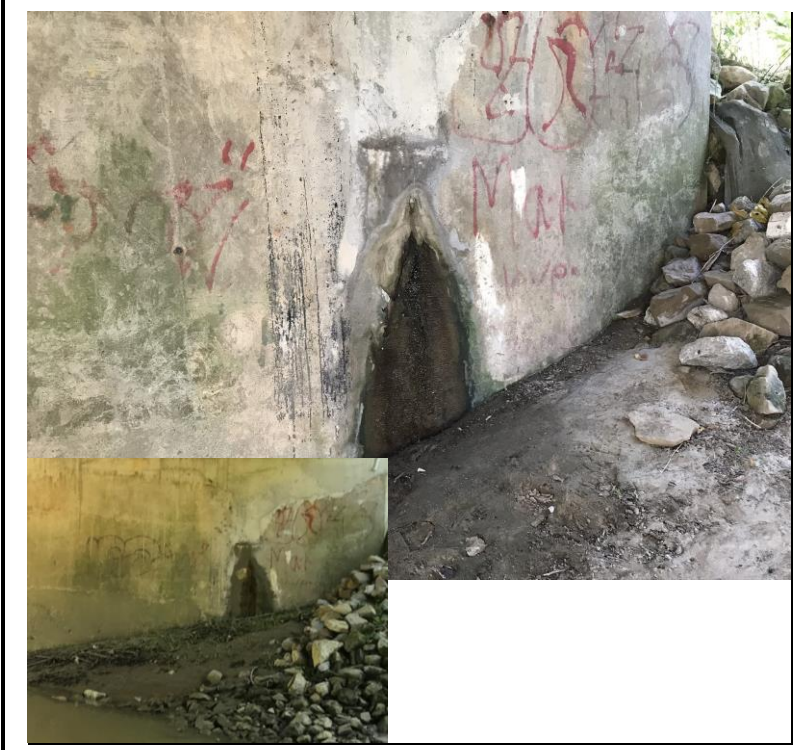
Description
Medium crack with active wet areas and efflorescence at South abutment wall.

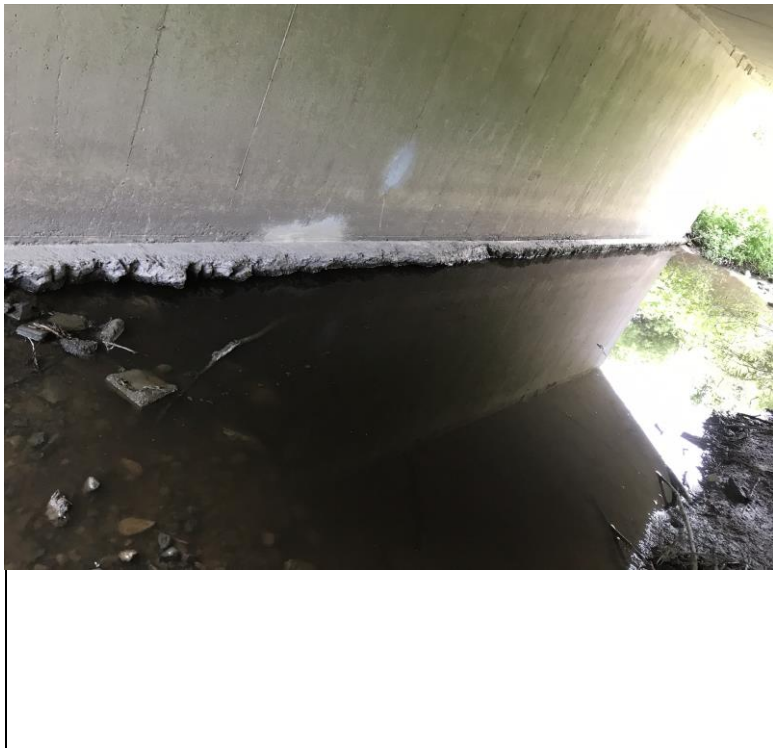
Scour and concrete erosion at South abutment footings (Typ.).

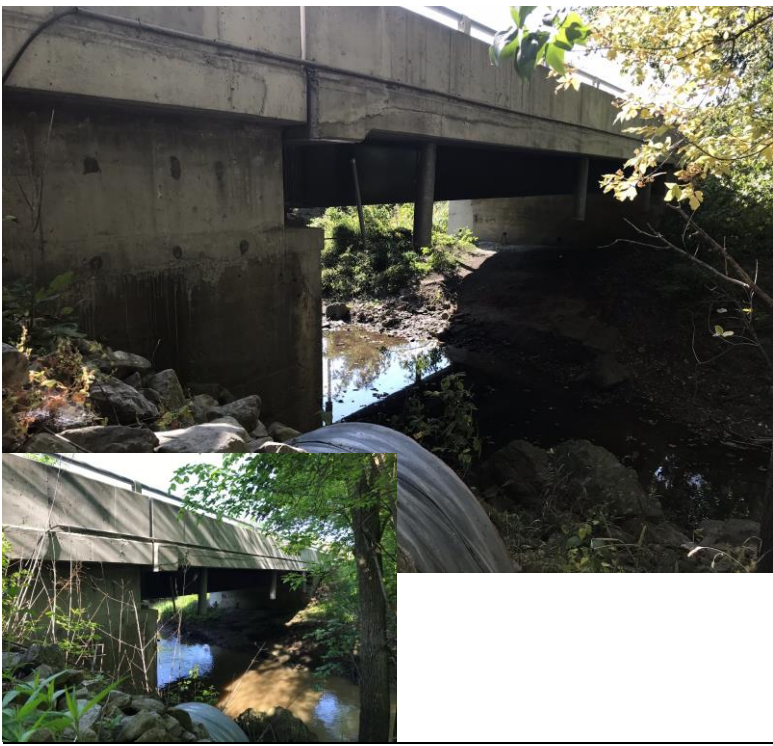
<p>Description North deck fascia, stream, and embankments (Looking West). Longitudinal cracks in fascia with active wet areas and efflorescence (typ.)</p>
---	---

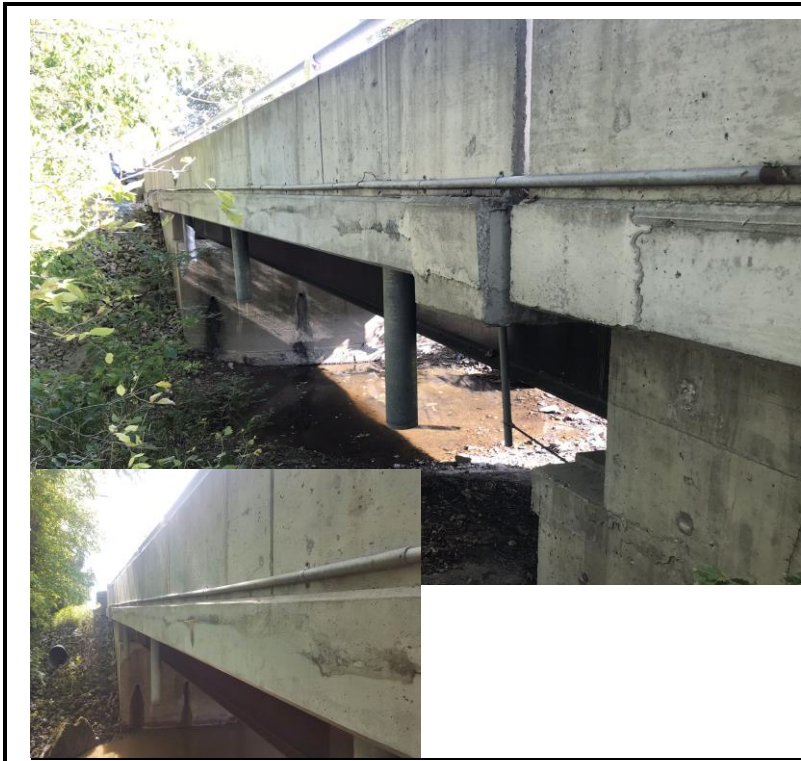
Description
South deck fascia, and deck drainage, (Looking North). Longitudinal cracks in fascia with active wet areas and efflorescence (typ.)

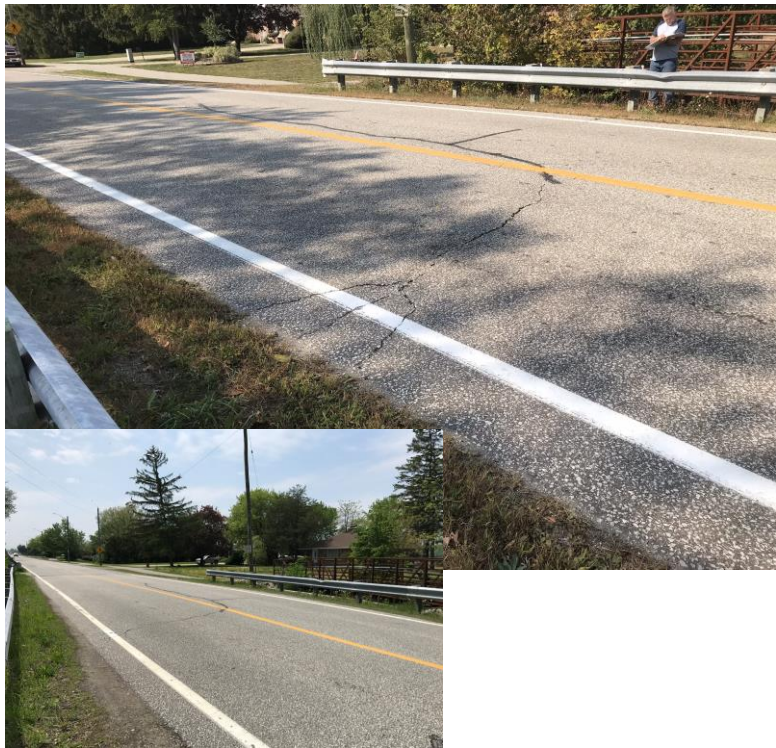
Description
Wearing surface over the bridge. New transverse crack. (Looking West)

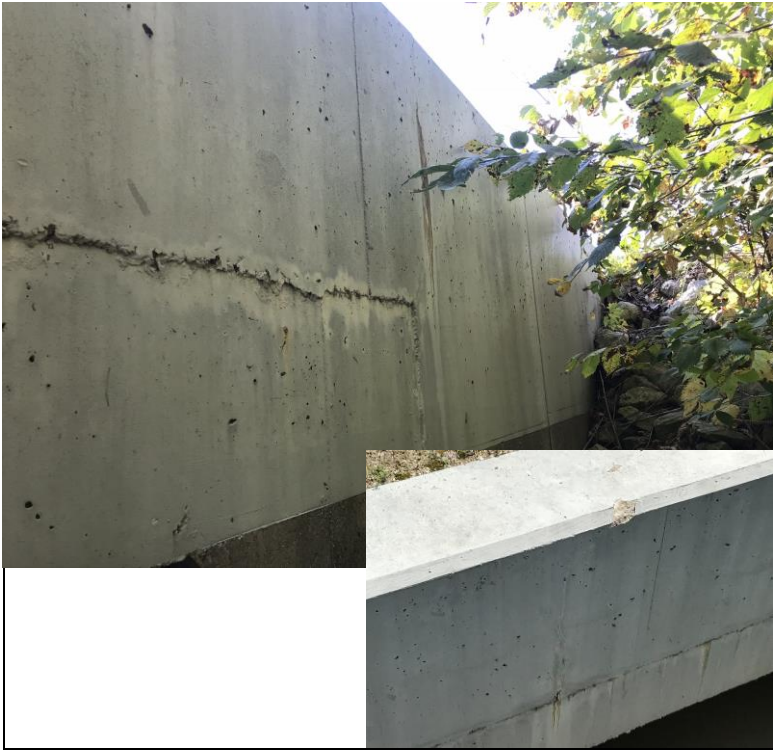
<p>Description</p> <p>Typical cracking with stain at the headwalls.</p>
--	--

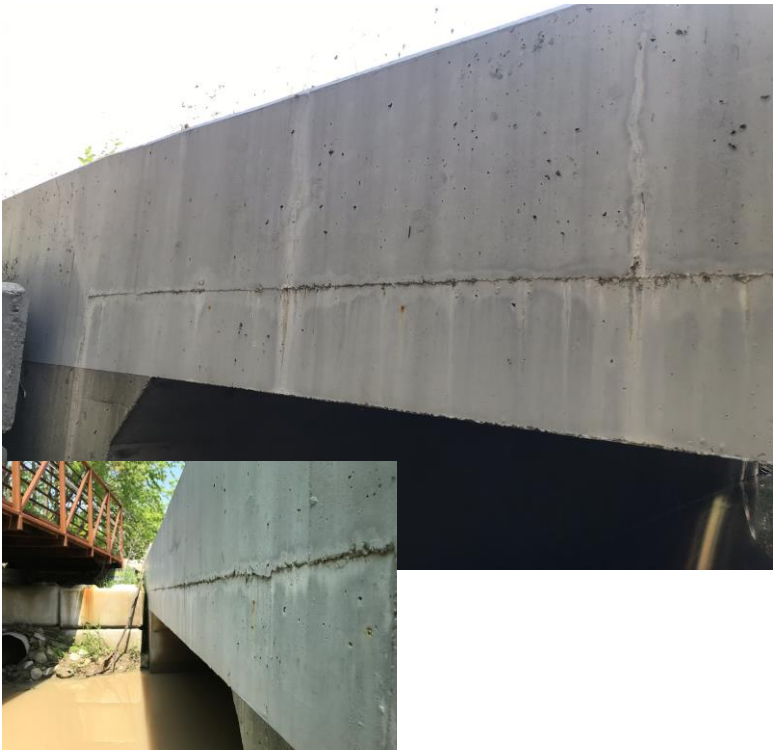
<p>Description</p> <p>Cracking with stain at the headwalls. (West elevation)</p>
---	---

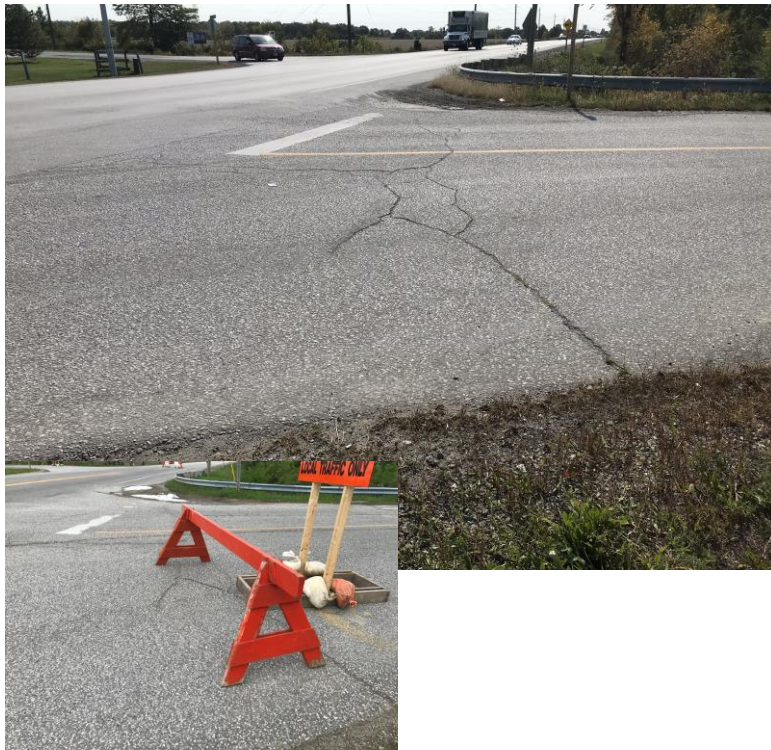
Description
Wide crack at joint between wearing surface over the culvert section and east approach slab.

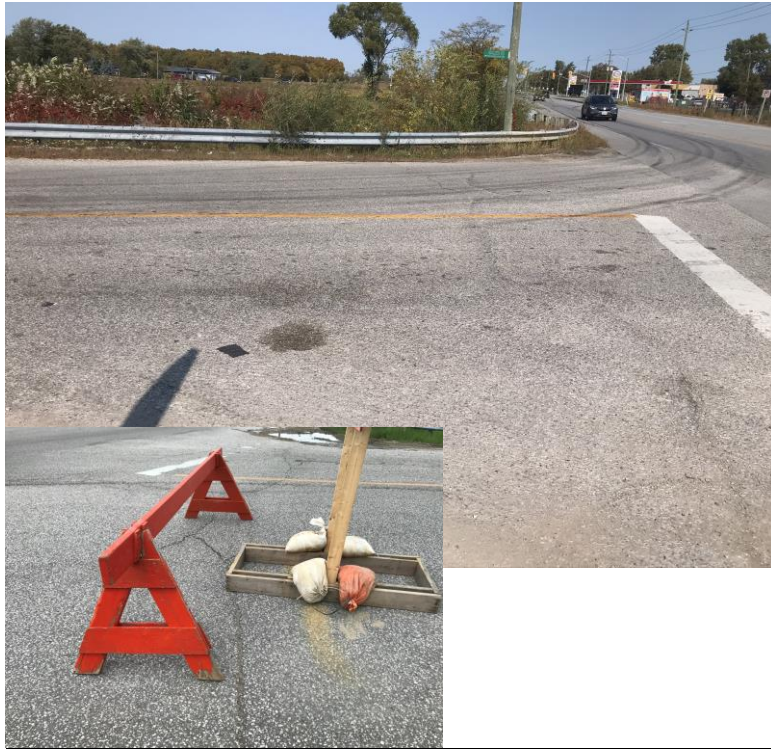
Wide transverse cracking at east approach slab. (Looking North)

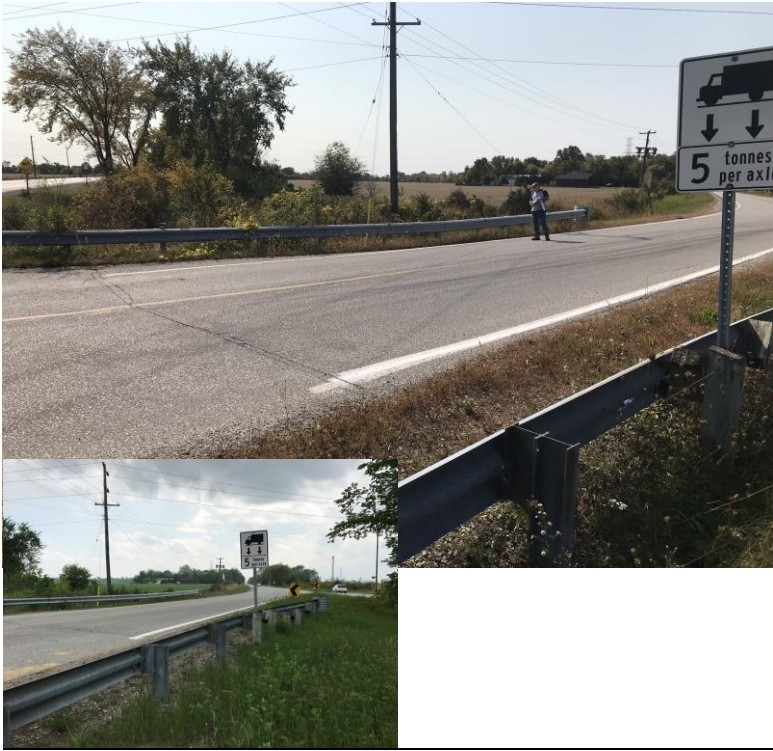
<p>Description</p> <p>Load limit sign and loose guide rails at the north-west end treatment.</p>
--	---

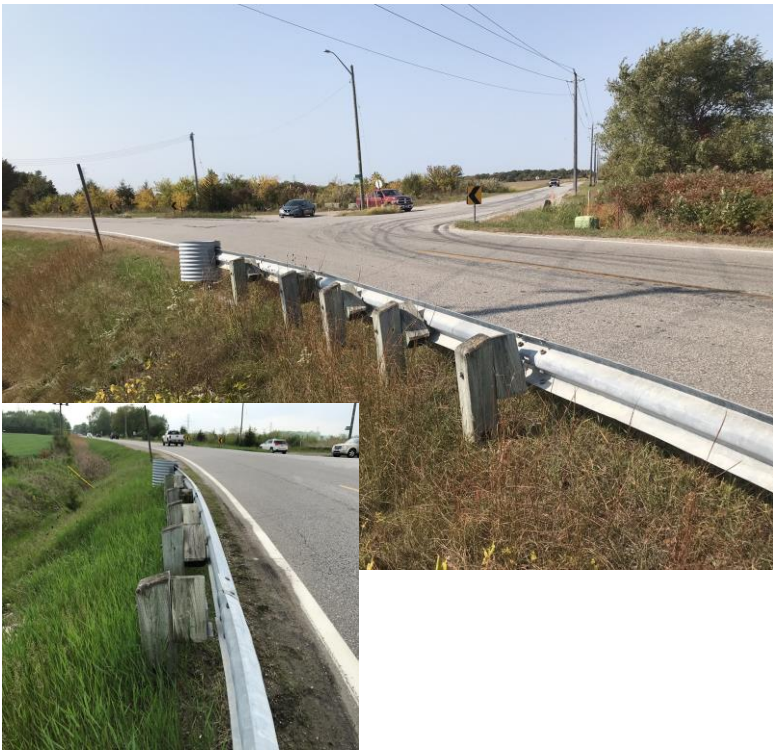
<p>Description</p> <p>Loose guide rails at the south-west end treatment.</p>
---	---

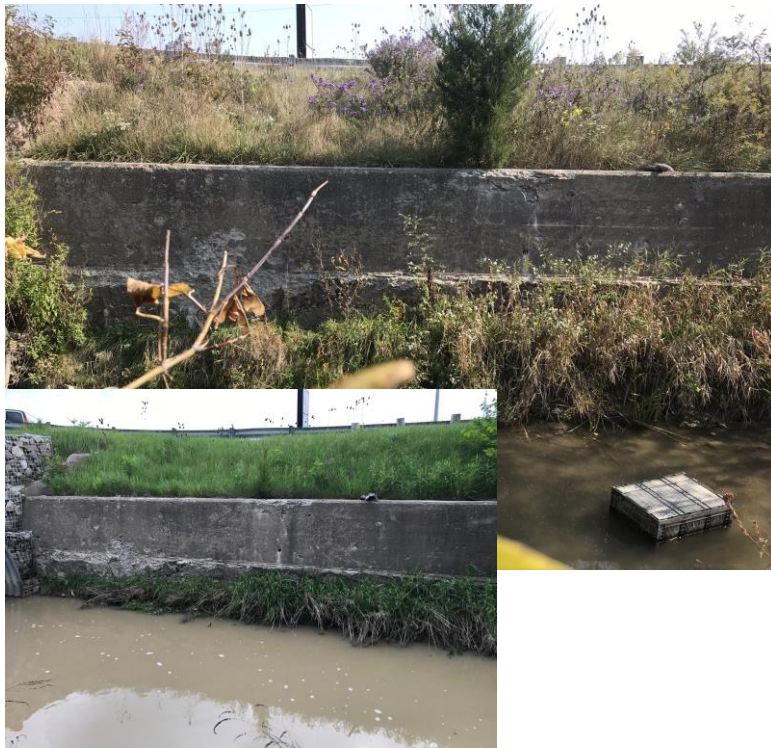
Medium spalling at retaining wall bottom at south east embankment.

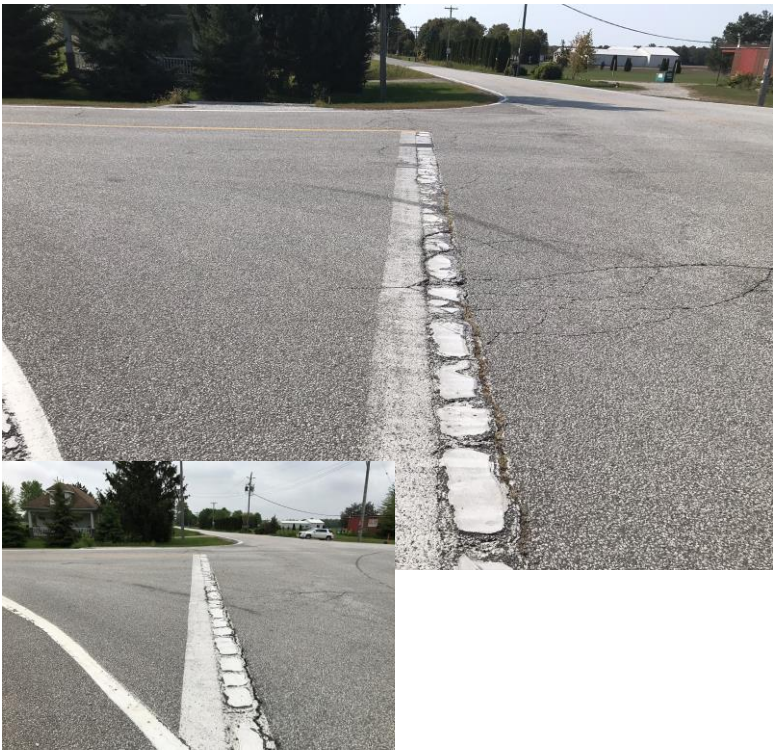
<p>Description</p> <p>Wearing surface cracking at the west approach, (Looking South)</p>
---	---

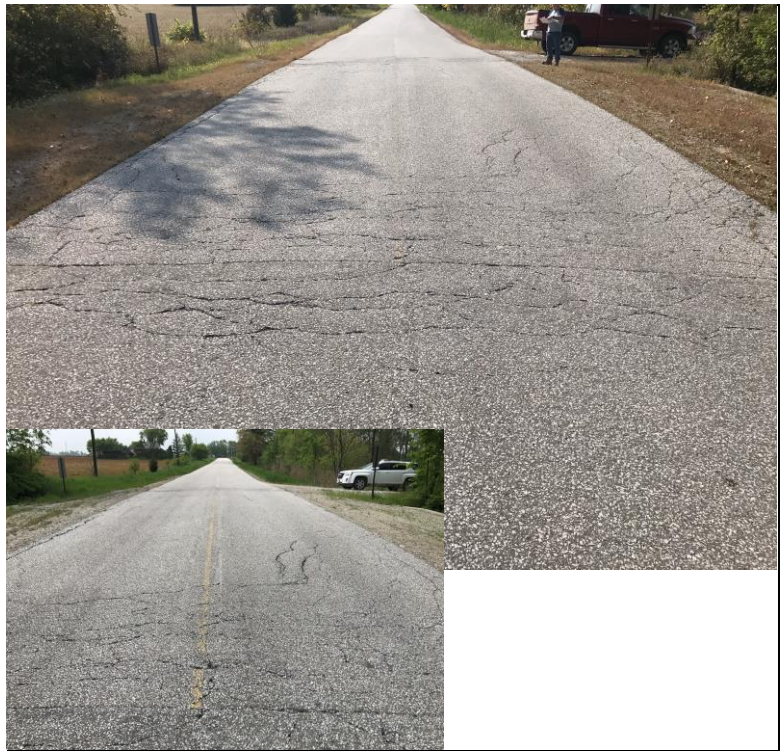
<p>Description</p> <p>Cracking of asphalt pavement at junction of deck top and north approach. (Looking South)</p>
--	---

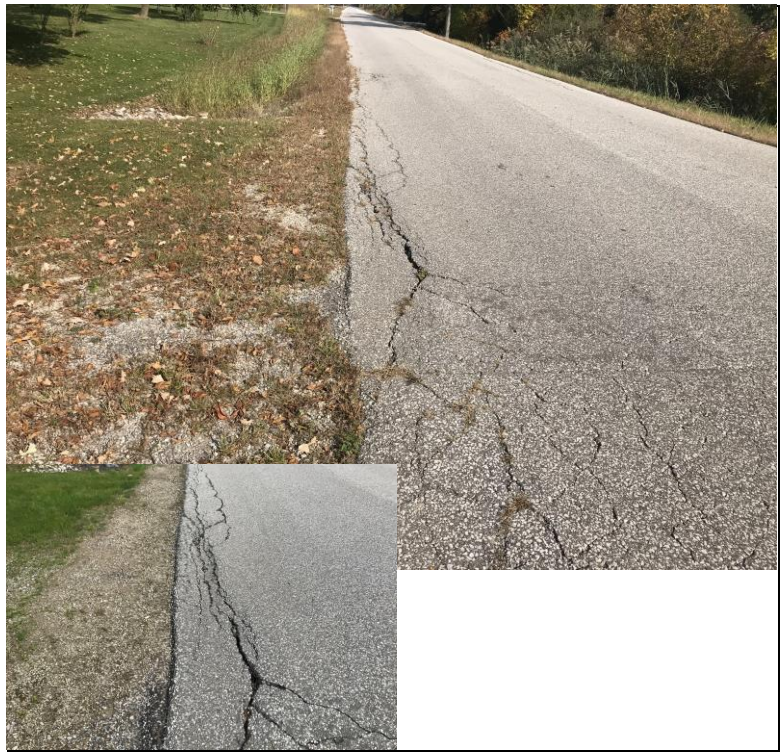
<p>Description</p> <p>Edge cracks at north approach. (Looking North)</p>
---	---

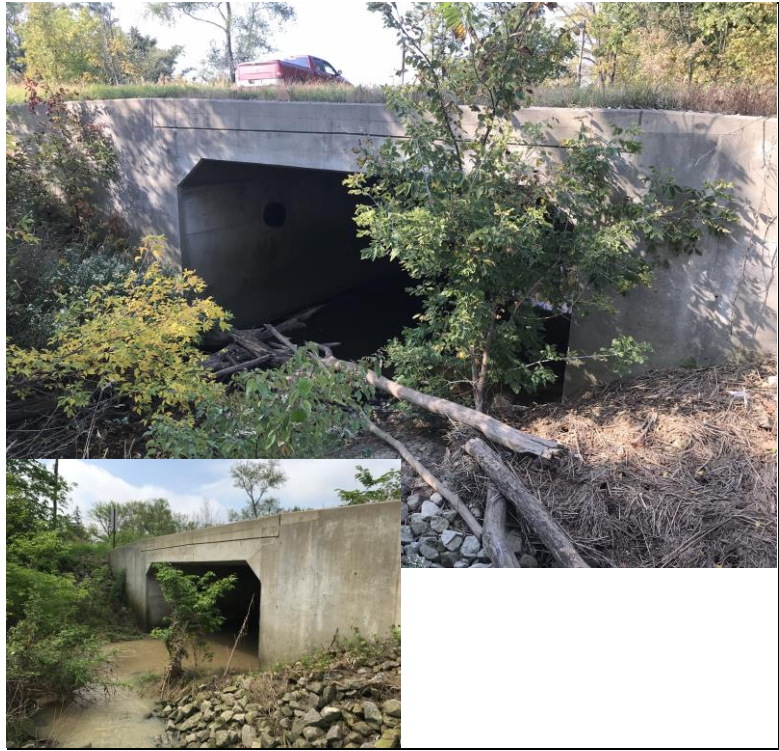
<p>Description</p> <p>East elevation, wingwalls, abutment walls, and HDPE outlet. (Looking West) Vegetation and heavy debris blocking flow.</p>
--	--

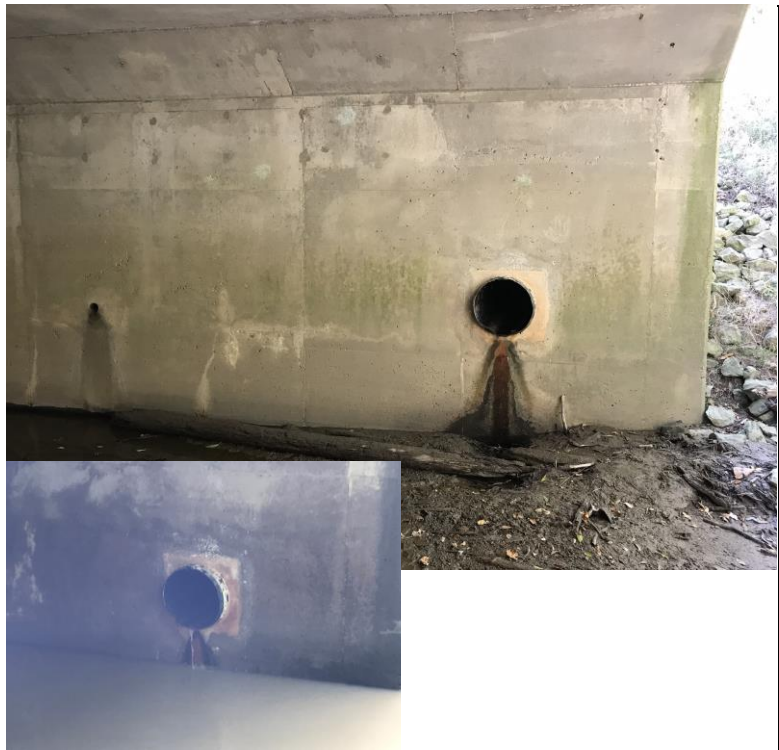
<p>Description</p> <p>South abutment wall near west extent, HDPE outlet with corrosion staining beneath. (Looking South)</p>
---	---

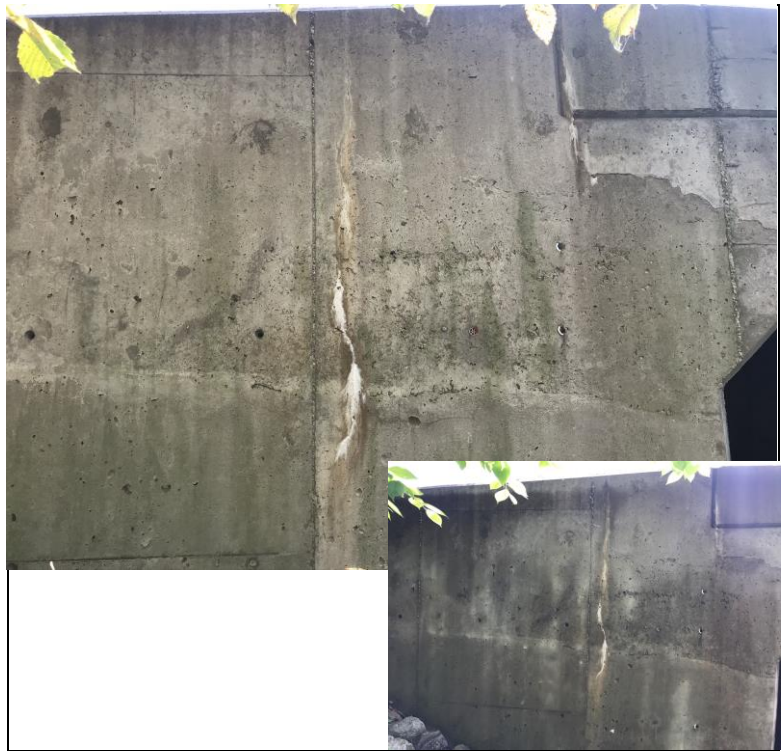
<p>Description</p> <p>North-west wingwall. Vertical crack with efflorescence staining.</p>
--	---

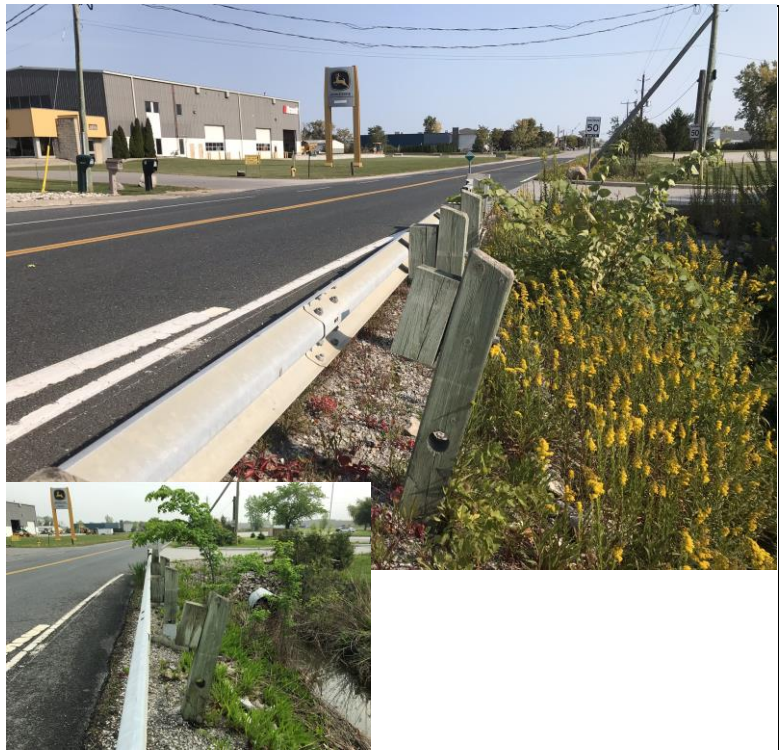
<p>Description</p> <p>Settled, rotated post of railing system at the north-east corner, (Looking Northeast)</p>
---	--

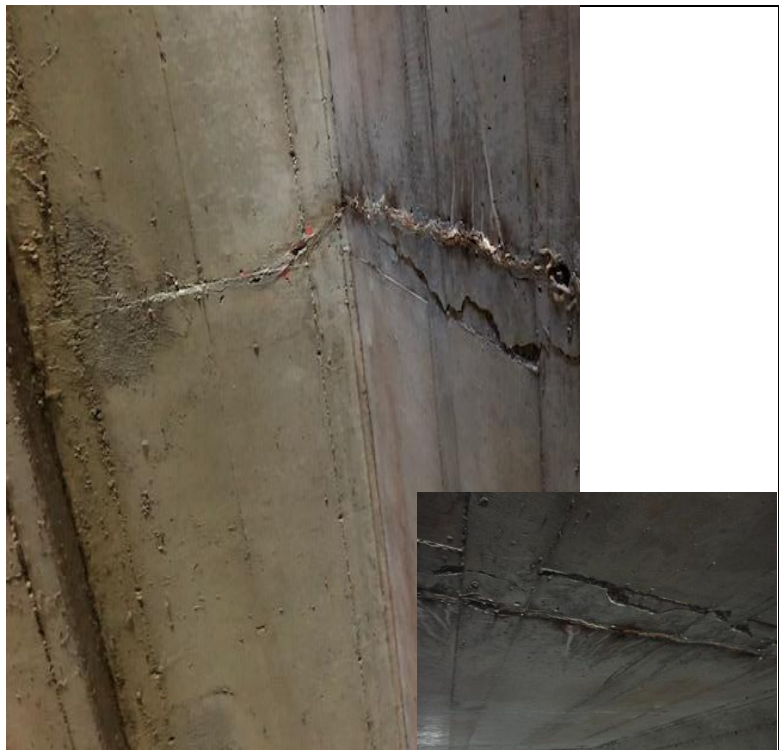
<p>Description</p> <p>Typical delamination, cracking with staining at deck soffit within the original section of the bridge.</p>
---	---

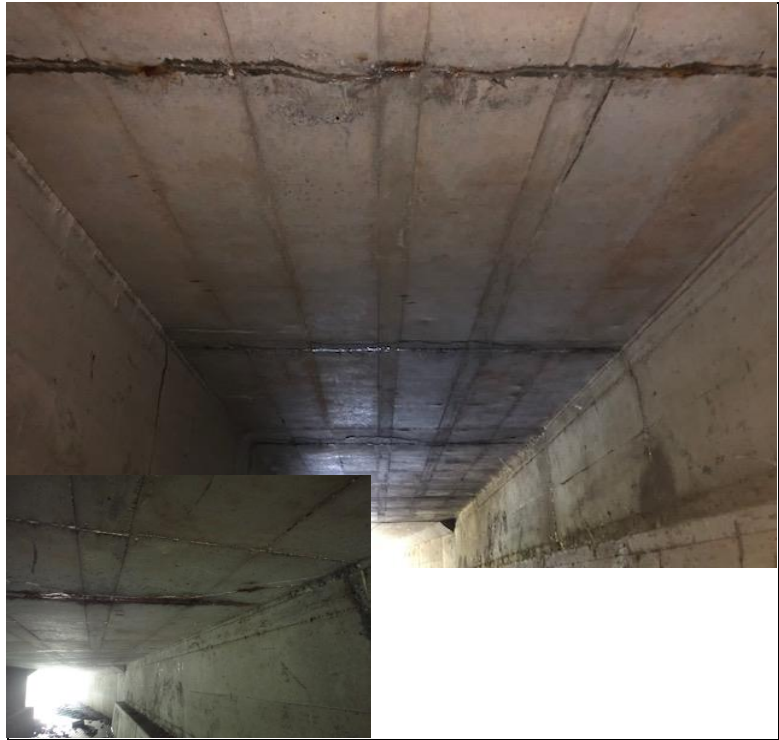
<p>Description</p> <p>Typical cracking with stain at deck soffit. (Looking Northwest)</p>
--	--

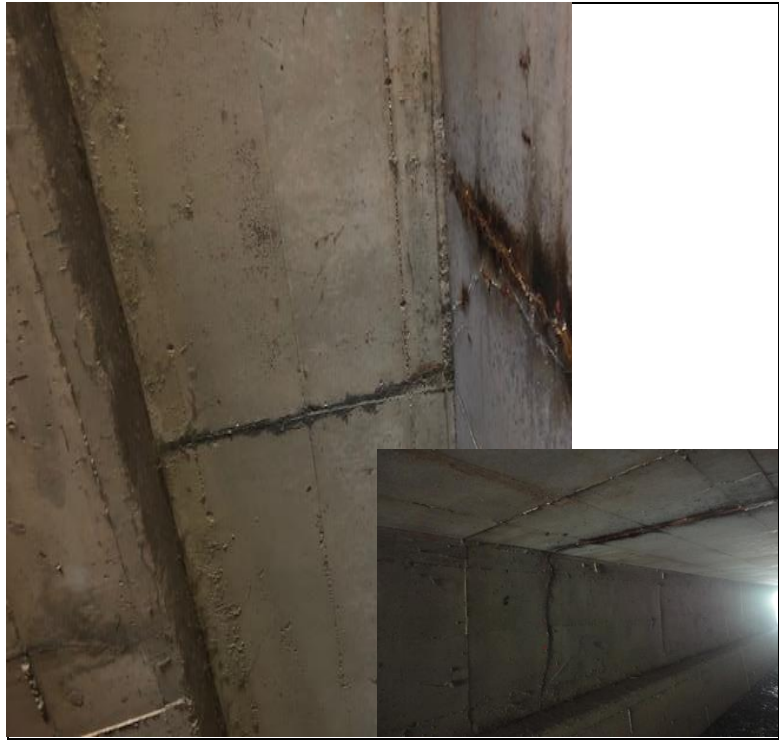
<p>Description</p> <p>Cracks extending at from the deck soffit to the abutments at the north abutment wall.</p>
---	--

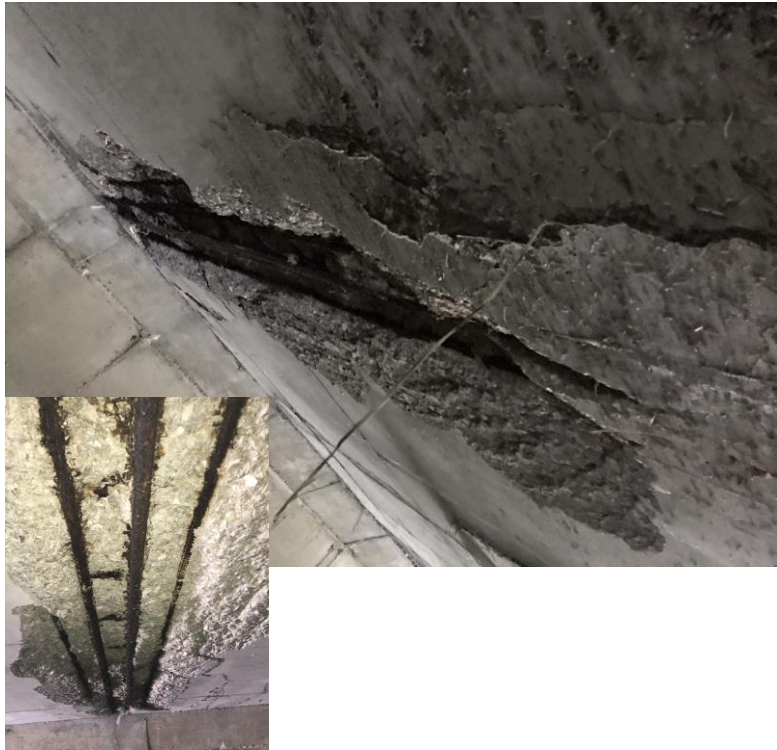
<p>Description</p> <p>Soffit deterioration. Very severe spall with exposed and severely corroded reinforcement, severe delamination in adjacent areas.</p>
---	---

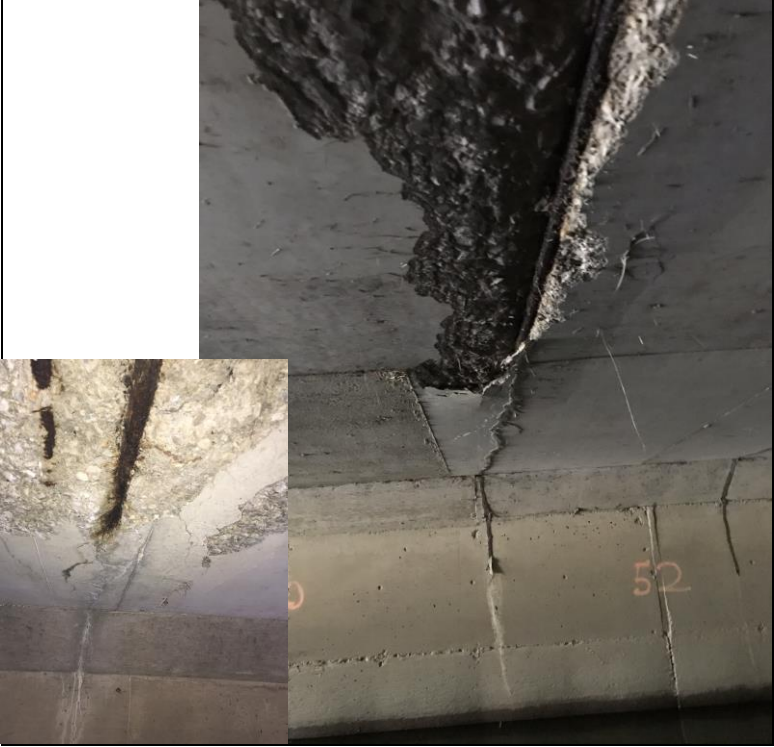
<p>Description</p> <p>Soffit deterioration. Very severe spall with exposed and severely corroded reinforcement, delamination in adjacent area. Medium vertical cracks (sealed) with efflorescence staining on abutment wall near soffit deterioration.</p>
--	---

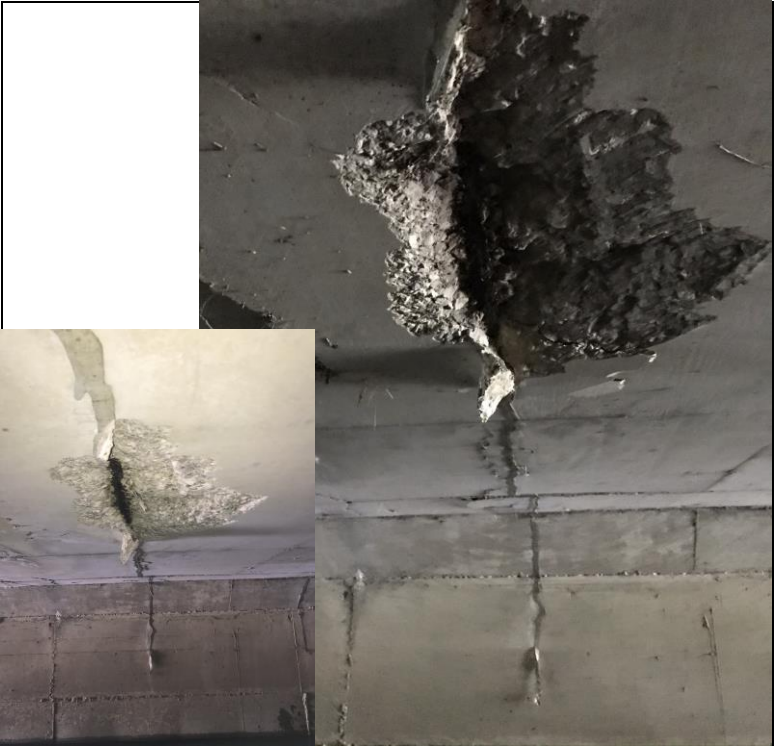
<p>Description</p> <p>Soffit deterioration. Severe spall with exposed and severely corroded reinforcement, delamination in adjacent area. Medium vertical cracks (sealed) with efflorescence staining on abutment wall near soffit deterioration.</p>
---	--

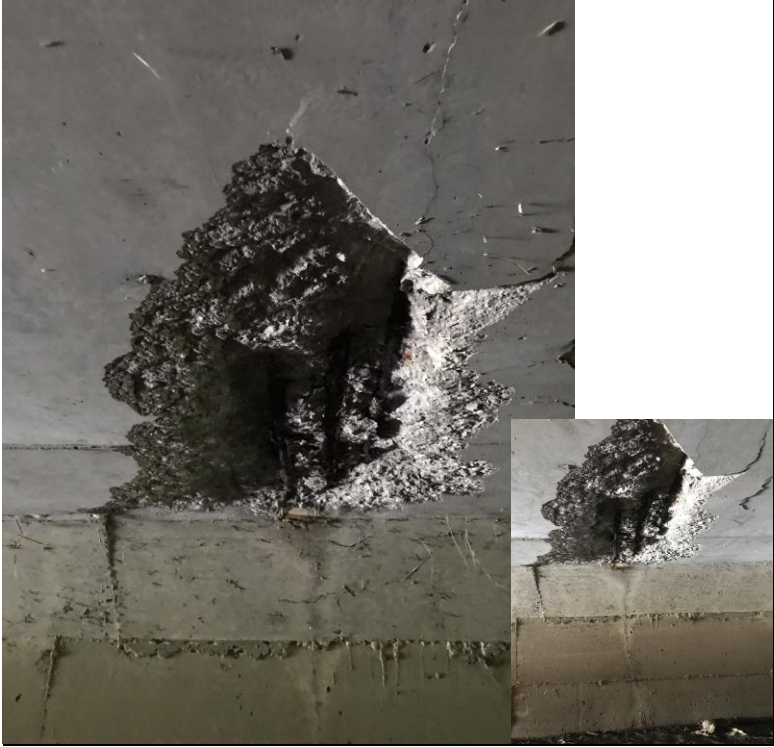
<p>Description</p> <p>Culvert soffit with very severe spalling and very severely corroded reinforcement. Severe delamination in surrounding regions. Medium vertical crack with efflorescence staining on abutment wall.</p>
--	---

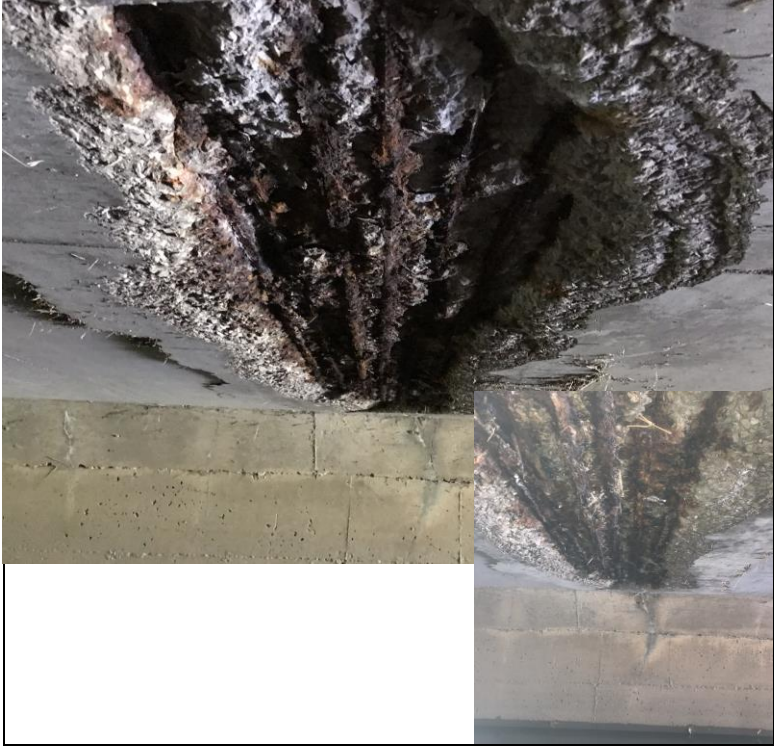
<p>Description</p> <p>Culvert soffit with very severe spalling and very severely corroded reinforcement. Very severe delamination in surrounding regions. Wide vertical crack with efflorescence staining on abutment wall.</p> <p>Steel plate placed on deck over this area in 2016.</p>
---	--

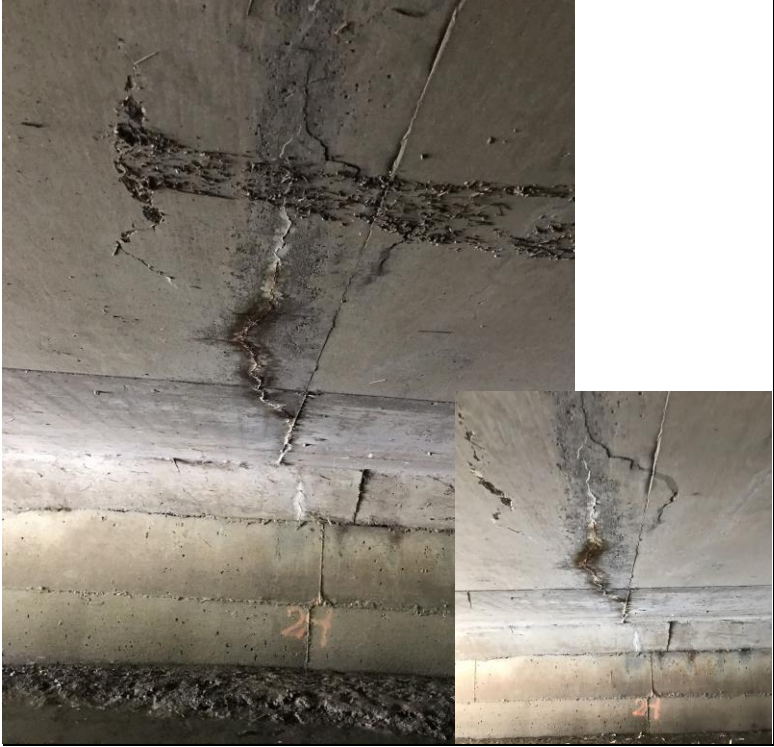
<p>Description</p> <p>Medium cracking on soffit and abutment wall with efflorescence and corrosion staining. Area of severe delamination extending from crack.</p>
--	---

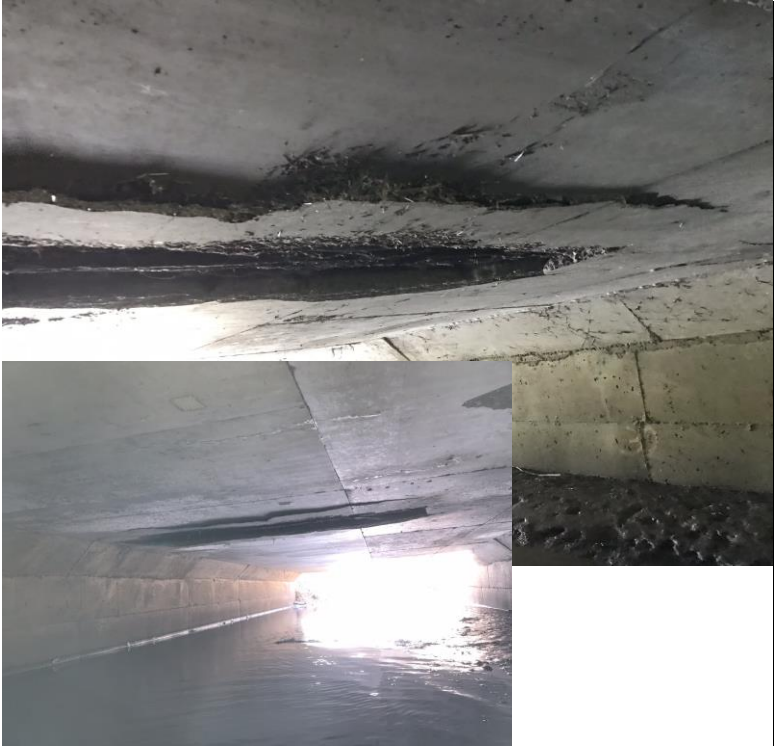
<p>Description</p> <p>Very severe soffit spalling, reinforcement corrosion and delamination. A 36x5100x4000 steel plate was installed above this location in the 2016 rehabilitation.</p>
---	--

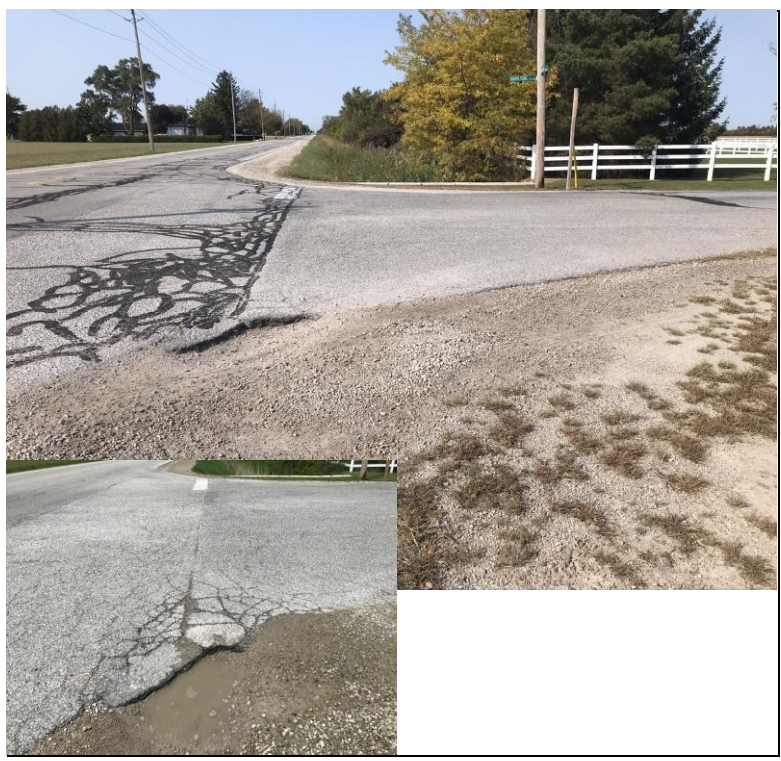
<p>Description</p> <p>Alligator cracking of wearing surface at southeast corner (Looking West)</p>
---	---

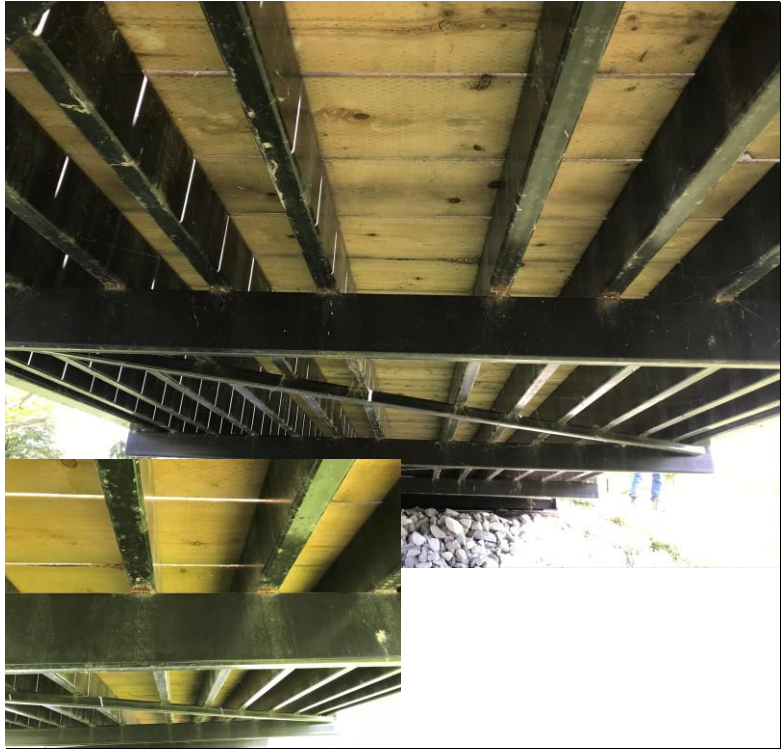
<p>Description</p> <p>Typical corrosion at weld locations.</p>
--	---
