CORPORATION OF THE TOWN OF TECUMSEH

2024 Bridge and Culvert Needs Study Structures with Spans > 3.0 m

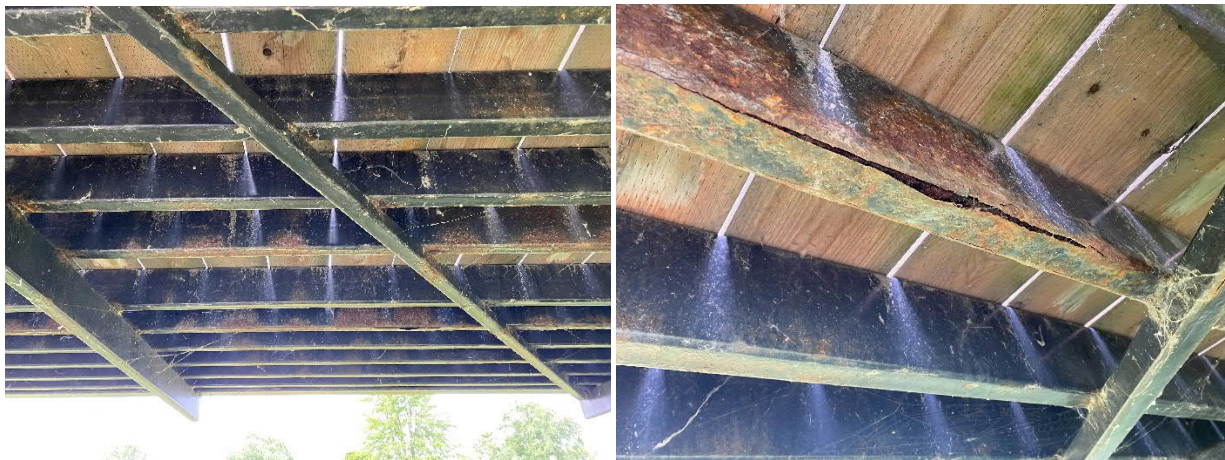
(a) Typical condition of the floor system with light corrosion and coating failure across all members.

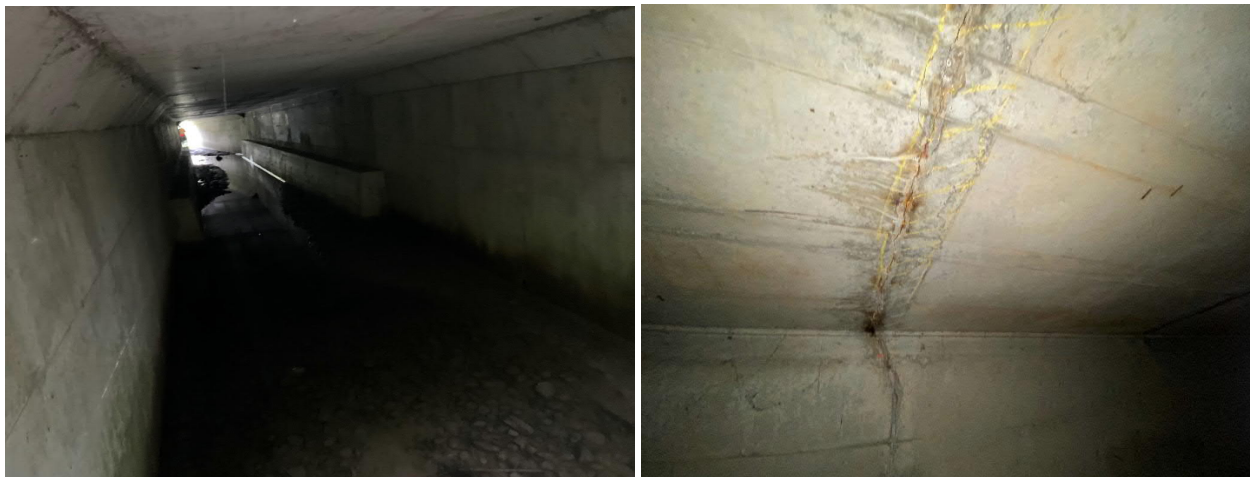
In the original culvert section, medium to wide cracks with active efflorescence and a severe delamination was observed across the barrel soffit. The barrel walls were noted to have light scaling and footing scour throughout. The scour has not led to undermining of the footings and is not considered to need any repairs. The scour should be monitored as part of the biennial inspection. Two (2) wide cracks were observed in the north wall footing jacket. No deterioration was observed in the new culvert extensions. Excessive vegetation growth was noted in the waterway to the north of the structure and object markers were noted to be missing at two corners of the approaches.

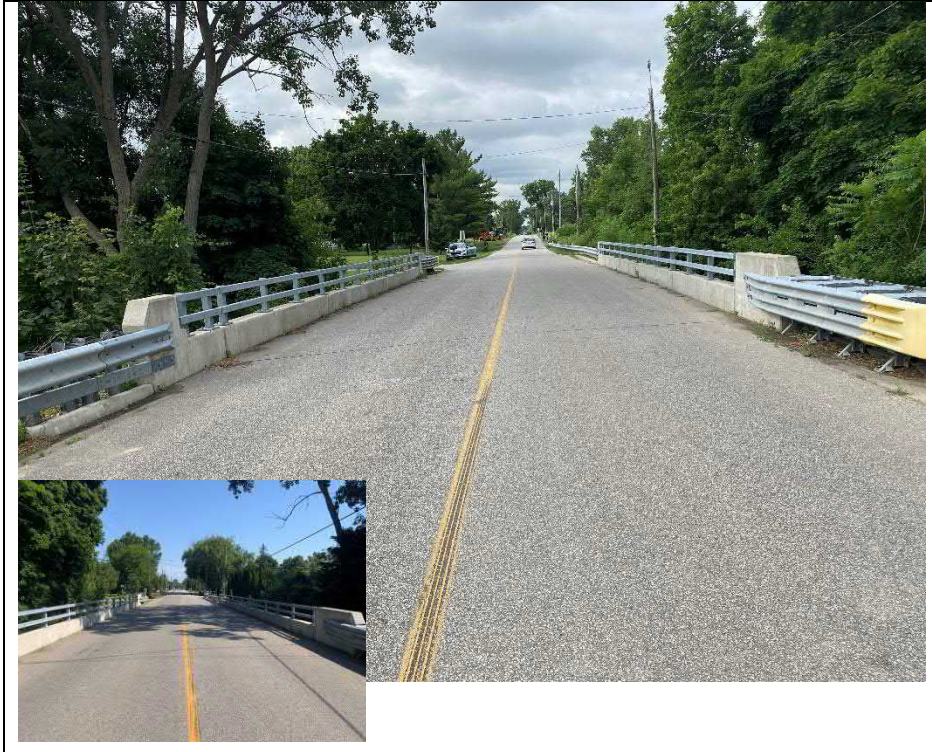
Photograph 1: Overview of the structure (Looking South)

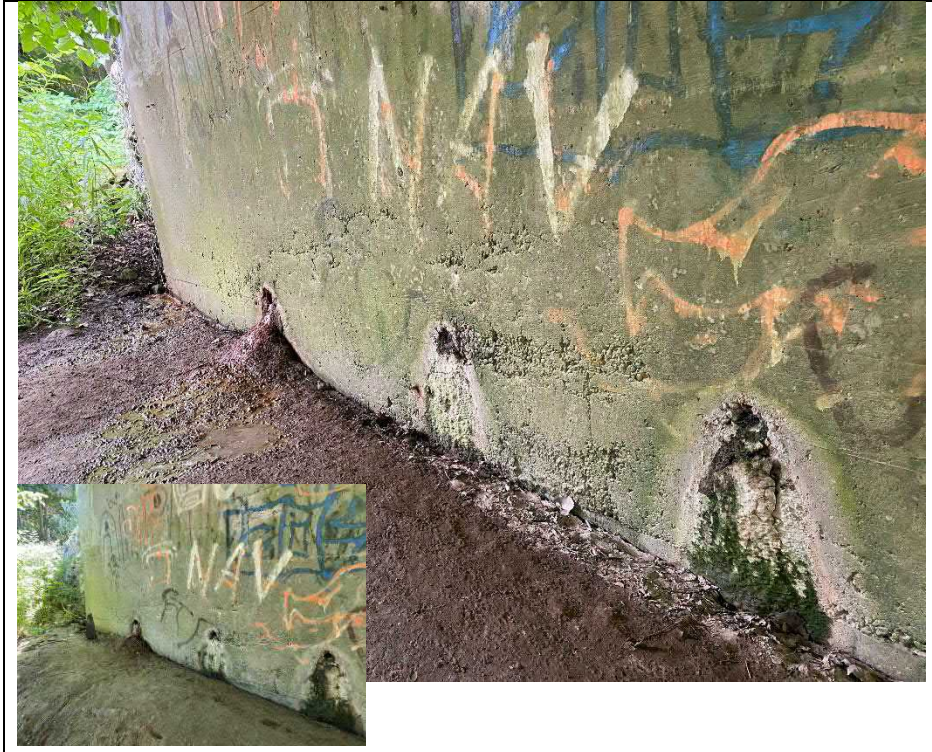
Photograph 17: Typical condition of wall drains on the south abutment wall and typical honeycombing

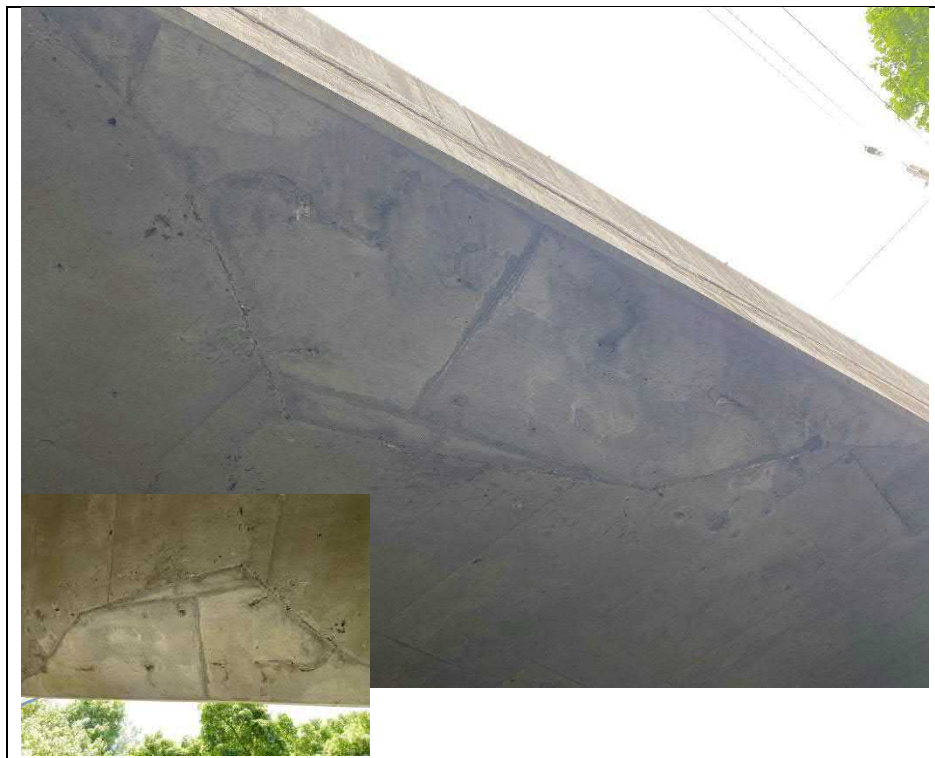
Photograph 18: Former wet staining and efflorescence on west edge of soffit (Rehab in 2016)

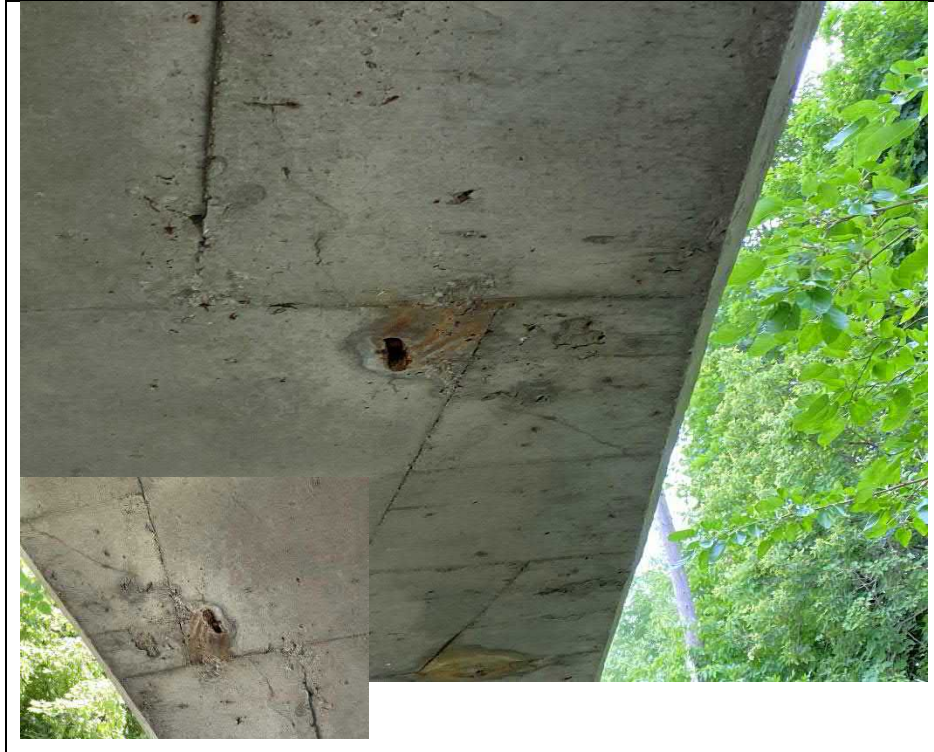
Photograph 19: Localized spall, wet staining, and light honeycombing on the edge of soffit

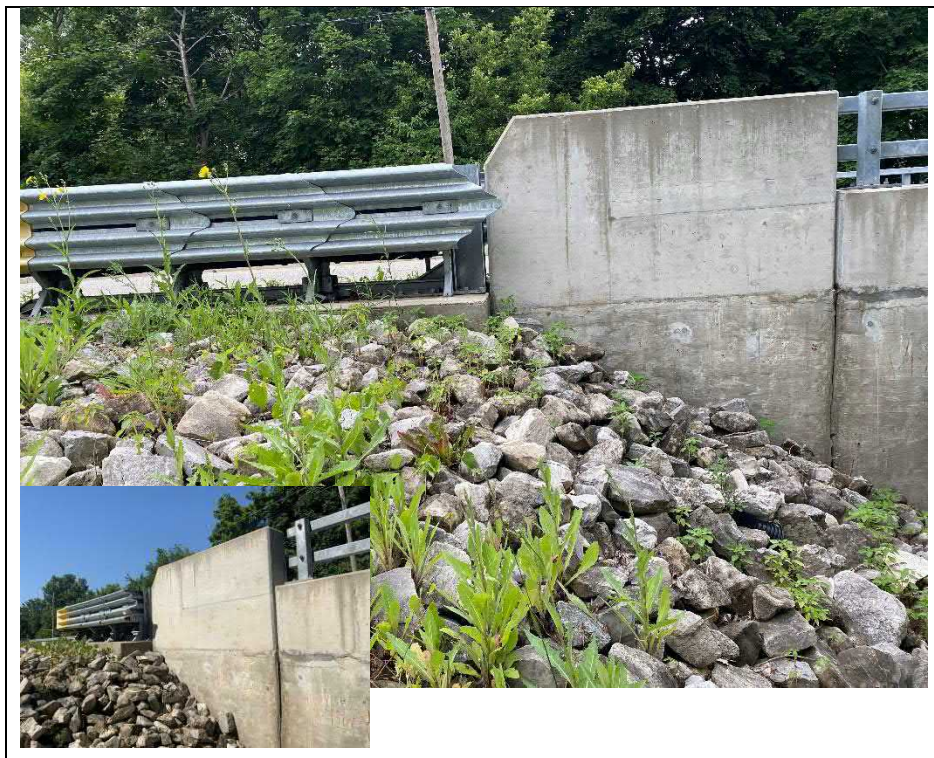
Photograph 20: Typical condition of wingwalls (Southeast quadrant shown)

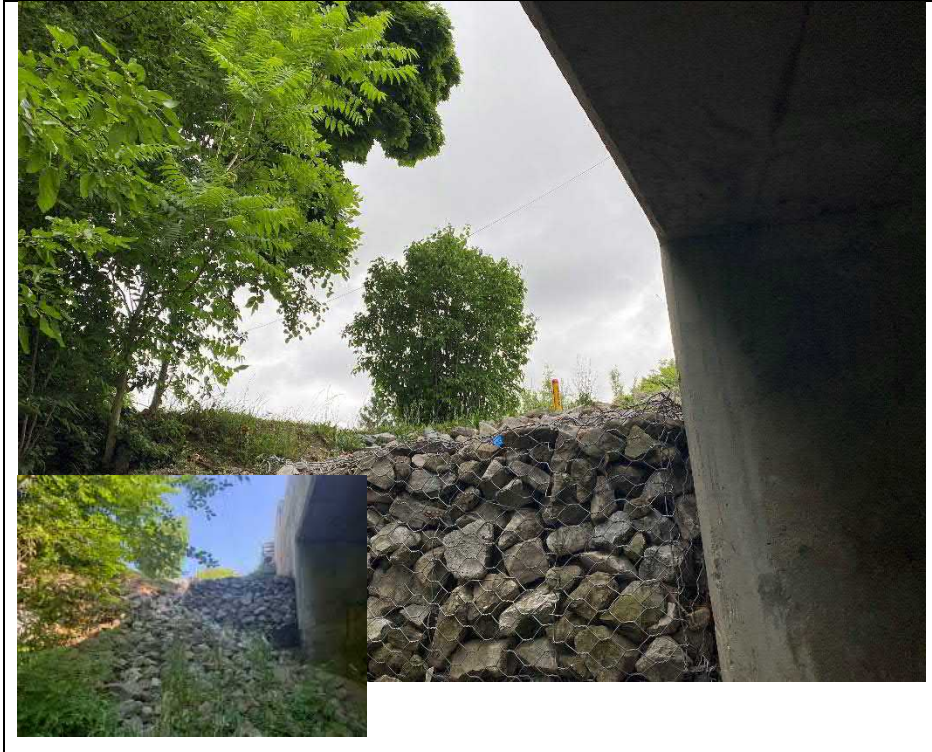
Photograph 21: Embankment at northwest quadrant of the structure

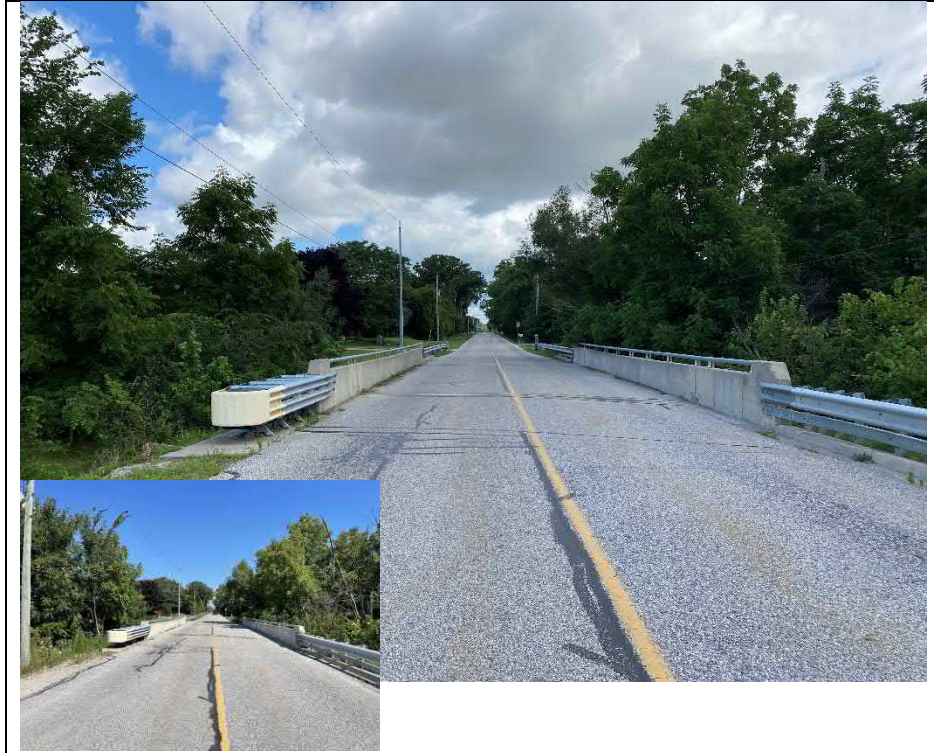
Photograph 1: Overview of structure (Looking North)

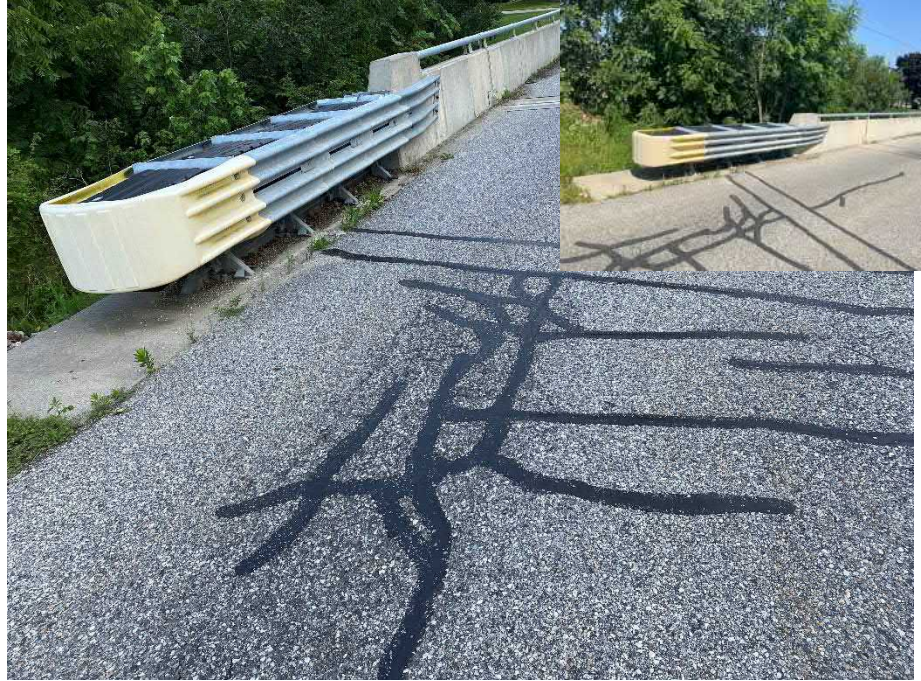
Photograph 3: Wearing surface at the south approach (Looking West)

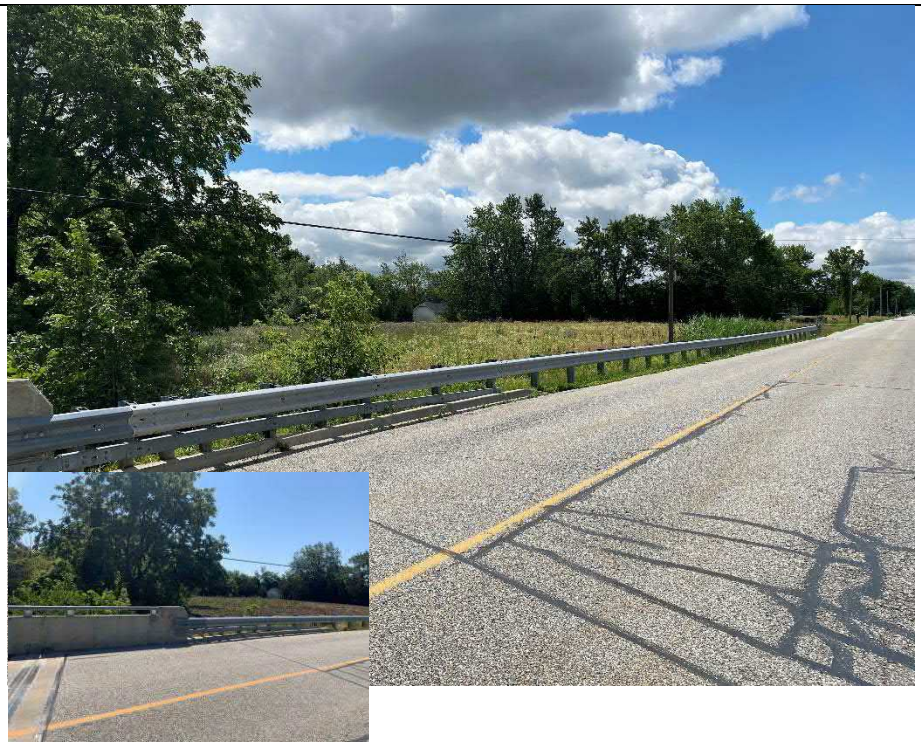
Photograph 4: Wearing surface at the south approach (Looking East)

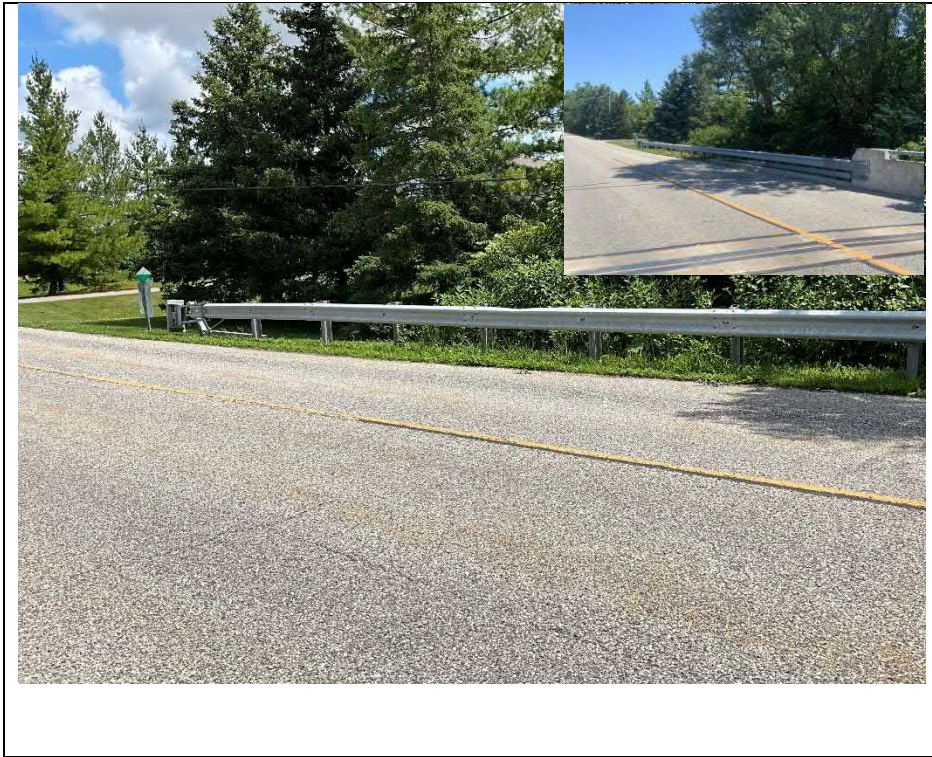
Photograph 5: Wearing surface at the north approach (Looking North)

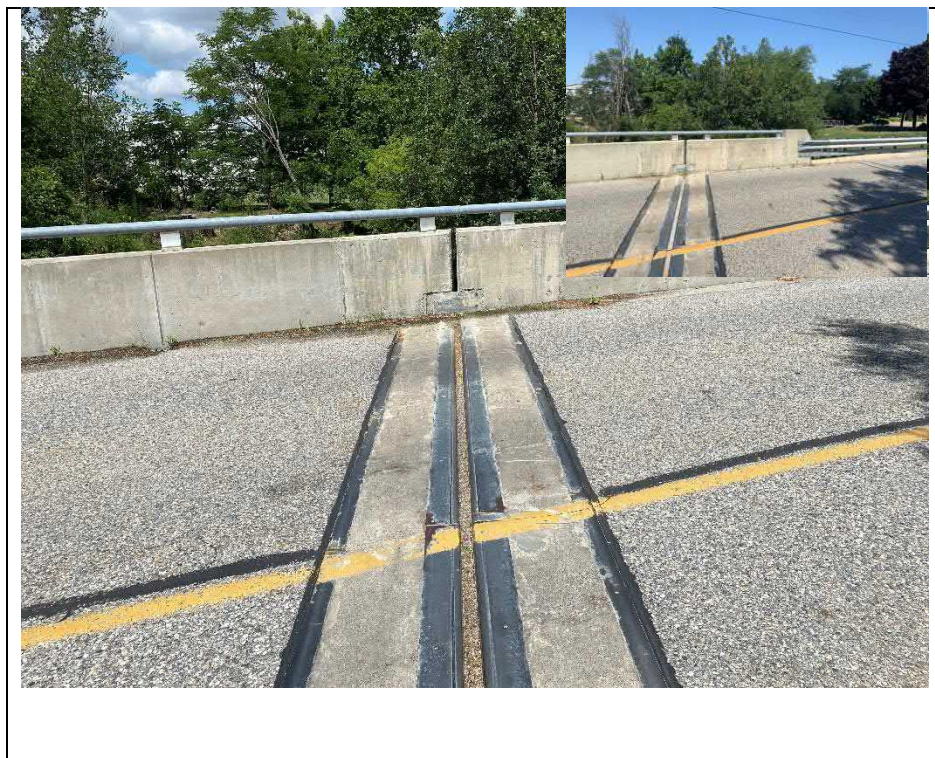
Photograph 6: Typical condition of expansion joints (South joint shown)

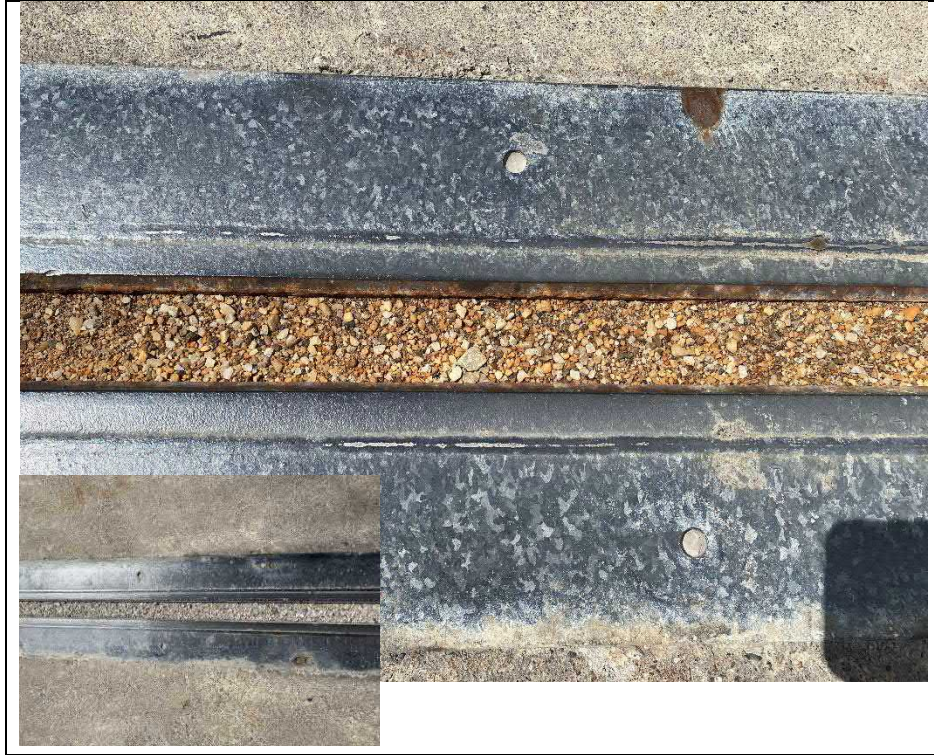
Photograph 7: Typical debris build up in expansion joints

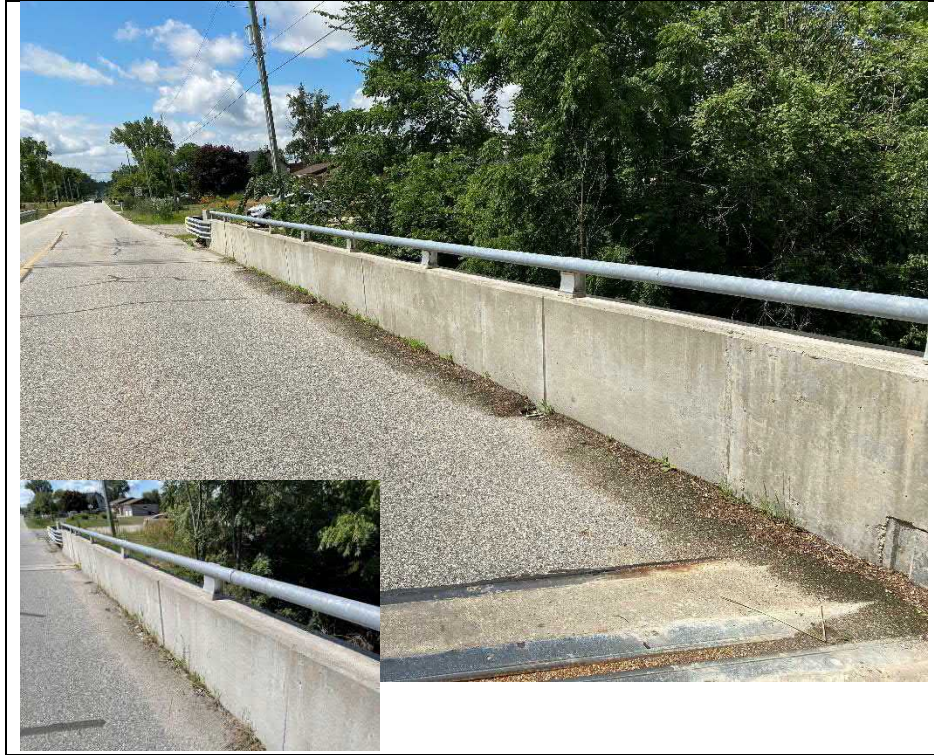
Photograph 9: Typical condition of parapet walls

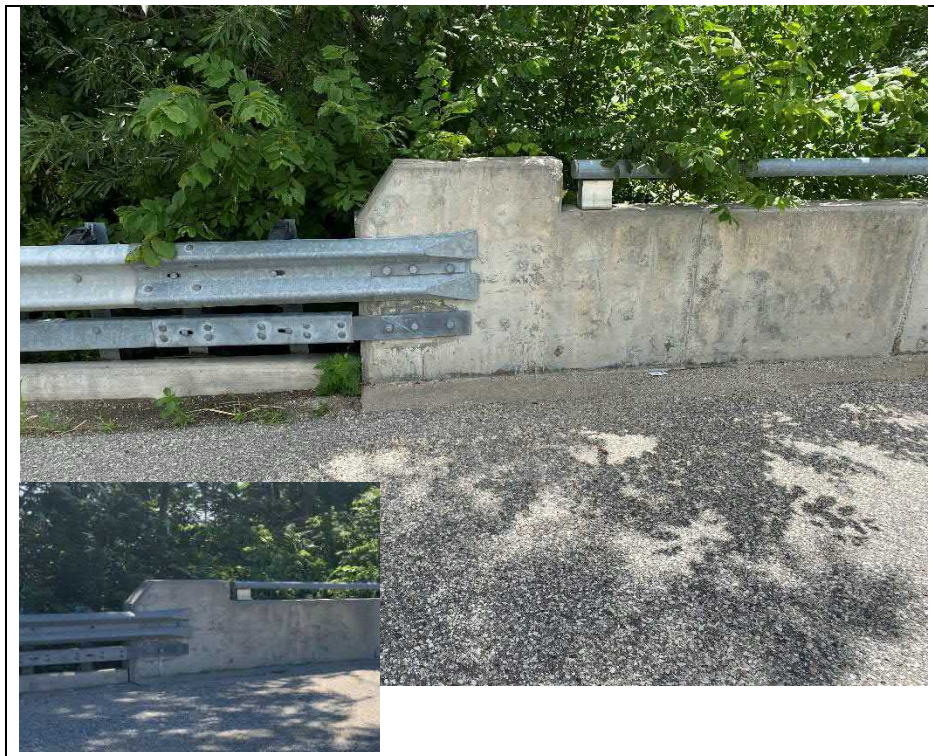
Photograph 10: Typical condition of parapet end walls

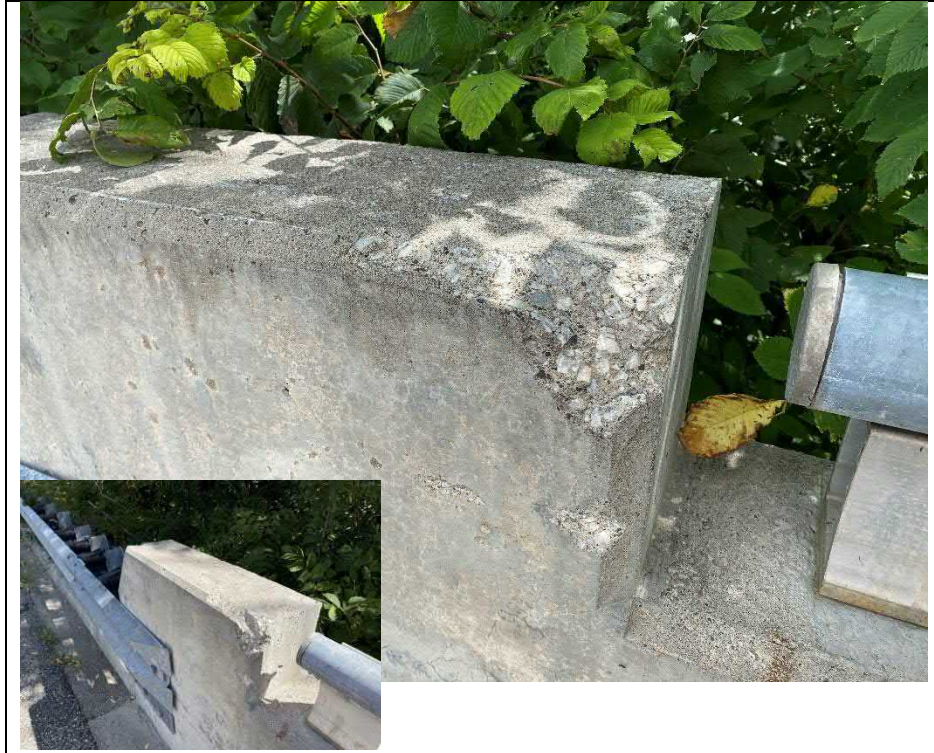
Photograph 11: Light spall on north east end wall

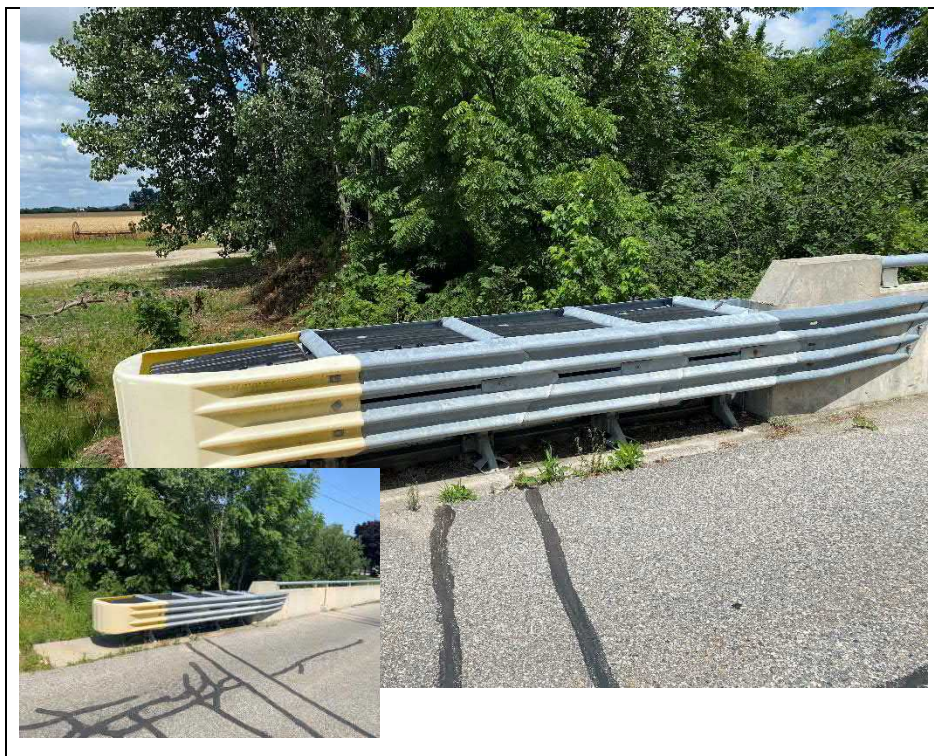
Photograph 12: Typical condition of energy attenuator at the southwest approach (Looking North)

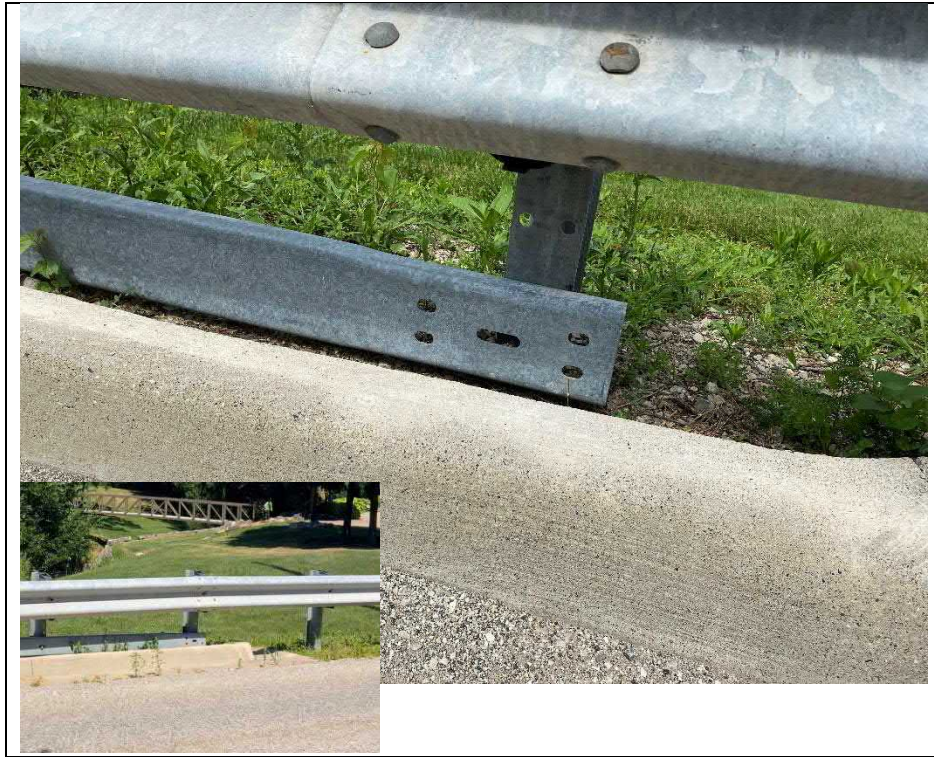
Photograph 13: Missing bolt(s) at bottom of northwest guardrail

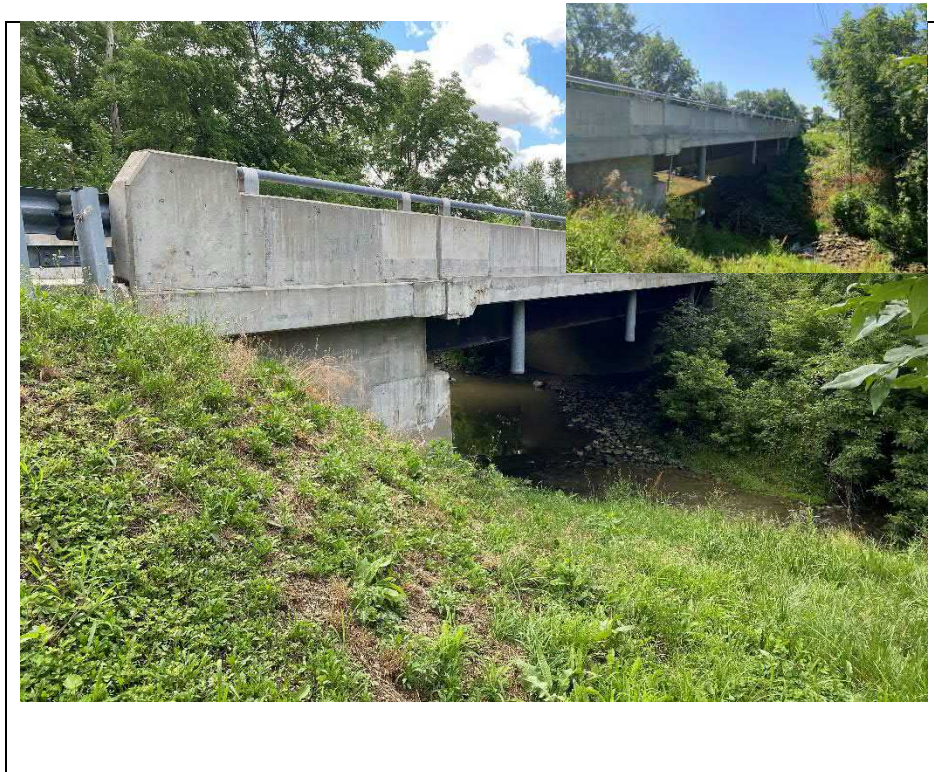
Photograph 14: West elevation

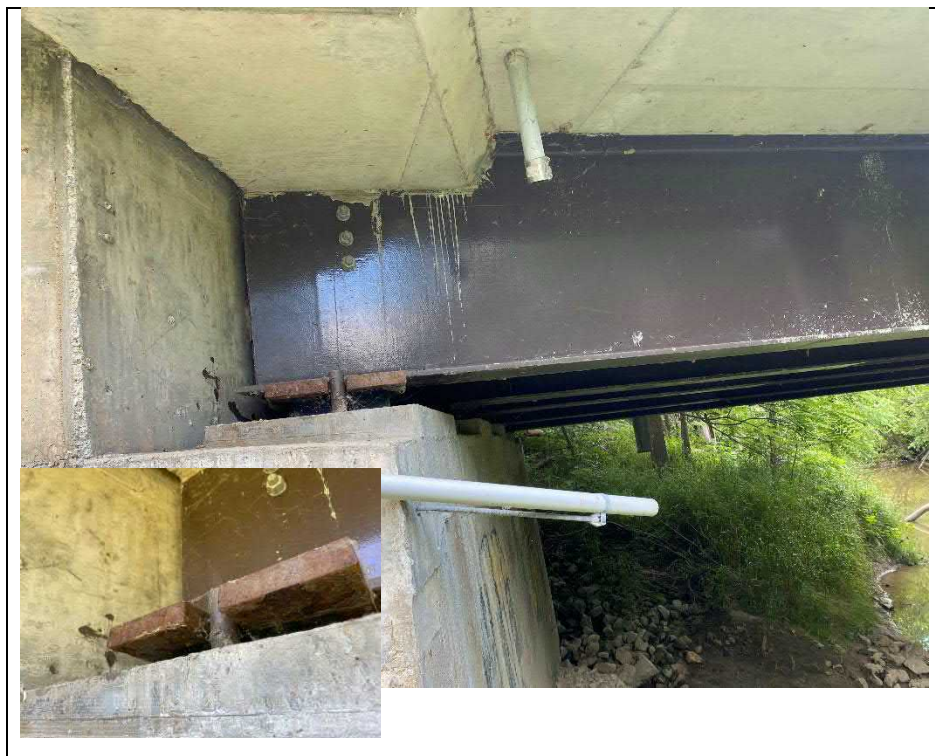
Photograph 18: Shoe plate corrosion at north abutment wall

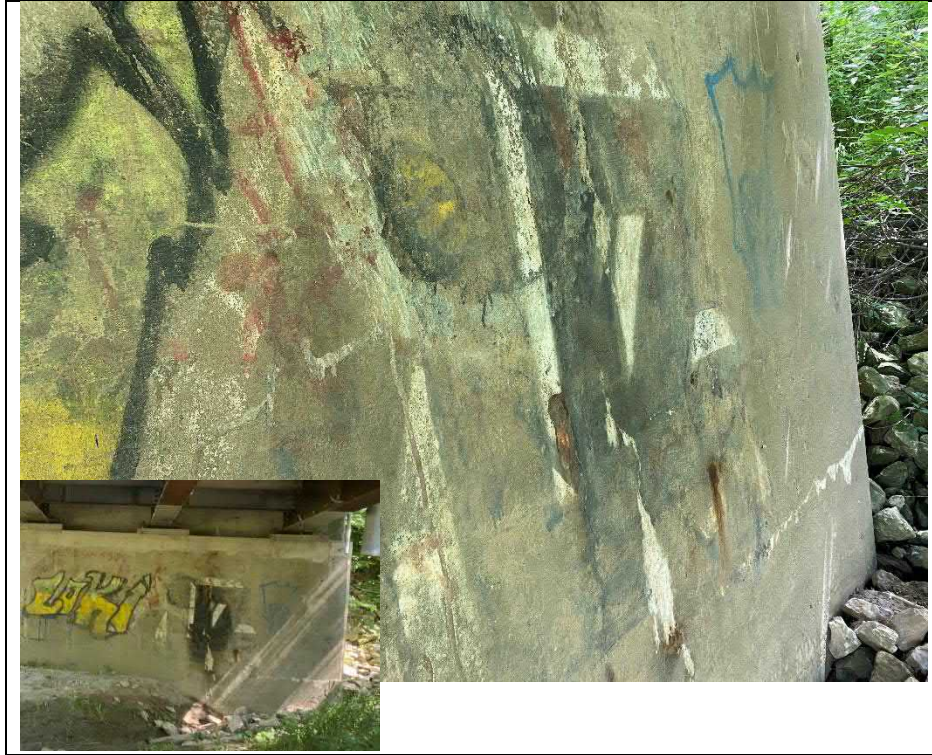
Photograph 19: Medium crack with active wet areas and efflorescence at north abutment wall

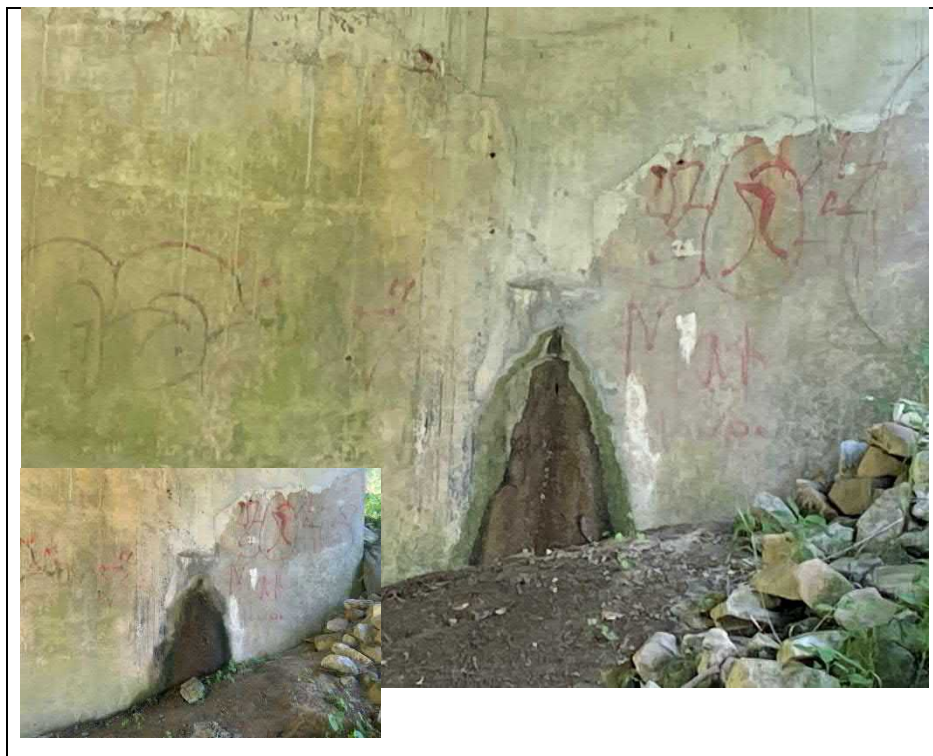
Photograph 20: Medium crack with active wet areas and efflorescence at south abutment wall

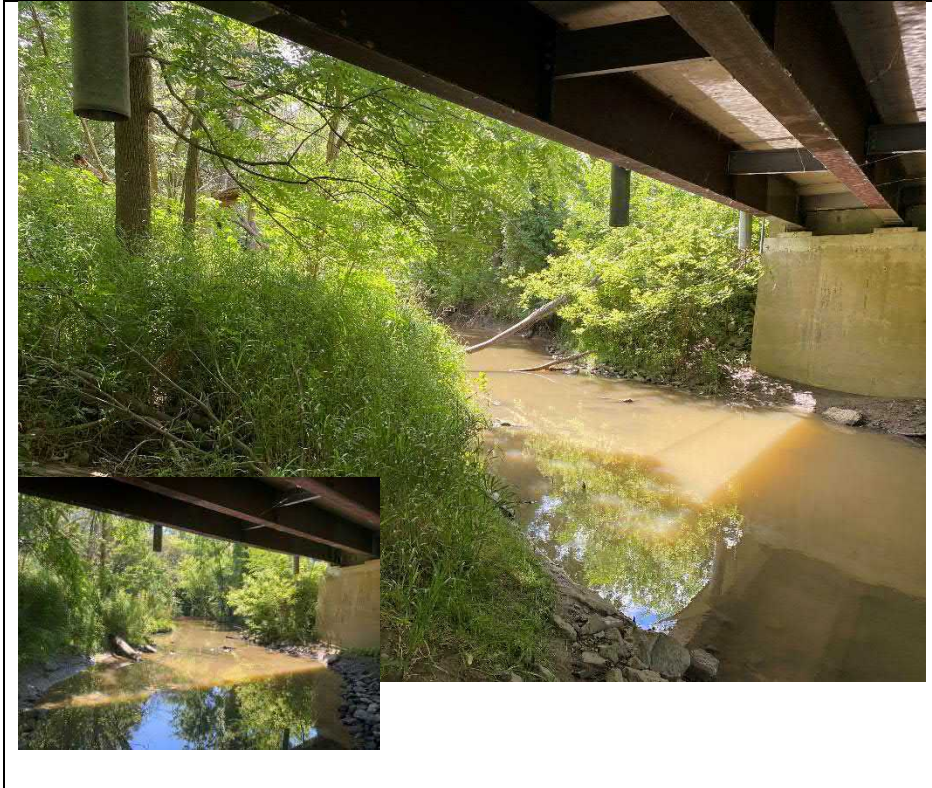
Photograph 21: Embankments and waterway east of structure

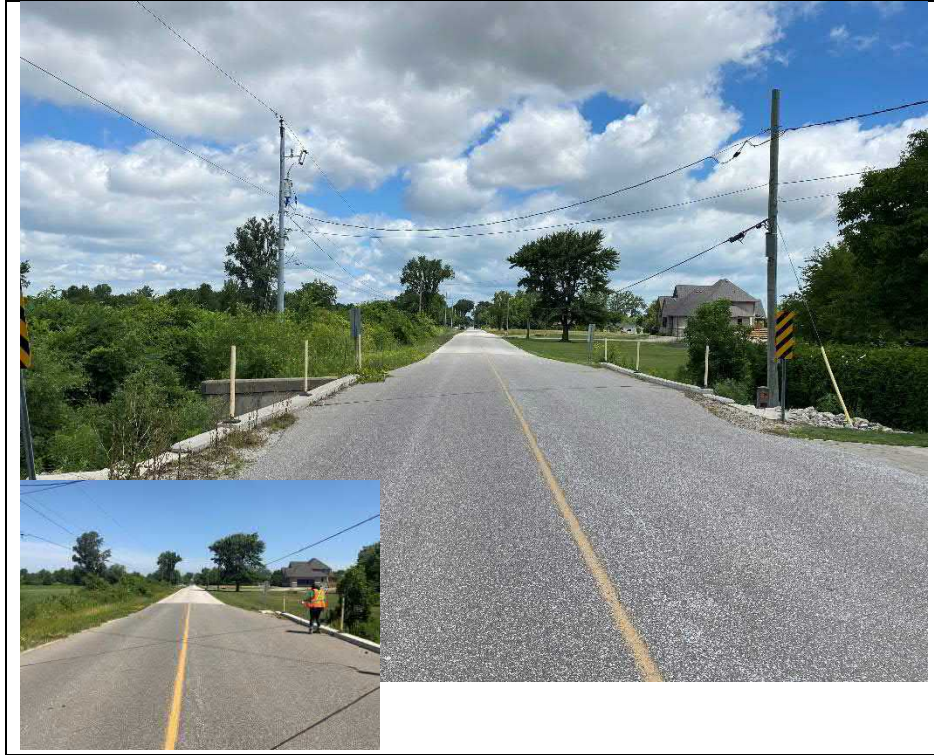
Photograph 1: Overview of structure (Looking North)

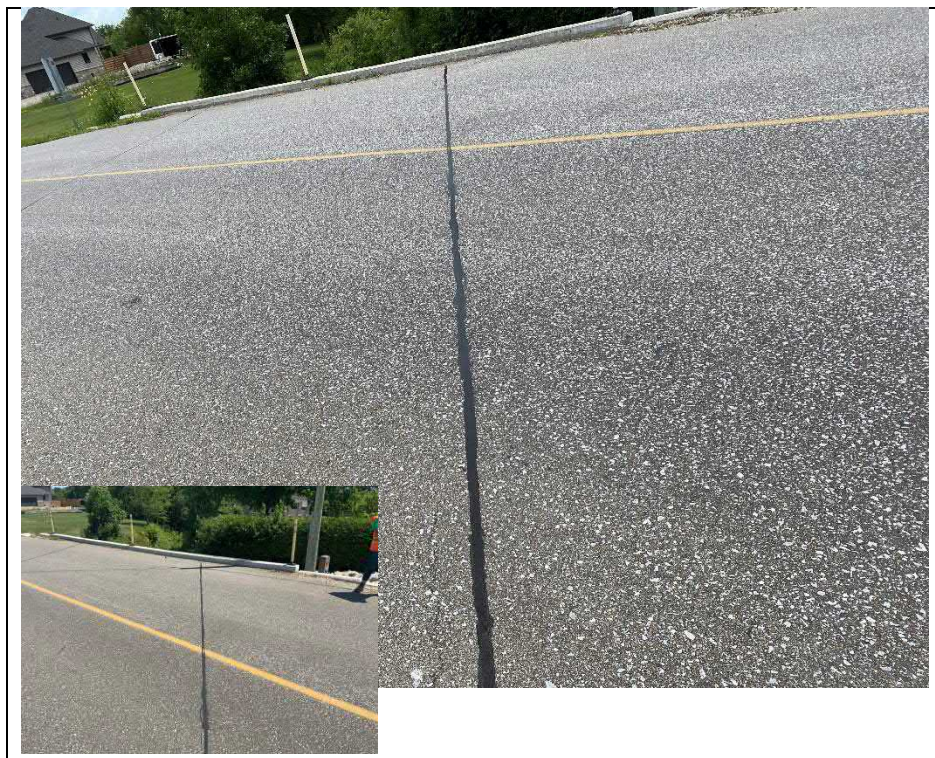
Photograph 2: Wearing surface over the structure (Looking North)

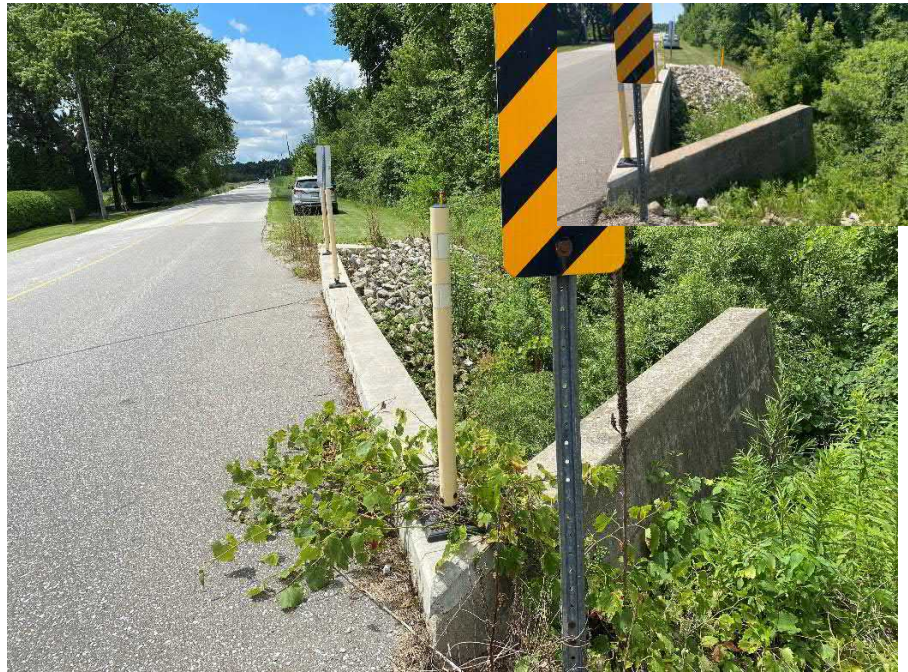
Photograph 3: Object marker and raised curbs on west side (Looking South)

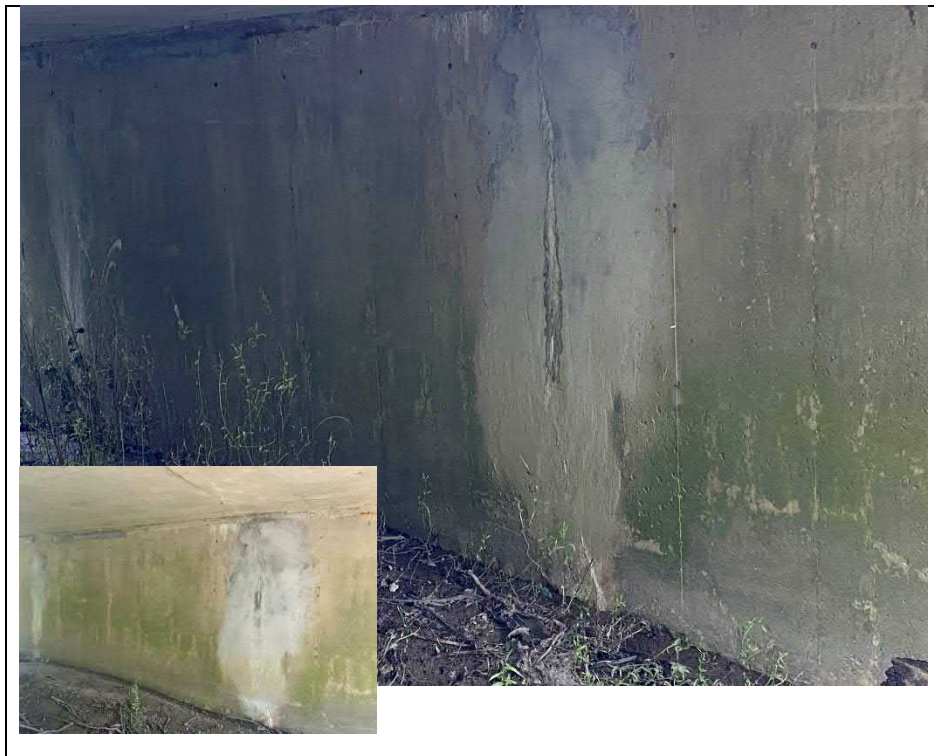
Photograph 8: Crack repairs at north abutment wall

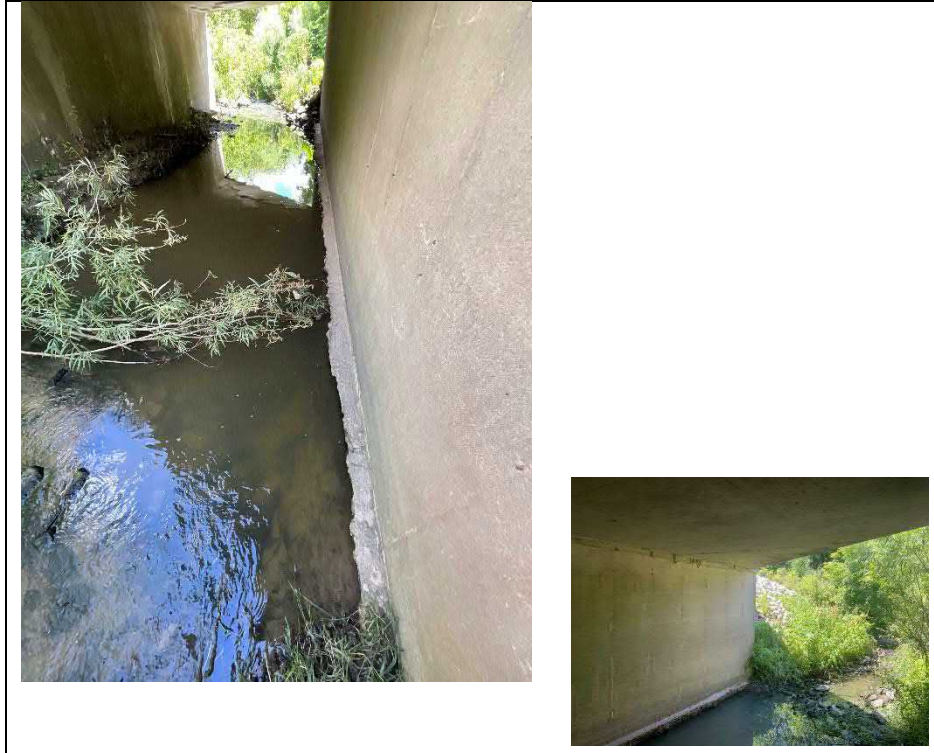
Photograph 9: Scour and concrete erosion at south abutment footings (typ.)

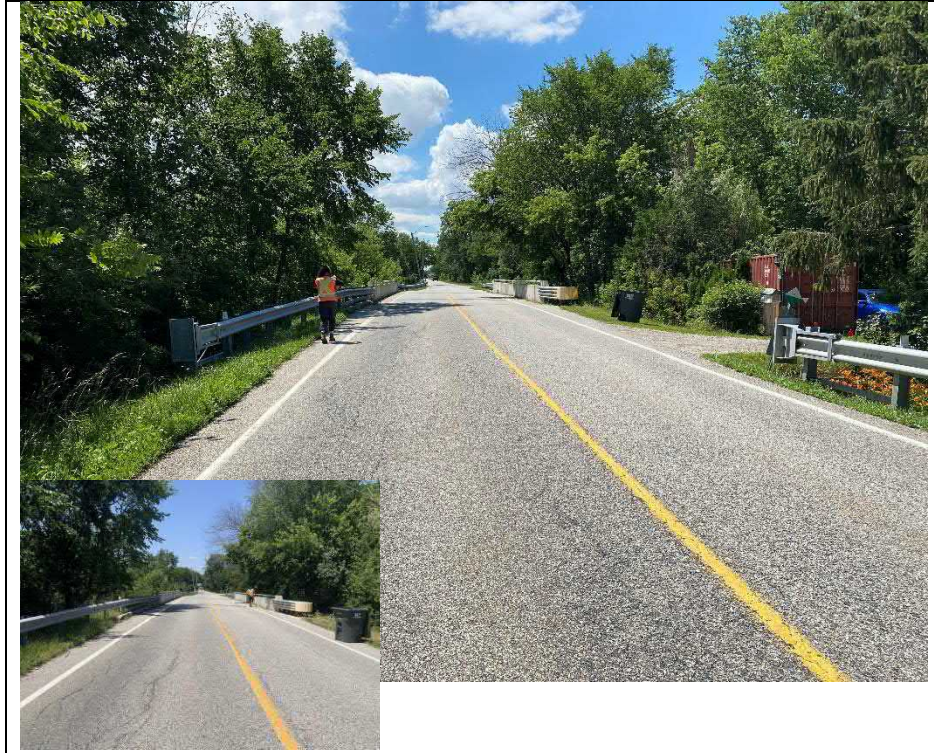
Photograph 1: Overview of structure looking east

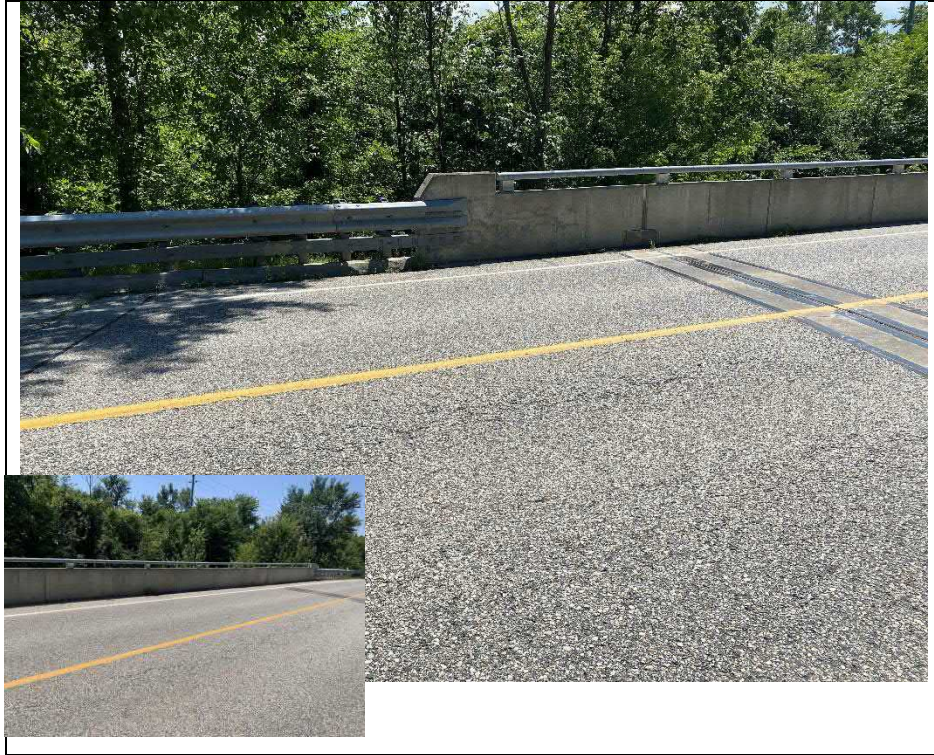
Photograph 3: Typical condition of wearing surface

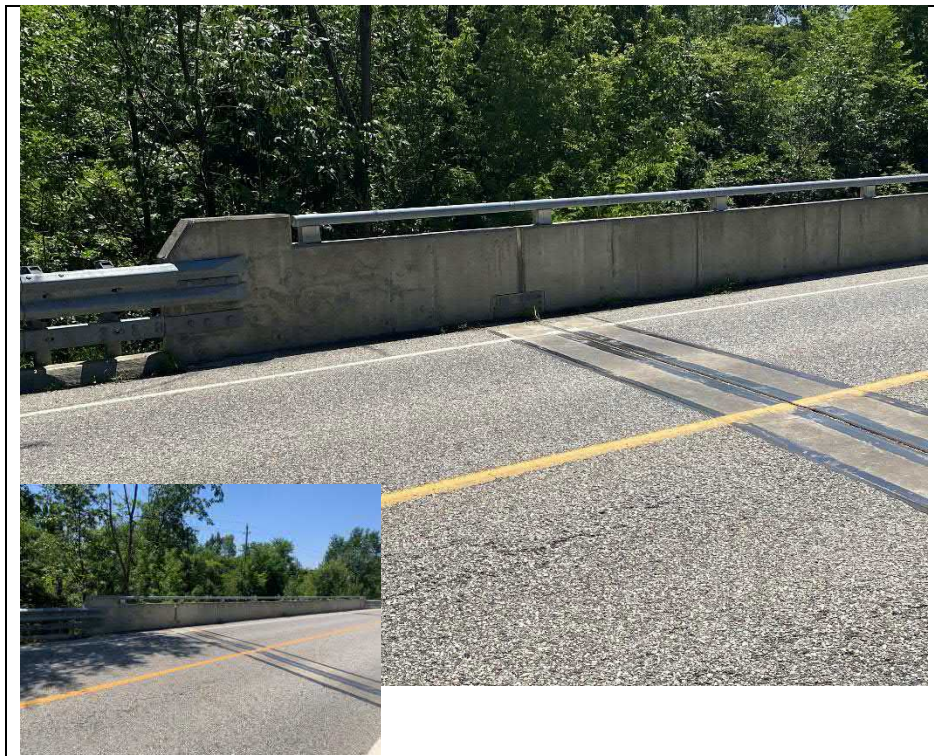
Photograph 4: Typical condition of parapet wall (Looking West)
