CORPORATION OF THE TOWN OF TECUMSEH

2024 Bridge and Culvert Needs Study Structures with Spans > 3.0 m

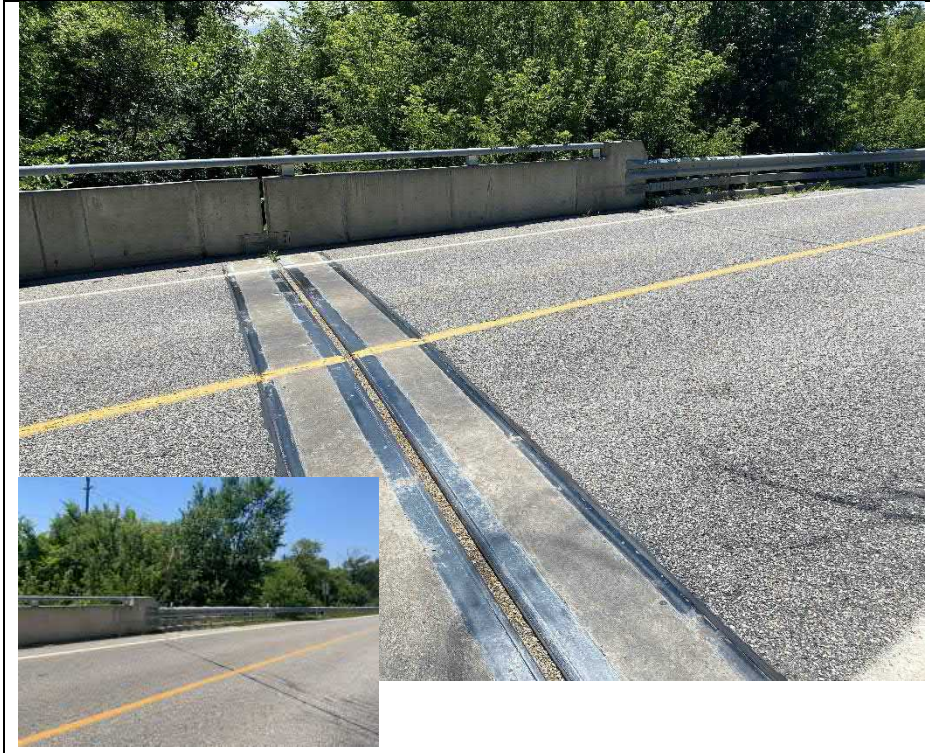
Photograph 5: Expansion joint and railing system at northeast quadrant of structure

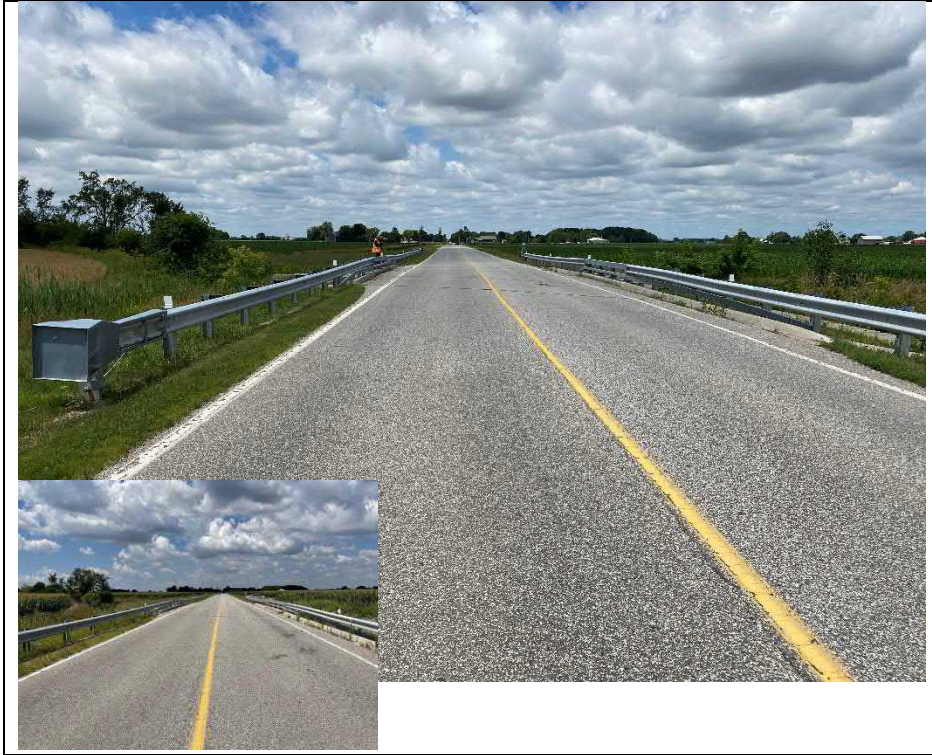
Photograph 1: East approach

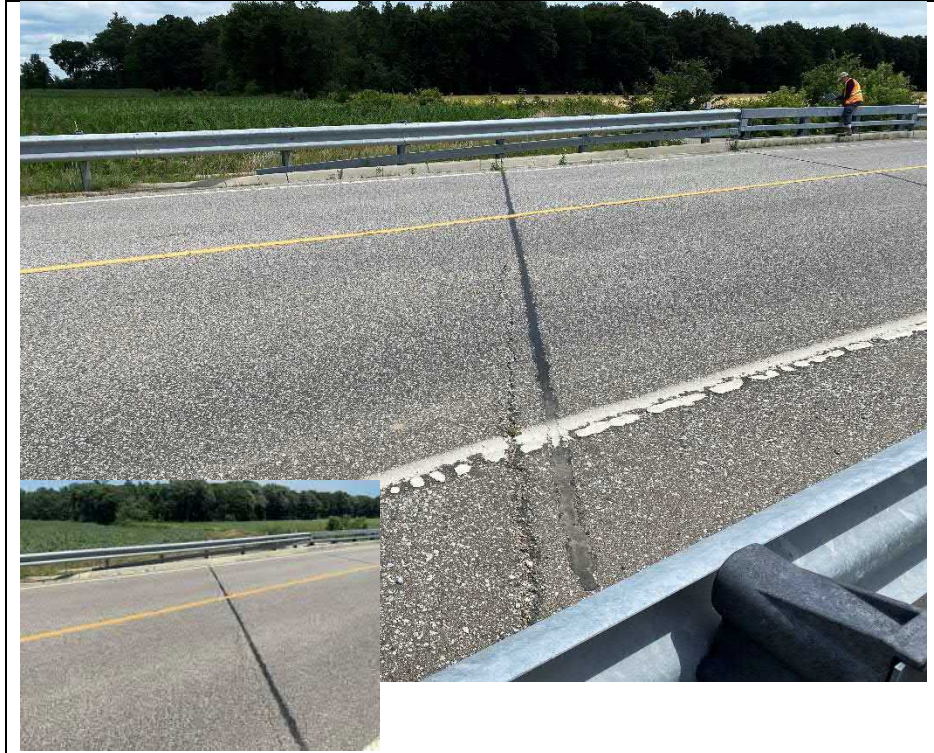
Photograph 3: Typical condition of wearing surface at approaches (Looking East)

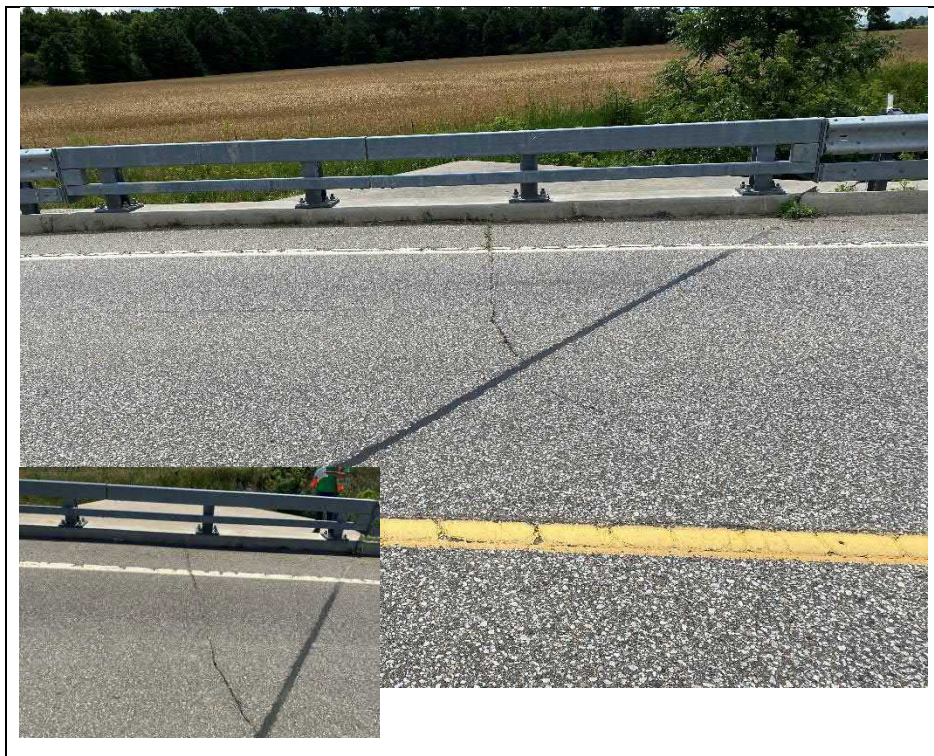
Photograph 4: Typical condition of barrier and wearing surface over the structure with medium transverse crack (Looking South)

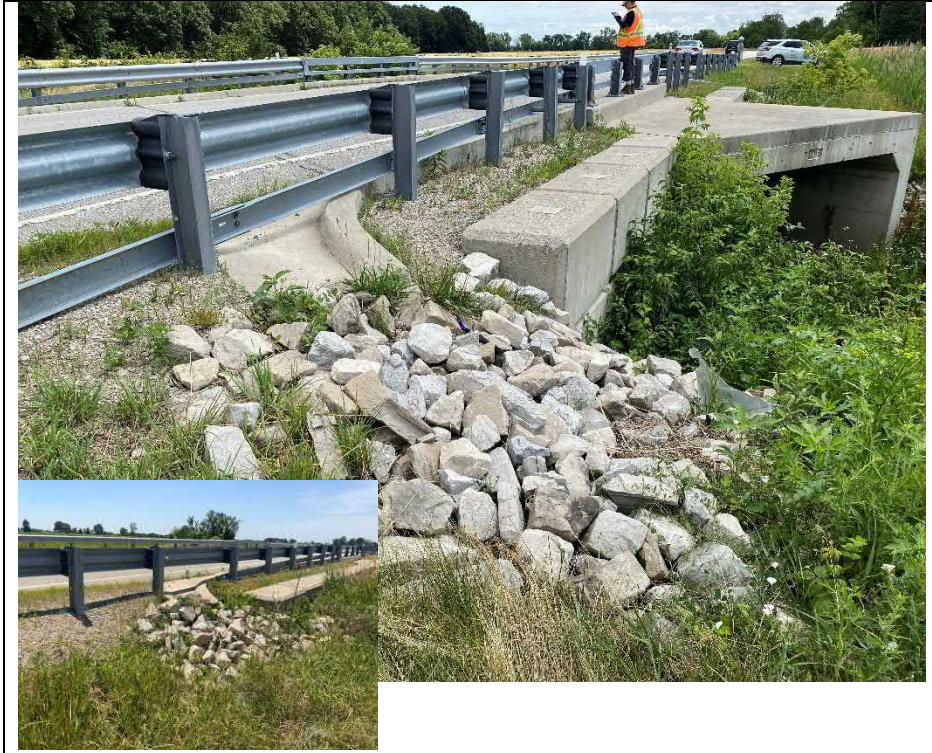
Photograph 5: Spillway at southwest quadrant of structure

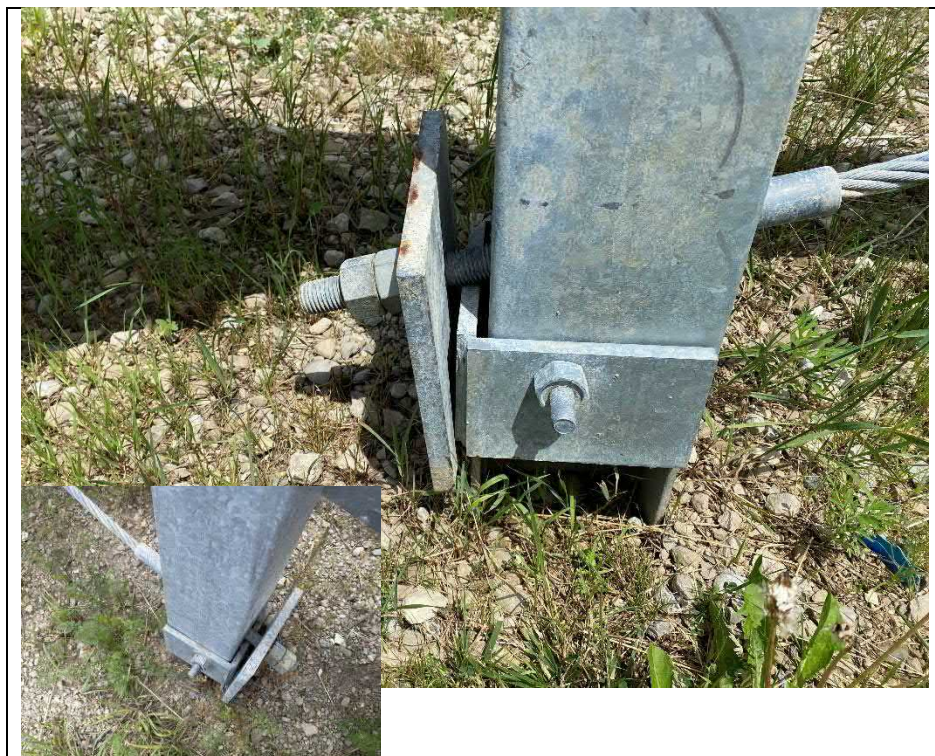
Photograph 6: Guiderrail cable anchorage observed to be loose at all 4 quadrants

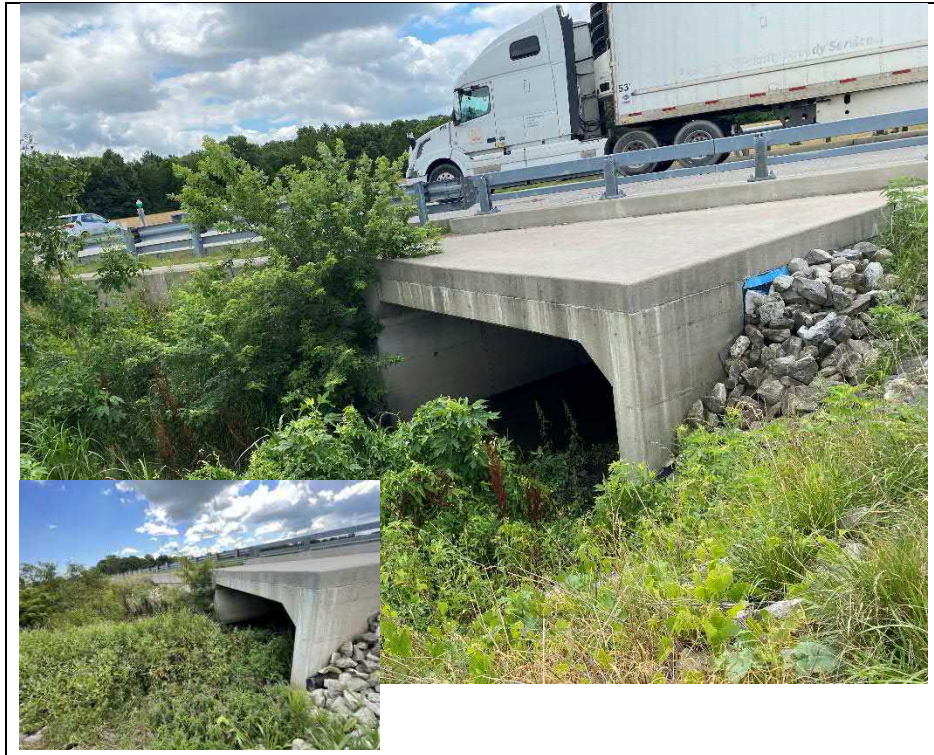
Photograph 7: North elevation

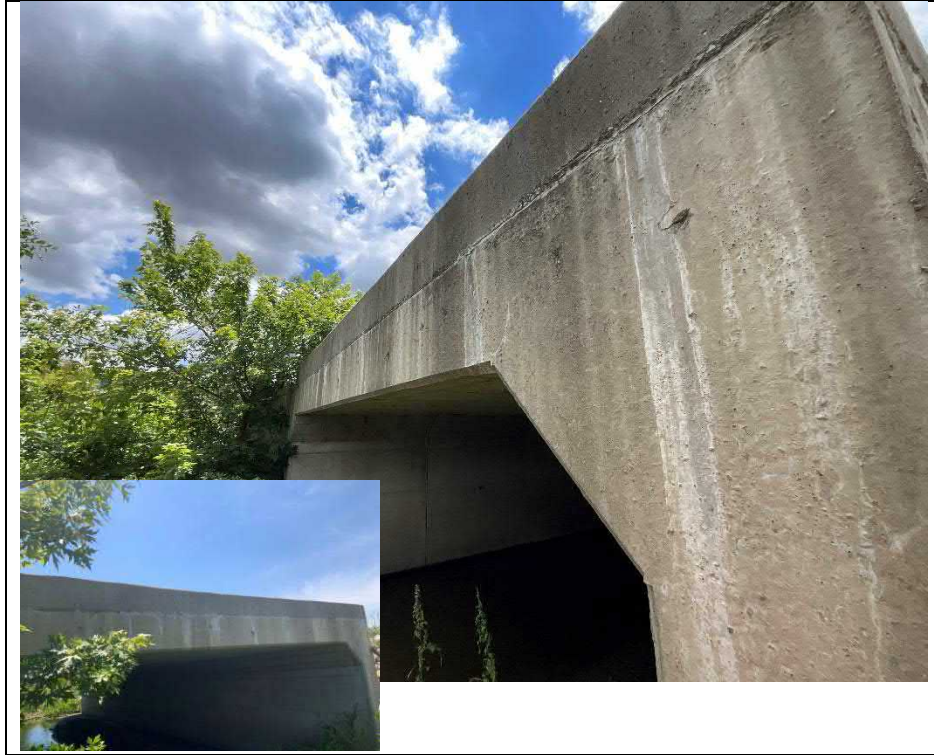
Photograph 9: Discrete locations of light spalling at the south headwall

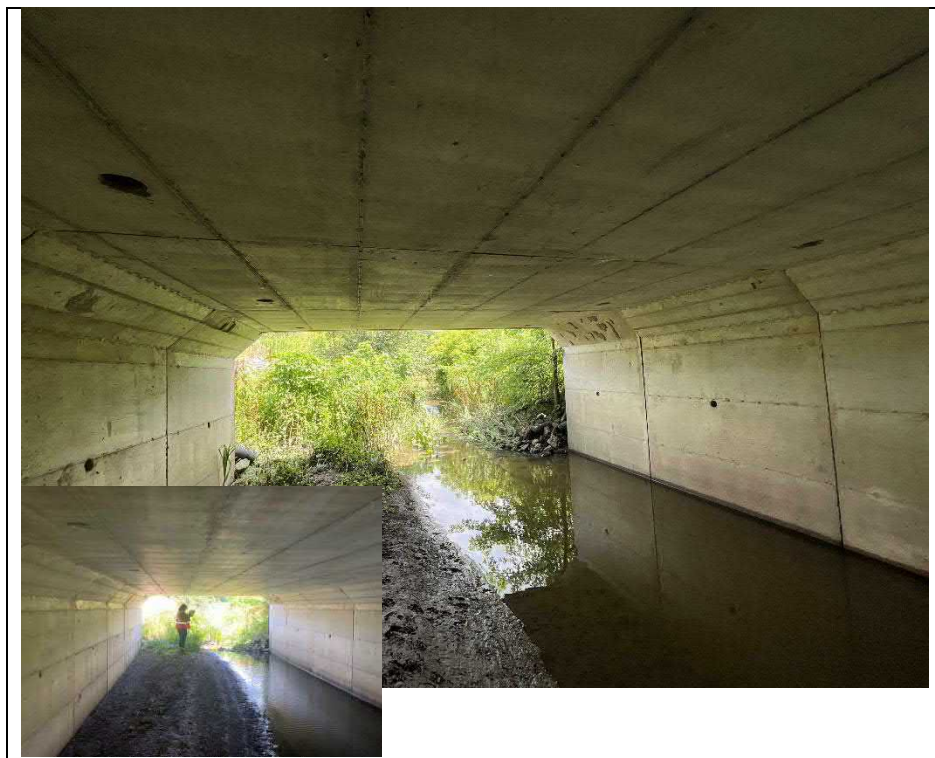
Photograph 10: Typical condition of culvert barrel (Looking North)

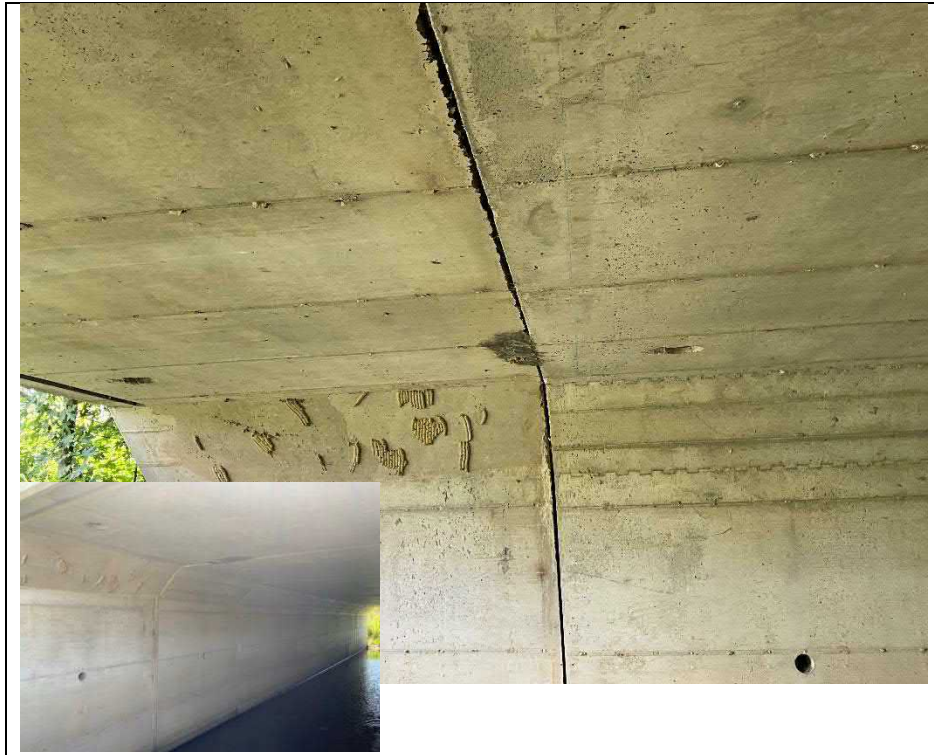
Photograph 11: Existing concrete parging at precast unit joint

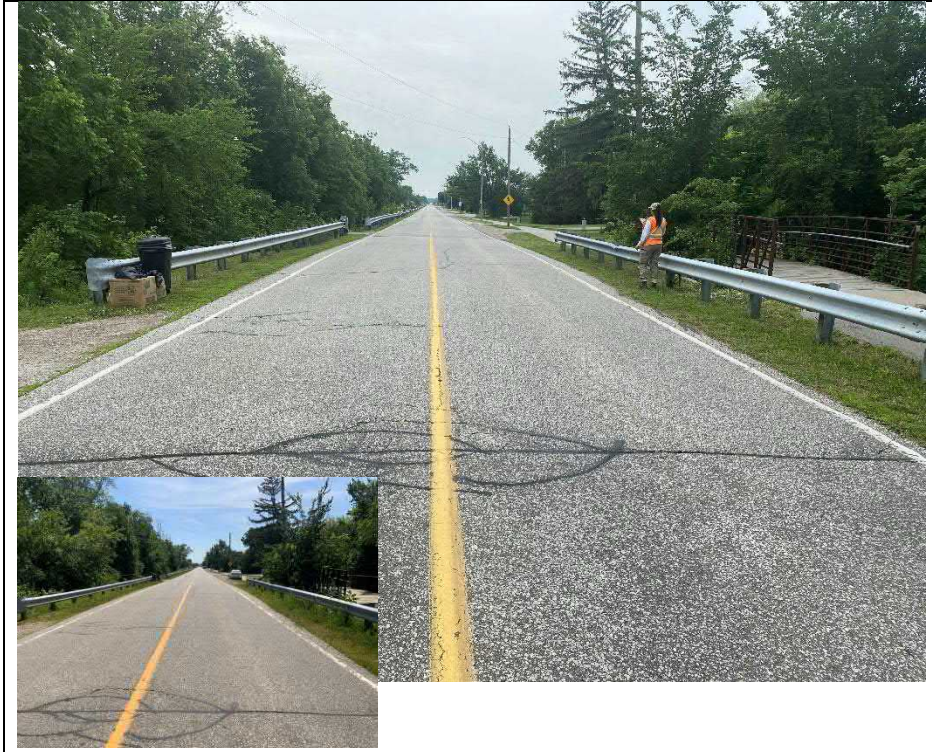
Photograph 1: North approach (Looking south)

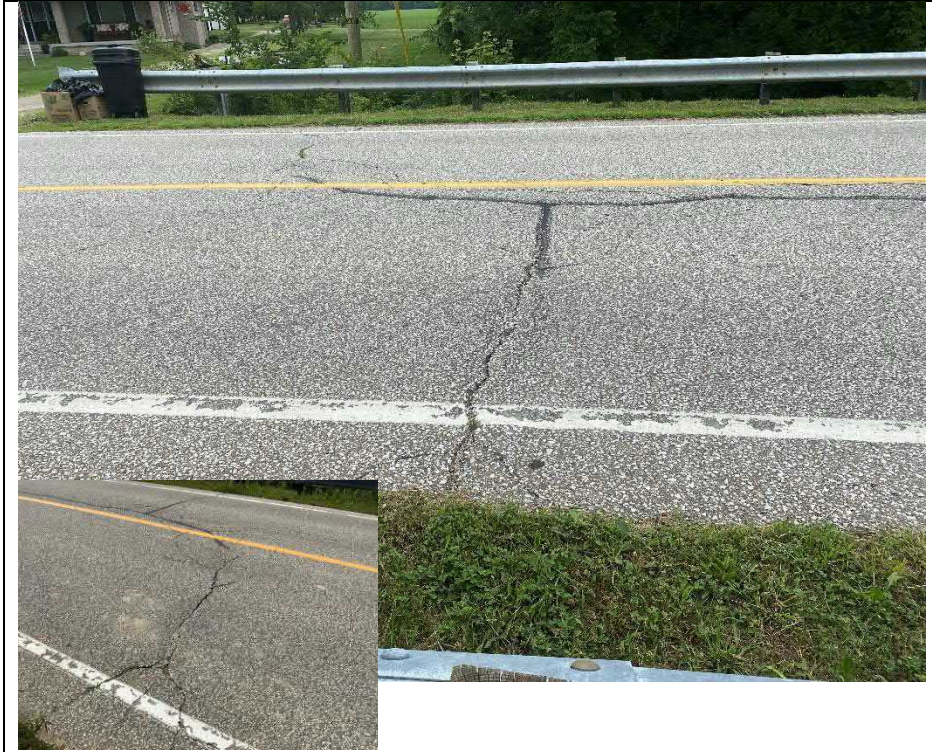
Photograph 3: Wearing surface over the structure with transverse crack (Looking West)

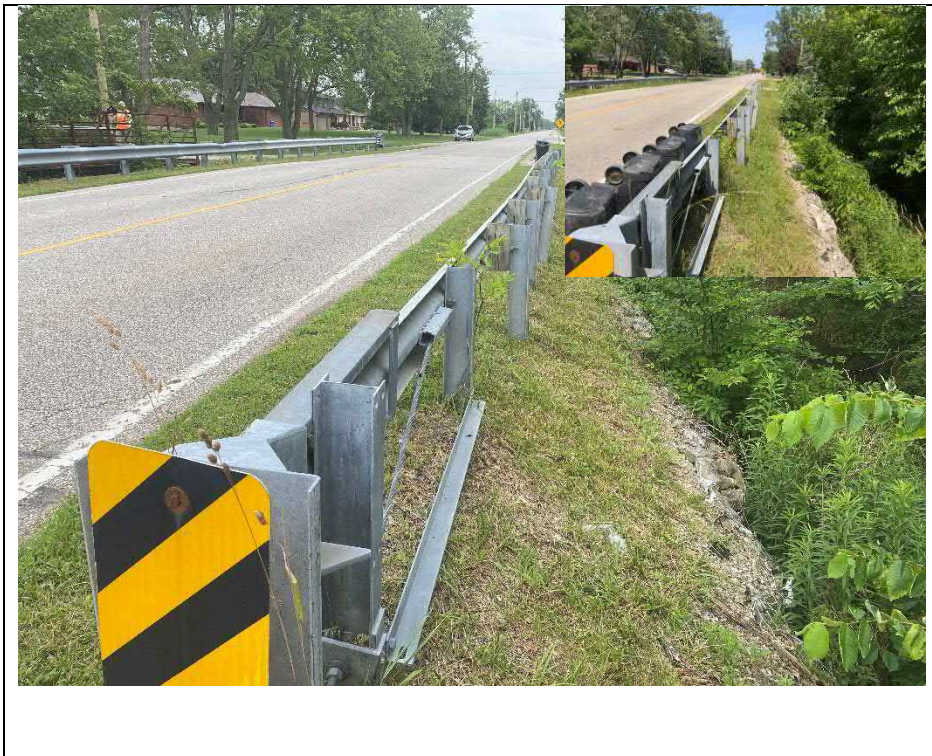
Photograph 4: Guide rail end treatment at the southeast quadrant of structure

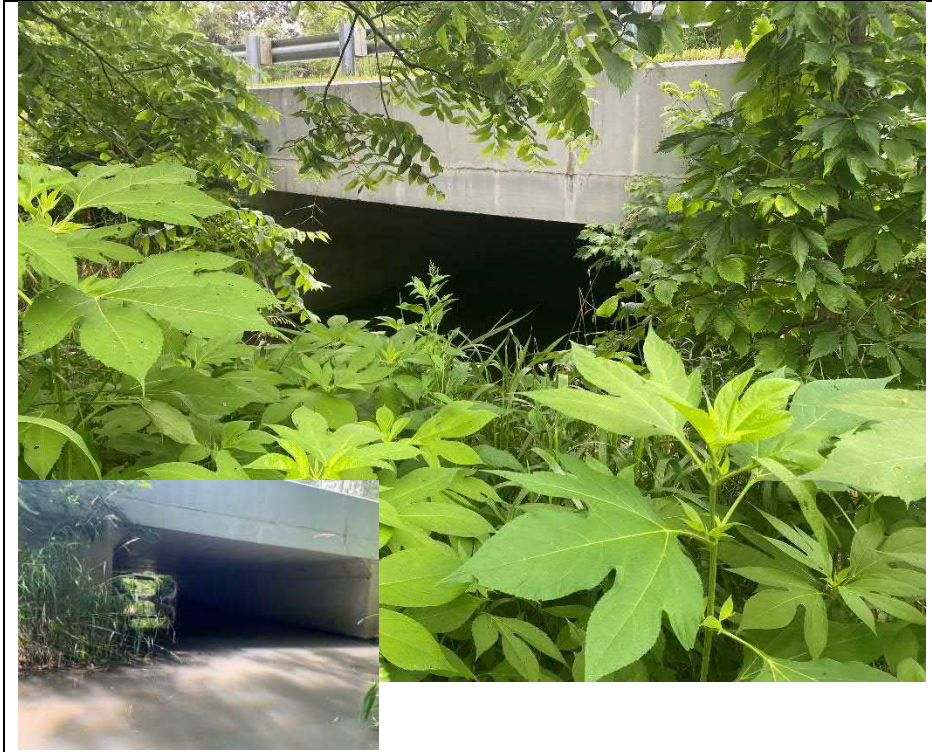
Photograph 7: East elevation with typical cracking with efflorescence at the headwalls

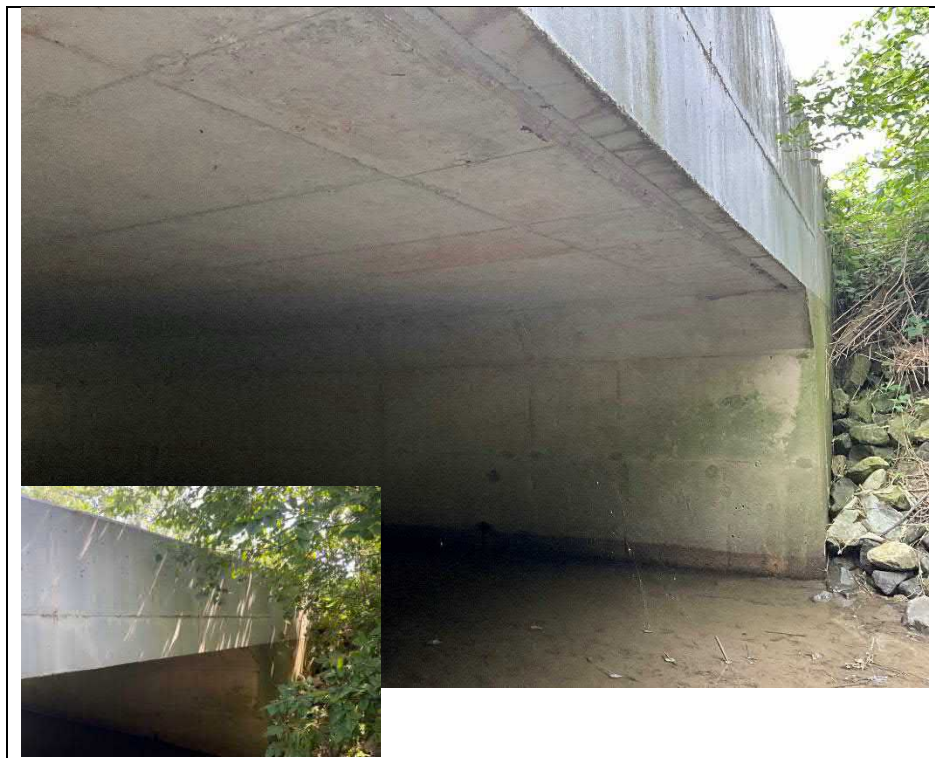
Photograph 8: West elevation with typical cracking at headwalls with efflorescence

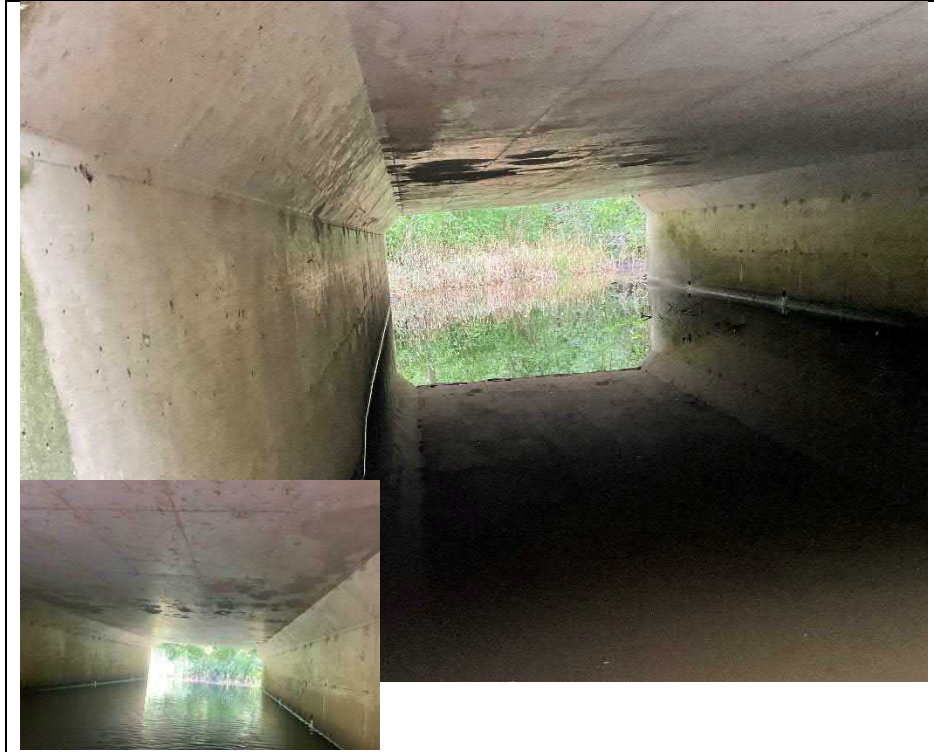
Photograph 9: Culvert barrel (Looking West)

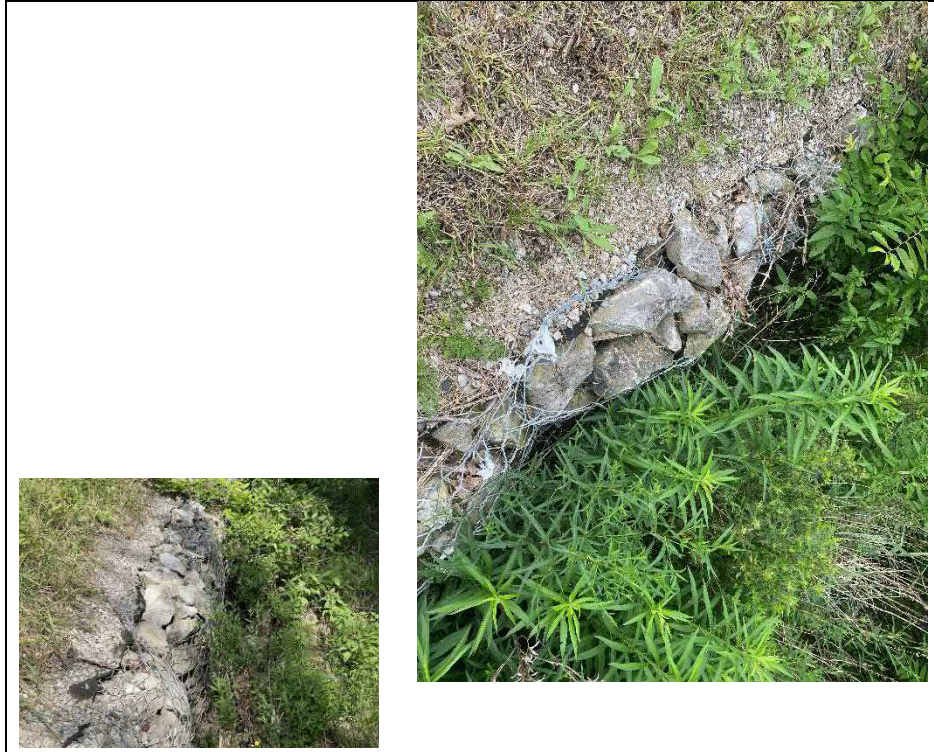
Photograph 13: Ruptured gabion basket at west embankment

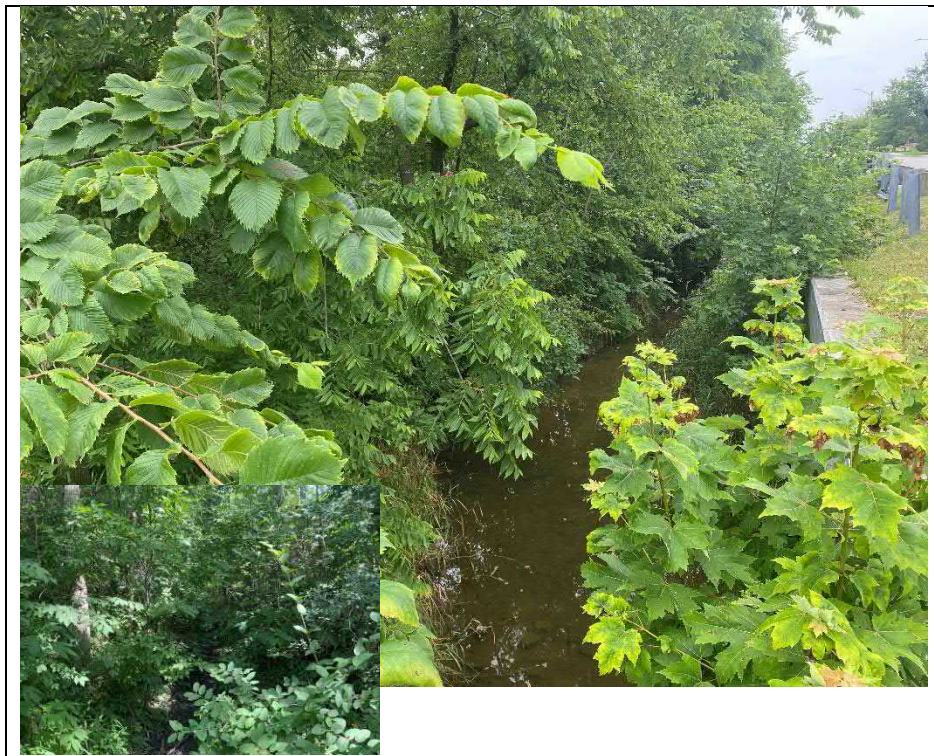
Photograph 14: Waterway at the east inlet (Looking East)

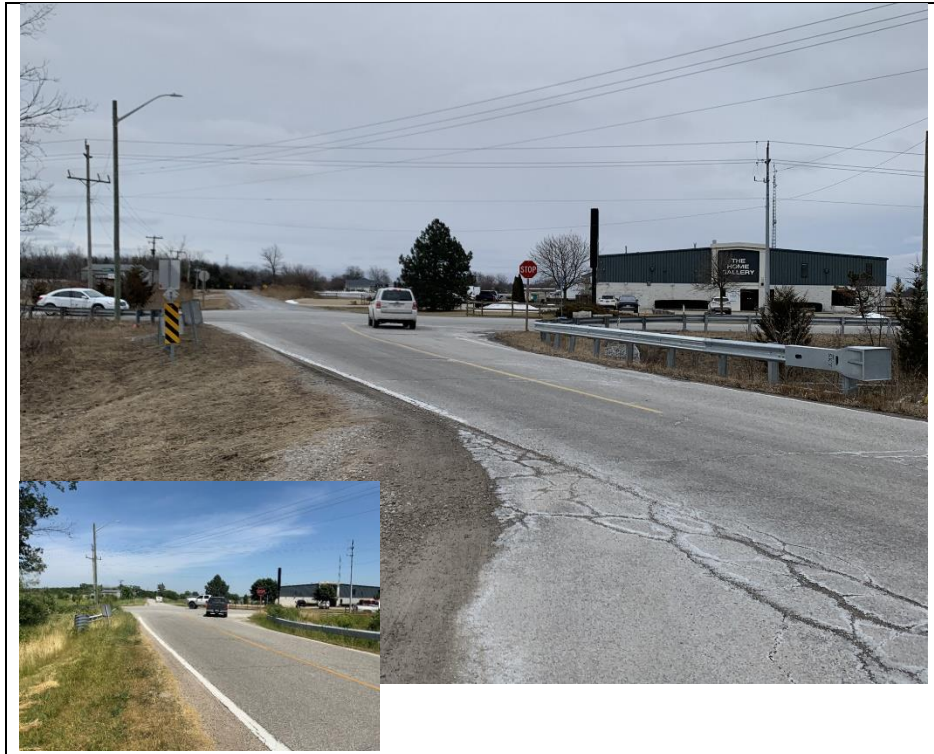
Photograph 1: West Approach (Looking East)

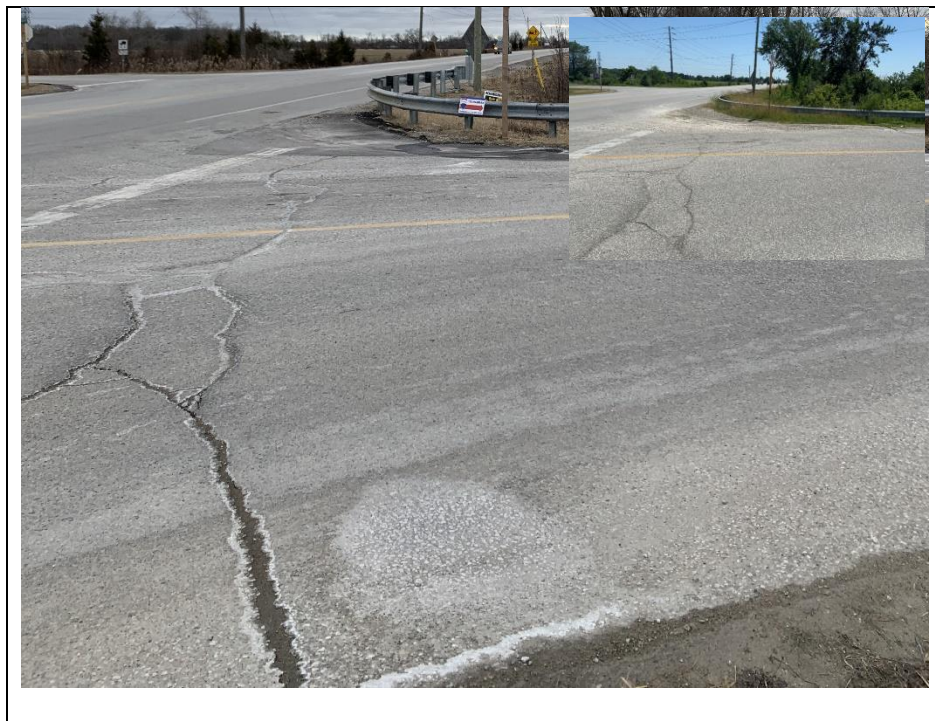
Photograph 2: Wide crack at joint between wearing surface over the culvert and the east approach

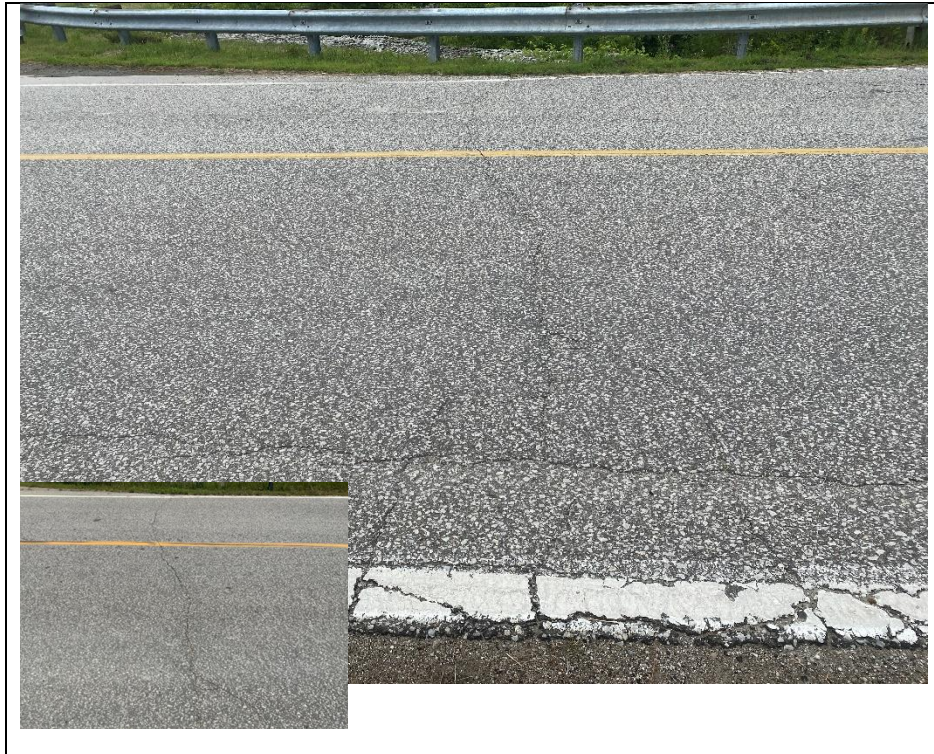
Photograph 3: Wide transverse cracking (Looking North)

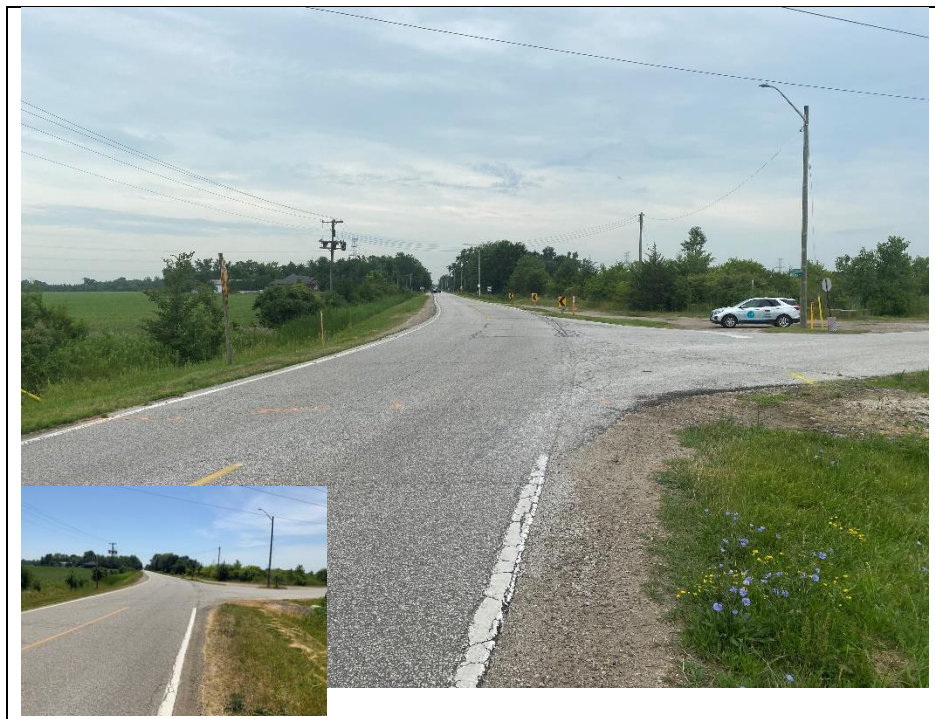
Photograph 4: Wearing surface at west approach

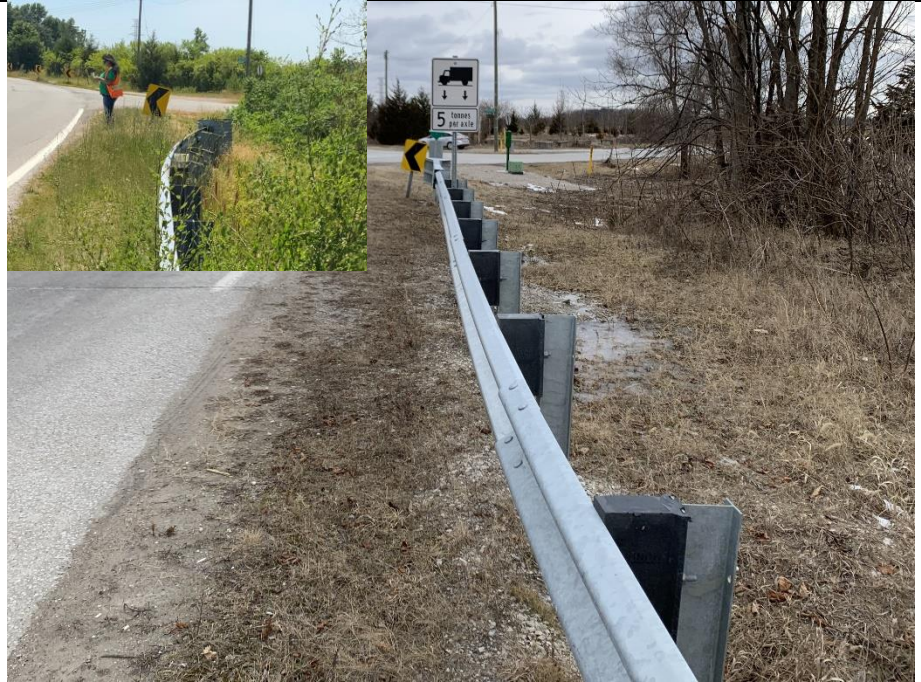
Photograph 5: Load limit sign and new guide rail section at the northwest end

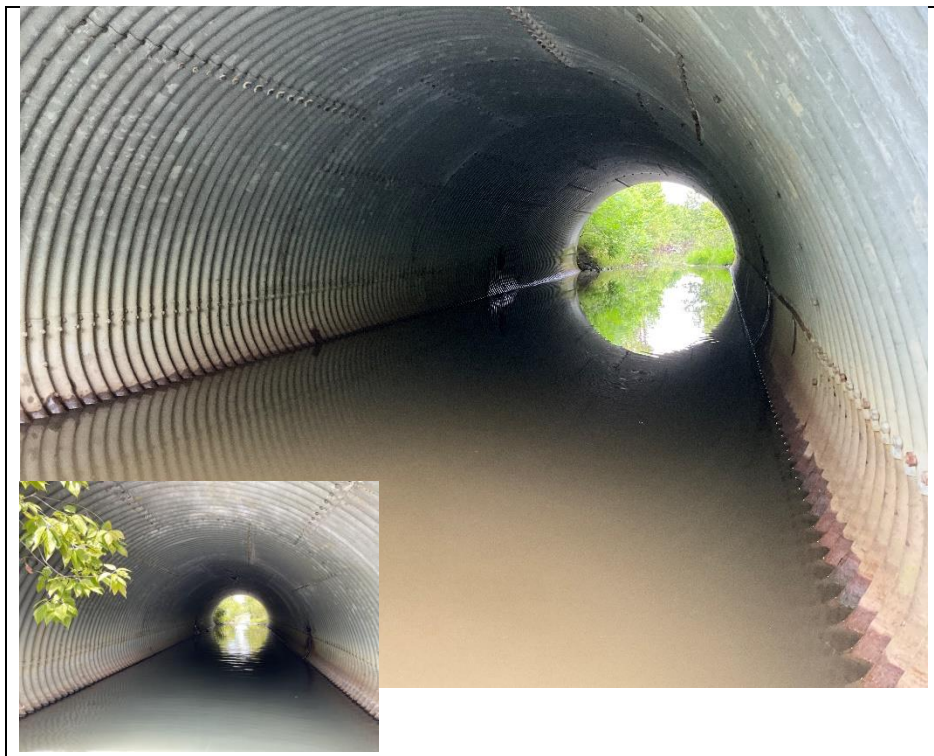
Photograph 10: Typical condition of culvert barrel

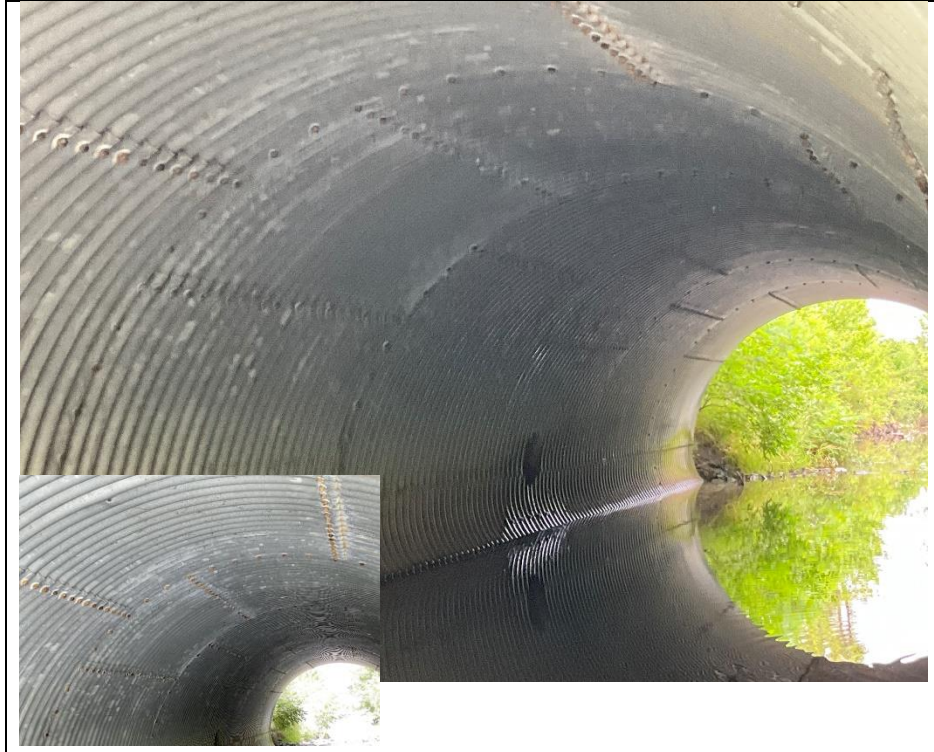
Photograph 11: Typical condition of culvert barrel soffit

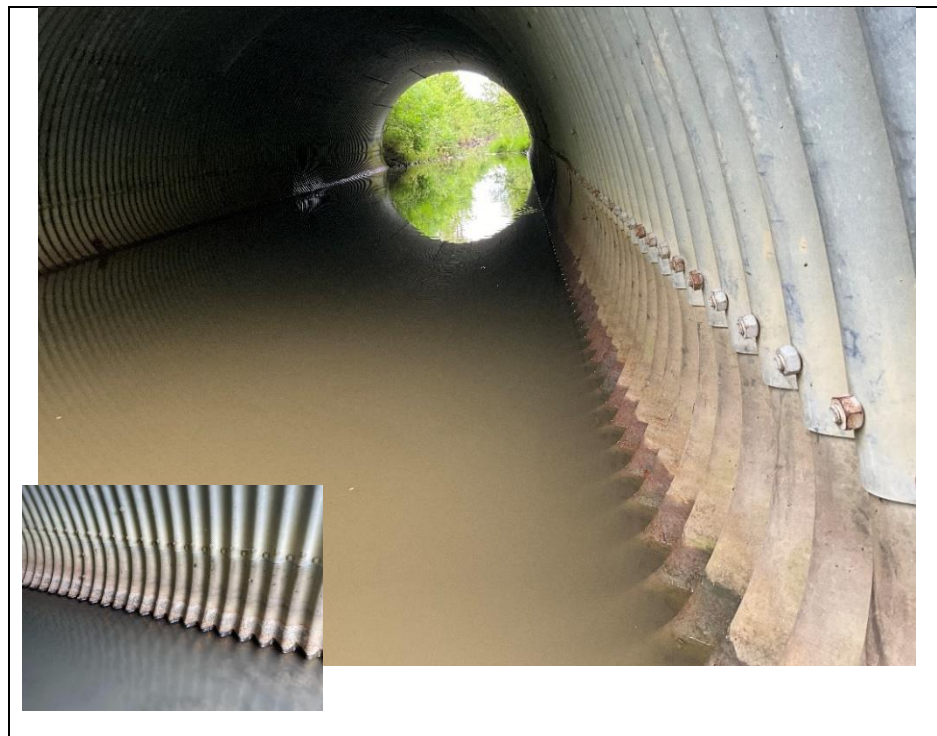
Photograph 12: Typical loss of coating and light to medium corrosion along the water line

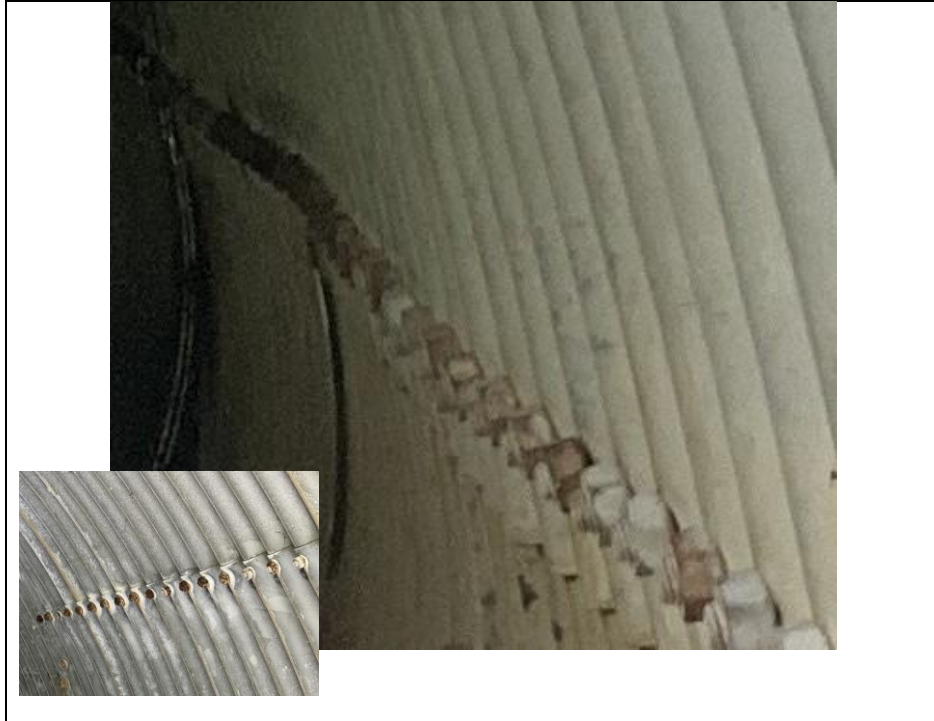
Photograph 13: Typical light to medium corrosion on bolts heads

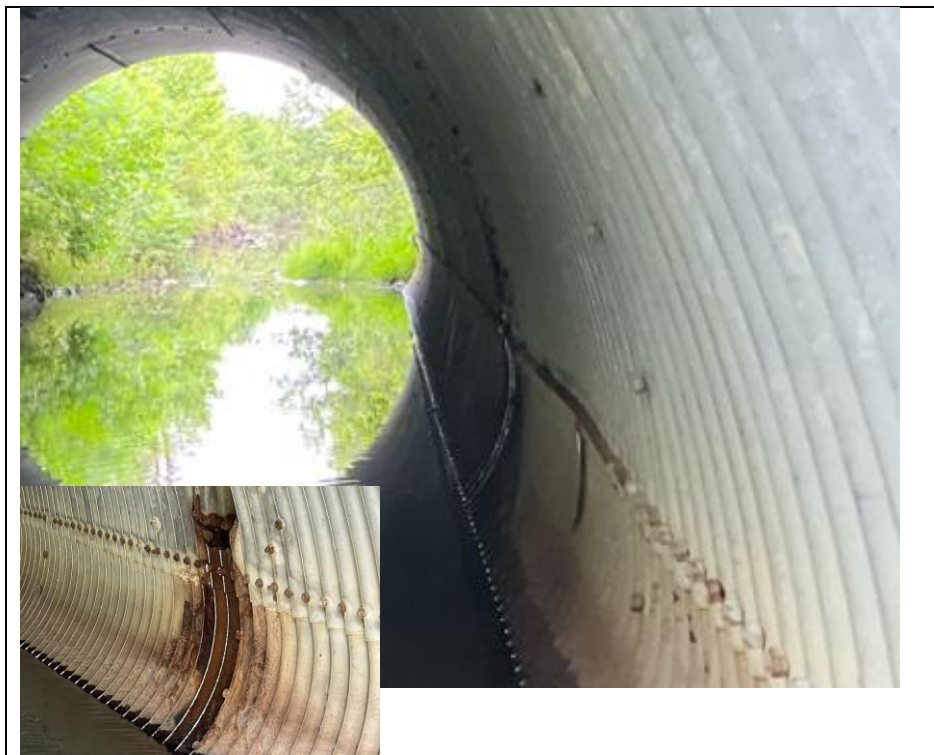
Photograph 14: Severe corrosion below inlet pipe at west wall

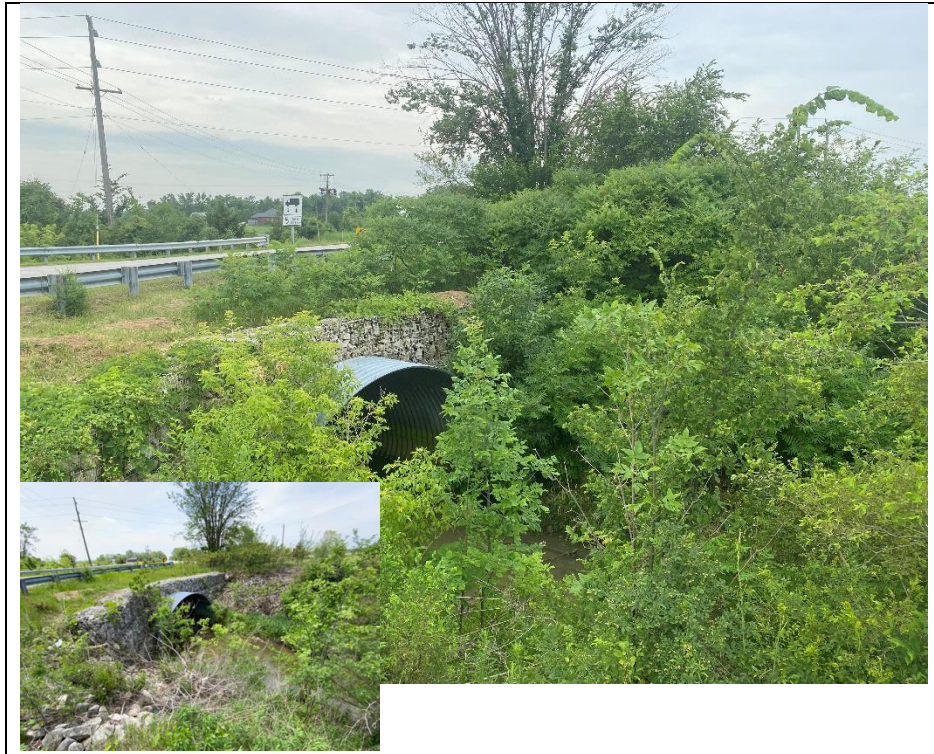
Photograph 15: North embankments with gabion basket retaining walls at north (Looking South)

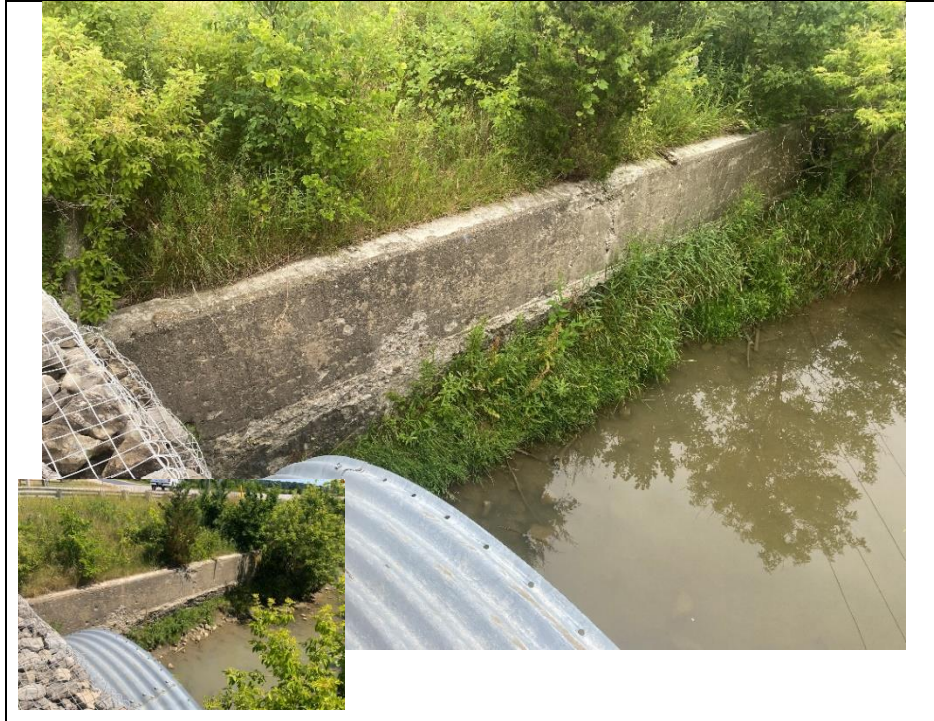
Photograph 17: Deterioration along the retaining wall at the southeast embankment consisted of medium spalling, severe scaling, pop outs and severe honeycombing along the bottom of the wall

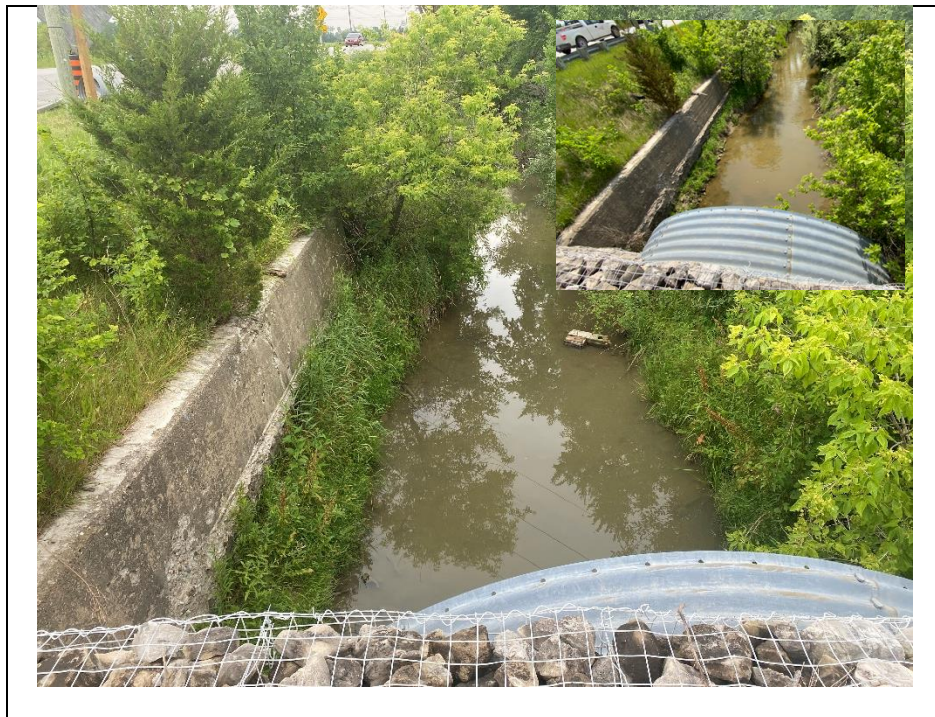
Photograph 18: Watercourse (Looking South)

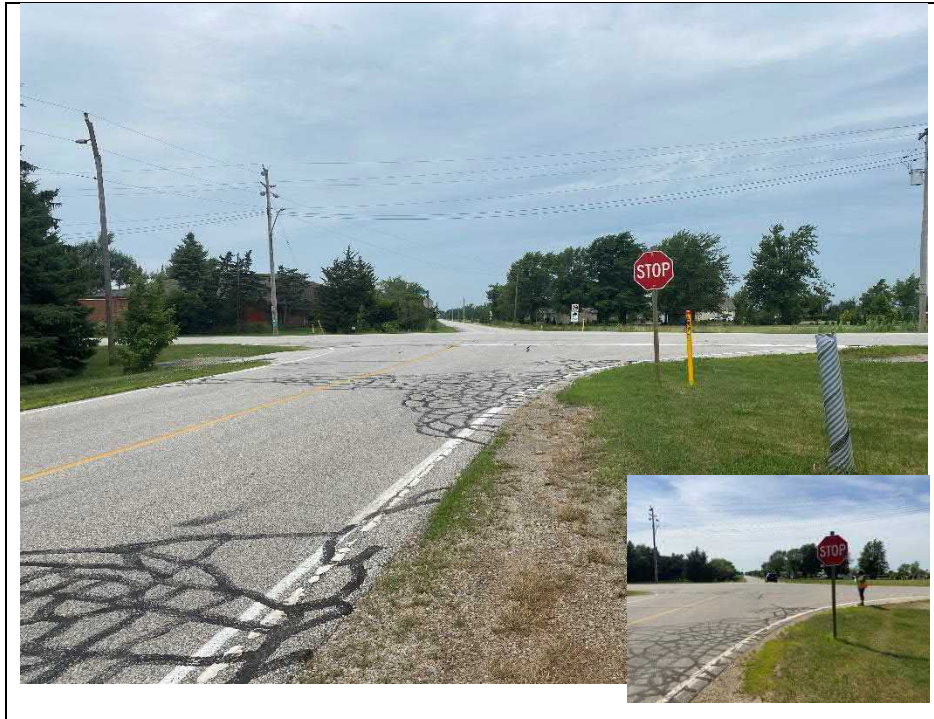
Photograph 1: Wearing surface over structure (Looking West). Cracks have been sealed since the last inspection
