CORPORATION OF THE TOWN OF TECUMSEH

2024 Bridge and Culvert Needs Study Structures with Spans > 3.0 m

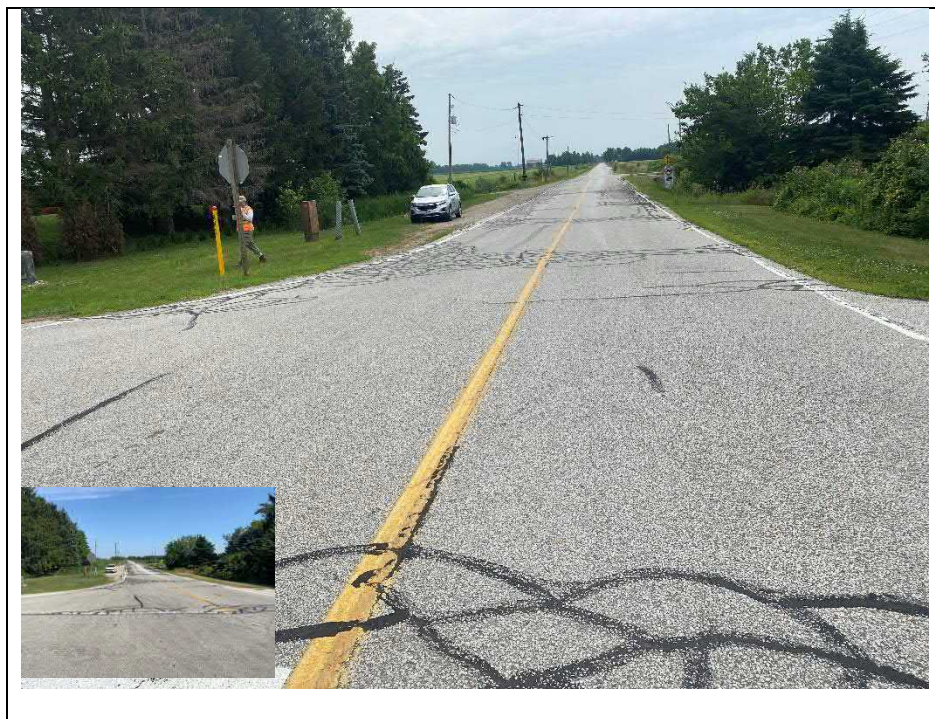
Photograph 2: Wearing surface over structure (Looking East). Cracks have been sealed since the last inspection

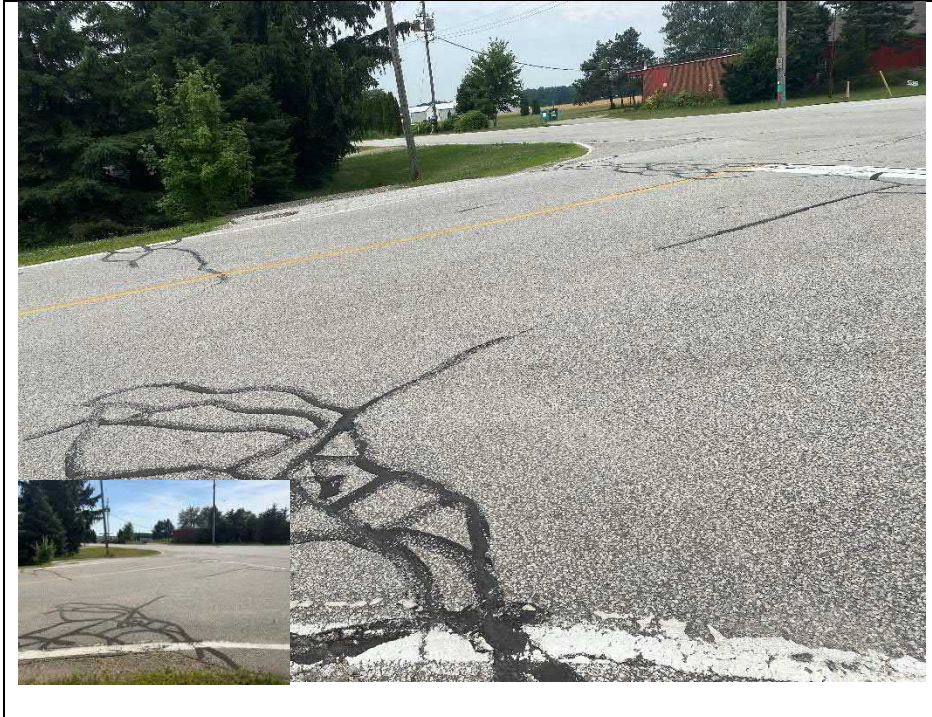
Photograph 3: Sealed map cracking on the Wearing surface at the east approach (Looking South)

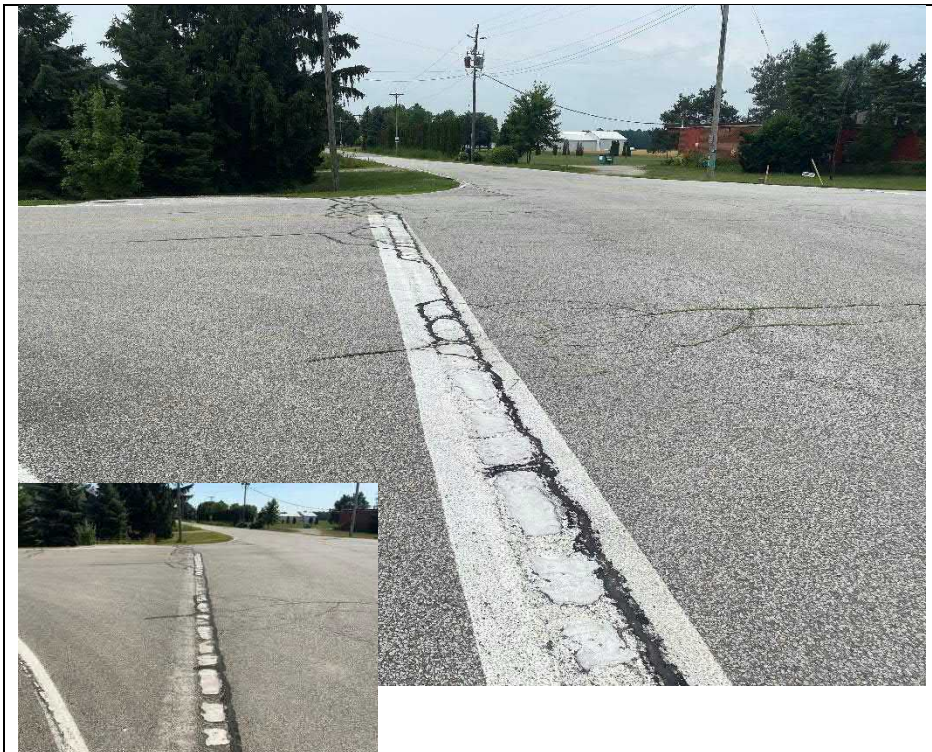
Photograph 4: Sealed wide cracks on the wearing surface at the west approach (Looking South)

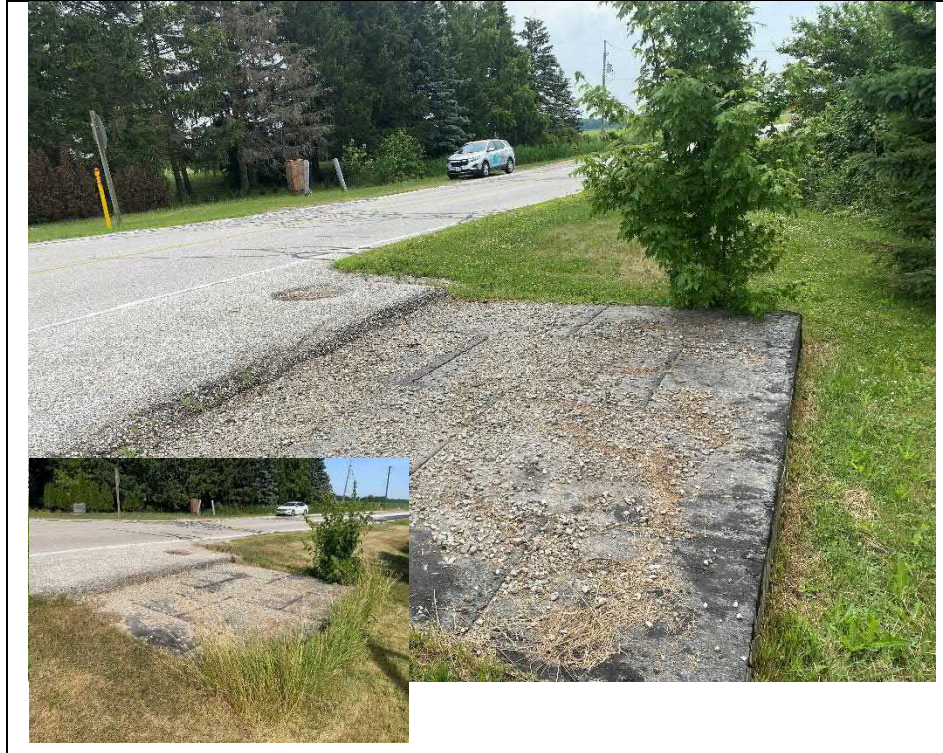
Photograph 5: Southern closed end of structure with exposed waterproofing (Looking North)

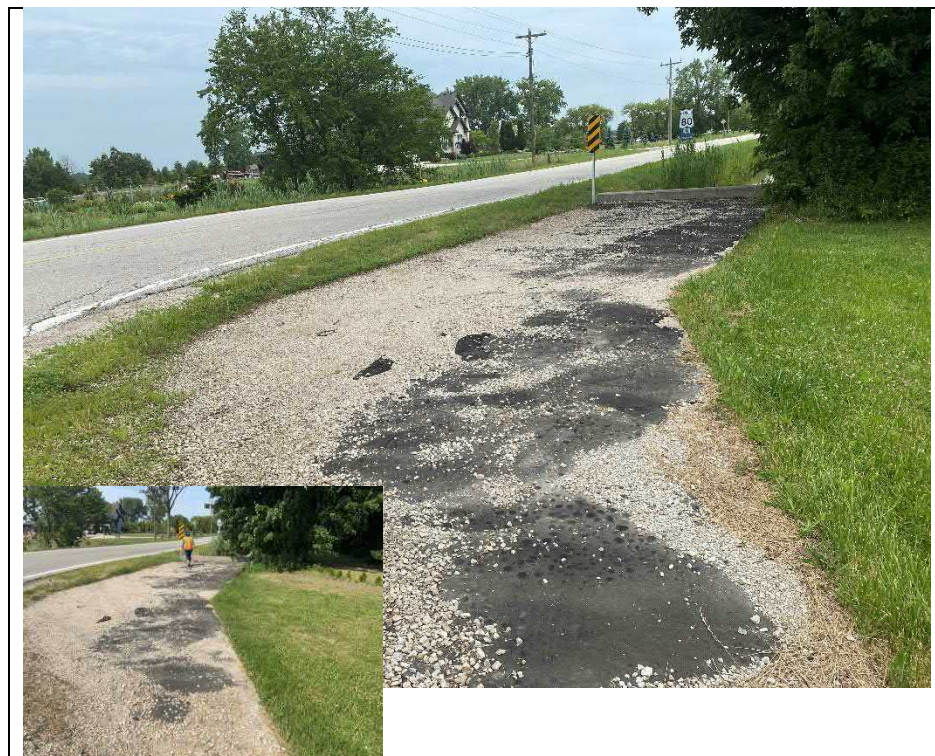
Photograph 6: Exposed waterproofing on the top of deck showing signs of bubbling and deterioration in areas not covered by granular material (Looking North)

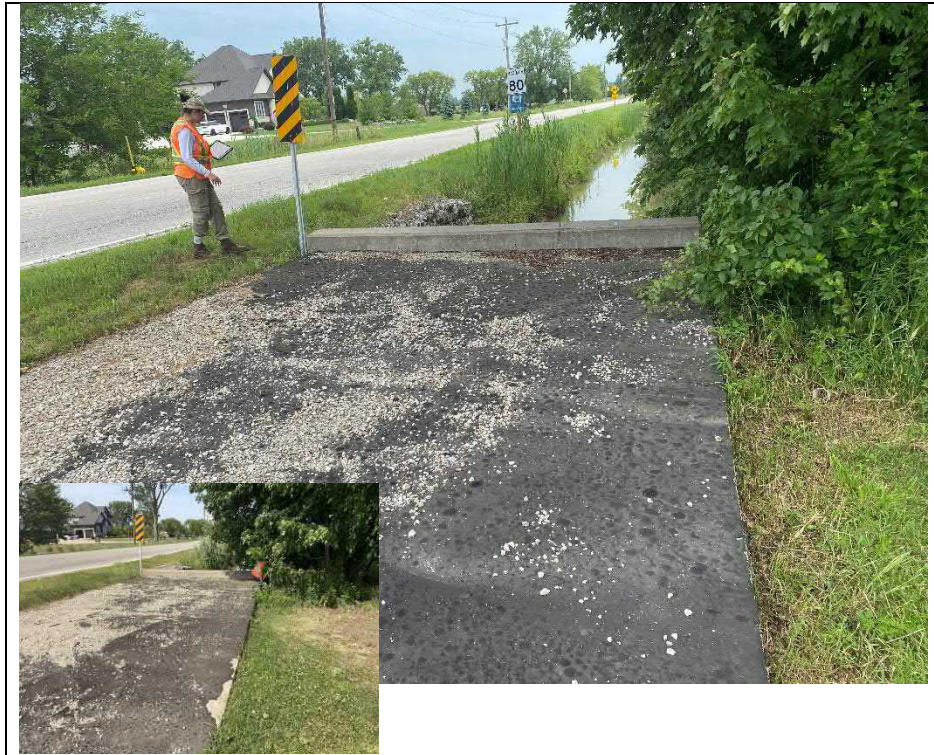
Photograph 7: Exposed waterproofing deterioration on north side of structure

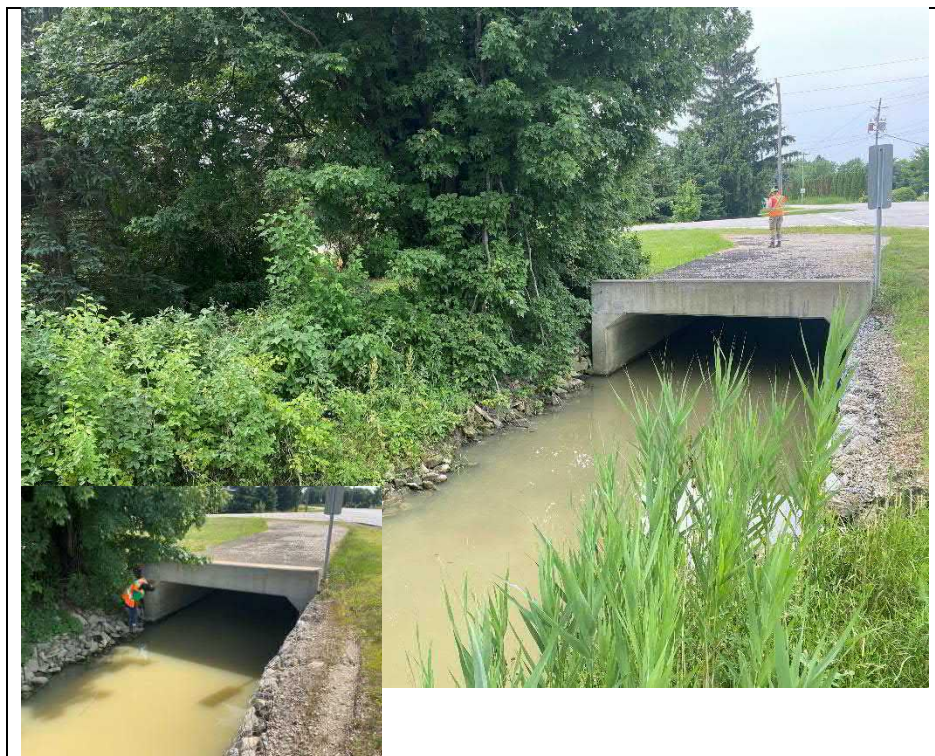
Photograph 8: North inlet with exposed waterproofing along the top of deck (Looking South)

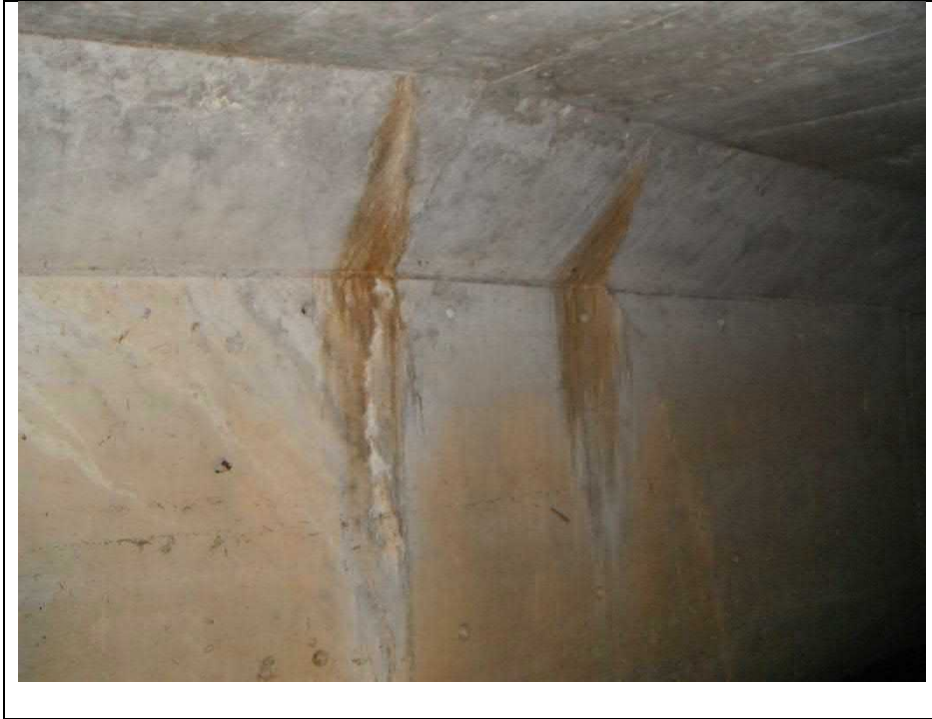
Photograph 11: Two vertical cracks at the east barrel wall.
Note: Picture from 2016. Barrel access is deemed Confined Space Entry

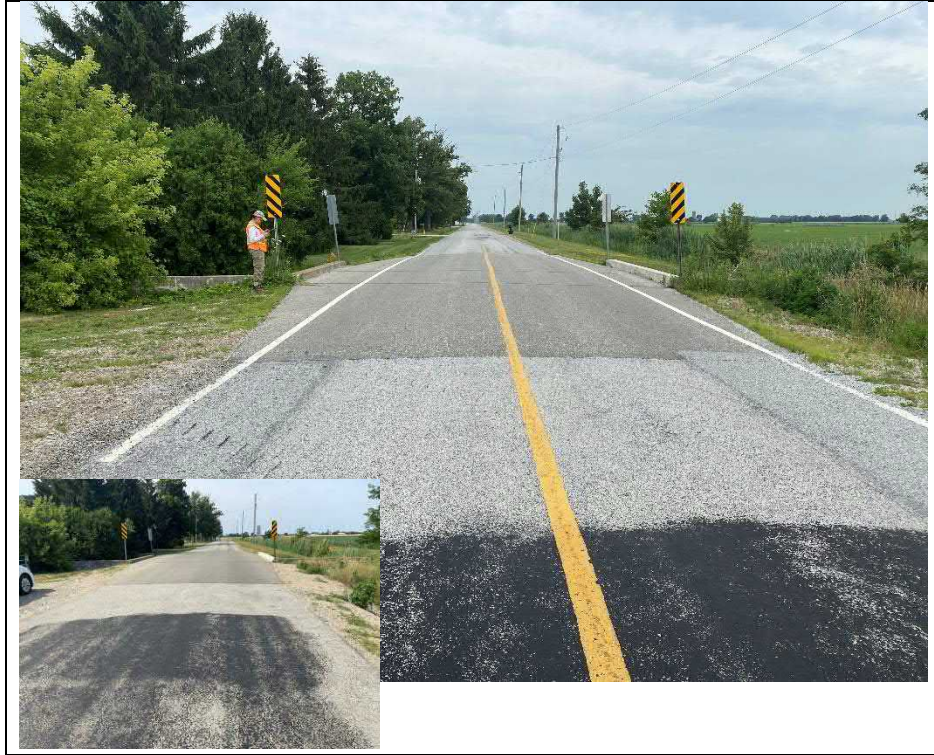
Photograph 1: South approach (Looking North)

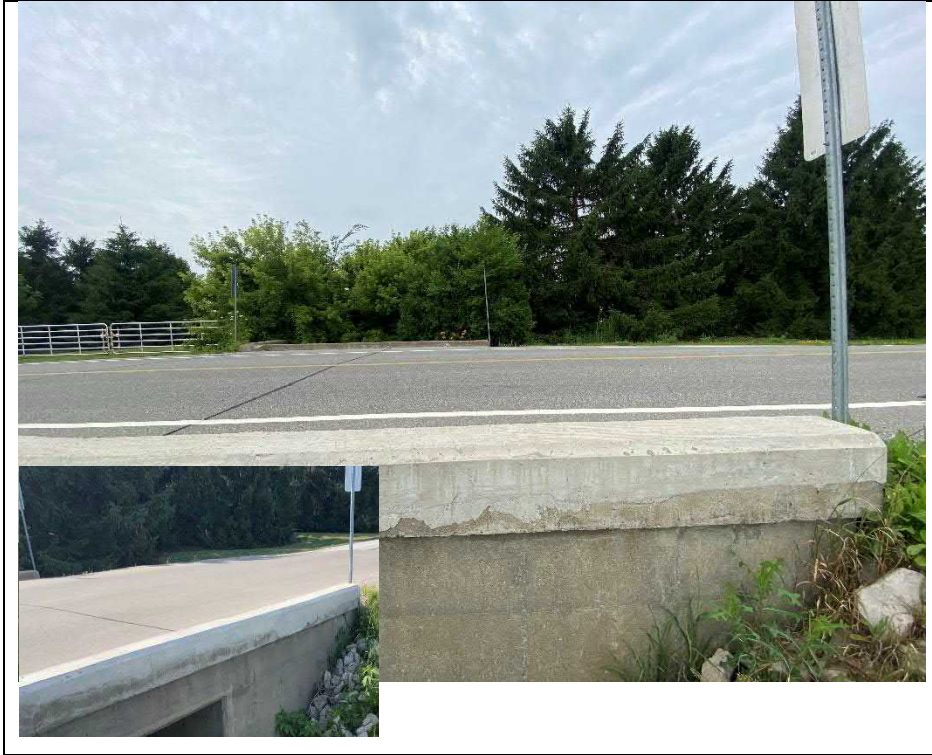
Photograph 3: Wearing surface over the structure (Looking West)

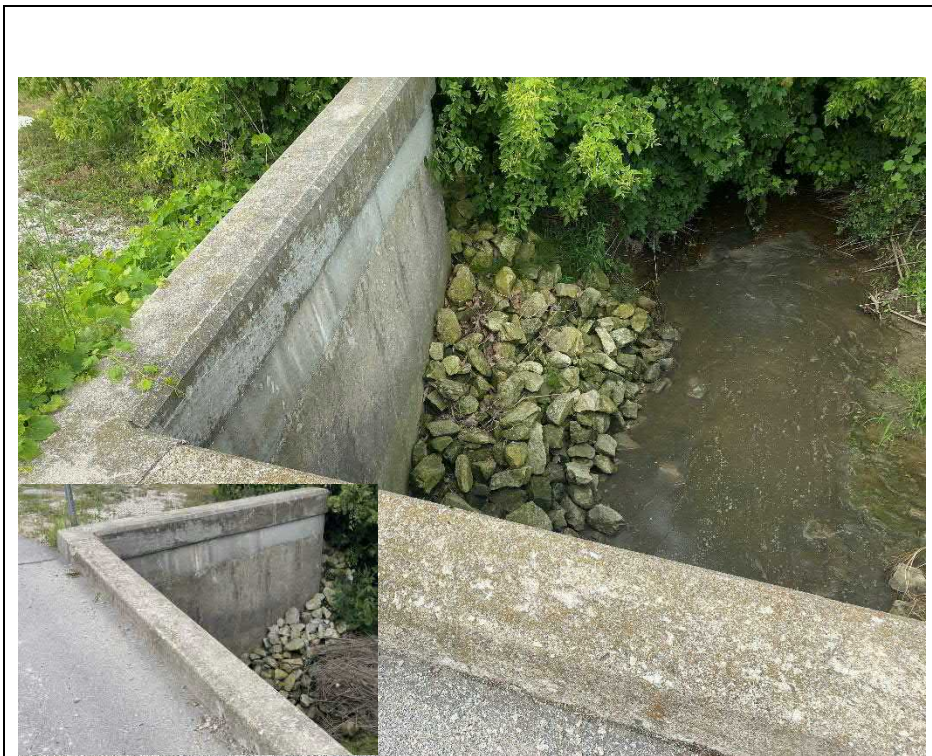
Photograph 4: Curb and wingwall at southwest quadrant of structure

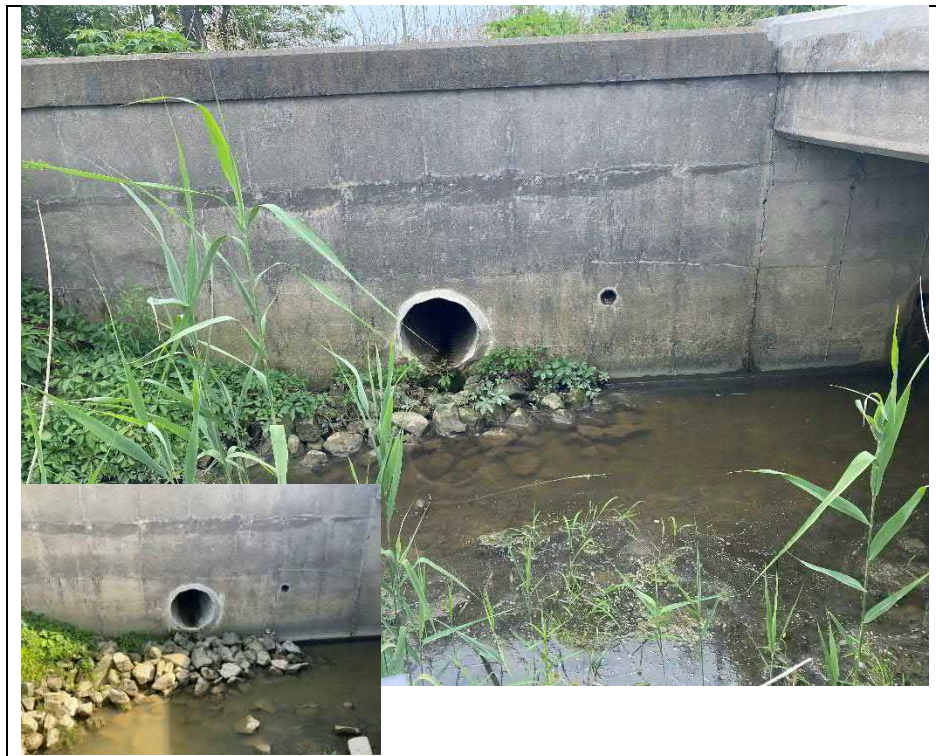
Photograph 8: Typical condition of CSP outlet through the southeast wingwall

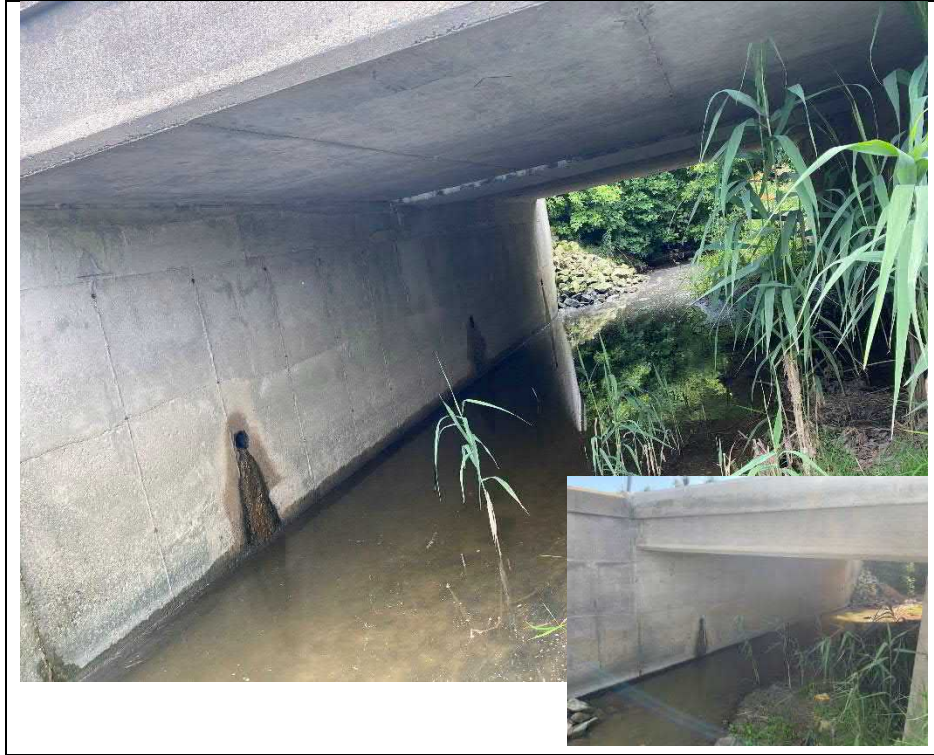
Photograph 9: South abutment wall and wall drains

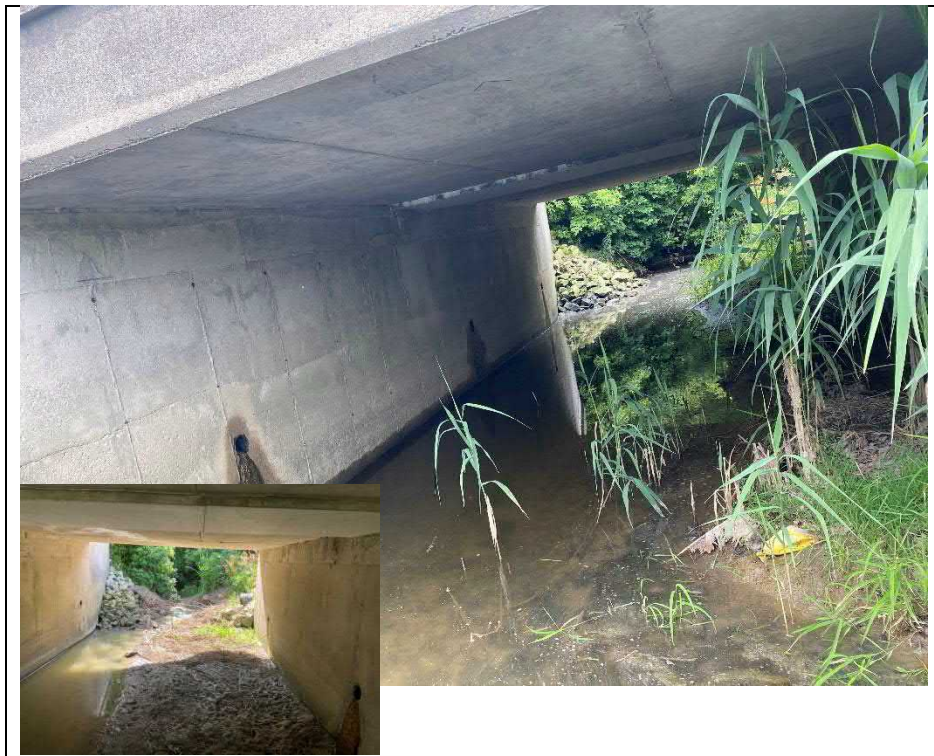
Photograph 10: Typical condition of culvert barrel (Looking West)

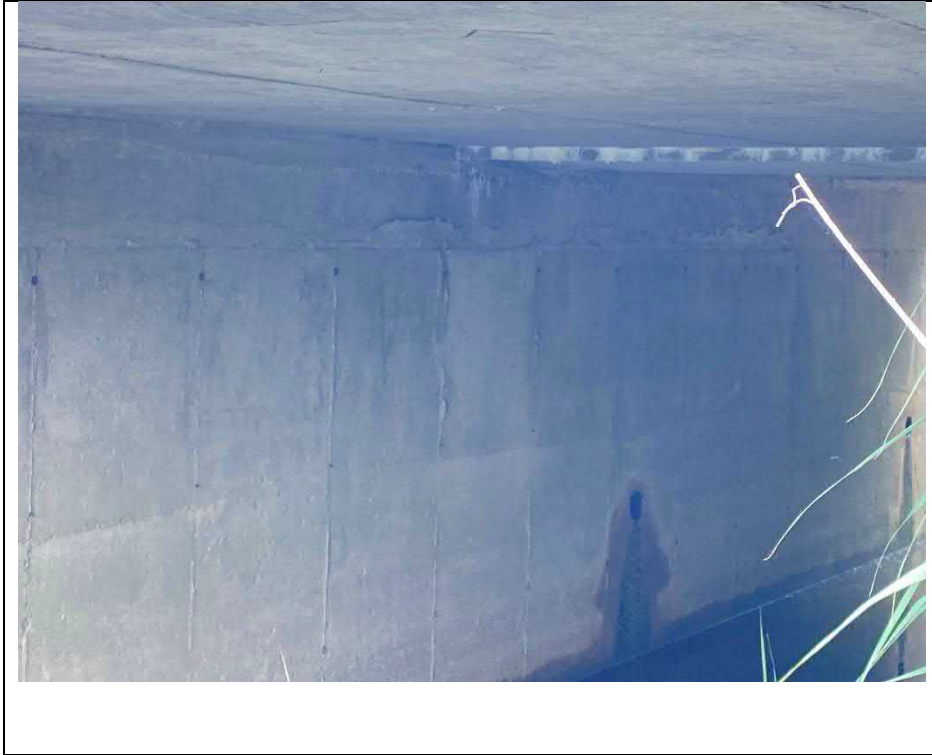
Photograph 11: Soffit patch repair completed in 2019 (Looking Southwest)

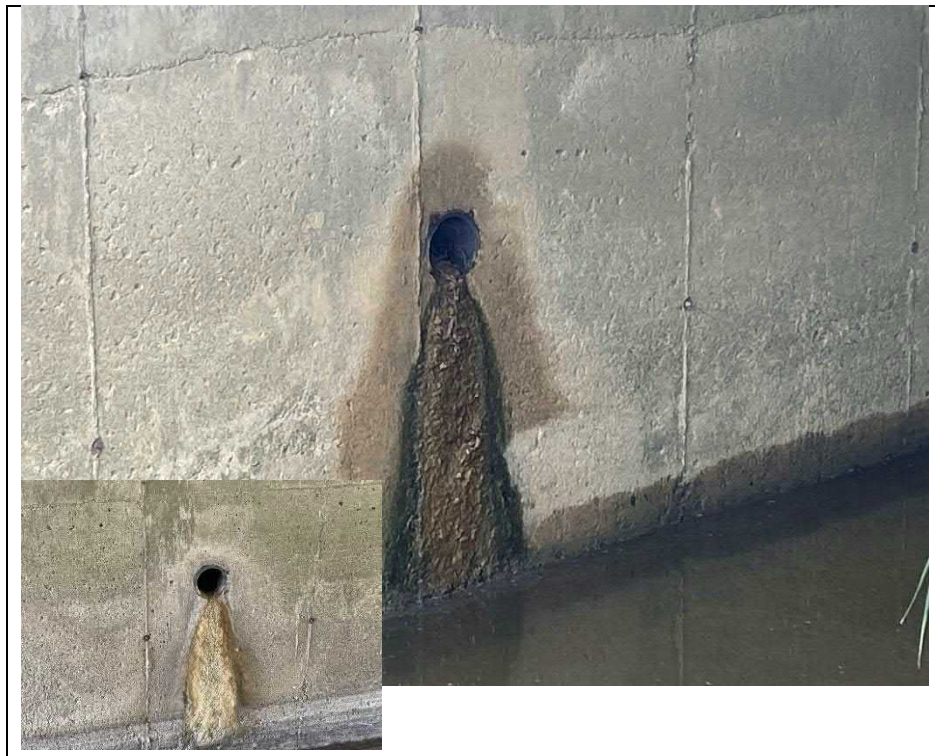
Photograph 12: Typical condition of wall drains in culvert barrel with wet staining and efflorescence

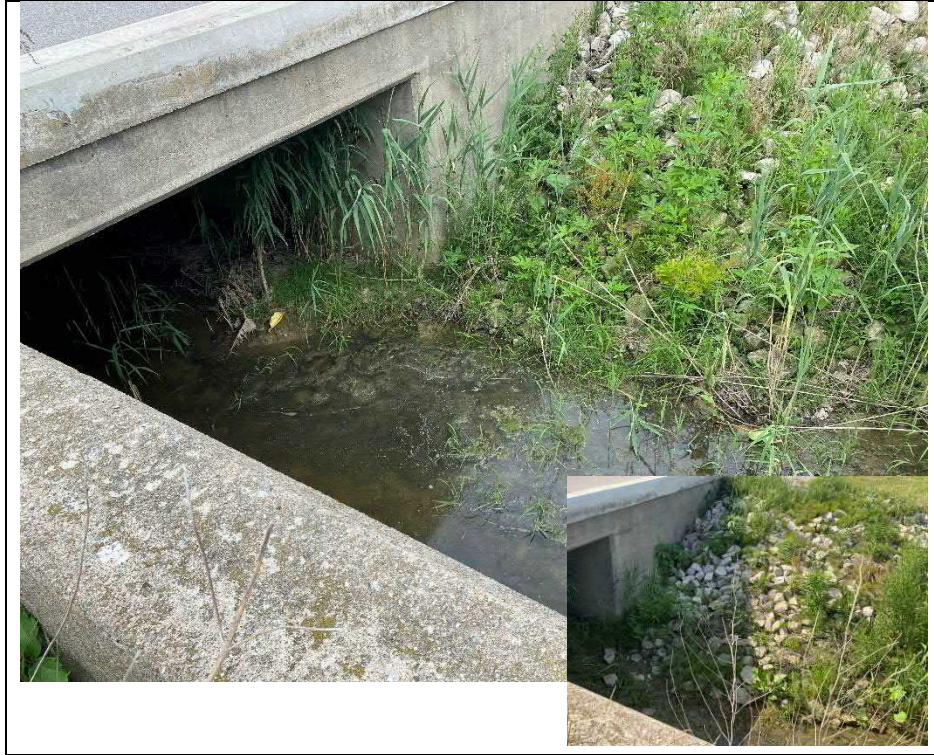
Photograph 13: Watercourse on east side of structure, and slope protection rip-rap (Looking North)

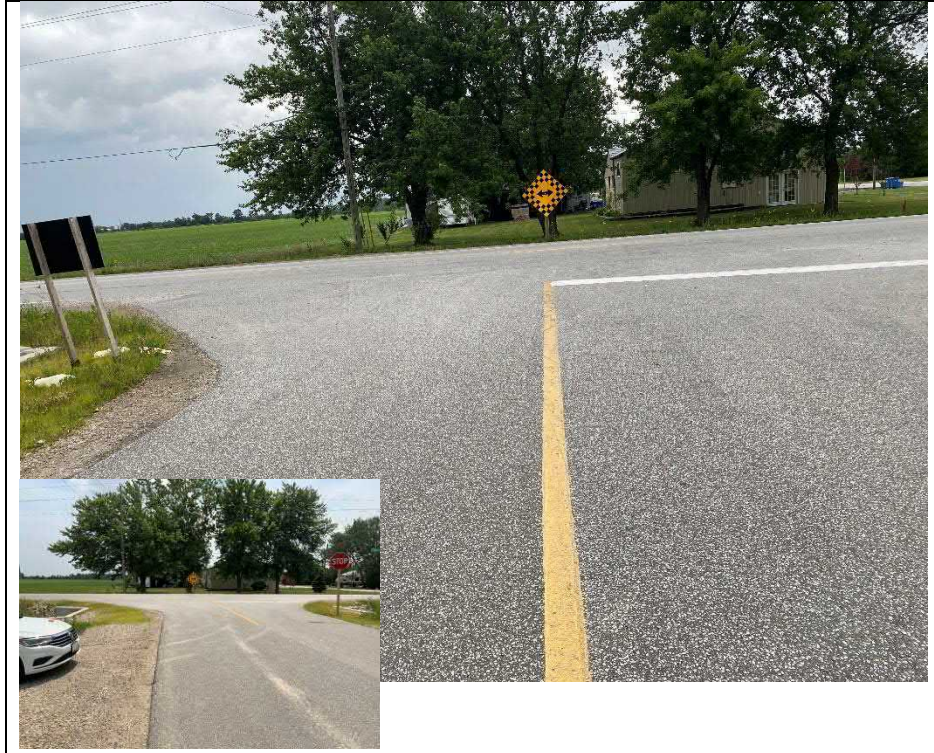
Photograph 1: North approach (Looking South)

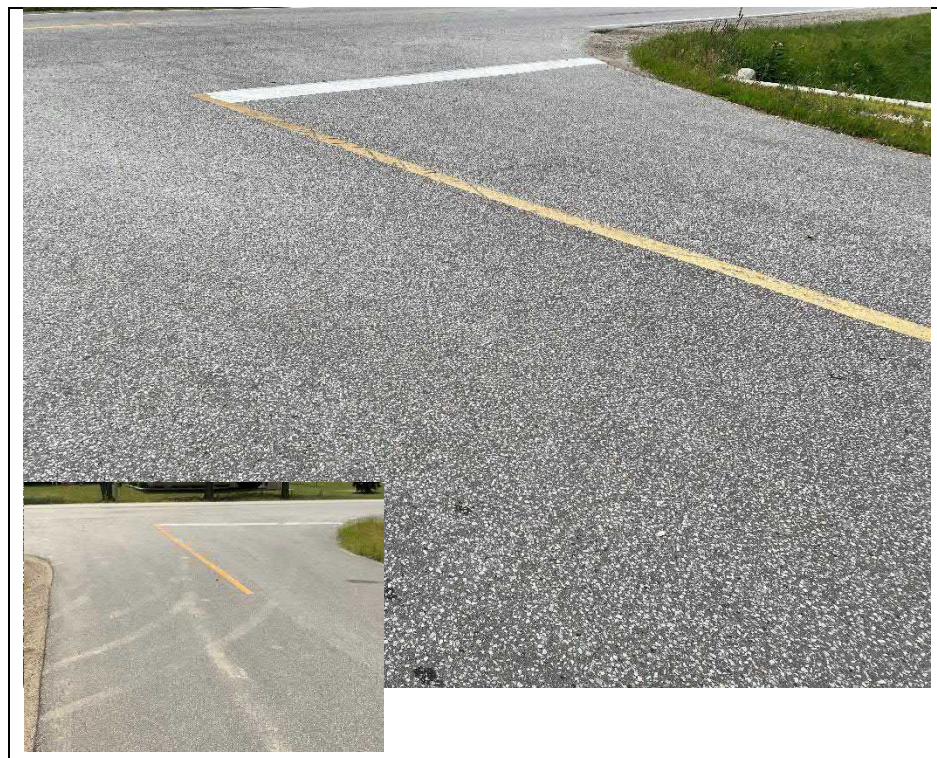
Photograph 2: Wearing surface at north approach (Looking South)

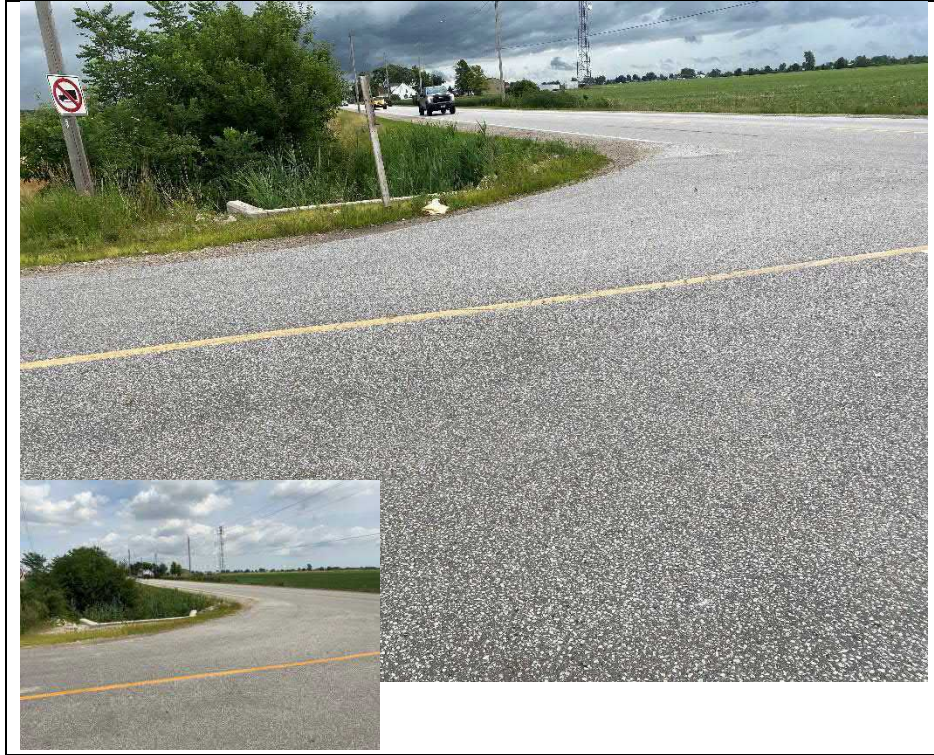
Photograph 3: Wearing surface over the structure (Looking East)

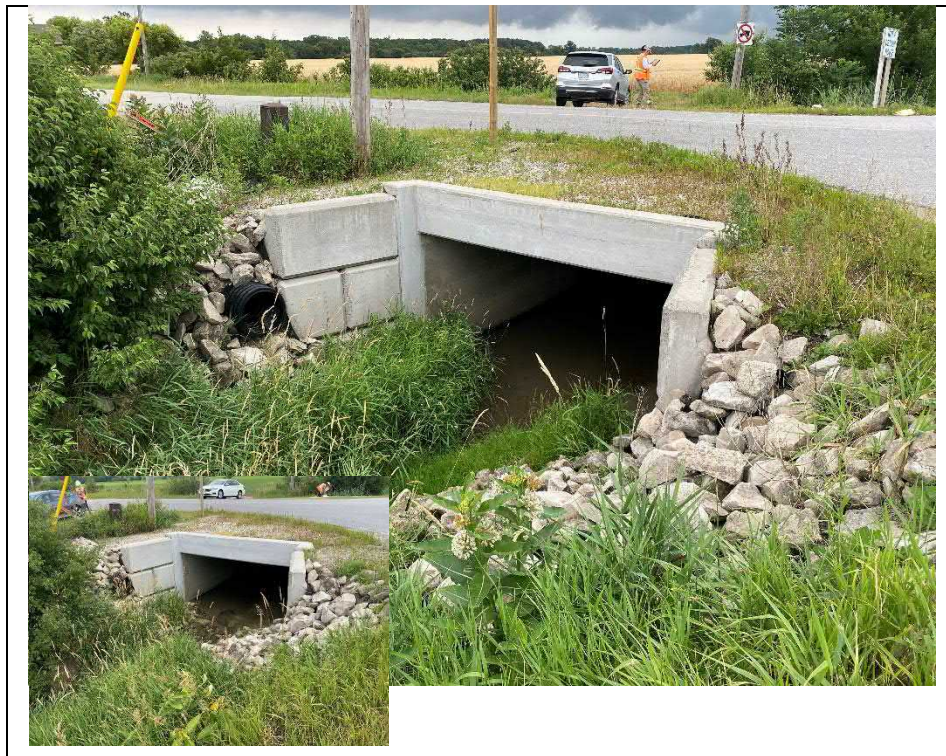
Photograph 4: West elevation (Looking Northeast)

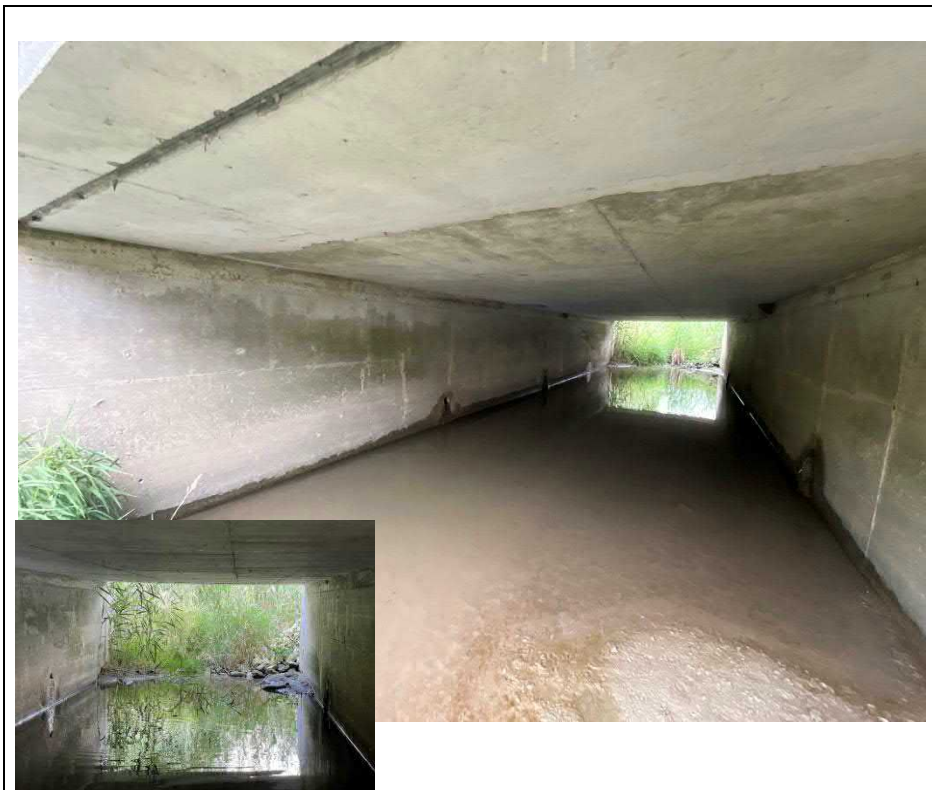
Photograph 6: Typical condition culvert barrel

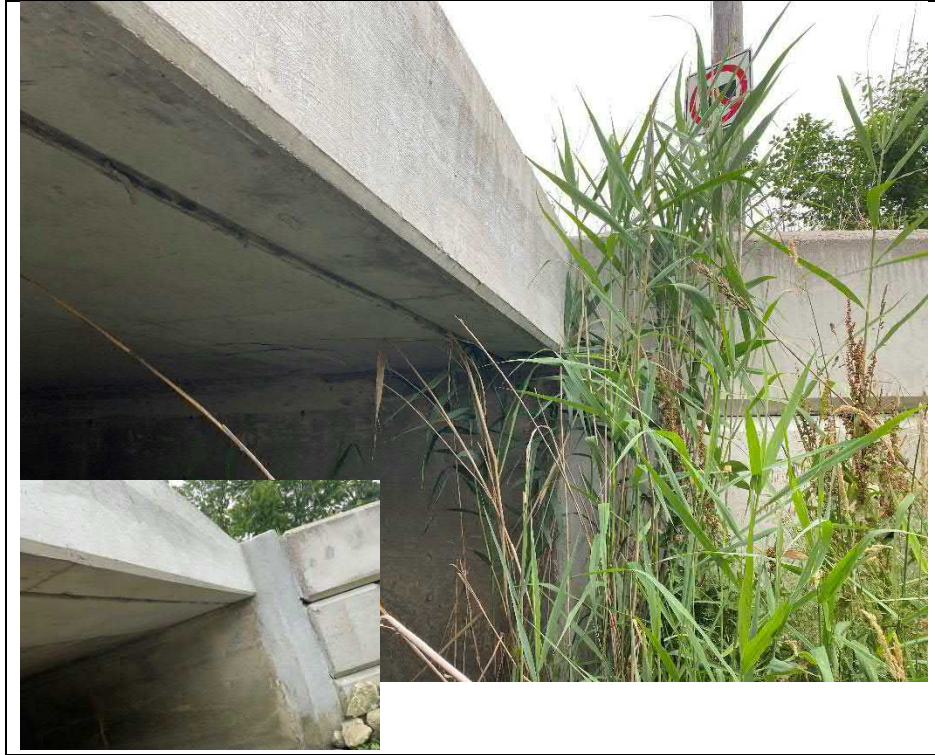
Photograph 7: Typical condition of fascia (west end shown)

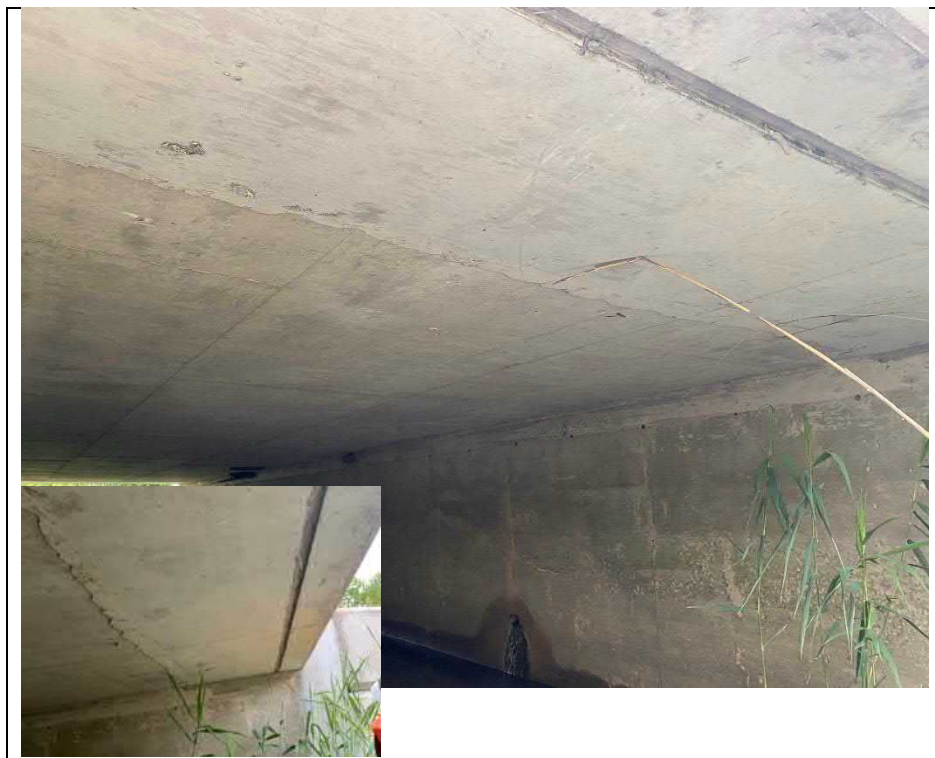
Photograph 8: Typical condition of deck soffit (East end shown)

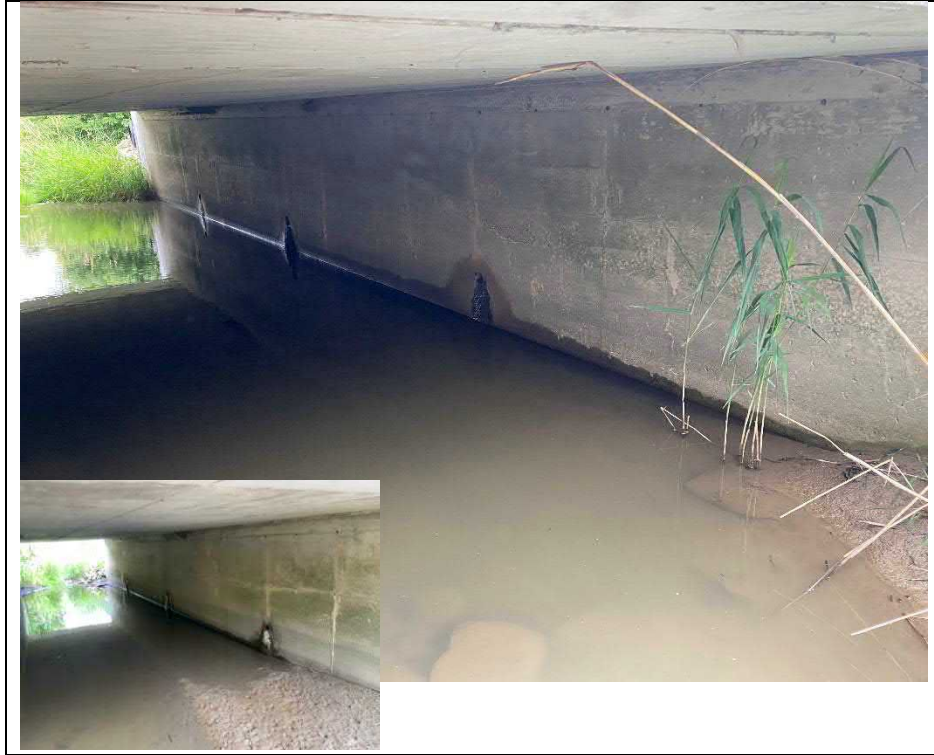
Photograph 9: Abutment wall and deck soffit inside the structure

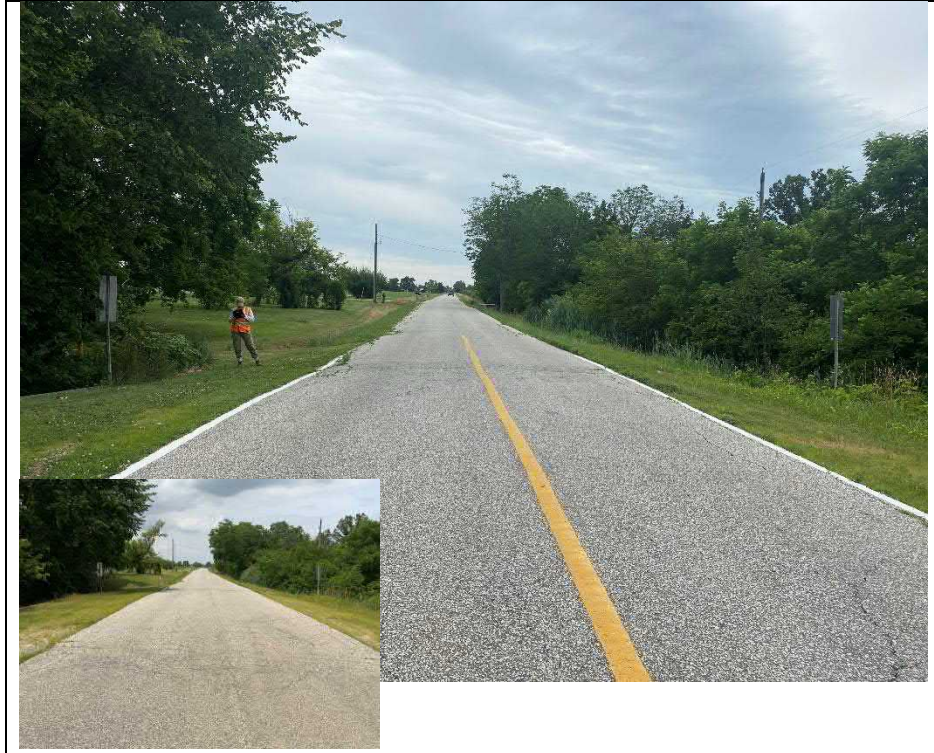
Photograph 1: South approach (Looking North)

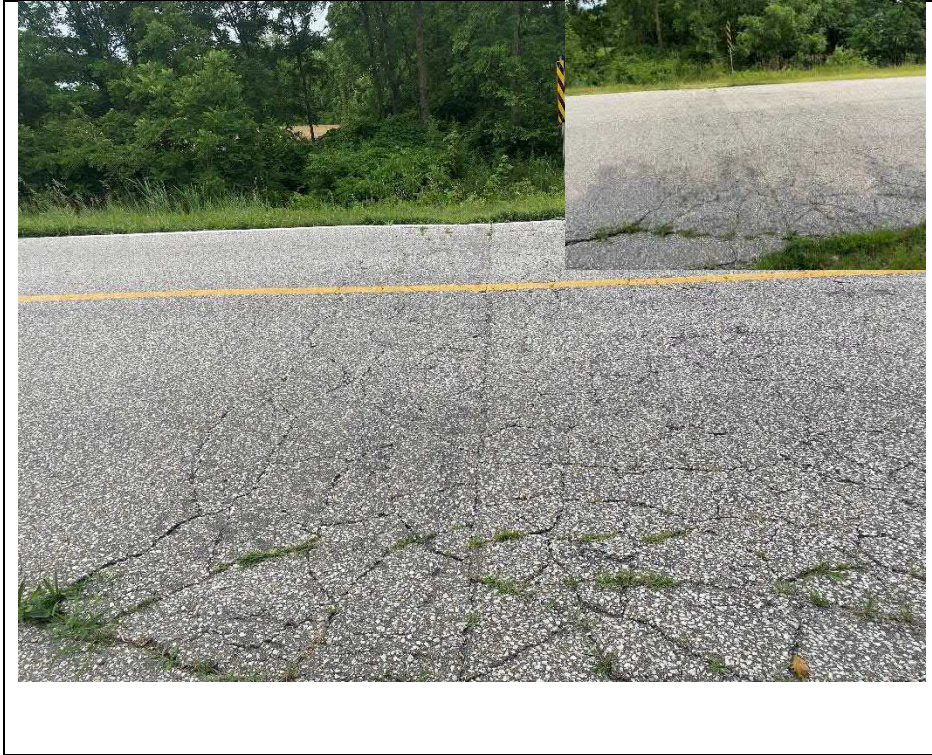
Photograph 3: Cracking of asphalt pavement at interface of deck and south approach (Looking East)

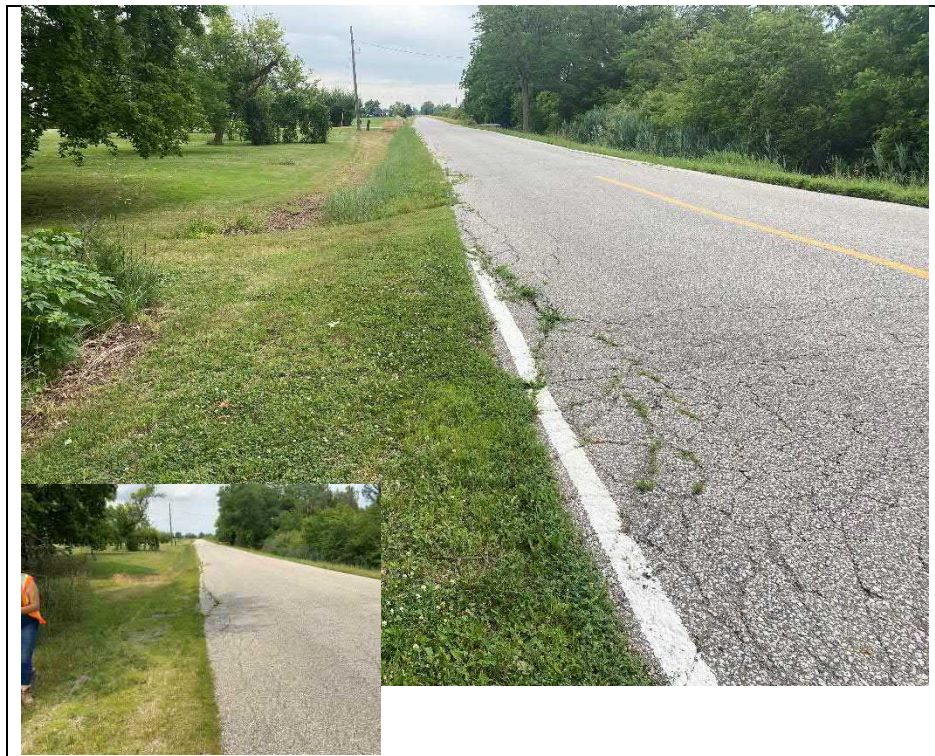
Photograph 4: Edge cracking of wearing surface at north approach (Looking North)

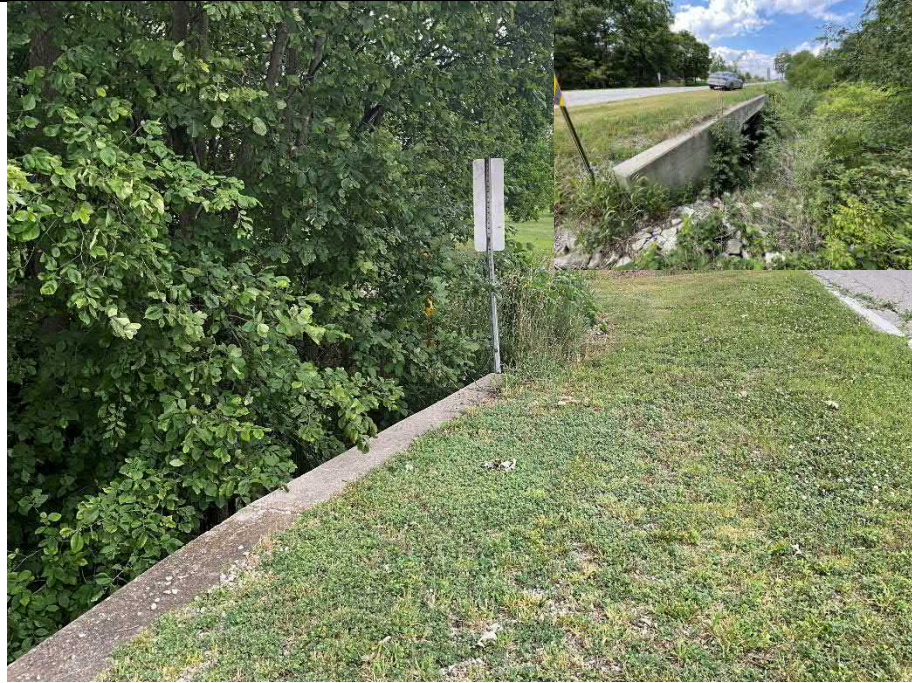
Photograph 5: Severe erosion of the shoulder at the southeast embankment

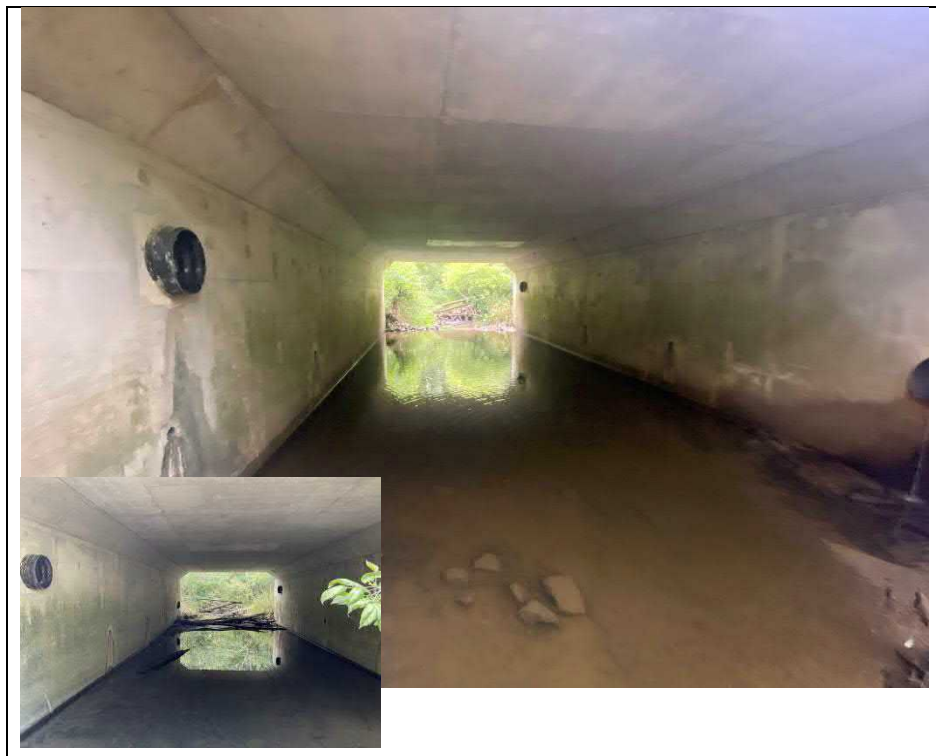
Photograph 8: Typical condition of culvert barrel

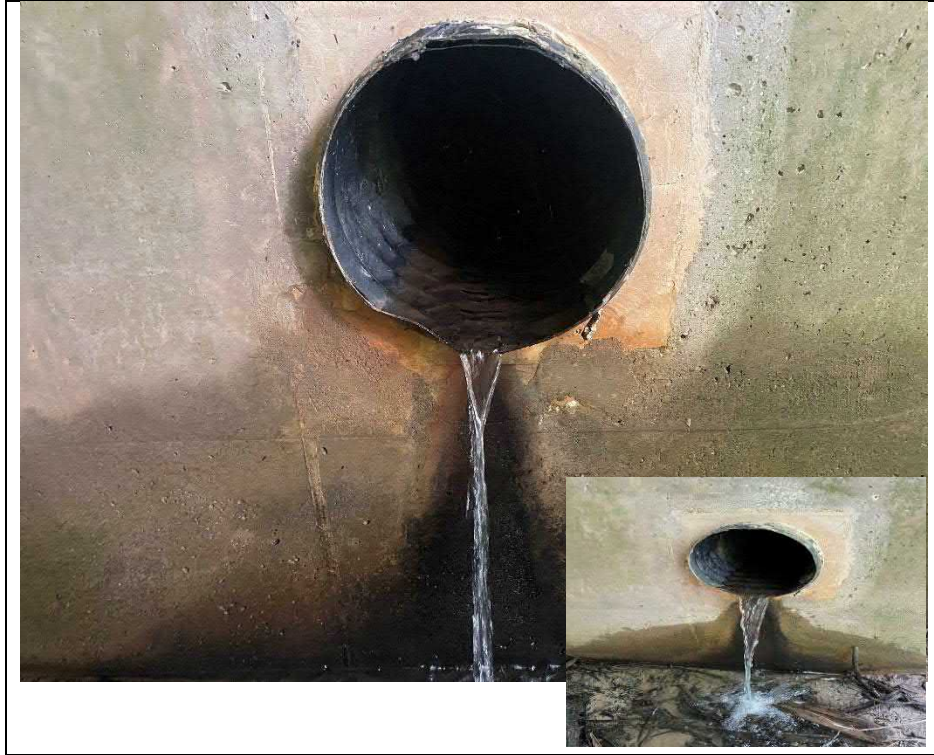
Photograph 9: South abutment wall near west extent of structure, HDPE outlet with corrosion staining beneath (Looking South)

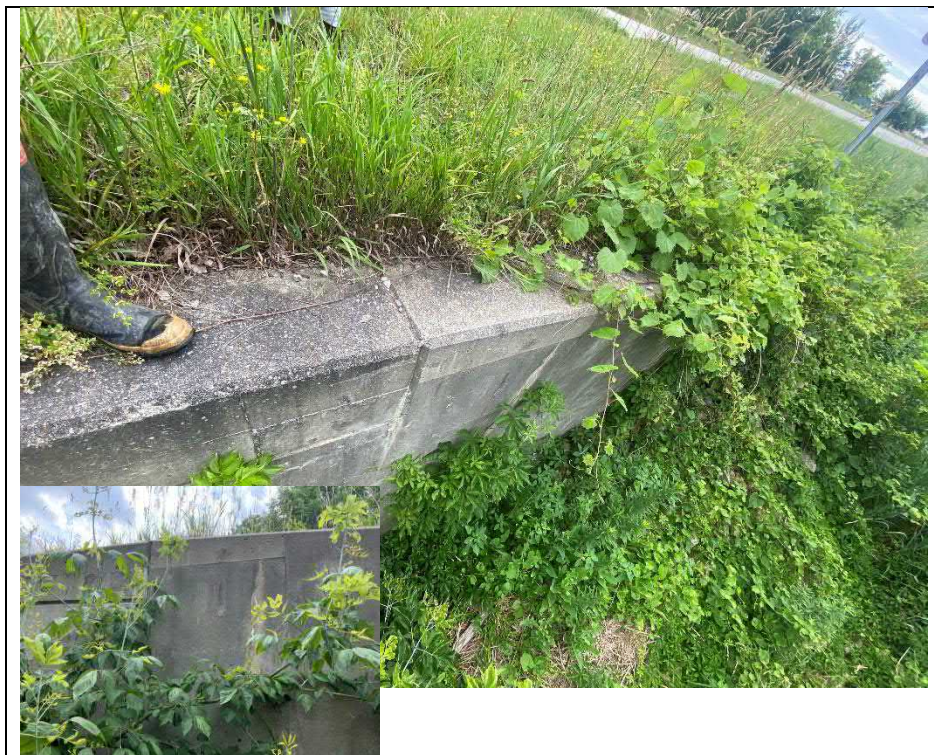
Photograph 10: North-west wing wall with efflorescent-stained vertical crack
