CORPORATION OF THE TOWN OF TECUMSEH

2024 Bridge and Culvert Needs Study Structures with Spans > 3.0 m

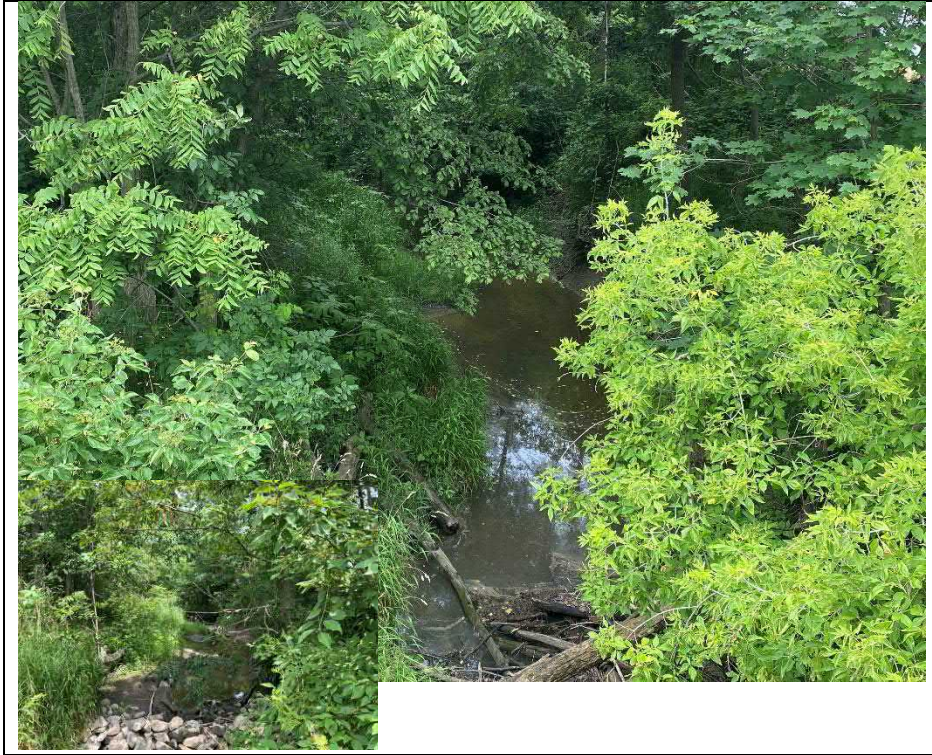
Photograph 11: Watercourse on west side of structure (Looking West)

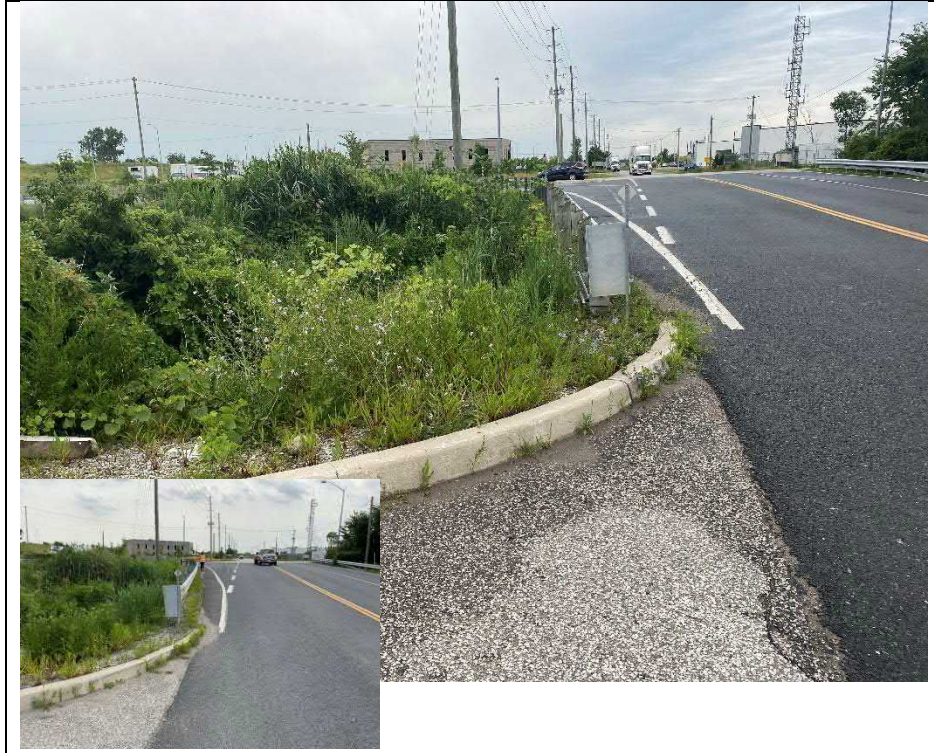
Photograph 1: South Approach (Looking Southwest)

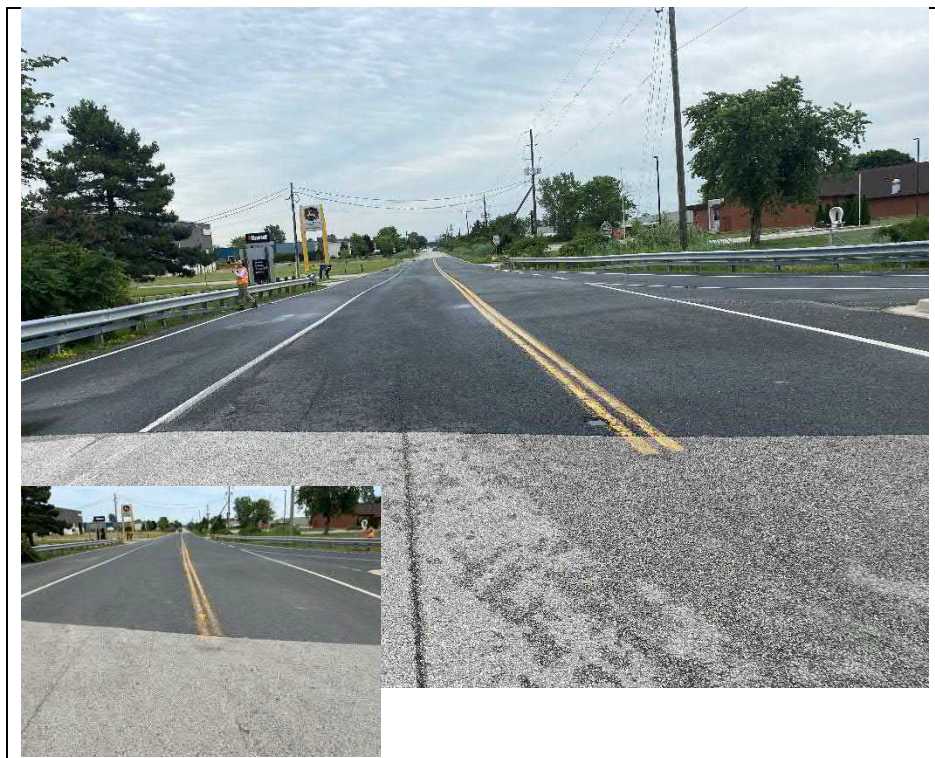
Photograph 4: Centreline of the road wearing surface approximately at mid span of the structure

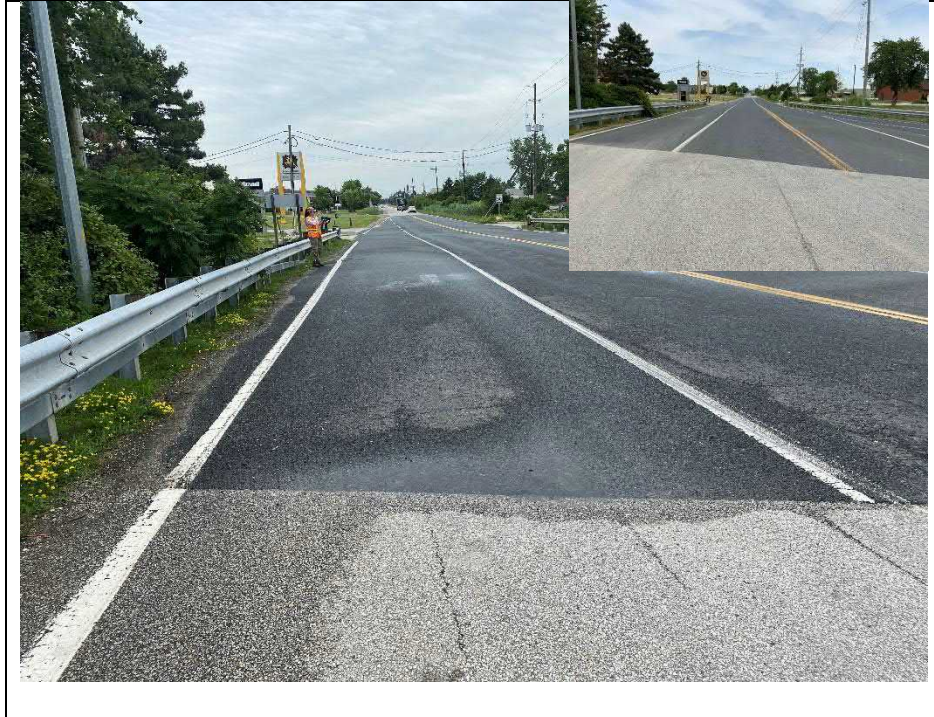
Photograph 5: E.B.L wearing surface (Looking Northeast)

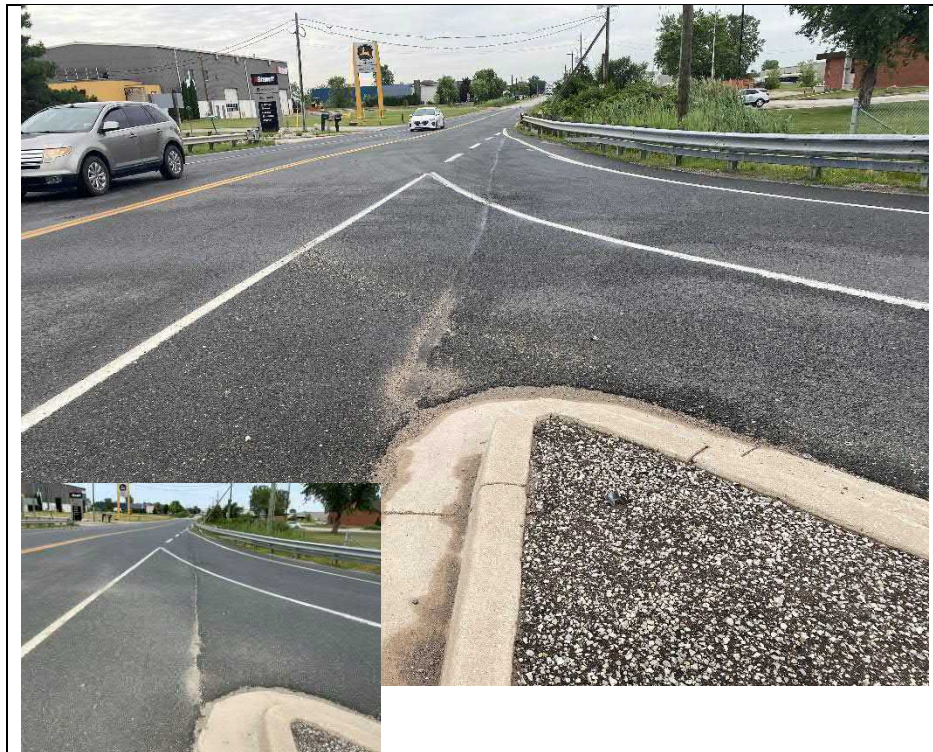
Photograph 6: Pavement joint between the deck and approach wearing surfaces (Looking Northeast)

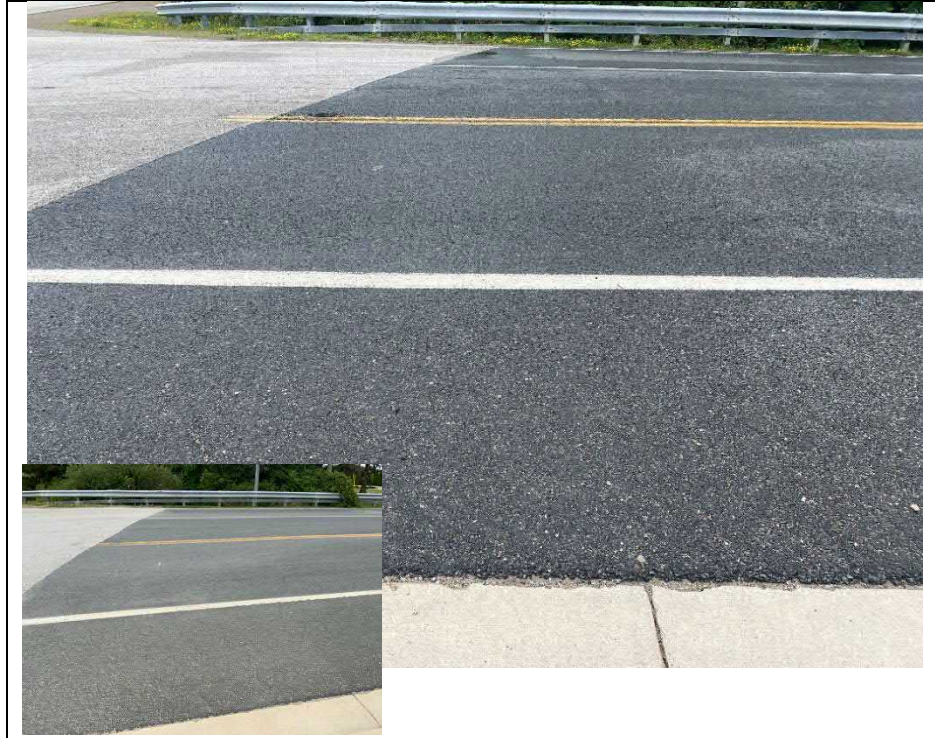
Photograph 7: Wearing surface over the structure (Looking Northwest)

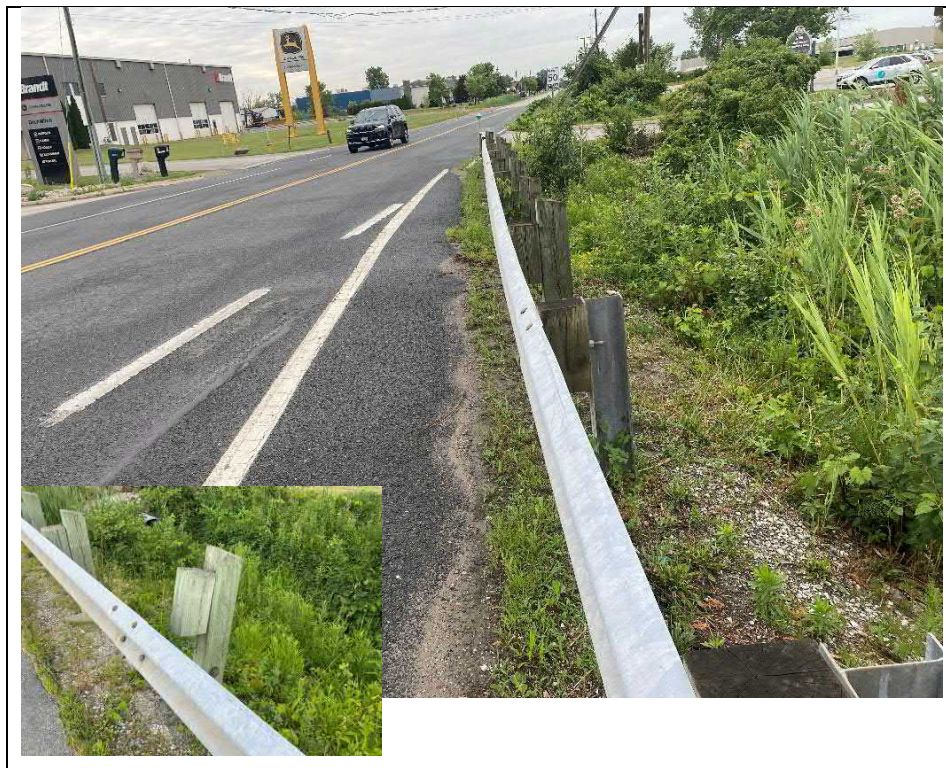
Photograph 8: Settled, rotated post of railing system at the northeast quadrant of structure (Looking Northeast)

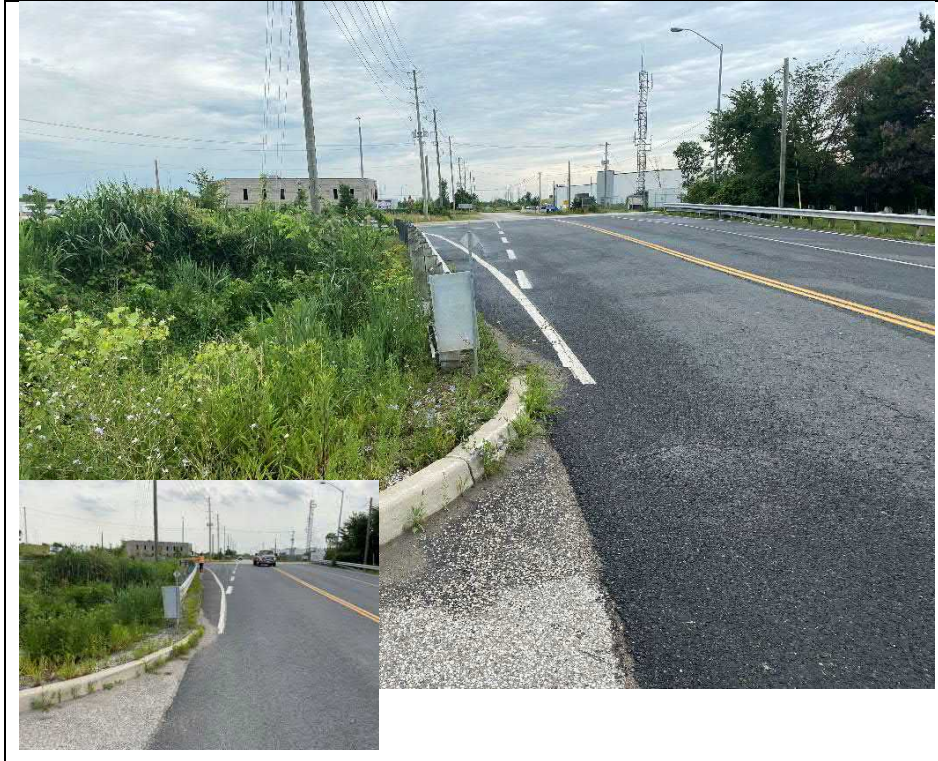
Photograph 9: Missing hazard marker sign at northeast quadrant of structure (Looking Southwest)

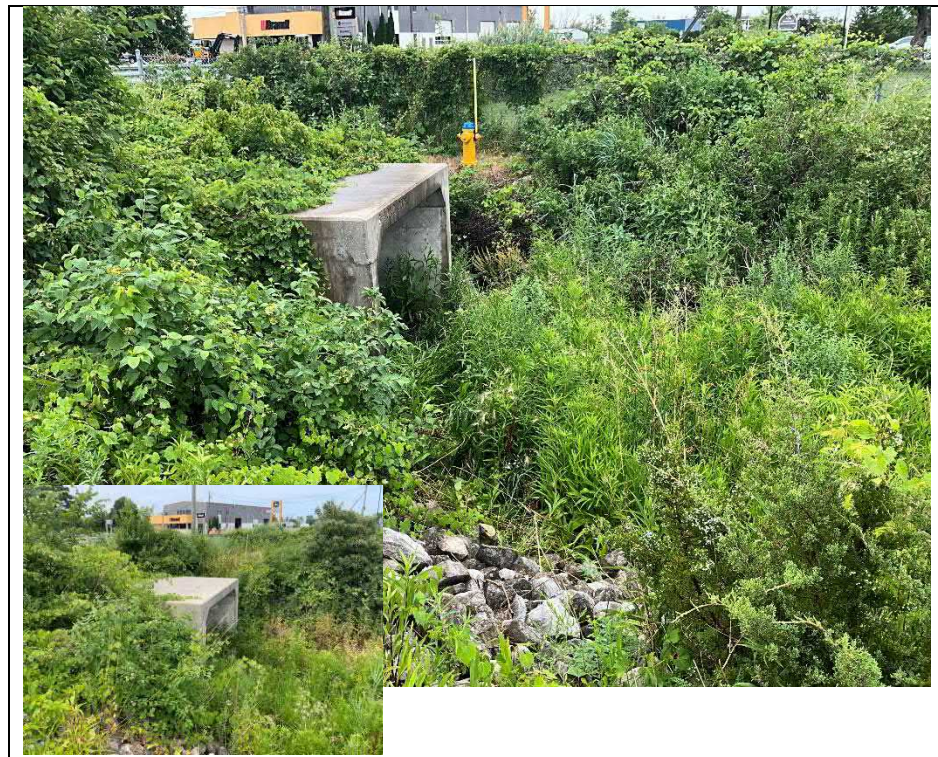
Photograph 10: East elevation (Looking North)

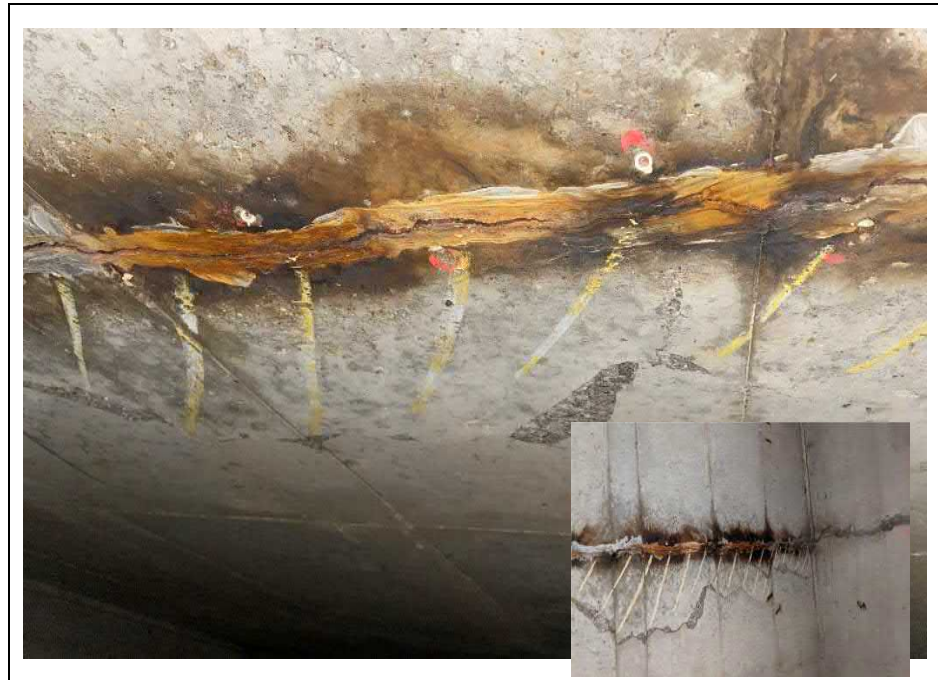
Photograph 12: Typical delamination, and epoxy injected cracks with staining along soffit within the original section of the culvert

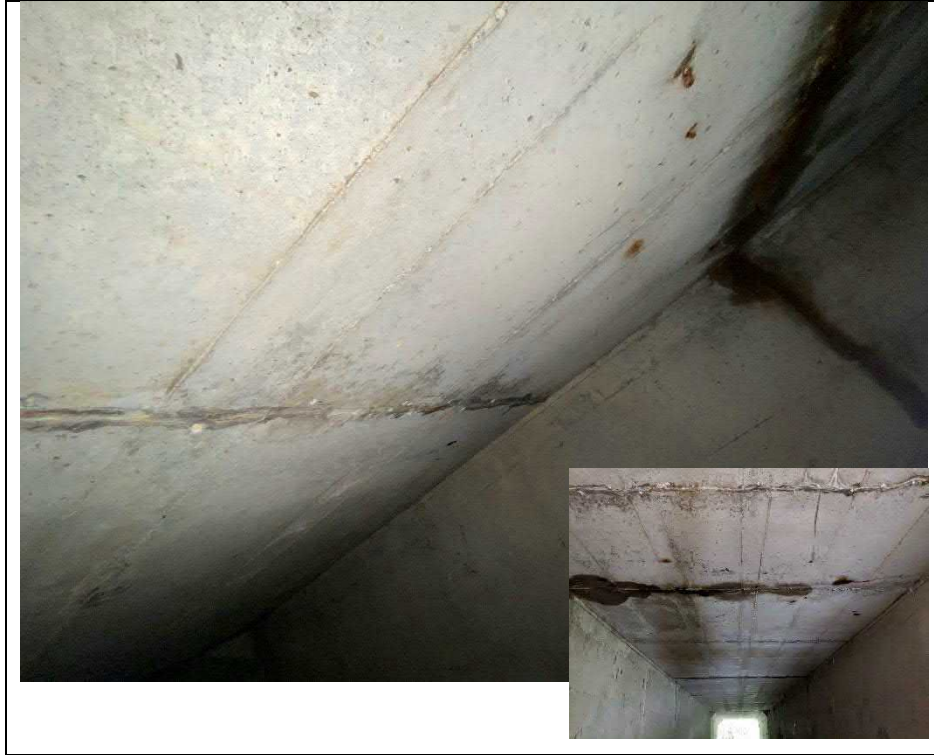
Photograph 13: Typical stained medium to wide cracks throughout the soffit (Looking Northwest)

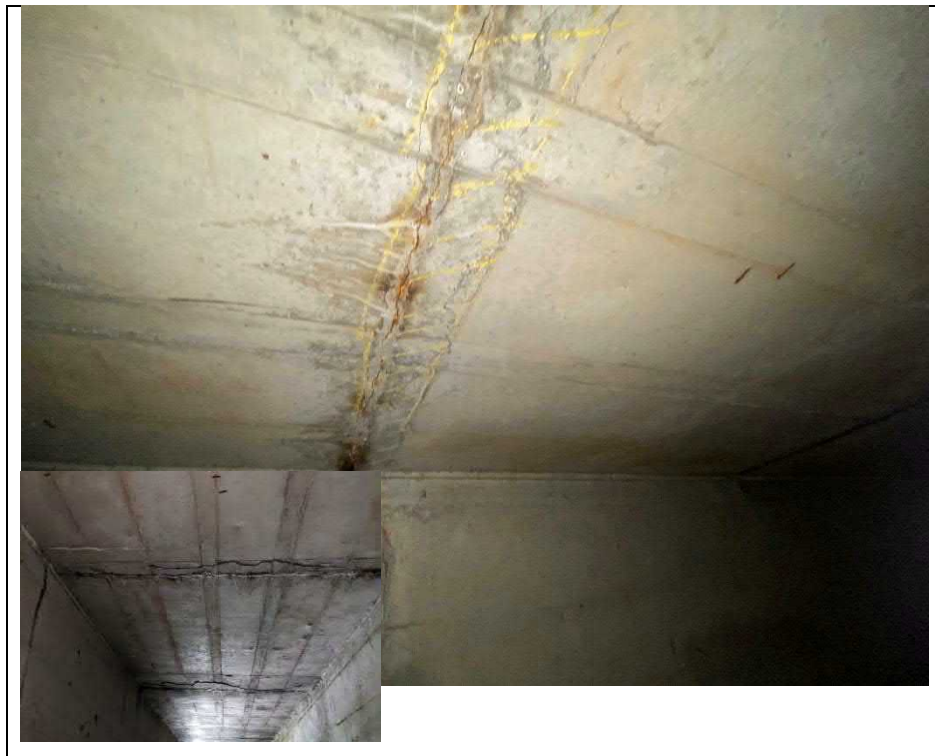
Photograph 14: Cracks extending from the culvert soffit to the abutments

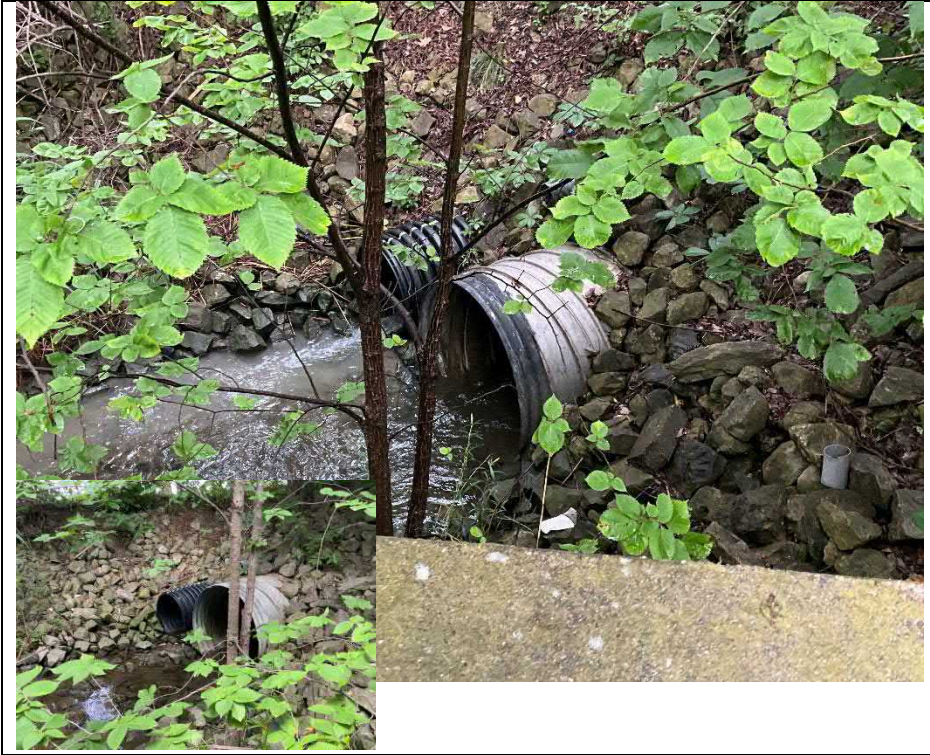
Photograph 15: Watercourse at west extent of culvert (Looking West)

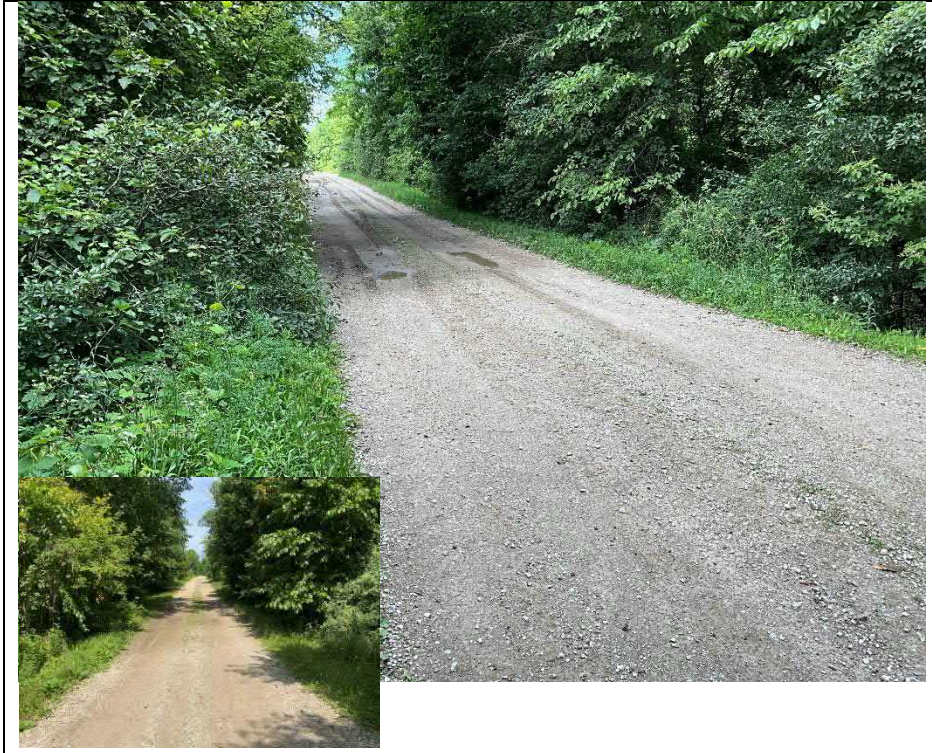
Photograph 1: North approach (Looking North)

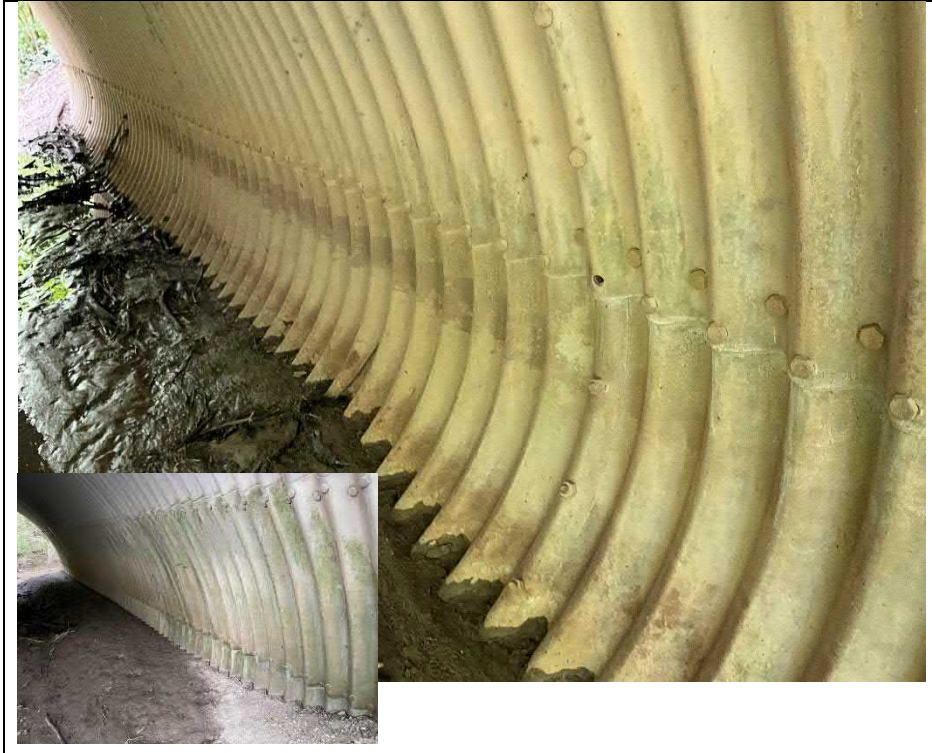
Photograph 7: Typical condition along spring line

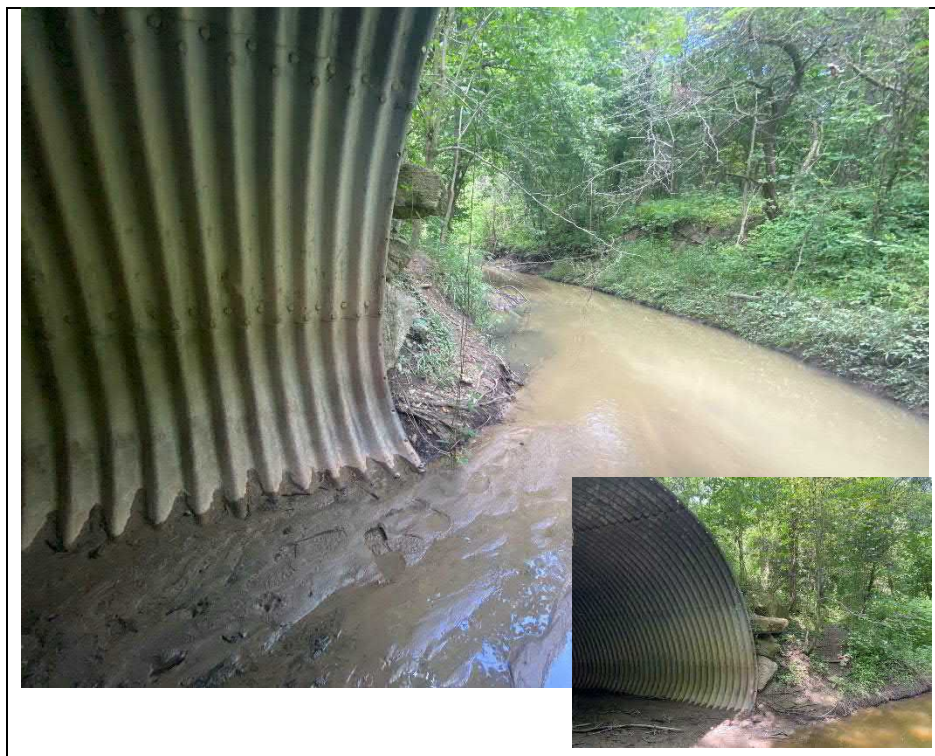
Photograph 8: North spring line (Looking West)

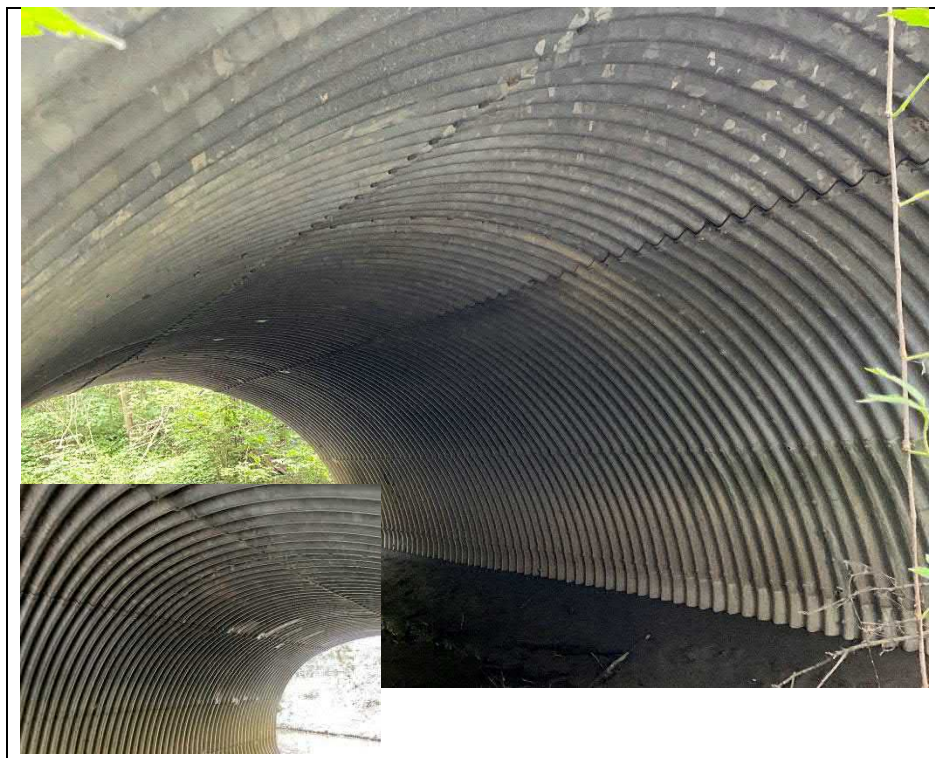
Photograph 10: Typical condition of culvert barrel soffit

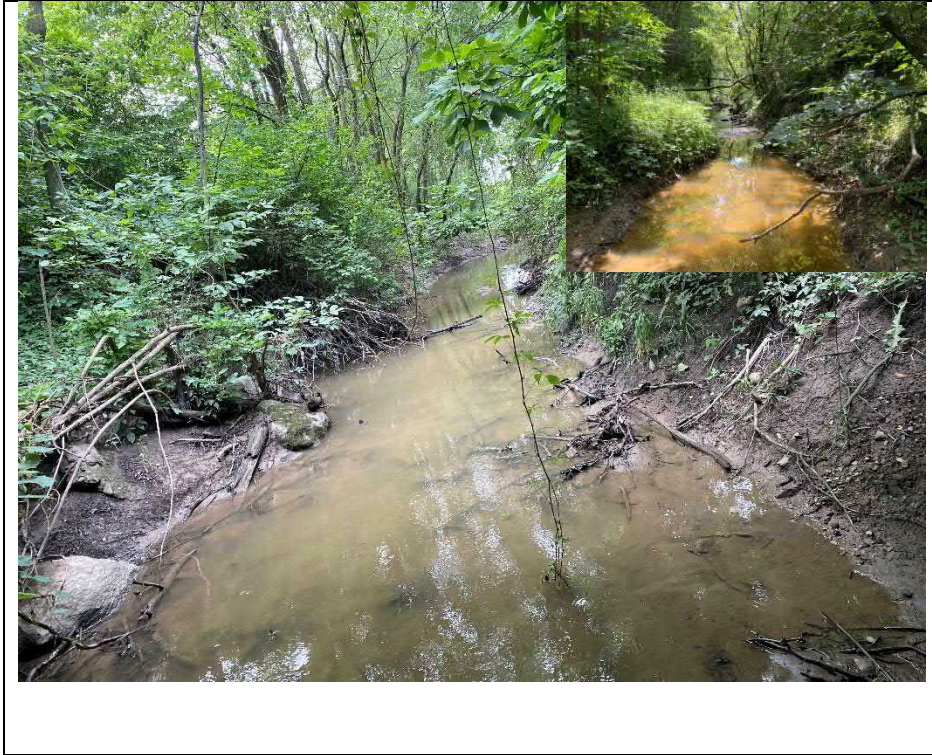
Photograph 11: Watercourse inlet at east end of structure (Looking South)

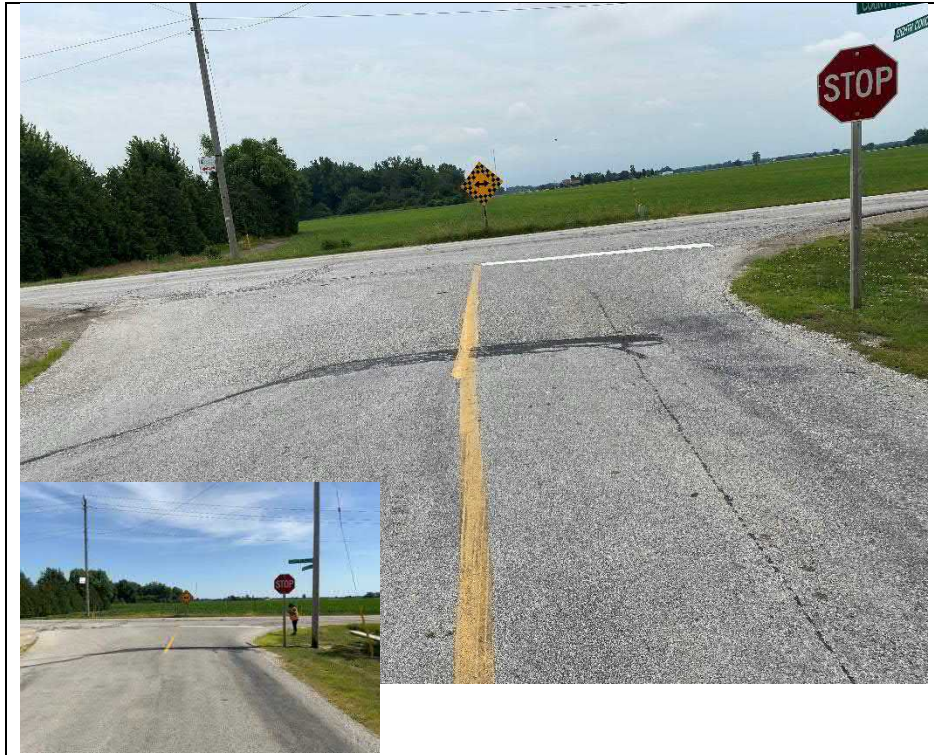
Photograph 1: North approach

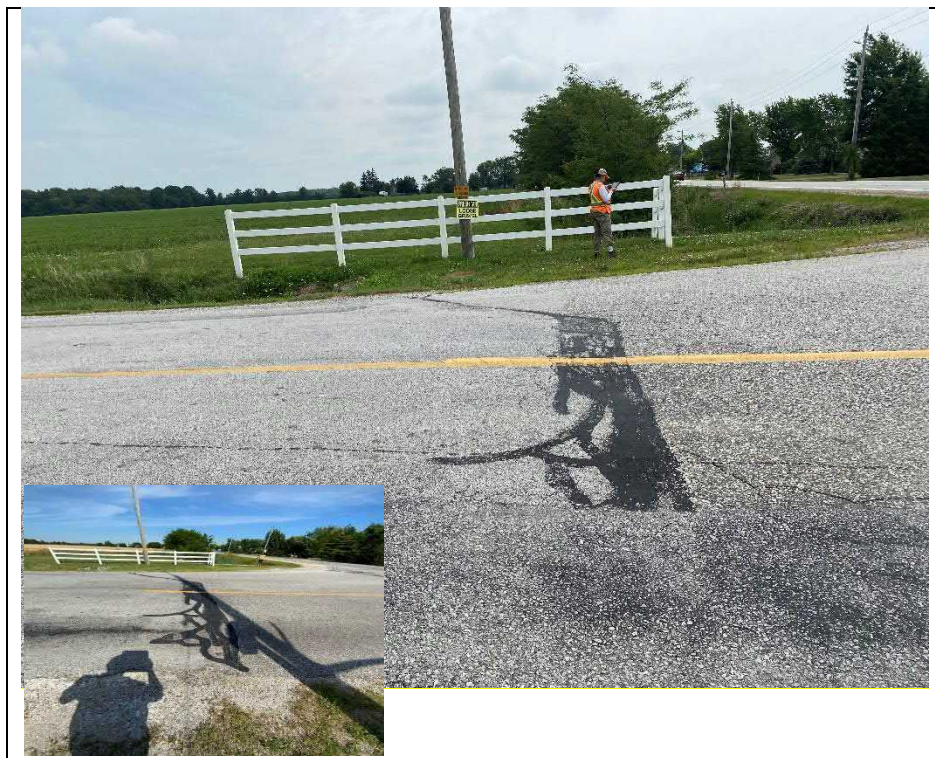
Photograph 2: Wearing surface at south approach (Looking East)

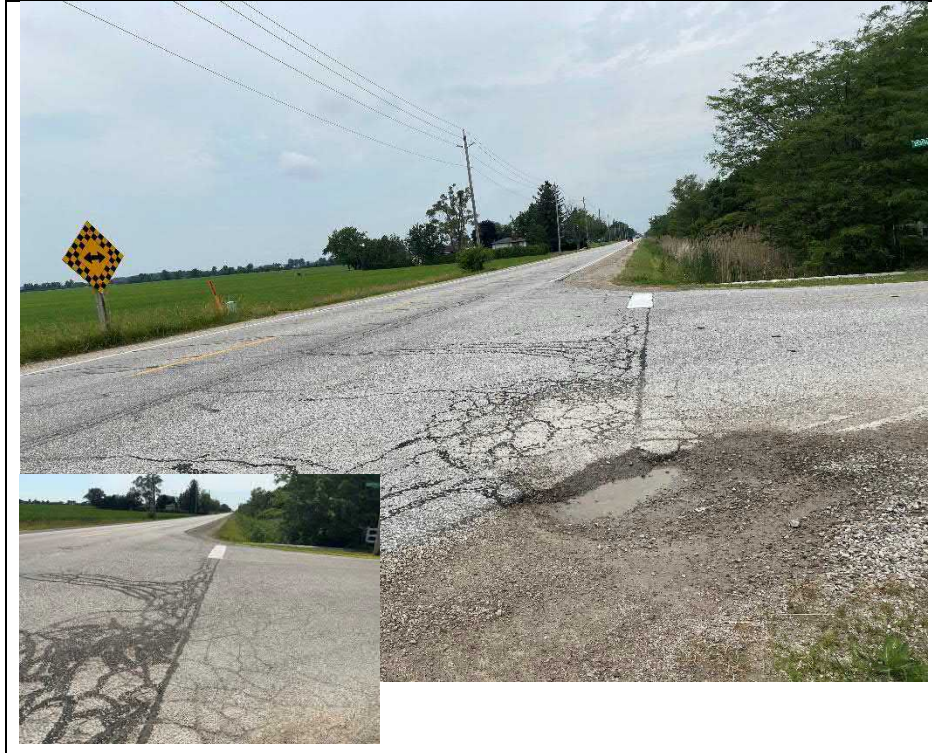
Photograph 3: Alligator cracking of wearing surface at southeast quadrant (Looking West)

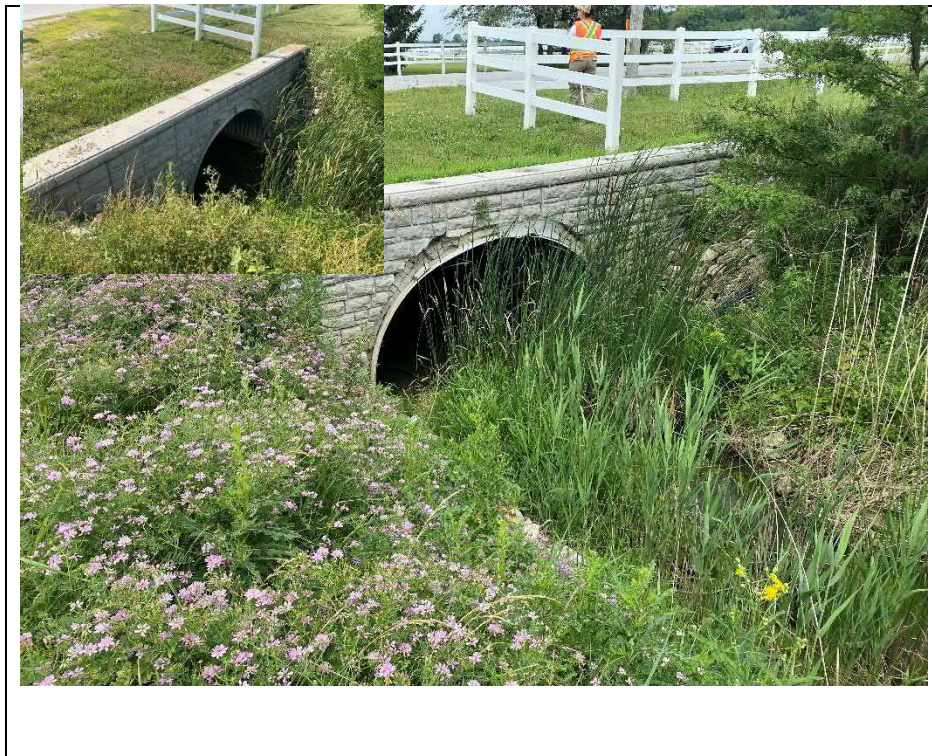
Photograph 4: East elevation with excessive vegetation (Looking North)

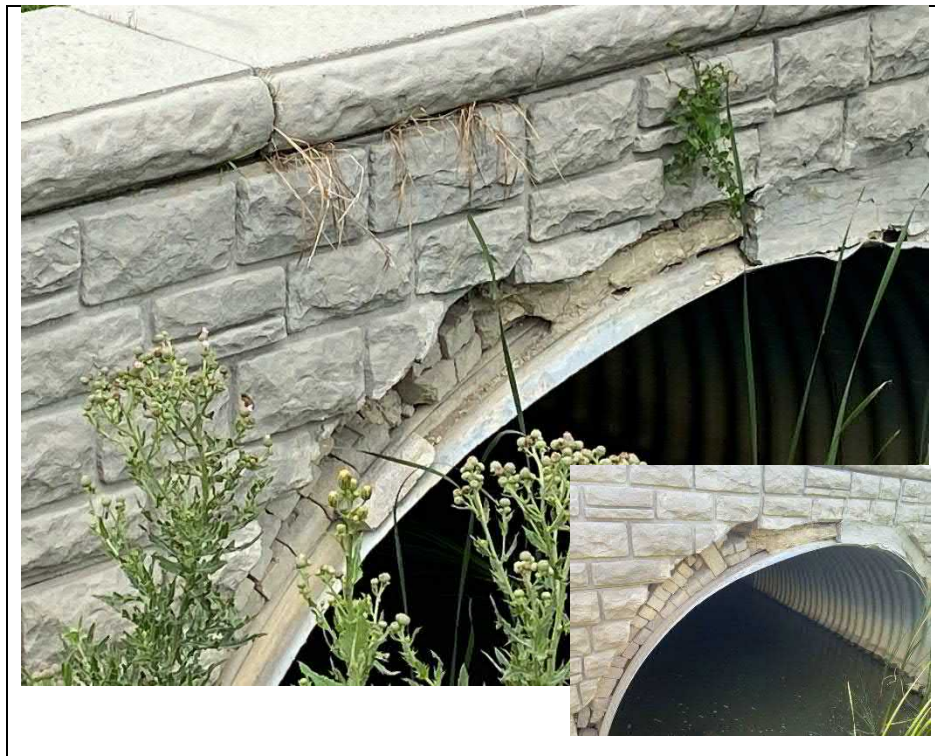
Photograph 6: Headwall joint with severe spalling of grout, signs of precast wall unit movement (typ.)

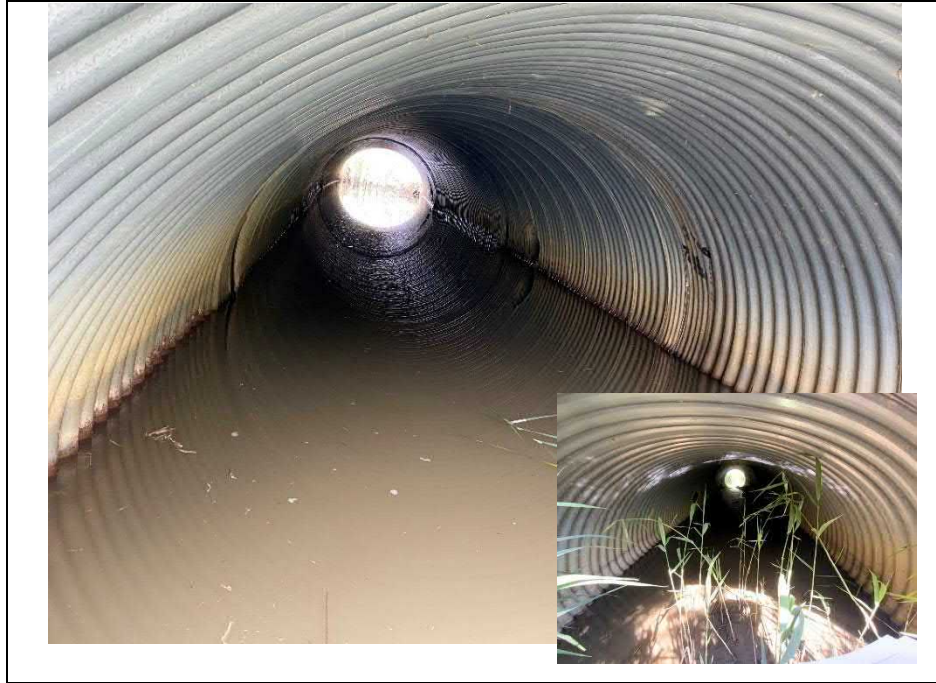
Photograph 7: Typical condition of the culvert barrel

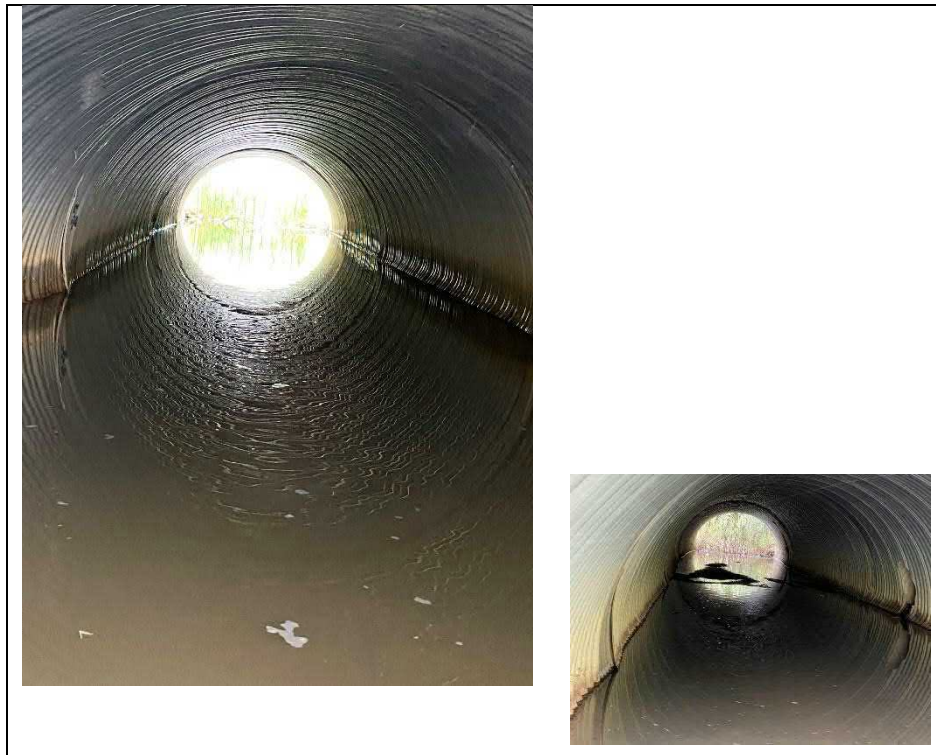
Photograph 8: Typical transverse joint deformation and light to medium corrosion along the waterline

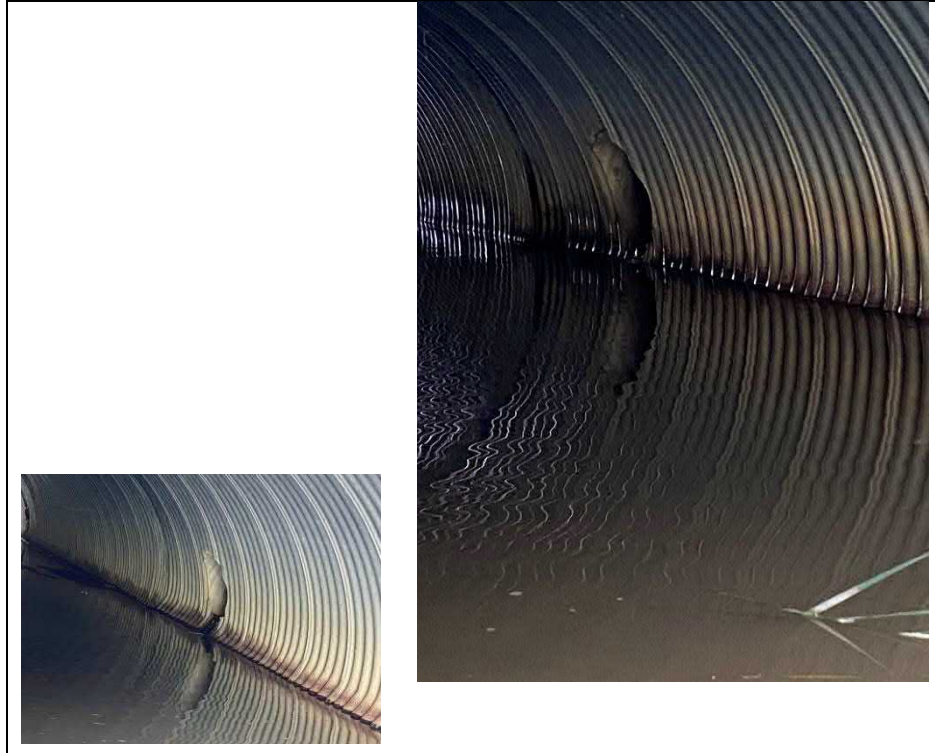
Photograph 9: Severe corrosion below outlet pipe in culvert wall

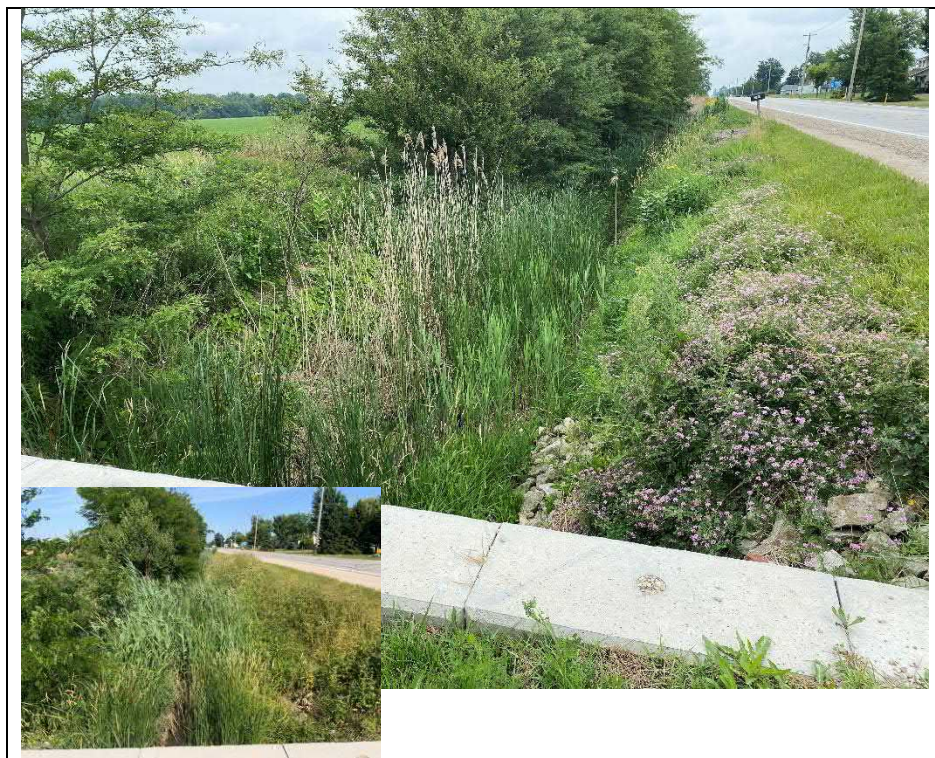
Photograph 10: Waterway, embankments and vegetation (Looking East)

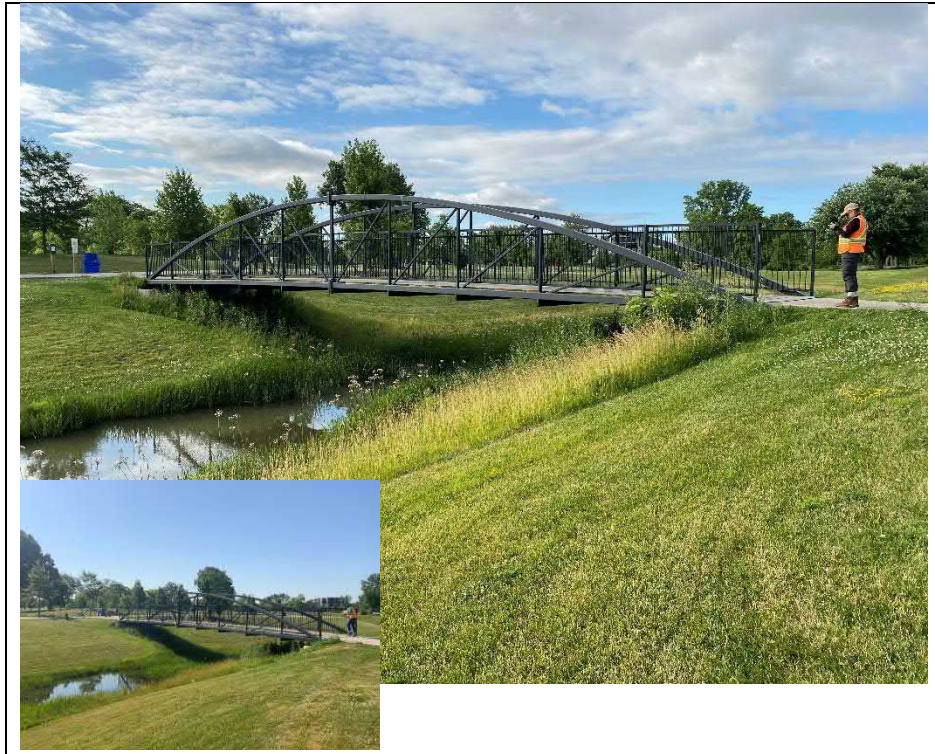
Photograph 1: North elevation

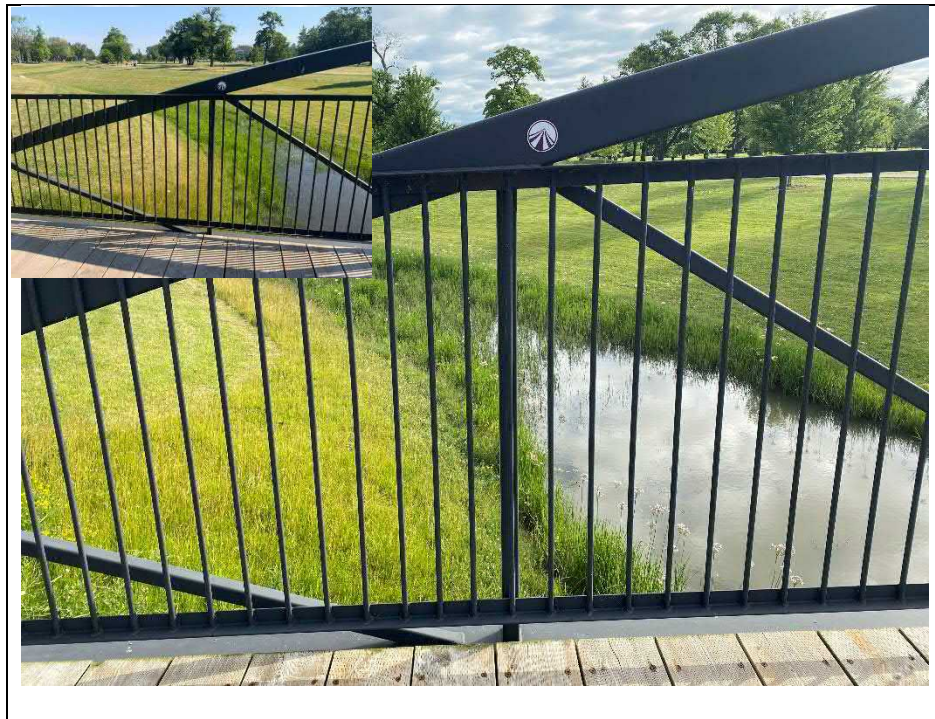
Photograph 6: Typical condition of railing (Looking North)

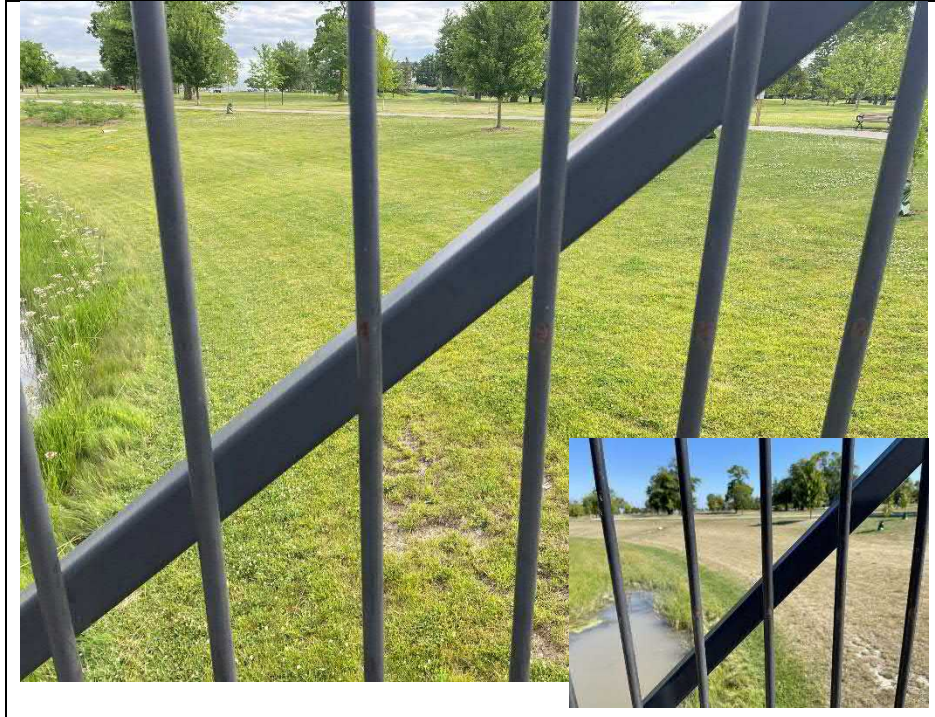
Photograph 7: Coating damage to north railing

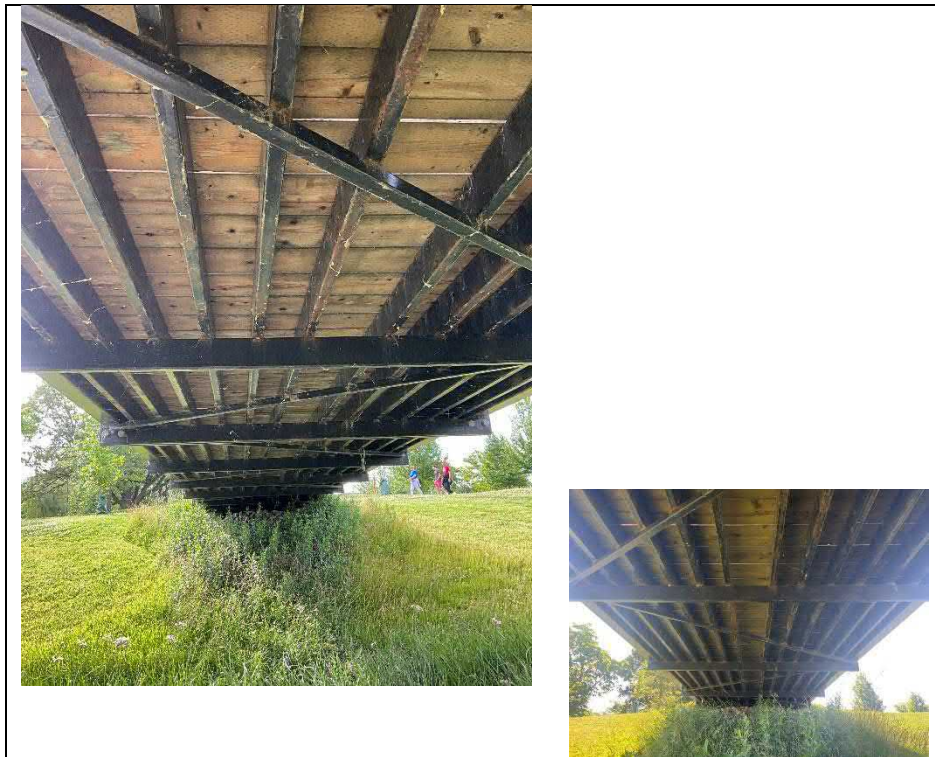
Photograph 8: Underside of deck (Looking West)

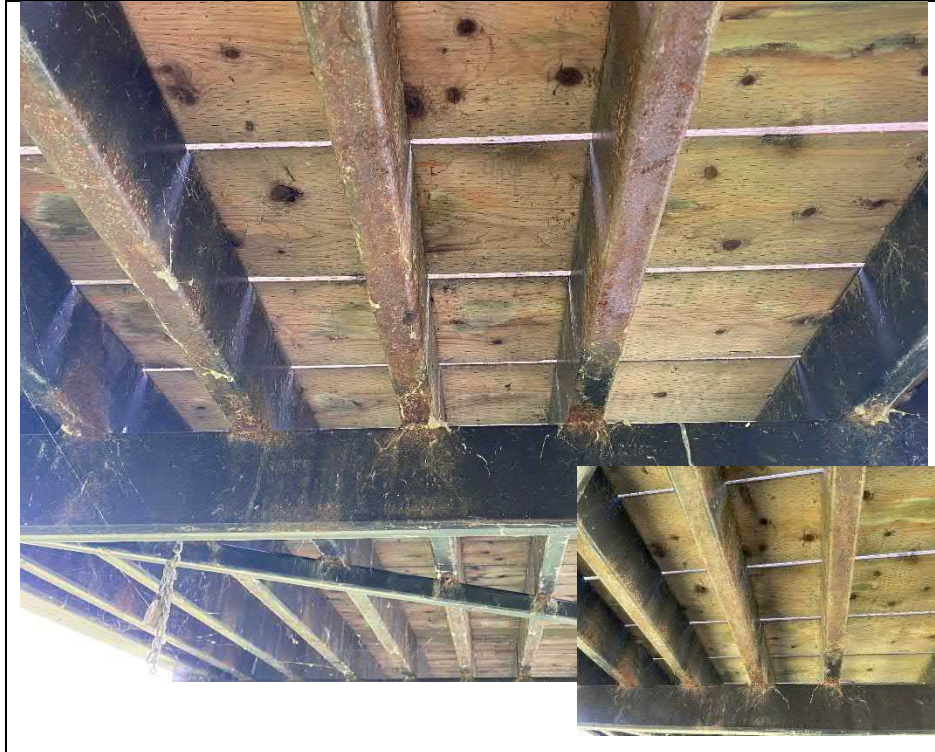
Photograph 9: Typical severe corrosion at stringer to floor beam weld locations
