CORPORATION OF THE TOWN OF TECUMSEH

2024 Bridge and Culvert Needs Study Structures with Spans > 3.0 m

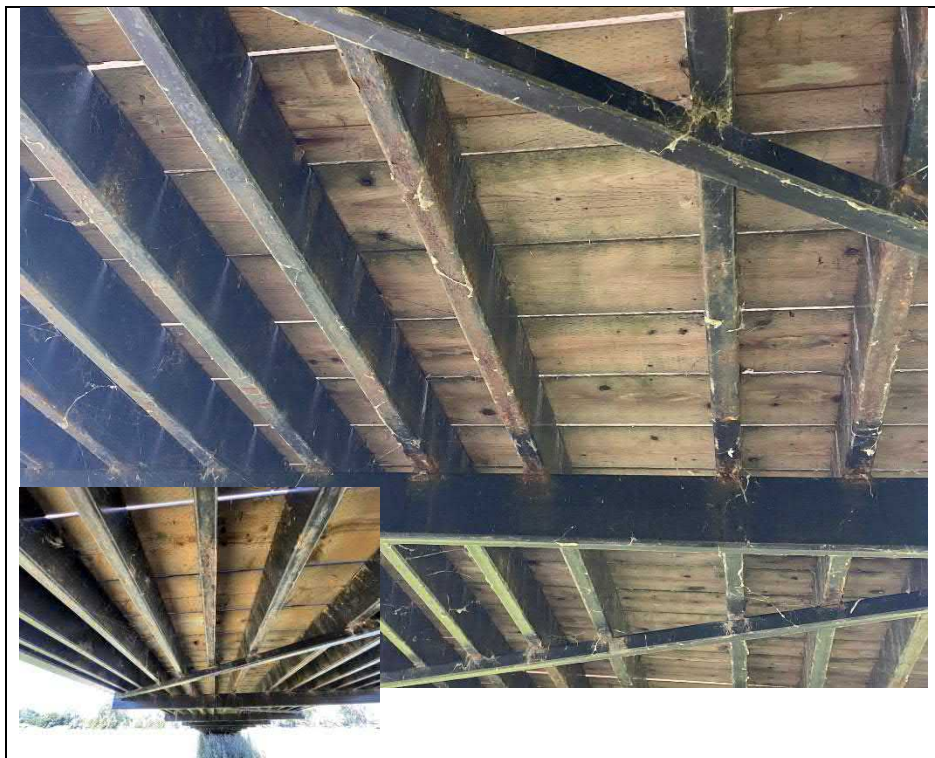
Photograph 10: Typical coating failure and light to medium corrosion throughout all stringers

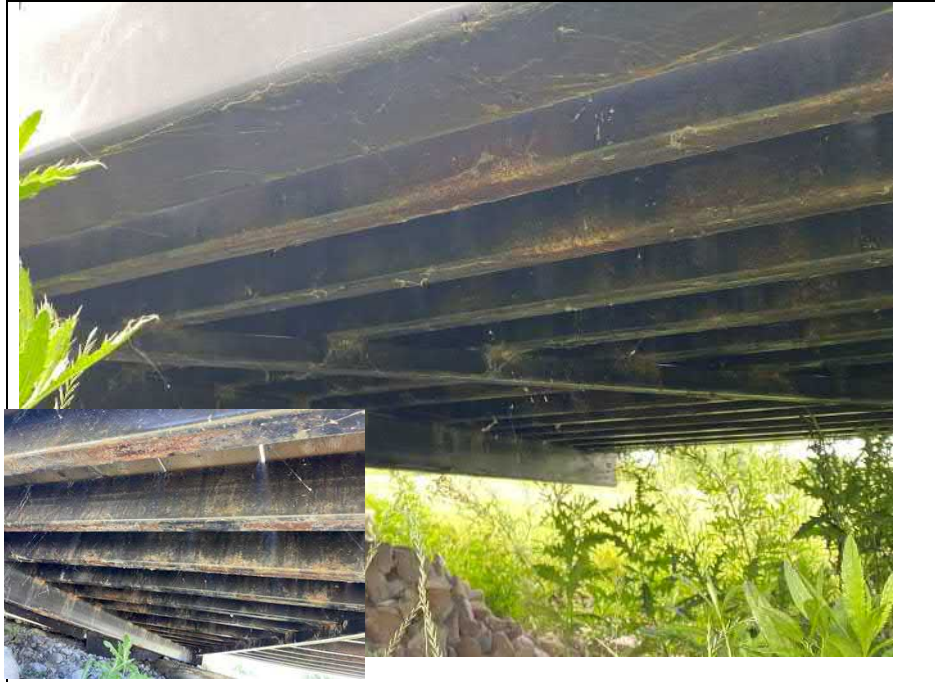
Photograph 11: Typical severe corrosion on several stringer members

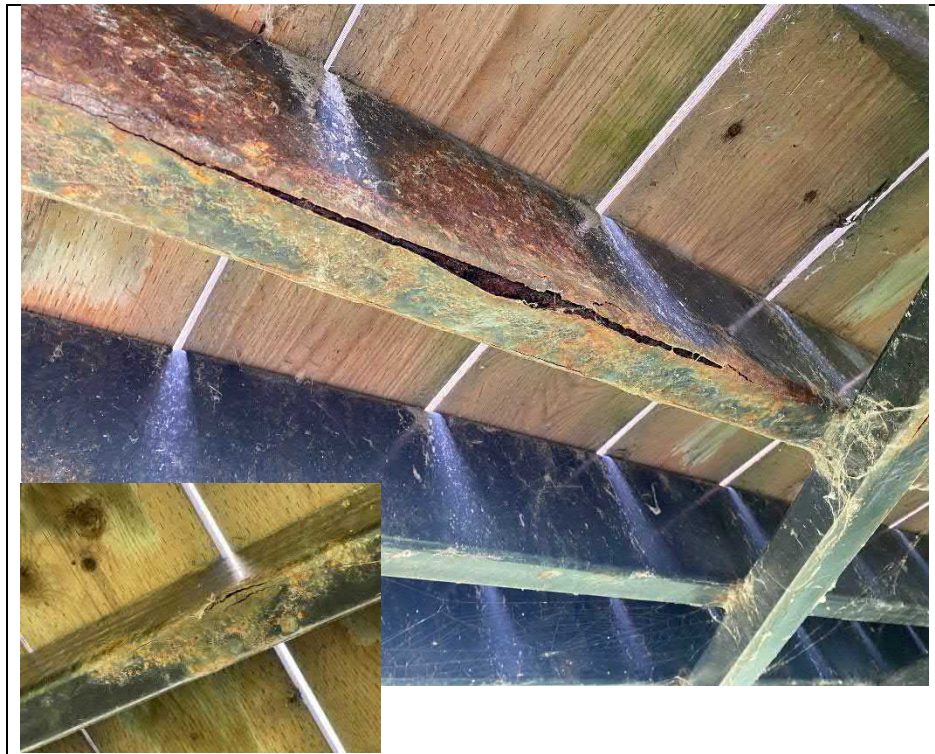
Photograph 12: Perforation observed on one stringer member

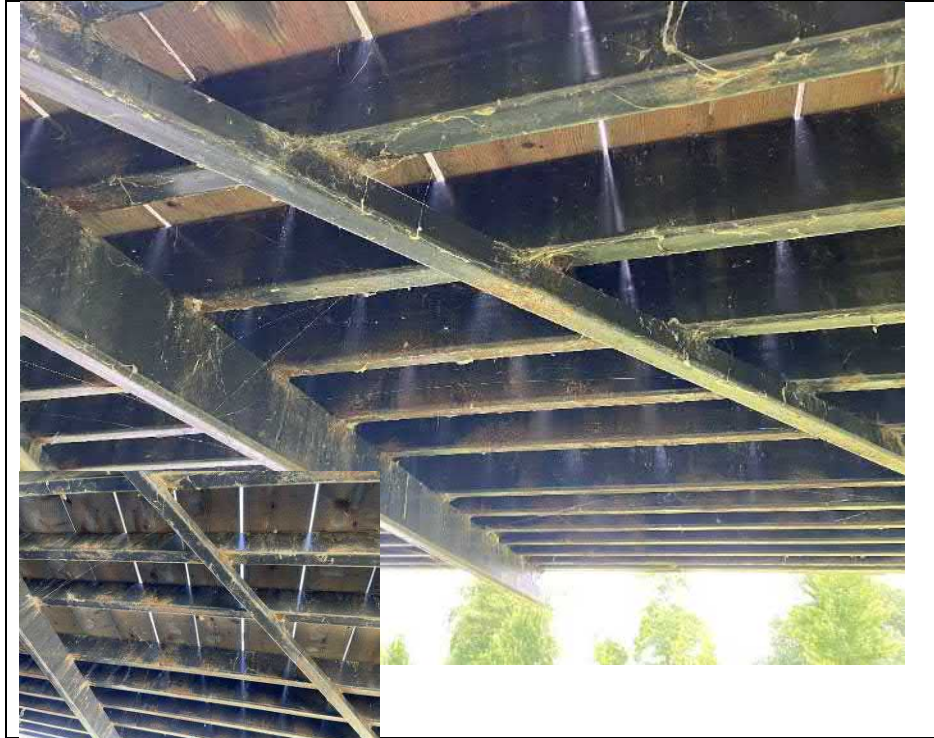
Photograph 13: Typical corrosion and coating failure of all members in the floor system

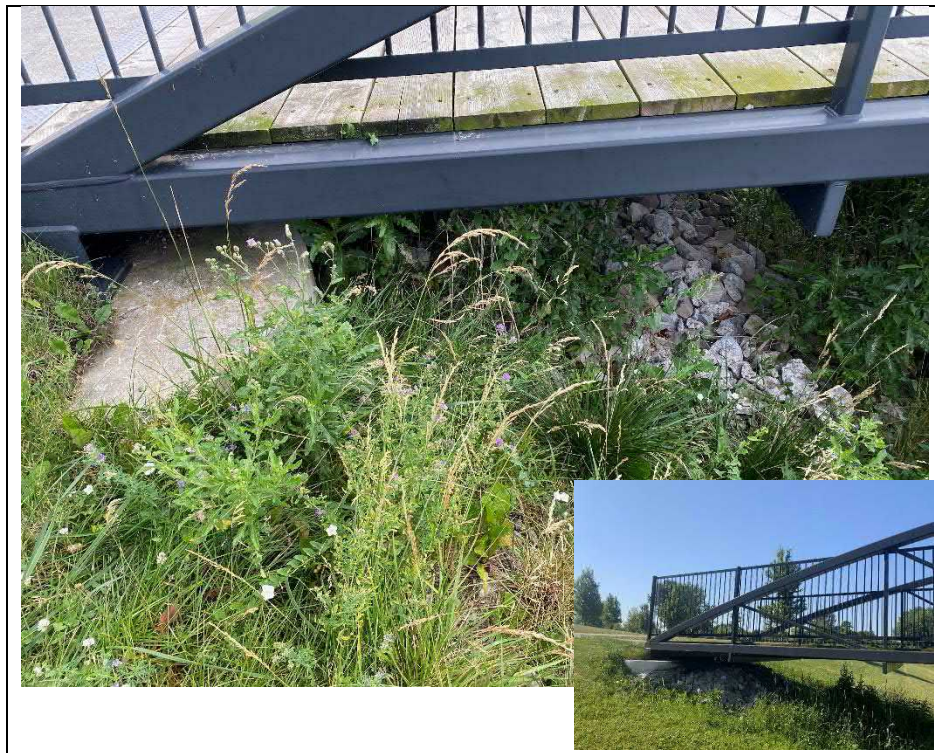
Photograph 14: Typical reinforced concrete caisson and embankment

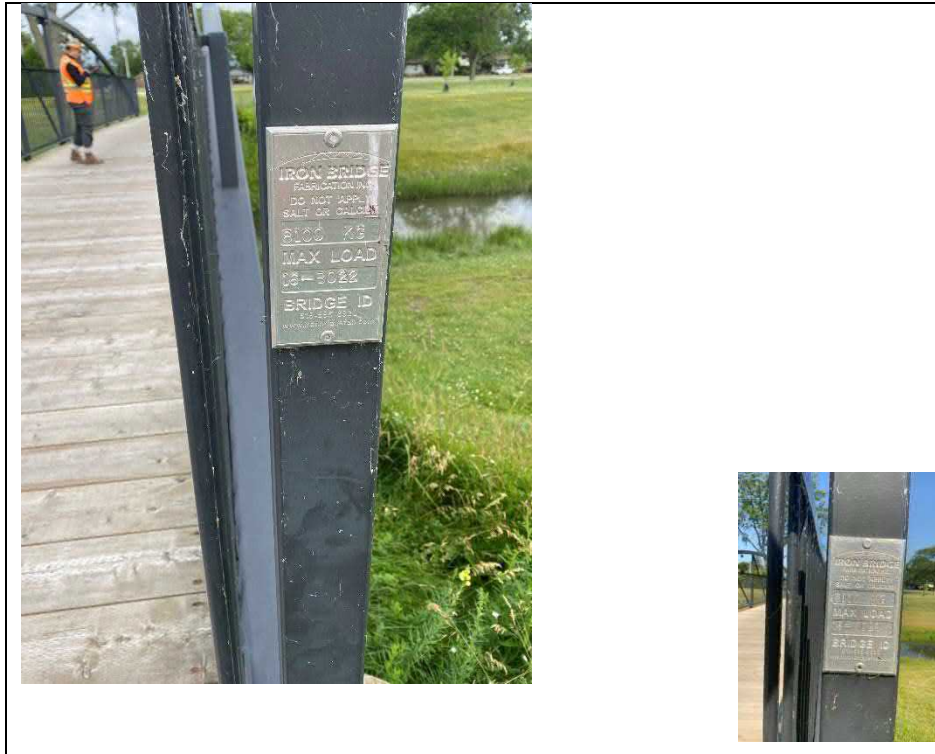
Photograph 15: Bridge ID found at northeast quadrant of structure

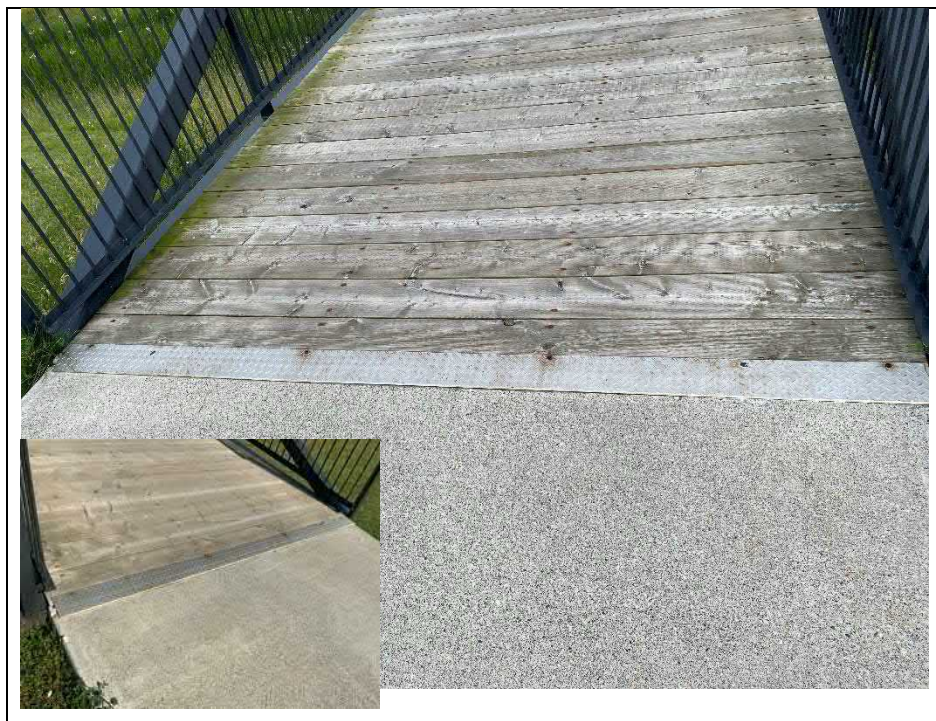
Photograph 16: Threshold plate at east approach

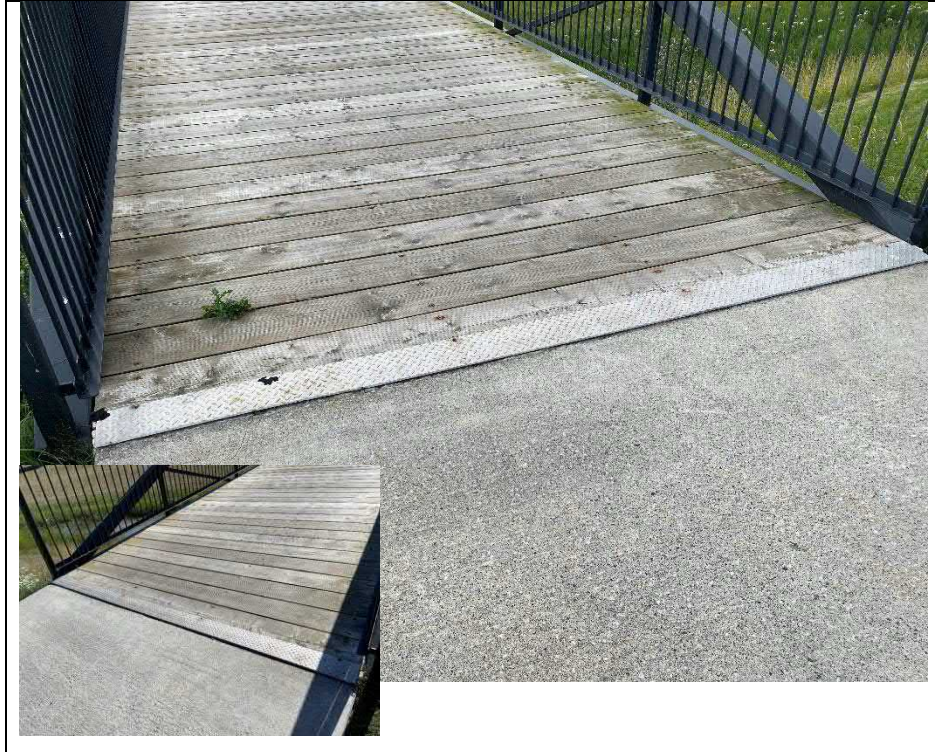
Photograph 17: Loose Threshold plate at west approach

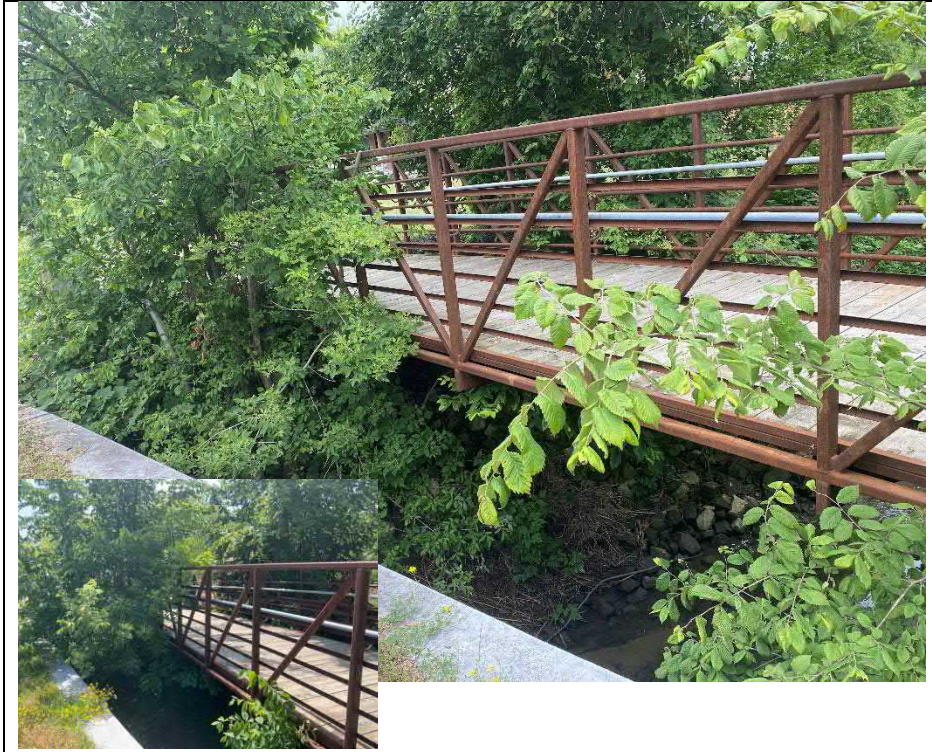
Photograph 1: East elevation of structure (Looking Southwest)

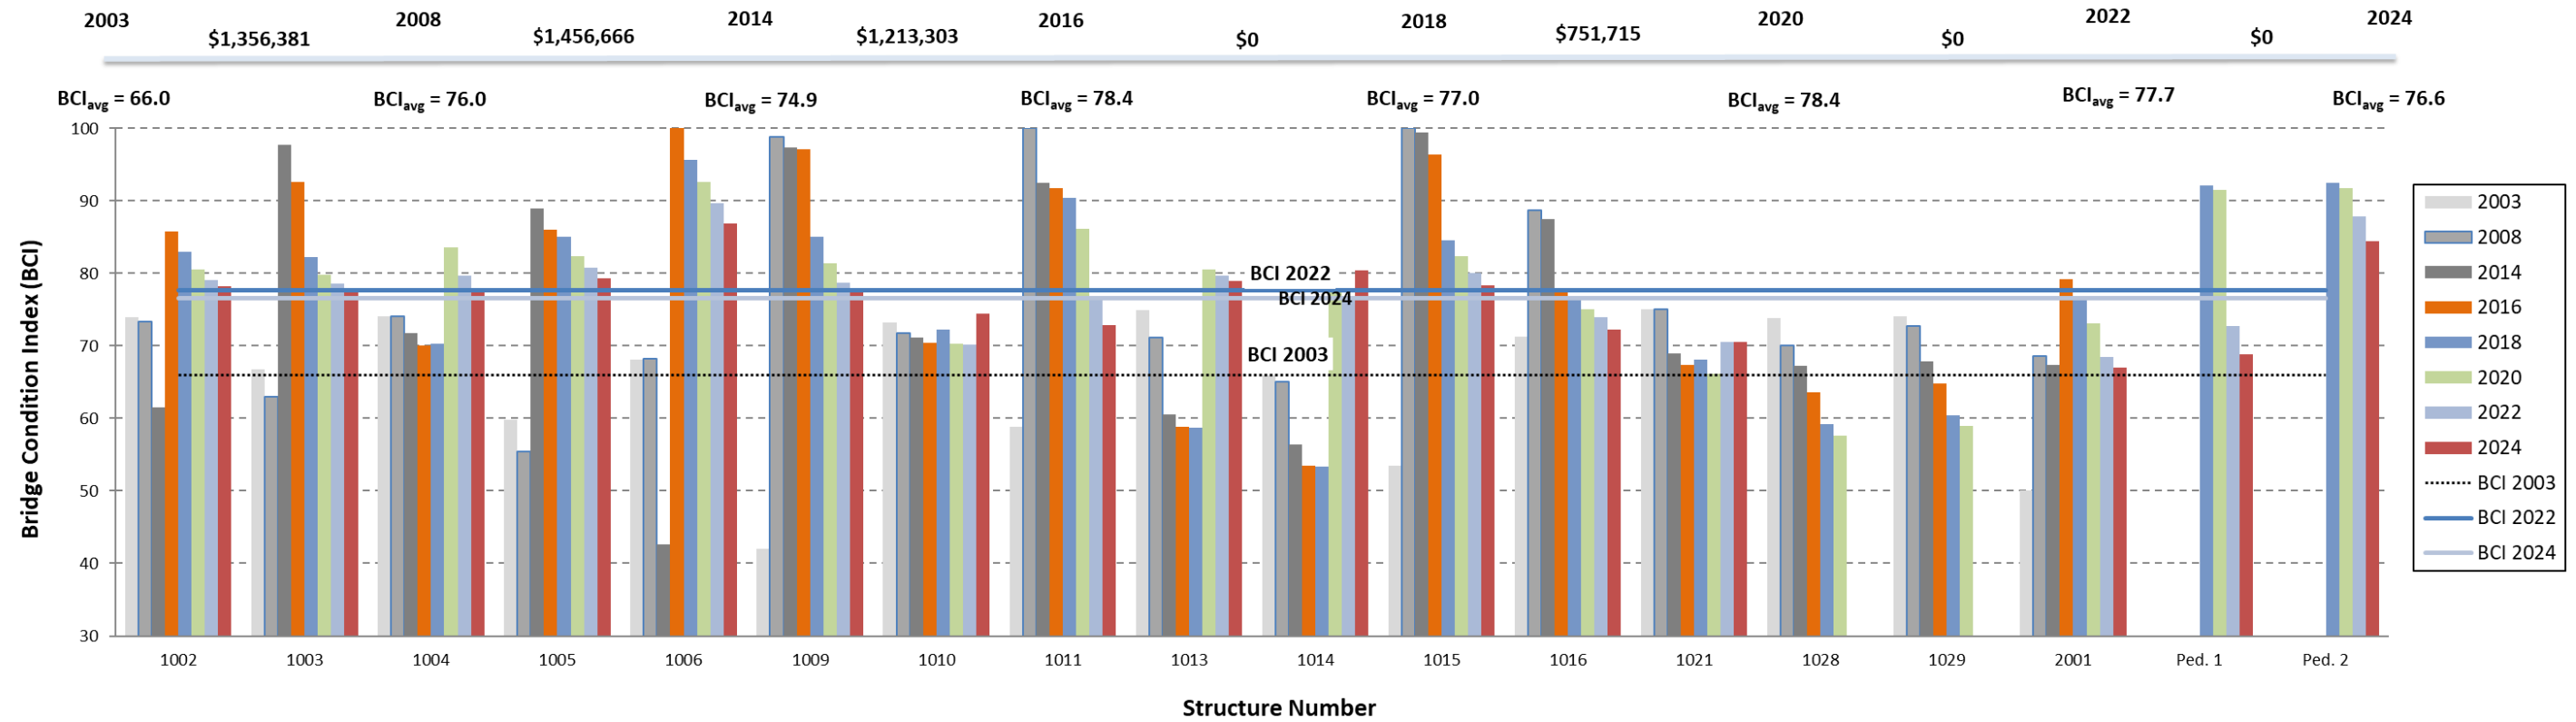
Town of Tecumseh - BCI Trends

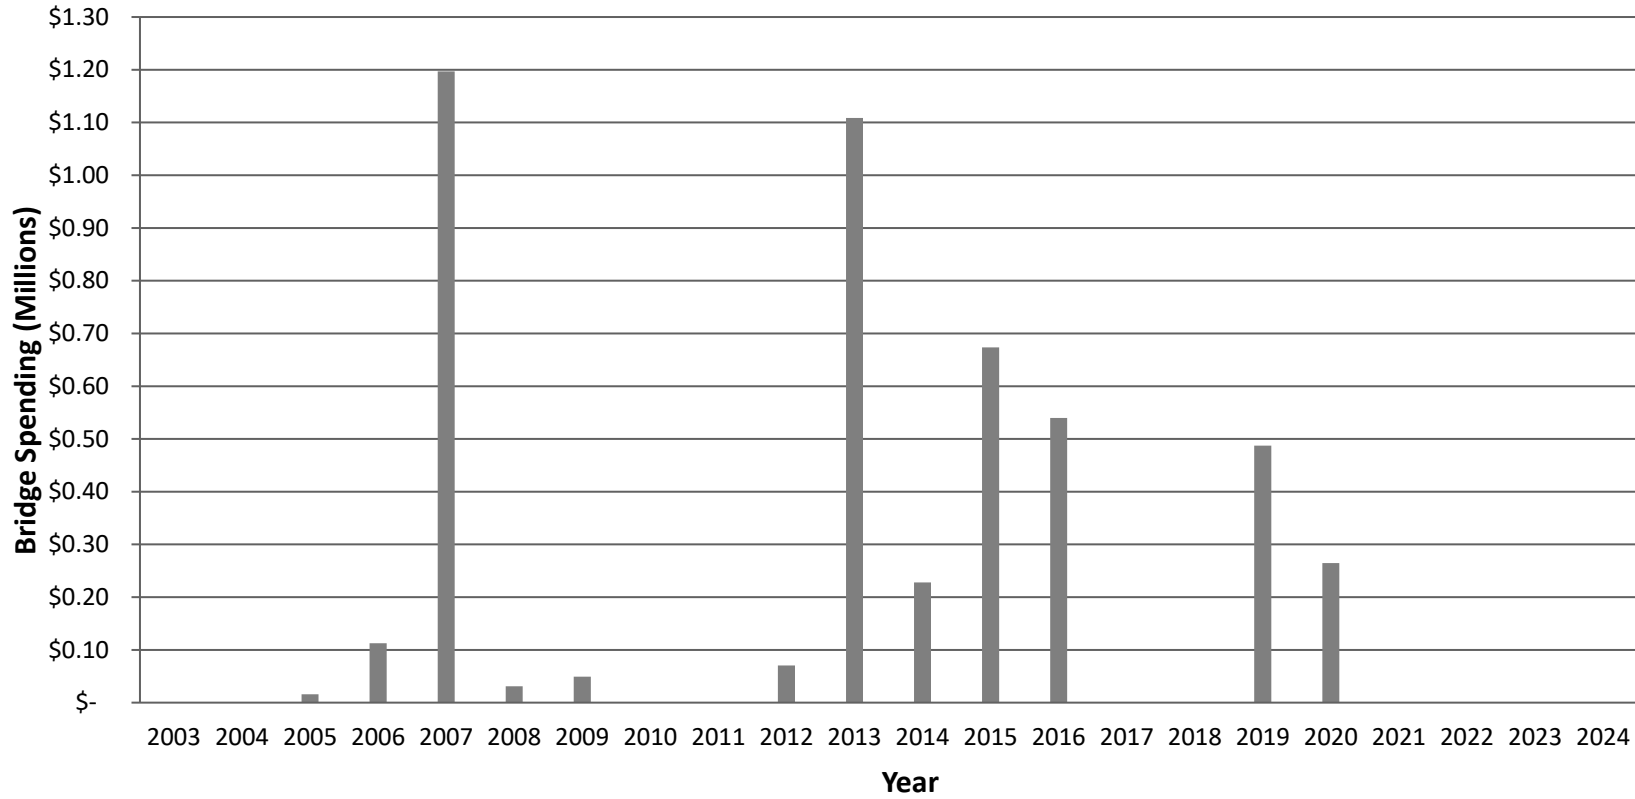
Town of Tecumseh - Historic Major Bridge (Rehab./Replacement) Spending (2003 - 2024)
