CORPORATE OF THE TOWN OF TECUMSEH
2016 Culvert Needs Study

Structures with Spans $\leq 3.0\text{m}$ – Final Report

Our File: 15-2977

October 28, 2016

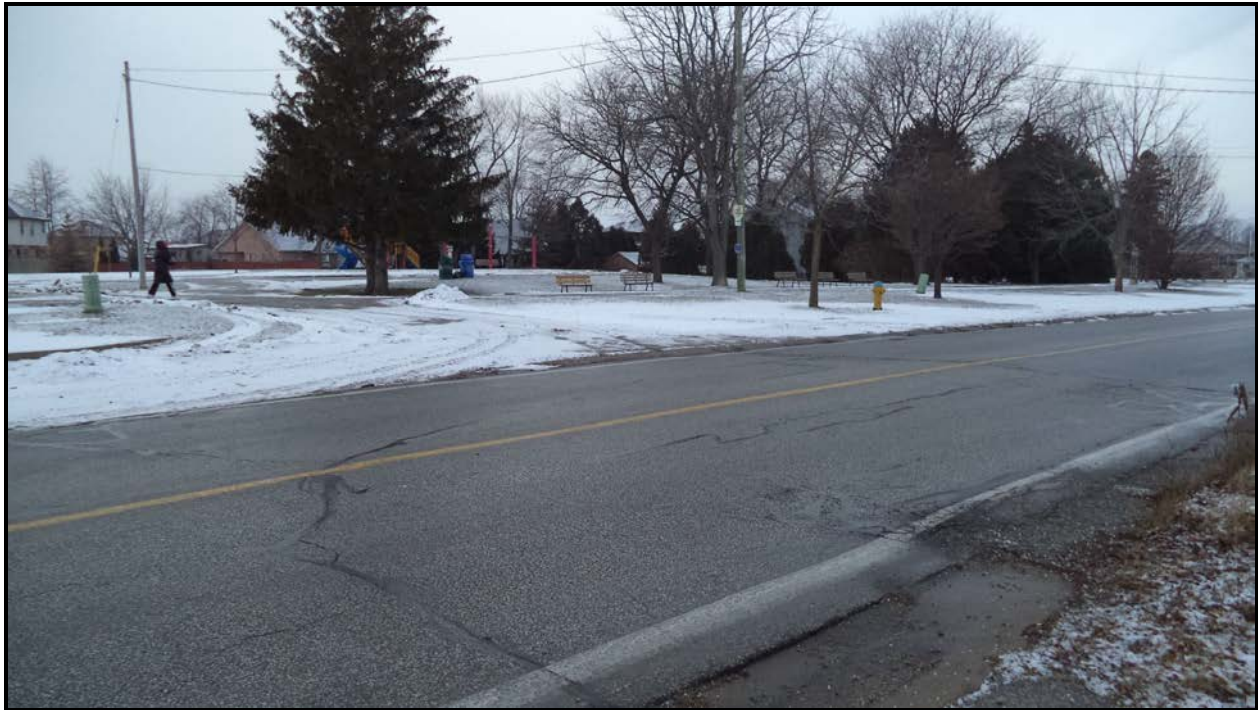
Photograph 1 – Road over Culvert (Looking South)

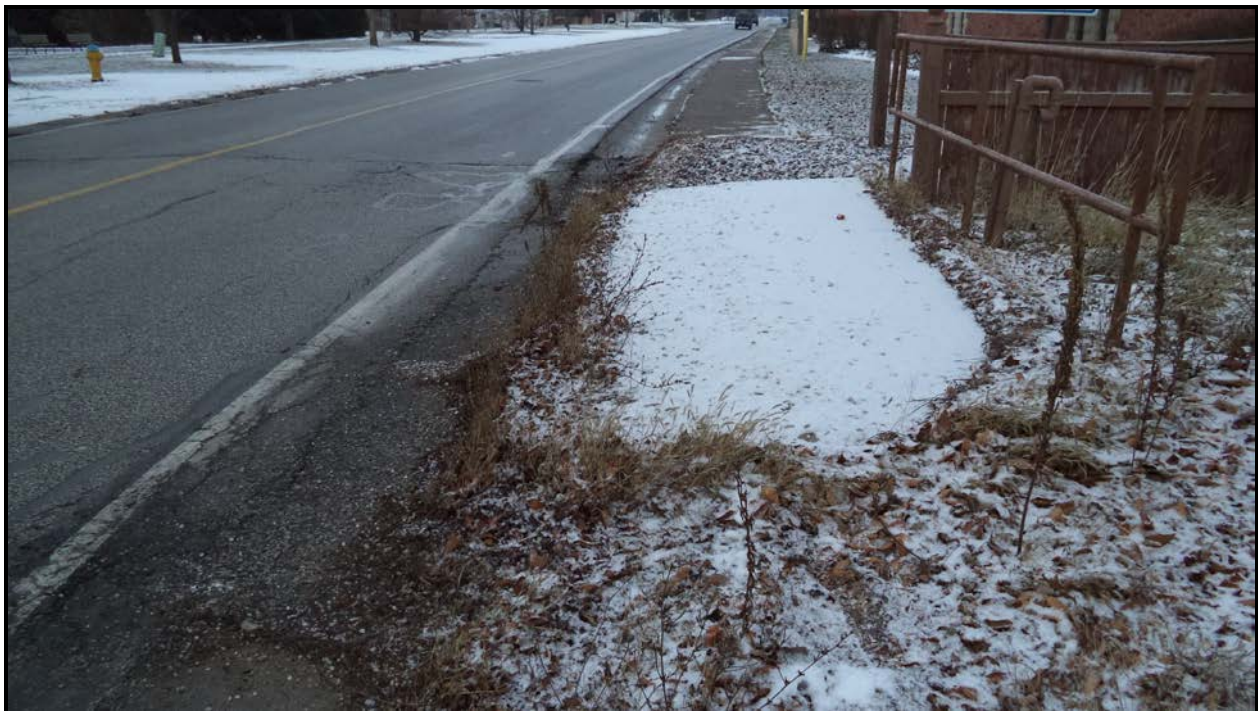
Photograph 2 – Sidewalk and Handrail over North Outlet (Looking West)

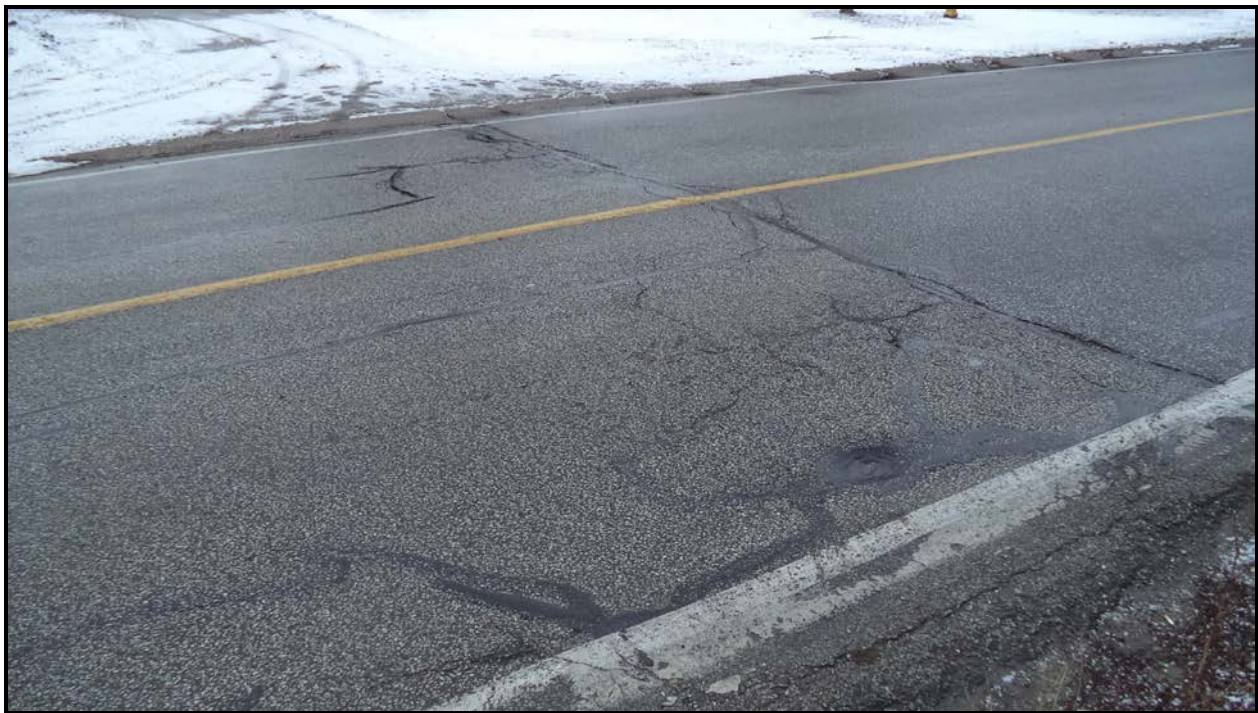
Photograph 4 – Wearing Surface over Culvert (Looking South)

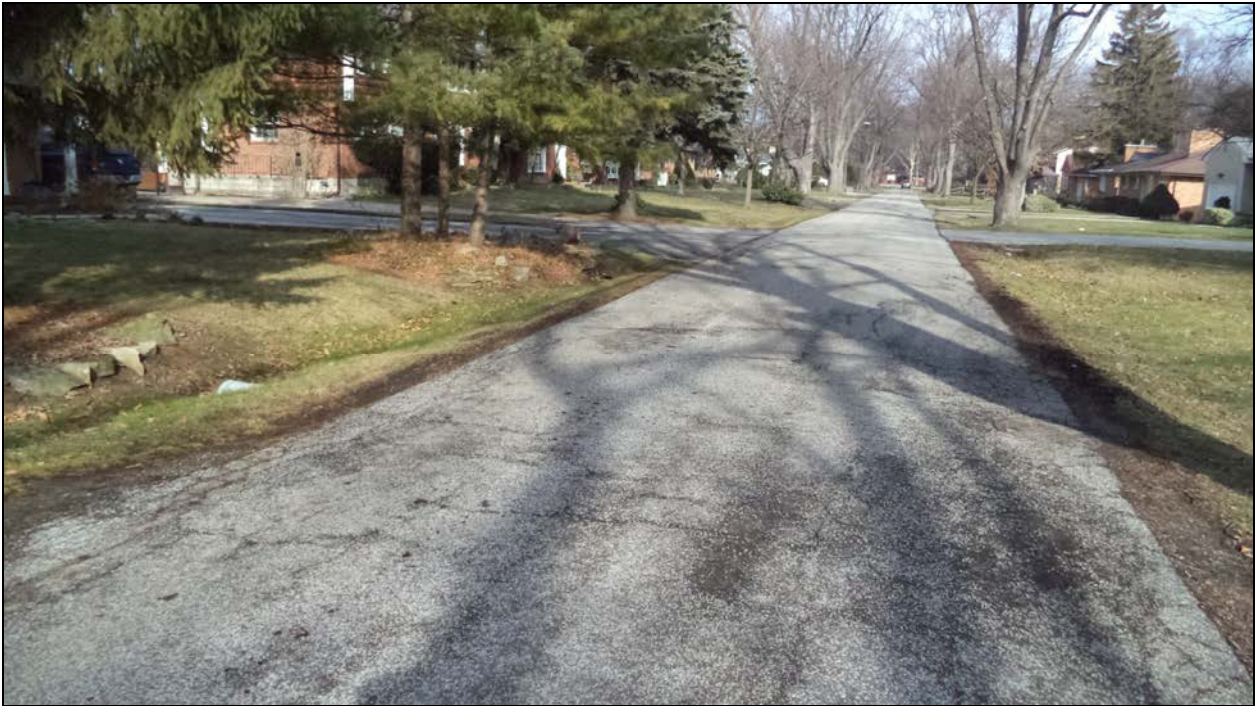
Photograph 1 – Road over Culvert (Looking North)

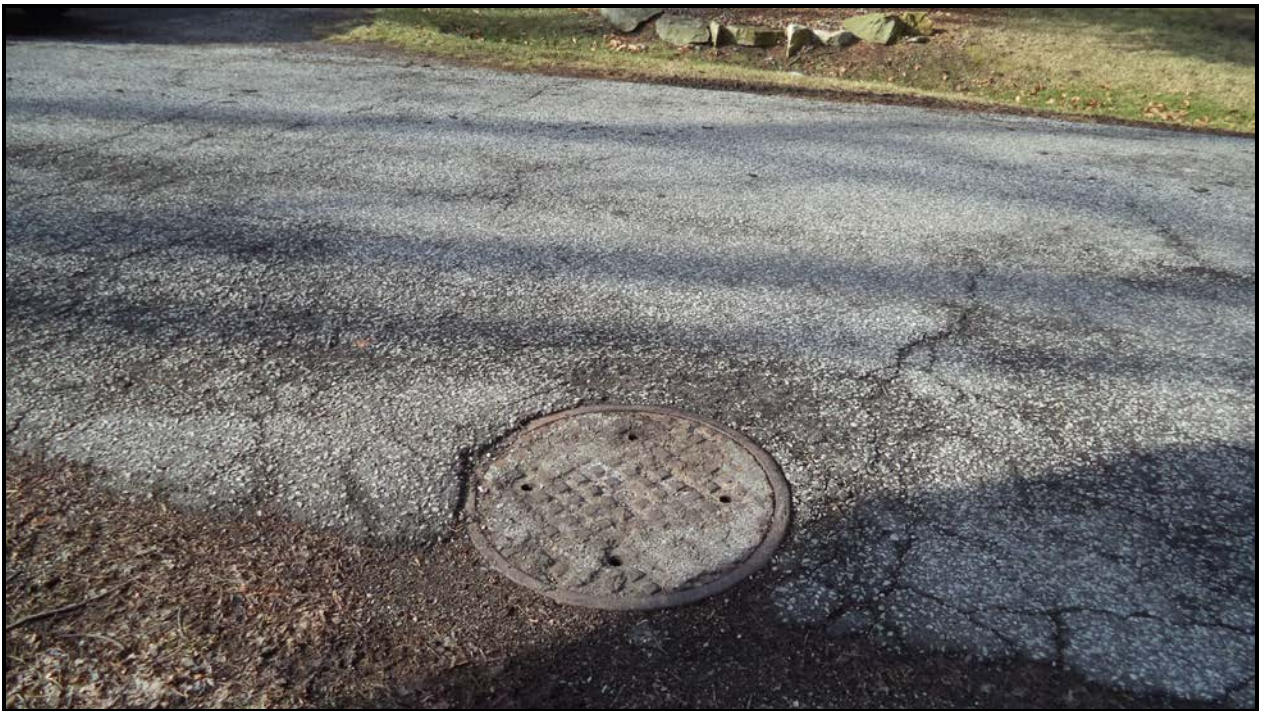
Photograph 4 – Wearing Surface over Culvert (Looking West)

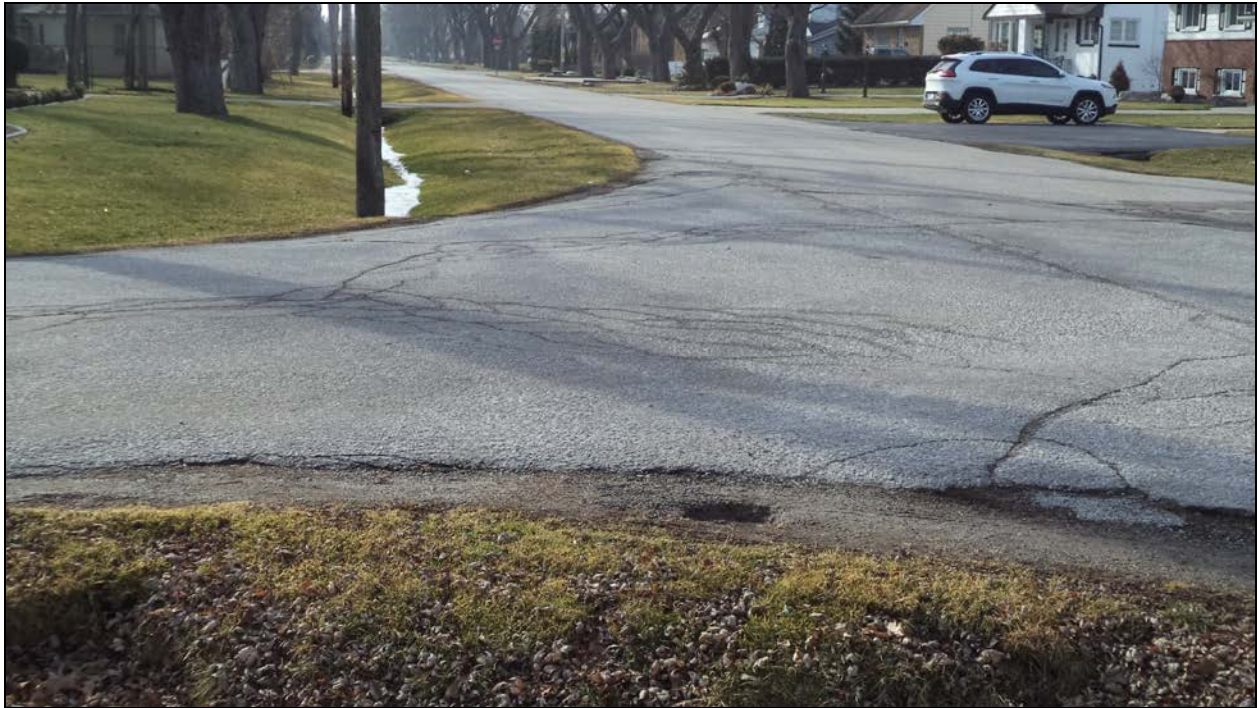
Photograph 1 – Road over Culvert (Looking West)

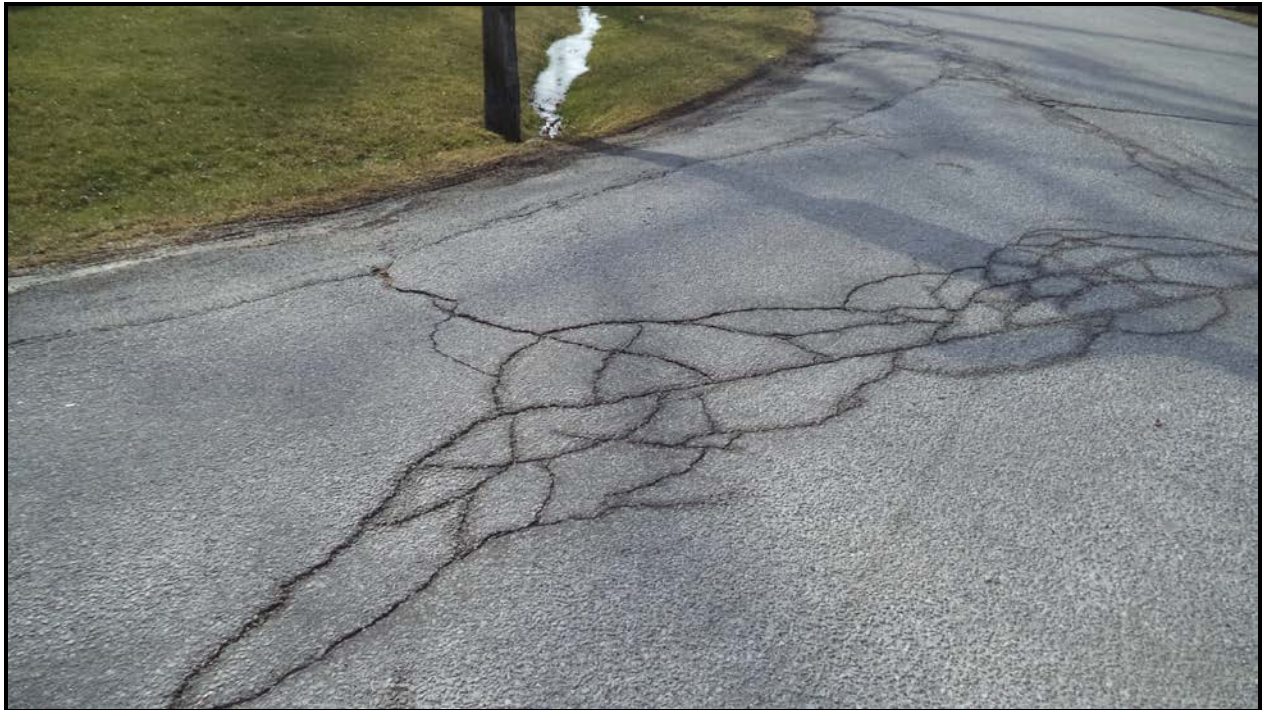
Photograph 5 – Wearing Surface over Culvert (Looking South)

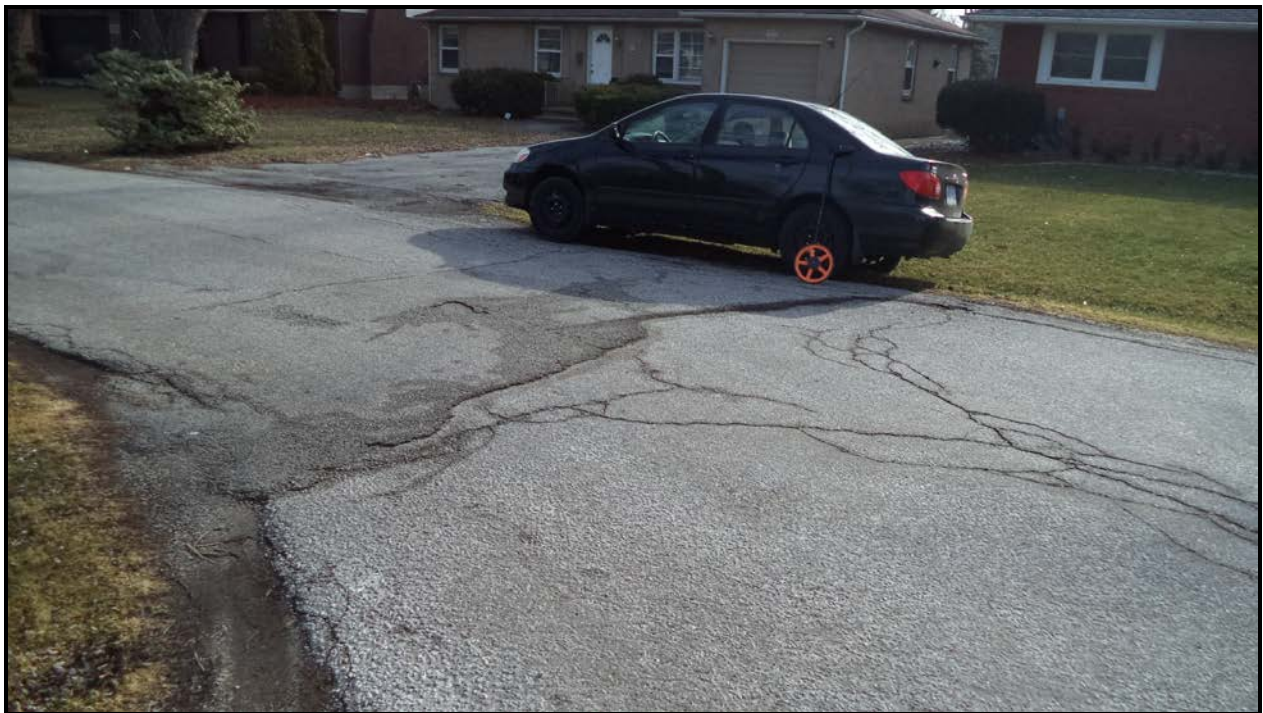
Photograph 6 – Wearing Surface at East approach

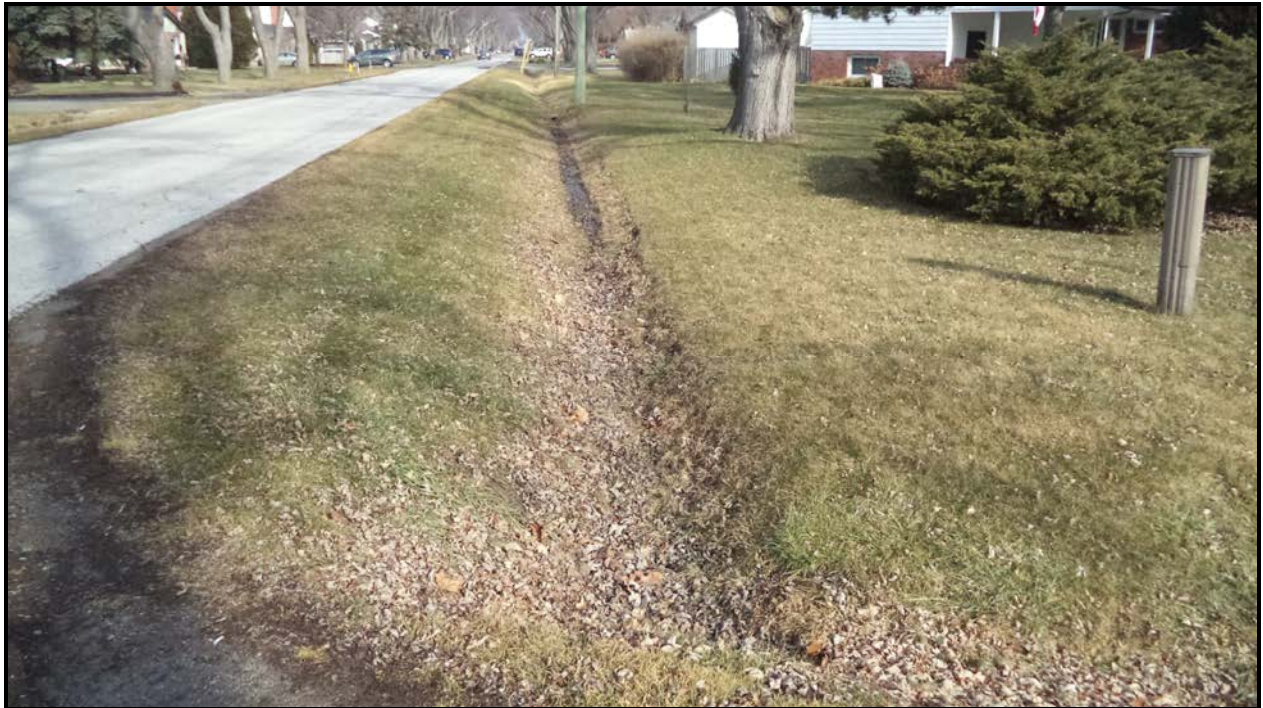
Photograph 7 – Water Stream (Arlington Blvd. Road East Side - Looking North)

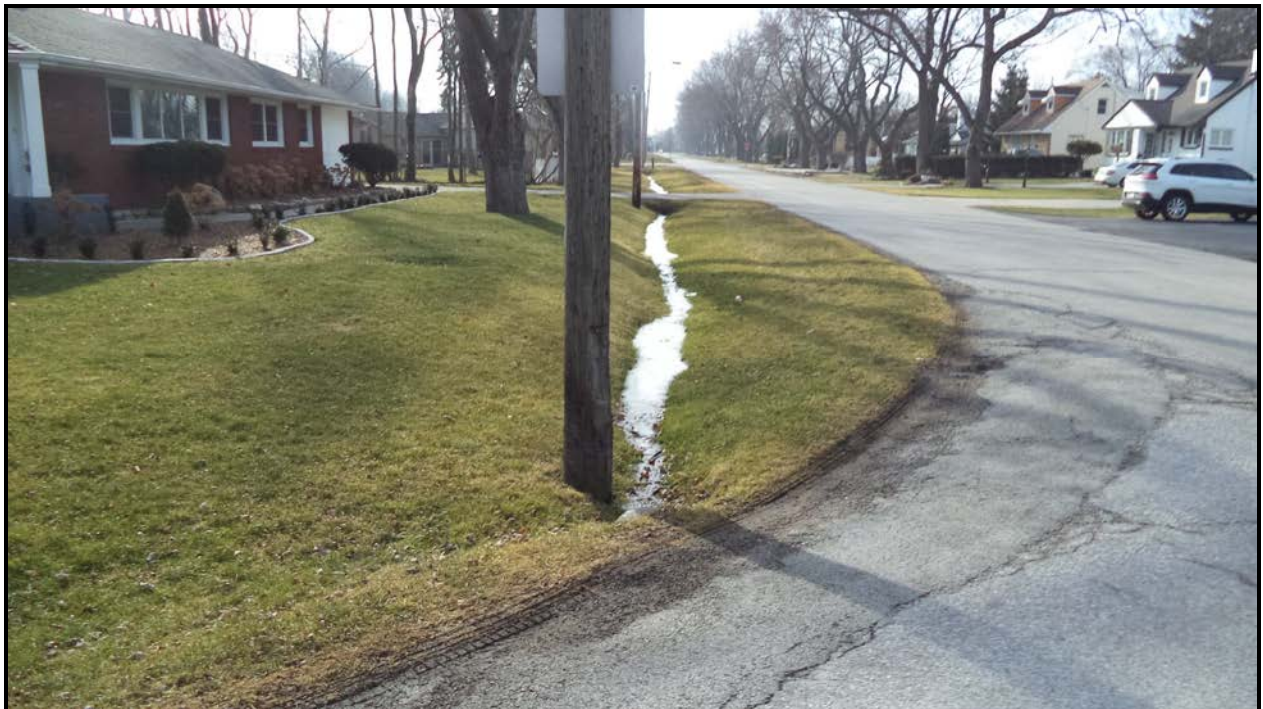
Photograph 8 – Water Stream (Arlington Blvd. Road East Side - Looking South)

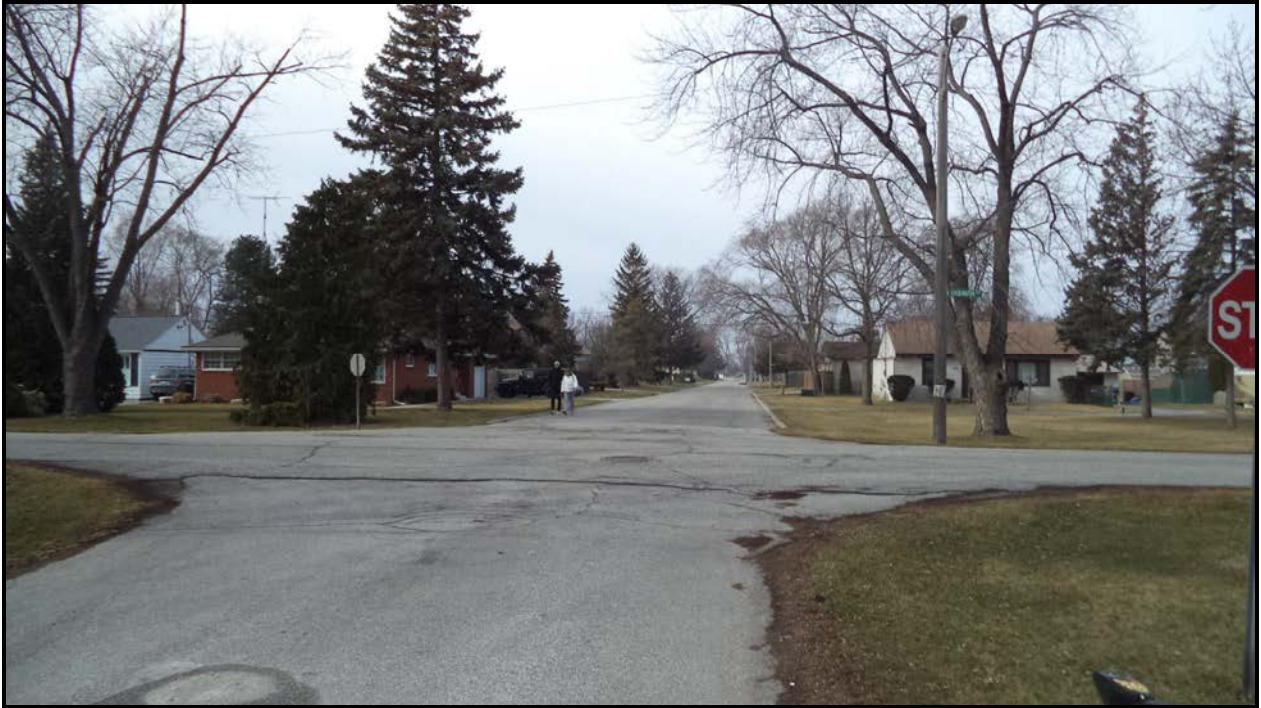
Photograph 1 – Road over Culvert (Looking West)

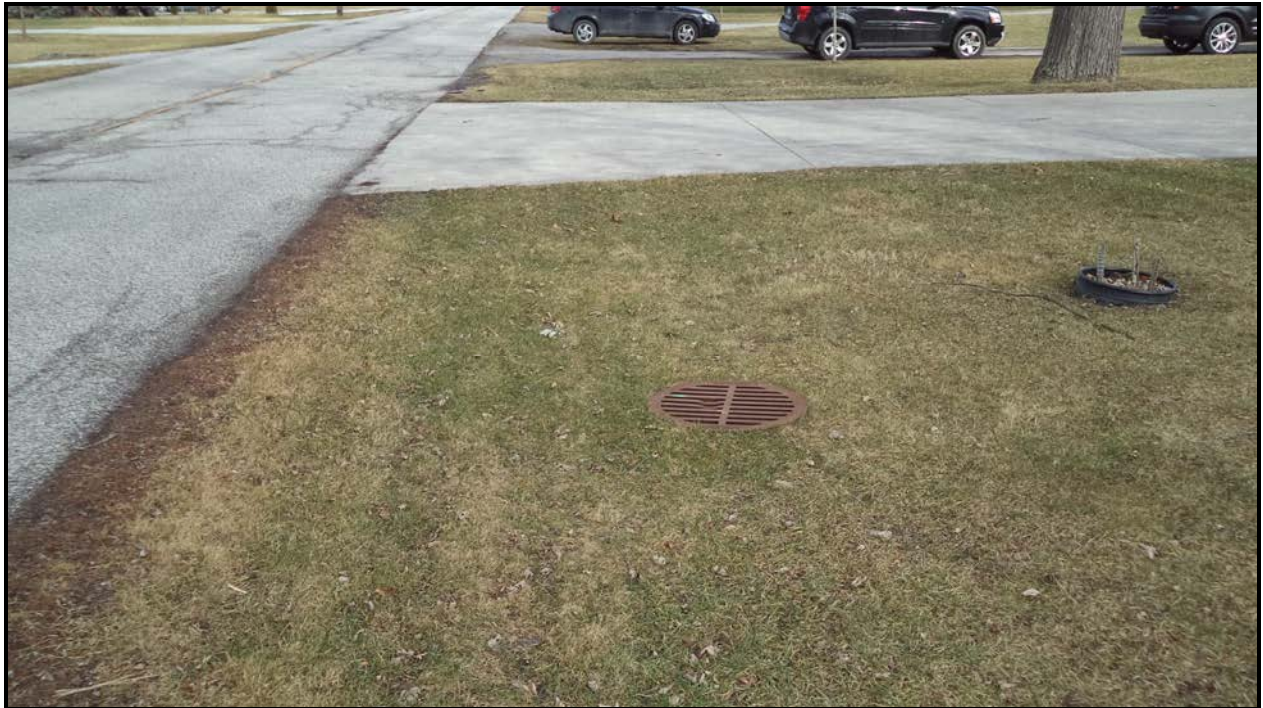
Photograph 3 – North Inlet Manhole

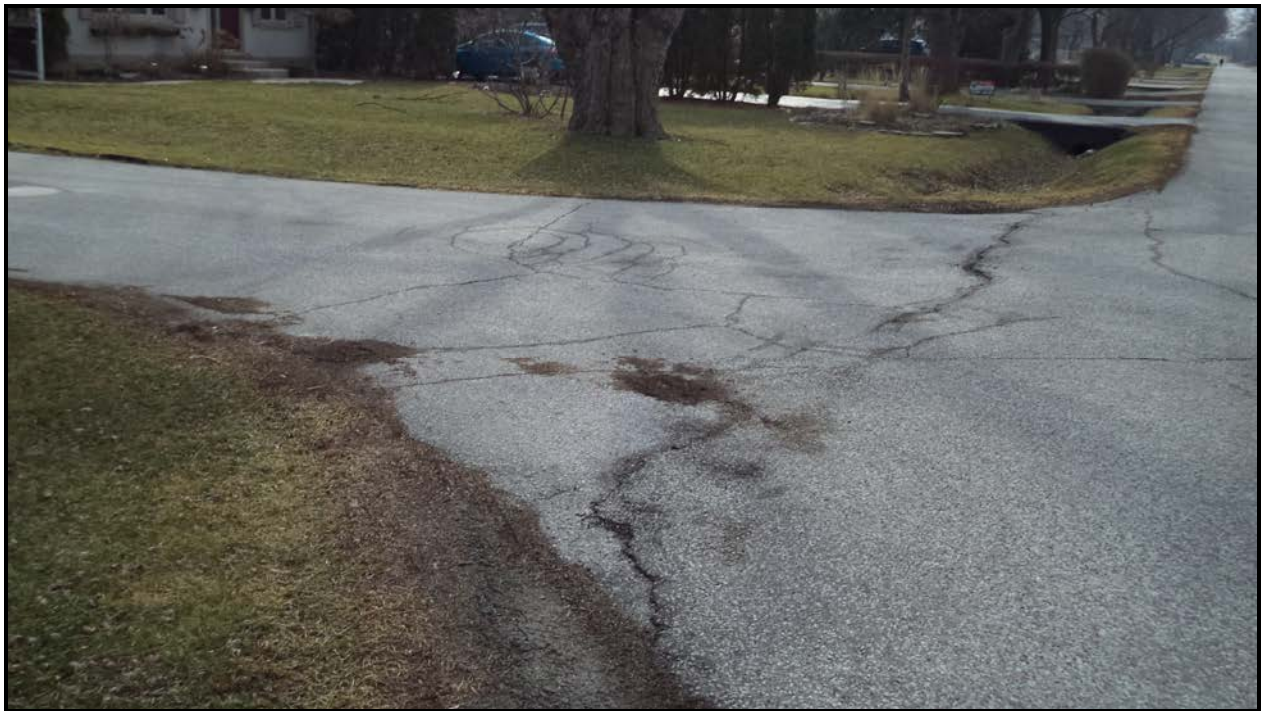
Photograph 6 – Wearing Surface over Culvert (Looking South)

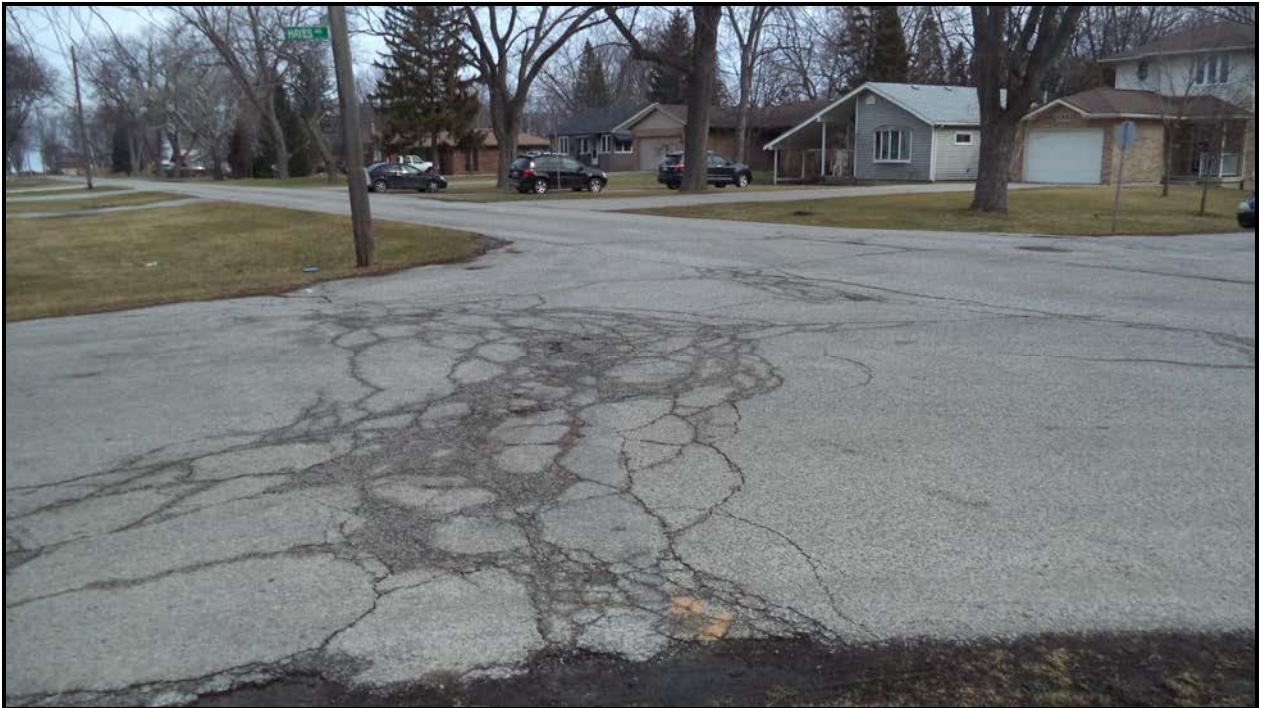
Photograph 1 – Road over Culvert (Looking North)

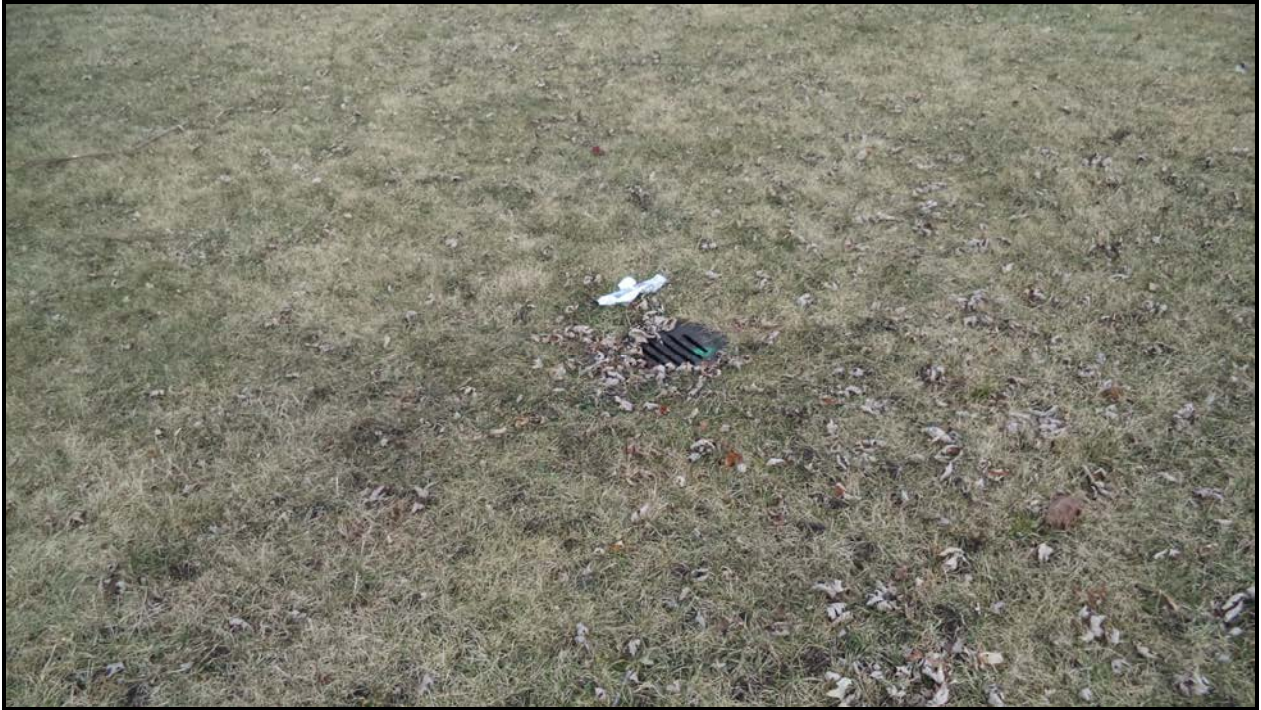
Photograph 3 – North Inlet Manhole

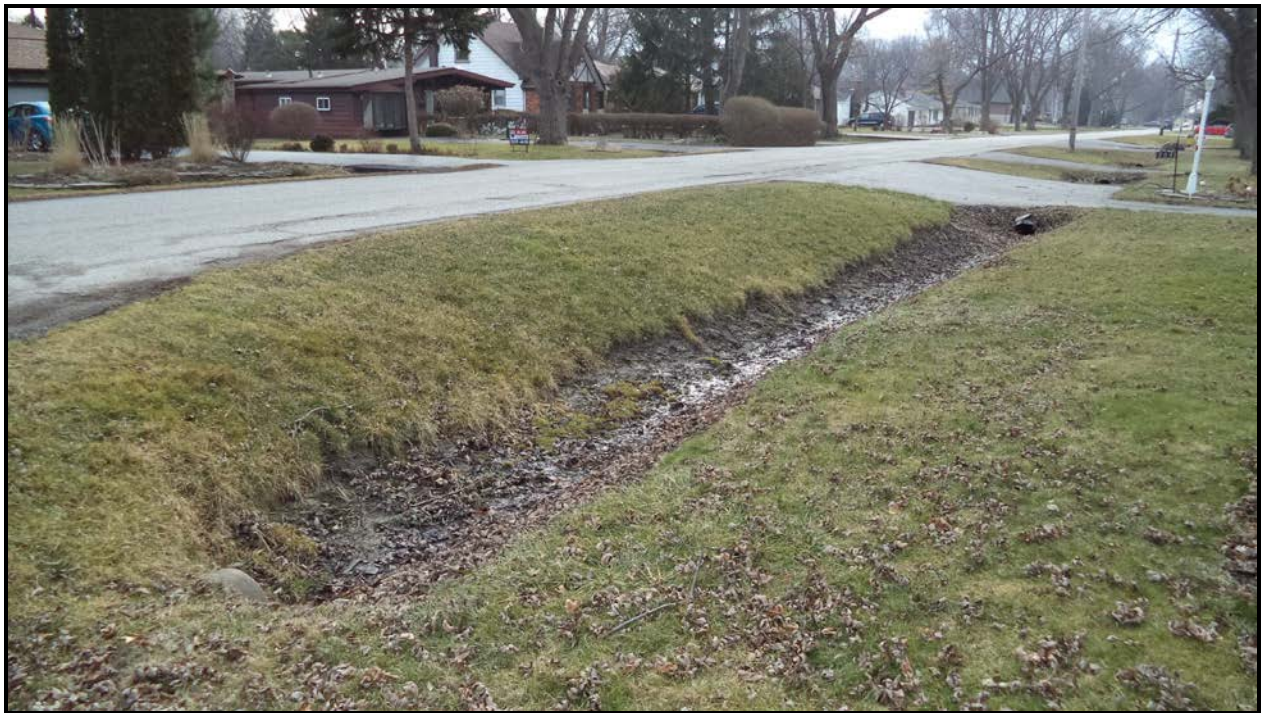
Photograph 6 – Water Stream (Edgewater Road West Side – Looking South)

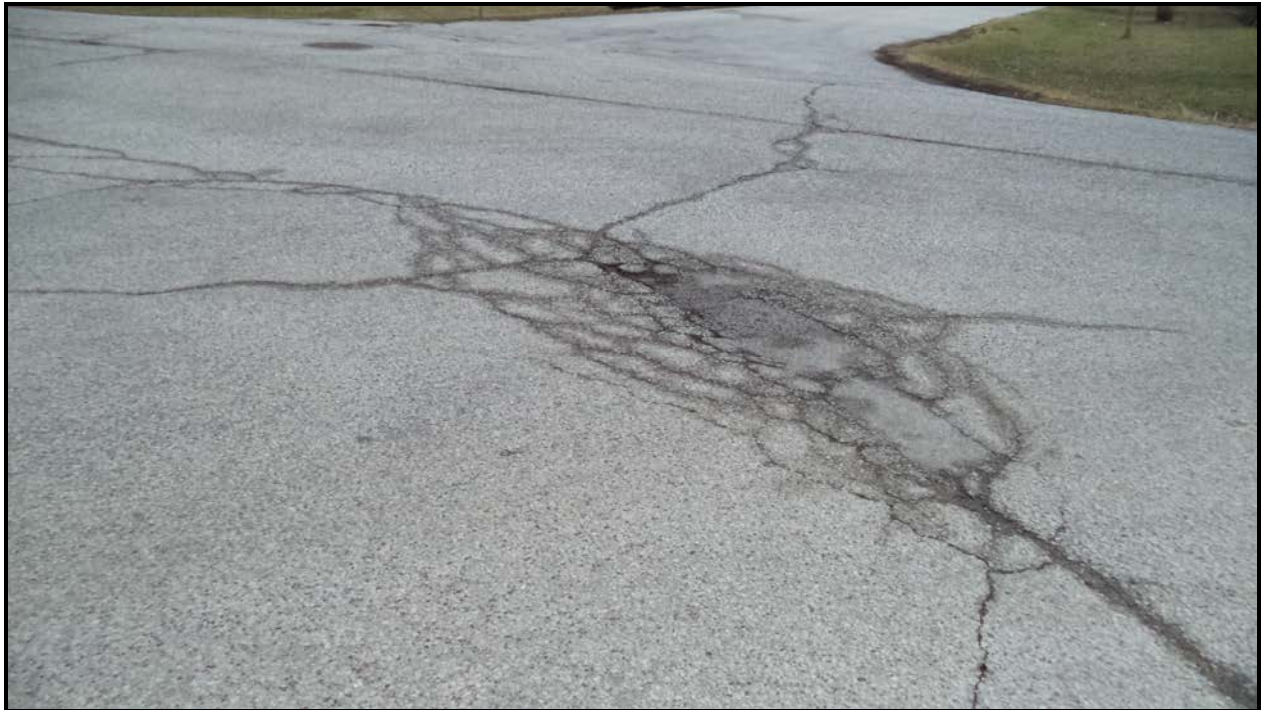
Photograph 7 – Wearing Surface at East Approach

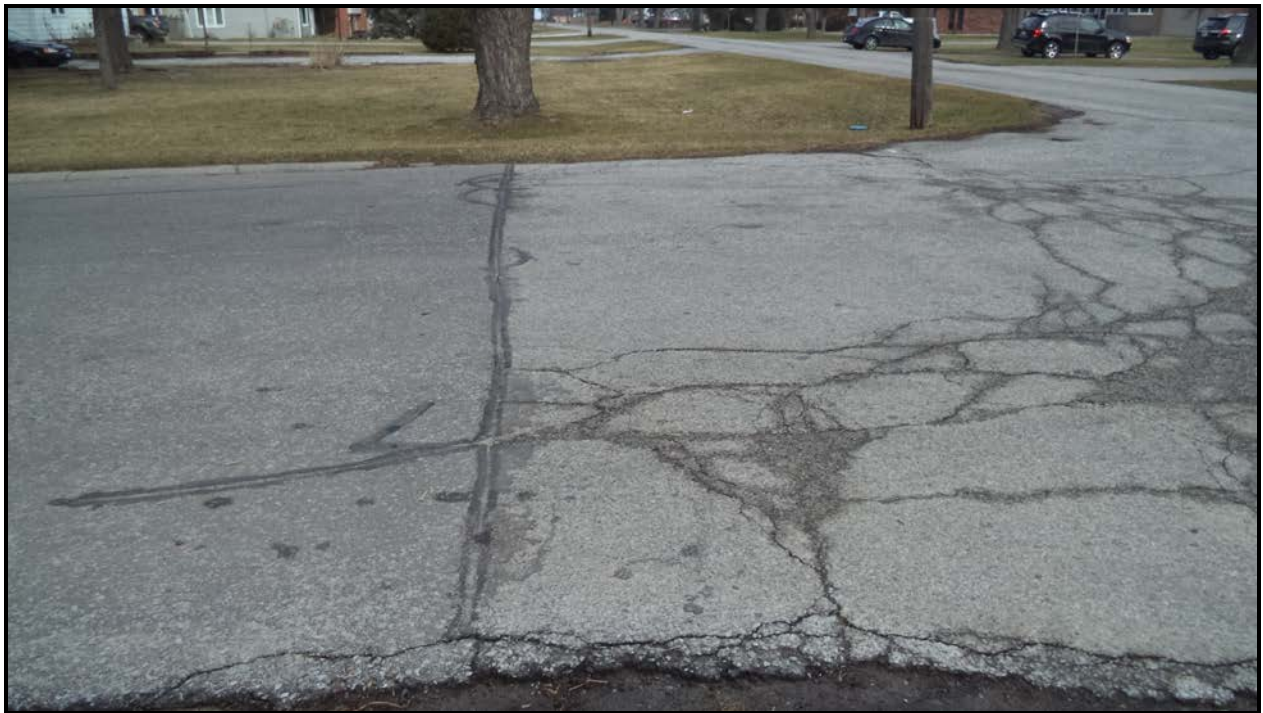
Photograph 8 – Wearing Surface at West Approach

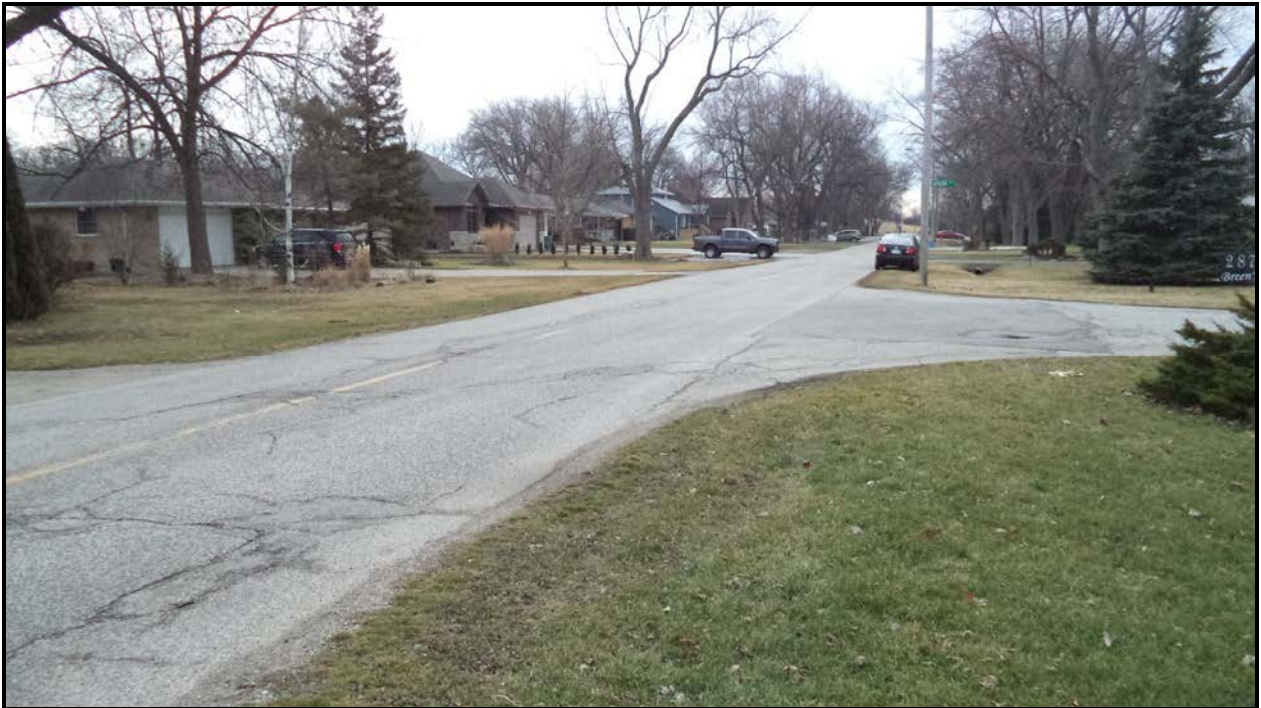
Photograph 1 – Road over Culvert (Looking South)

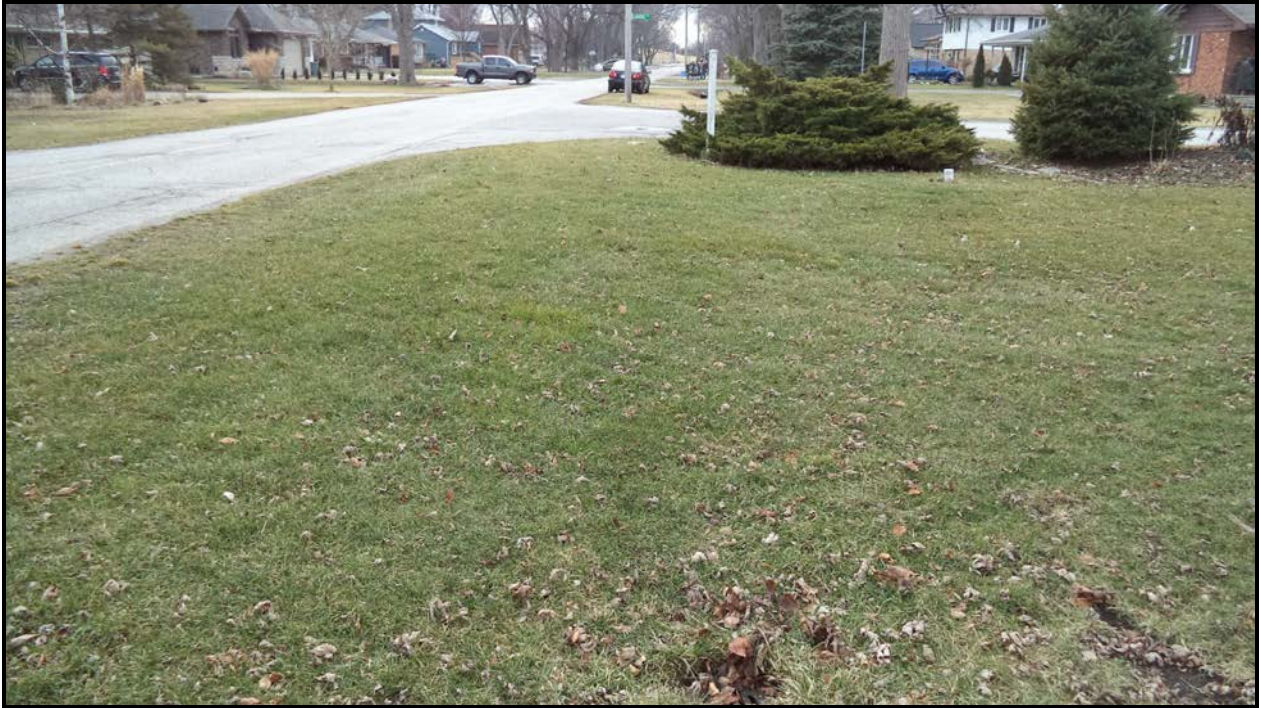
Photograph 3 – North Inlet Manhole

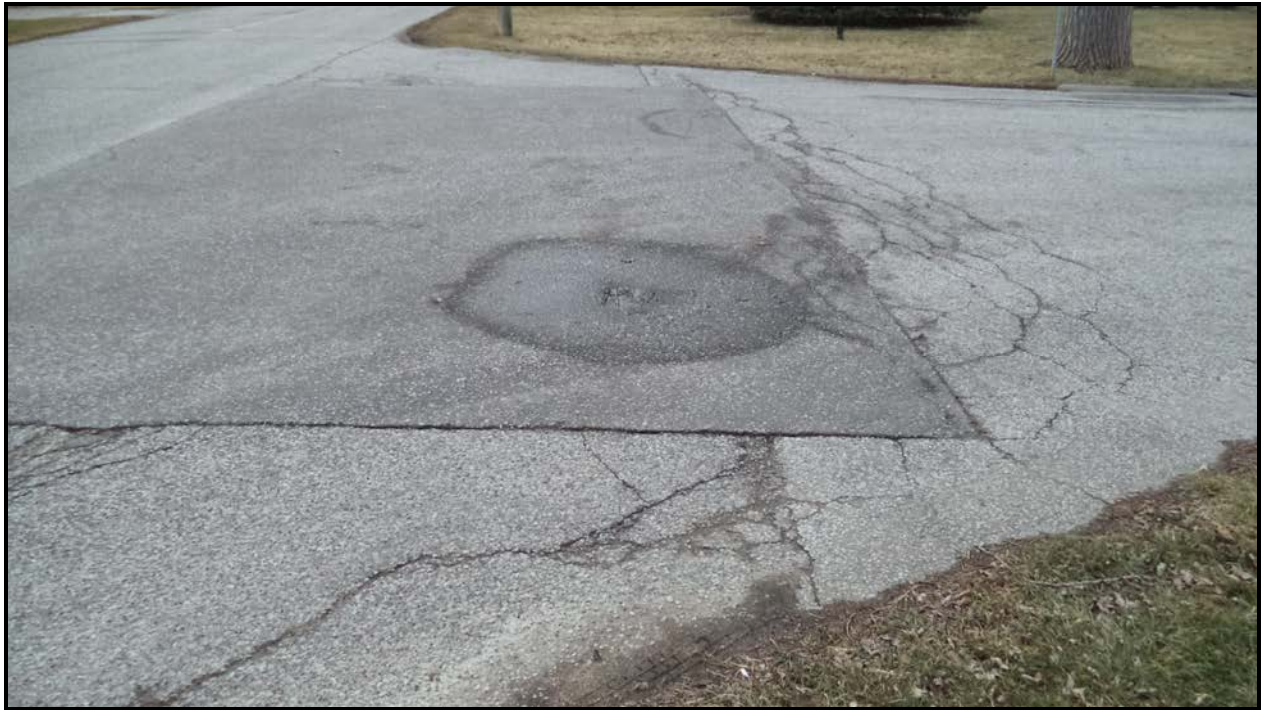
Photograph 5 – Wearing Surface over Culvert (Looking South)

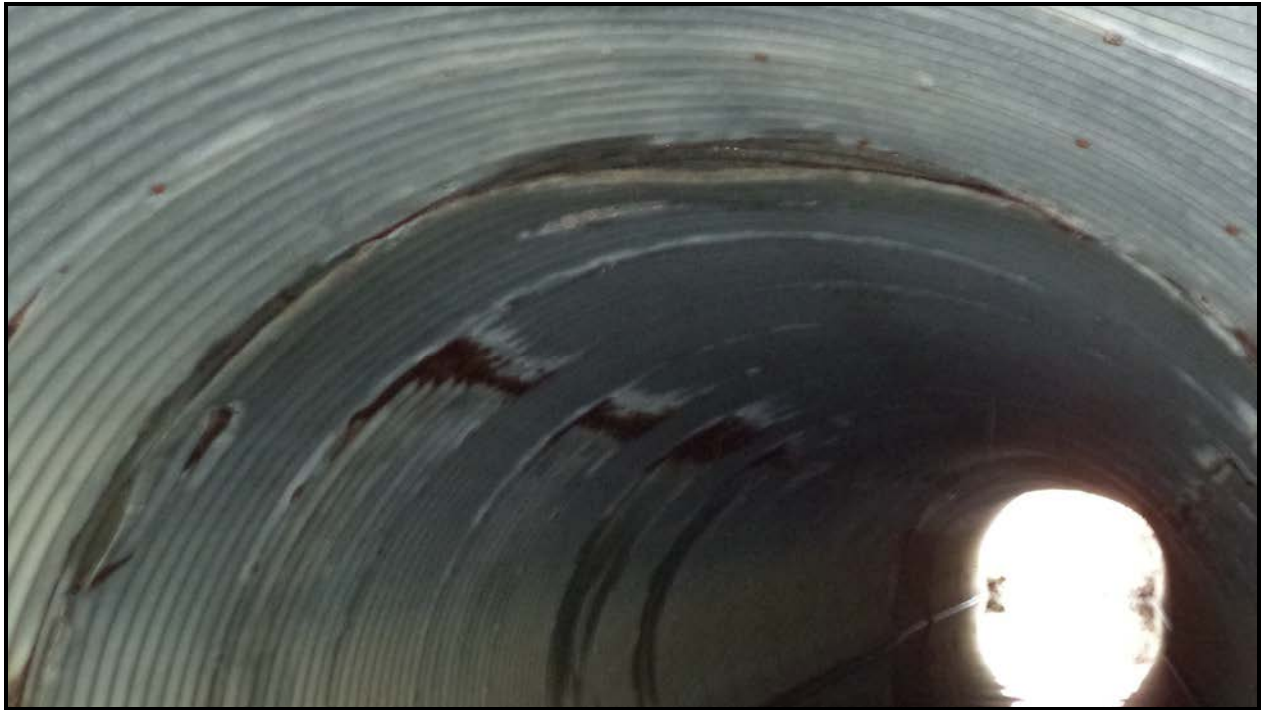
Photograph 3 – Bending and Settlement at the Barrel Top

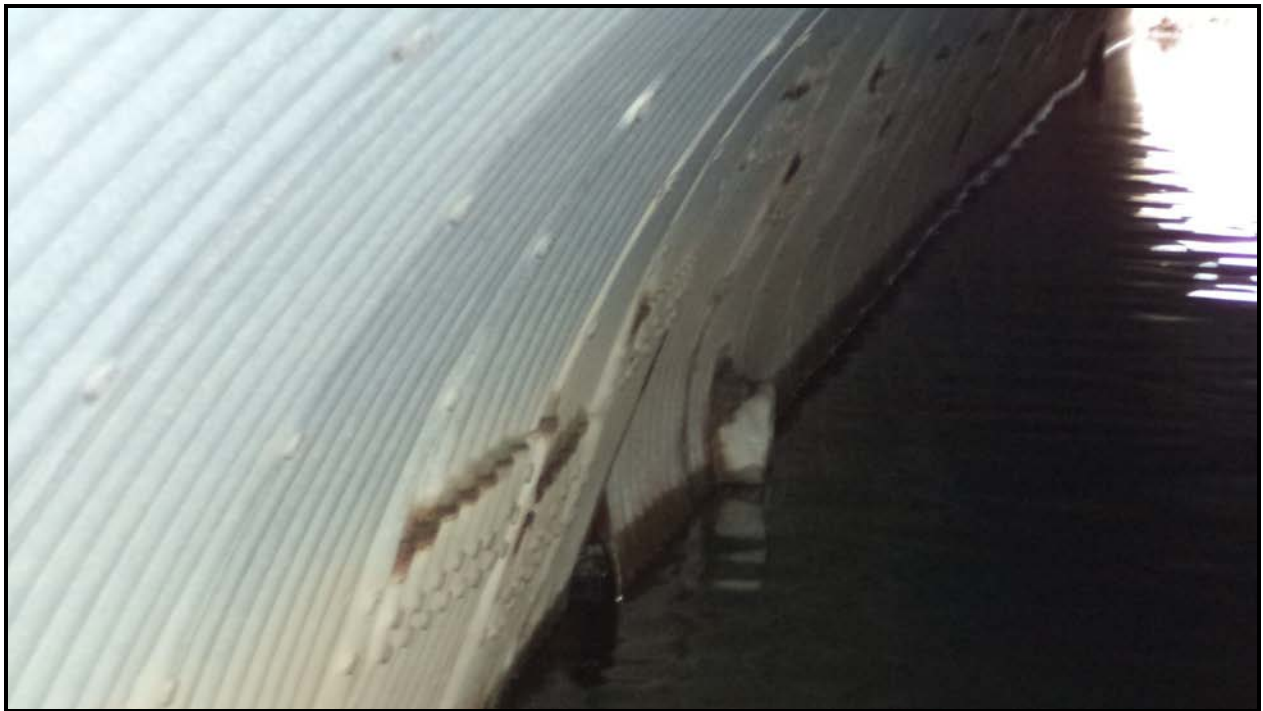
Photograph 4 – Culvert Barrel Connection

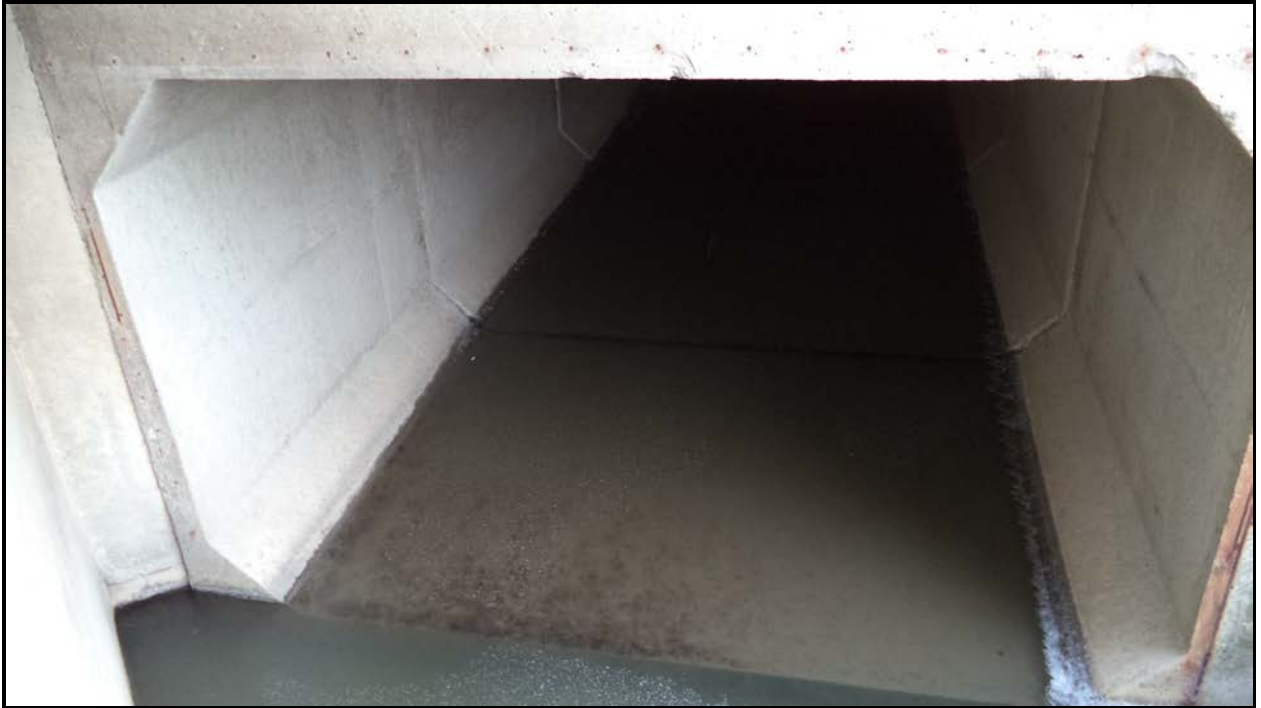
Photograph 3 – Western Culvert Inlet (Inside Box – Limited Inspection)

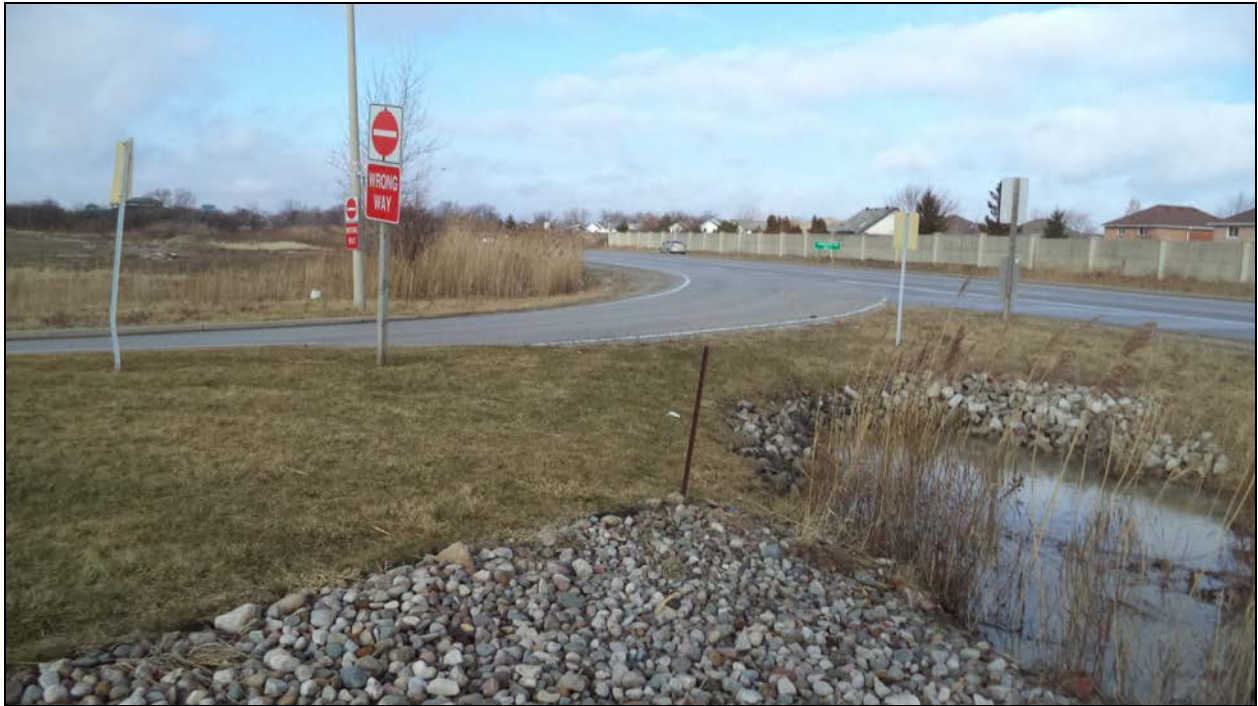
Photograph 1 – Road over Culvert (Looking West)
