CORPORATE OF THE TOWN OF TECUMSEH
2016 Culvert Needs Study

Structures with Spans $\leq 3.0\text{m}$ – Final Report

Our File: 15-2977

October 28, 2016

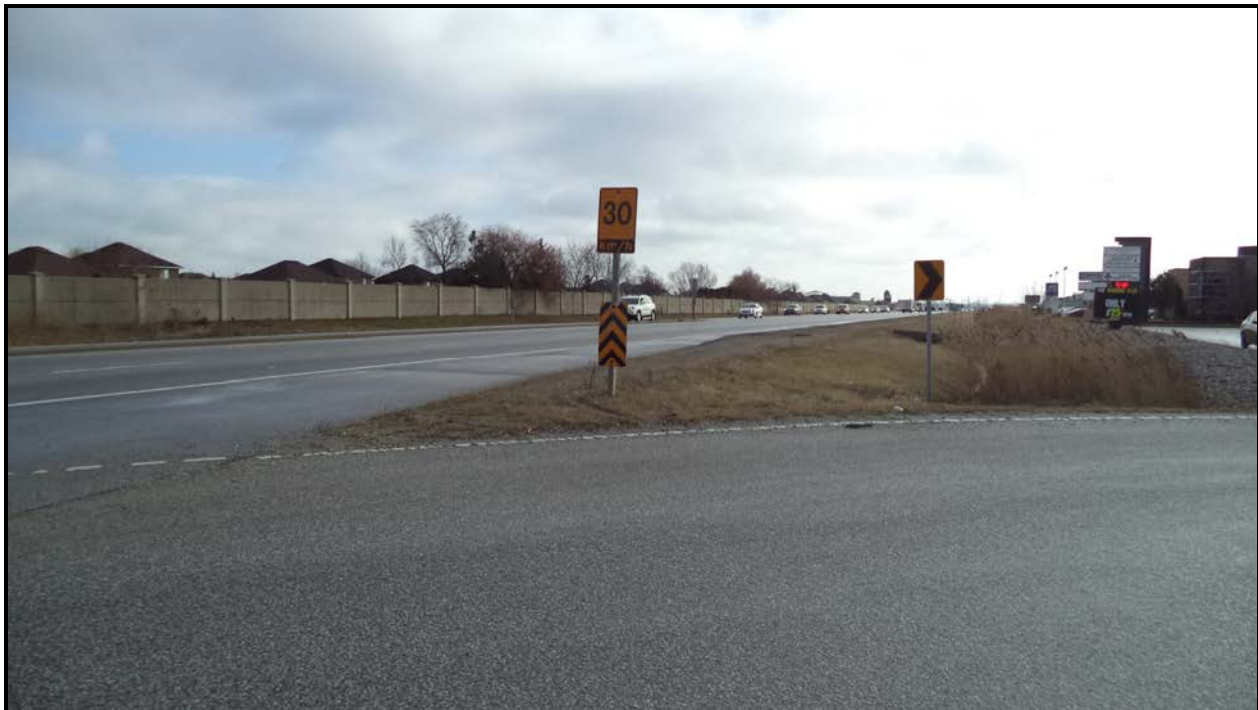
Photograph 2 – Road over Culvert (Looking East)

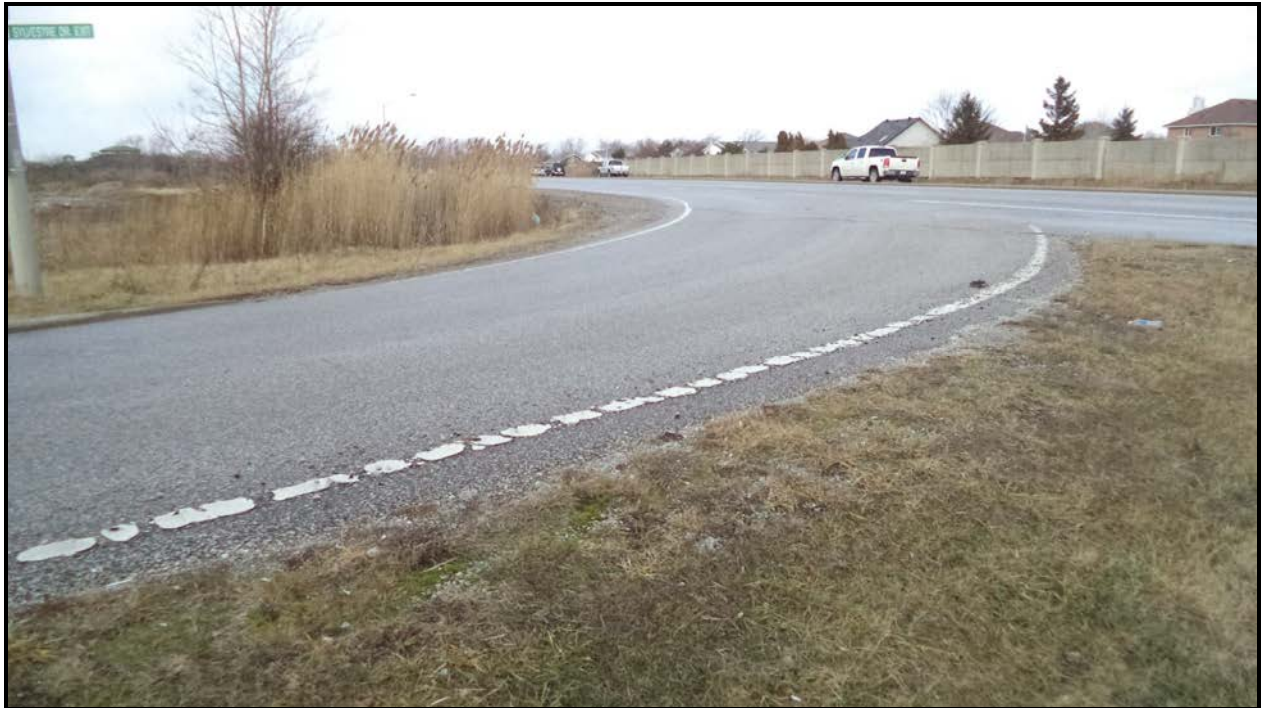
Photograph 5 – Wearing Surface over Culvert (Looking West)

Element Group:	Decks		Length:	0.5 m		
Element Name:	Wearing Surface		Width:	17.0 m		
Location:			Height:			
Material:	Asphalt		Count:			
Element Type:			Total Quantity:	8.5 Sq.m		
Environment:			Limited Inspection	<input type="checkbox"/>		
Protection System:						Perform. Deficiencies
Condition Data:	Units	Exc.	Good	Fair	Poor*	
	m ² <input type="checkbox"/> /m <input type="checkbox"/> / each <input type="checkbox"/> / % <input type="checkbox"/> / all <input type="checkbox"/>		5.0	2.5		
Comments: - Longitudinal crack over the culvert section - Medium Progressive edge cracks at the South edge of Intersection Road						
Recommended Work:		<input checked="" type="checkbox"/> Rehab	<input type="checkbox"/> Replace	Maintenance Needs:		
		<input checked="" type="checkbox"/> 1-5 years	<input type="checkbox"/> 6-10 years	<input type="checkbox"/> Urgent	<input type="checkbox"/> 1 year	<input type="checkbox"/> 2 year

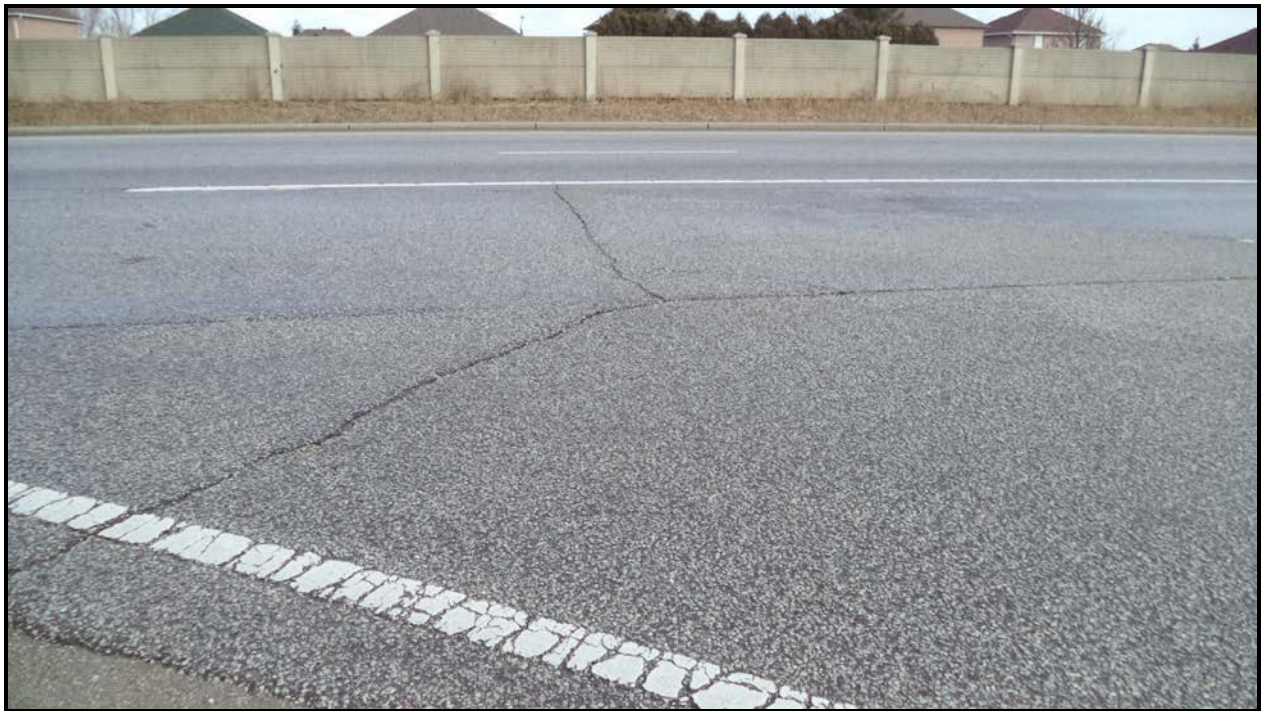
Photograph 6 – Wearing Surface at North Approach

Element Group:	Approaches		Length:	6.0 m		
Element Name:	Wearing Surface		Width:	17.0 m		
Location:	East - West		Height:			
Material:	Asphalt		Count:	2		
Element Type:			Total Quantity:	204.0 Sq.m		
Environment:			Limited Inspection	<input type="checkbox"/>		
Protection System:						Perform. Deficiencies
Condition Data:	Units	Exc.	Good	Fair	Poor*	
	m ² <input type="checkbox"/> /m <input type="checkbox"/> / each <input type="checkbox"/> / % <input type="checkbox"/> / all <input type="checkbox"/>		150.0	54.0		
Comments: - Medium map cracking at both approaches - Medium Progressive edge cracks at the South edge of Intersection Road						
Recommended Work:		<input checked="" type="checkbox"/> Rehab	<input type="checkbox"/> Replace	Maintenance Needs:		
		<input checked="" type="checkbox"/> 1-5 years	<input type="checkbox"/> 6-10 years	<input type="checkbox"/> Urgent	<input type="checkbox"/> 1 year	<input type="checkbox"/> 2 year

Recommended Work on Structure	<input type="checkbox"/> None <input type="checkbox"/> Minor Rehab. <input type="checkbox"/> Major Rehab. <input checked="" type="checkbox"/> Replace
Timing of Recommended Work	<input checked="" type="checkbox"/> 1 to 5 years <input type="checkbox"/> 6 to 10 years
Overall Comments	Limited Inspection - The structure is in poor condition. Culvert barrel is severely corroded with heavy loss along the bottom surface at the spring level. Wearing surface was observed with longitudinal, traversal and medium progressive edge cracks extending along the approaches,
Date of Next Inspection

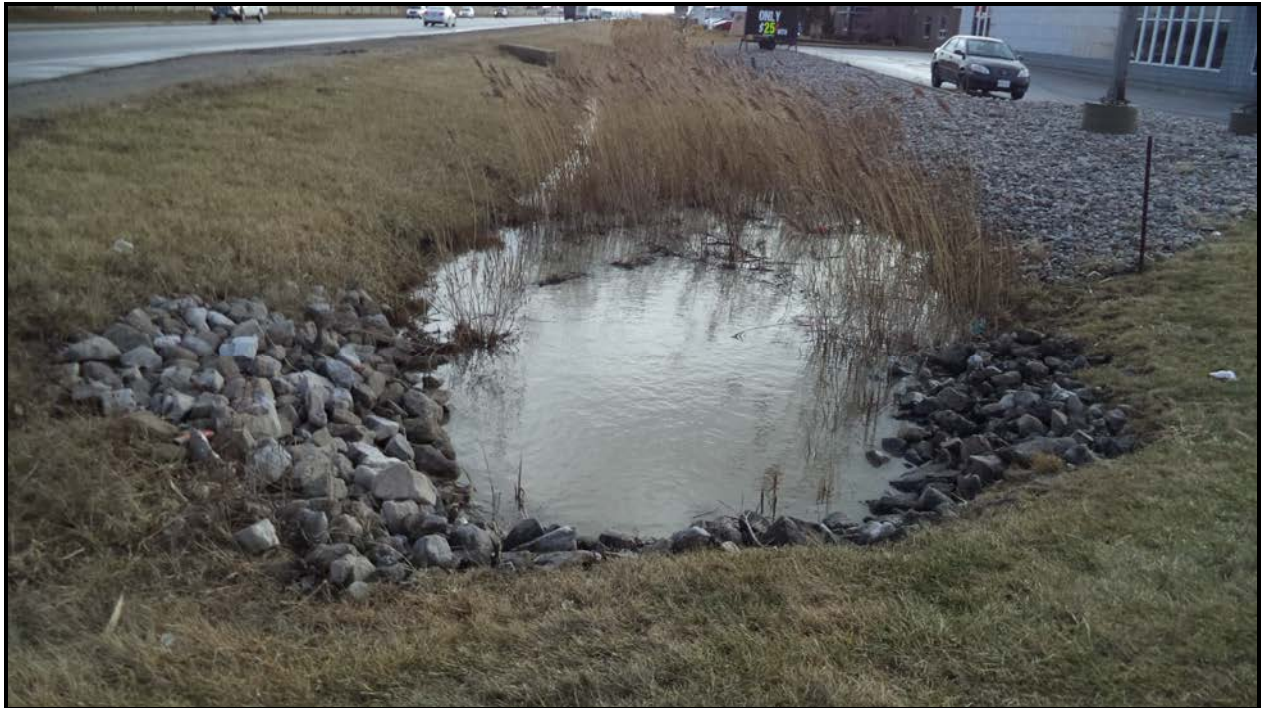
Photograph 7 – Water Stream (CR 22 Road South Side - Looking East)

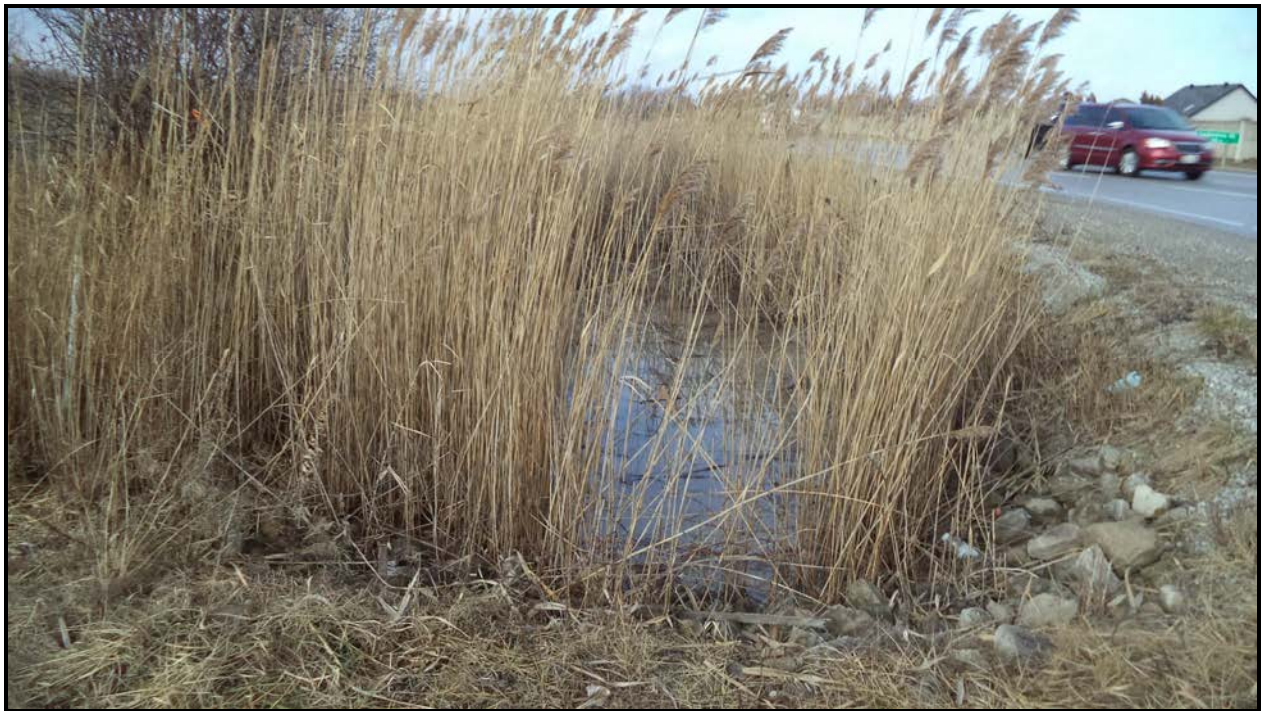
Photograph 8 – Water Stream (CR 22 Road South Side - Looking West)

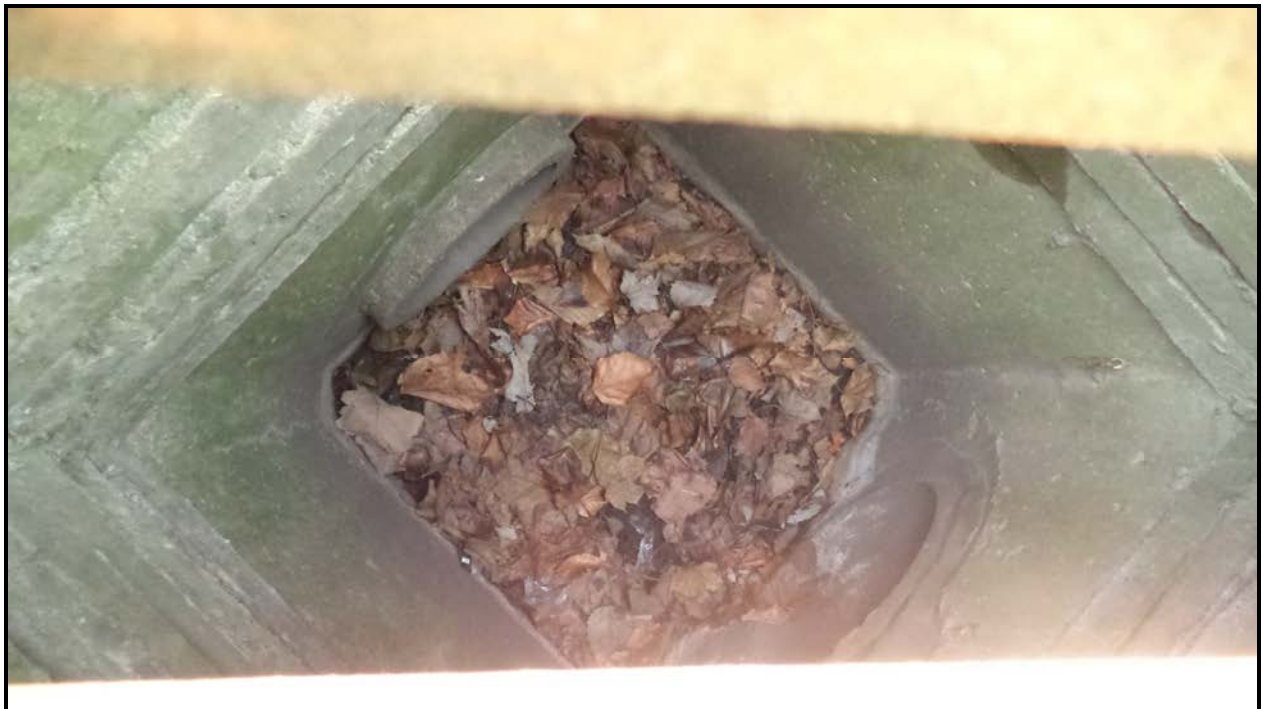
Element Group:	Culverts		Length:	m		
Element Name:	Inlet Components		Width:	m		
Location:	East Side		Height:	m		
Material:	Cast-in-place concrete		Count:			
Element Type:	Rectangular Manhole		Total Quantity:	Sq.m		
Environment:			Limited Inspection	<input checked="" type="checkbox"/>		
Protection System:						Perform. Deficiencies
Condition Data:	Units	Exc.	Good	Fair	Poor*	
	m ² <input checked="" type="checkbox"/> /m <input type="checkbox"/> / each <input type="checkbox"/> / % <input type="checkbox"/> / all <input type="checkbox"/>					
Comments: Limited Inspection - Covered Manhole						
Recommended Work:		<input type="checkbox"/> Rehab	<input type="checkbox"/> Replace	Maintenance Needs:		
		<input type="checkbox"/> 1-5 years	<input type="checkbox"/> 6-10 years	<input type="checkbox"/> Urgent	<input type="checkbox"/> 1 year	<input type="checkbox"/> 2 year

Photograph 4 – East Inlet Manhole

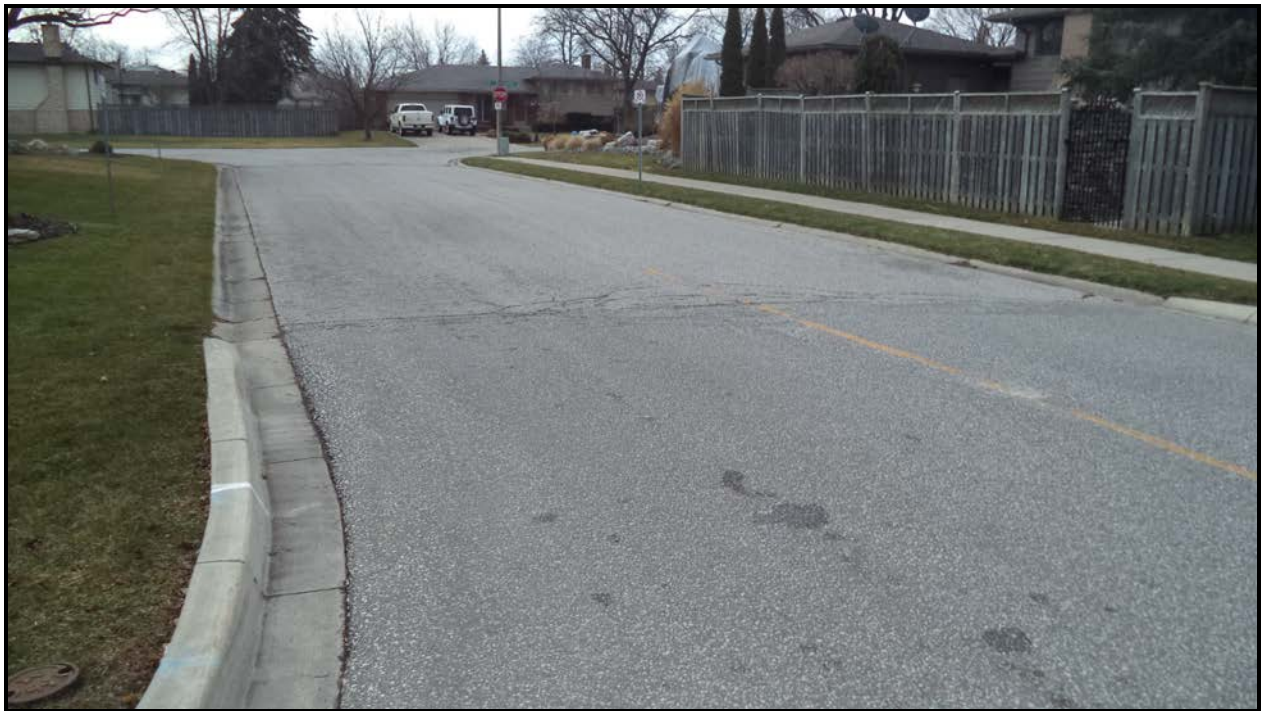
Element Group:	Approaches		Length:	6.0 m		
Element Name:	Wearing Surface		Width:	9.5 m		
Location:	North - South		Height:			
Material:	Asphalt		Count:	2		
Element Type:			Total Quantity:	114.0 Sq.m		
Environment:	Severe		Limited Inspection	<input type="checkbox"/>		
Protection System:						Perform. Deficiencies
Condition Data:	Units	Exc.	Good	Fair	Poor*	
	m ² <input type="checkbox"/> /m <input type="checkbox"/> / each <input type="checkbox"/> / % <input type="checkbox"/> / all <input type="checkbox"/>		114.0			
Comments: In Good Condition						
Recommended Work:		<input type="checkbox"/> Rehab	<input type="checkbox"/> Replace	Maintenance Needs:		
		<input type="checkbox"/> 1-5 years	<input type="checkbox"/> 6-10 years	<input type="checkbox"/> Urgent	<input type="checkbox"/> 1 year	<input type="checkbox"/> 2 year

Photograph 8 – Wearing Surface at South Approach

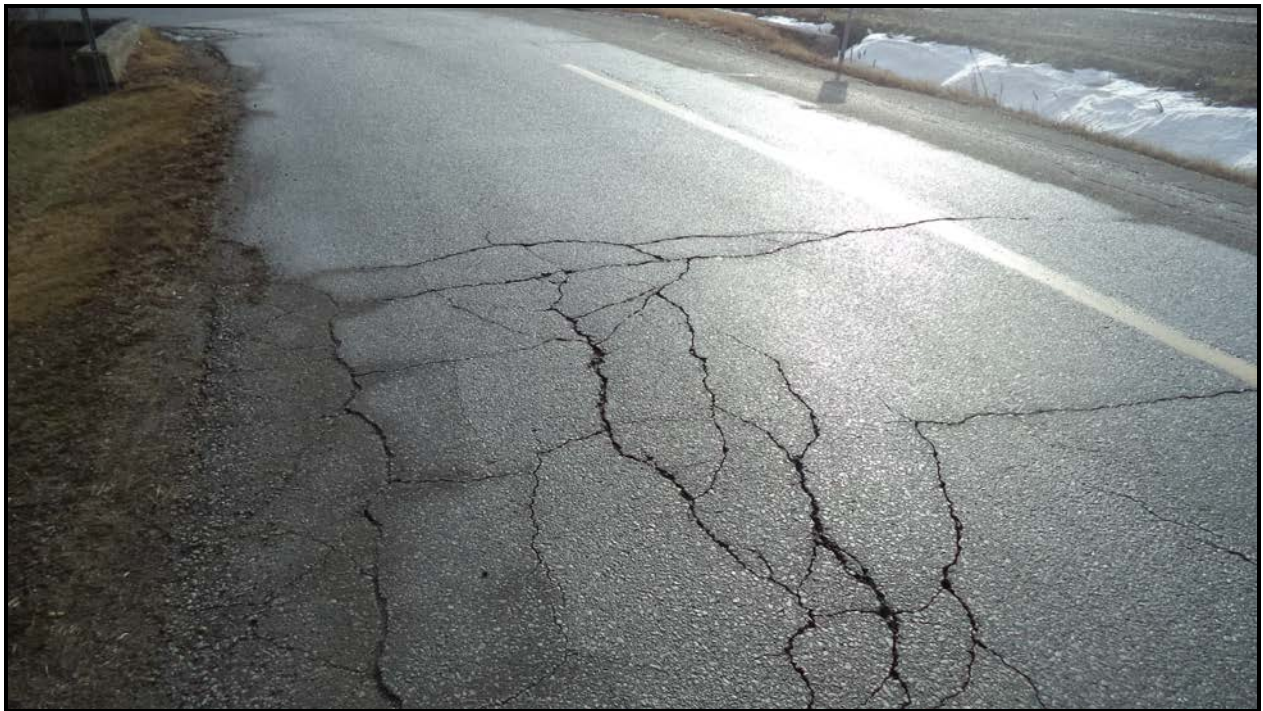
Photograph 6 – Wearing Surface at West Approach

Asphalt repairs

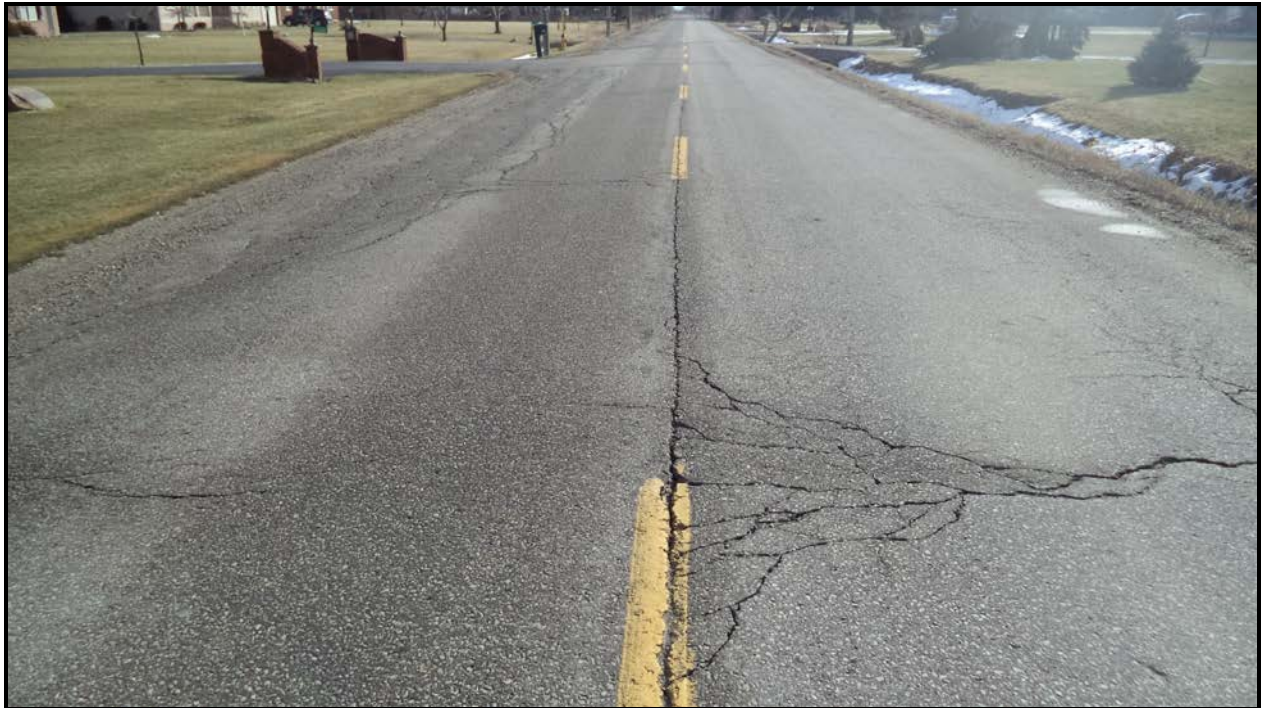
Photograph 5 – Wearing Surface over Culvert (Looking East)

Asphalt repairs

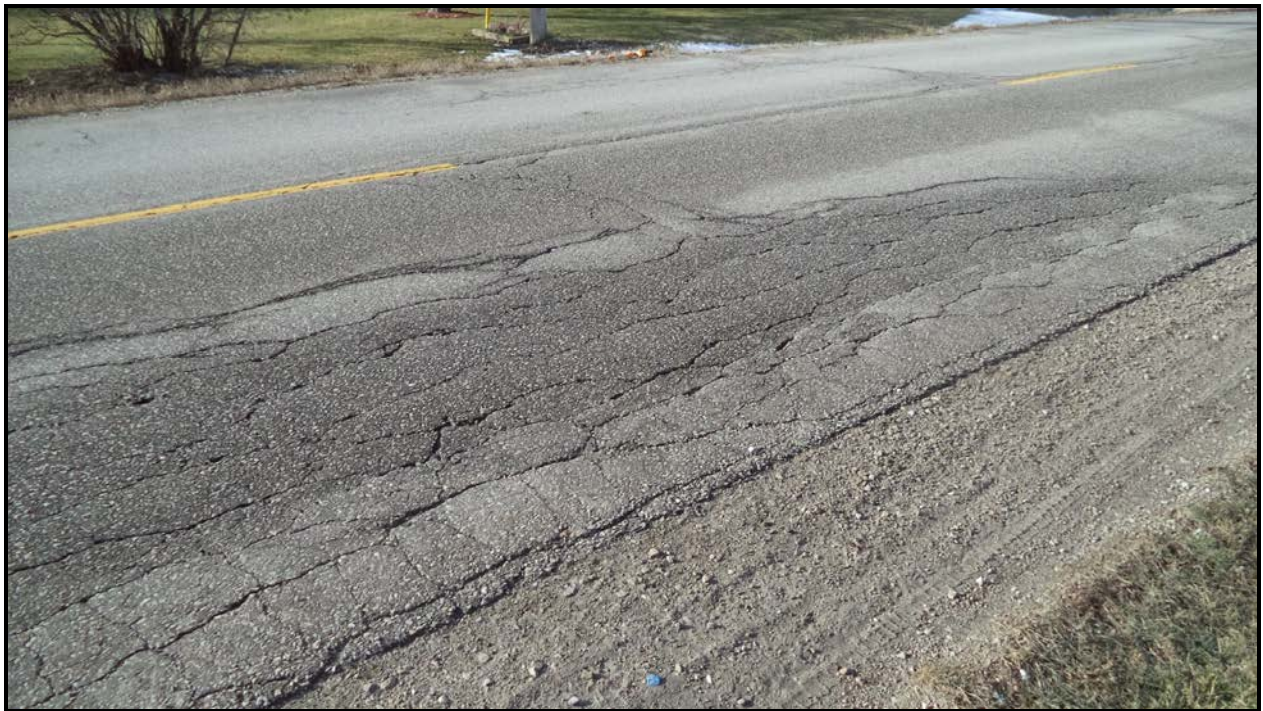
Photograph 6 – Wearing Surface at East Approach

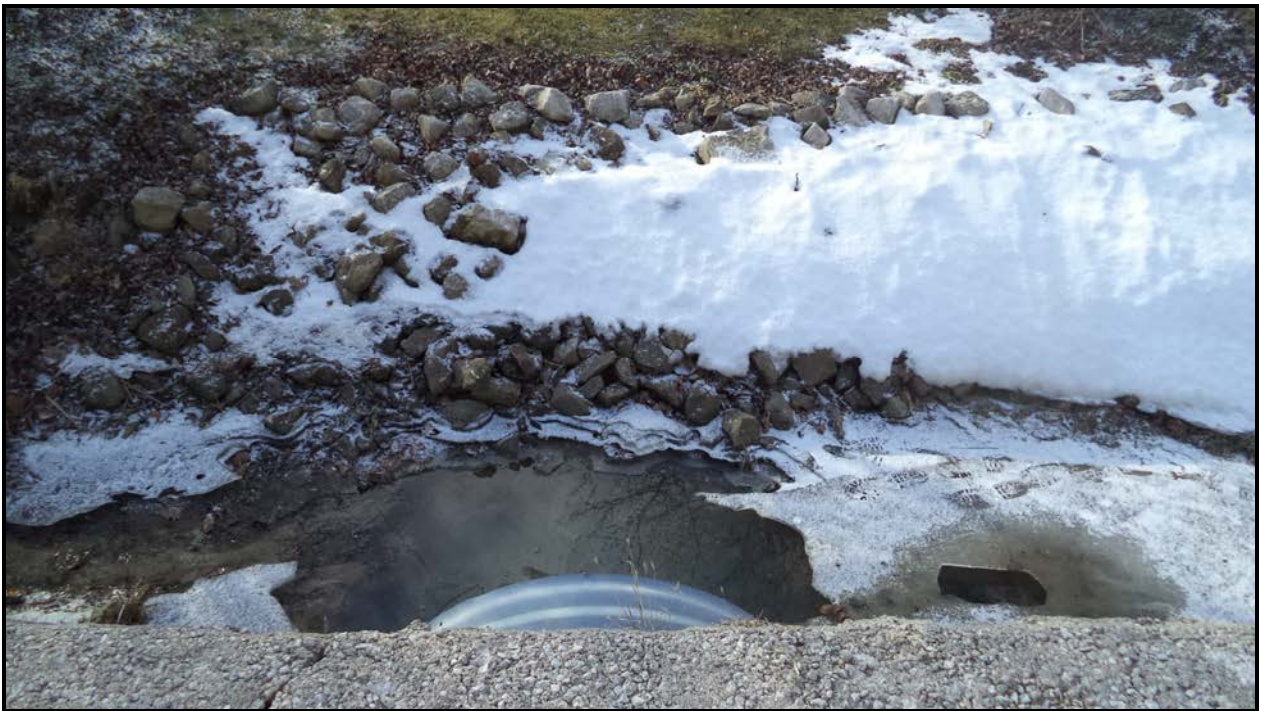
Photograph 8 – Water Stream (North Talbot Road South Side - Looking South)

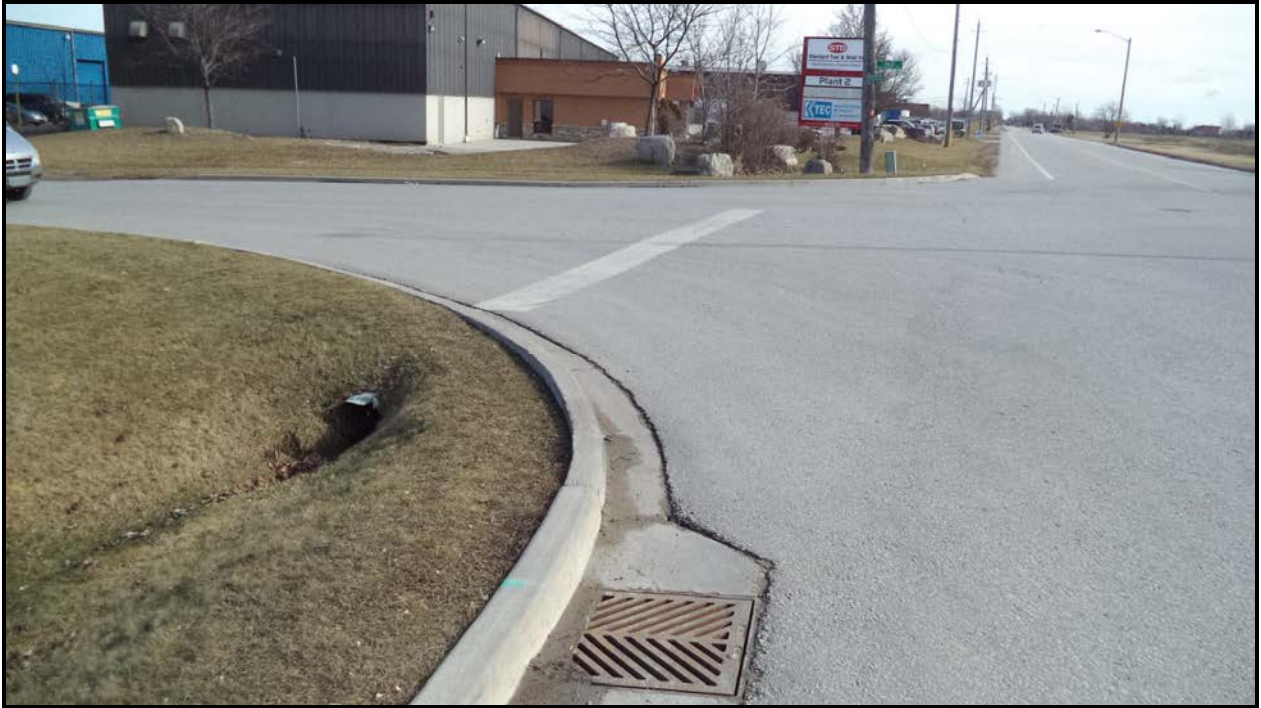
Photograph 2 – Culvert Barrel

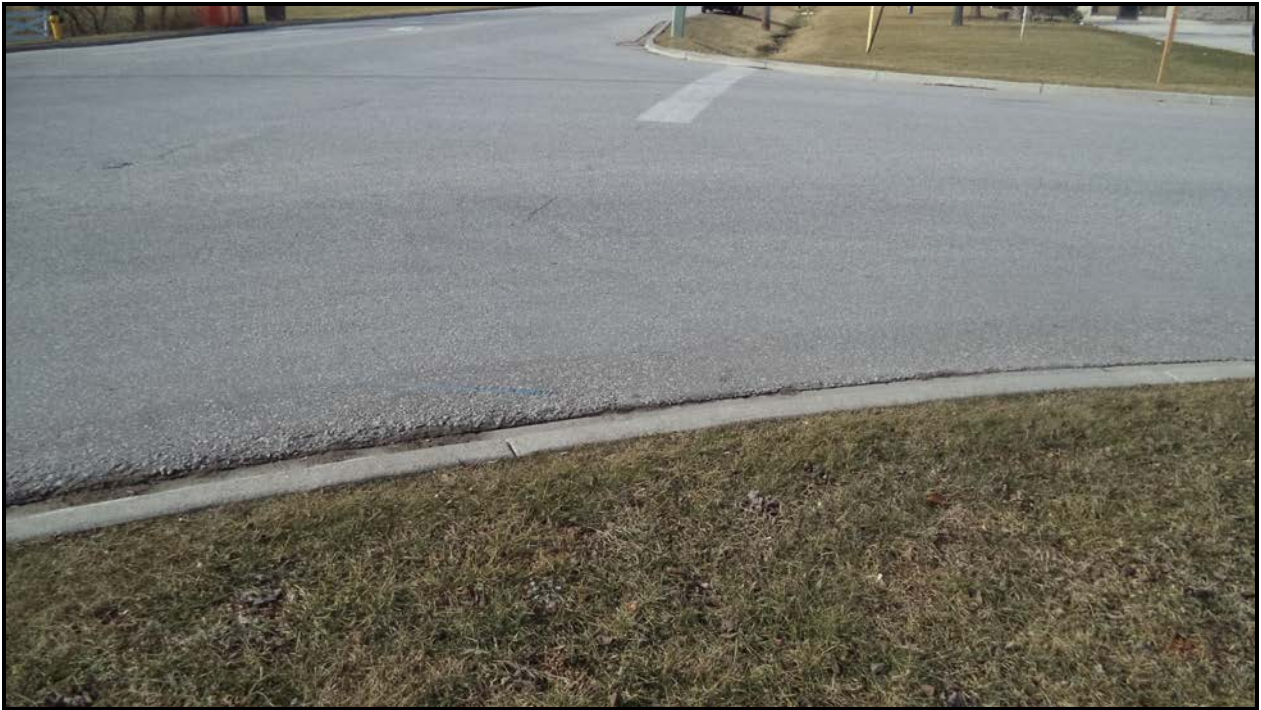
Photograph 6 – Wearing Surface over Culvert (Looking East)

Recommended Work on Structure	<input type="checkbox"/> None <input type="checkbox"/> Minor Rehab. <input type="checkbox"/> Major Rehab. <input type="checkbox"/> Replace
Timing of Recommended Work	<input type="checkbox"/> 1 to 5 years <input type="checkbox"/> 6 to 10 years
Overall Comments	Generally, the structure is assumed to be in good condition. Existing manhole with cast iron cover at the eastern Inlet causing limited inspection. Wide transverse cracks were observed at the wearing surface over the culvert section.t.
Date of Next Inspection

Element Group:	Decks		Length:	0.9 m	
Element Name:	Wearing Surface		Width:	8.8 m	
Location:			Height:		
Material:	Asphalt		Count:		
Element Type:			Total Quantity:	7.9 Sq.m	
Environment:			Limited Inspection	<input type="checkbox"/>	
Protection System:					Perform. Deficiencies
Condition Data:	Units	Exc.	Good	Fair	
	m ² <input checked="" type="checkbox"/> /m <input type="checkbox"/> / each <input type="checkbox"/> / % <input type="checkbox"/> / all <input type="checkbox"/>		6.0	1.9	
Comments: The asphalt surface has wide transverse crack over the culvert section.					
Recommended Work:	<input type="checkbox"/> Rehab <input type="checkbox"/> Replace		Maintenance Needs:		
	<input type="checkbox"/> 1-5 years <input type="checkbox"/> 6-10 years		<input type="checkbox"/> Urgent <input type="checkbox"/> 1 year <input type="checkbox"/> 2 year		
			Asphalt Repair

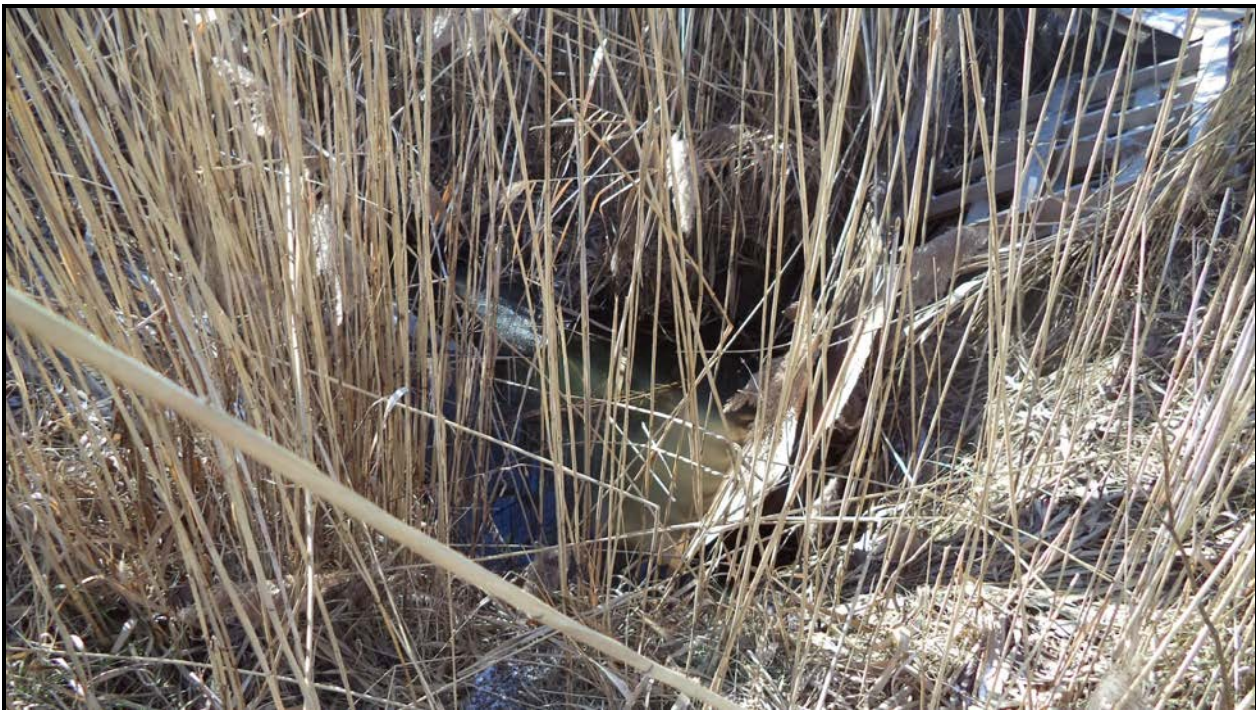
Photograph 2 – Culvert Inlet at South Elevation

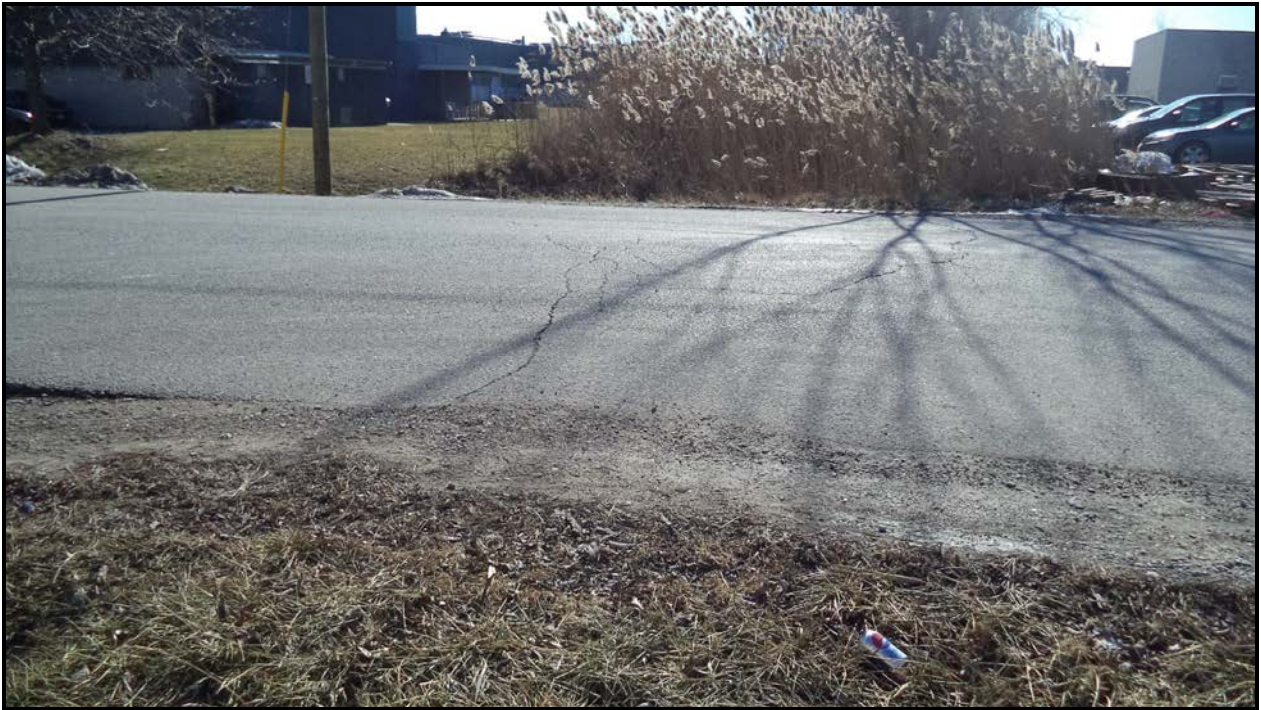
Photograph 5 – Wearing Surface over Culvert (Looking South)

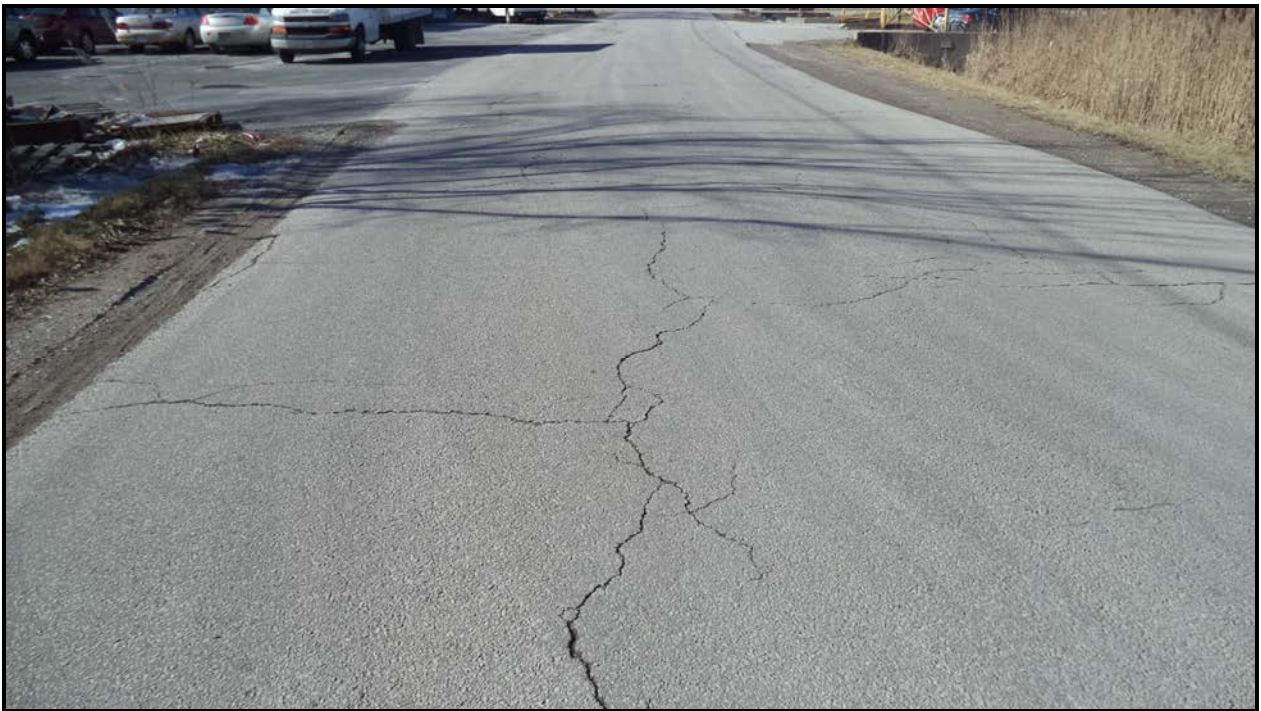
Photograph 6 – Wearing Surface over Culvert (Looking East)

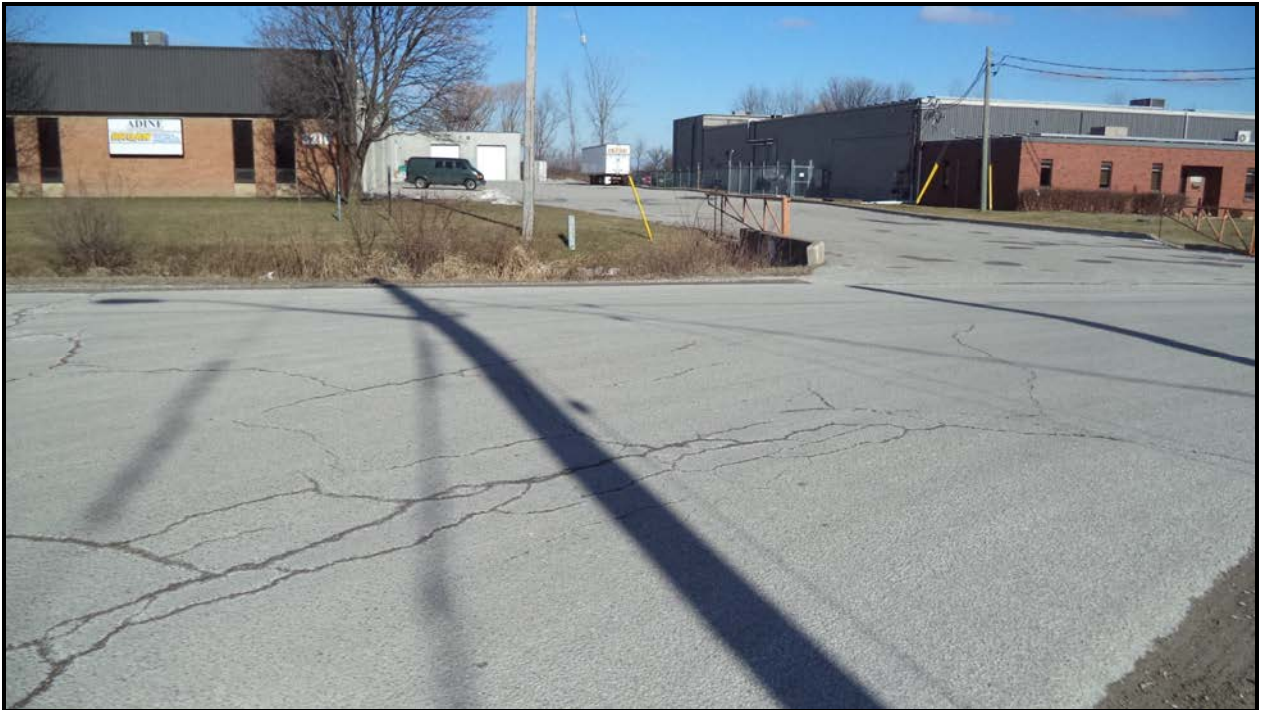
Photograph 5 – Wearing Surface over Culvert (Looking North)

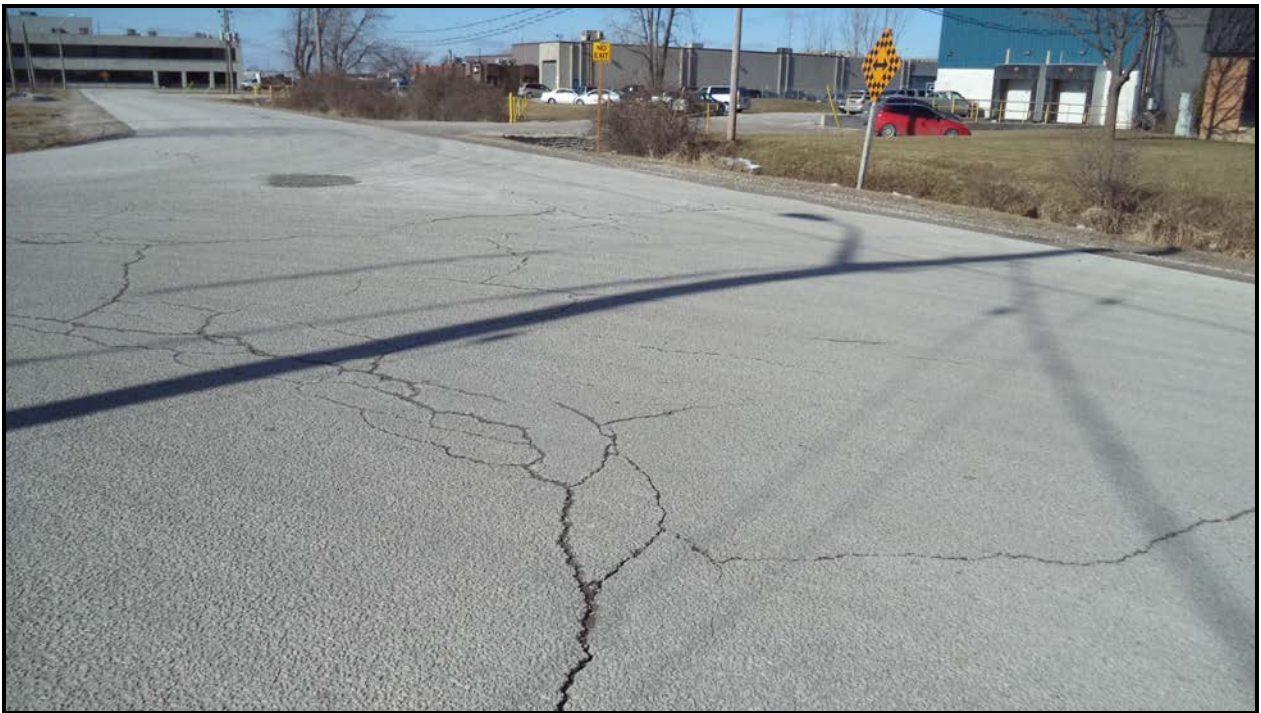
Photograph 6 – Wearing Surface at West Approach

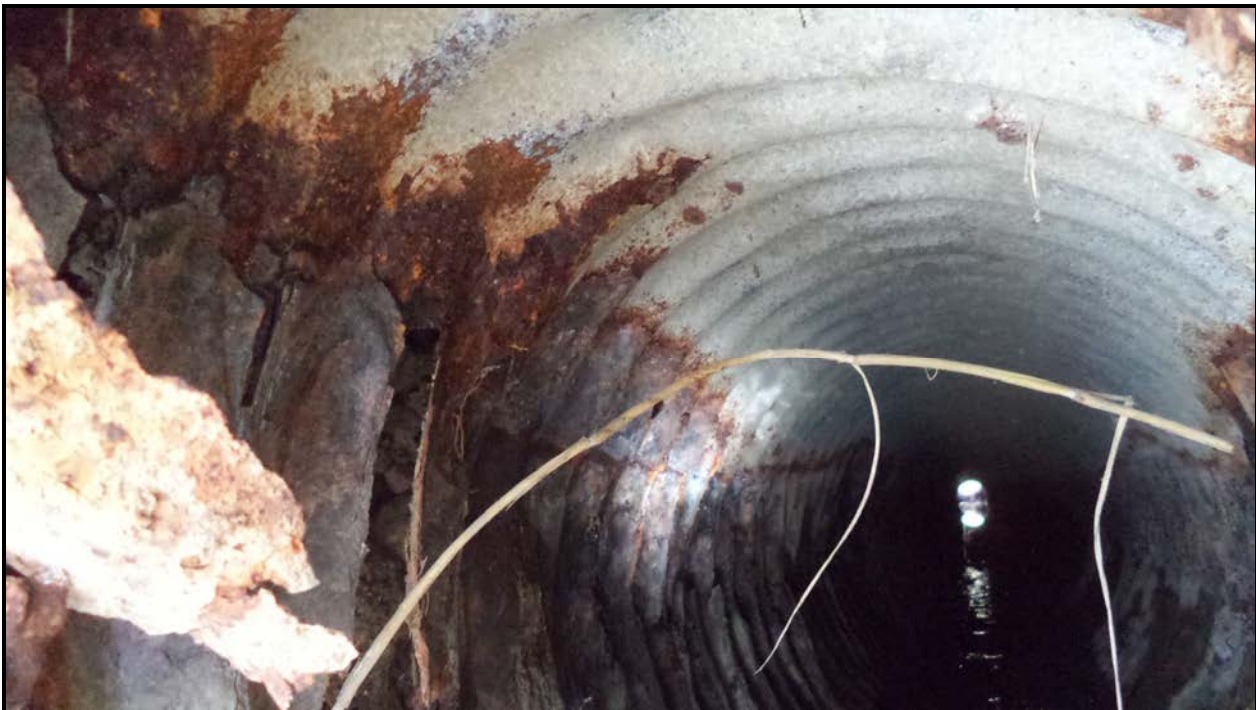
Photograph 2 – Culvert Barrel top at South Inlet

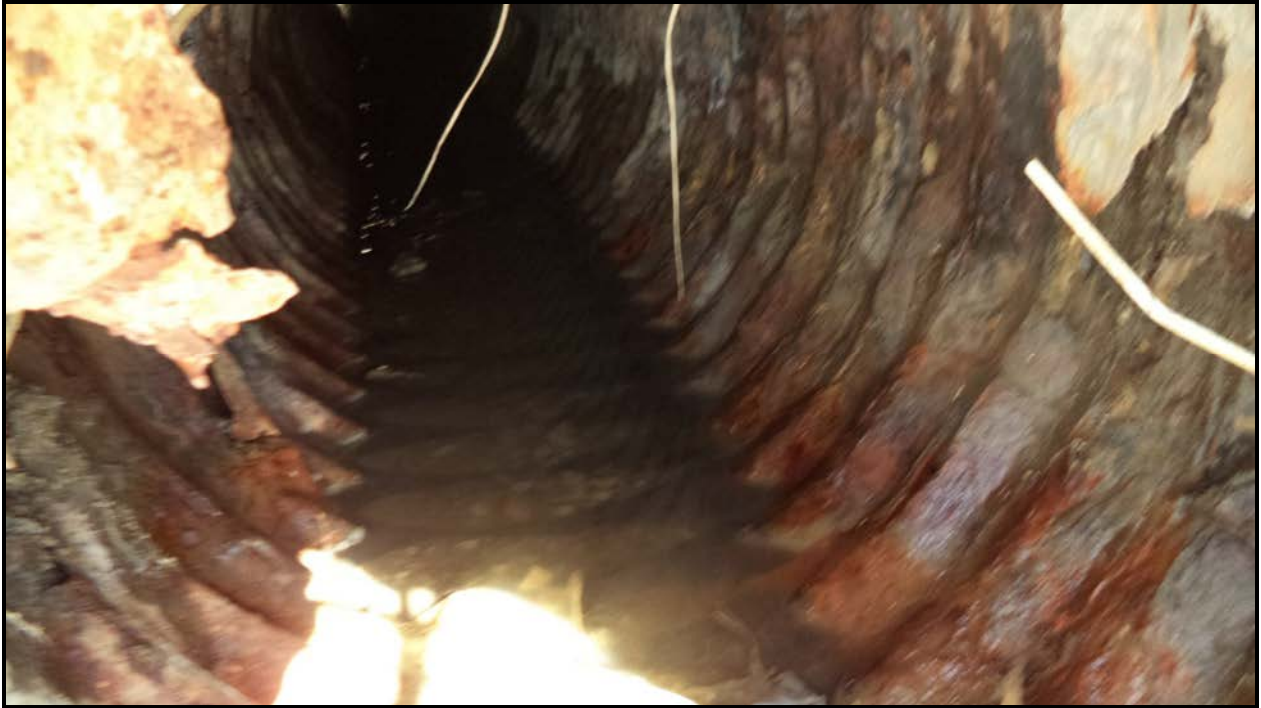
Photograph 3 – Culvert Barrel Bottom at South Inlet

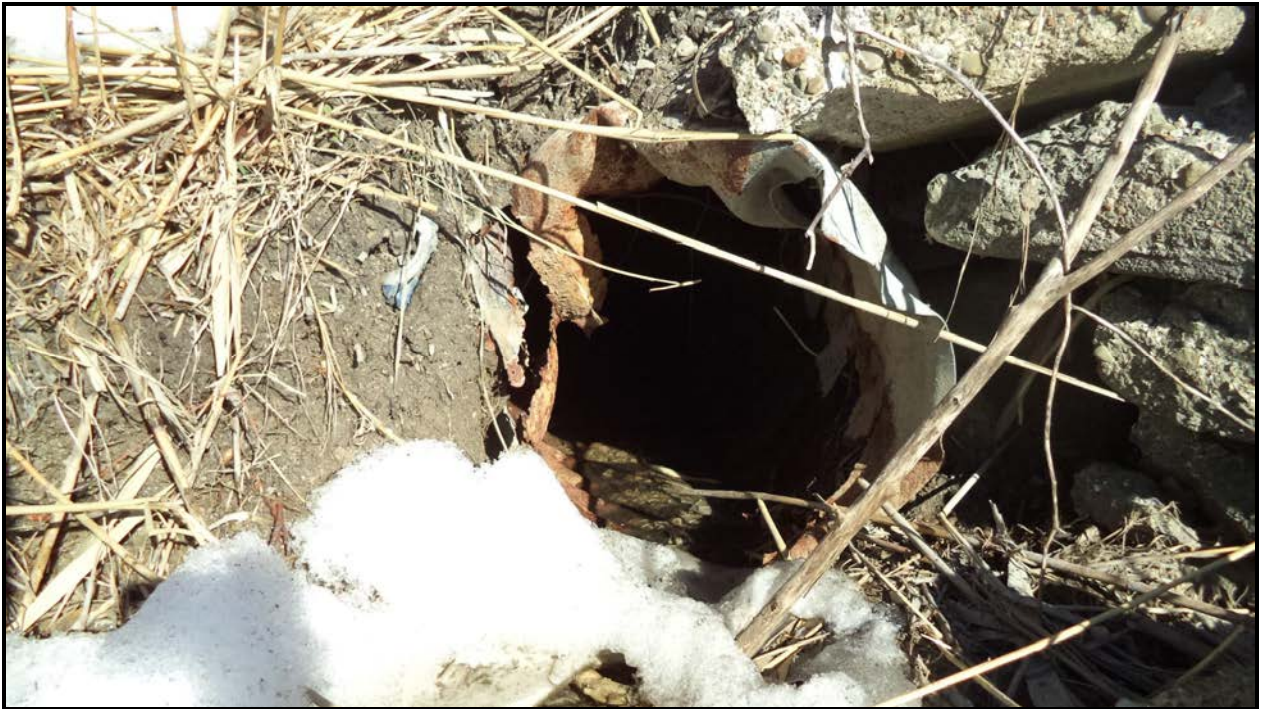
Photograph 4 – Culvert Inlet at South Elevation

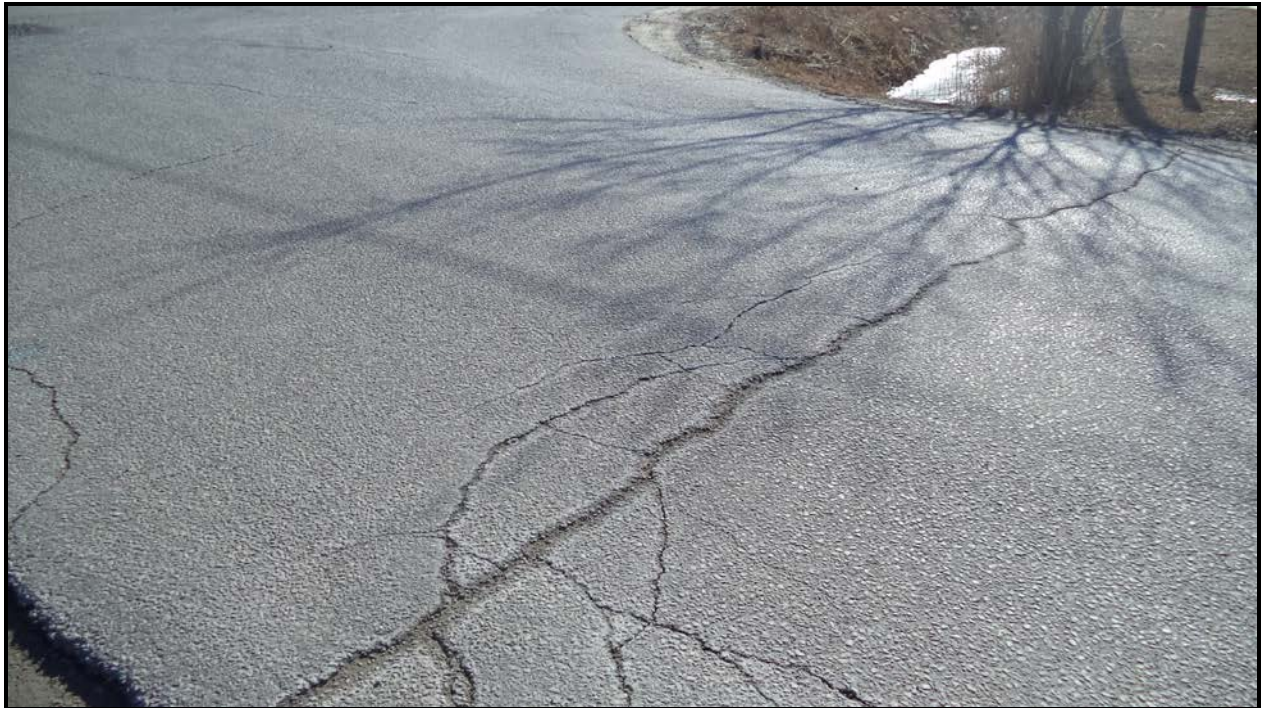
Photograph 7 – Wearing Surface over Culvert (Looking South)

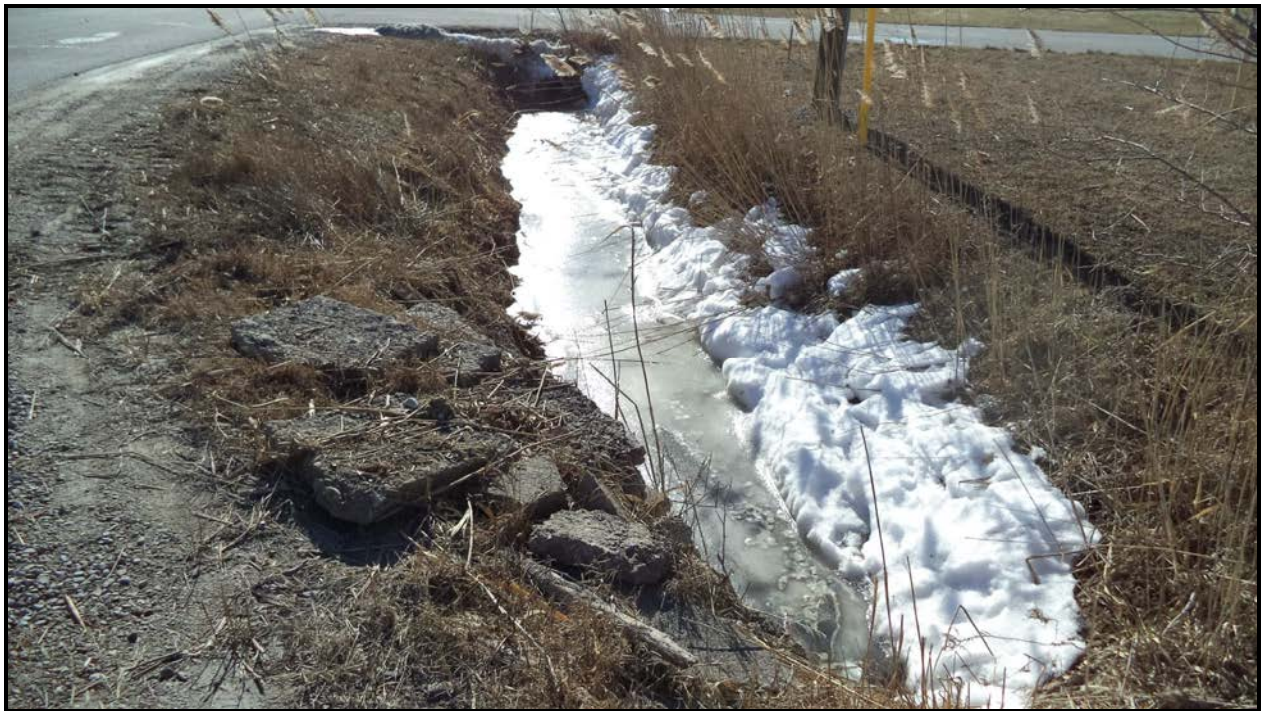
Photograph 8 – Water Stream (Moyanahan Street South Side - Looking South)
