CORPORATE OF THE TOWN OF TECUMSEH
2016 Culvert Needs Study

Structures with Spans $\leq 3.0\text{m}$ – Final Report

Our File: 15-2977

October 28, 2016

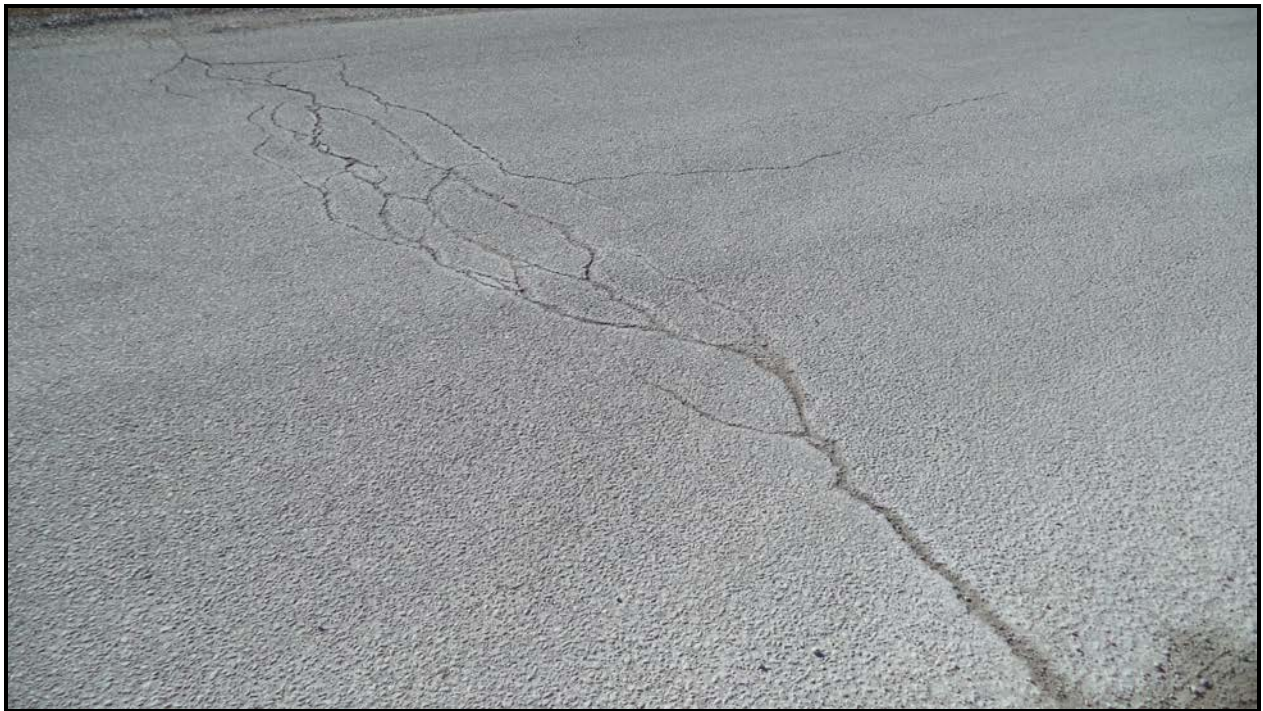
Photograph 6 – Wearing Surface at East Approach

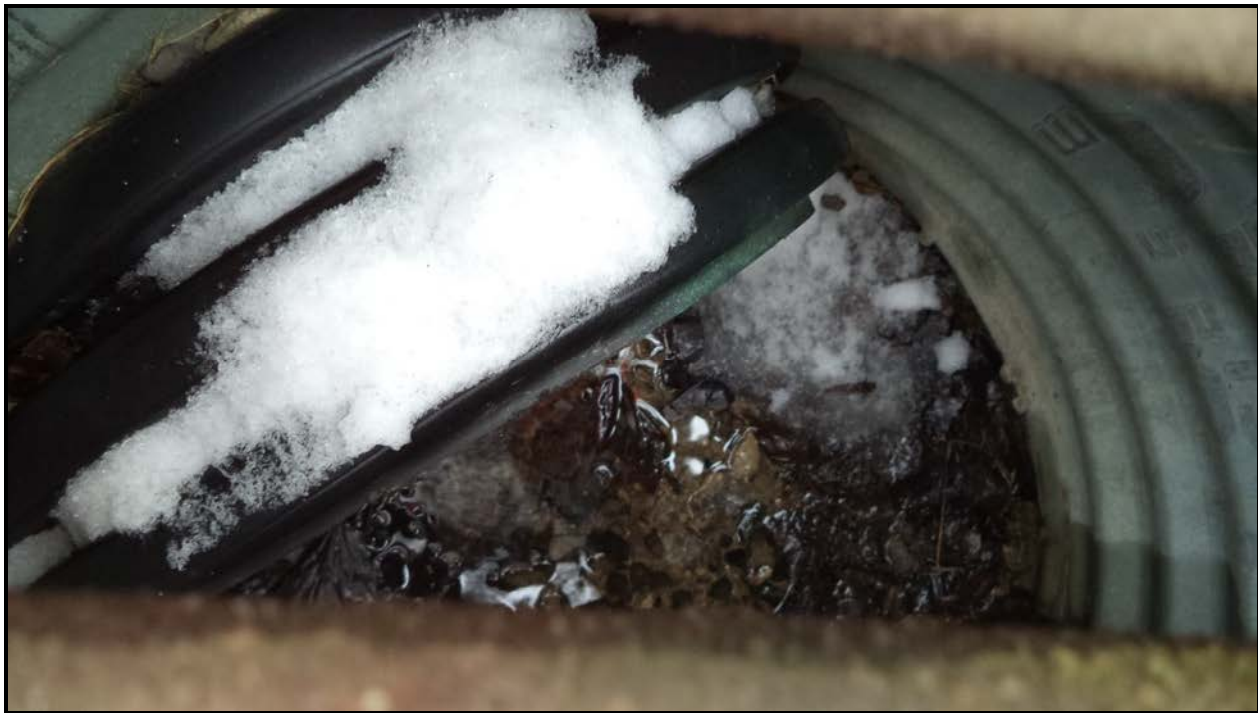
Photograph 2 – Culvert Barrel (at South Inlet)

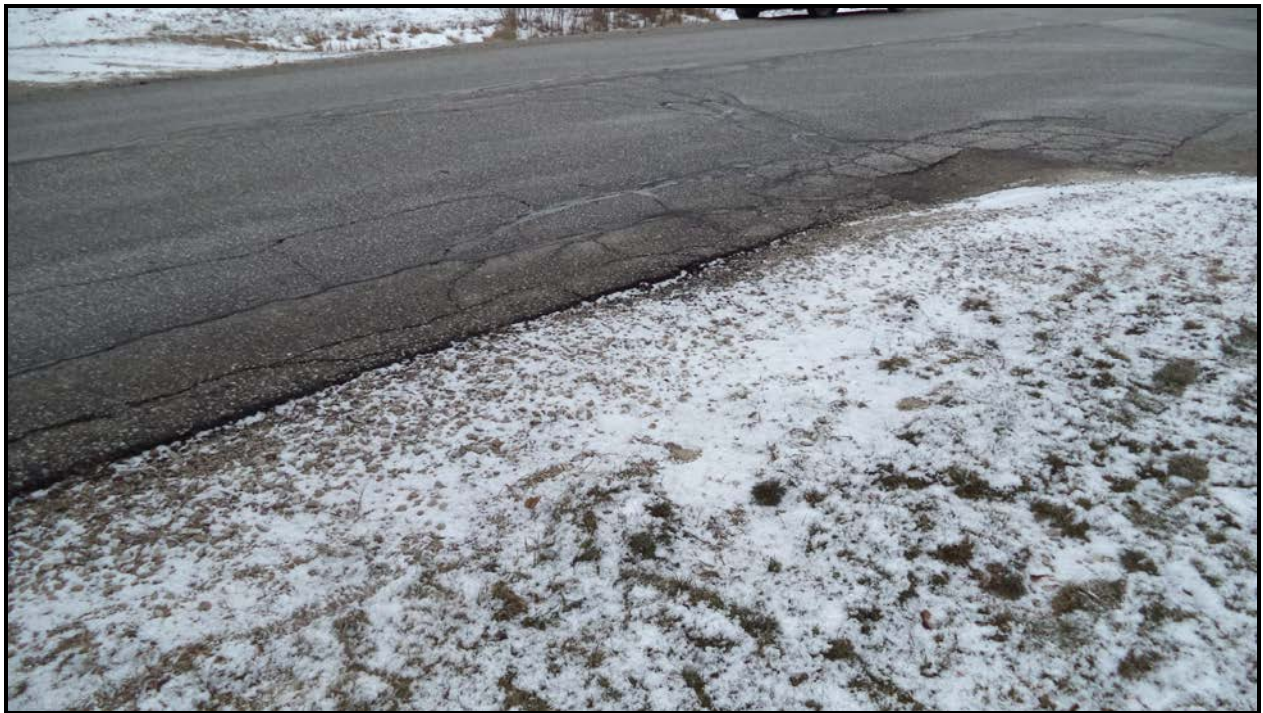
Photograph 6 – Wearing Surface at East Approach (Looking East)

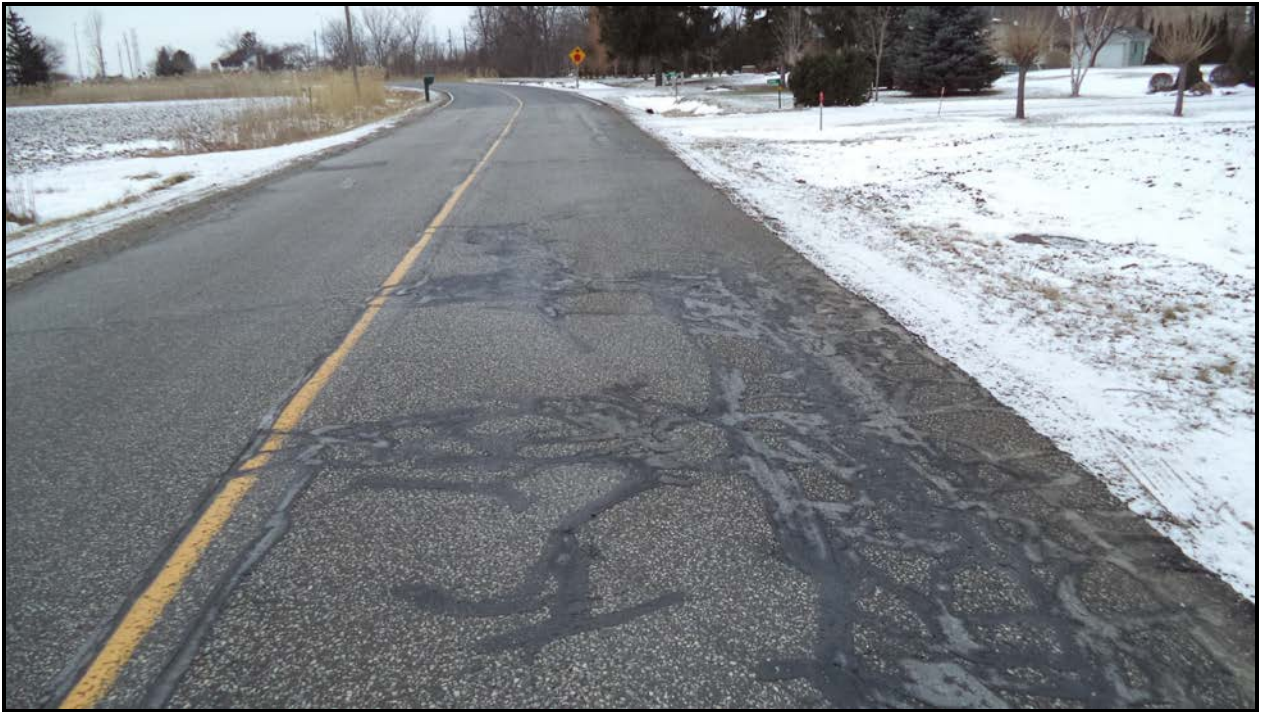
Photograph 5 – Wearing Surface over Culvert (Looking South)

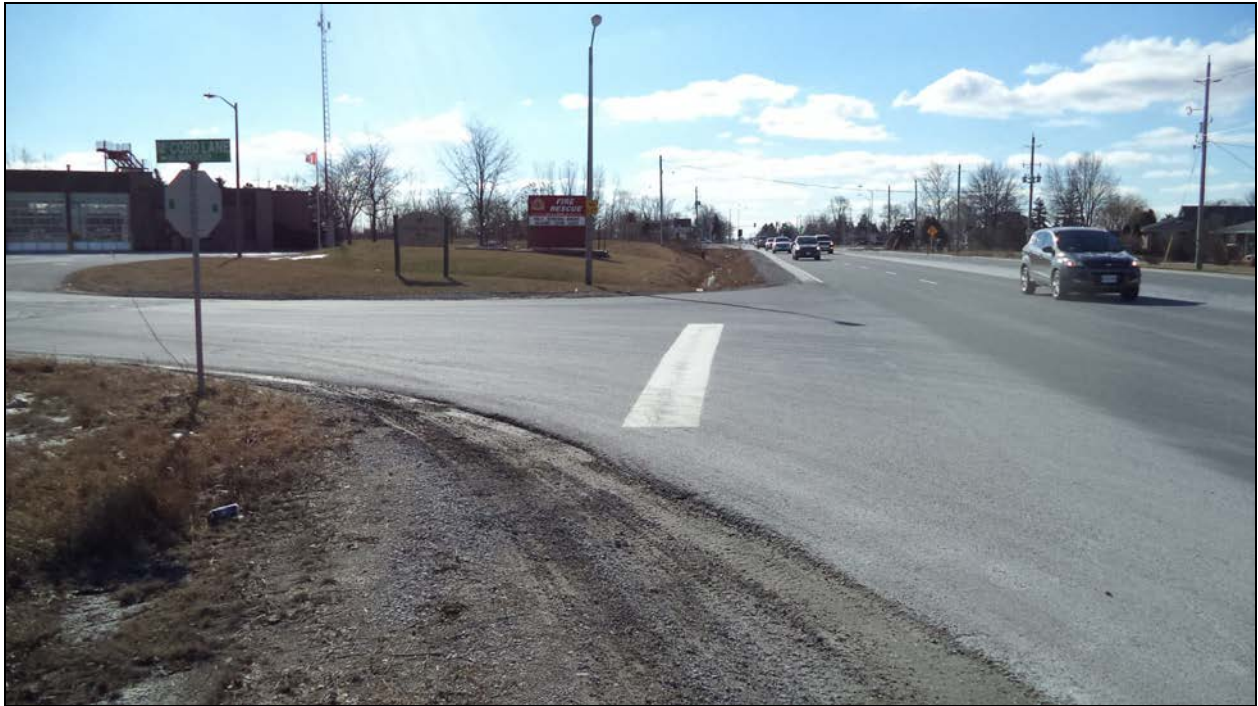
Photograph 1 – Road over Culvert (Looking North)

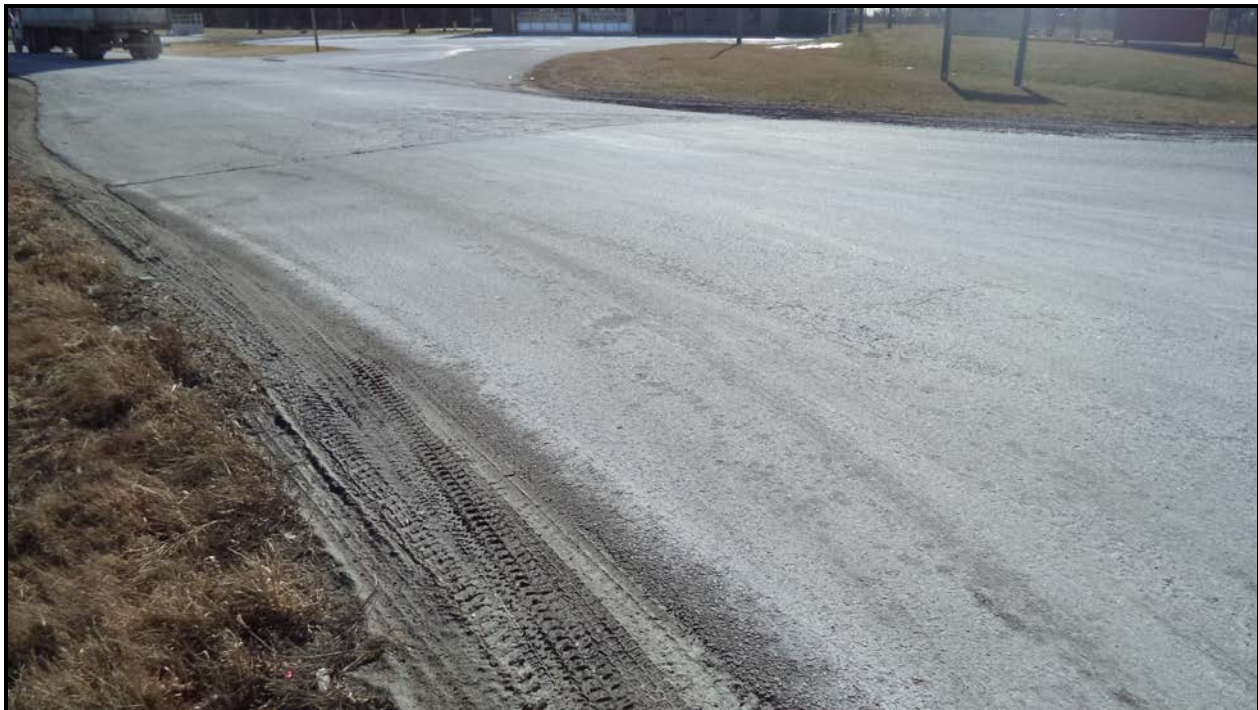
Photograph 2 – Wearing Surface at East Approach

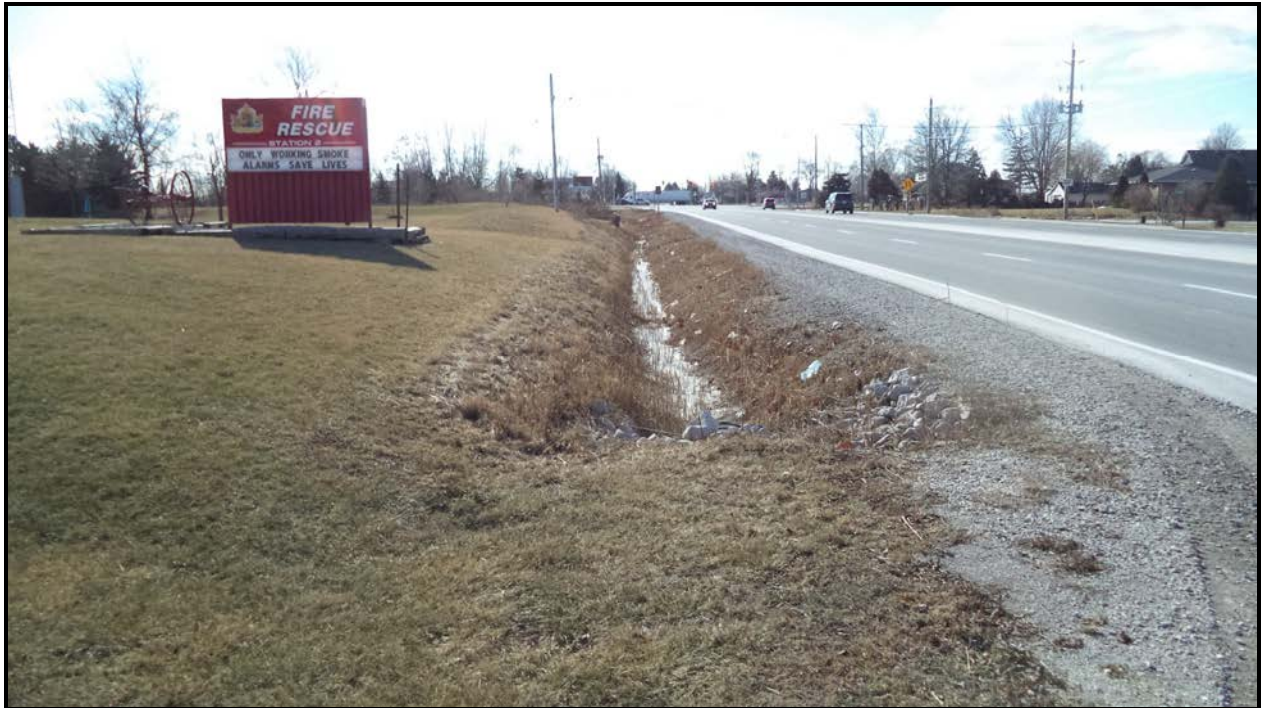
Photograph 5 – Water Stream (McCord Lane South Side - Looking South)

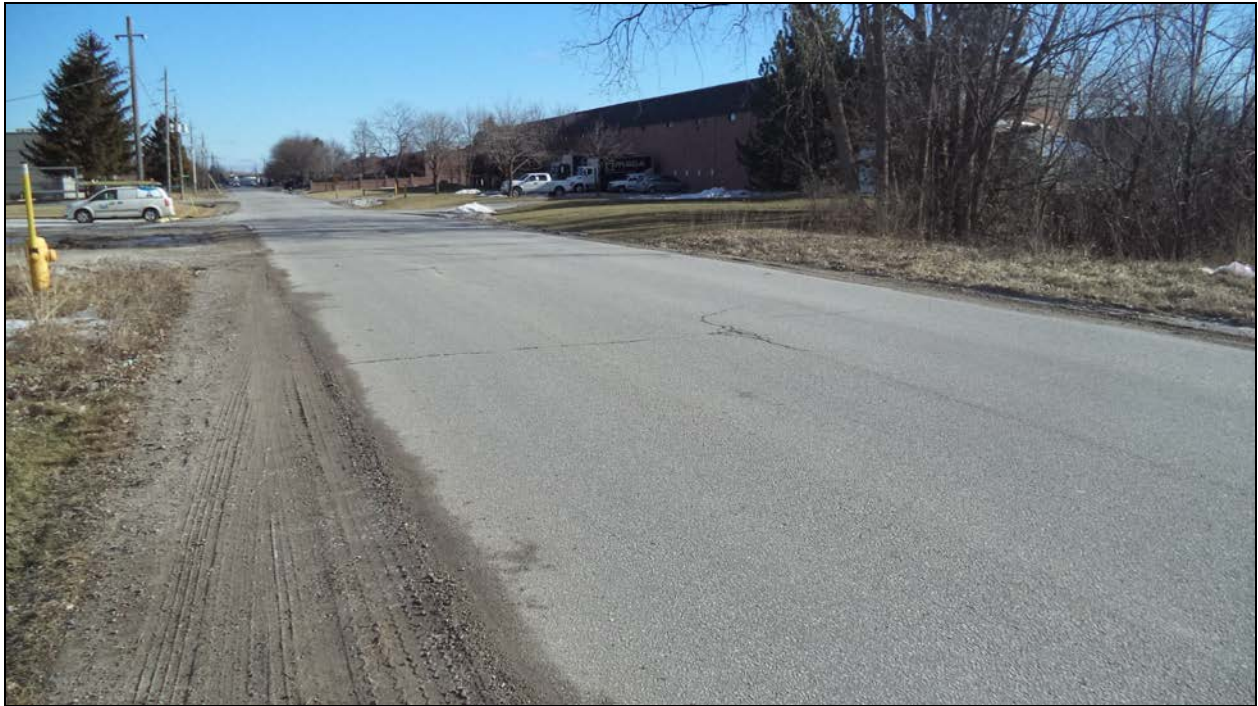
Photograph 1 – Road over Culvert (Looking North)

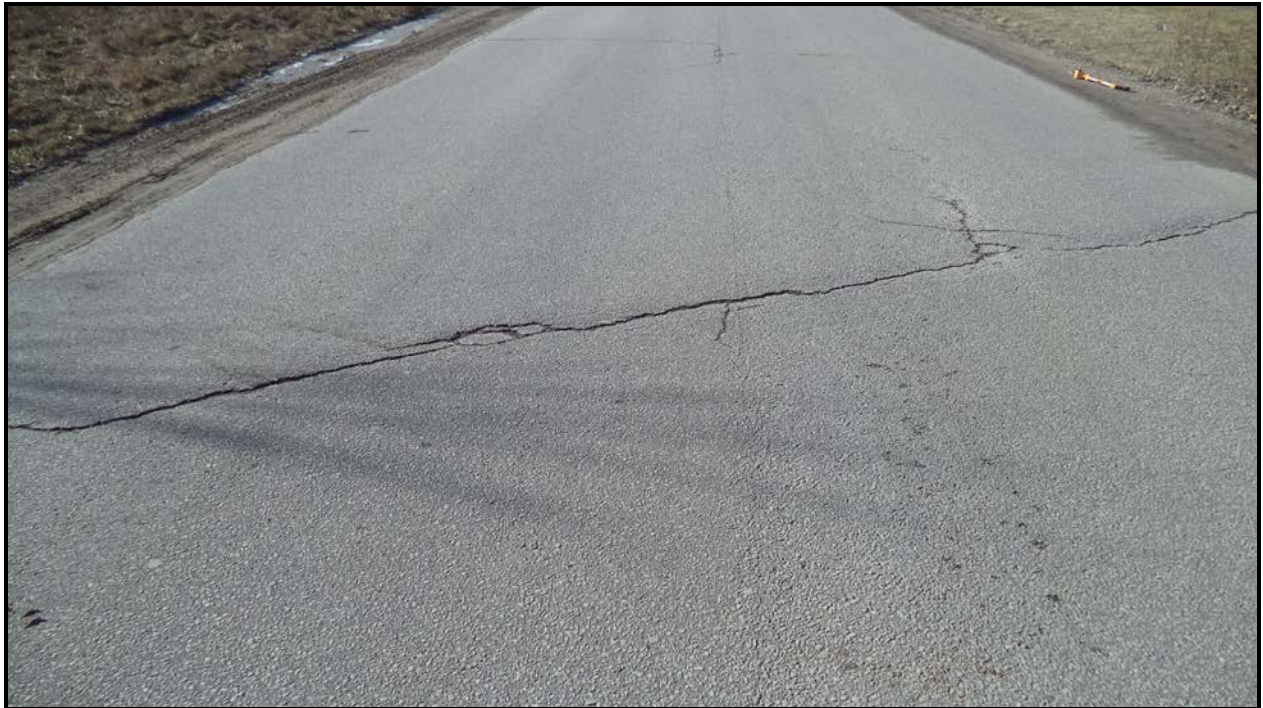
Photograph 5 – Wearing Surface over Culvert (Looking South)

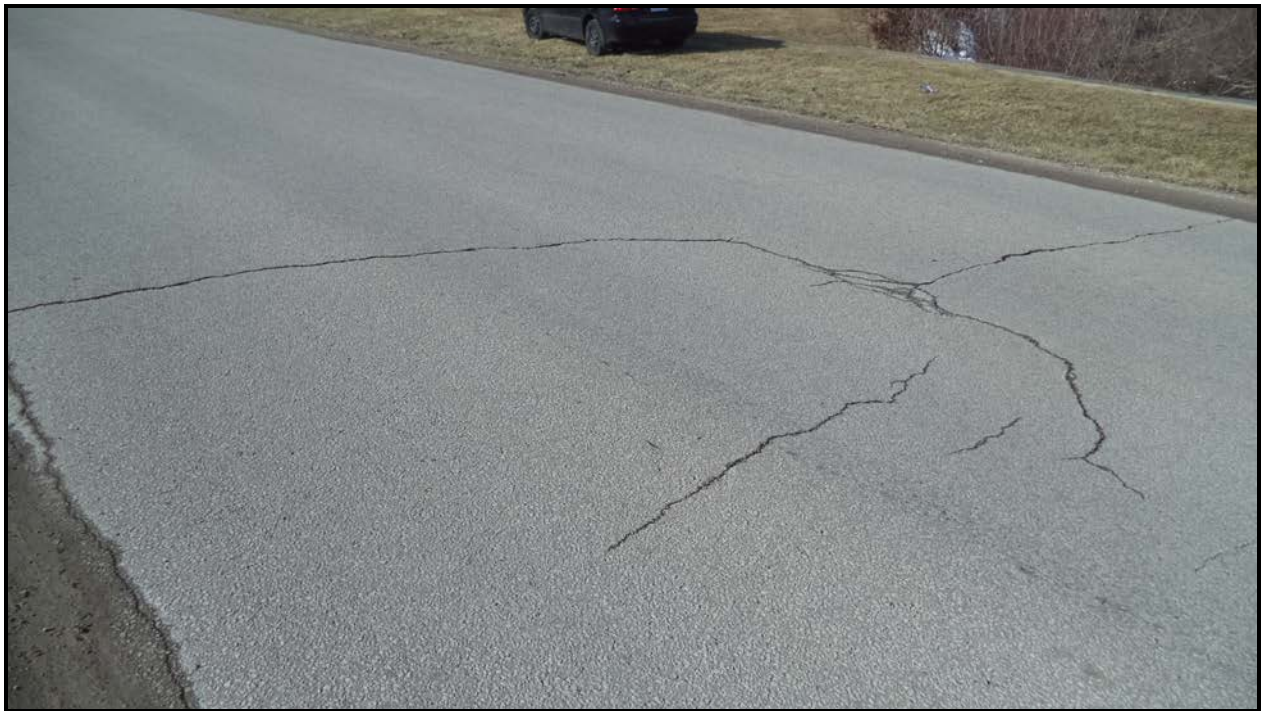
Photograph 6 – Wearing Surface at South Approach

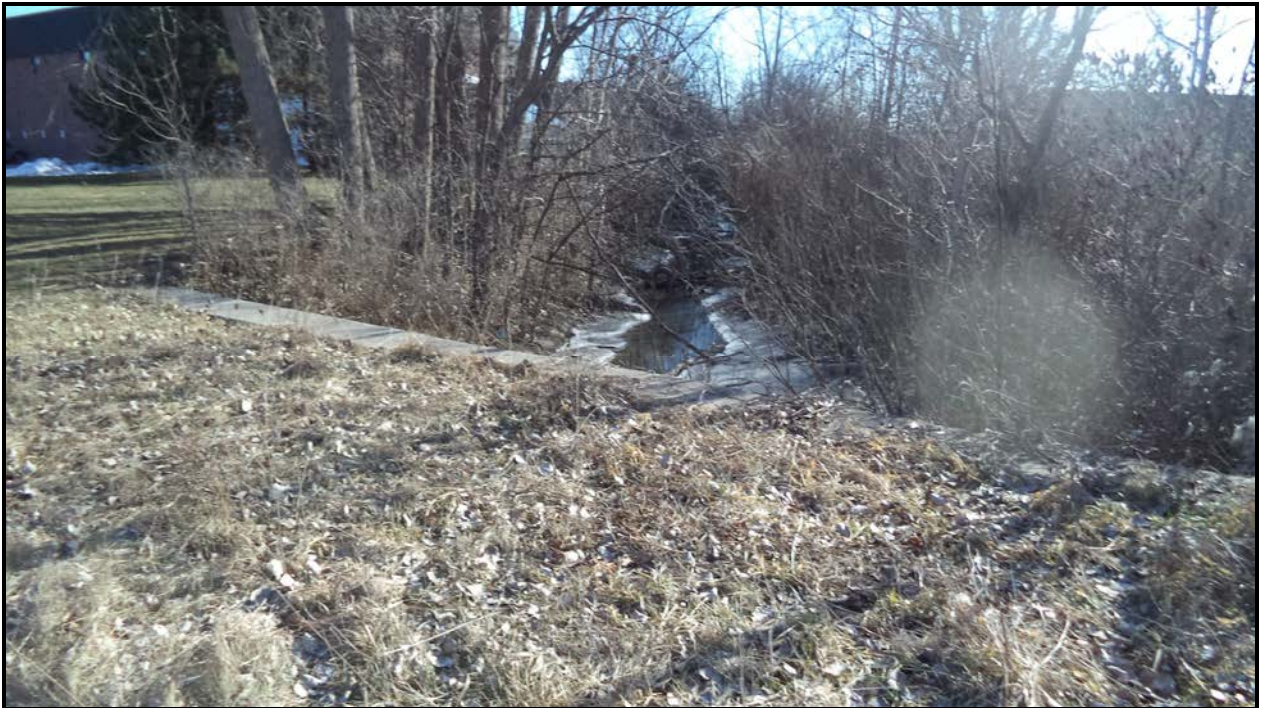
Photograph 7 – Water Stream (Pulleyblank Street East Side - Looking East)

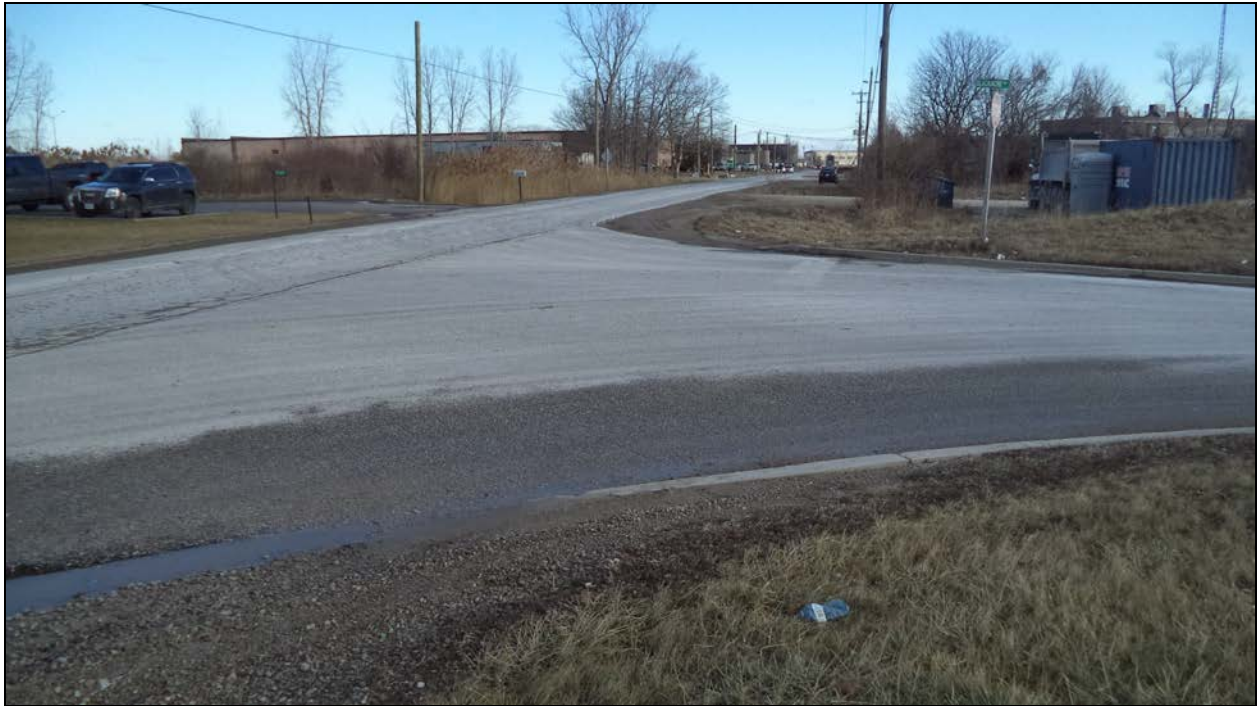
Photograph 1 – Road over Culvert (Looking North)

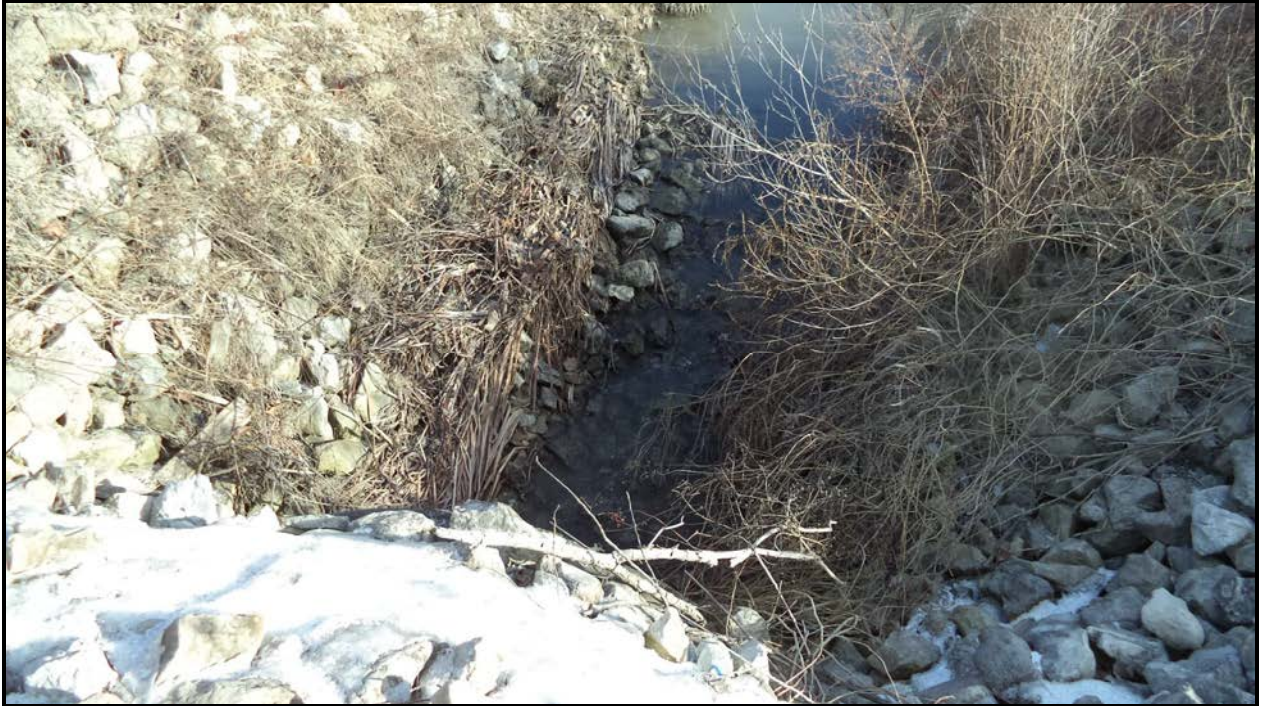
Photograph 5 – Water Stream (Blackacre Drive North Side - Looking North)

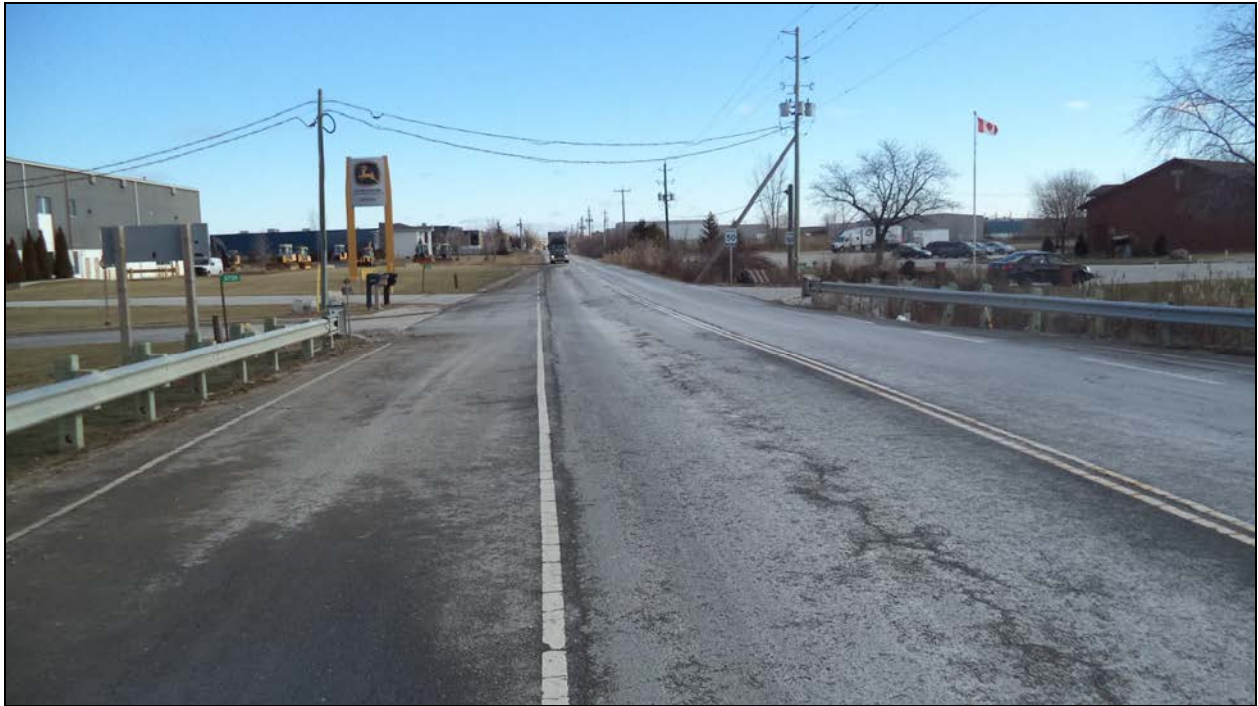
Photograph 1 – Road over Culvert (Looking North)

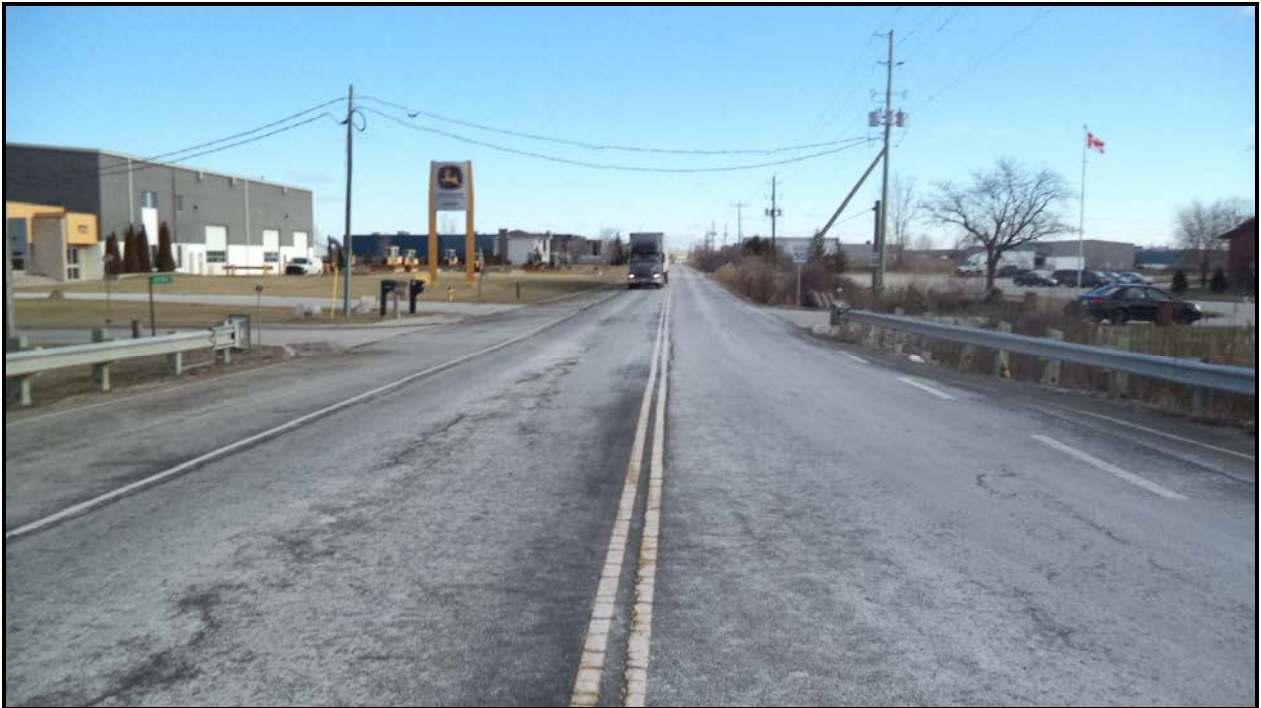
Photograph 5 – Wearing Surface over Culvert (Looking South)

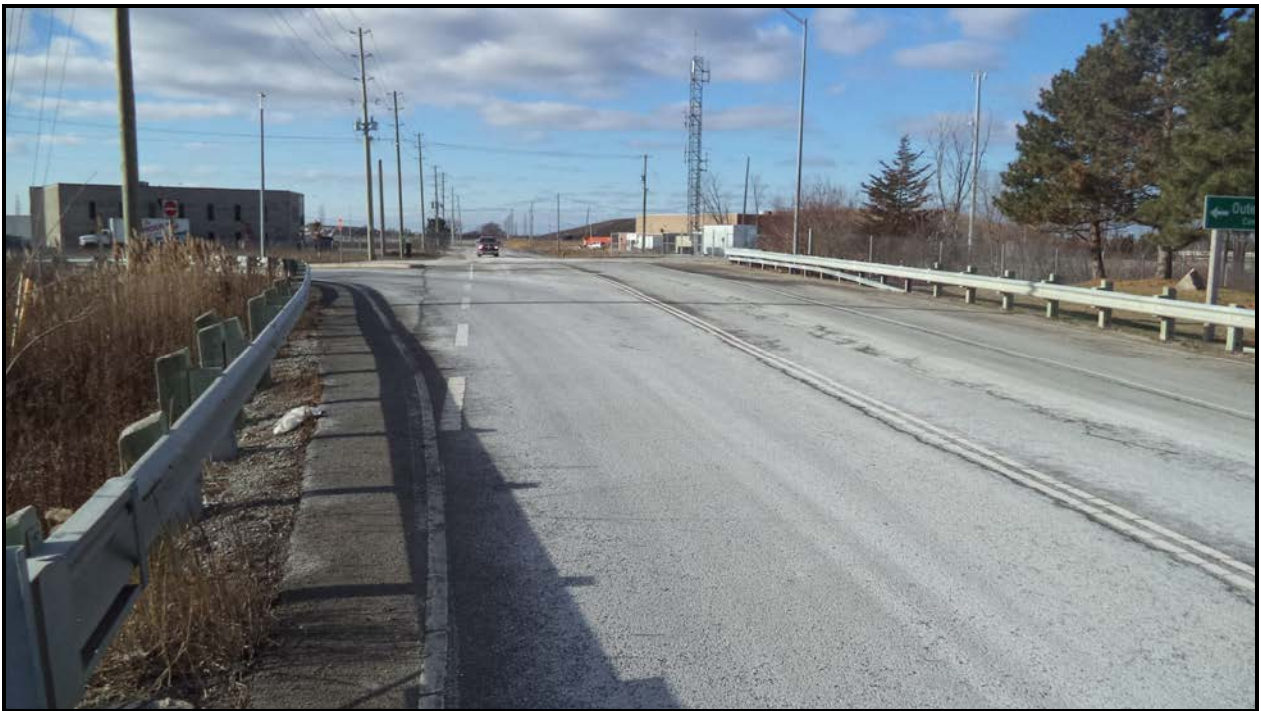
Photograph 6 – Wearing Surface over Culvert (Looking North)

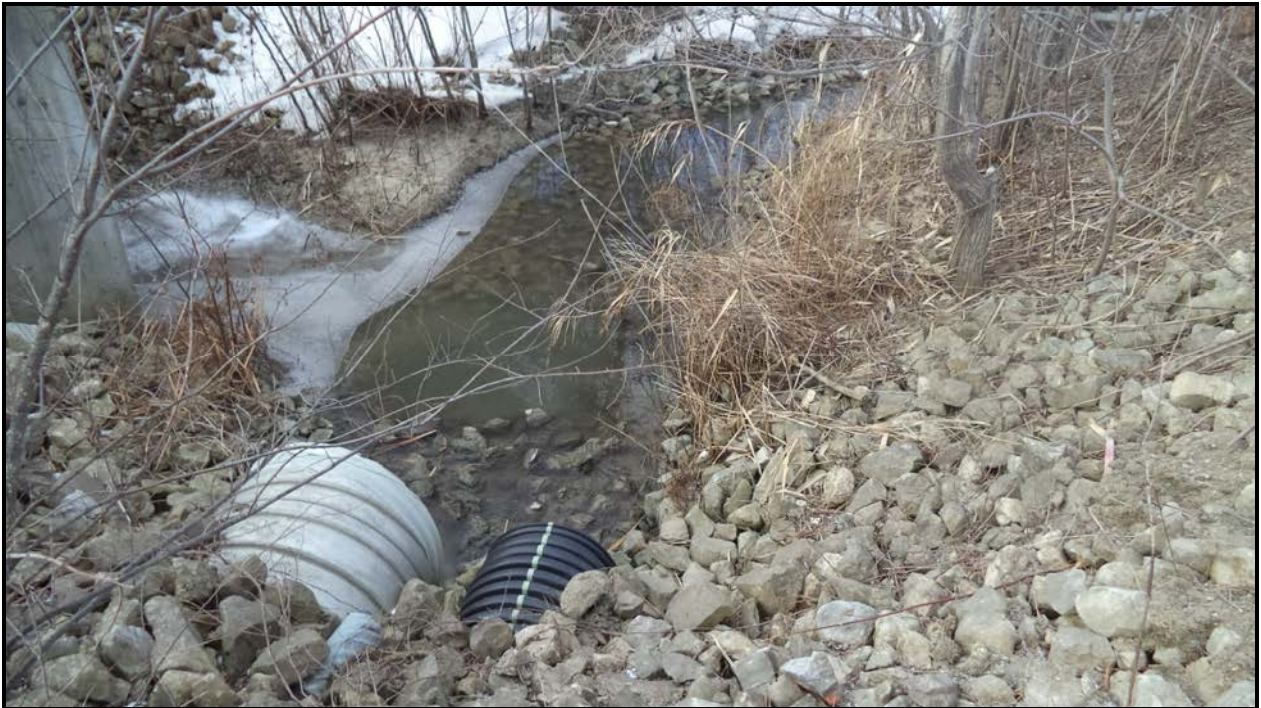
Photograph 7 – Water Stream (Outer Drive West Side – Looking West)

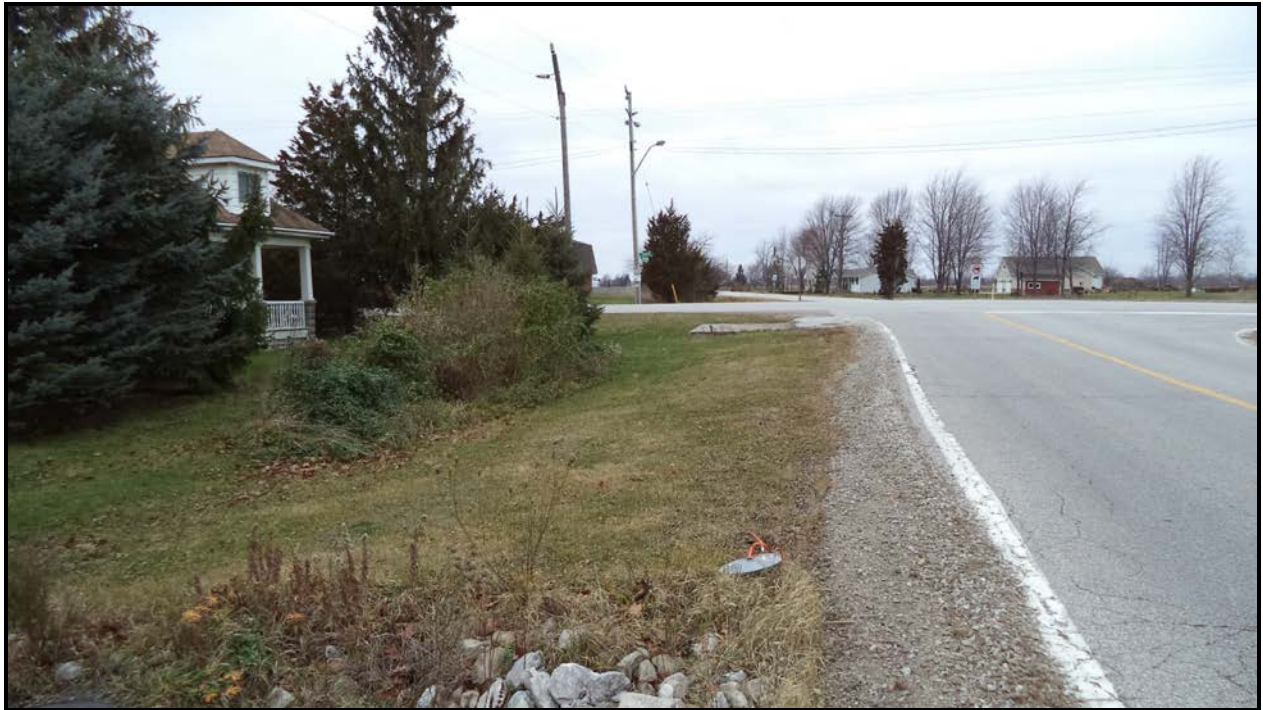
Photograph 1 – Road over Culvert (Looking West)

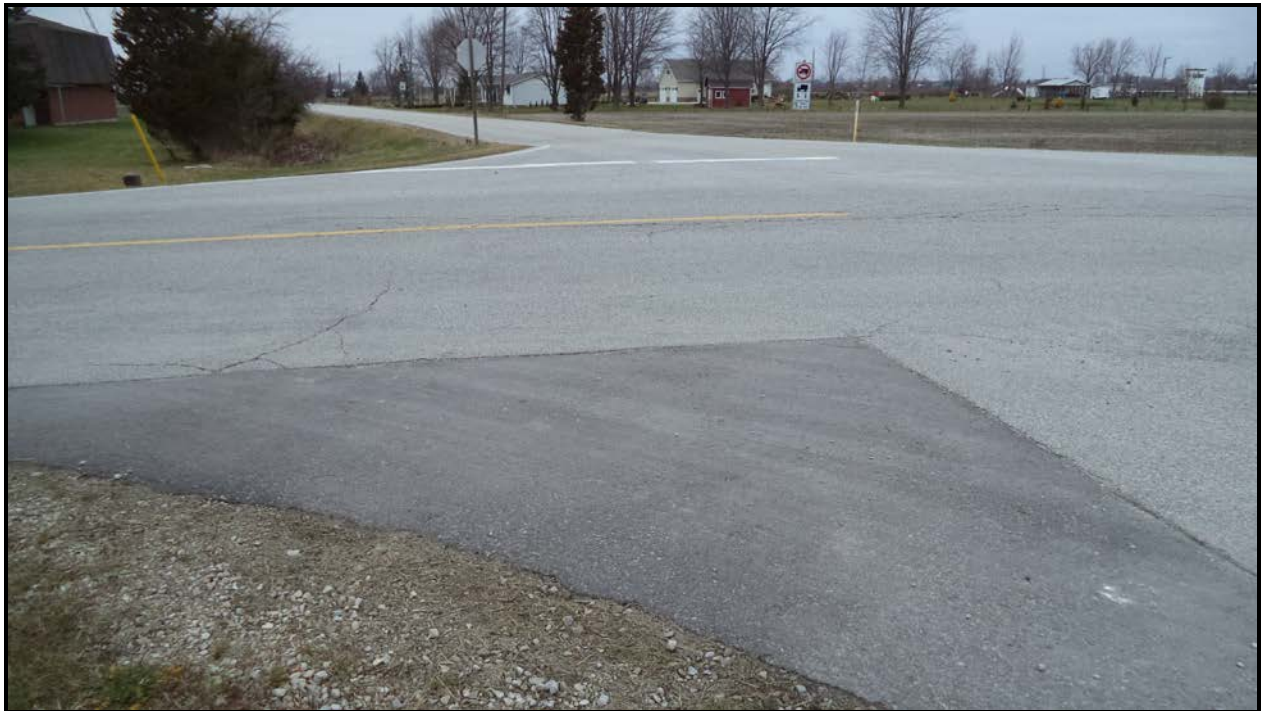
Photograph 2 – Road over Culvert (Looking West)

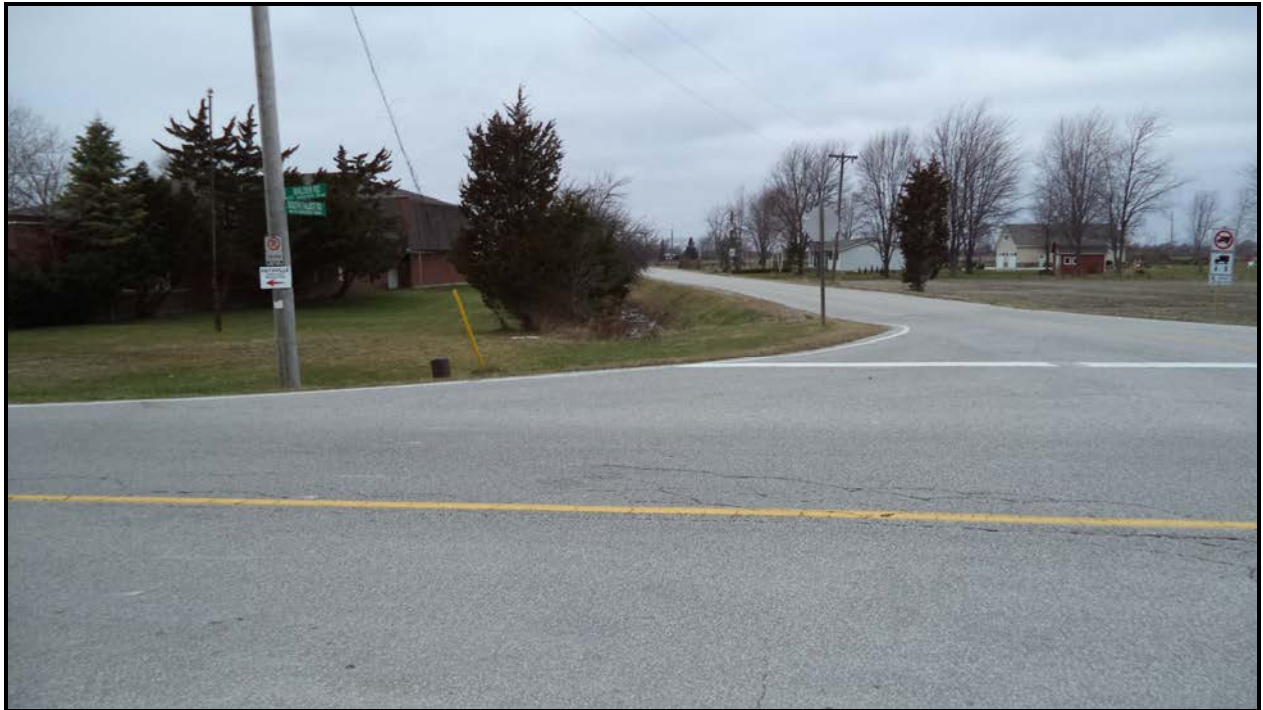
Photograph 5 – Wearing Surface over Culvert (Looking West)

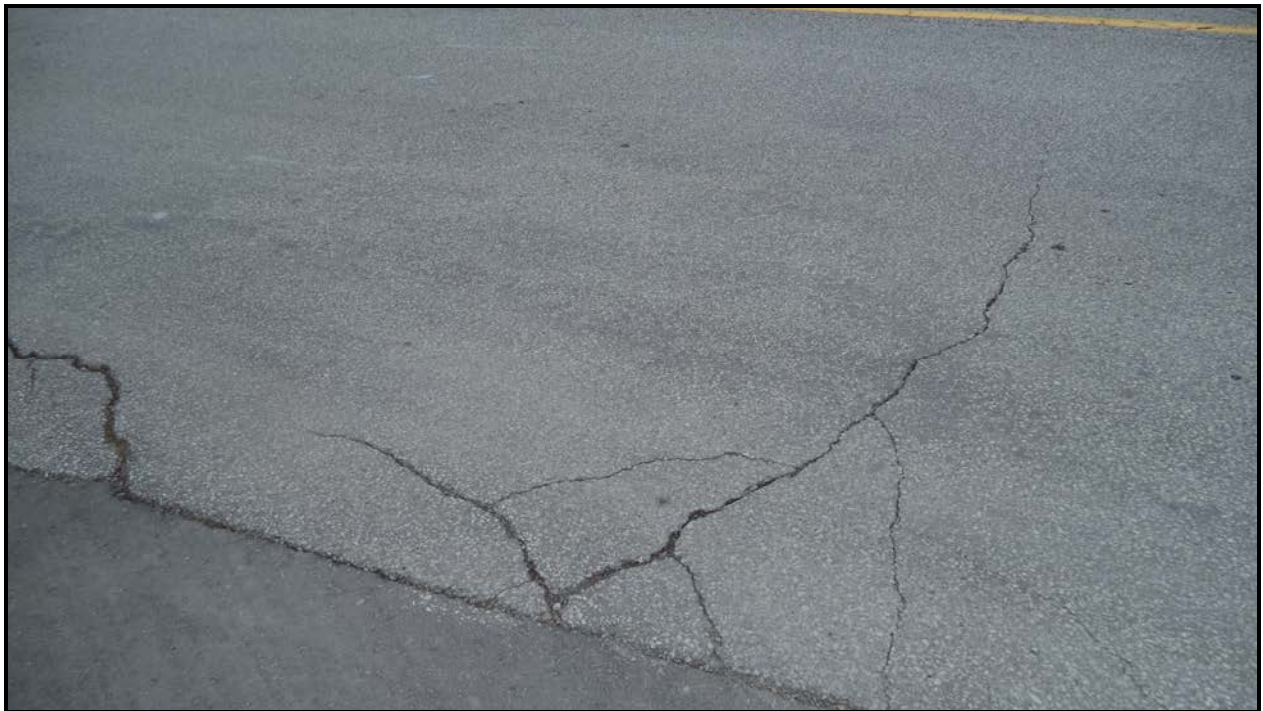
Photograph 6 – Wearing Surface over Culvert (Looking West)

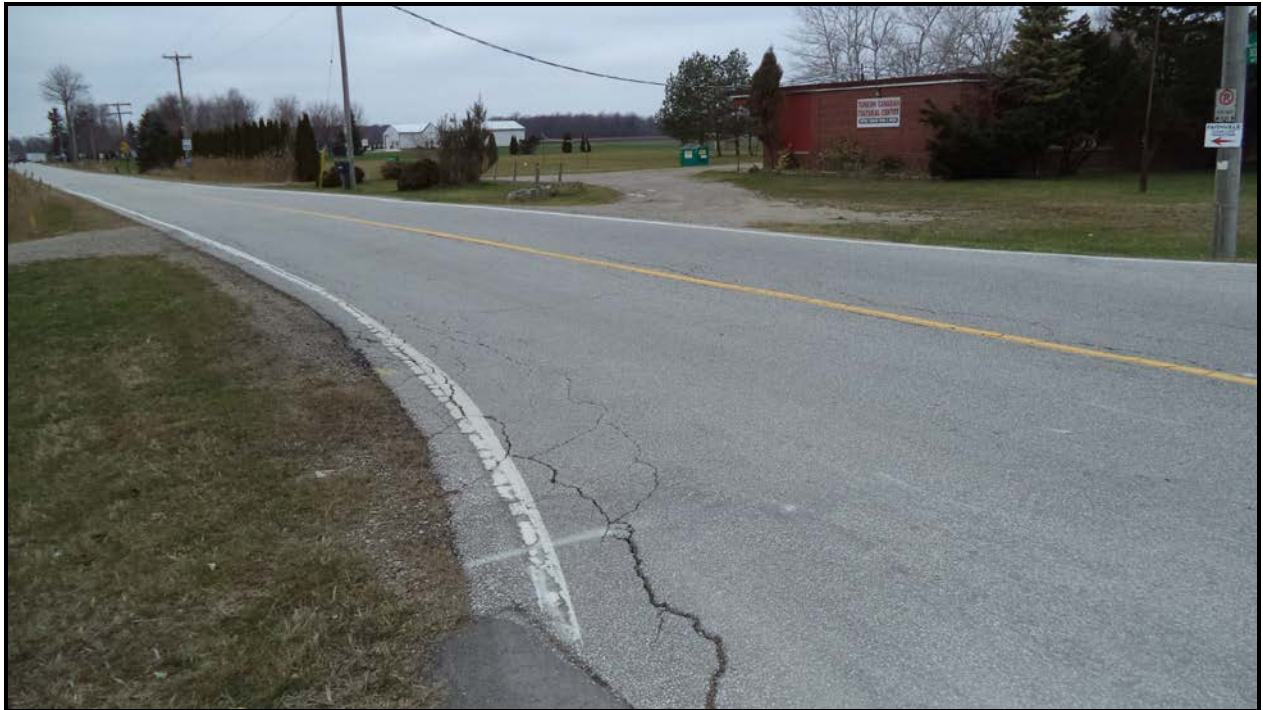
Photograph 7 – Wearing Surface at South Approach (Looking South)

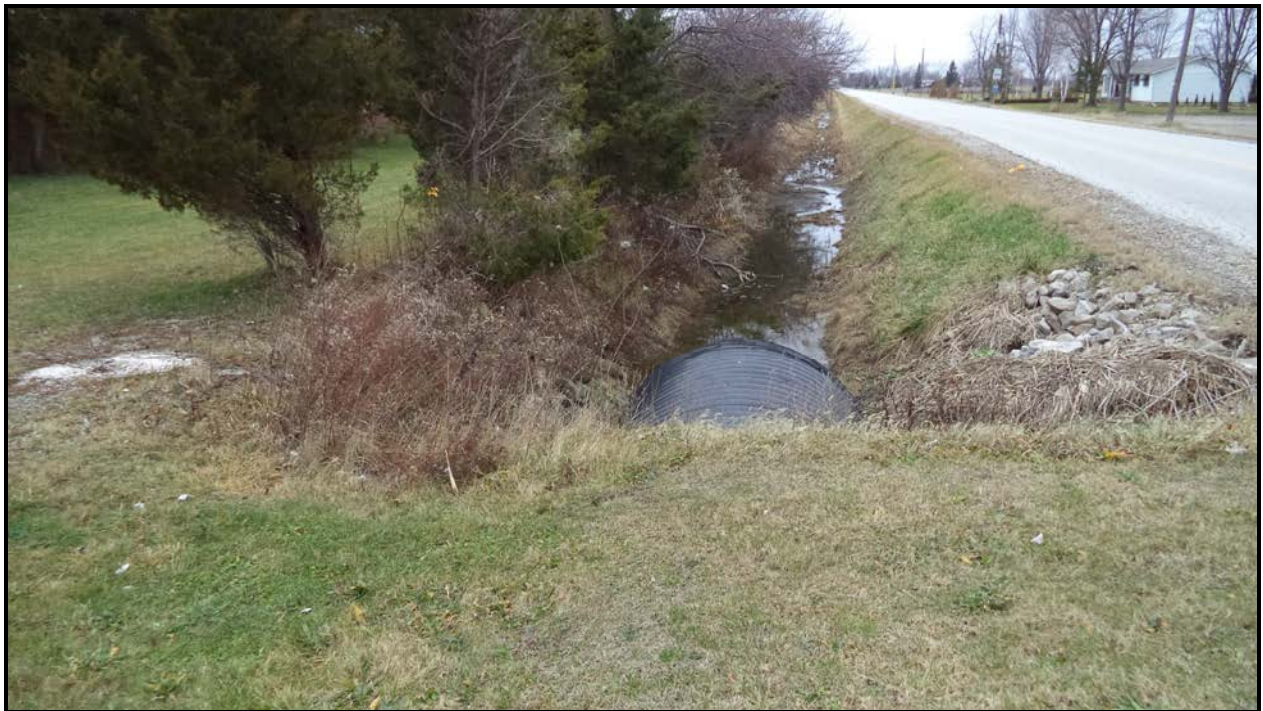
Photograph 8 – Water Stream (Malden Road East Side – Looking West)

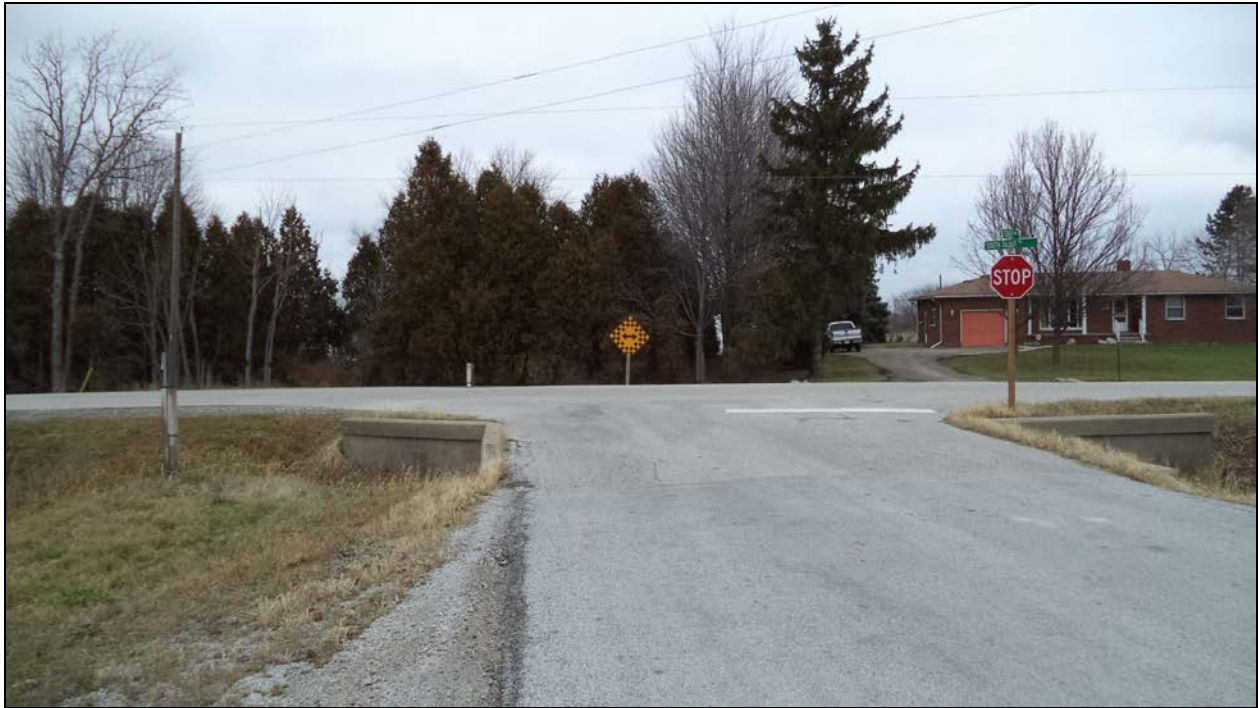
Photograph 1 – Road over Culvert (Looking North)

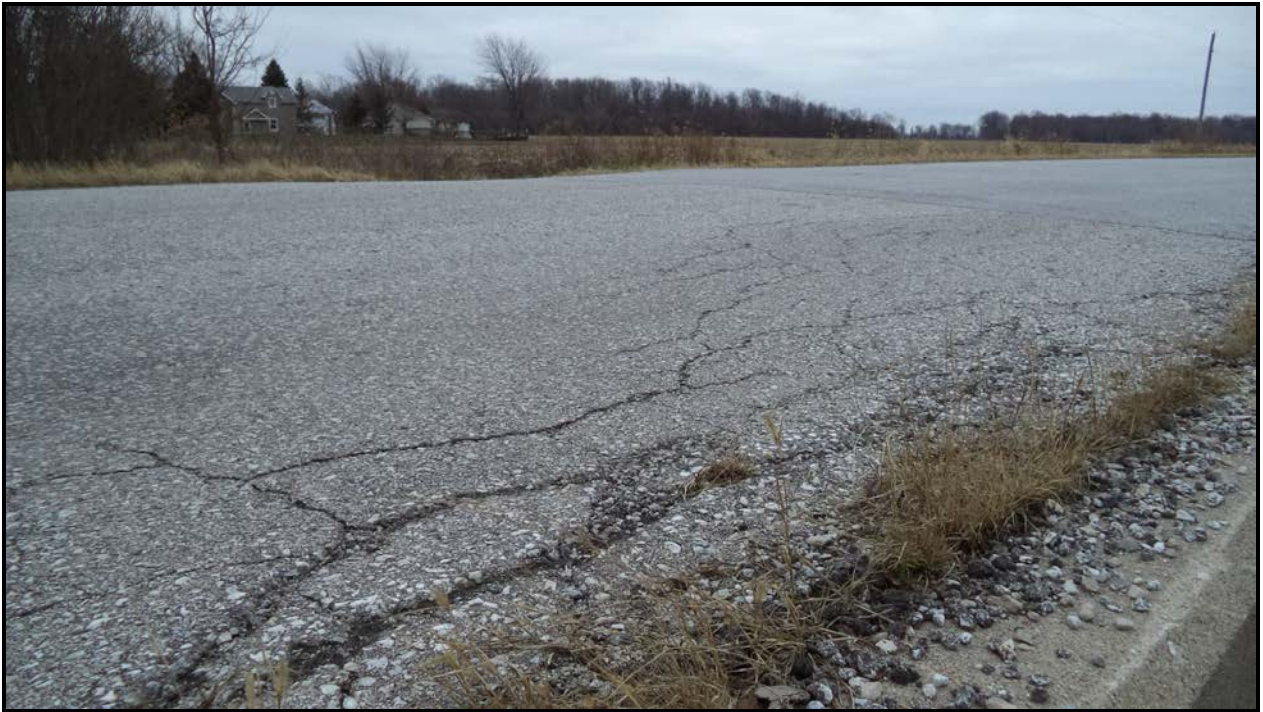
Photograph 5 – Wearing Surface over Culvert (Looking East)
