CORPORATE OF THE TOWN OF TECUMSEH
2016 Culvert Needs Study

Structures with Spans $\leq 3.0\text{m}$ – Final Report

Our File: 15-2977

October 28, 2016

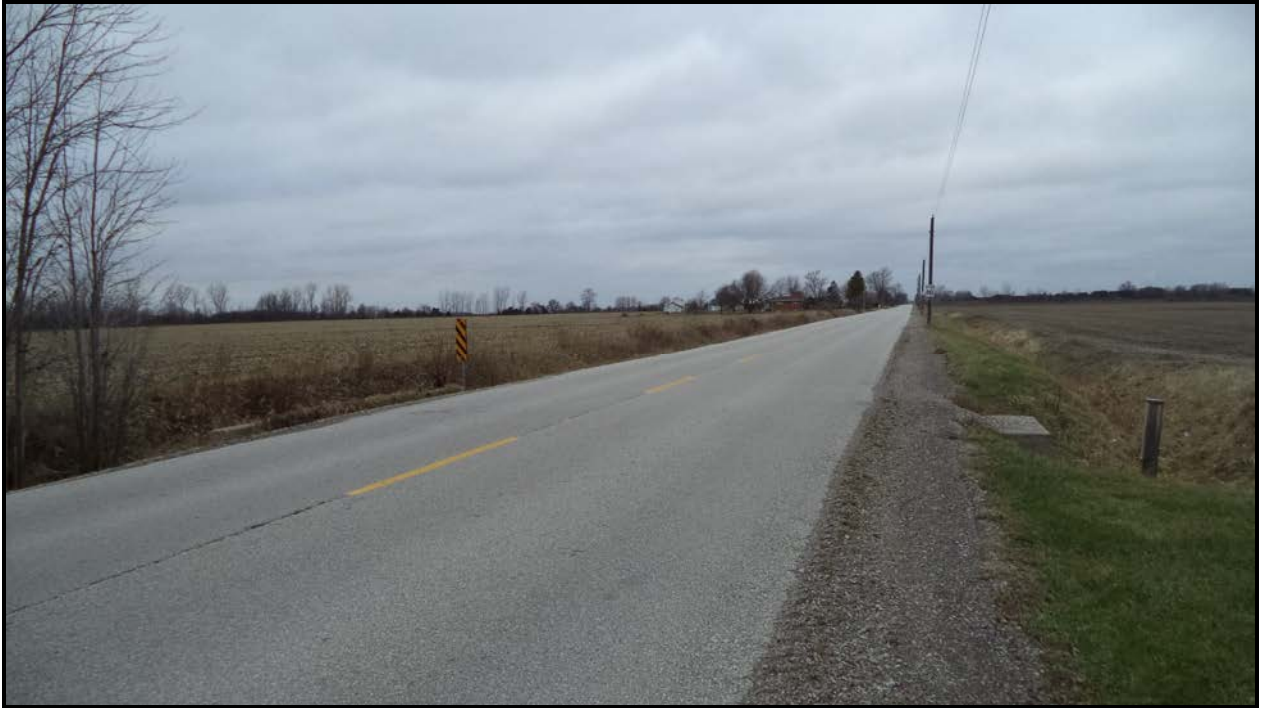
Photograph 1 – Road over Culvert (Looking West)

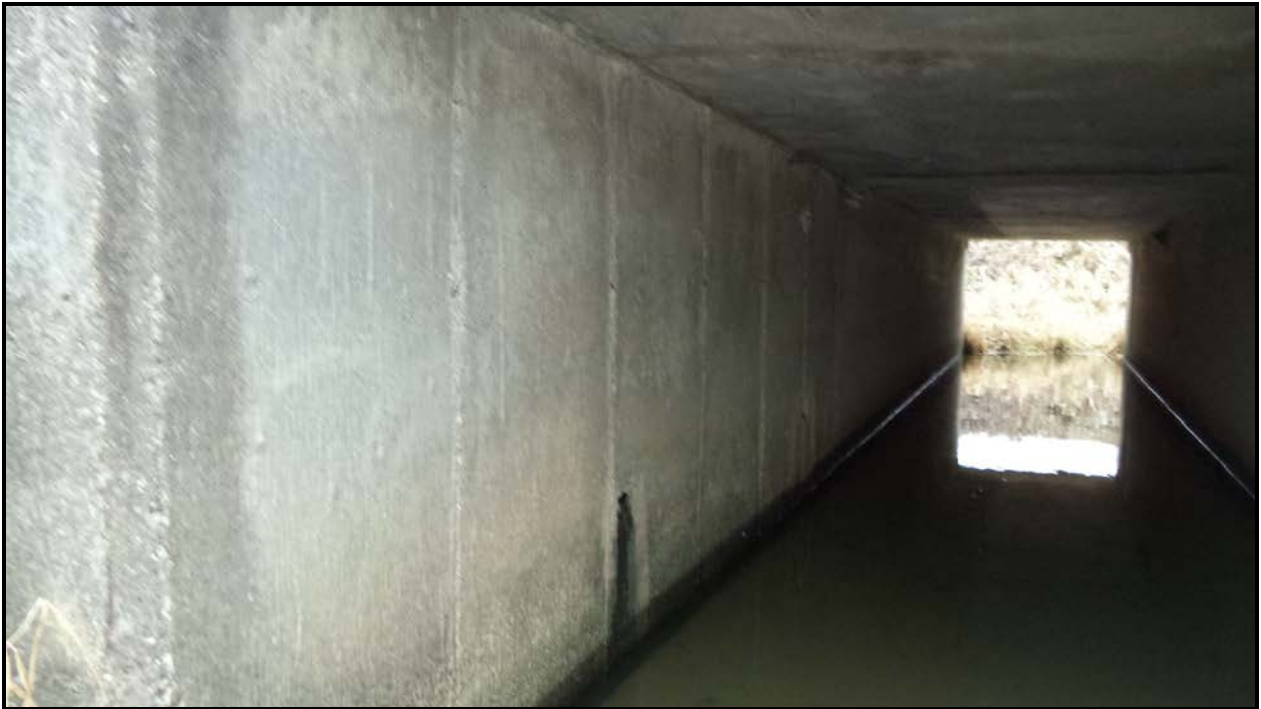
Photograph 2 – Culvert inside Box (Looking North)

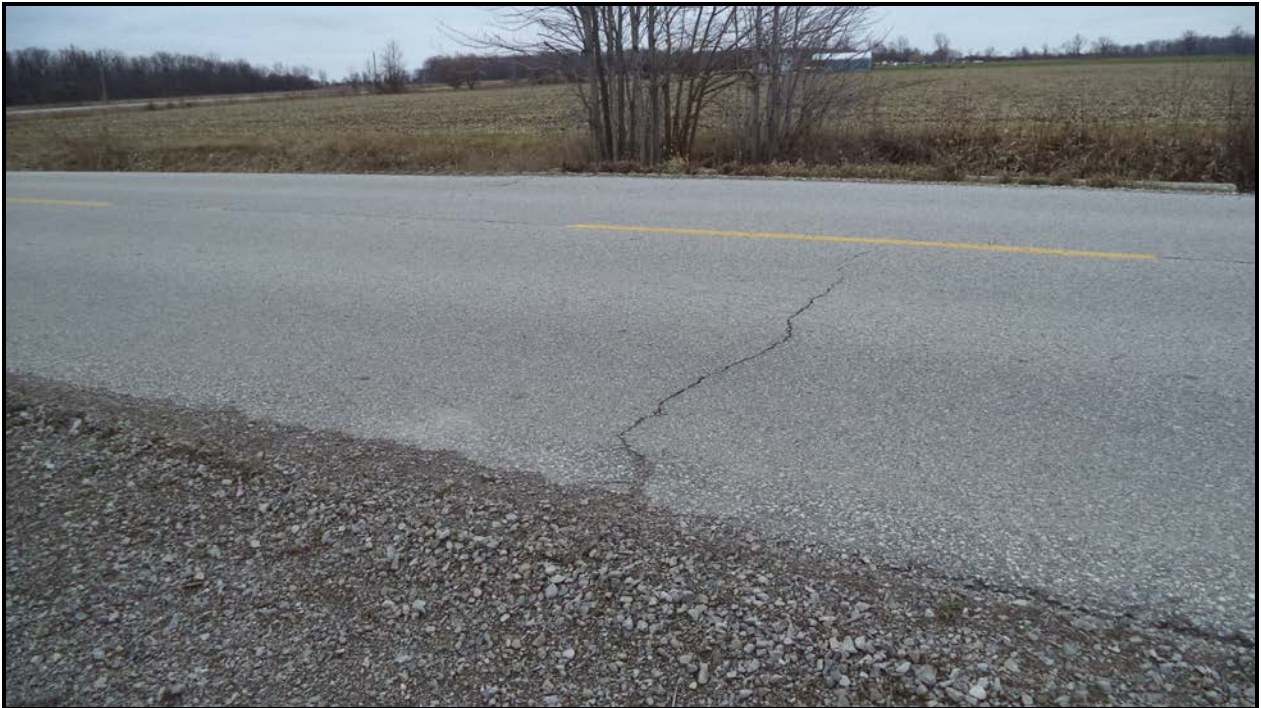
Photograph 5 – Wearing Surface over Culvert (Looking South)

Element Group:	Decks		Length:	1.10 m		
Element Name:	Wearing Surface		Width:	8.50 m		
Location:			Height:			
Material:	Asphalt		Count:			
Element Type:			Total Quantity:	9.35 Sq.m		
Environment:			Limited Inspection	<input type="checkbox"/>		
Protection System:						Perform. Deficiencies
Condition Data:	Units	Exc.	Good	Fair	Poor*	
	m ² <input checked="" type="checkbox"/> /m <input type="checkbox"/> / each <input type="checkbox"/> / % <input type="checkbox"/> / all <input type="checkbox"/>		6.25	2.0	1.1	
Comments: - Medium transverse and longitudinal cracks. - Medium progressive edge cracks over the culvert.						
Recommended Work:	<input type="checkbox"/> Rehab <input type="checkbox"/> Replace		Maintenance Needs:			
	<input type="checkbox"/> 1-5 years <input type="checkbox"/> 6-10 years		<input type="checkbox"/> Urgent <input type="checkbox"/> 1 year <input type="checkbox"/> 2 year			
						Asphalt Repair

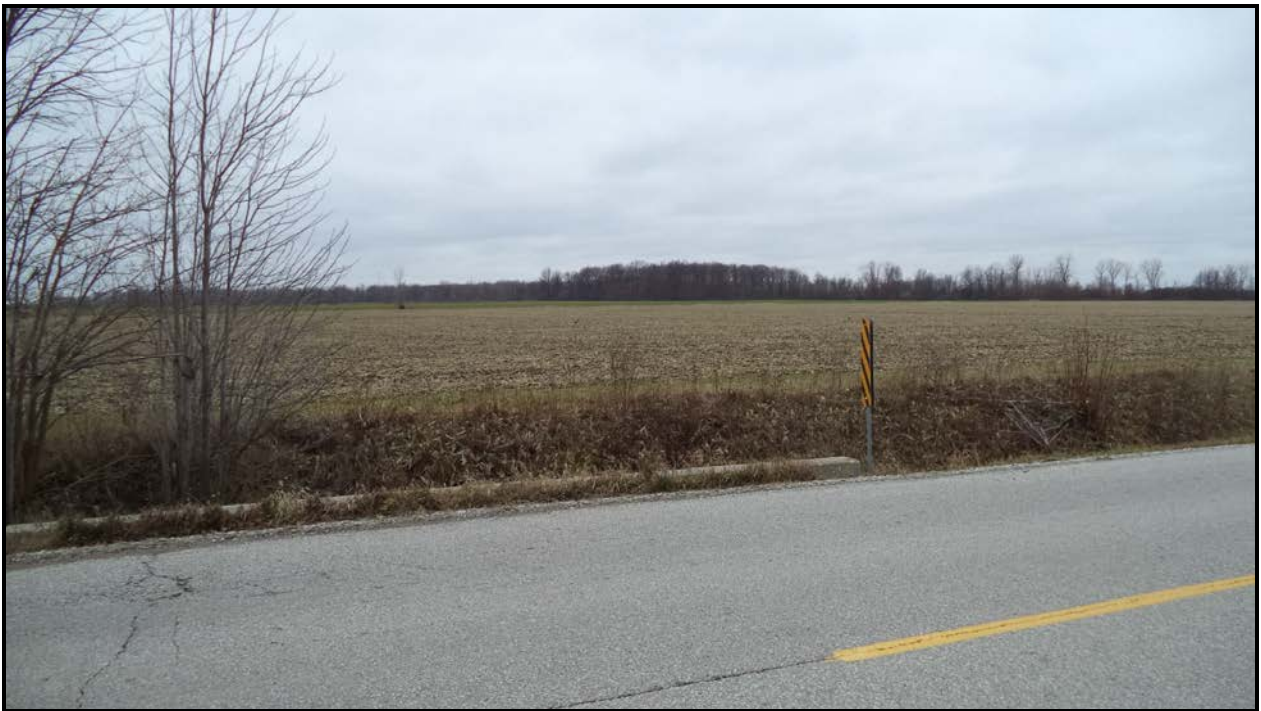
Photograph 6 – Wearing Surface over Culvert (Looking South)

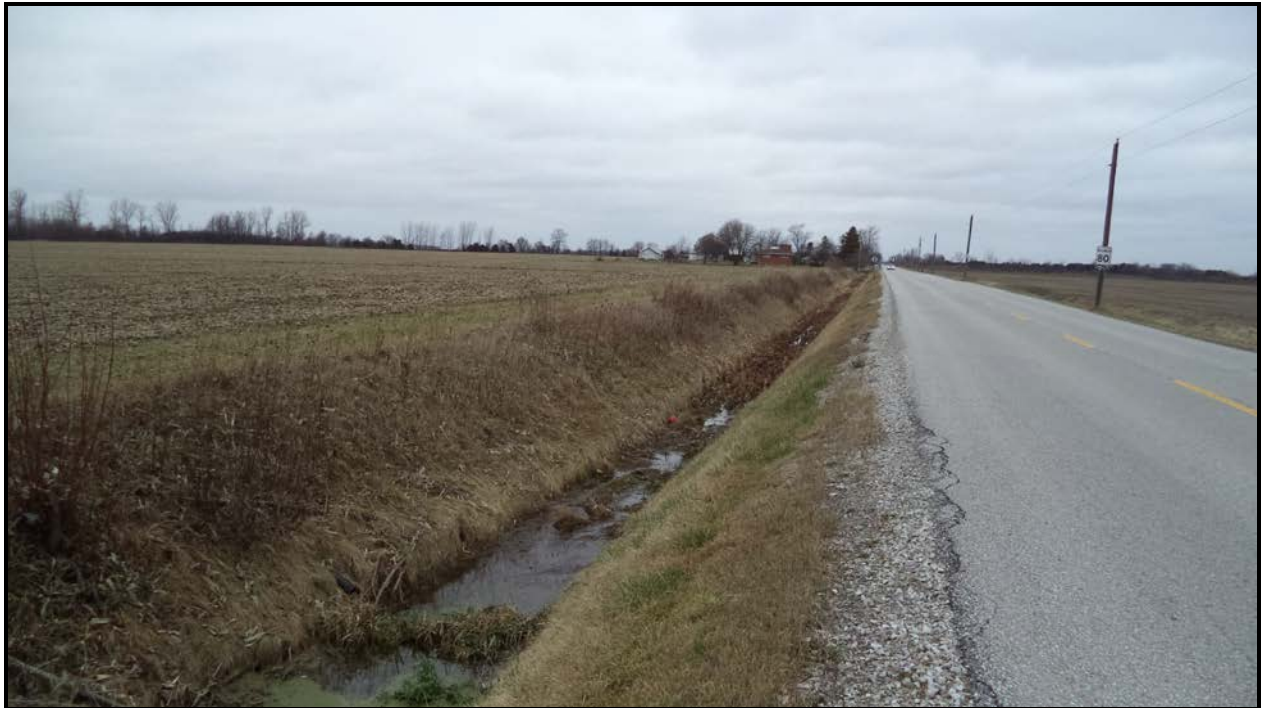
Photograph 7 – Water Stream (S. Talbot Road South Side - Looking West)

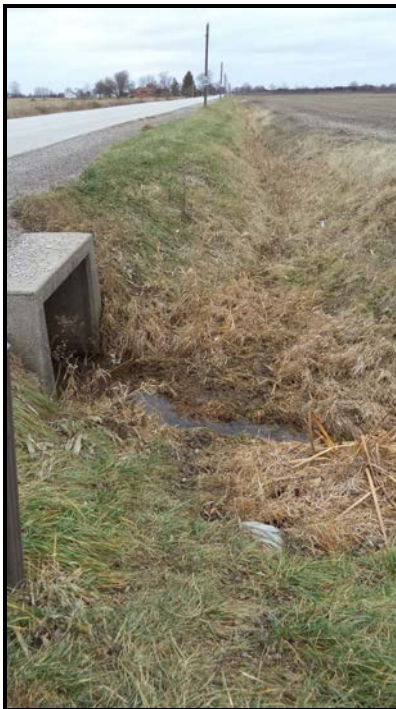
Photograph 8 – Water Stream (S. Talbot Road North Side - Looking West)

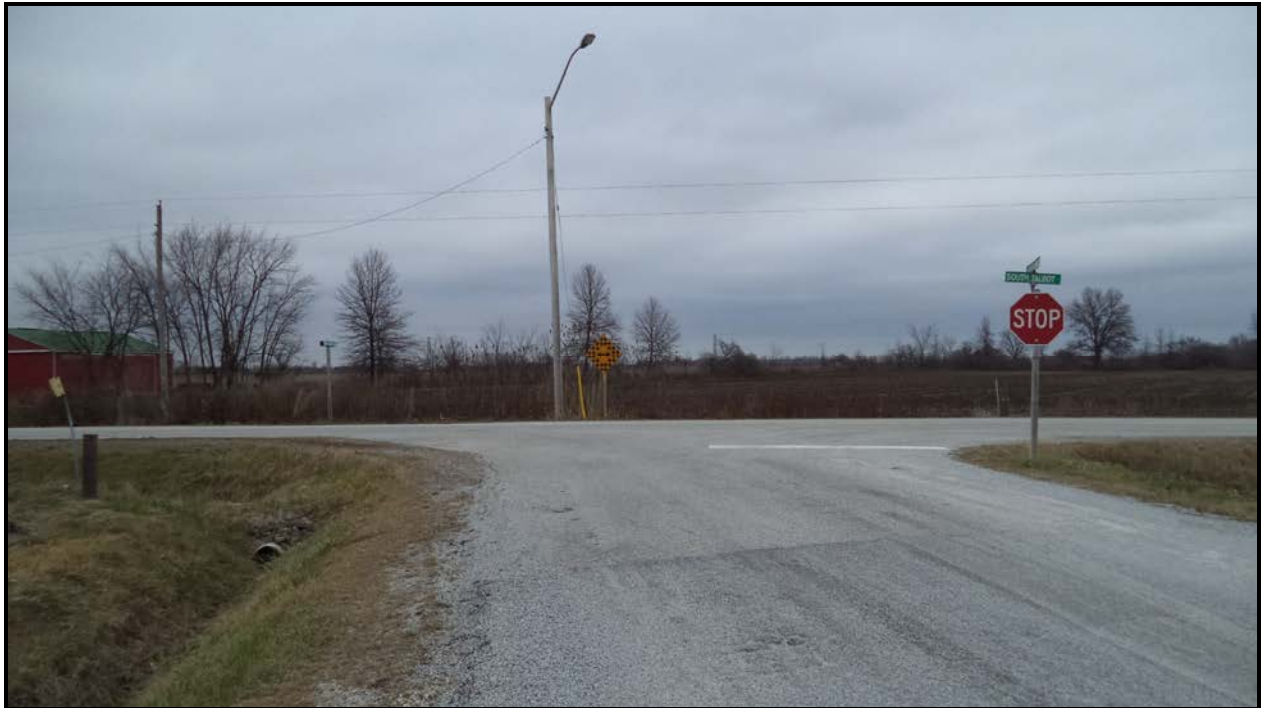
Photograph 1 – Road over Culvert (Looking North)

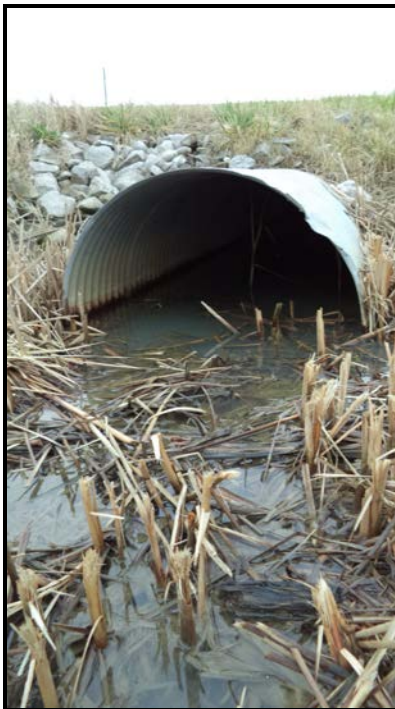
Photograph 2 – Culvert Barrel (West Elevation)

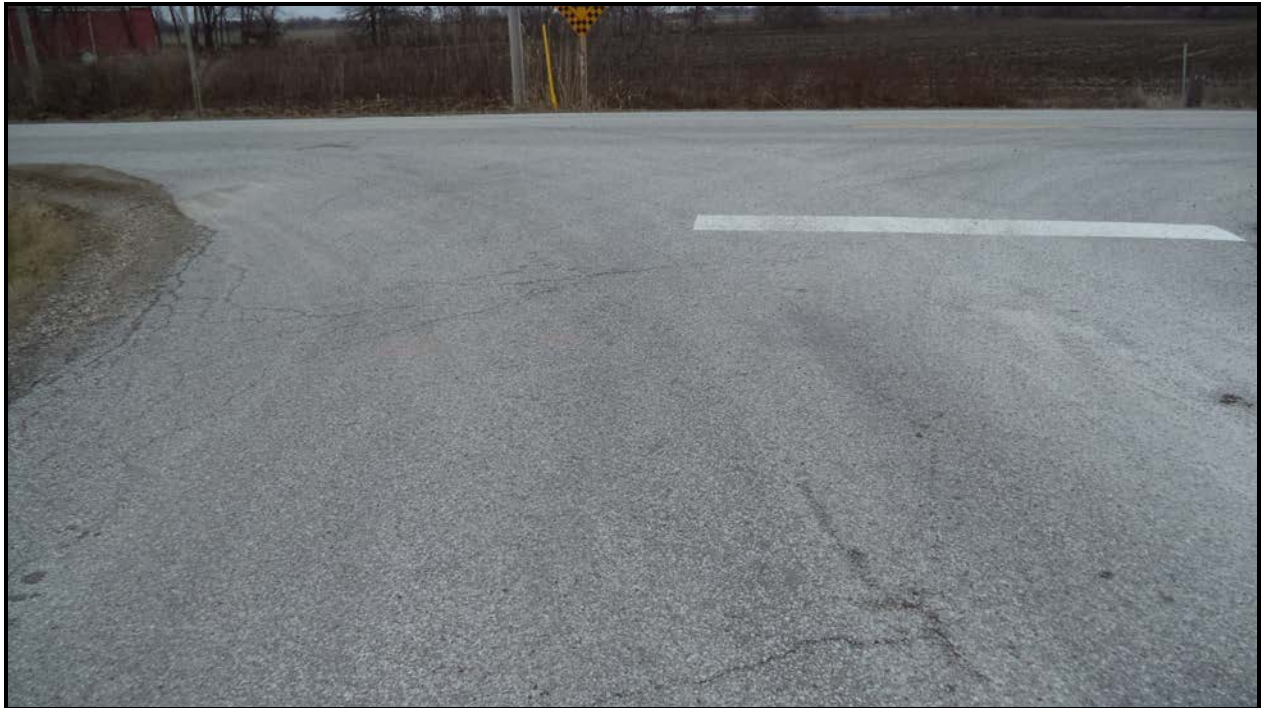
Photograph 5 – Wearing Surface over Culvert (Looking North)

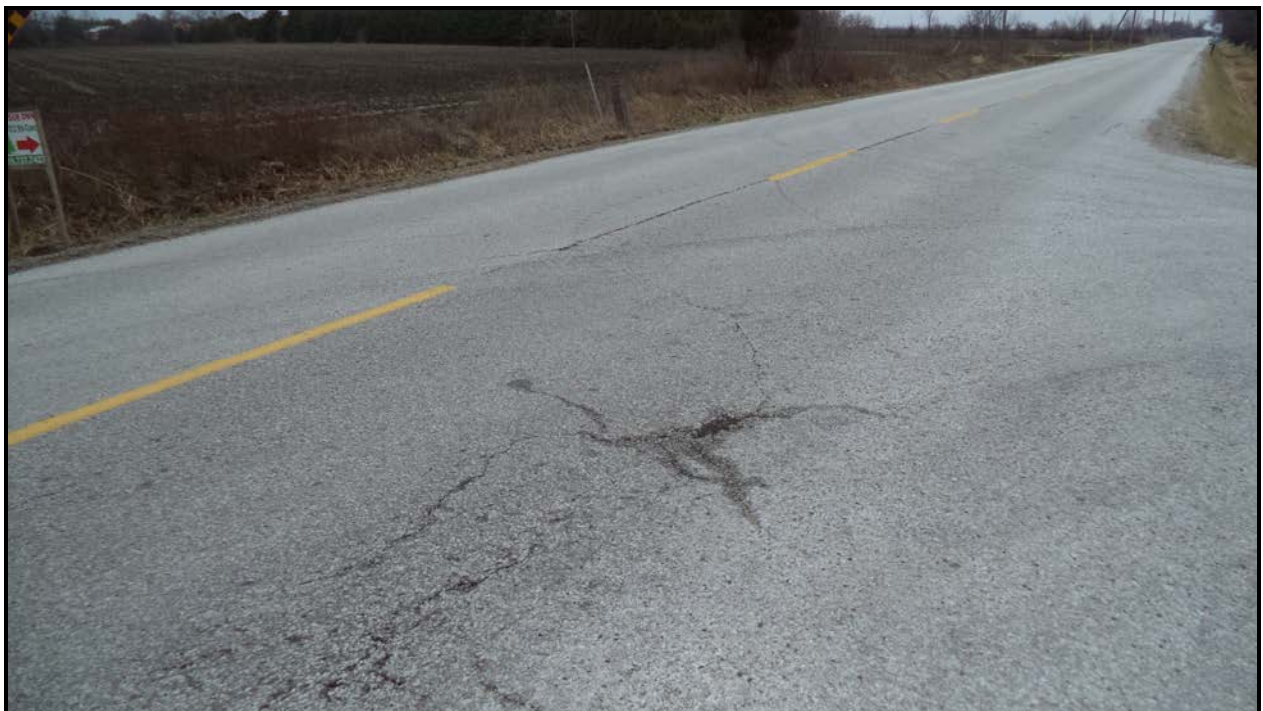
Photograph 6 – Wearing Surface at North Approach (Looking East)

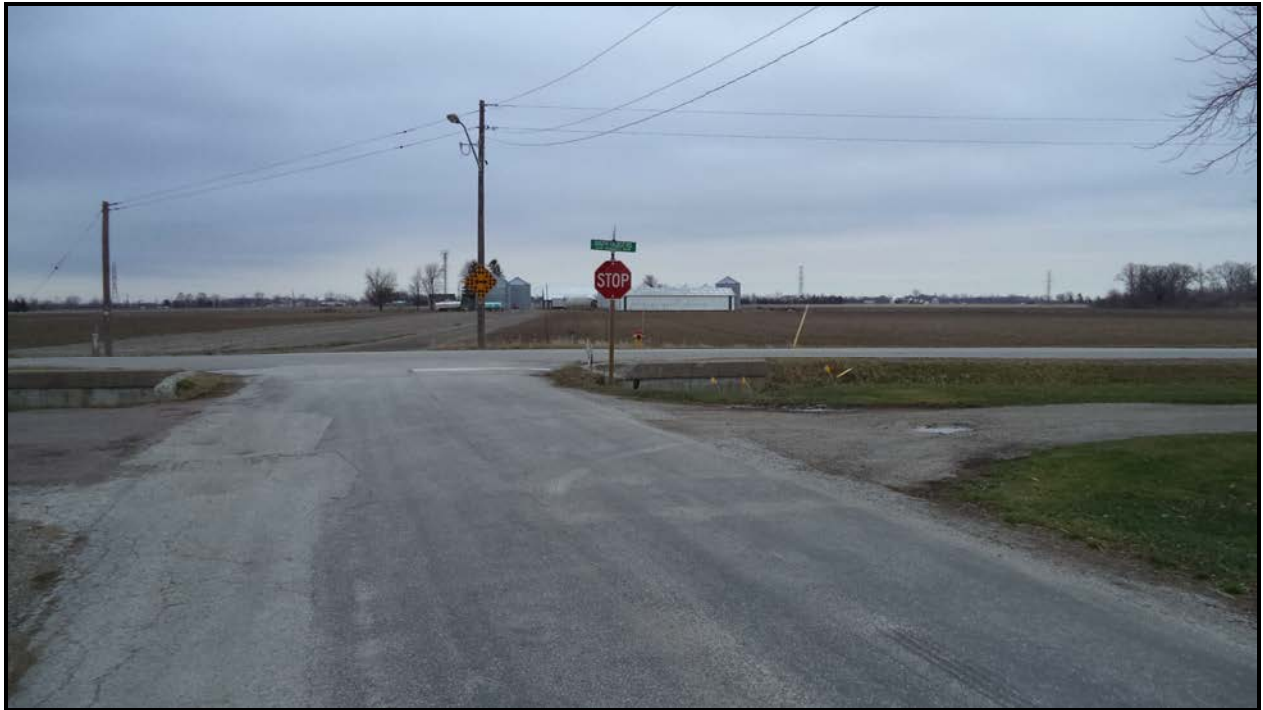
Photograph 1 – Road over Culvert (Looking North)

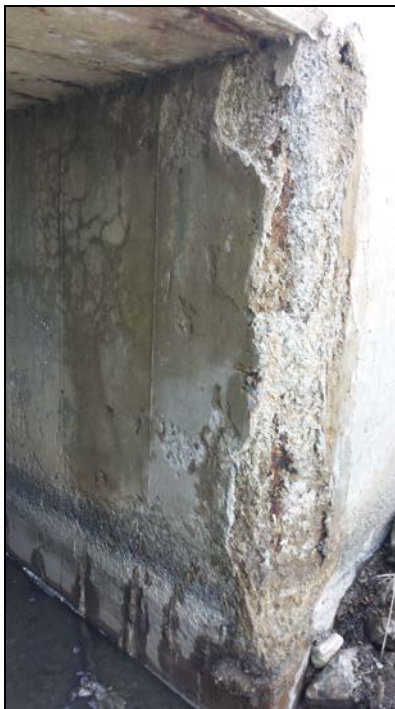
Photograph 2 – Culvert inside Boxes

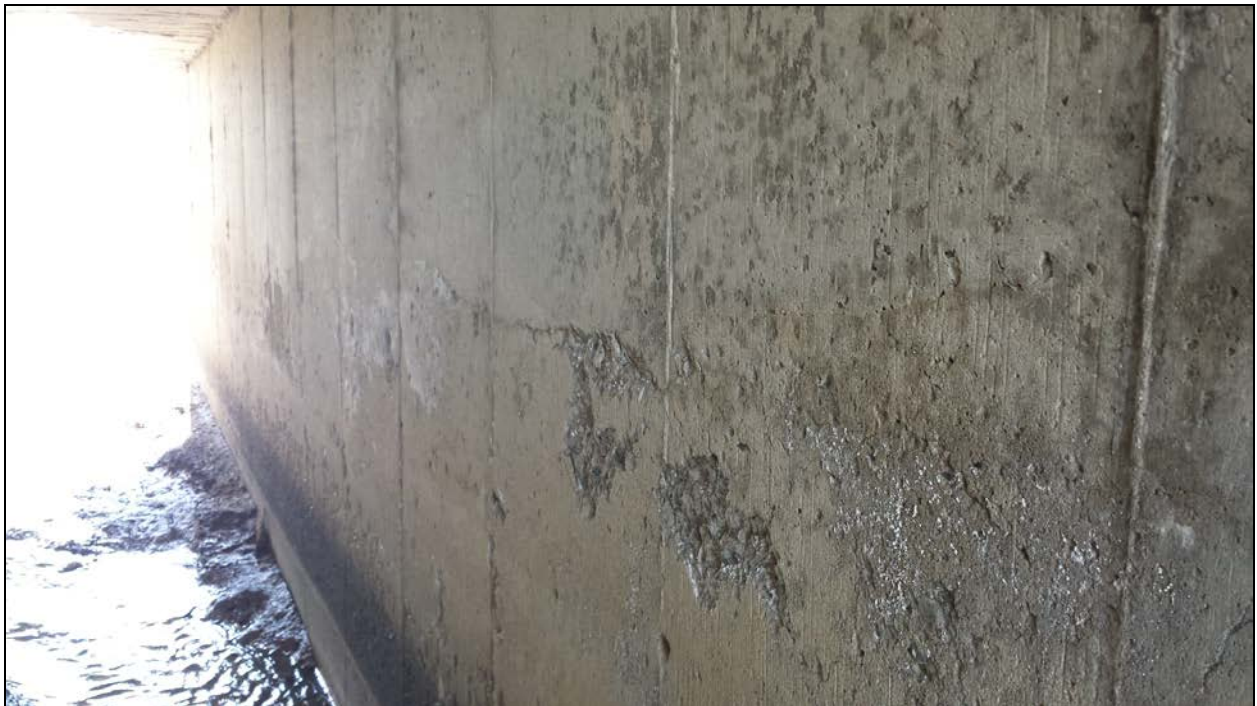
Photograph 4 – Typical scaling and honeycombing at both walls

Concrete patch repair

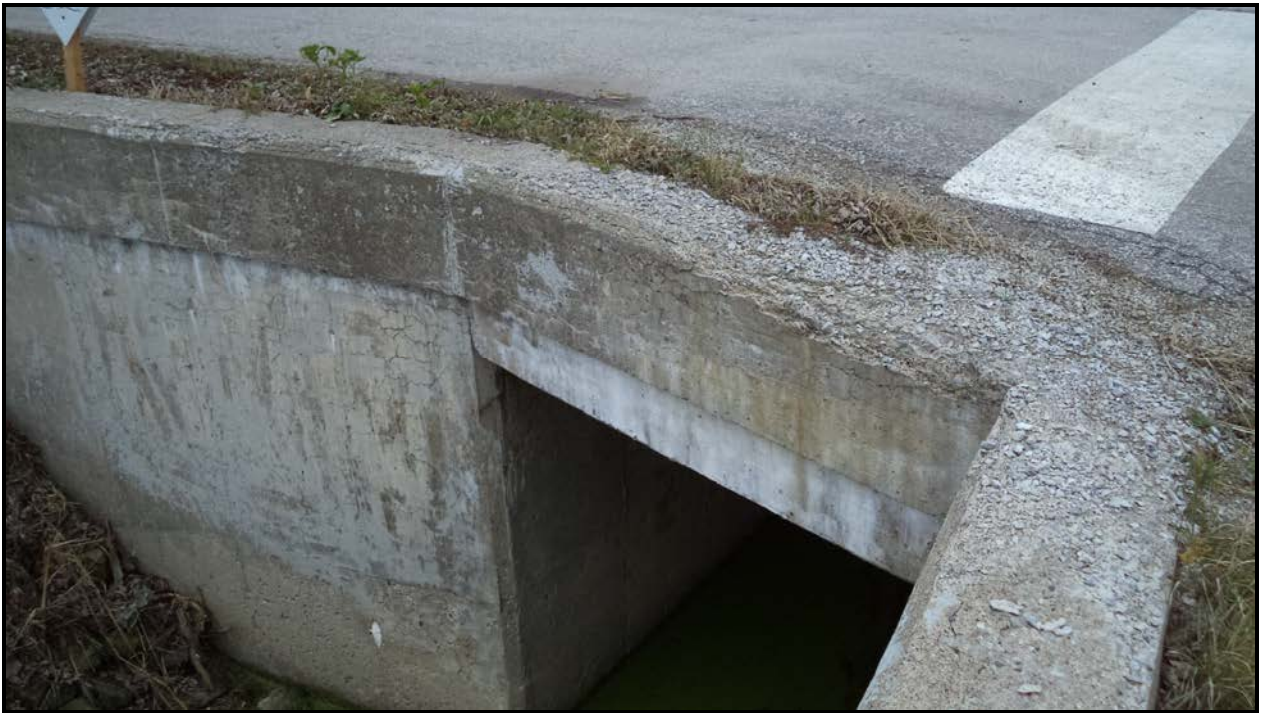
Photograph 6 – Headwall (East Elevation)

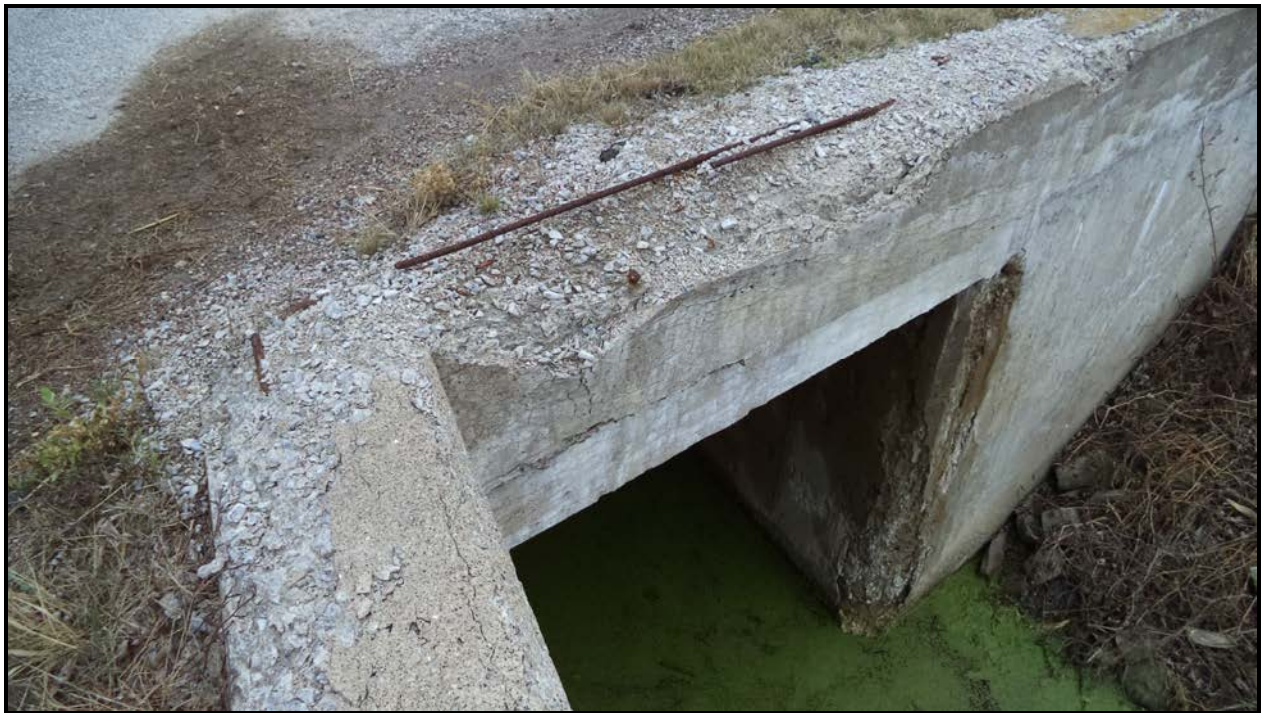
Photograph 8 – Headwall (West Elevation)

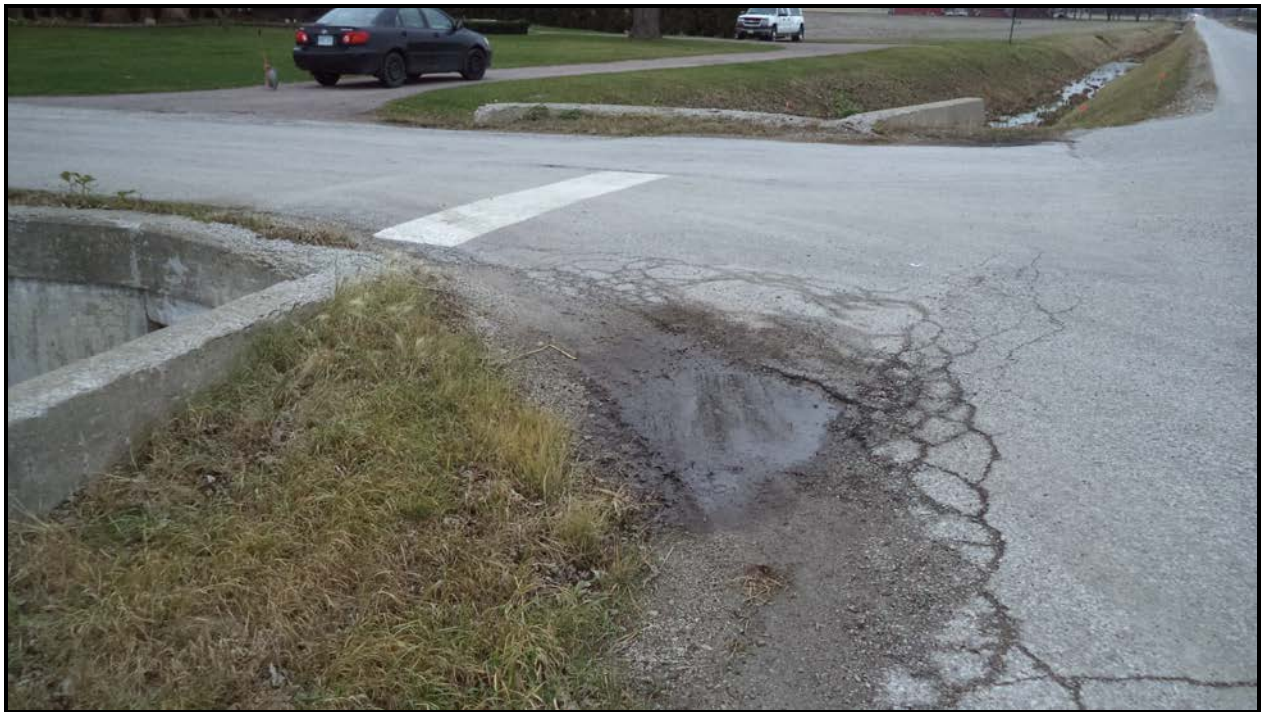
Photograph 9 – Wearing Surface over Culvert (Looking West)

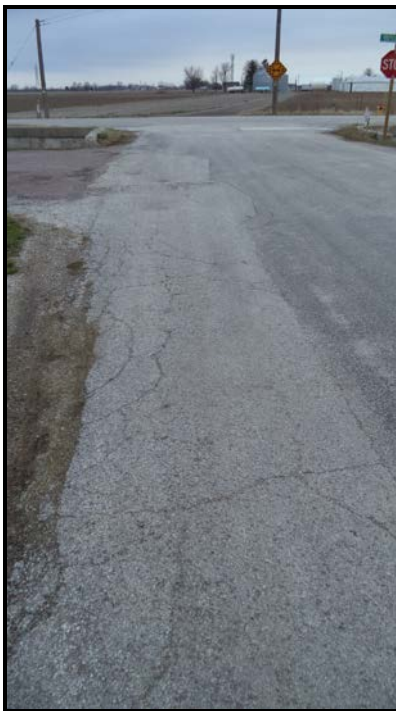
Photograph 10 – Wearing Surface at South Approach (Looking North)

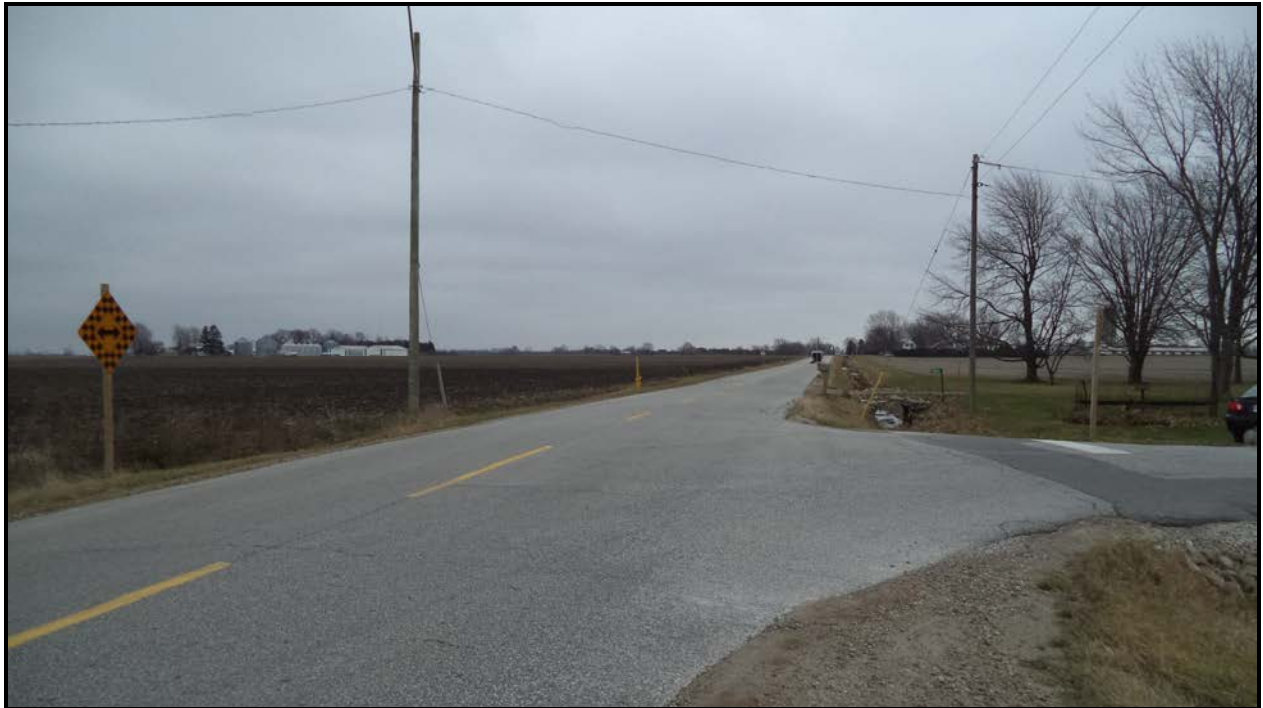
Photograph 1 – Road over Culvert (Looking East)

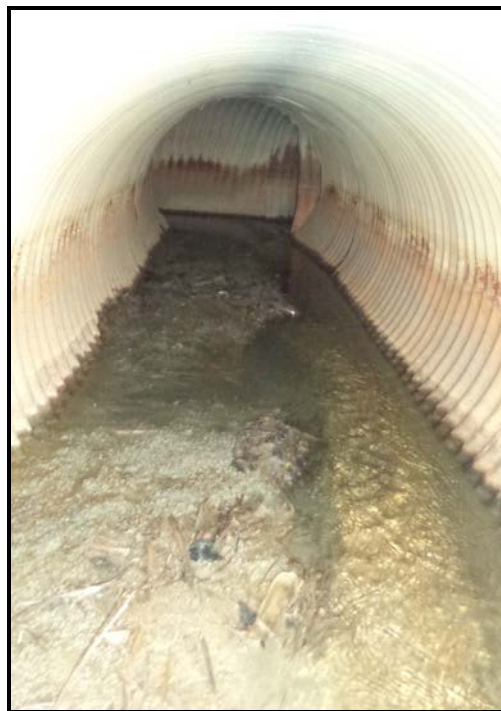
Photograph 2 – Culvert Barrel Intersection with Culvert No. 68 (Looking East)

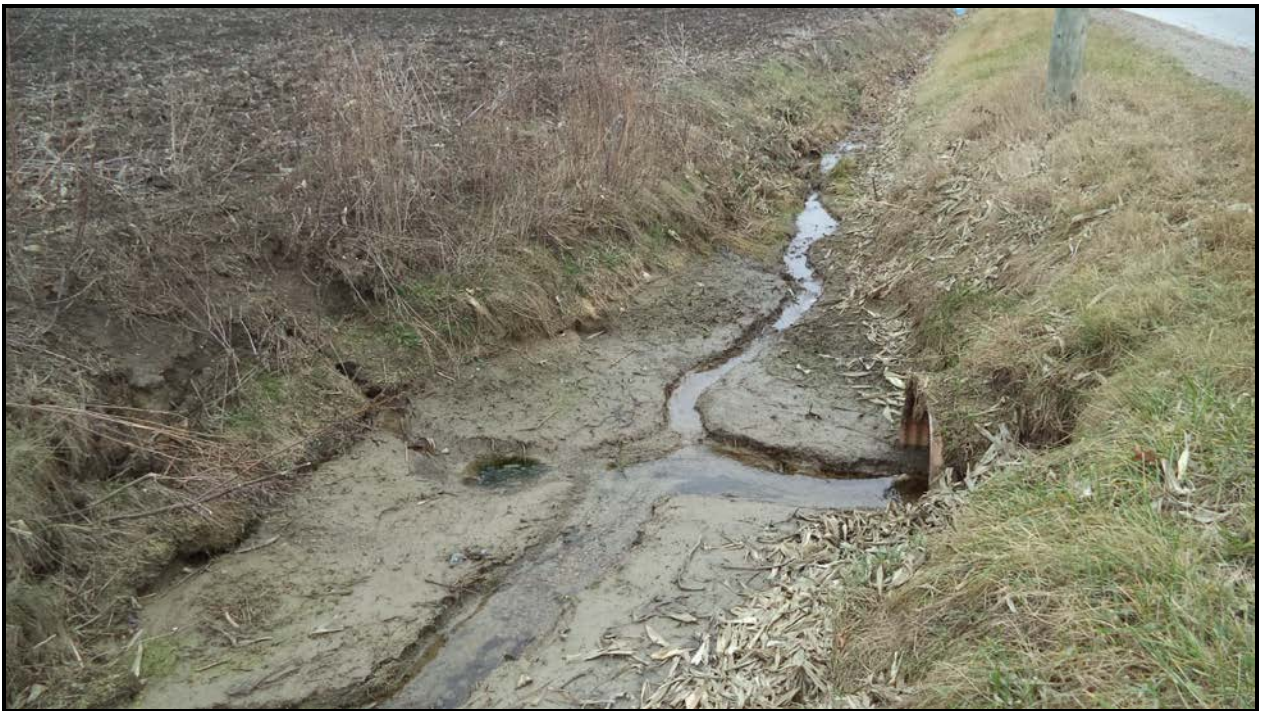
Photograph 4 – North Elevation (Looking East)

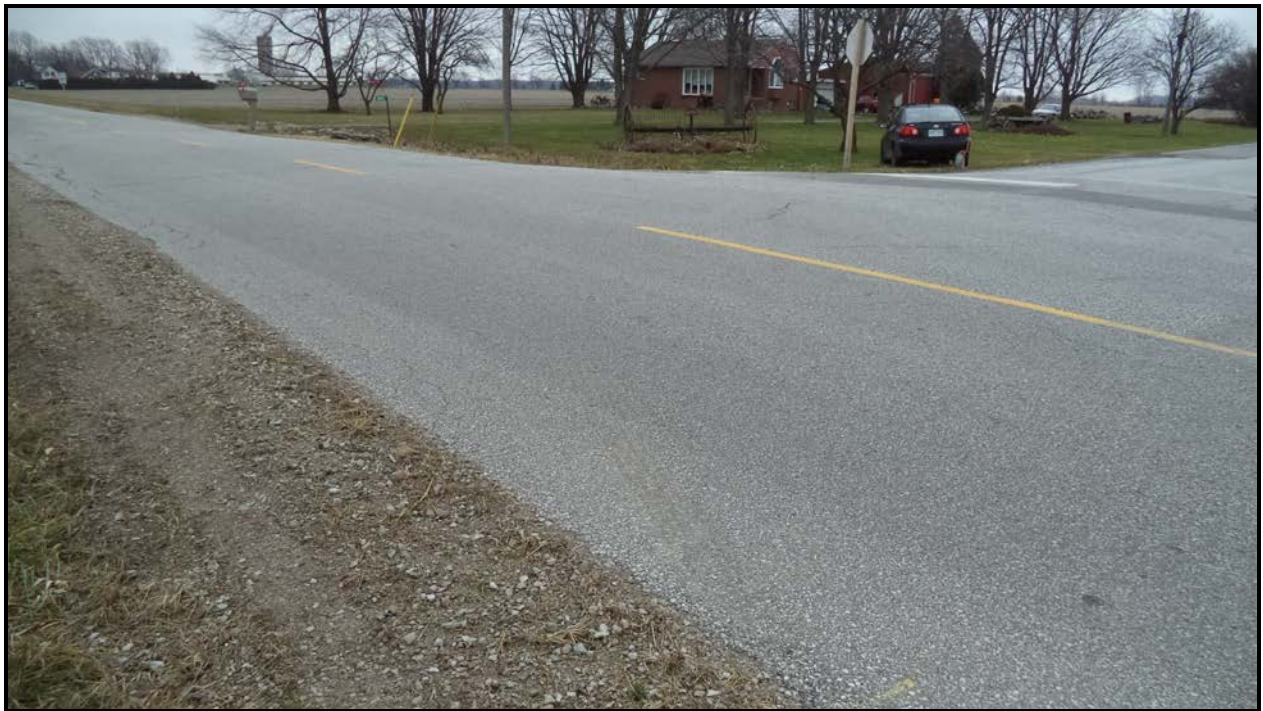
Photograph 6 – Wearing Surface at West Approach

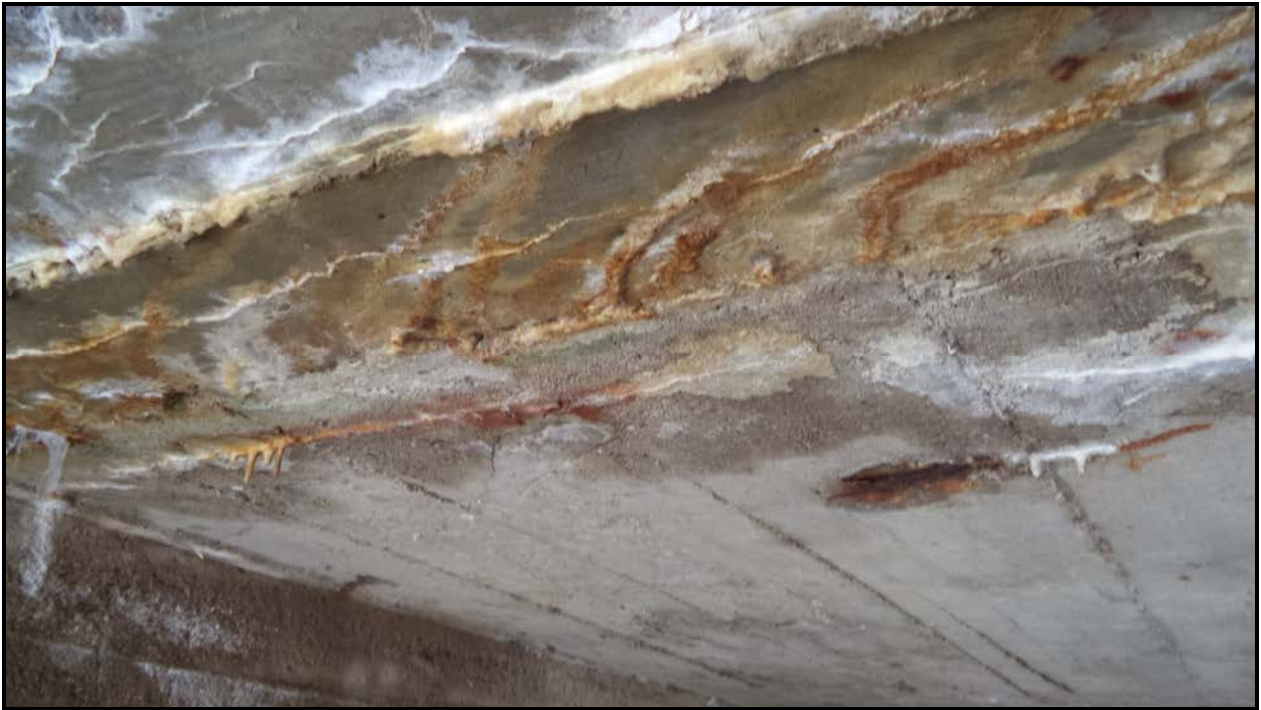
Photograph 3 – Culvert Barrel - Soffit

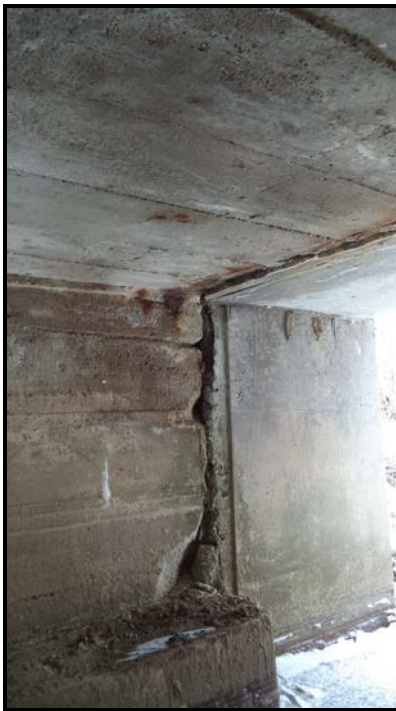
Photograph 4 – Culvert Barrel (At joint between Old/New Structure)

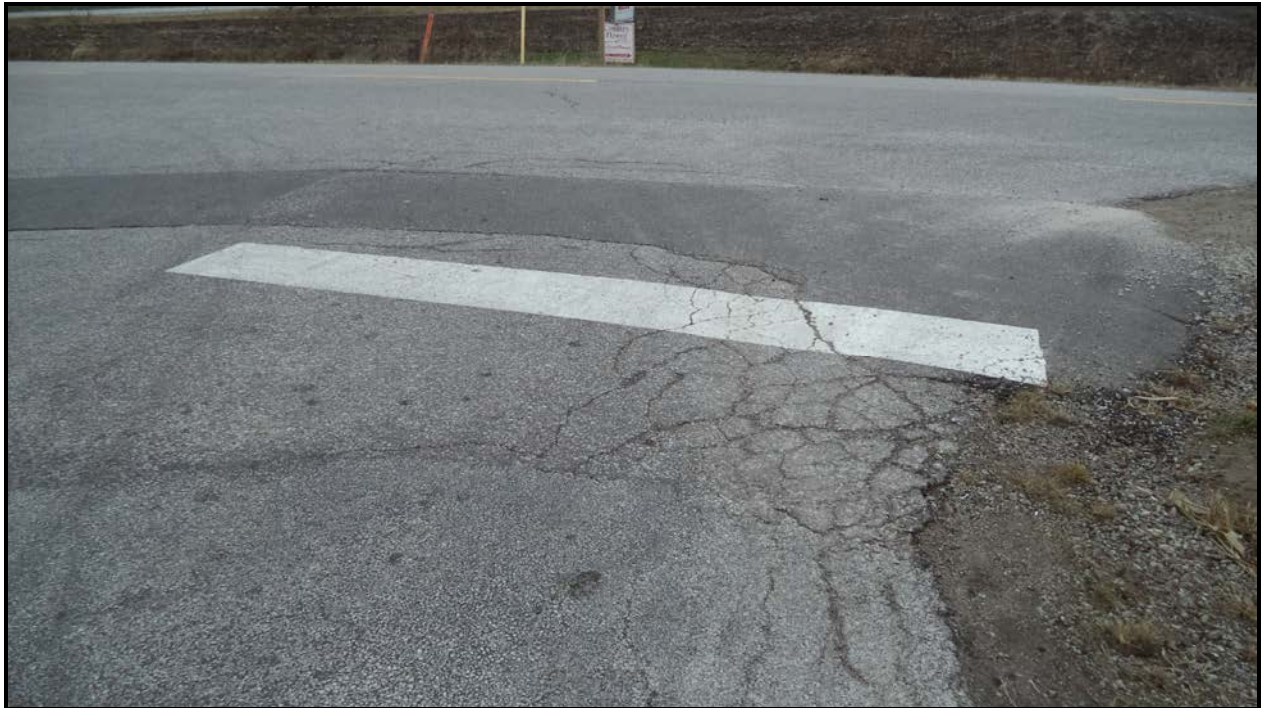
Photograph 5 – Wearing Surface over Culvert (Looking North)

Asphalt repairs.

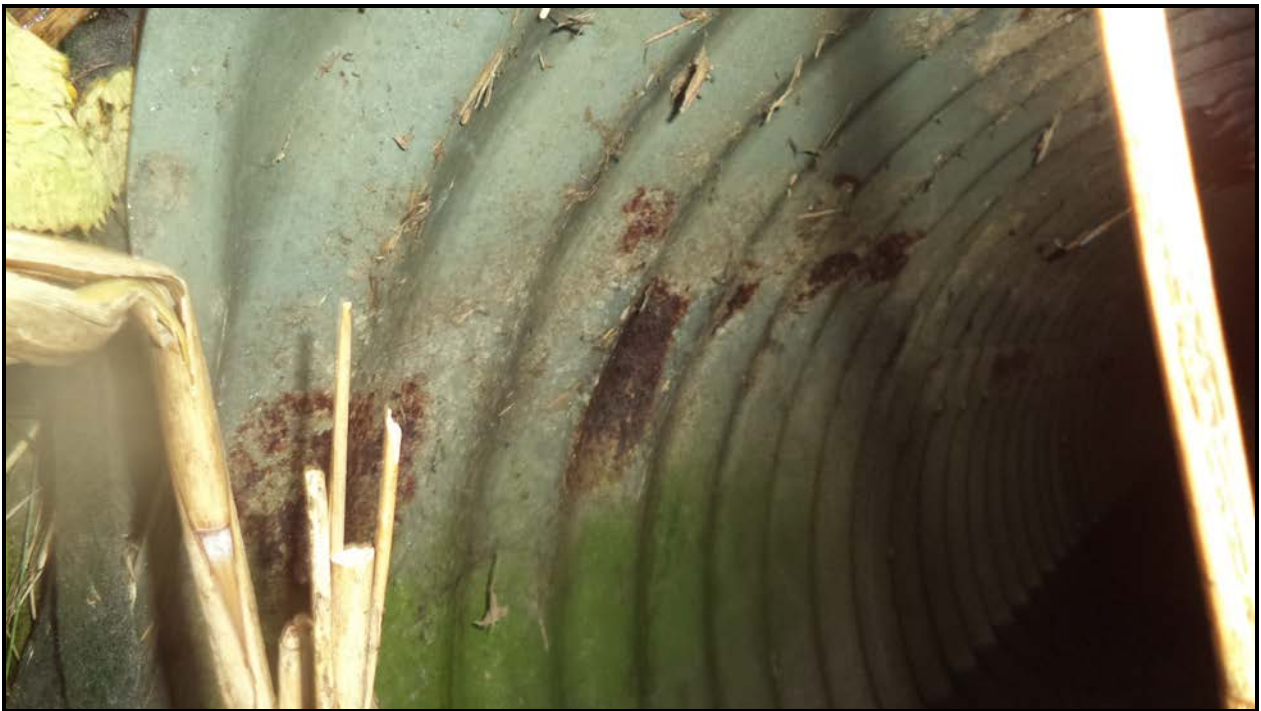
Photograph 4 – Culvert Barrel Side Corrosion

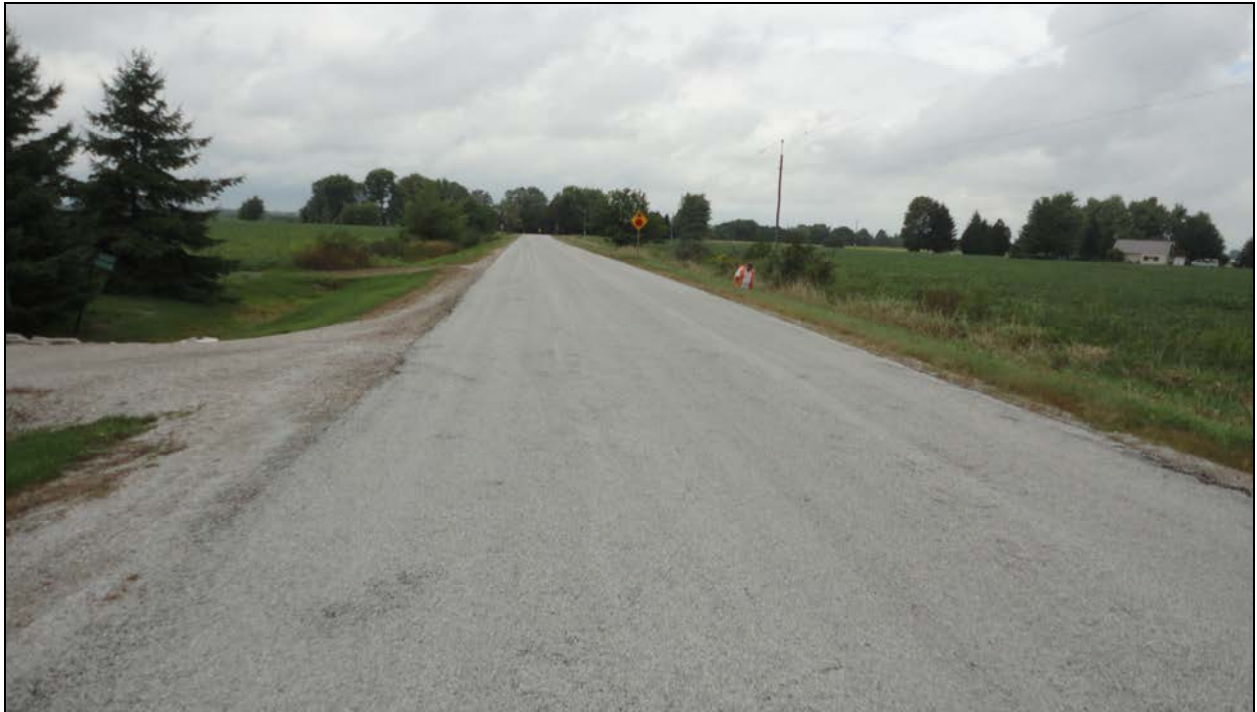
Photograph 1 – Road view over Culvert (Looking North)

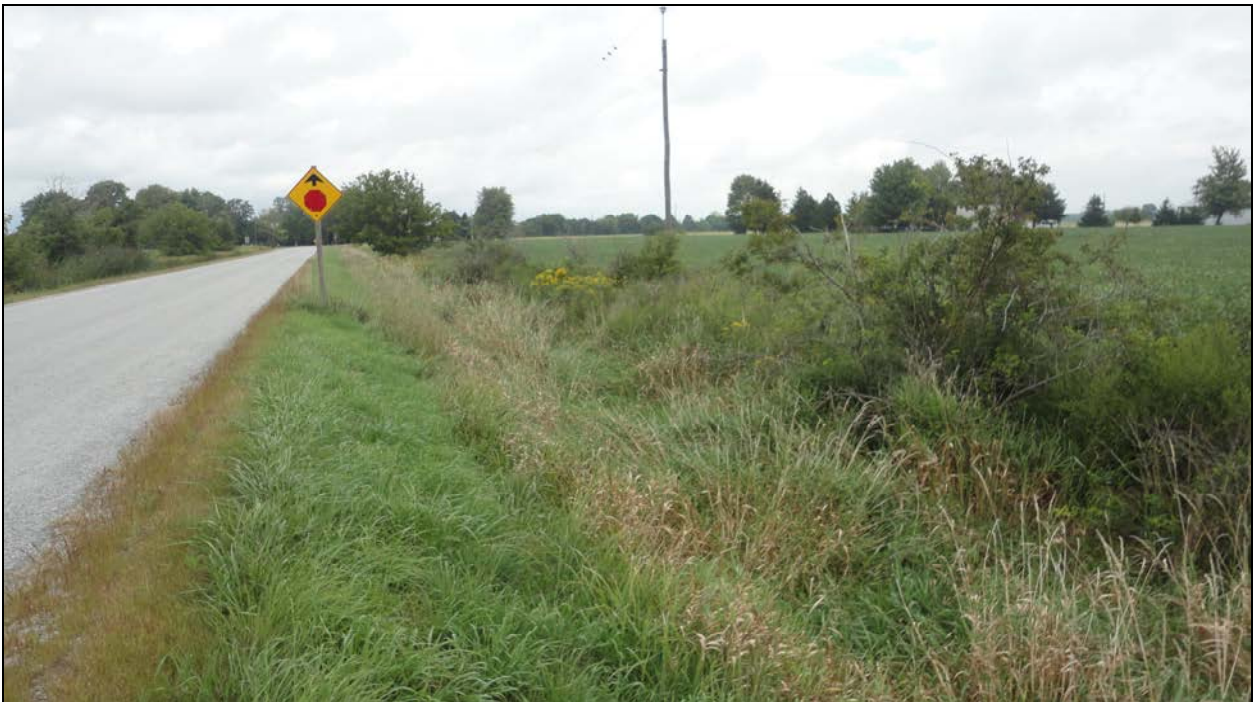
Photograph 4 – East Embankments & Waterway (Looking North)

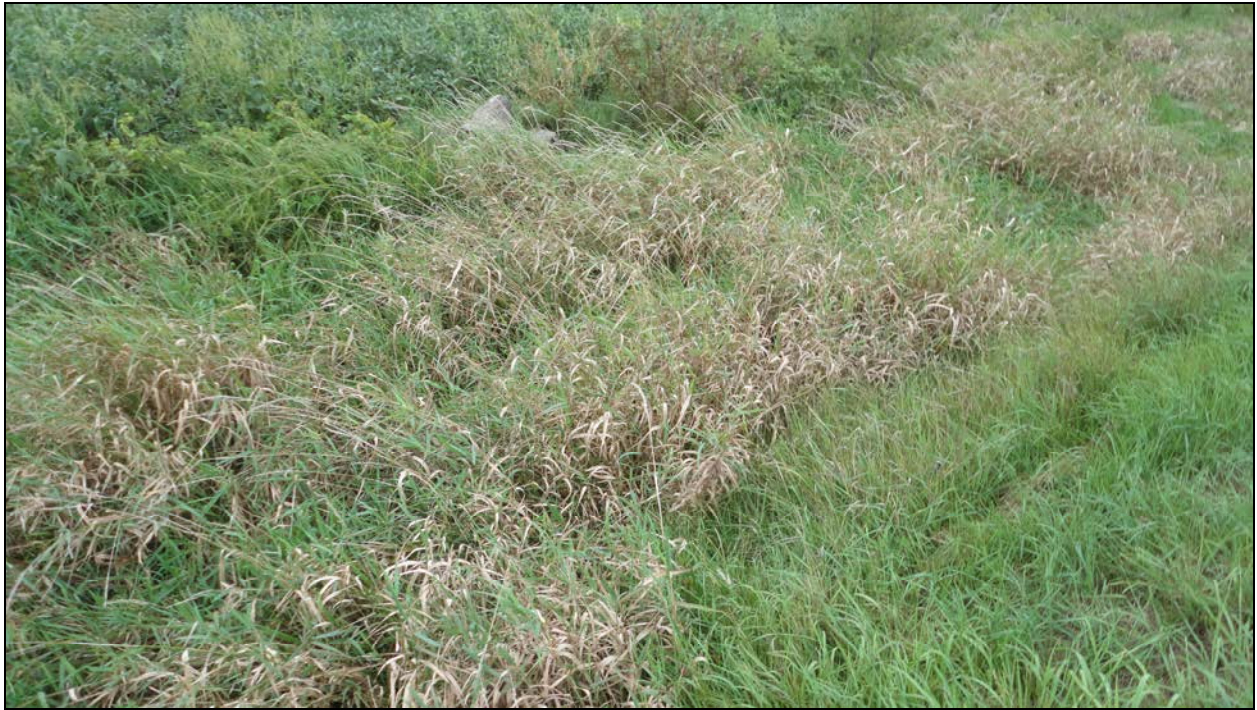
Photograph 5 – Heavy Plants Growth at East Elevation (Looking East)

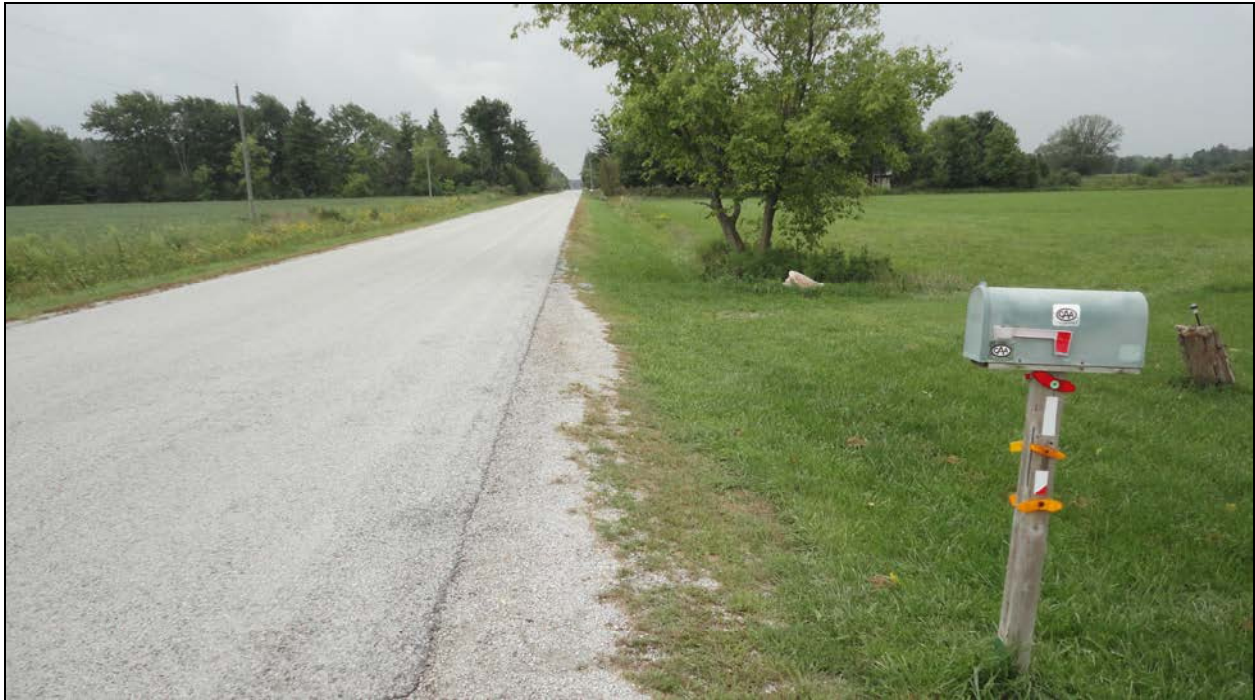
Photograph 1 – Road view over Culvert (Looking South)
