CORPORATE OF THE TOWN OF TECUMSEH
2016 Culvert Needs Study

Structures with Spans $\leq 3.0\text{m}$ – Final Report

Our File: 15-2977

October 28, 2016

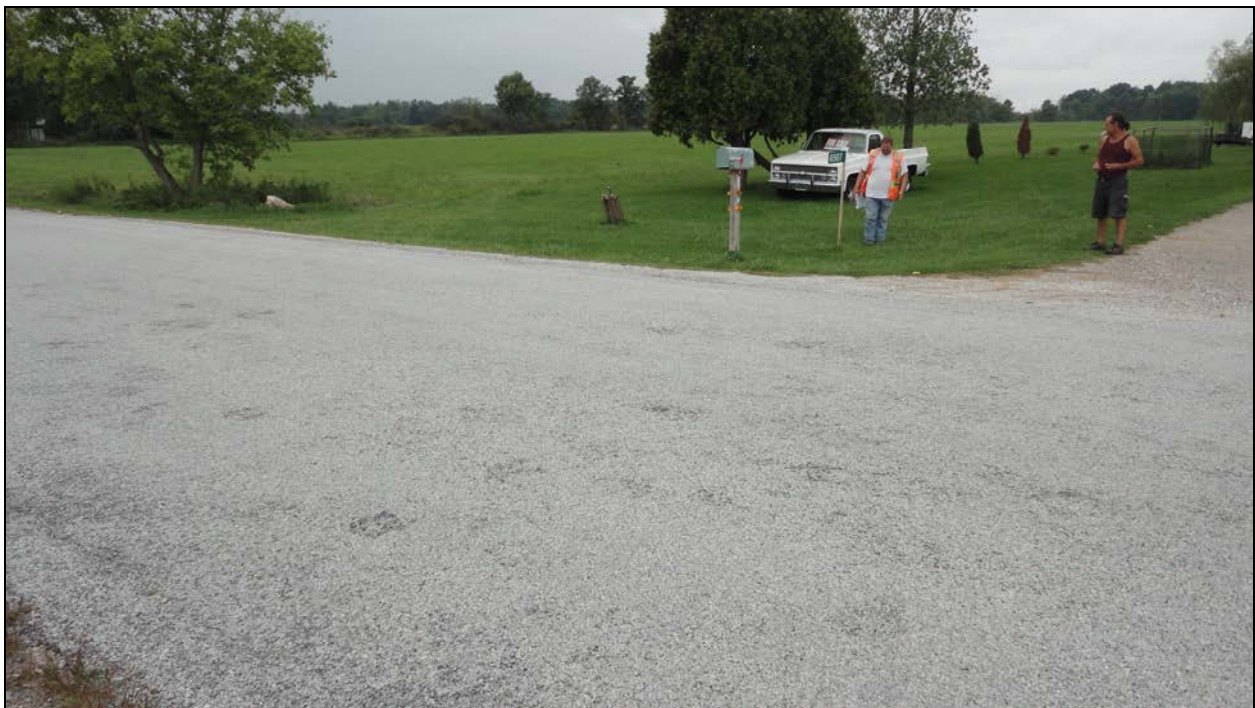
Photograph 2 – Wearing Surface over Culvert (Looking West)

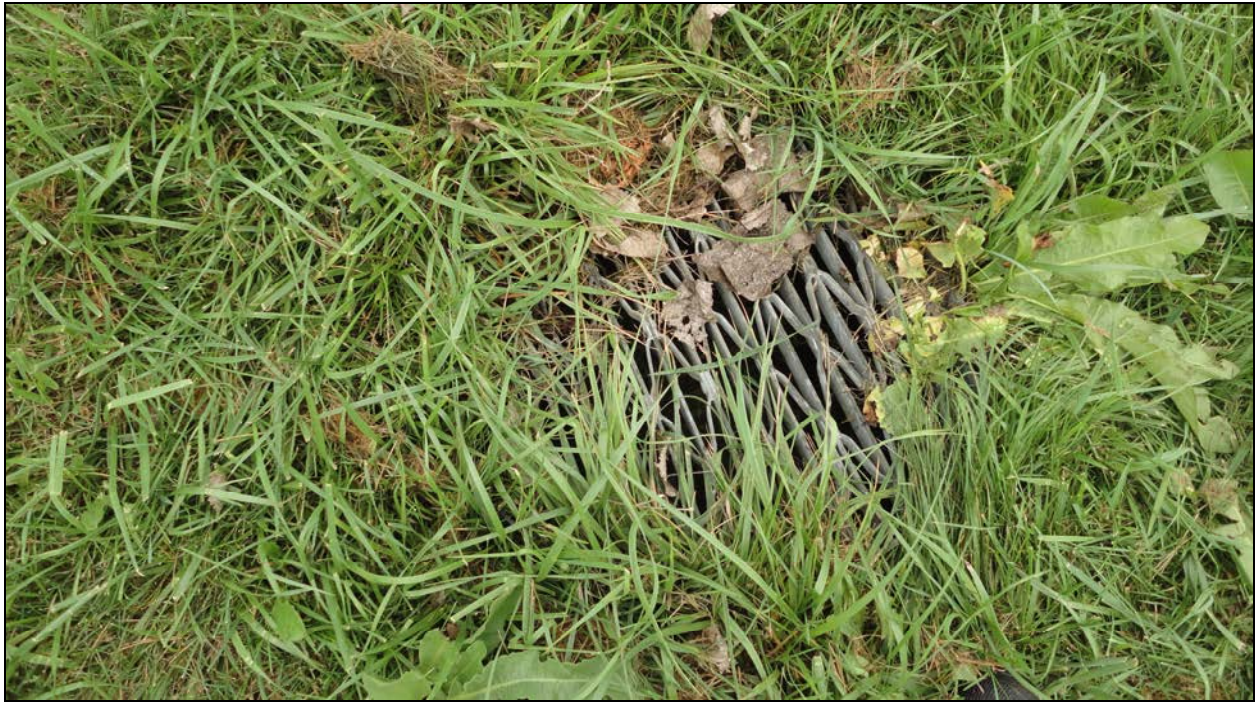
Photograph 3 – Inlet Manhole at West Elevation

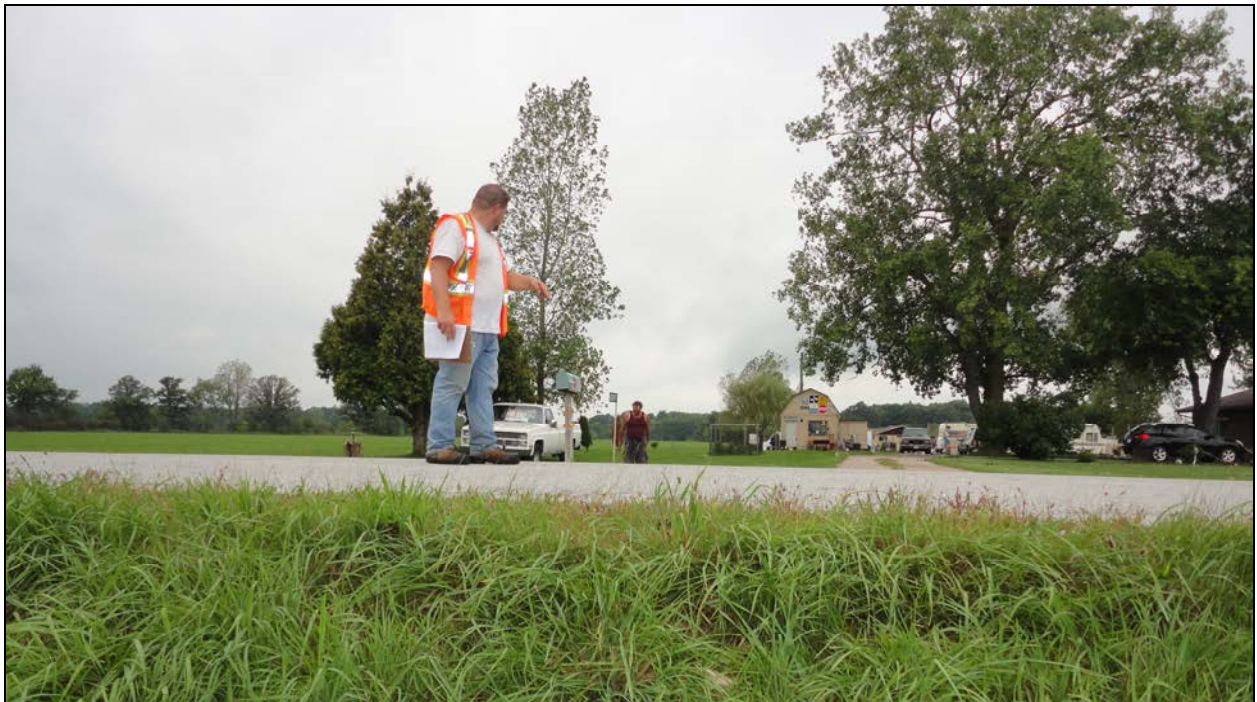
Photograph 4 – Road over Culvert (Looking West)

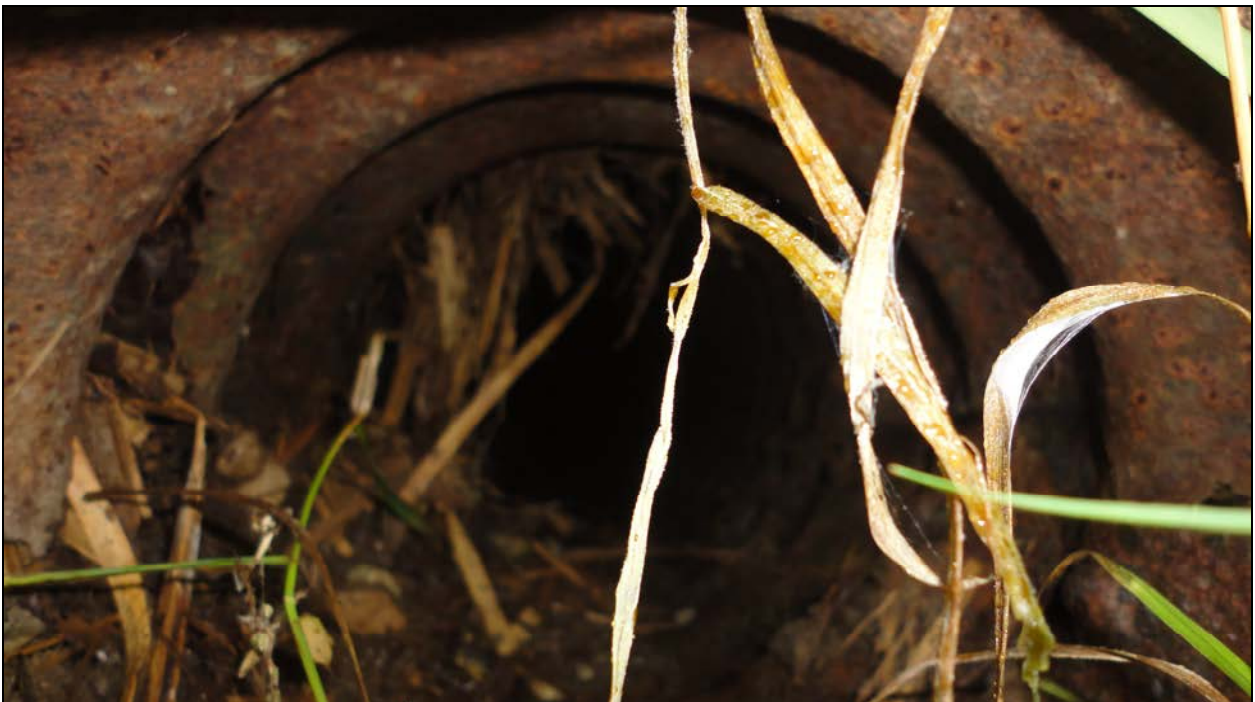
Photograph 6 – Culvert Barrel (Looking West)

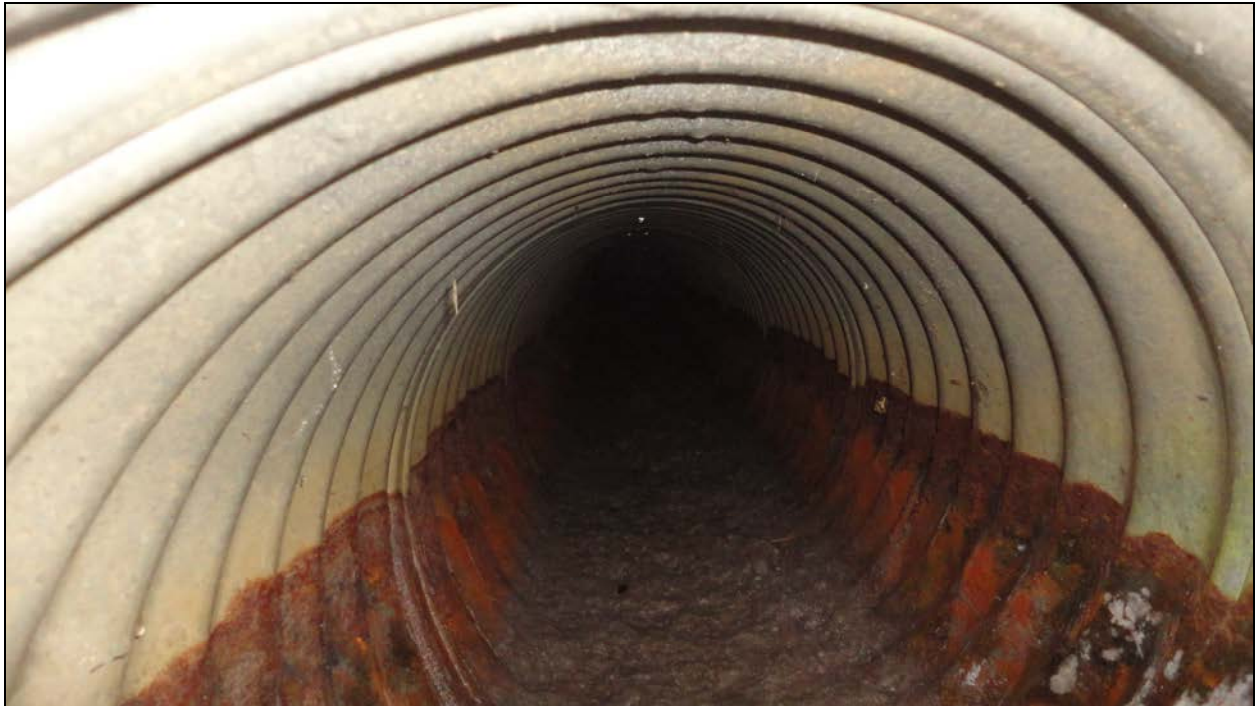
Photograph 7 – Culvert Parallel to Road at West Edge (Intersecting with Crossing Culvert)

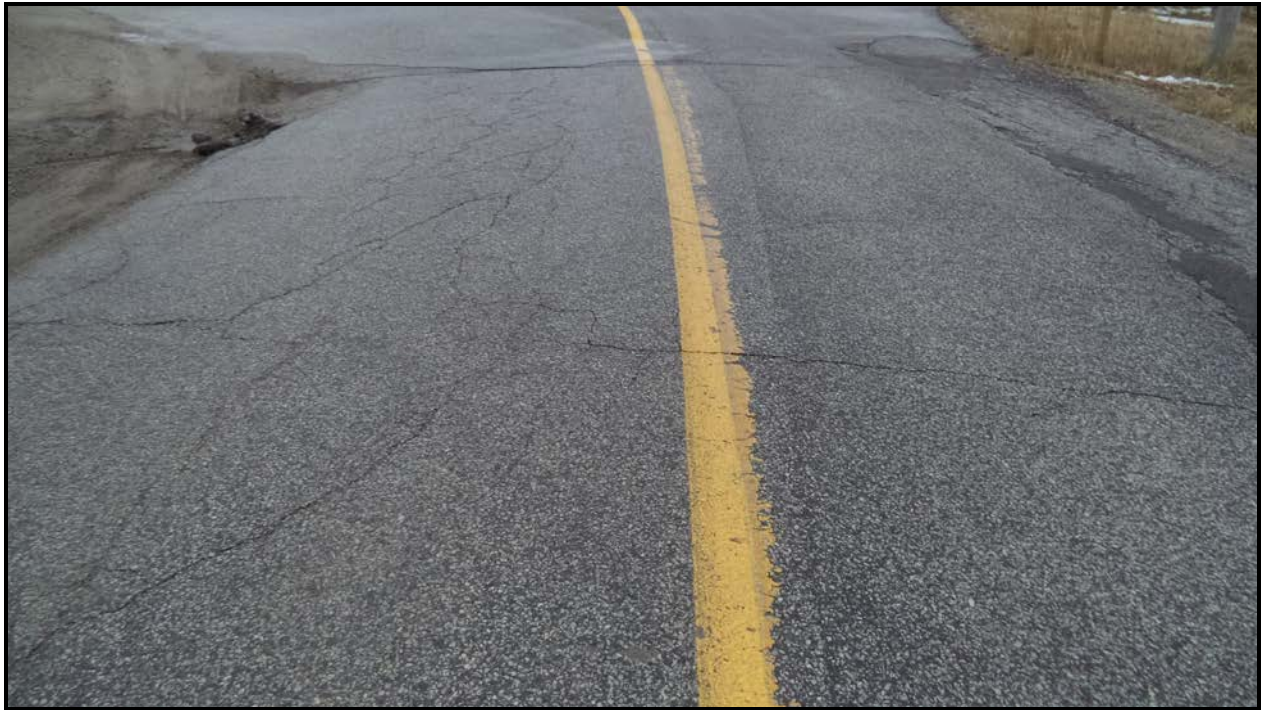
Photograph 5 – Wearing Surface over Culvert (Looking South)

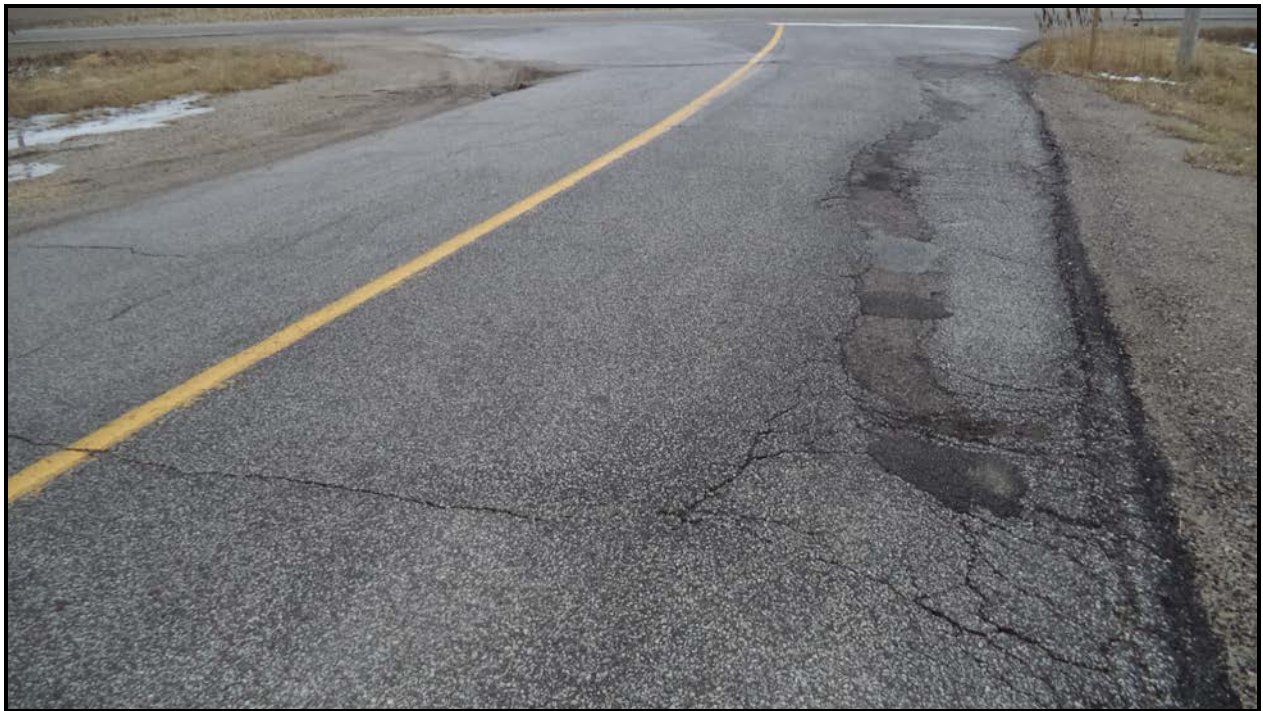
Photograph 6 – Wearing Surface at North Approach

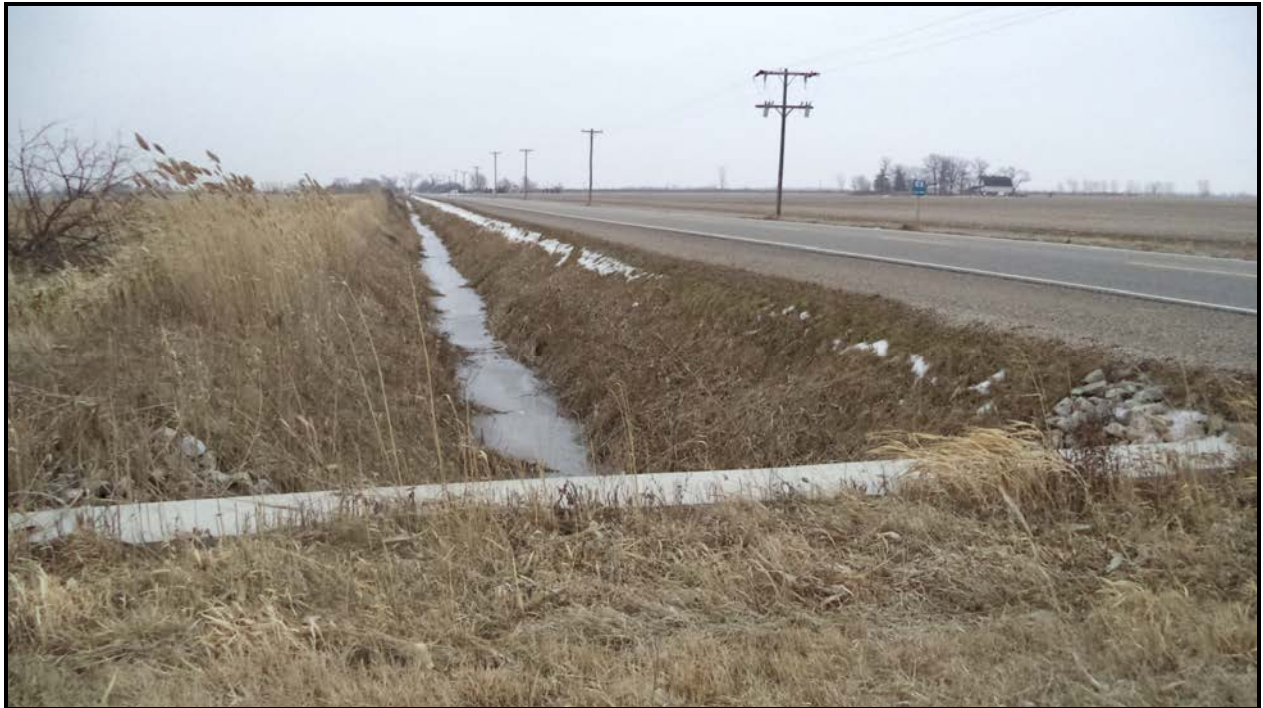
Photograph 7 – Water Stream (Malden Road West Side – Looking East)

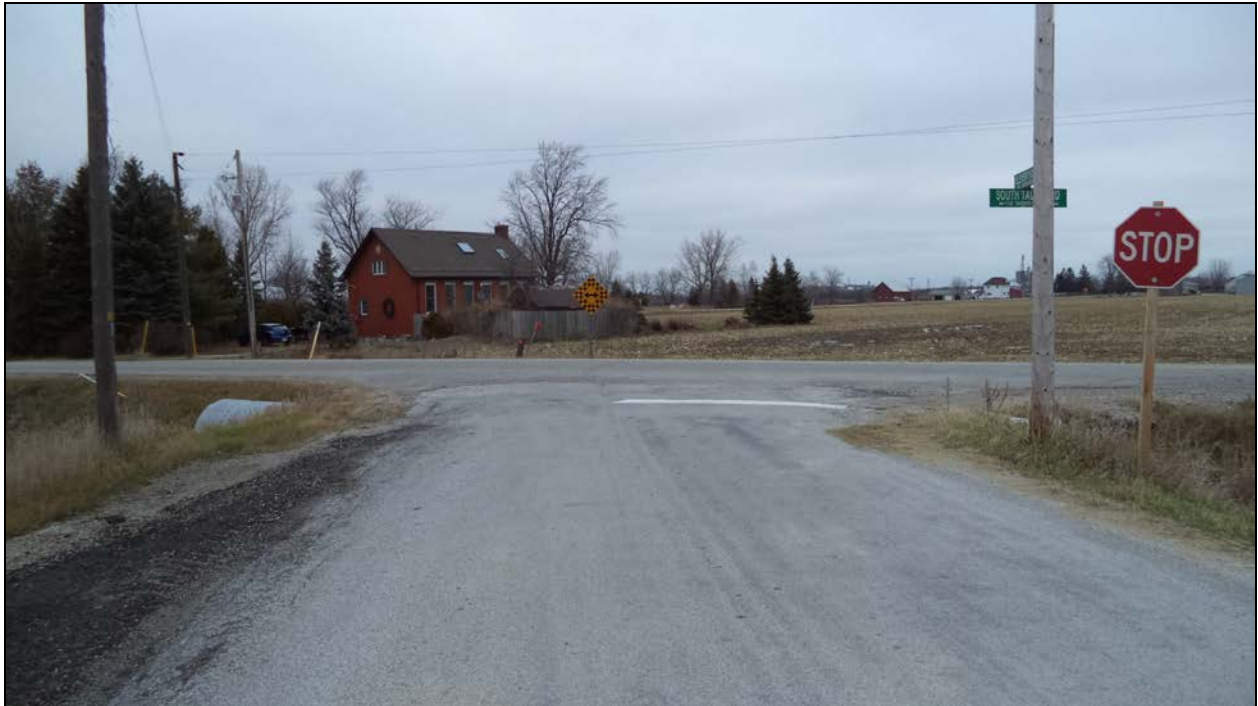
Photograph 1 – Road over Culvert (Looking North)

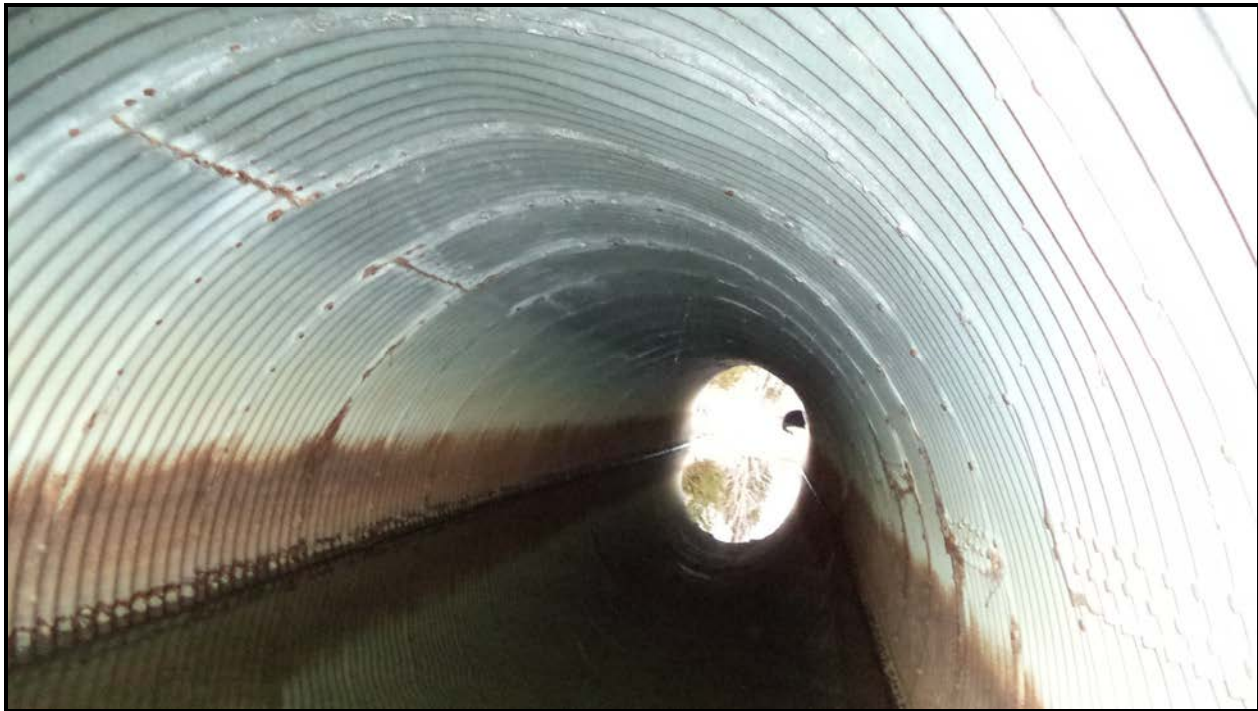
Photograph 2 – Culvert Barrel (Looking West)

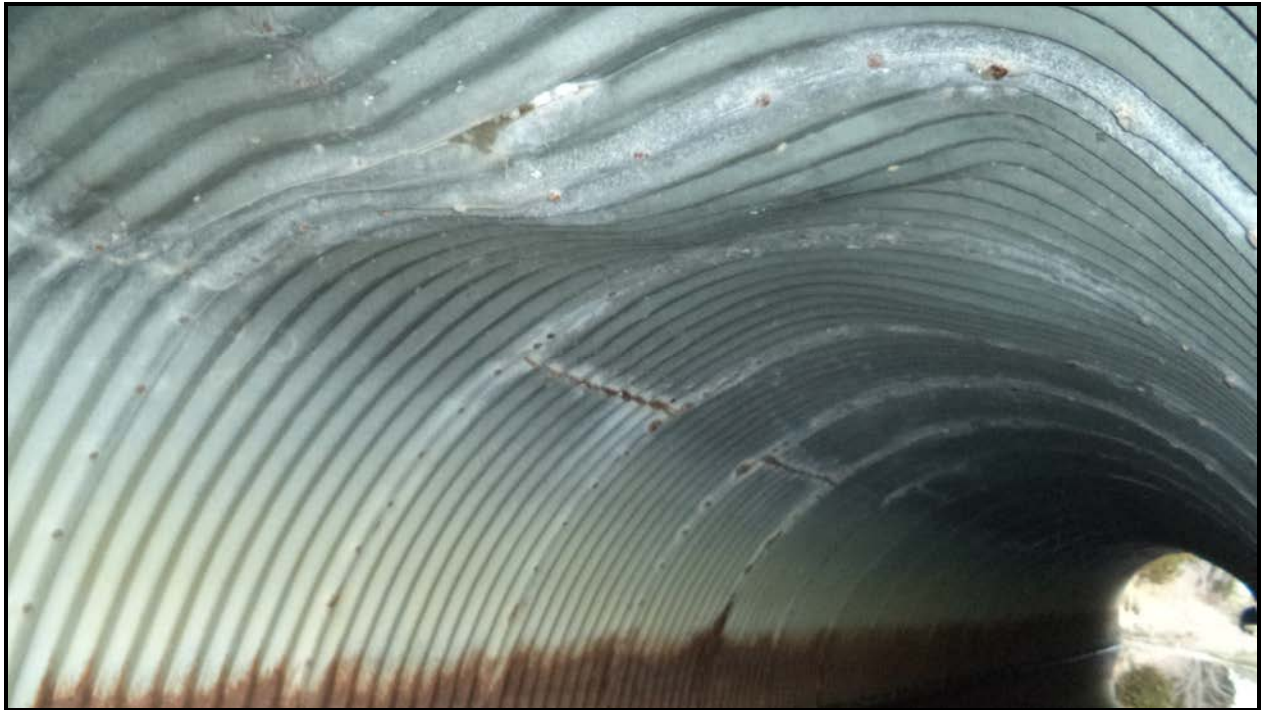
Photograph 3 – Culvert Barrel (Looking North)

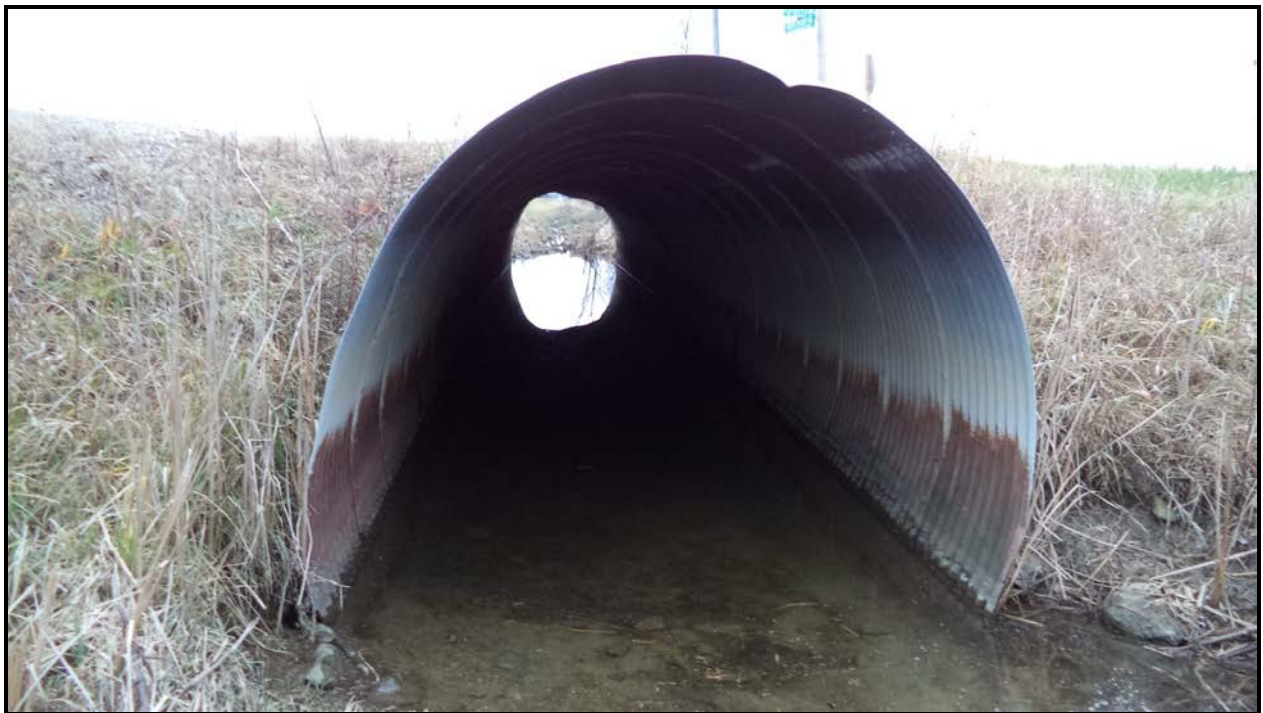
Photograph 4 – Culvert Barrel (Looking East)

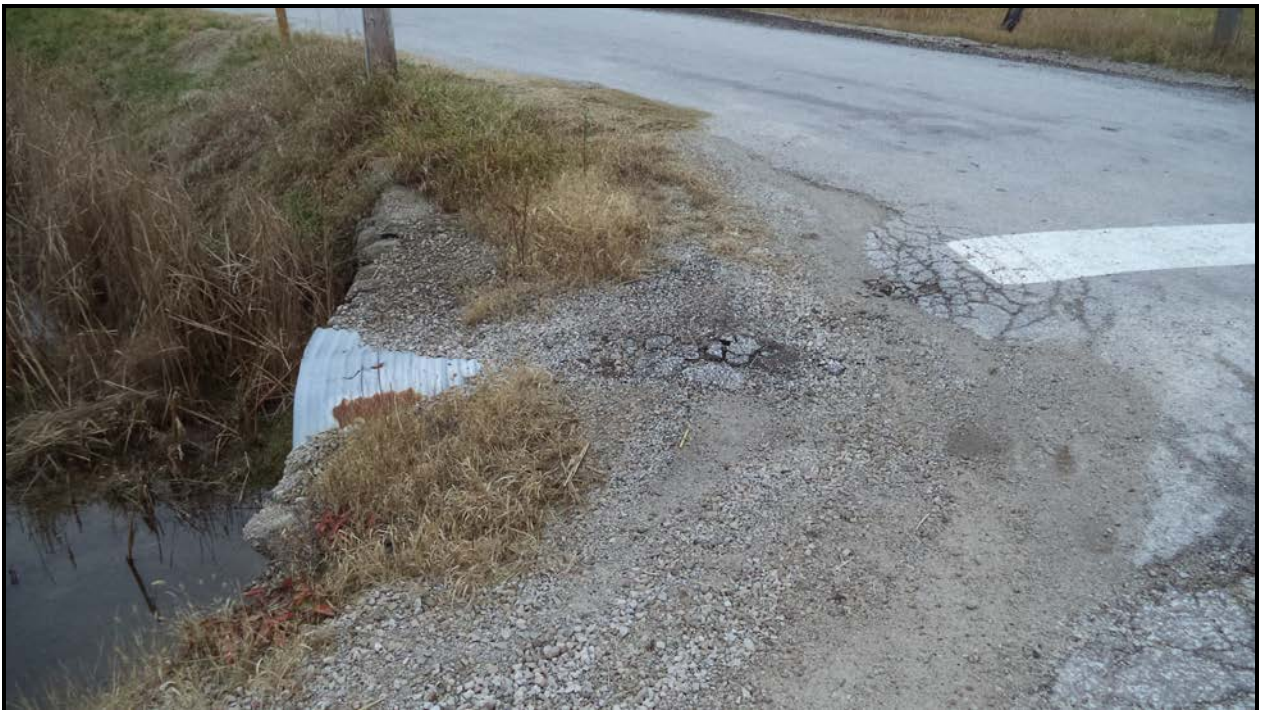
Photograph 8 – Wearing Surface over Culvert (Looking West)

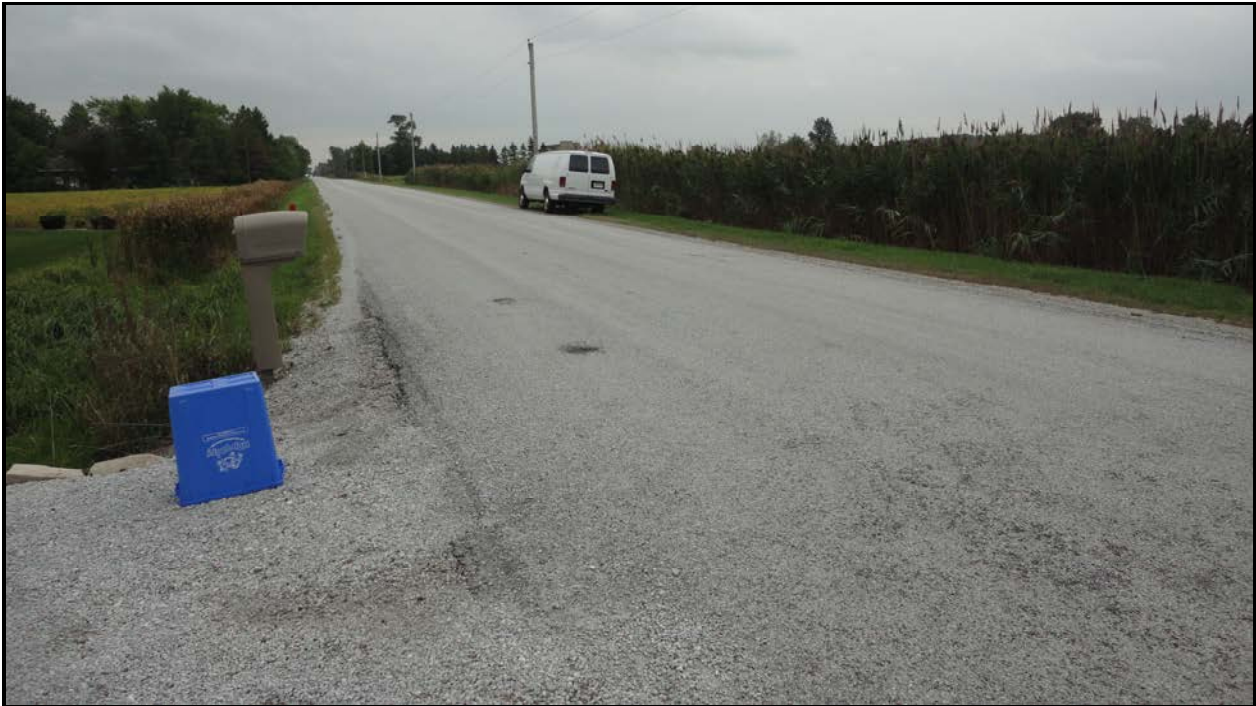
Photograph 1 – Road over Culvert (Looking South)

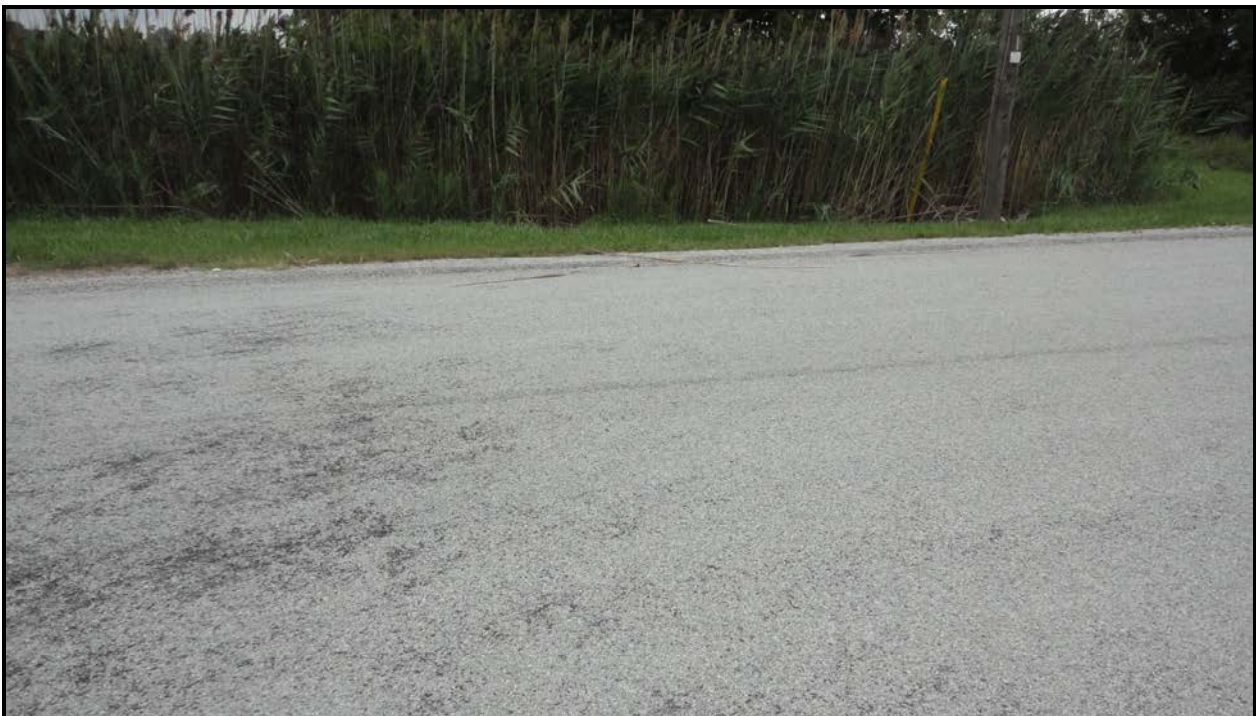
Photograph 2 – Wearing Surface over Culvert (Looking West)

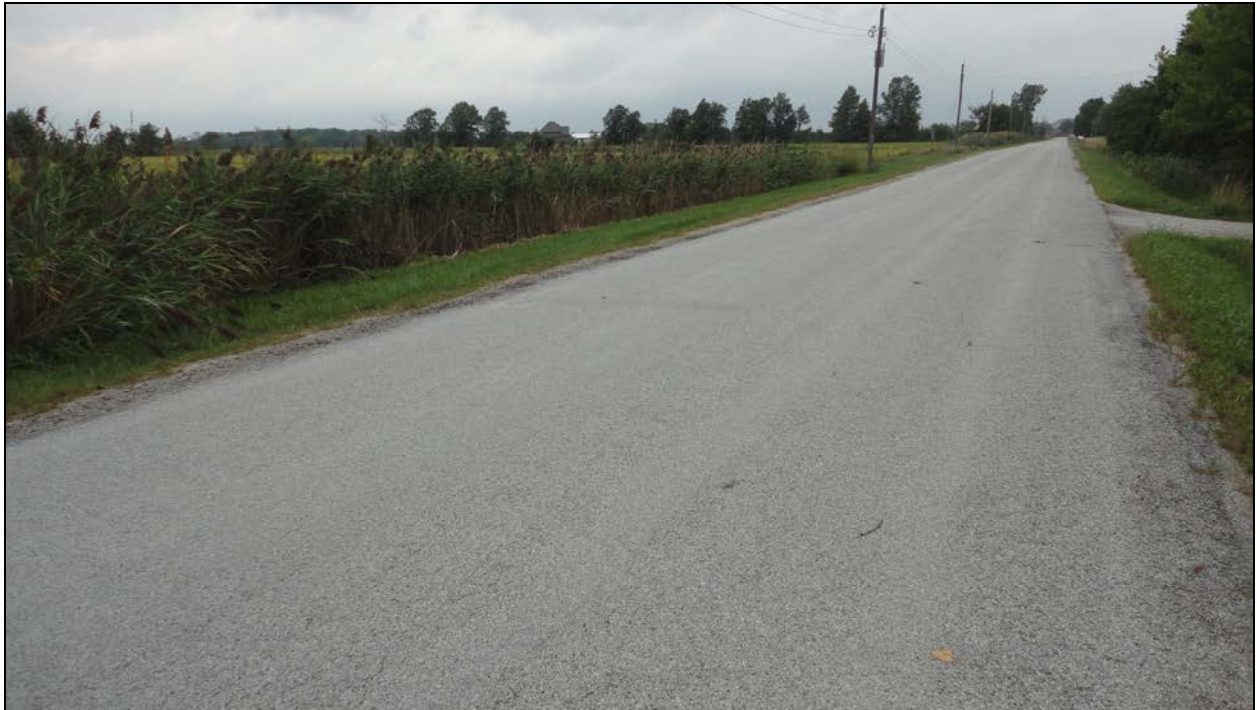
Photograph 1 – Wearing Surface over Culvert (Looking North)

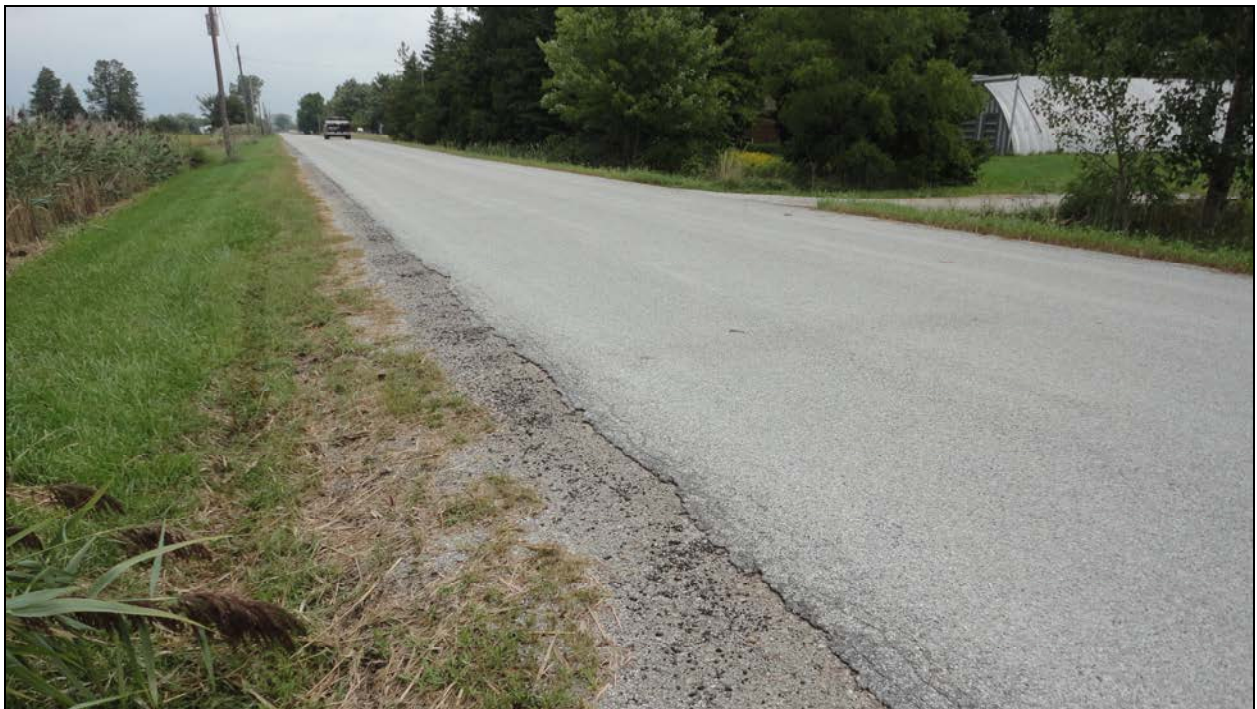
Photograph 2 – Wearing Surface over Culvert (Looking South)

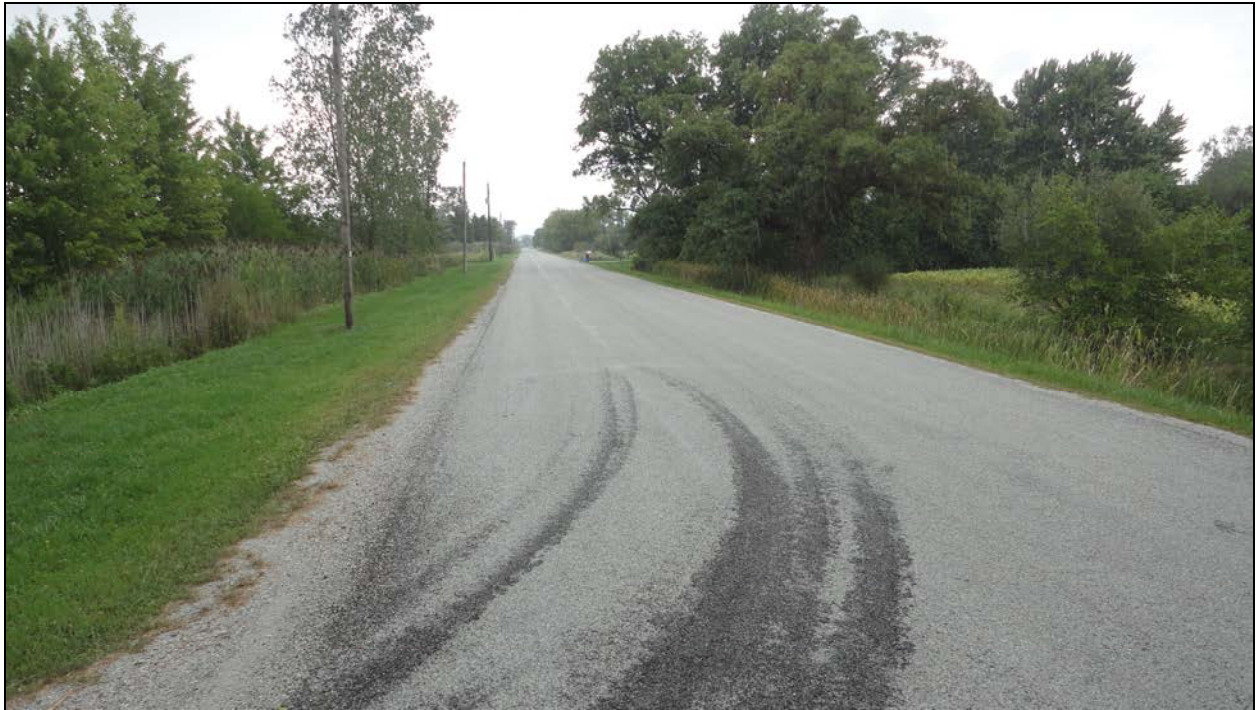
Photograph 1 – Wearing Surface over Culvert (Looking North)

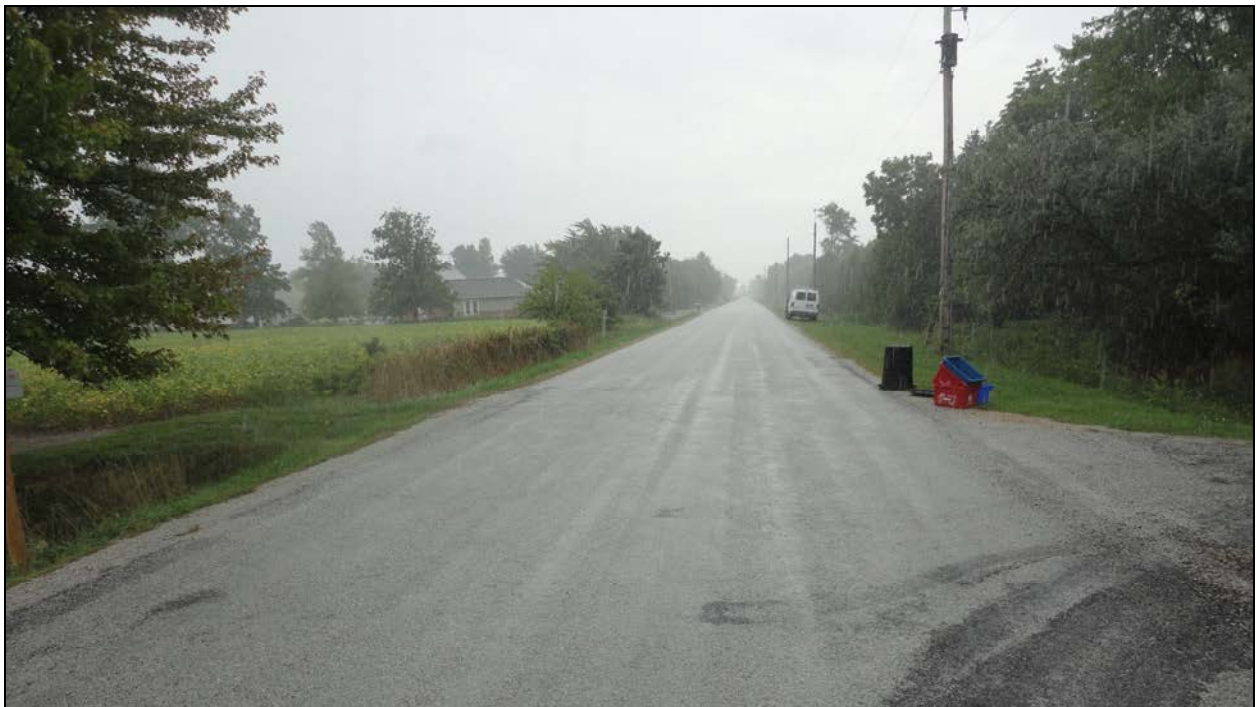
Photograph 2 – Wearing Surface over Culvert (Looking South)

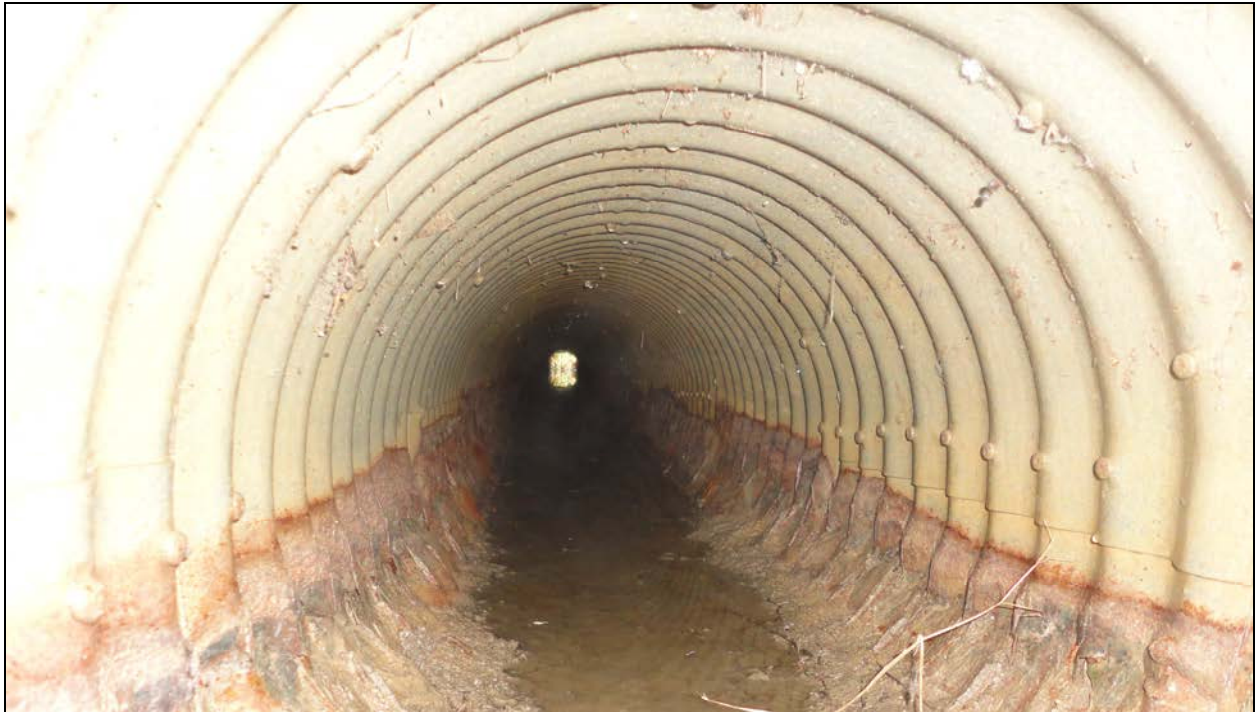
Photograph 3 – Culvert Barrel (Looking West)

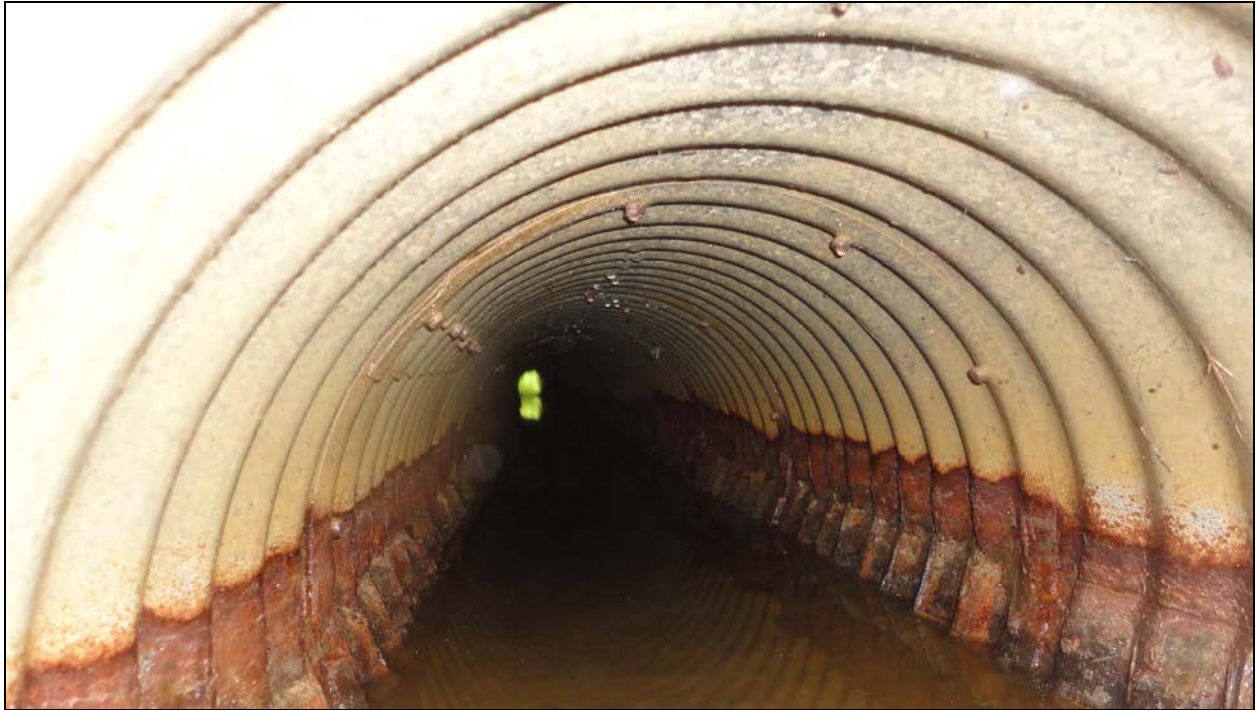
Photograph 4 – Culvert Barrel (Looking East)

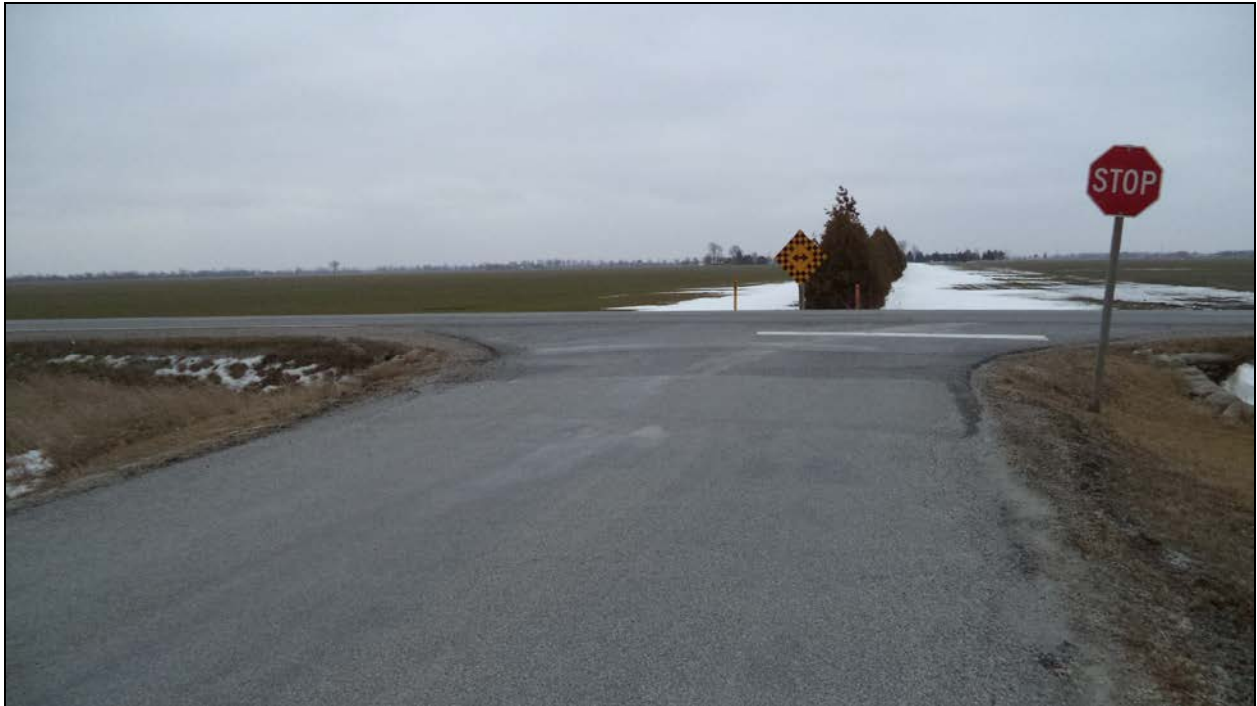
Photograph 1 – Road over Culvert (Looking South)

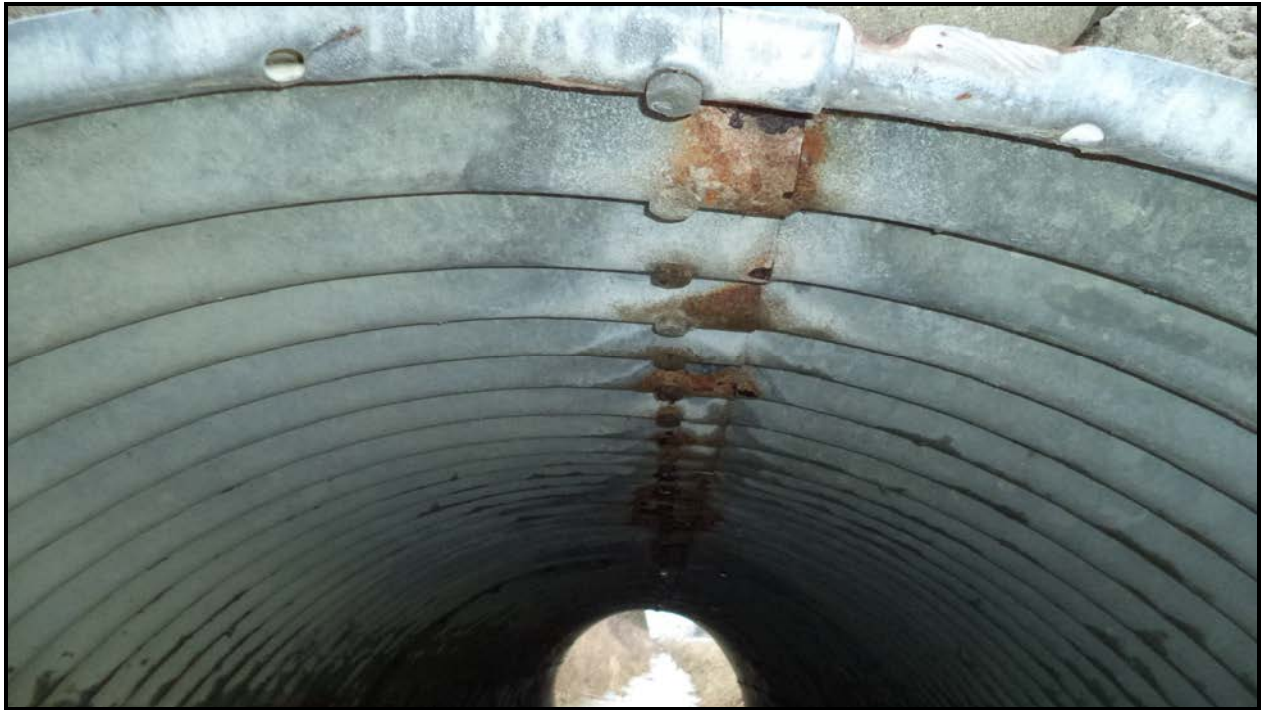
Photograph 3 – Bolts Corrosion at Culvert Soffit

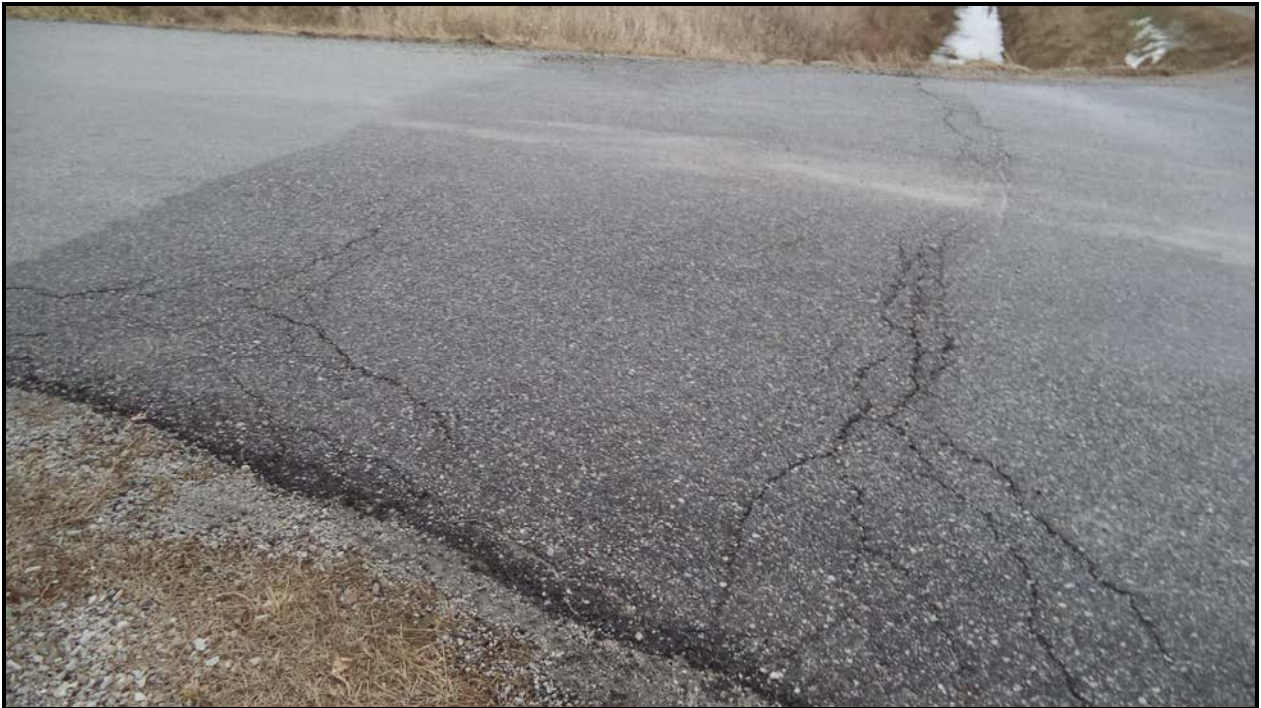
Photograph 7 – Wearing Surface over Culvert (Looking East)

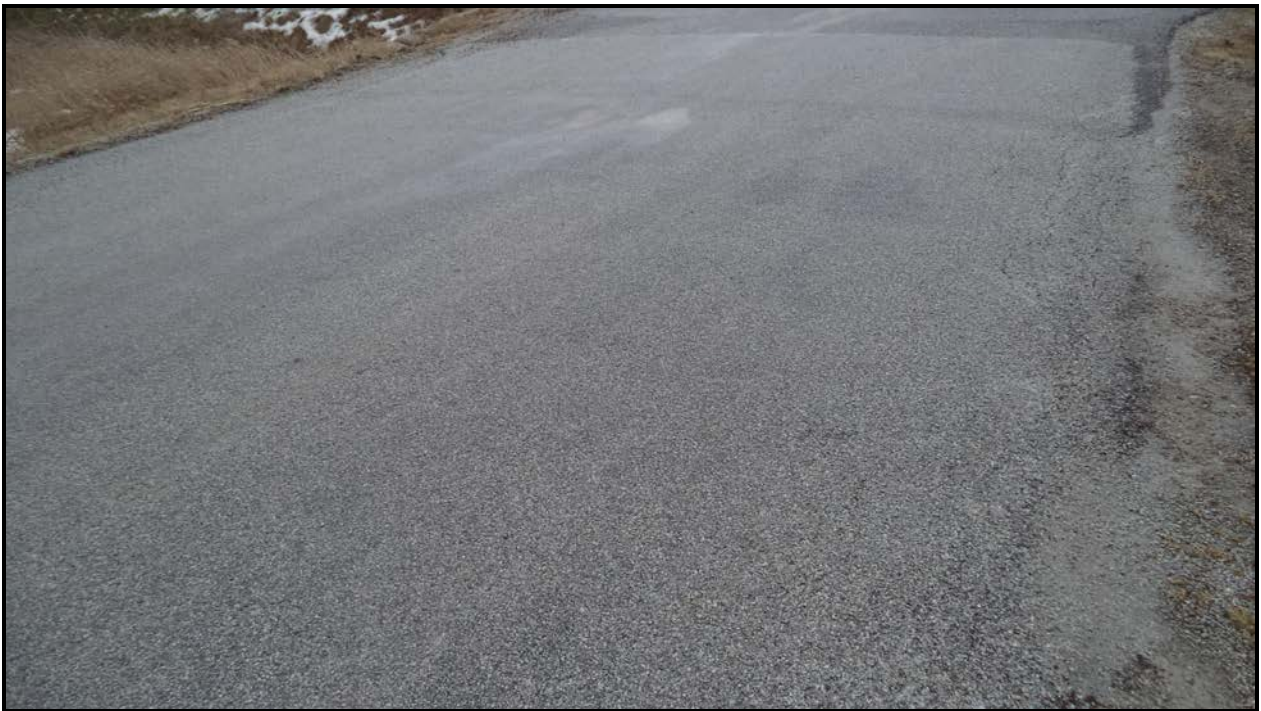
Photograph 8 – Wearing Surface at North Approach
