CORPORATE OF THE TOWN OF TECUMSEH
2016 Culvert Needs Study

Structures with Spans $\leq 3.0\text{m}$ – Final Report

Our File: 15-2977

October 28, 2016

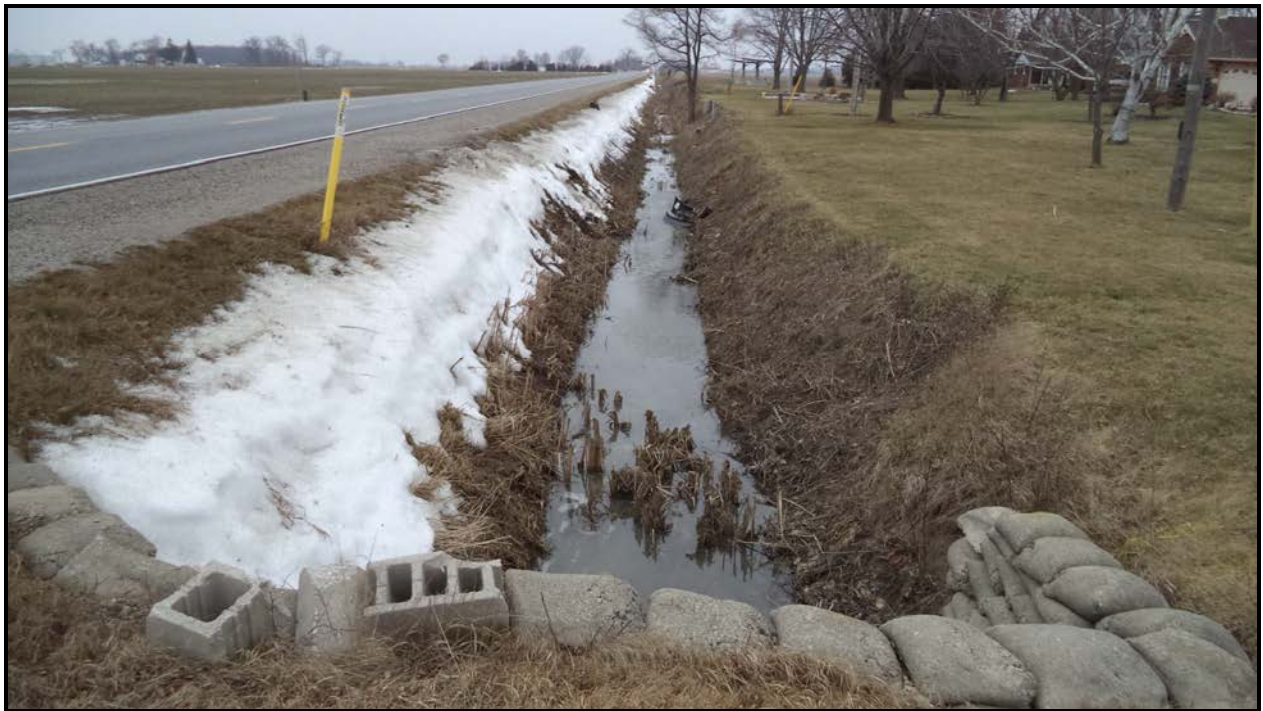
Photograph 10 – Water Stream (Concession Road 11 West Side - Looking West)

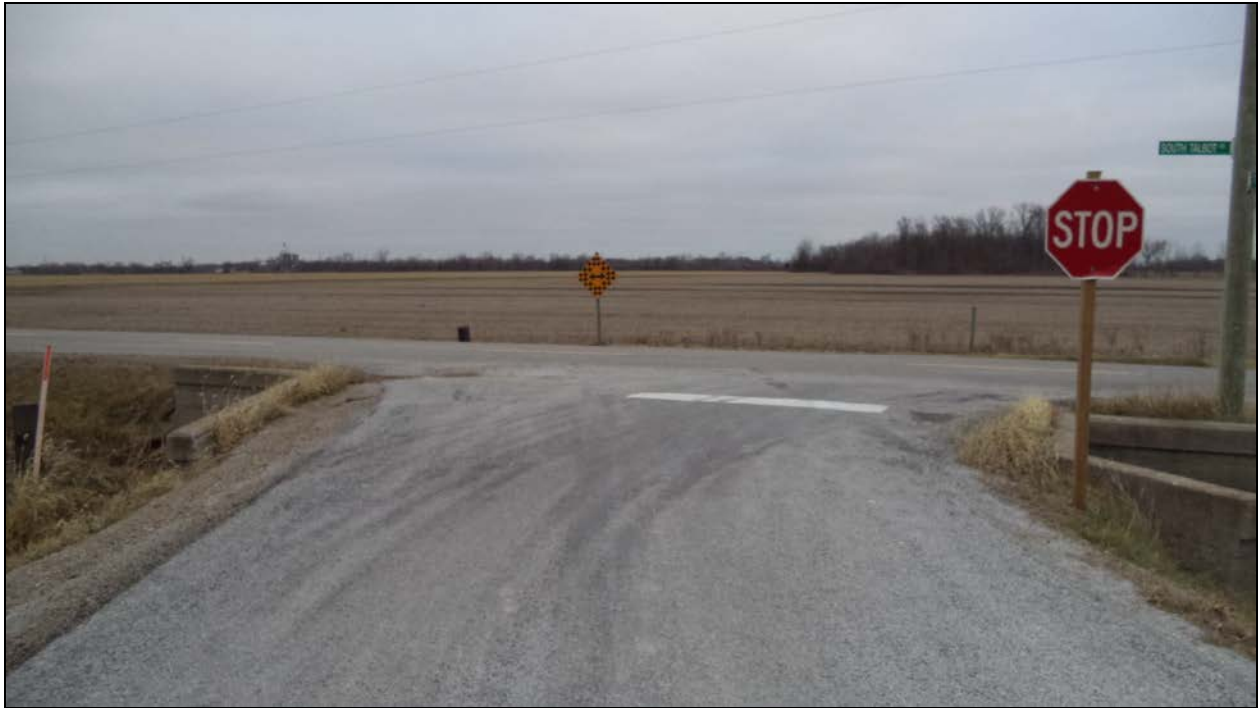
Photograph 1 – Road over Culvert (Looking North)

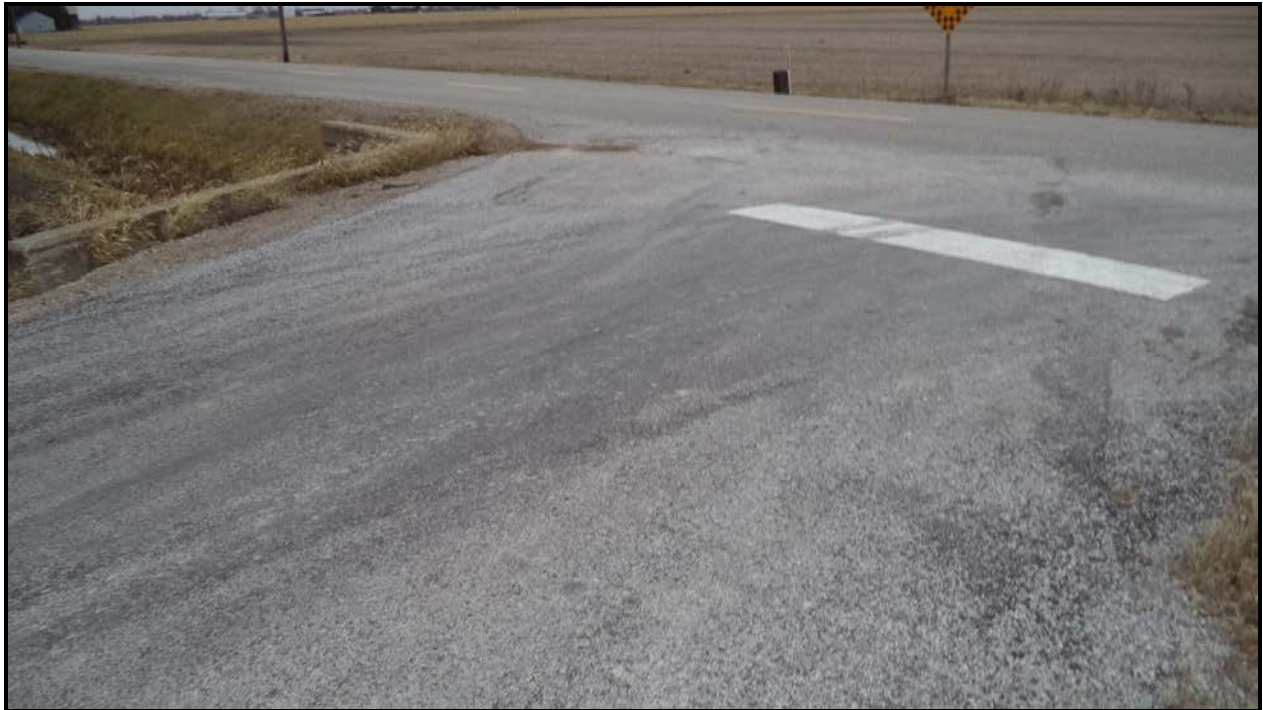
Photograph 4 – West Elevation

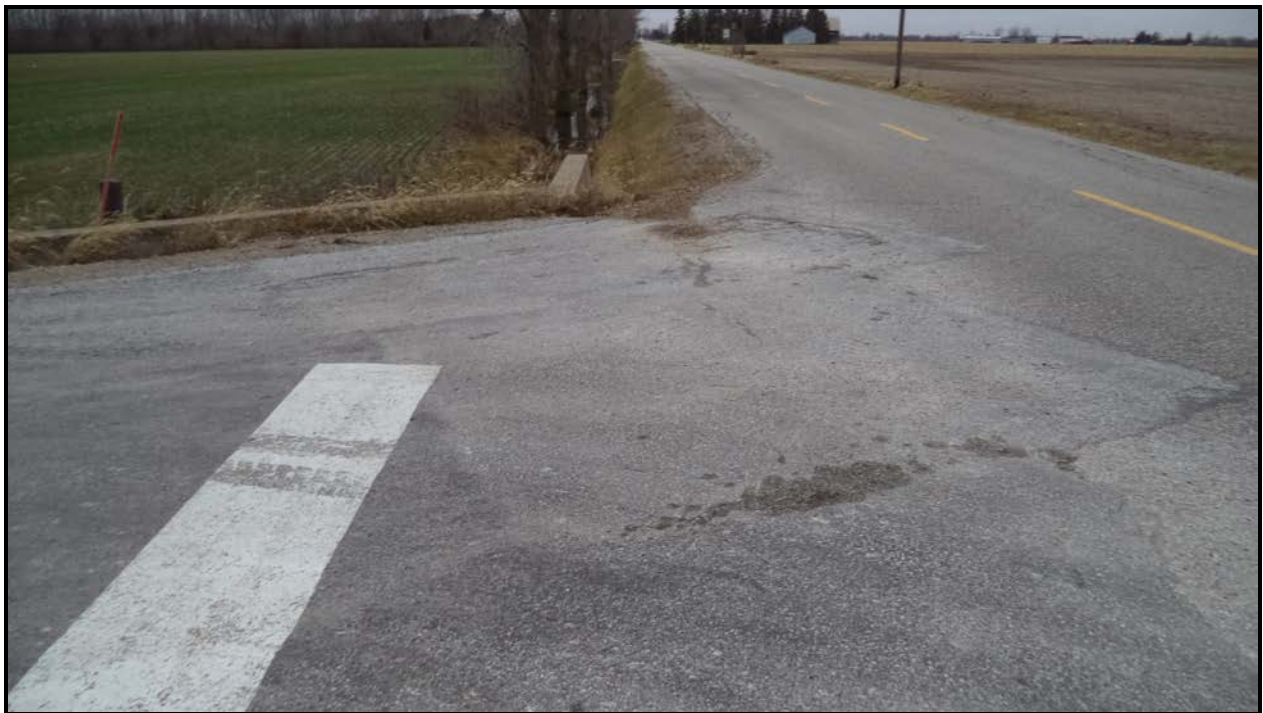
Photograph 5 – Wearing Surface over Culvert (Looking North)

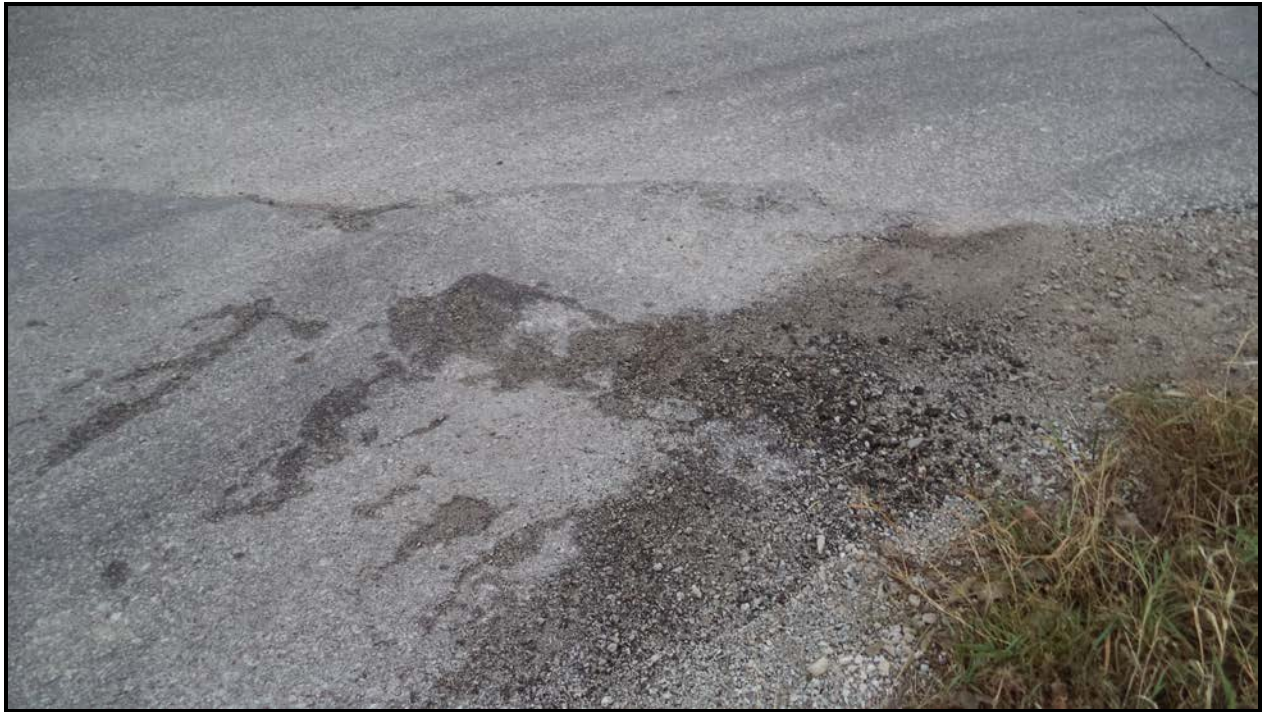
Photograph 6 – Wearing Surface over Culvert (Looking West)

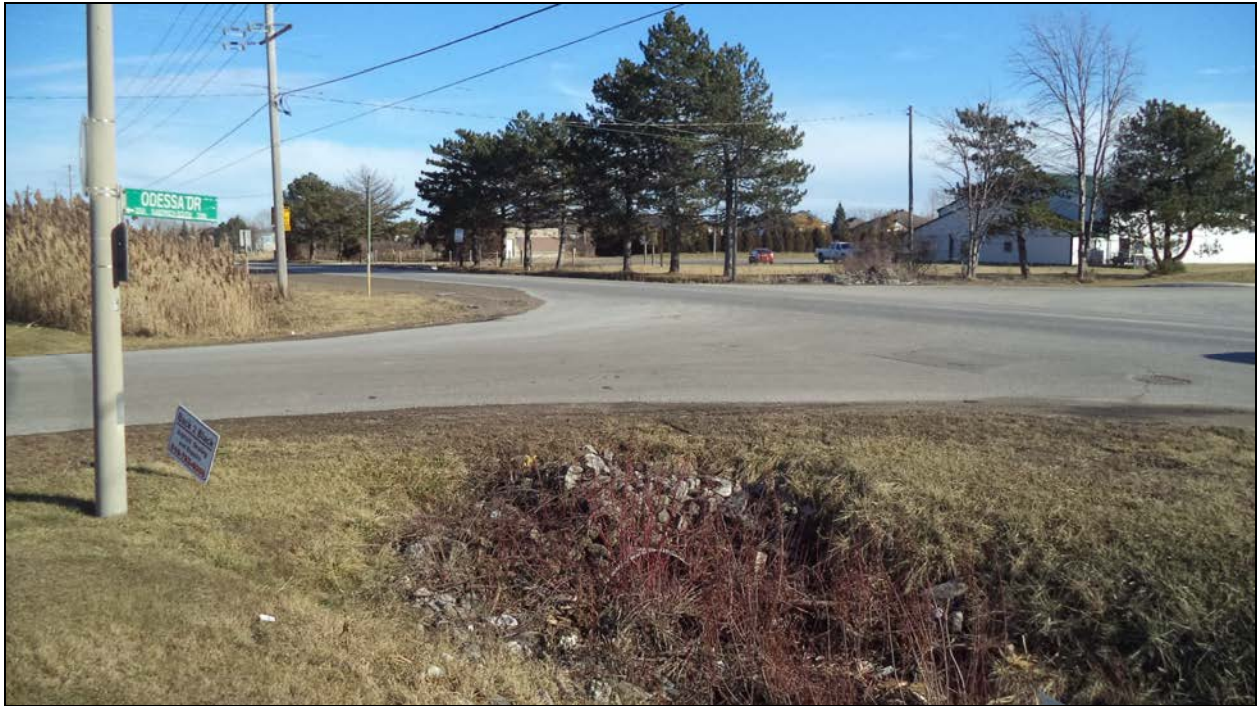
Photograph 1 – Road over Culvert (Looking West)

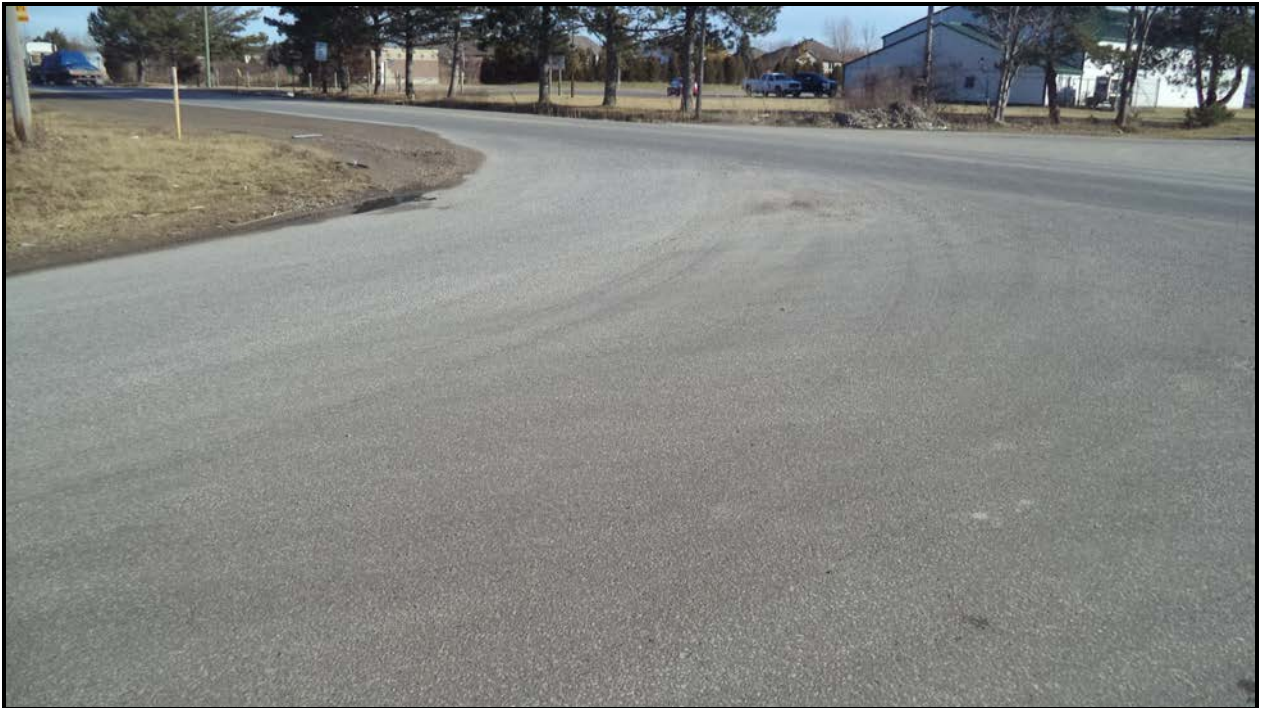
Photograph 5 – Wearing Surface over Culvert (Looking South)

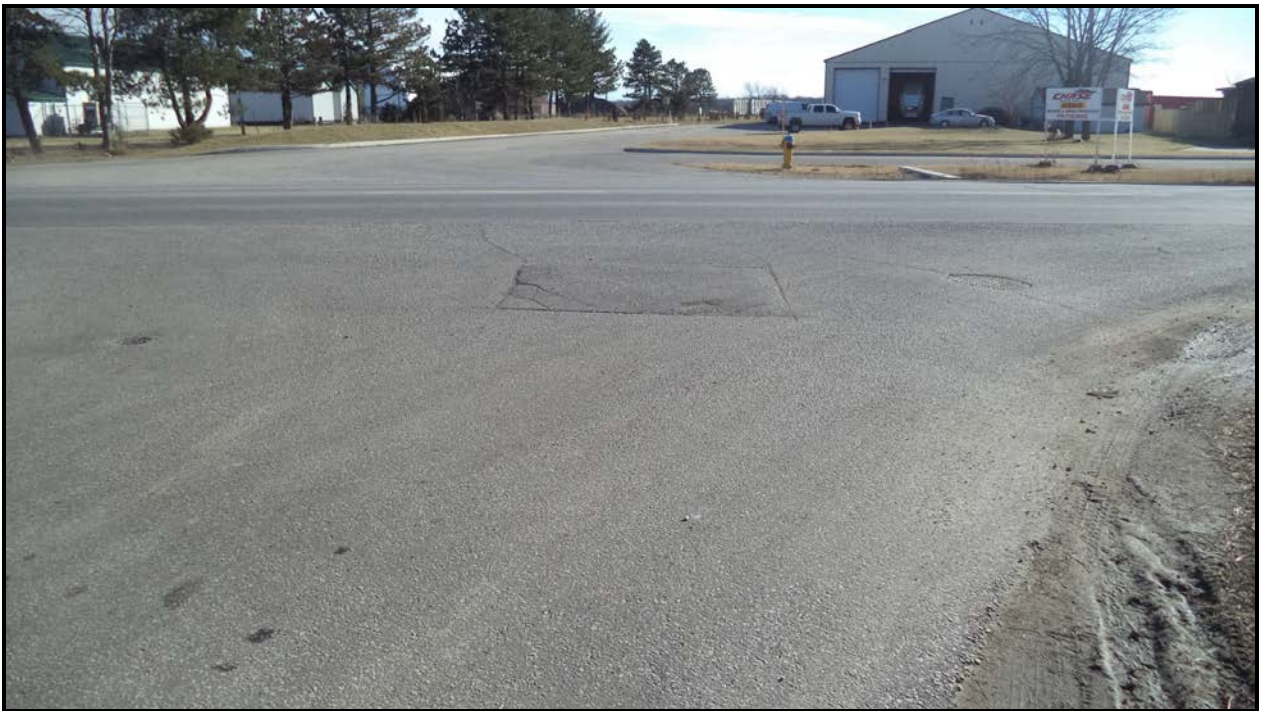
Photograph 6 – Wearing Surface at South Approach

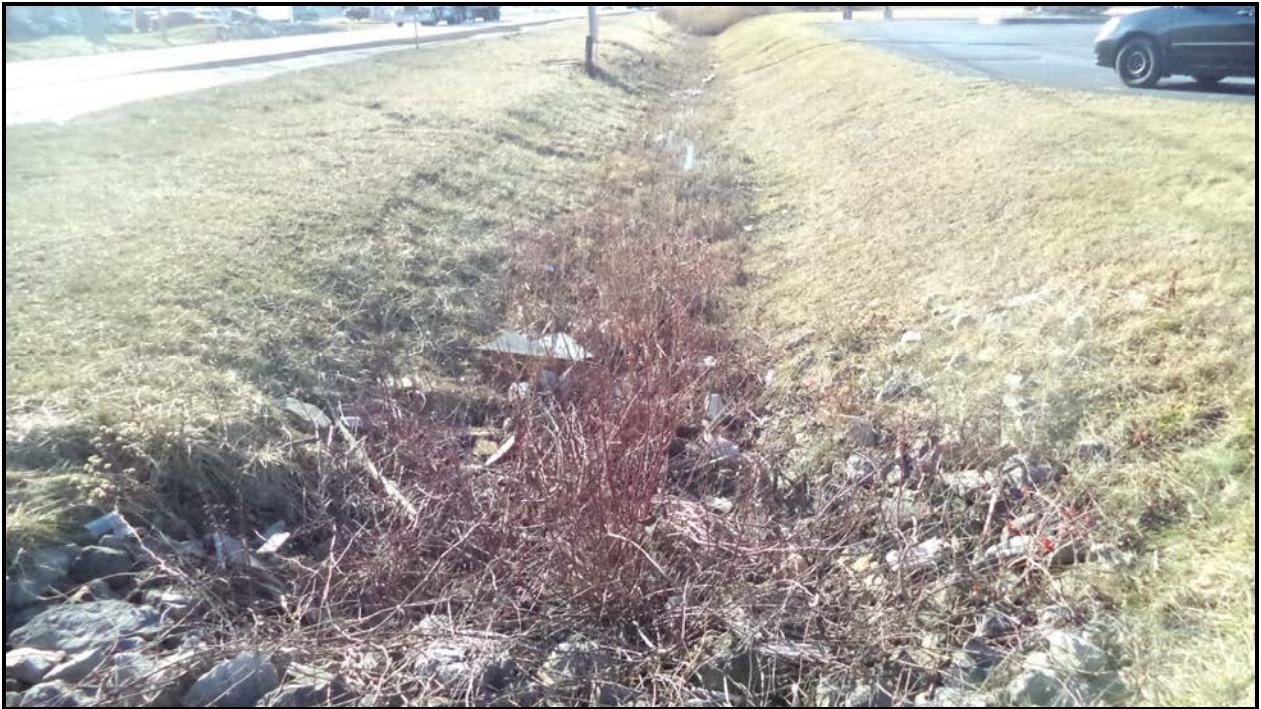
Photograph 8 – Water Stream (County Road 42 North Side - Looking West)
