CORPORATION OF THE TOWN OF TECUMSEH
2020 Bridge and Culvert Needs Study
Structures with Spans > 3.0 m

March 30, 2021

Town of Tecumseh
2020 Bridge and Culvert Needs Study
Structures with Spans > 3.0 m

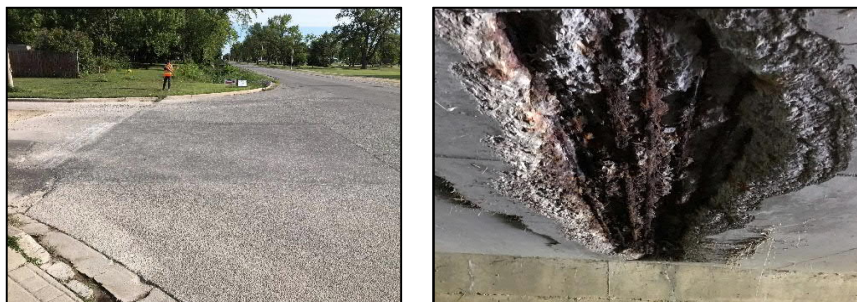
Figure 3: Asphalt over steel plate repair on deck top (left), typ. soffit deterioration (right)

This structure was built in 1975, and is a 4.8 m span cast-in-place concrete rigid frame culvert with open footings. To our knowledge, there have not been any major rehabilitations completed to this structure. The current BCI for this structure is 58.9.

Narrow to wide cracks with efflorescence staining were observed throughout the culvert barrel. Approximately four locations of severe to very severe delamination and very severe spalling with exposed and severely corroded reinforcing steel were observed in the culvert barrel soffit.

In July 2016, temporary repairs were completed by removing the asphalt wearing surface and placing a steel plate on the top of deck over the deteriorated soffit sections and re-paving the repaired areas. This repair was performed in anticipation that the structure will be fully replaced with a storm water sewer as part of the improvements on Manning Road (Phase 2) project in 2021.

Until the structure is replaced, Dillon recommends a monitoring program that consists of biannual inspections (two-times per year). The program should monitor the extents of the soffit deterioration to ensure the temporary repairs remain satisfactory. Additional temporary works may be warranted based on the results of the inspections and will be recommended to the Town upon the completion of each biannual investigation.

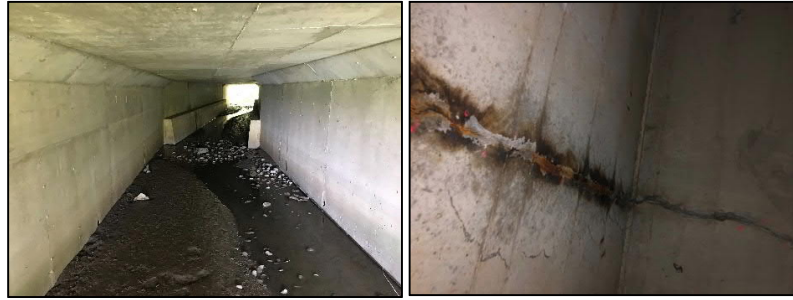
Figure 5: Culvert barrel (left), typ. soffit deterioration (right)

The current BCI for this structure is 75.0. However, this BCI rating is misleading because it does not evaluate the condition of the new and original sections independently, thus not accurately depicting the condition of the original culvert section in its current state of deterioration.

In the original culvert section, medium to wide cracks with active efflorescence and a single discrete severe delamination were observed on the barrel soffit. The barrel walls were noted to have light scaling and footing scour throughout, however, the scour has not lead to undermining of the footings and is not considered to be in need of any repairs. The scour should be monitored as part of the biennial inspection. Two (2) wide cracks were observed in the new footing jacket. In the new culvert extensions, no deterioration was observed. Excessive vegetation growth was noted in the waterway to the north of the structure and object markers were noted to be missing at two (2) corners of the approaches.

The proposed scope of rehabilitation includes: installation of new or replacement of waterproofing, concrete patch repairs and crack injection to the original culvert structure. Additional site works include: asphalt removal and replacement, excavations, backfilling steel beam guiderail post repair; routine maintenance on the north embankments and waterway; and add missing signs.
