**SULLIVAN CREEK DRAIN**  
**E09SU(102)**

**Repair and Improvement**  
**Geographic Township of Sandwich South**  
**TOWN OF TECUMSEH**

*REI Project 2015D010*  
*January 9th, 2023*

**SULLIVAN CREEK DRAIN  
E09SU(102)  
Repair and Improvement  
(Geographic Twp. of Sandwich South)  
Project REI2015D010  
Town of Tecumseh, County of Essex**

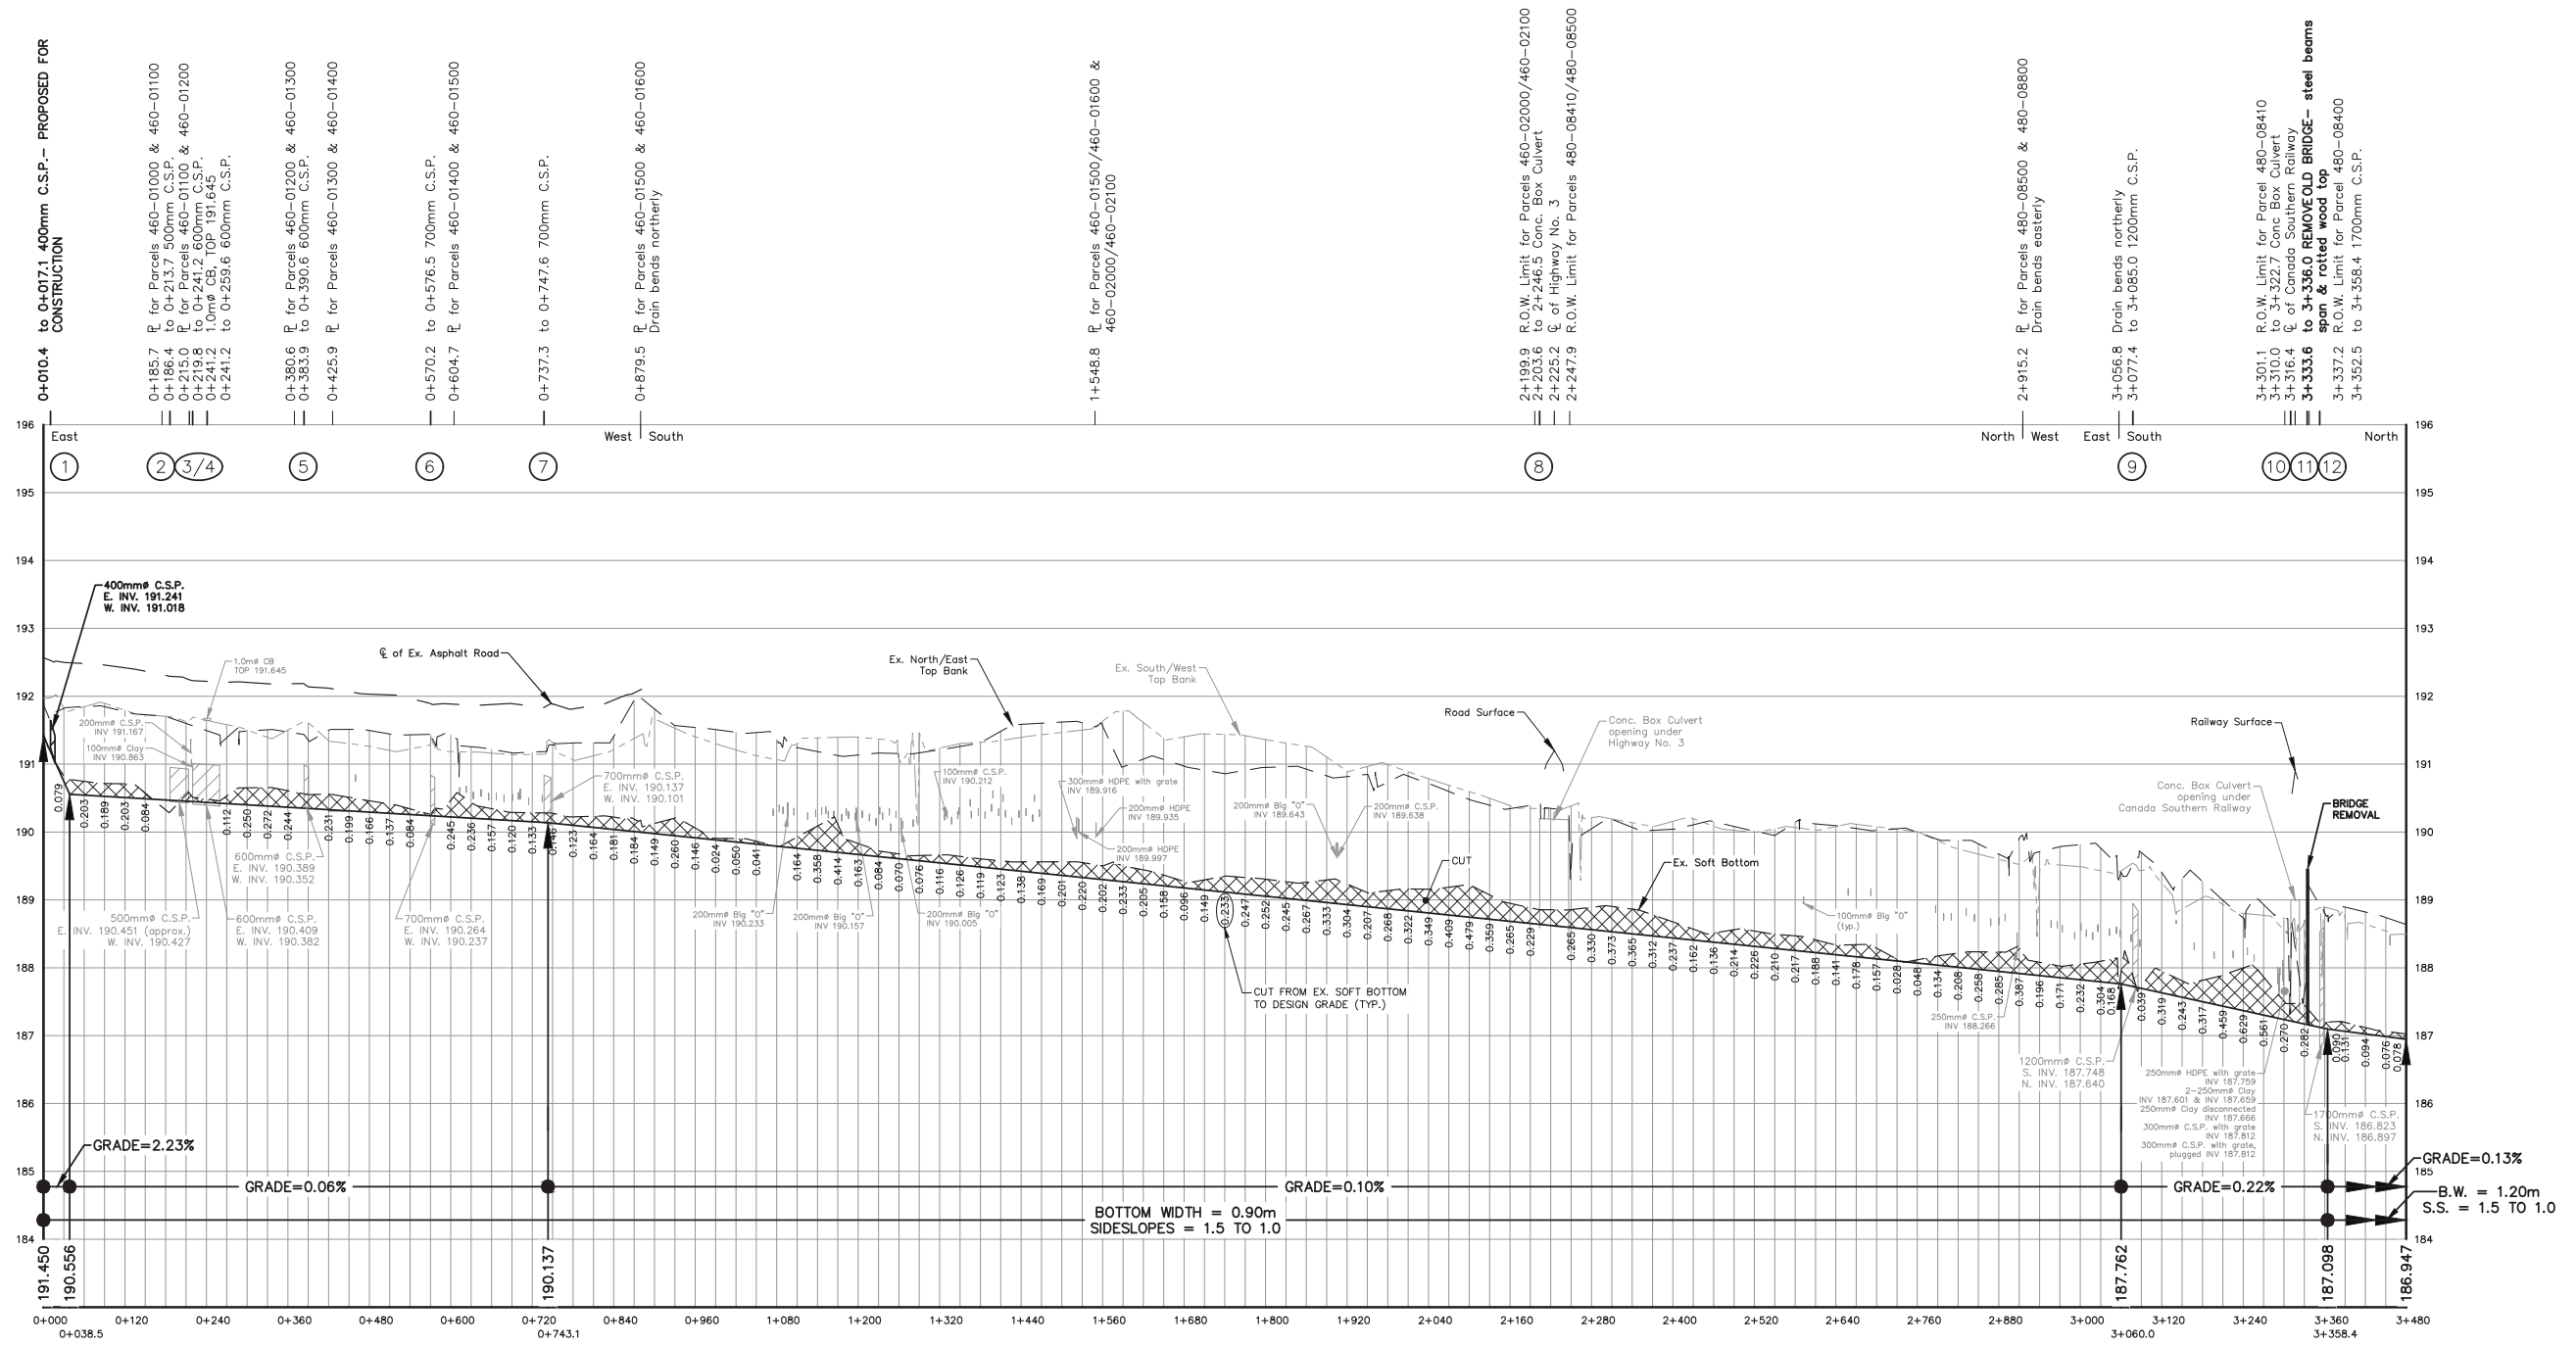
PROFILE OF SULLIVAN CREEK DRAIN— STA. 0+000 TO STA. 3+480

SCALE=1:5000 hor.  
1:50 vert.
