CORPORATE OF THE TOWN OF TECUMSEH
2016 Culvert Needs Study

Structures with Spans $\leq 3.0\text{m}$ – Final Report

Our File: 15-2977

October 28, 2016

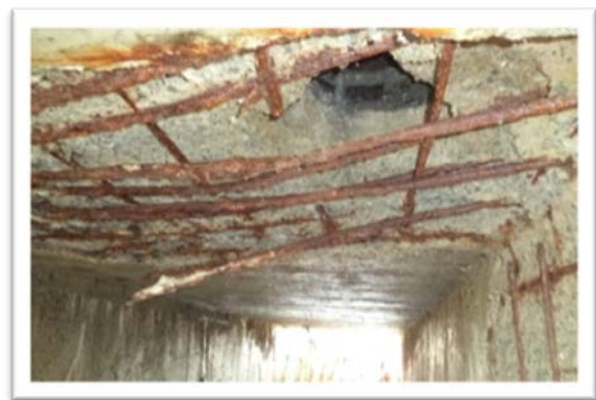
The structure was built in 1965 and is a 2.4 m single – span cast-in-place concrete non-rigid open footing frame culvert. Severe deterioration was observed at the deck soffit, walls, and wing walls which includes; spalling, scaling, exposed and corroded reinforcing steel.

This structure has reached the end of its useful service life due to its condition and is recommended for full replacement. Dillon has been assigned to provide design for replacement of this structure.

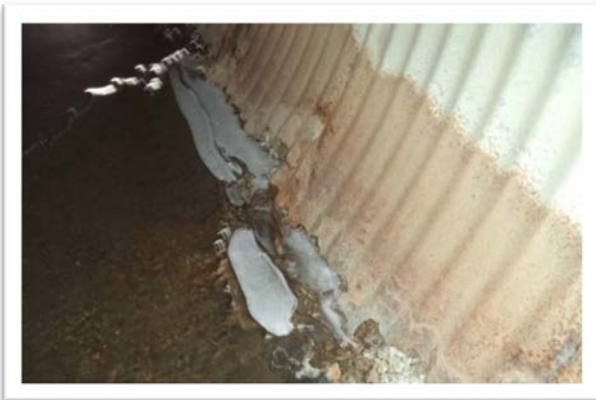
Structure No. 47: South Talbot Road

This structure was built in 1999 and is a 1.4 m diameter corrugated steel pipe. Severe corrosion was observed at the culvert barrel, along the full length at the spring line.

This structure has reached the end of its useful service life due to its condition, and is recommended for full replacement.

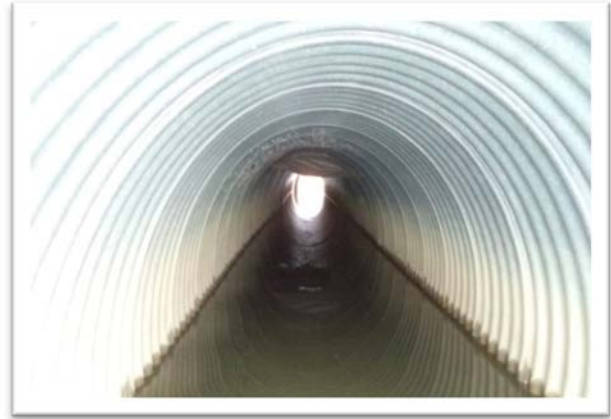
Structure No. 08: Jamsyl Drive

This structure was built in 1985 and is a 1.70 m diameter corrugated steel pipe. Failure of the C.S.P was observed directly below the road surface. The current condition provides a reduced hydraulic opening and a possible hazard for the traffic passing over the culvert section. Light corrosion is noticed at the surface surrounding this distorted section. It is recommended that the full structure be replaced.

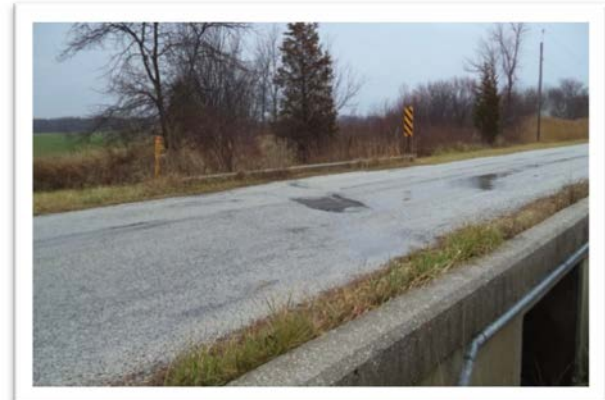
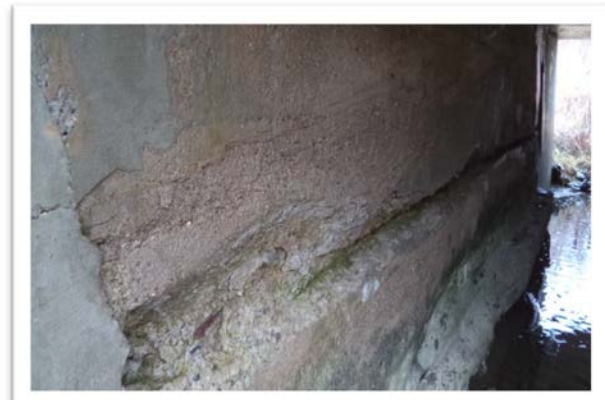
Structure No. 54: Snake Lane Road

The original structure was built in 1965 and is a 2.0 m single – span cast-in-place concrete non-rigid open footing frame culvert. The original structure was later extended, and wingwalls were added at both edges to provide wider road section and supporting element. A number of significant deficiencies were observed such as:

- Severe scour below the foundation;
- Large spalls at soffit with exposed and corroded rebar;
- Severe concrete erosion at the culvert walls; and
- The wearing surface is slippery and flushing over the culvert and severe settlement was observed over the culvert section.

This structure has reached the end of its useful service life due to its condition and apparent age and is required for replacement.

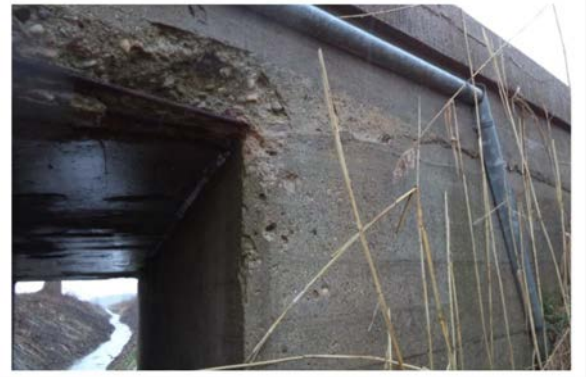
Structure No. 53: Snake Lane Road

This structure was built in 1960 and is a 1.5 m single – span cast-in-place concrete non-rigid open footing frame culvert. Severe spalling, delamination, and exposed corroded reinforcing steel were observed at the deck soffit, walls, and wingwalls.

It is recommended that the structure be fully replaced due to its deteriorated condition.

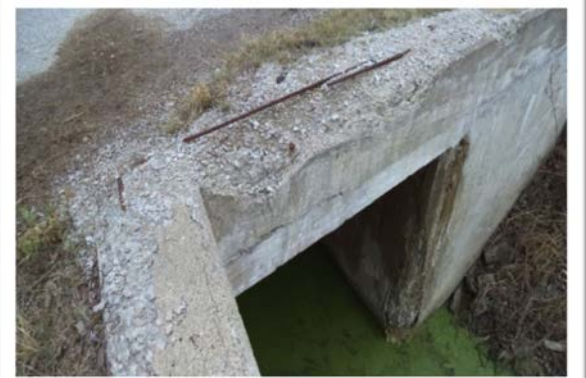
**Structure No. 42: Snake Lane Road**

This structure was built in 1965 and is a 1.8 m single – span cast-in-place concrete non-rigid open footing frame culvert. The wingwalls, abutment walls, soffit, and curbs were observed to have regions of severe delamination, spalling, cracks, exposed corroded reinforcing steel, and alkali silica aggregate reaction.

Rehabilitation or replacement of this structure is recommended.

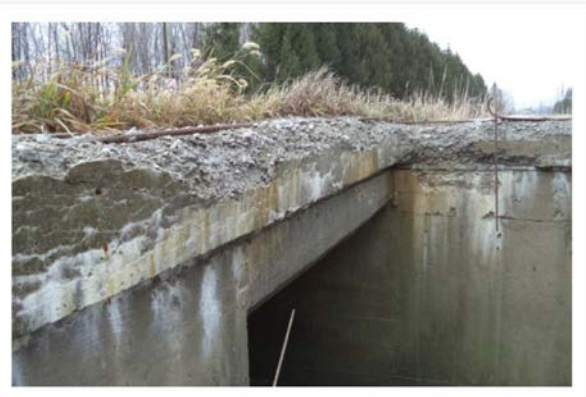
**Structure No. 46: South Talbot Road**

This structure was originally built in 1965 and is a 1.9 m single – span cast-in-place concrete non-rigid open footing frame culvert that was later lengthened. Severe disintegration of the concrete curb was observed and spalling at the northern headwalls. Apparent scouring was observed below the foundation at the original section. Asphalt surface with severe ravelling, and longitudinal and transverse cracking.

Although rehabilitation is an option, due to the size of the structure; full replacement was recommended as the most practical long term solution.

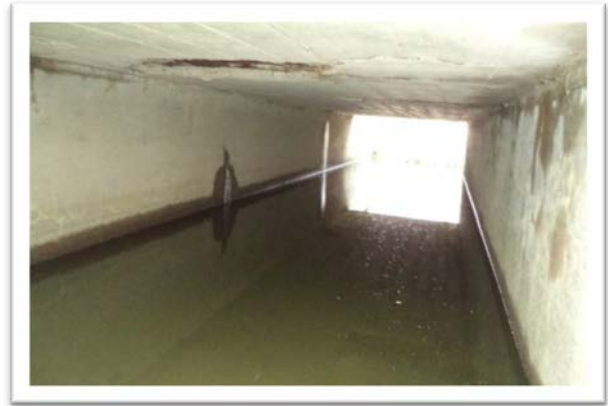
Structure No. 70: Concession Road 12

This structure was built in 1965 and is a 2.45 m single – span cast-in-place concrete non-rigid open footing frame culvert. Moderate to severe spalling of the culvert soffit was observed with exposed and corroded reinforcing steel approximately below the road center line.

Rehabilitation of the structure is recommended.

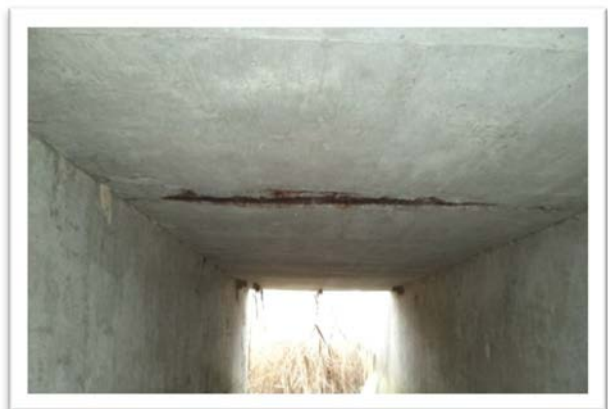
**Structure No. 51: Concession Road 8**

This structure was built in 1965 and is a 2.5 m single – span cast-in-place concrete non-rigid open footing frame culvert. Moderate to severe spalling of the culvert soffit was observed with exposed and corroded reinforcing steel below the road center line.

Rehabilitation of the structure is recommended.

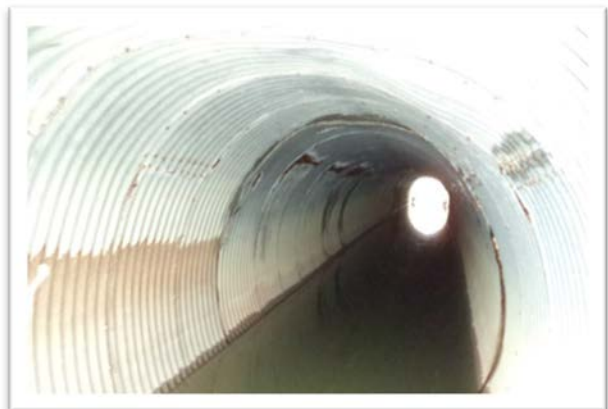
**Structure No. 07: Desro Drive**

This structure was built in 1985 and is a 1.90 m diameter corrugated steel pipe. Typical severe corrosion was noticed at the bolted connections. Moderate settlement was also observed at the culvert top side, approximately located below the road.

This structure is approaching to the end of its useful service life due to its condition and is recommended for replacement.

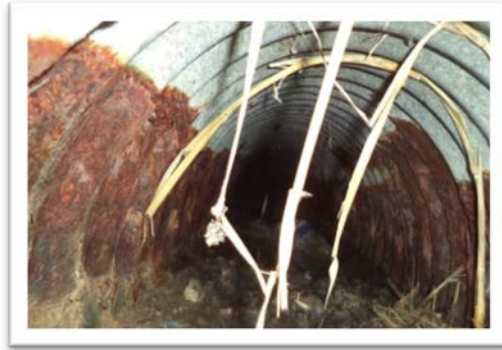
Structure No. 14: Intersection Road

This structure was built in 1990 and is a 0.50 m diameter corrugated steel pipe. Severe corrosion was observed at the culvert barrel, in addition to wide cracks in few sections at the spring line.

This structure is approaching to the end of its useful service life due to its condition and is recommended for replacement.

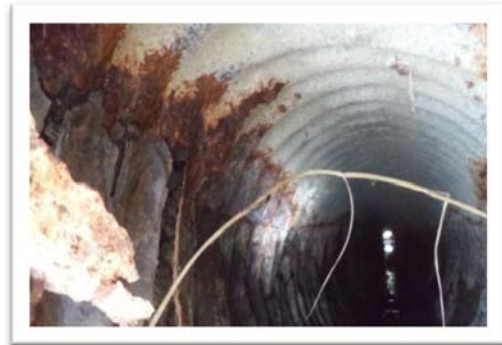
**Structure No. 29: Moynahan Street**

This structure was built in 1957 and is a 0.40 m diameter corrugated steel pipe. Severe corrosion was observed at the culvert barrel, mainly below the spring line.

This structure is approaching to the end of its useful service life due to its condition and is recommended for replacement.

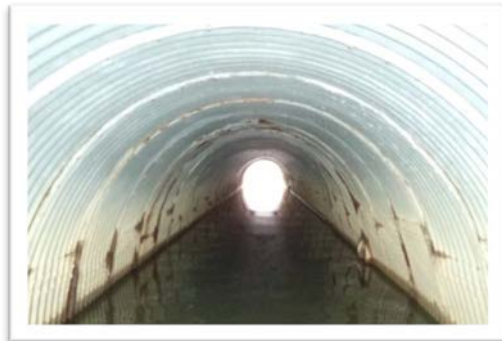
**Structure No.09: Sylvestre Drive**

This structure was built in 1990 and is a 2.0 m diameter corrugated steel pipe. The culvert barrel is moderately corroded below spring line with wide split located approximately 3.0m from the north edge. Mortar bags at the south-east corner were found in poor condition.

This culvert is recommended to be monitored for deformation, and settlement until it is fully replaced.

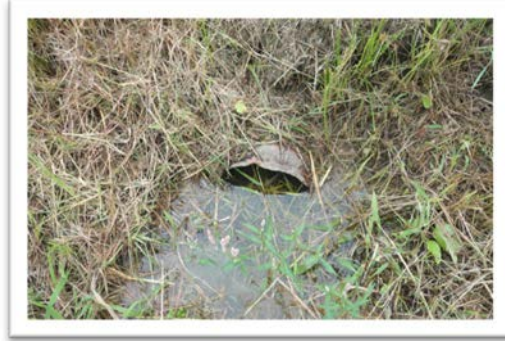
Structure No.58: Concession Road 10

This structure is 0.4m diameter corrugated steel pipe. The inspection of the culvert was limited due to the high water level. The east end was covered under the heavy plant growth.

In the drainage report, this structure is recommended to be replaced with new 750mm smooth wall concrete pipe.

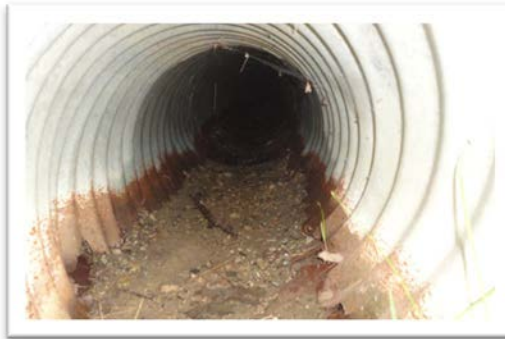
**Structure No.60: Concession Road 10**

This structure is 0.45m diameter corrugated steel pipe. The culvert barrel was observed with a full length split at the spring line.

In the drainage report, this structure is recommended to be replaced with new 600mm smooth wall concrete pipe.

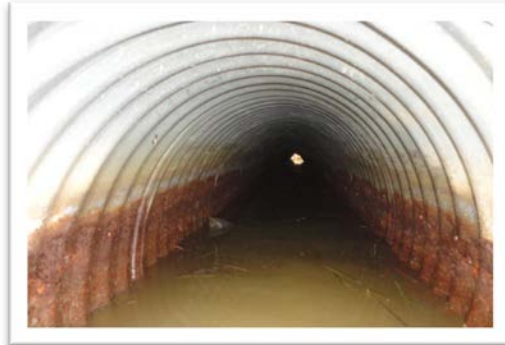
**Structure No.62: Concession Road 10**

This structure is 0.6m diameter corrugated steel pipe. The bottom half of the culvert barrel is moderately corroded. The water flow is partially blocked with debris and the heavy plants growth at both ends.

In the drainage report, this structure is recommended to be replaced with new 900mm smooth wall concrete pipe.

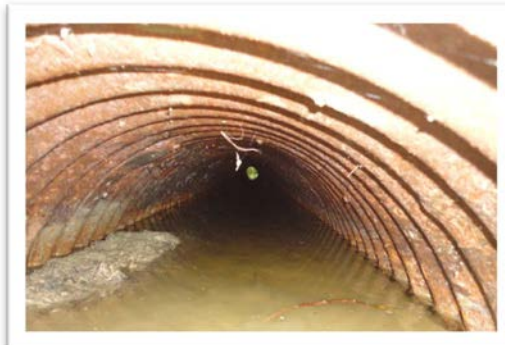
**Structure No.67: Concession Road 11**

This structure is 0.6m diameter corrugated steel pipe. The culvert barrel was observed with moderate to severe corrosion, and the bottom half was filled with sedimentation.

In the drainage report, this structure is recommended to be replaced with a new 600mm aluminized CSP as part of the Drainage Works.

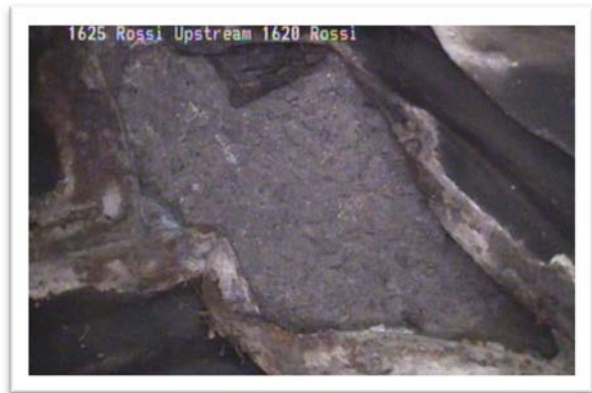
This structure is 0.6m diameter corrugated steel pipe. It was inaccessible at time of the field inspection. Therefore, camera inspection was conducted by a subcontractor. The video recording of the culvert barrel showed a joint displacement and a wide opening. The rest of the barrel length was found in good condition.

It is recommended to anticipate a full replacement of this culvert within 6 - 10 Years.

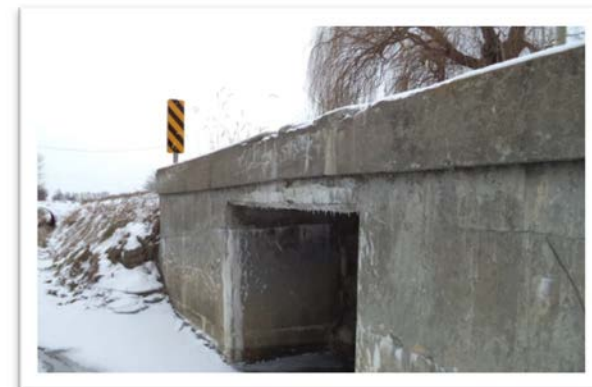
Structure No. 48: Holden Road

This structure was originally built in 1965 and is a 2.4 m single – span cast-in-place concrete non-rigid open footing frame culvert. The original structure span was lengthened at both ends. Severe alkali aggregate reaction was observed at the recently added wingwalls and headwalls. Signs of severe deposits were observed at the joint between both the original and new extension.

Structure is recommended to be fully replaced with widened structure.

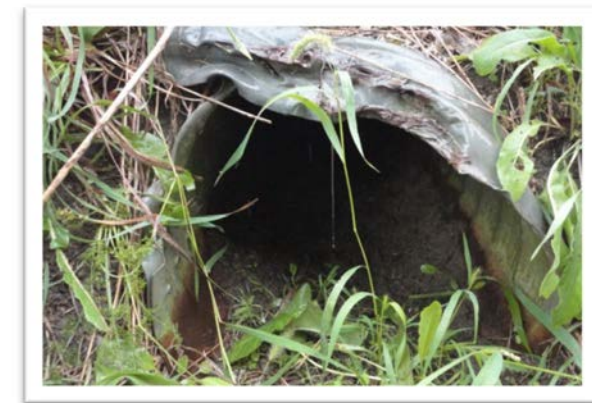
Structure No. 68: Concession Road 11

This structure is 0.45m diameter corrugated steel pipe. Existing pipe is in fair condition with distorted west end. The bottom half below the spring line is moderately corroded. Excessive plant growth needs to be repaired as part of the routine maintenance.

It is recommended to anticipate full replacement within 6 - 10 Years due to corrosion. (Monitor in interim).

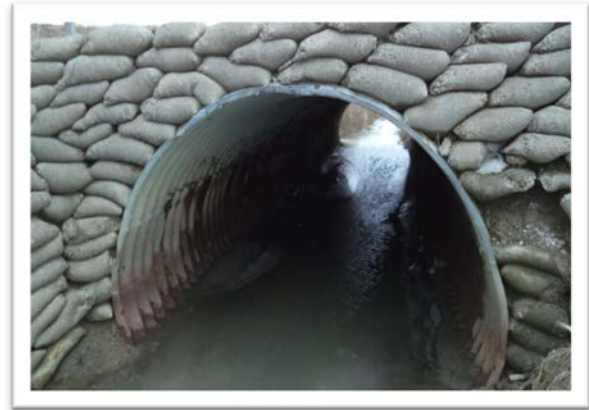
Structure No. 69: Concession Road 11

This structure is 1.8m diameter corrugated steel pipe. Culvert barrel was observed with moderate corrosion around the bolts, and lightly corroded haunches at the bottom. Wearing surface with wide transverse cracks over the culvert. Monitor structure for further corrosion loss.

It is recommended to anticipate a full replacement of this culvert within 6 - 10 Years.

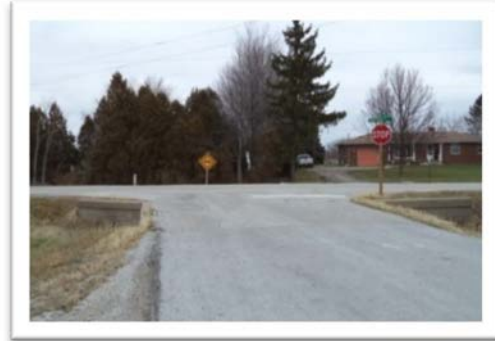
Concrete headwalls are a hazard that vehicles should be protected from. Guide rail may be warranted on South Talbot Road at this location whether this culvert is rehabilitated or replaced. If the culvert is replaced a widened culvert would reduce the risk associated with the headwalls perpendicular to Concession Road 10. At a minimum, Wb-33 object marker signs should be erected at the ends of each headwall due to their proximity to the existing edge of pavement. The need for guide rail should be confirmed during detailed design.

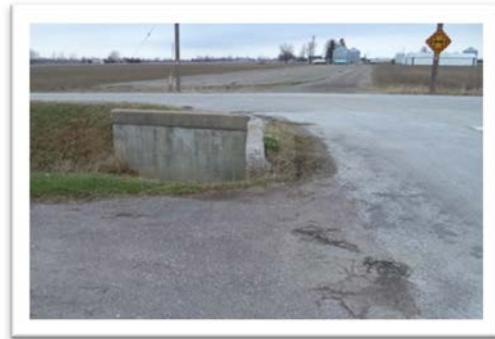
Structure No. 42: Snake Lane Road

Concrete headwalls are a hazard that vehicles should be protected from. Guide rail may be warranted on South Talbot Road at this location whether this culvert is rehabilitated or replaced. If the culvert is replaced a widened culvert would reduce the risk associated with the headwalls perpendicular to Snake Lane Road. At a minimum, Wb-33 object marker signs should be erected at the ends of each headwall due to their proximity to the existing edge of pavement. The need for guide rail should be confirmed during detailed design.

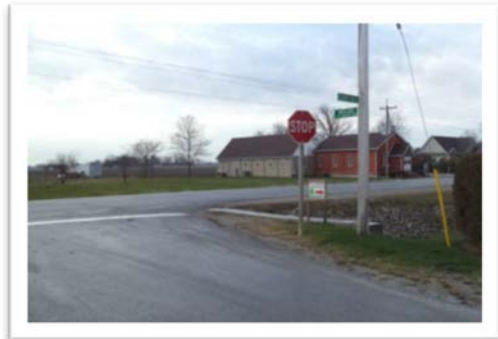
Structure No. 57: Concession Road 9

Concrete headwalls are a hazard that vehicles should be protected from. Guide rail is recommended.

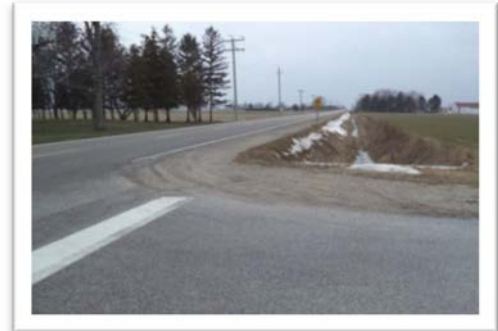
Structure No. 63: Concession Road 10

Concrete headwalls are a hazard that vehicles should be protected from. Guide rail is recommended.

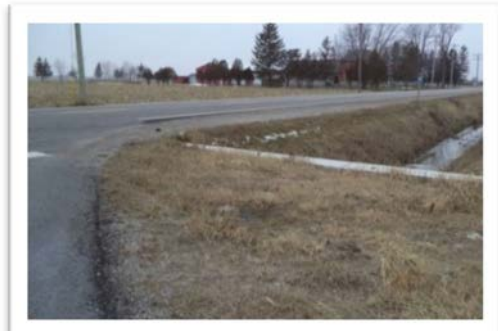
Structure No. 64: Malden Road

Concrete headwalls are a hazard that vehicles should be protected from. Guide rail is recommended.

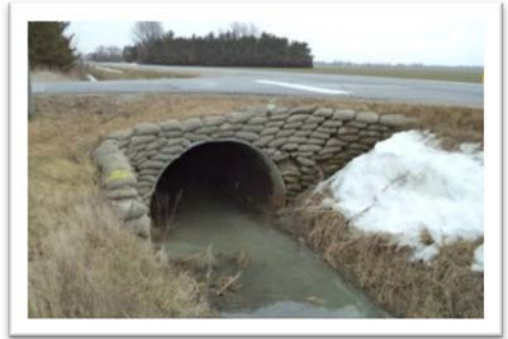
Structure No. 69: Concession Road 11Type of Hazard:

Concrete Headwalls

Concrete headwalls are a hazard that vehicles should be protected from. Guide rail may be warranted on County Road 8 (CR8) at this location whether this culvert is rehabilitated or replaced. If the culvert is replaced, extending the culvert length would reduce the risk associated with the headwalls perpendicular to Concession Road 11. At a minimum, Wb-33 object marker signs should be erected at the ends of each headwall due to their proximity to the existing edge of pavement. The need for guide rail should be confirmed during detailed design.

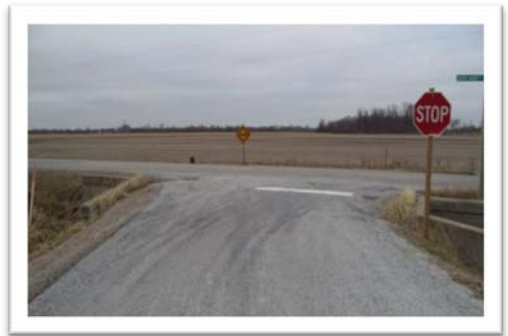
**Structure No. 70: Concession Road 12**Type of Hazard:

Concrete Headwalls

Concrete headwalls are a hazard that vehicles should be protected from. Guide rail is recommended on South Talbot Road. A widened culvert should be considered if culvert is replaced to reduce risk on Concession Road 12.

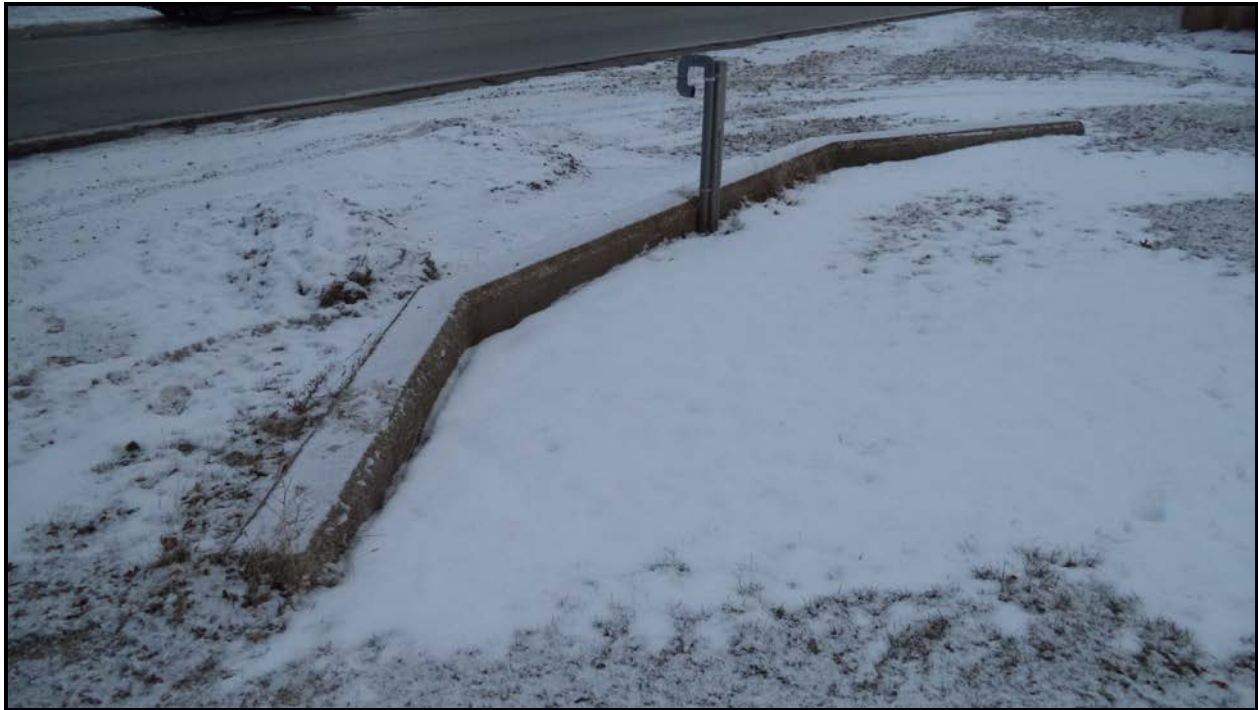
Photograph 3 – South Elevation

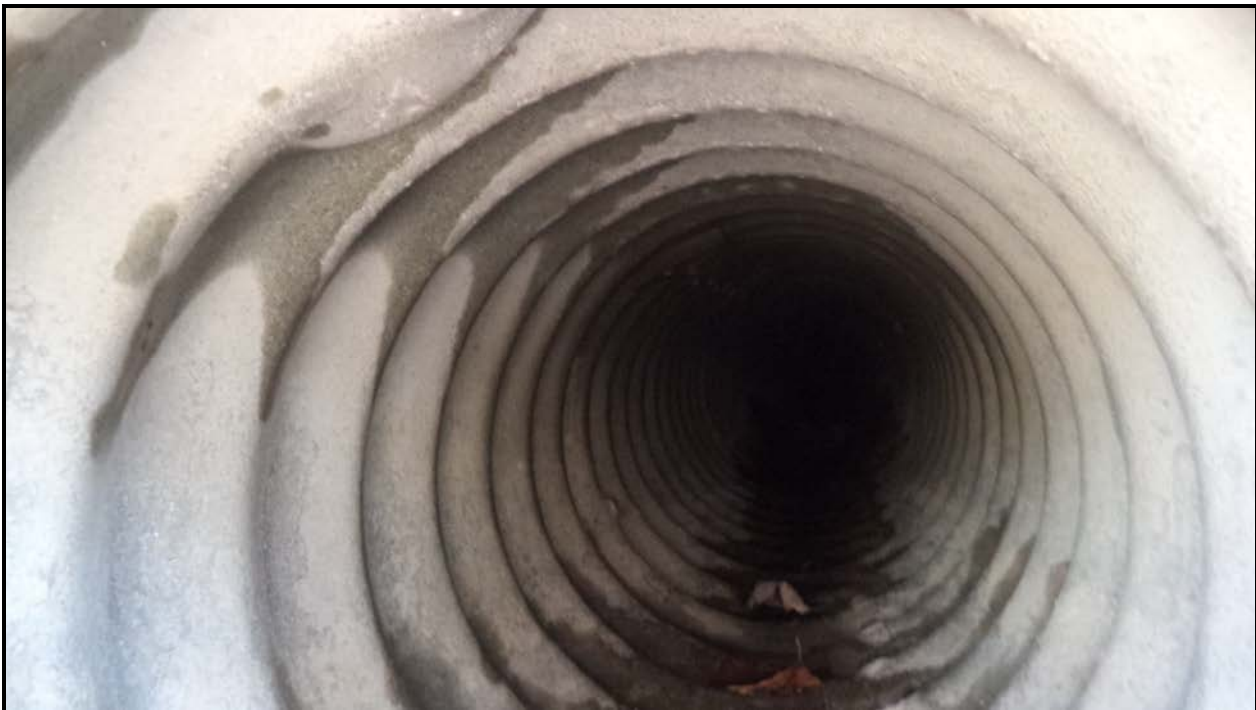
Photograph 2 – Culvert Barrel

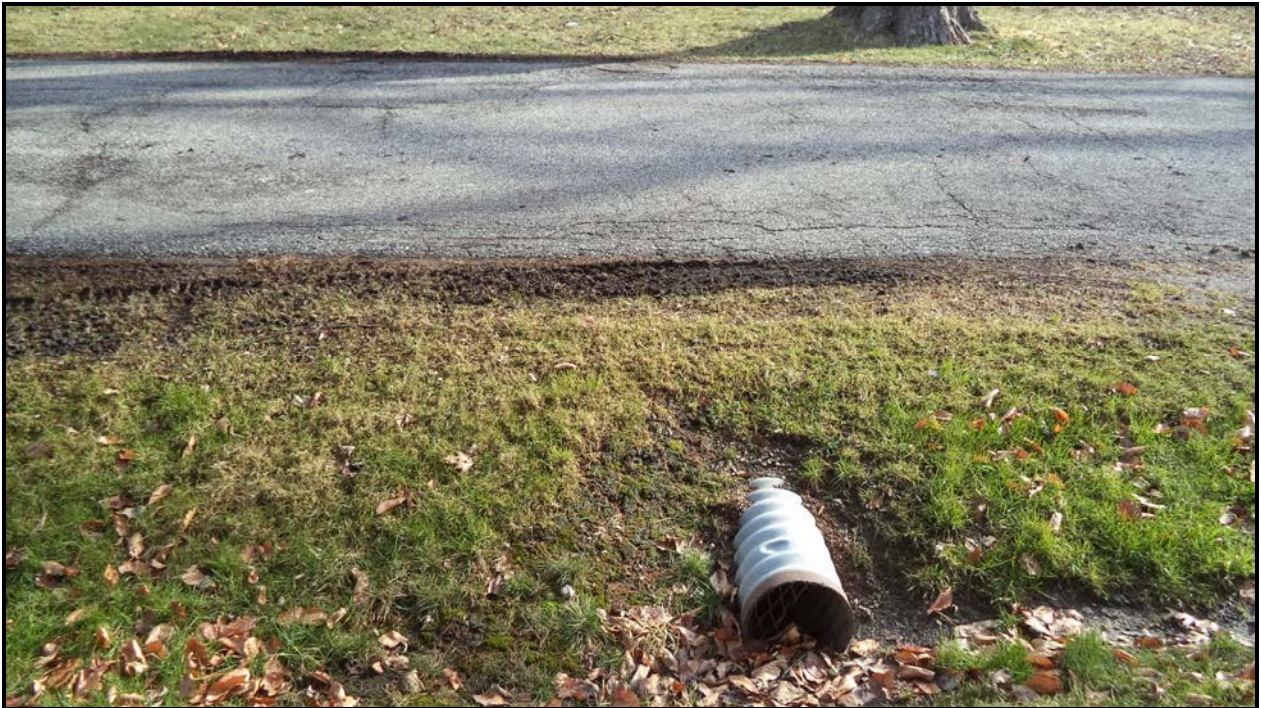
Photograph 3 – West Elevation

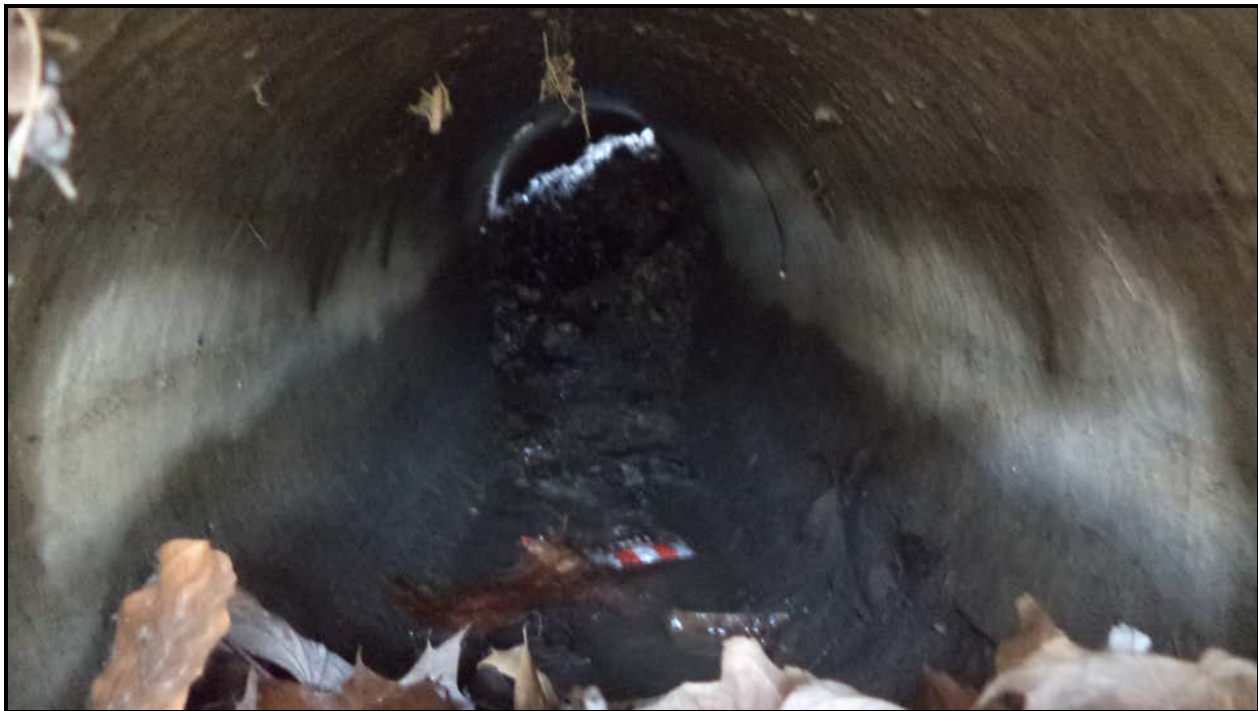
Photograph 2 – Culvert Barrel

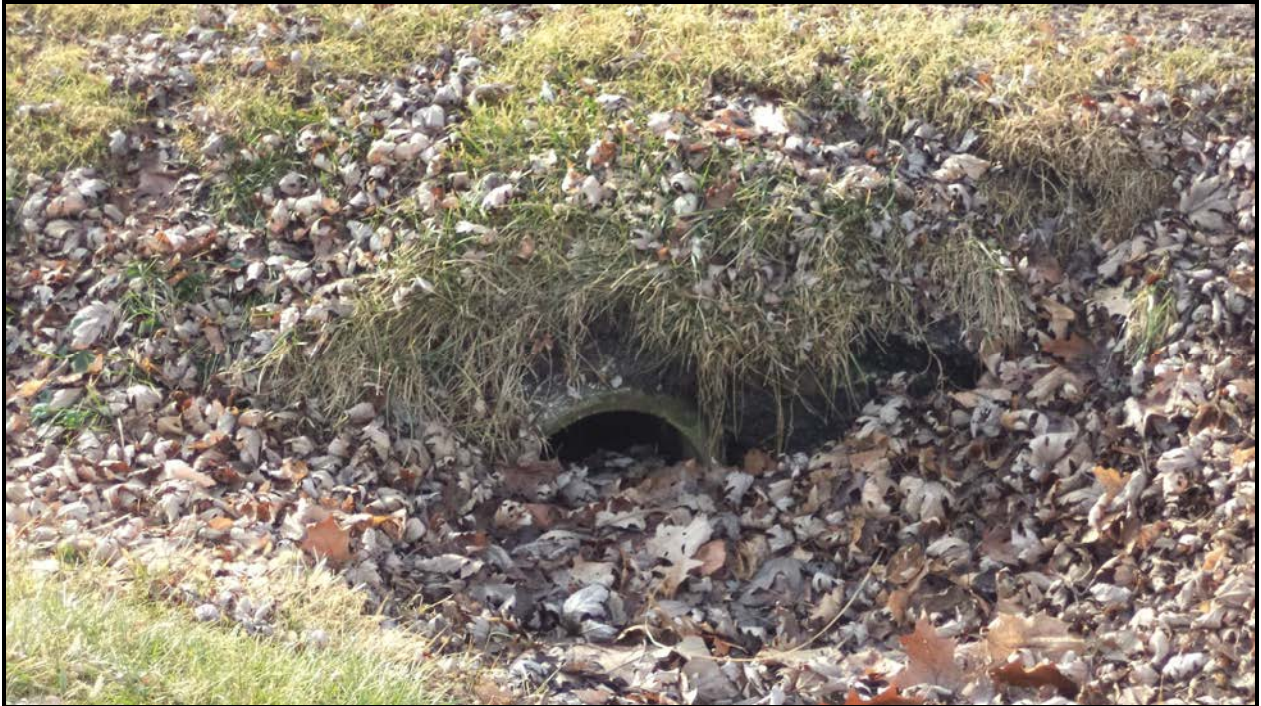
Photograph 3 – North Elevation

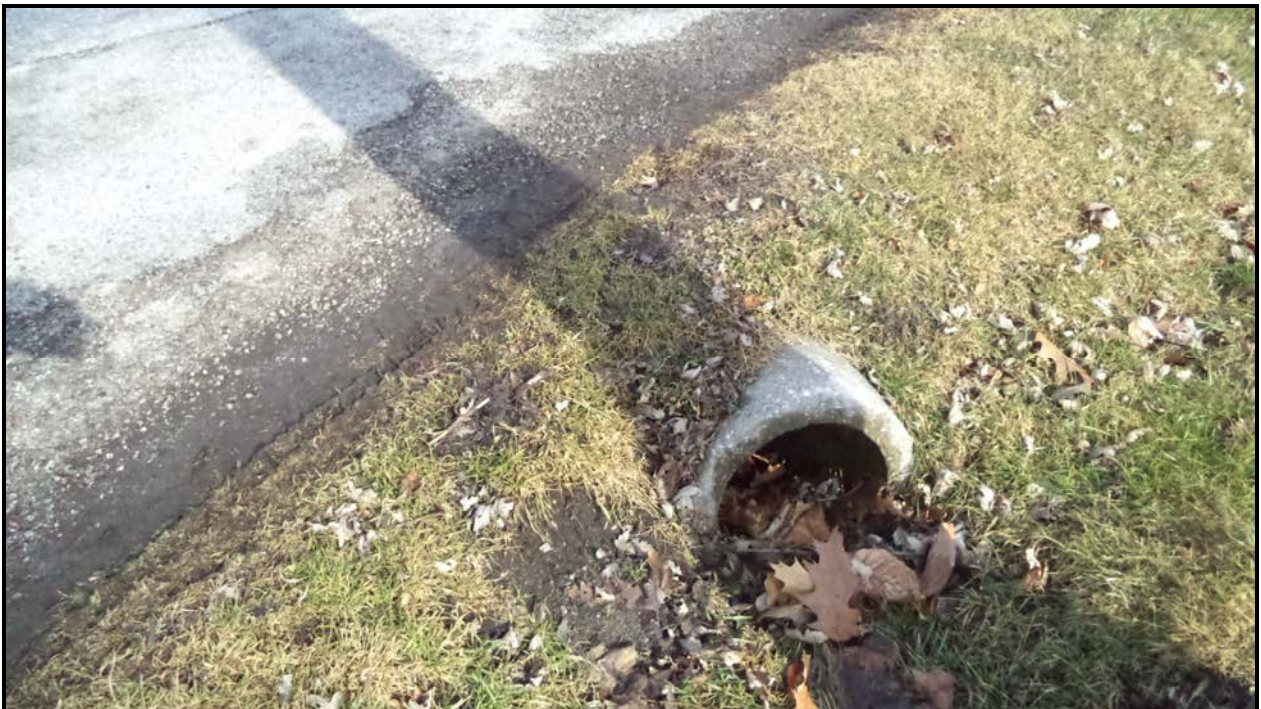
Photograph 4 – South Elevation

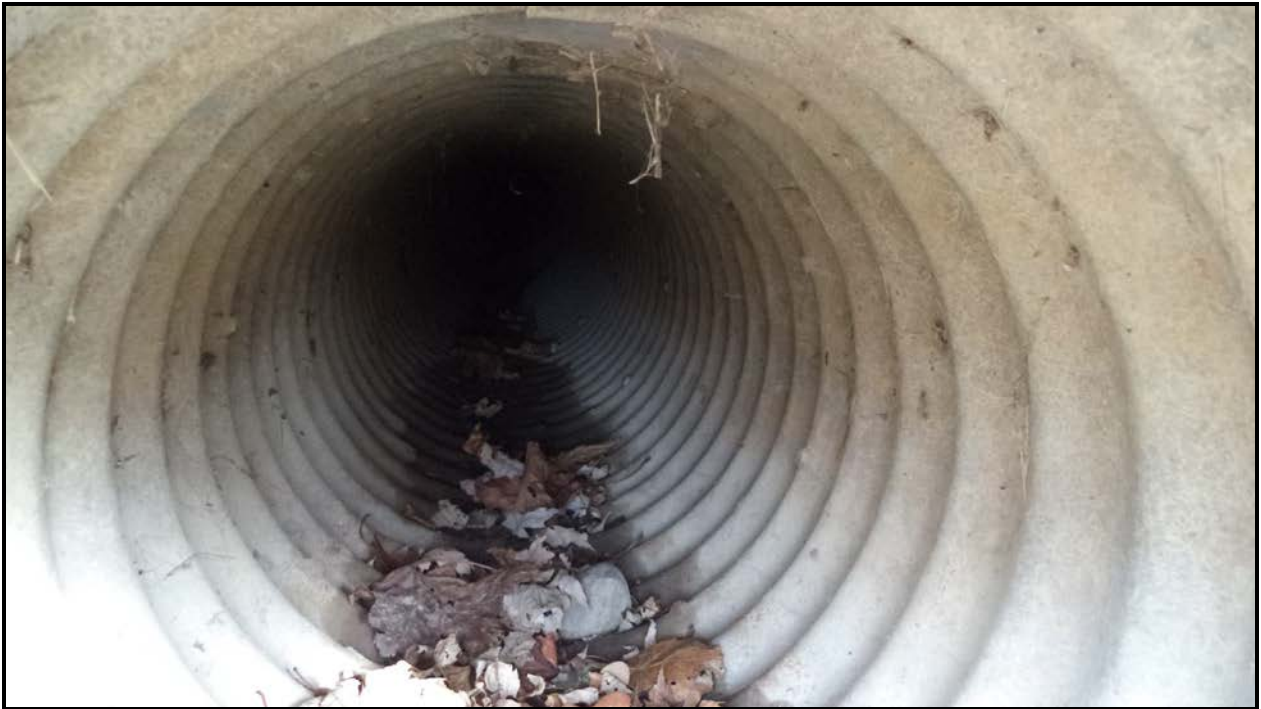
Photograph 2 – Culvert Barrel

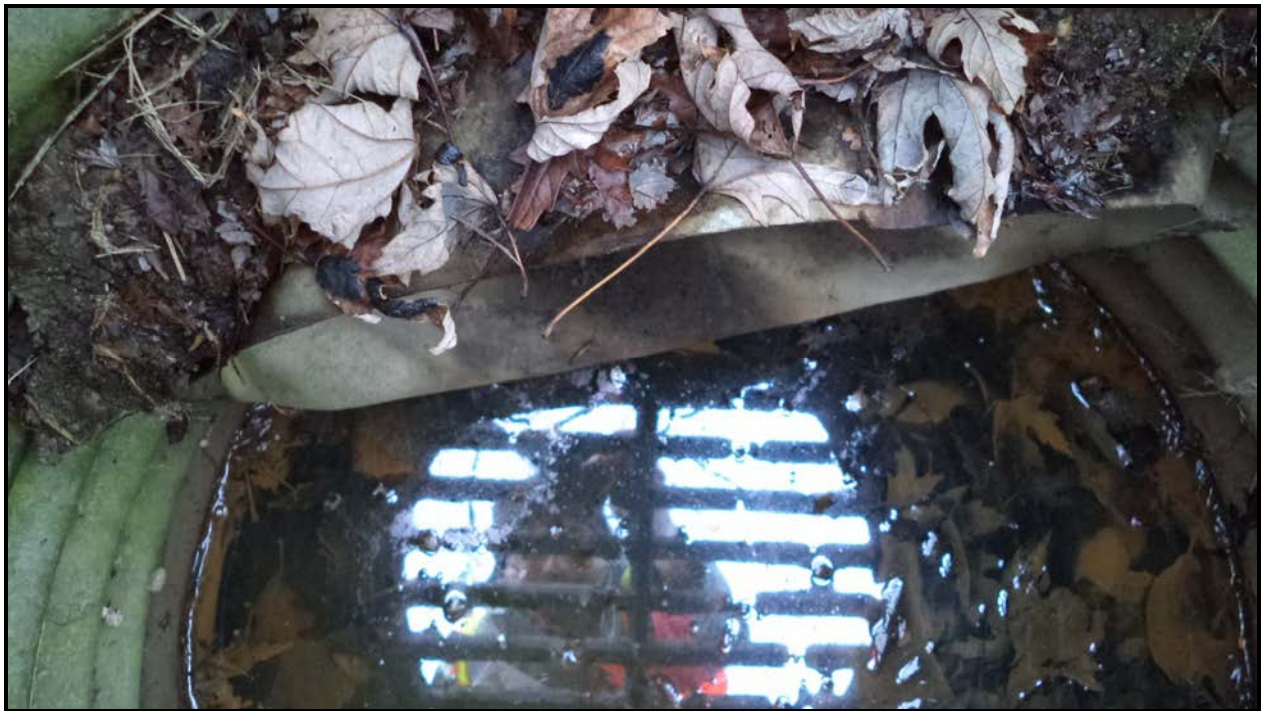
Photograph 4 – North Inlet

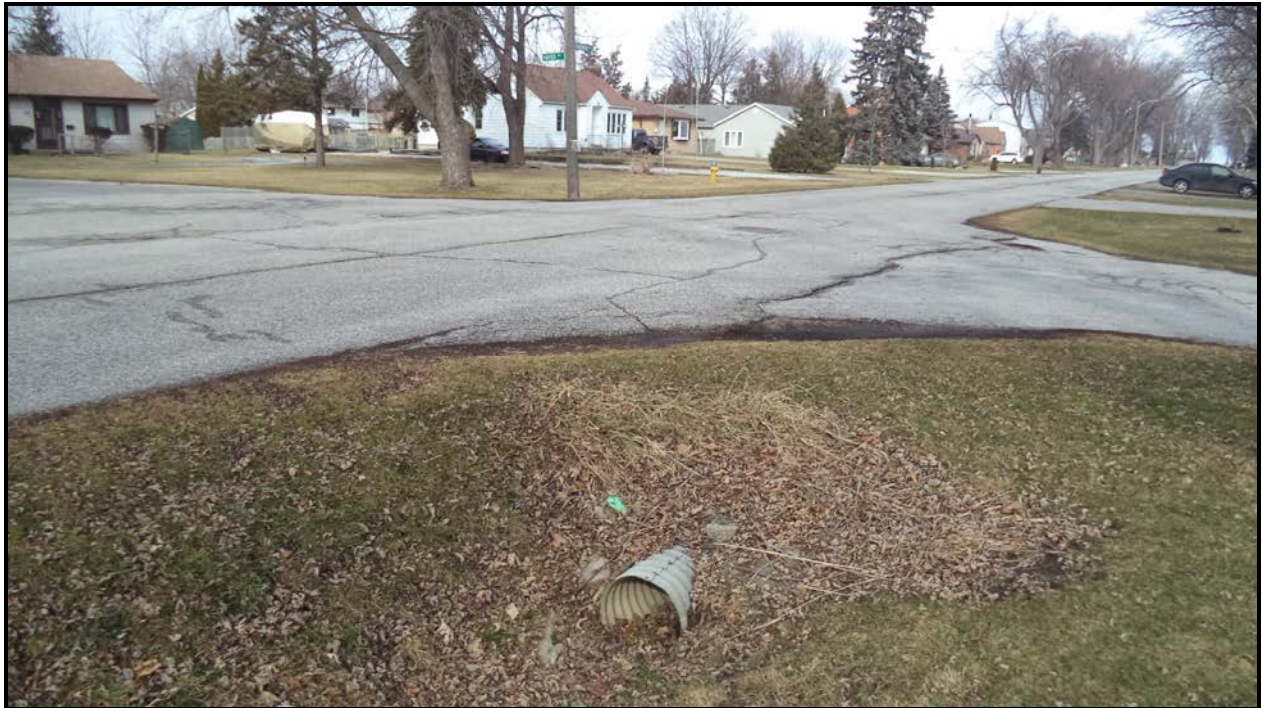
Photograph 5 – South Elevation

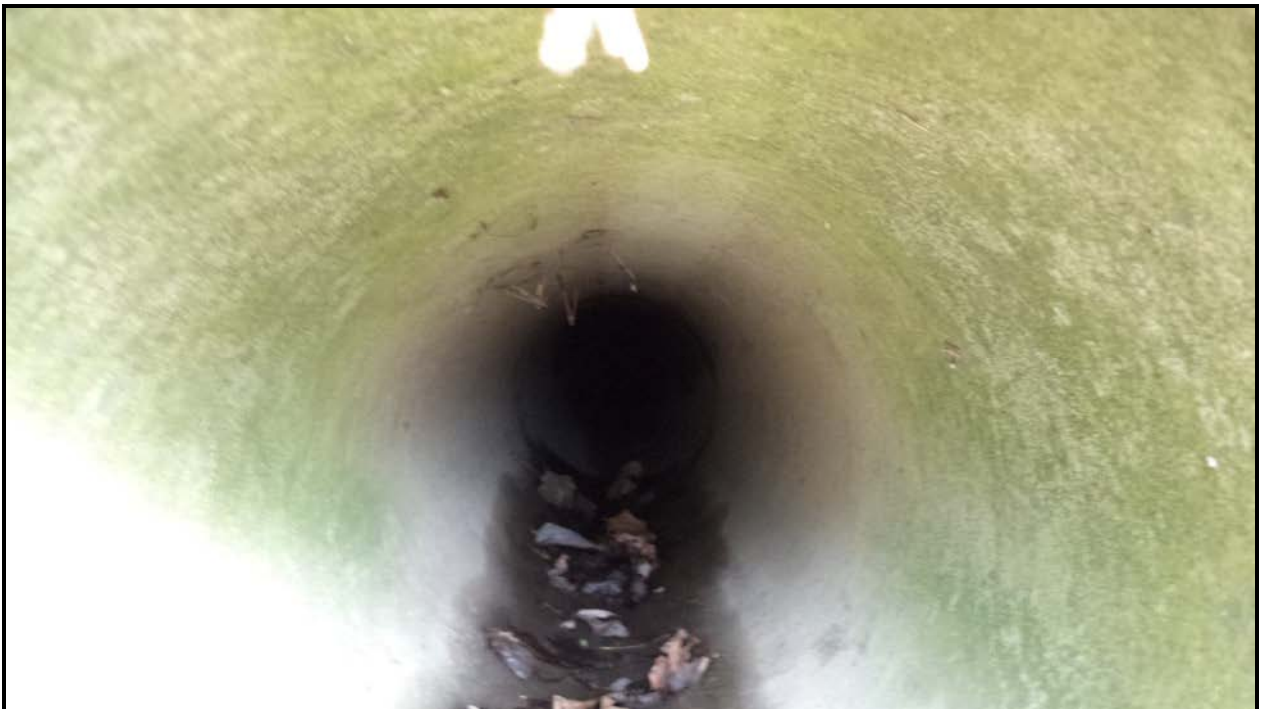
Photograph 2 – Culvert Barrel

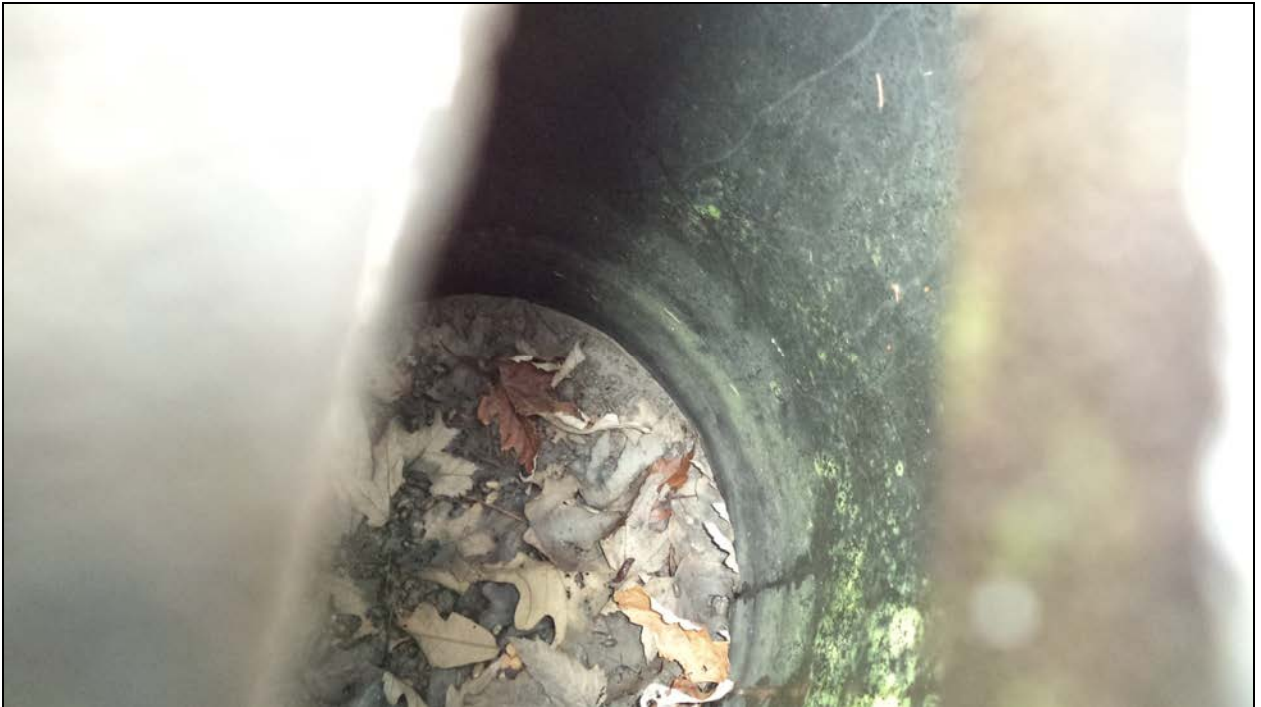
Photograph 4 – North Inlet

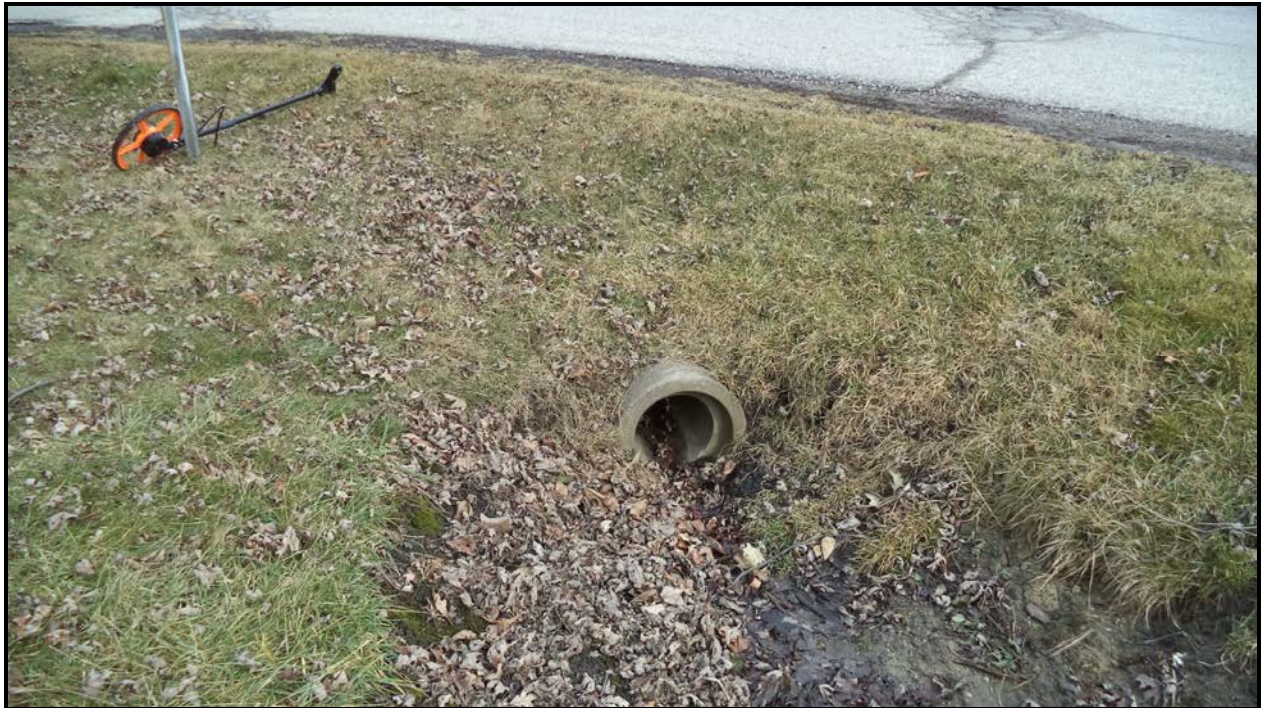
Photograph 5 – South Elevation

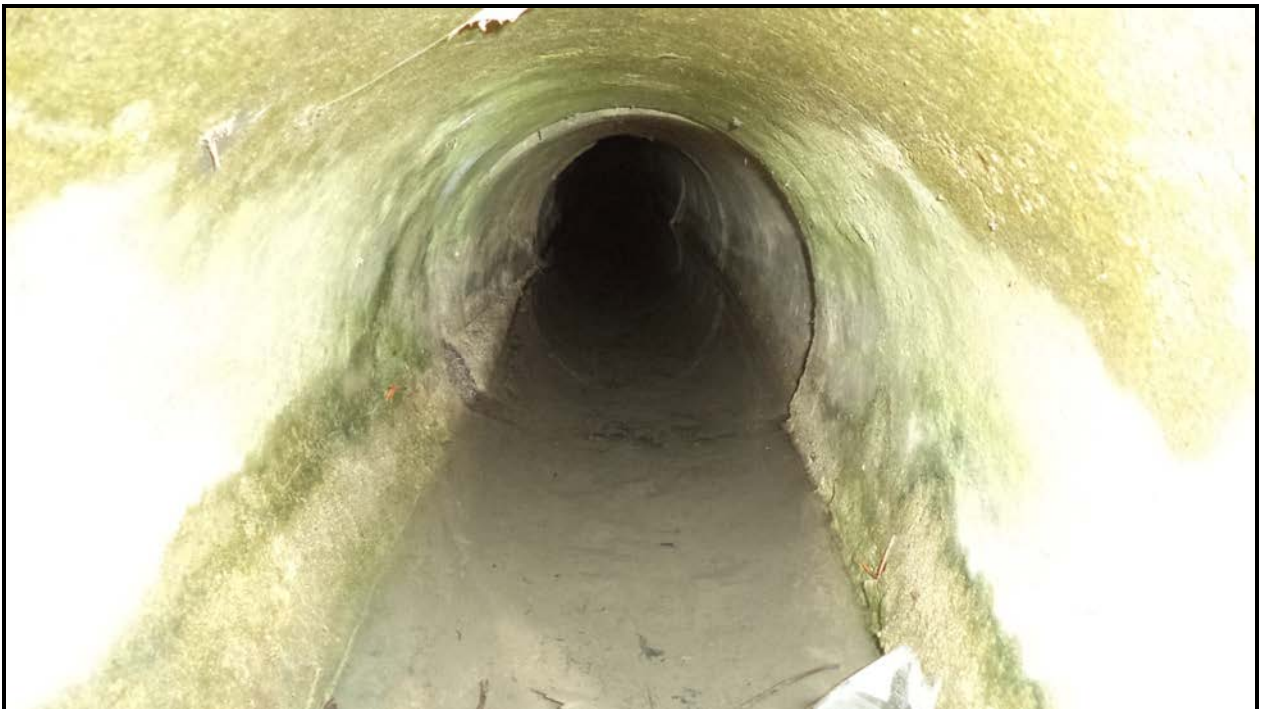
Photograph 2 – Culvert Barrel

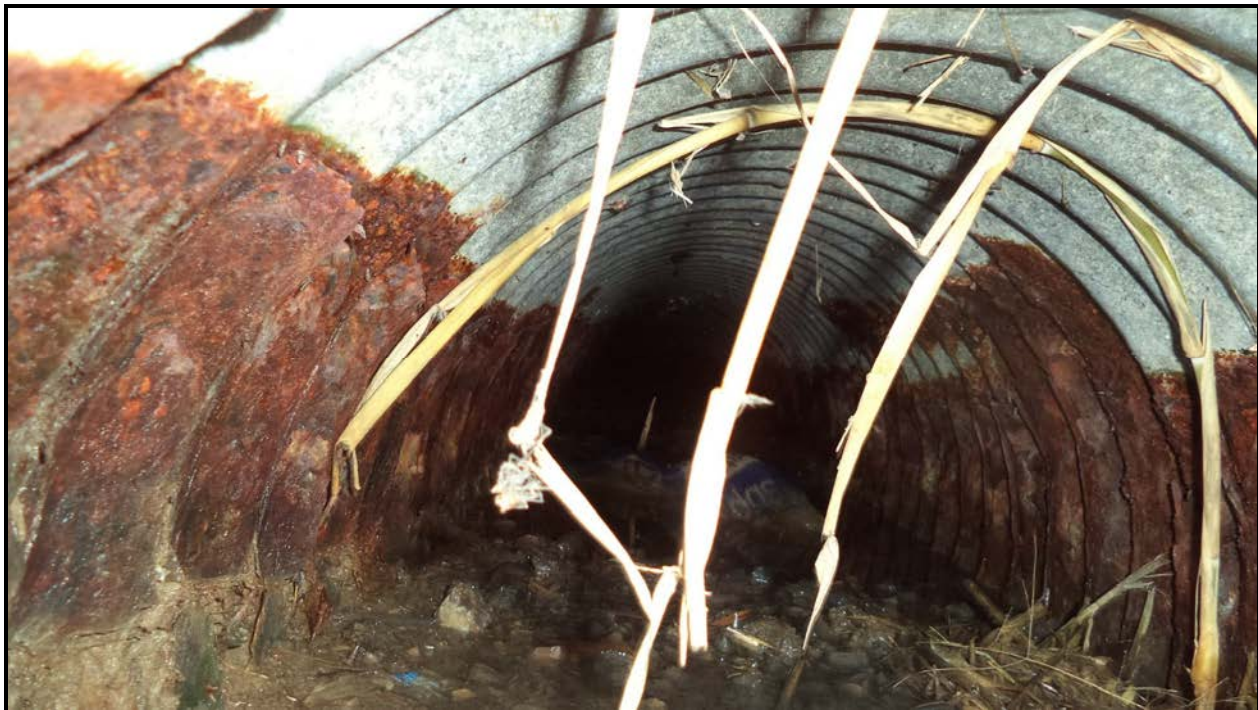
Photograph 2 – Culvert Barrel

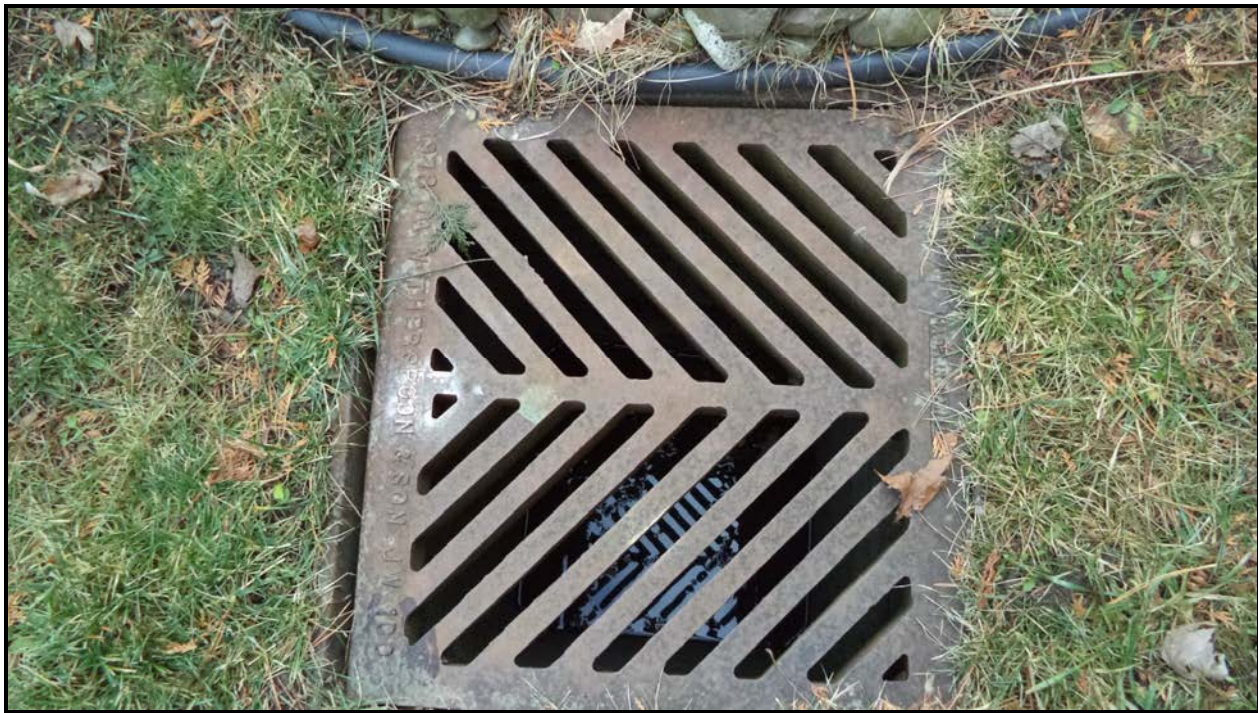
Photograph 2 – Culvert Manhole
