CORPORATE OF THE TOWN OF TECUMSEH
2016 Culvert Needs Study

Structures with Spans $\leq 3.0\text{m}$ – Final Report

Our File: 15-2977

October 28, 2016

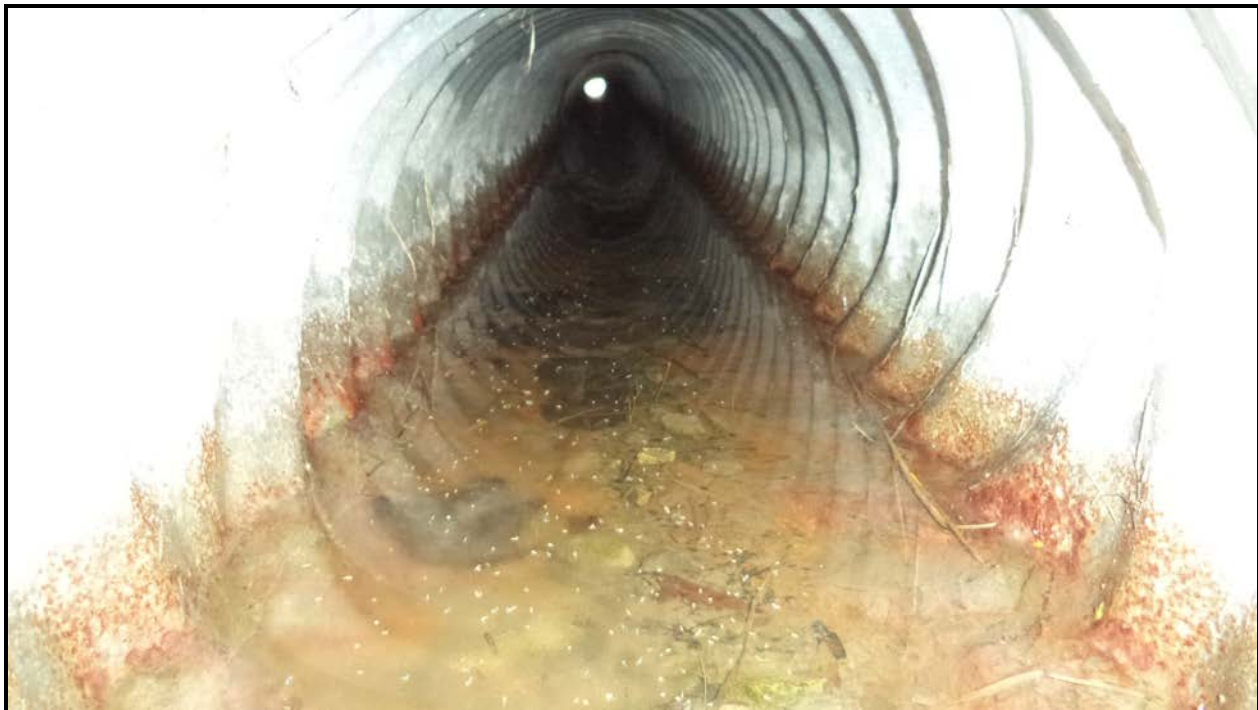
Photograph 2 – Culvert Barrel

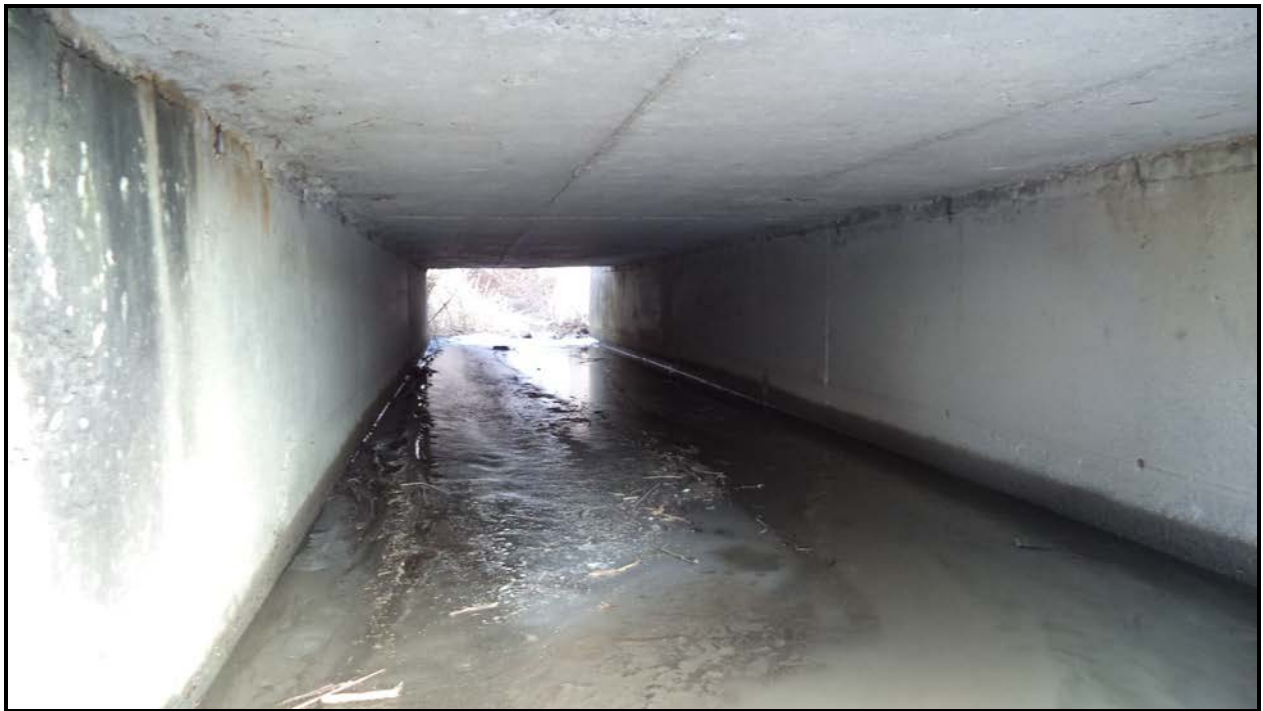
Photograph 2 – Culvert Barrel

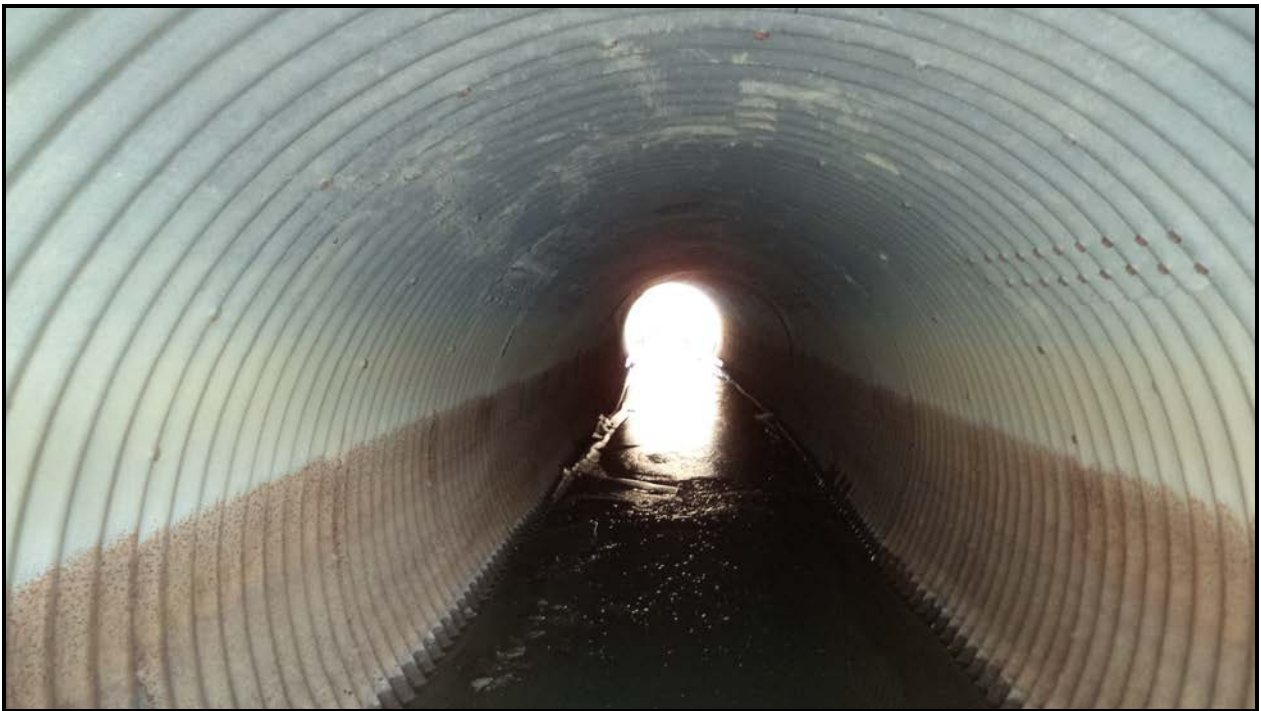
Photograph 2 – Culvert Barrel

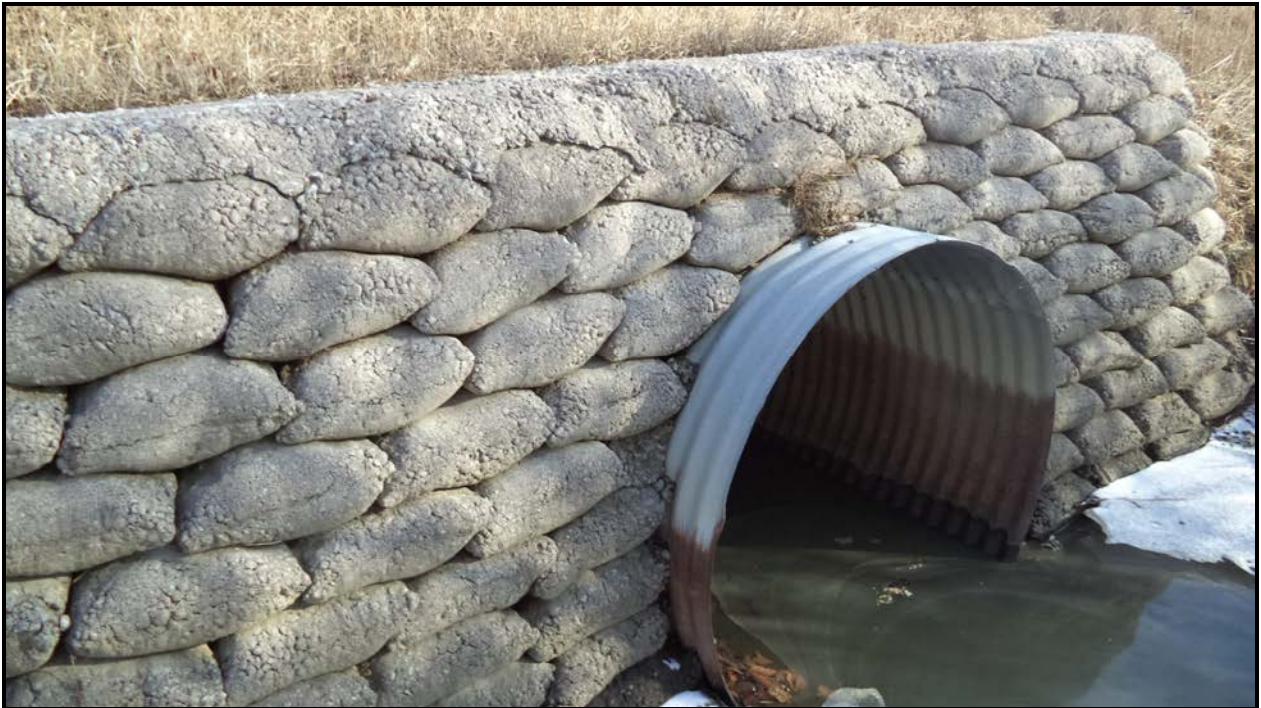
Photograph 3 – North Elevation

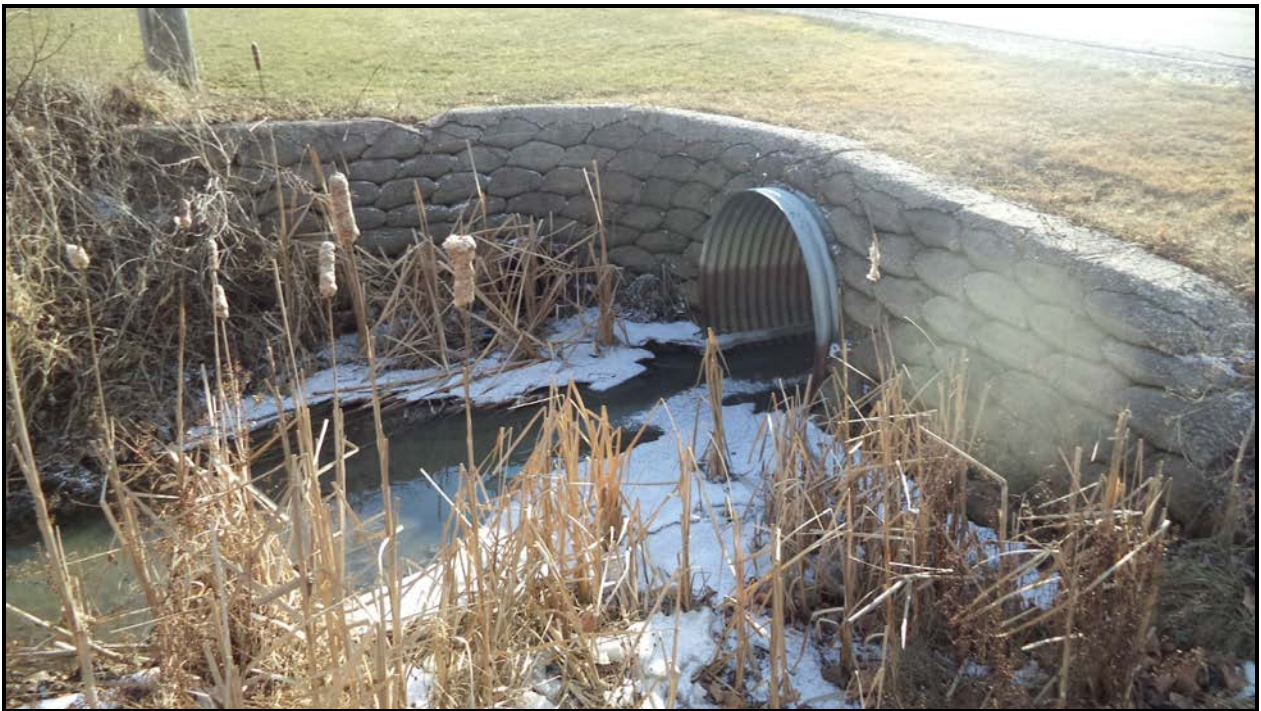
Photograph 4 – South Elevation

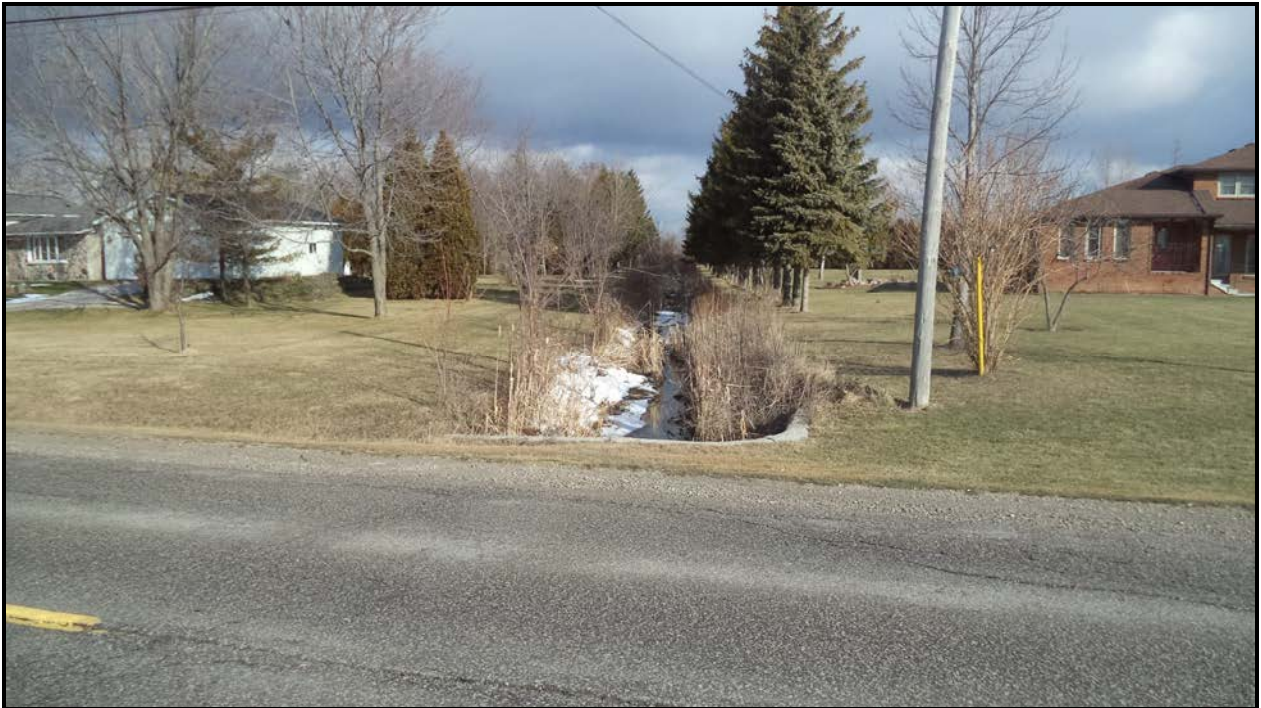
Photograph 7 – Water Stream (North Talbot Road North Side - Looking North)

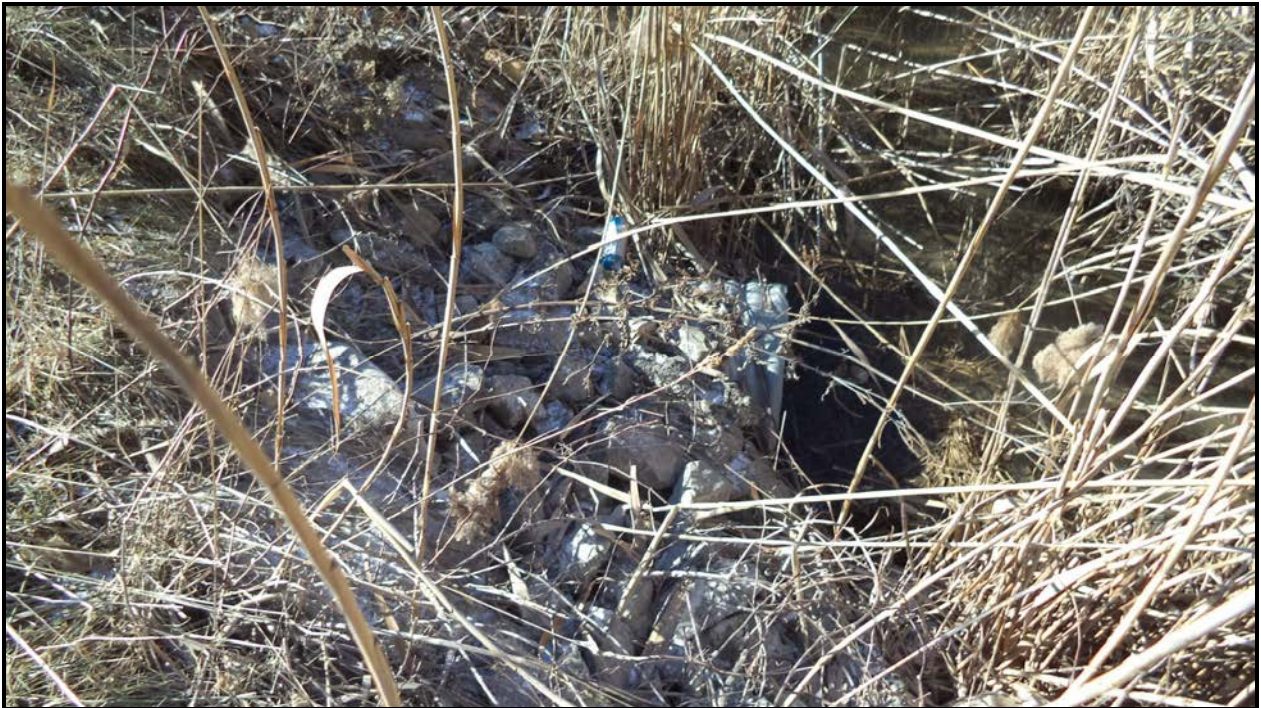
Photograph 3 – North Elevation

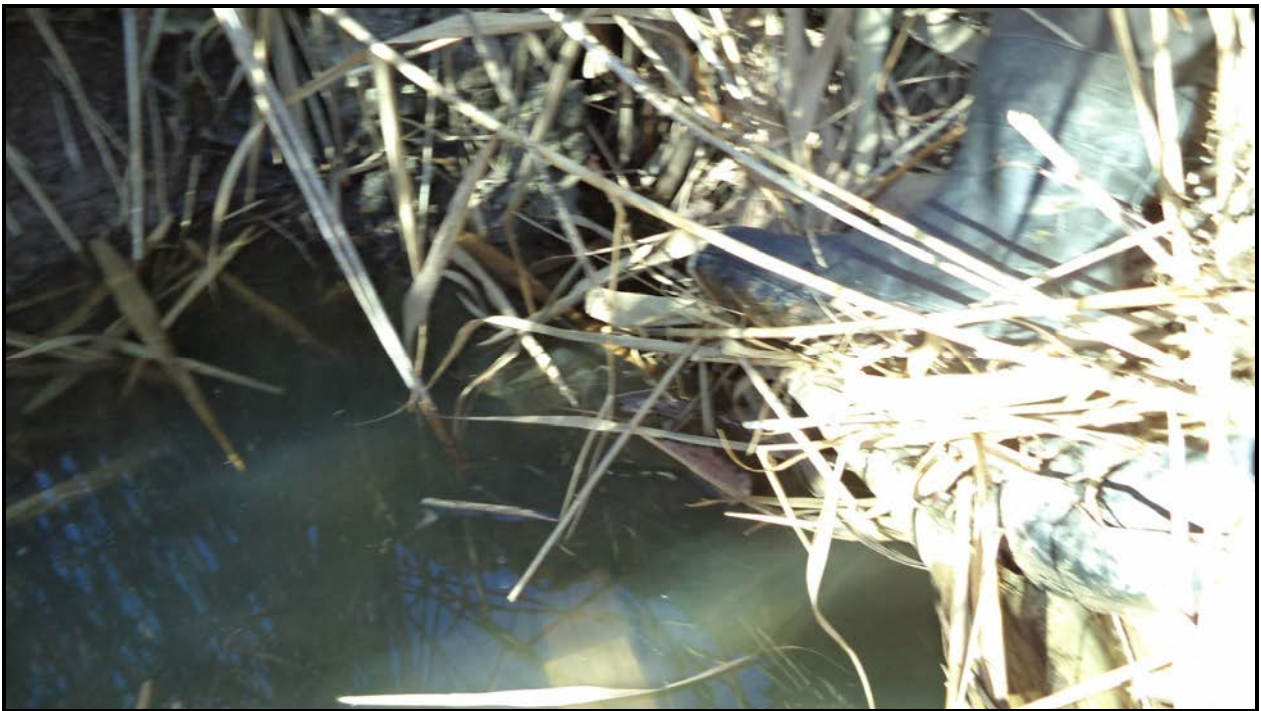
Photograph 4 – South Elevation

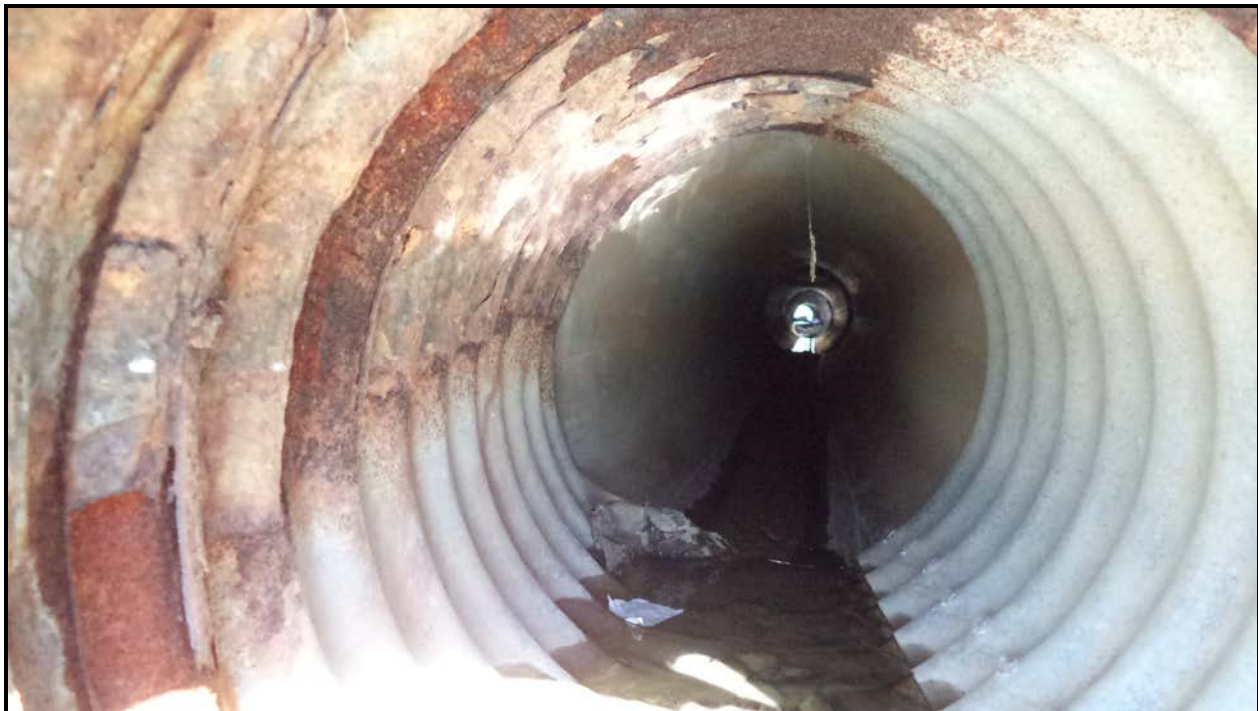
Photograph 2 – Culvert Barrel

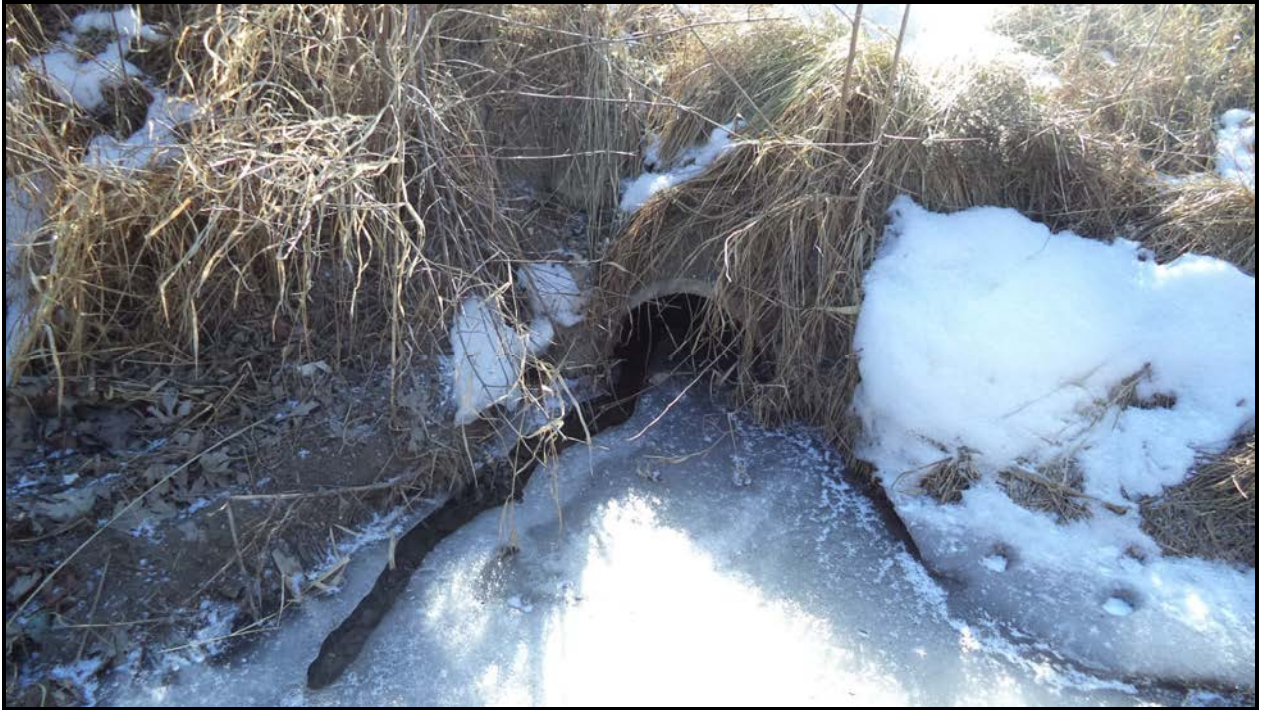
Photograph 3 – North Elevation

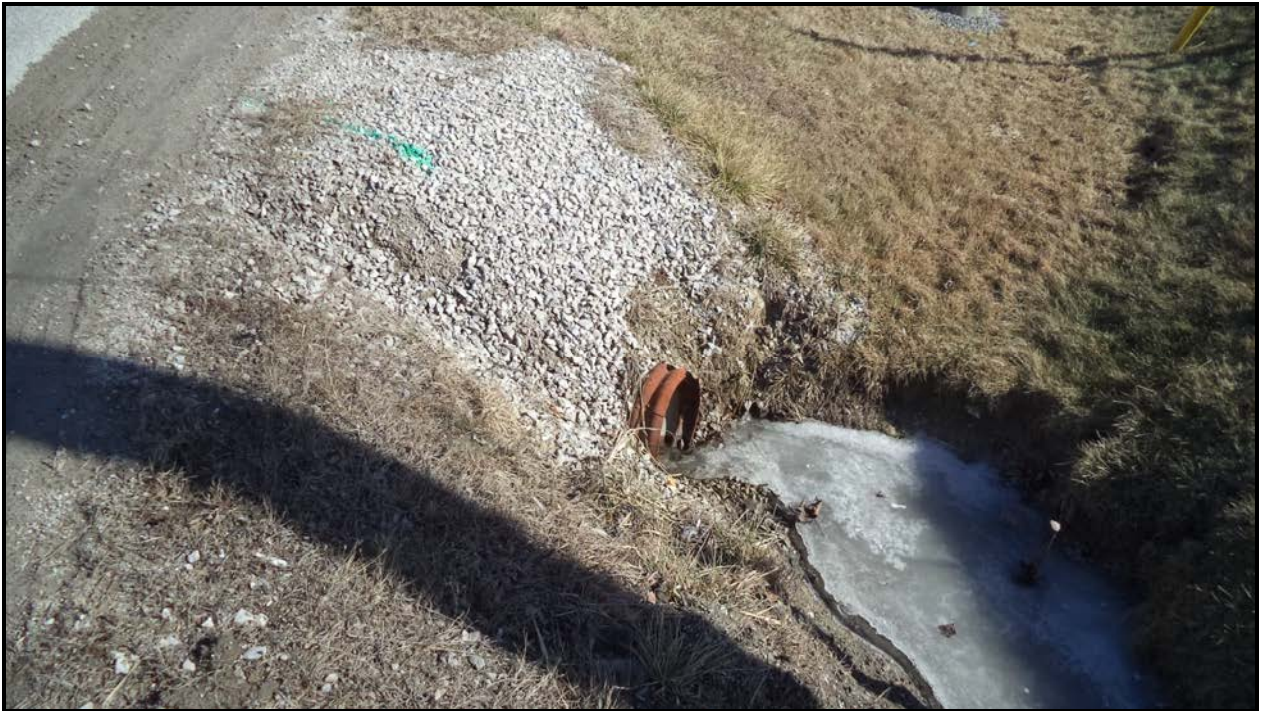
Photograph 4 – South Elevation

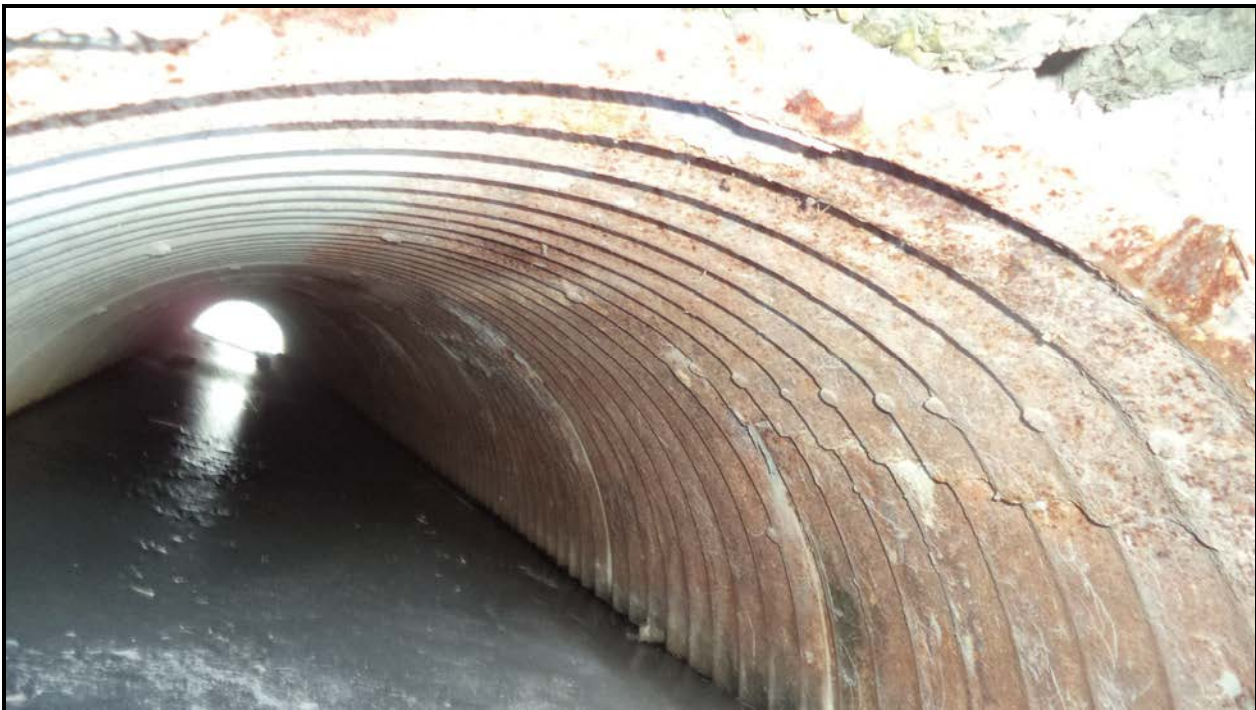
Photograph 2 – Culvert Barrel

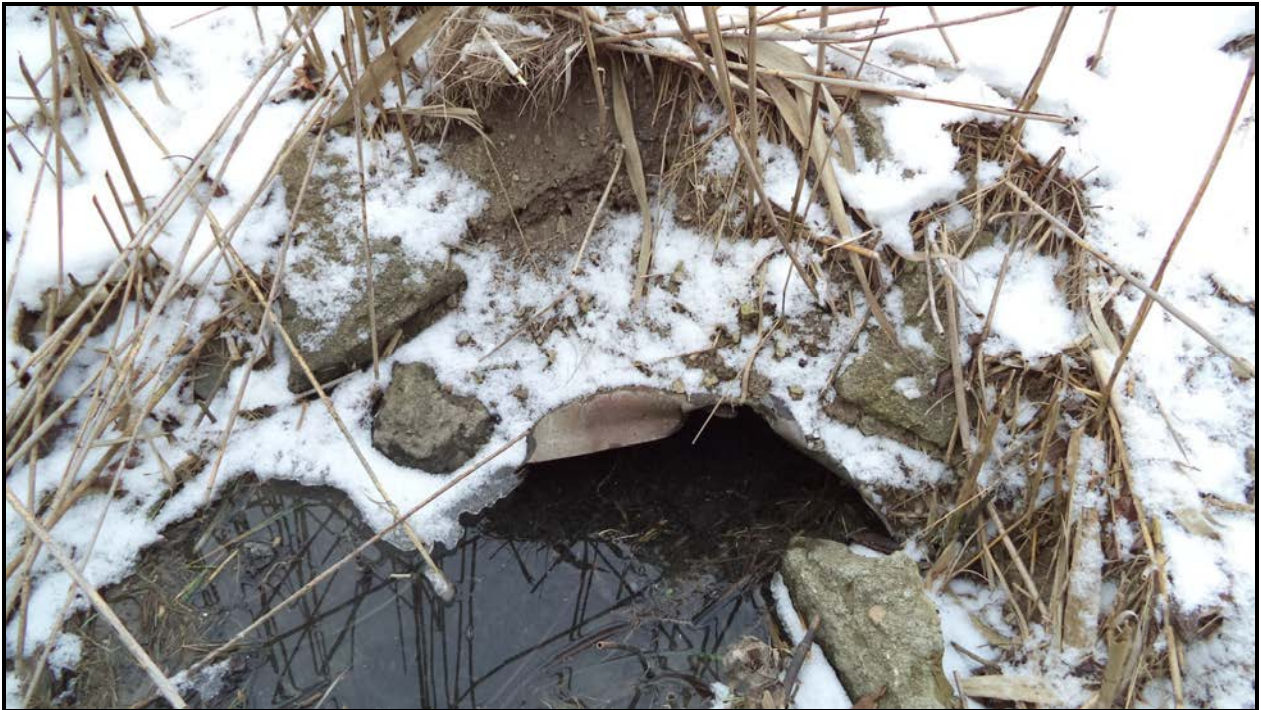
Photograph 3 – East Inlet

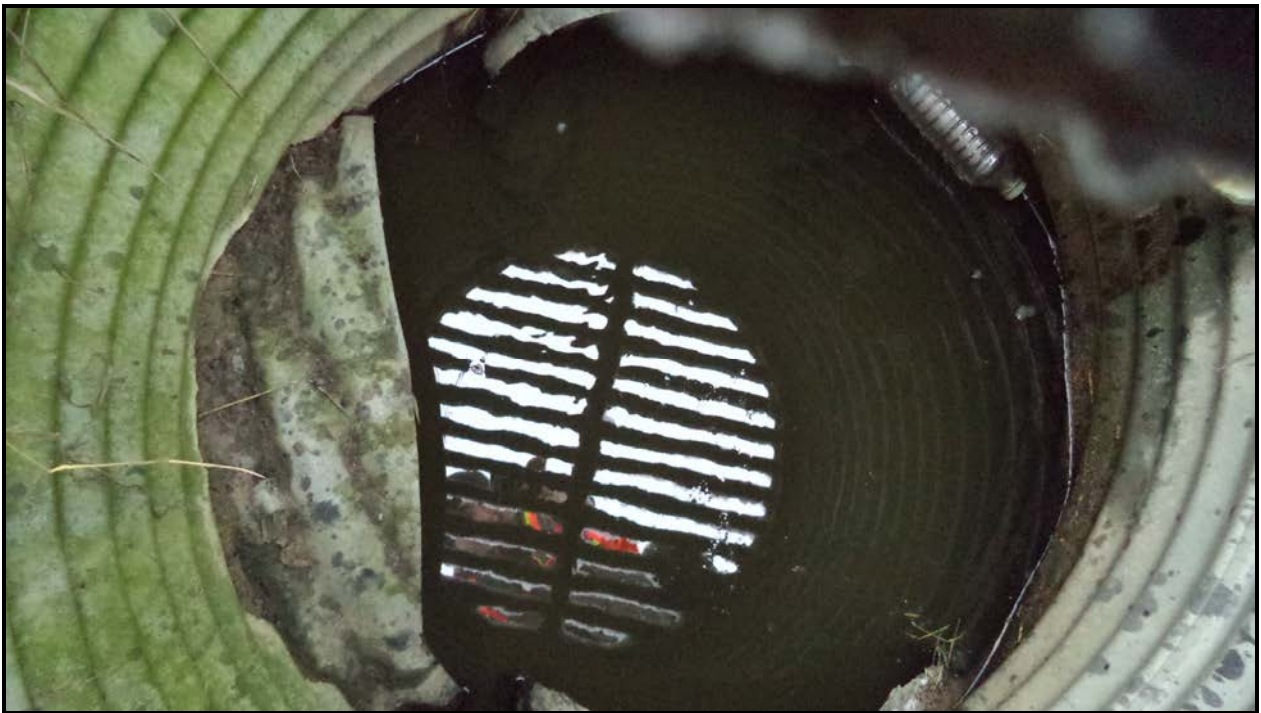
Photograph 4 – West Outlet

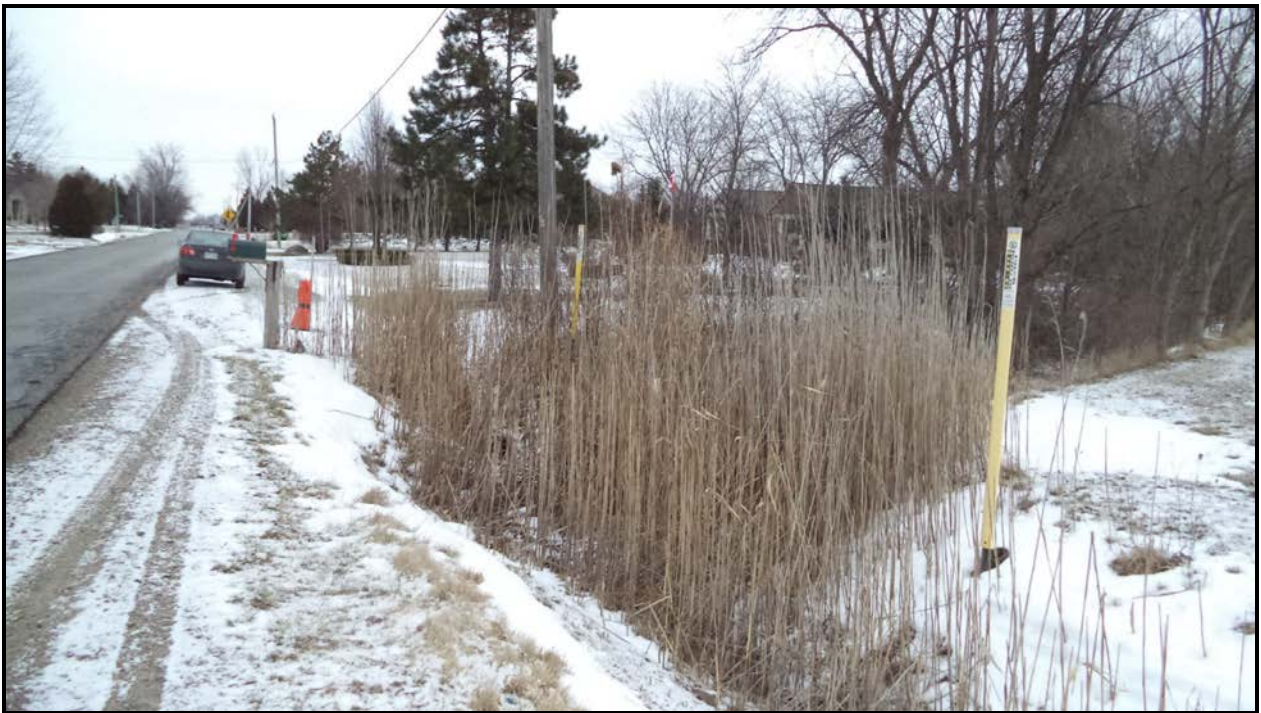
Photograph 6 – Water Stream (Oldcastle Road East Side - Looking North)

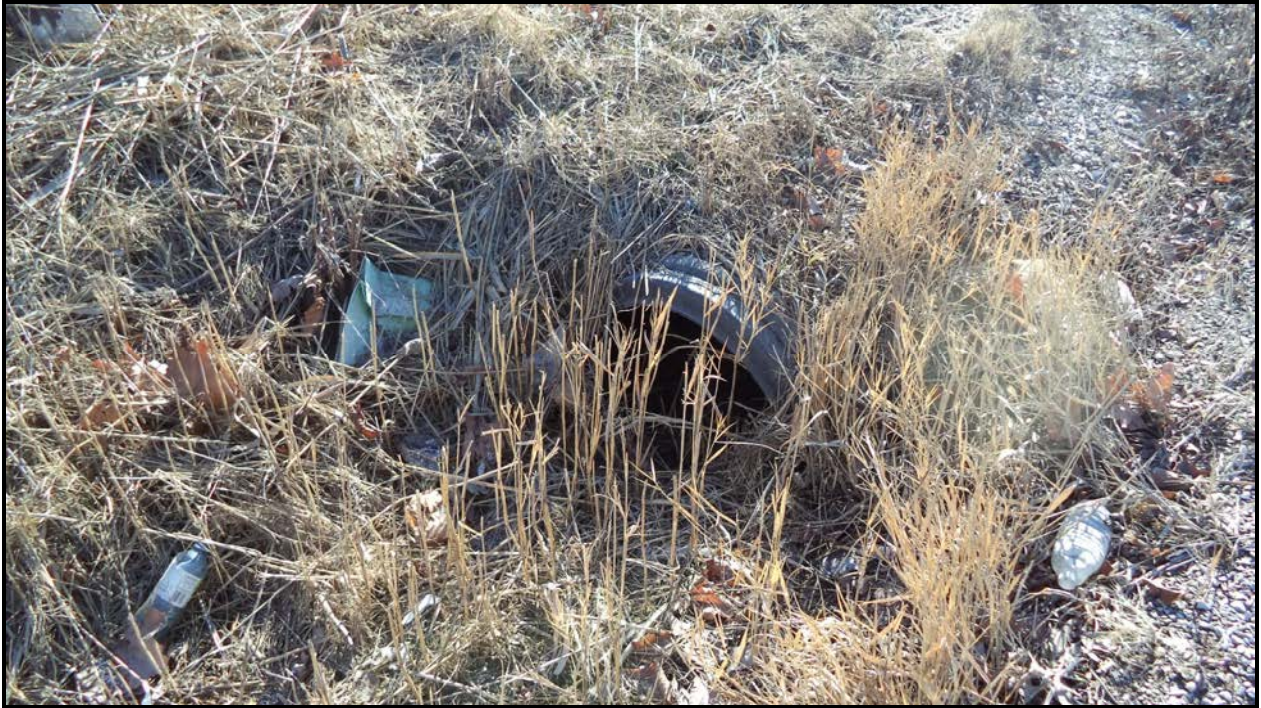
Photograph 3 – North Elevation

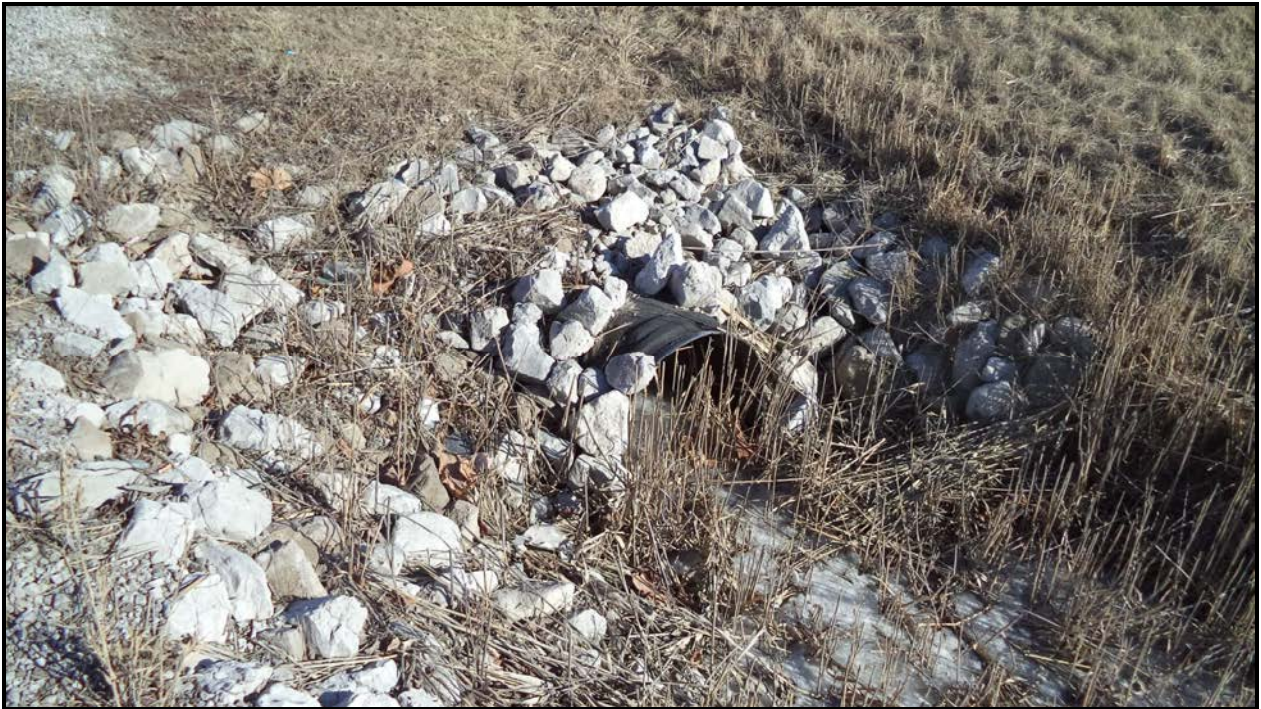
Photograph 4 – South Elevation

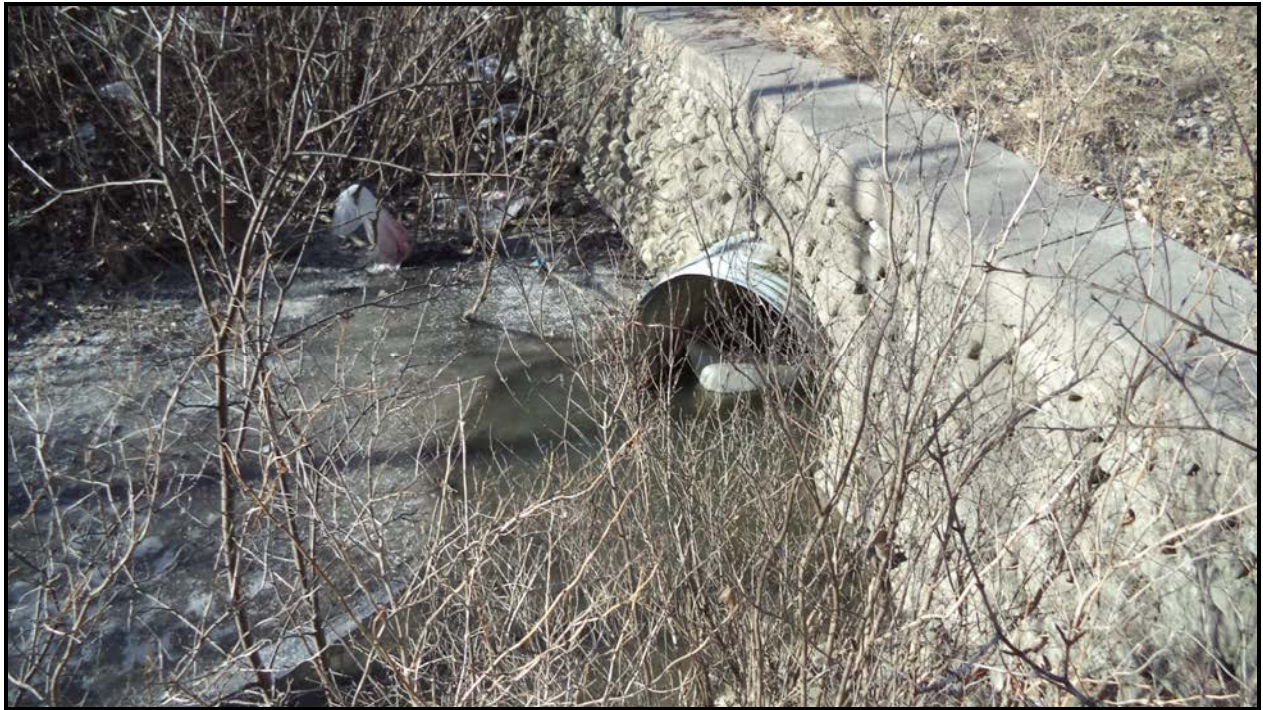
Photograph 3 – East Elevation

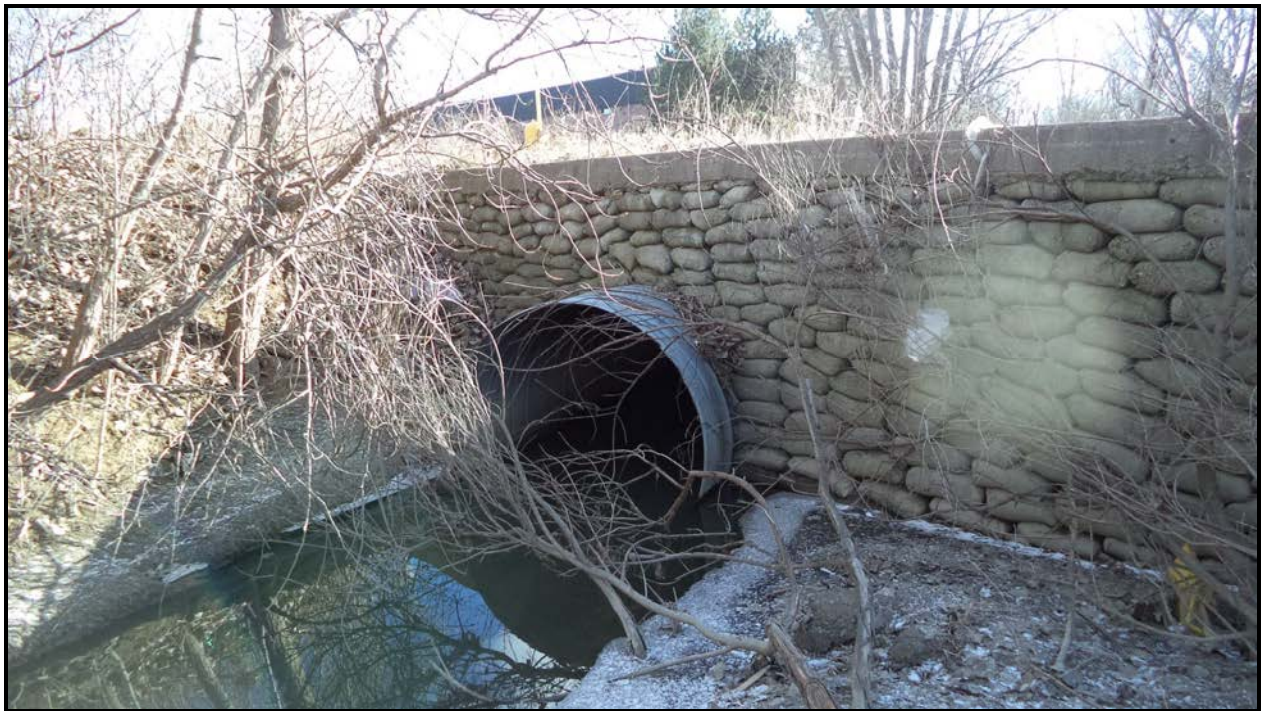
Photograph 4 – West Elevation

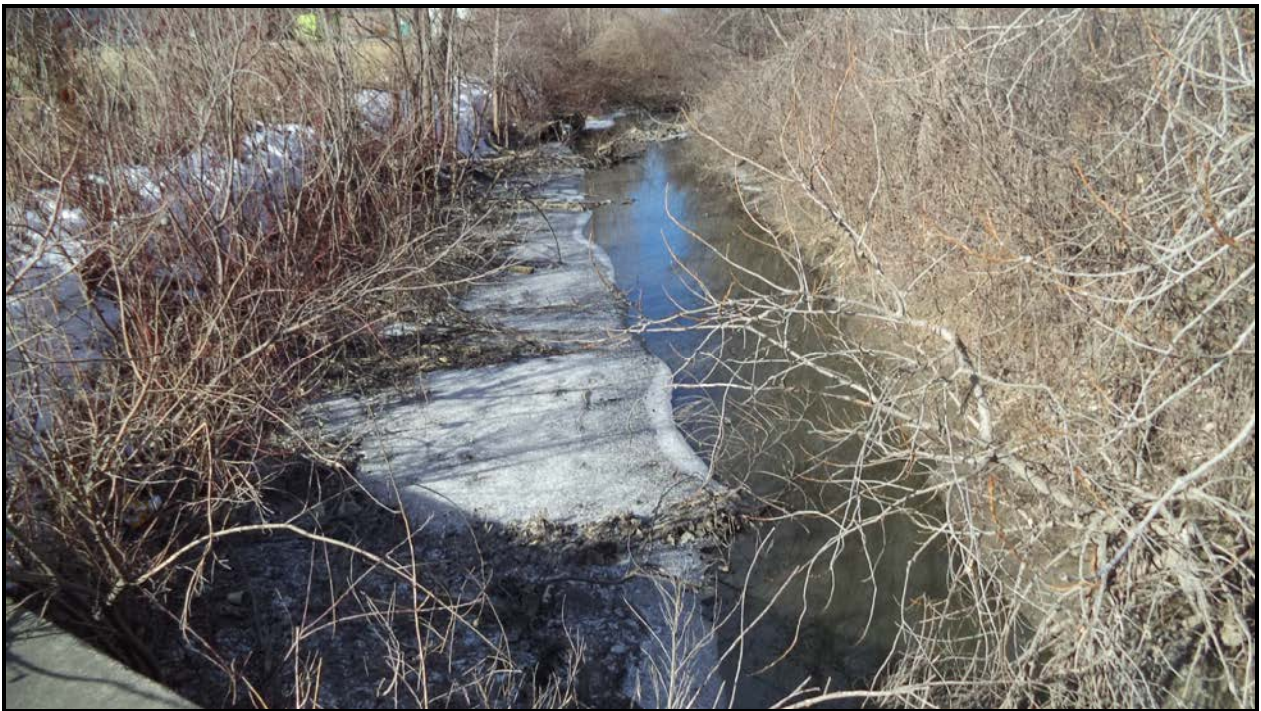
Photograph 8 – Water Stream (Pulleyblank Street West Side - Looking West)

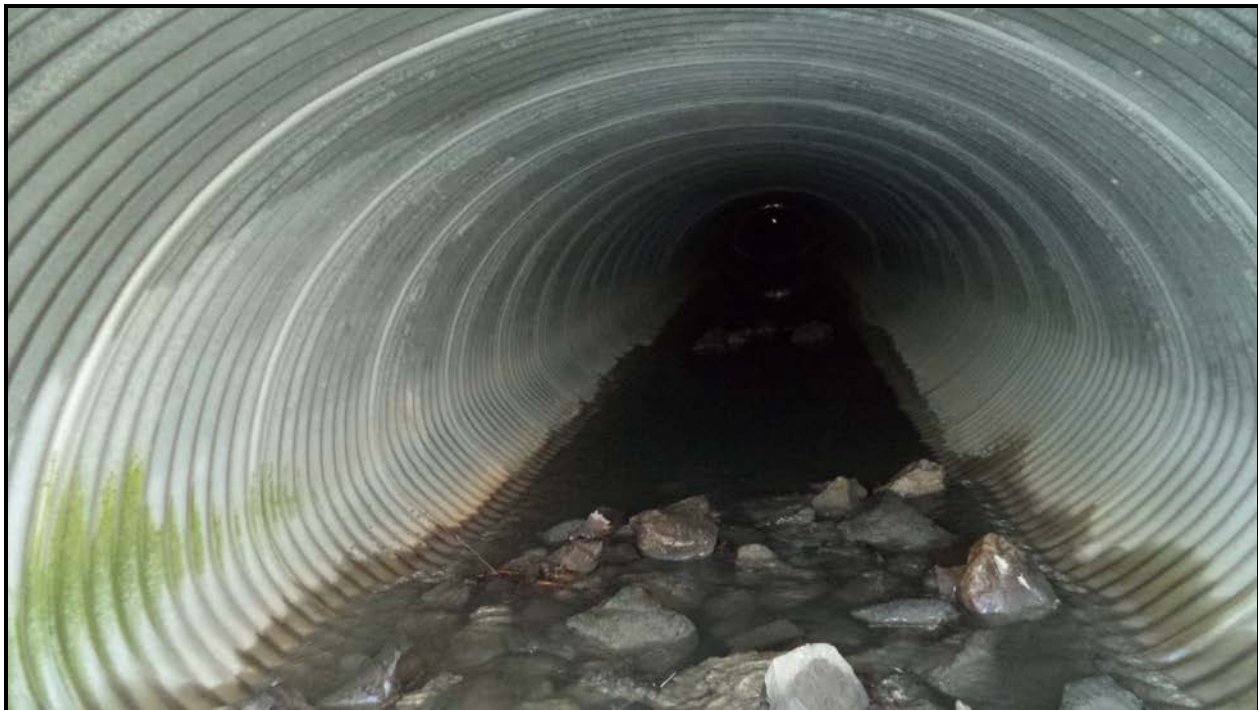
Photograph 2 – Culvert Barrel

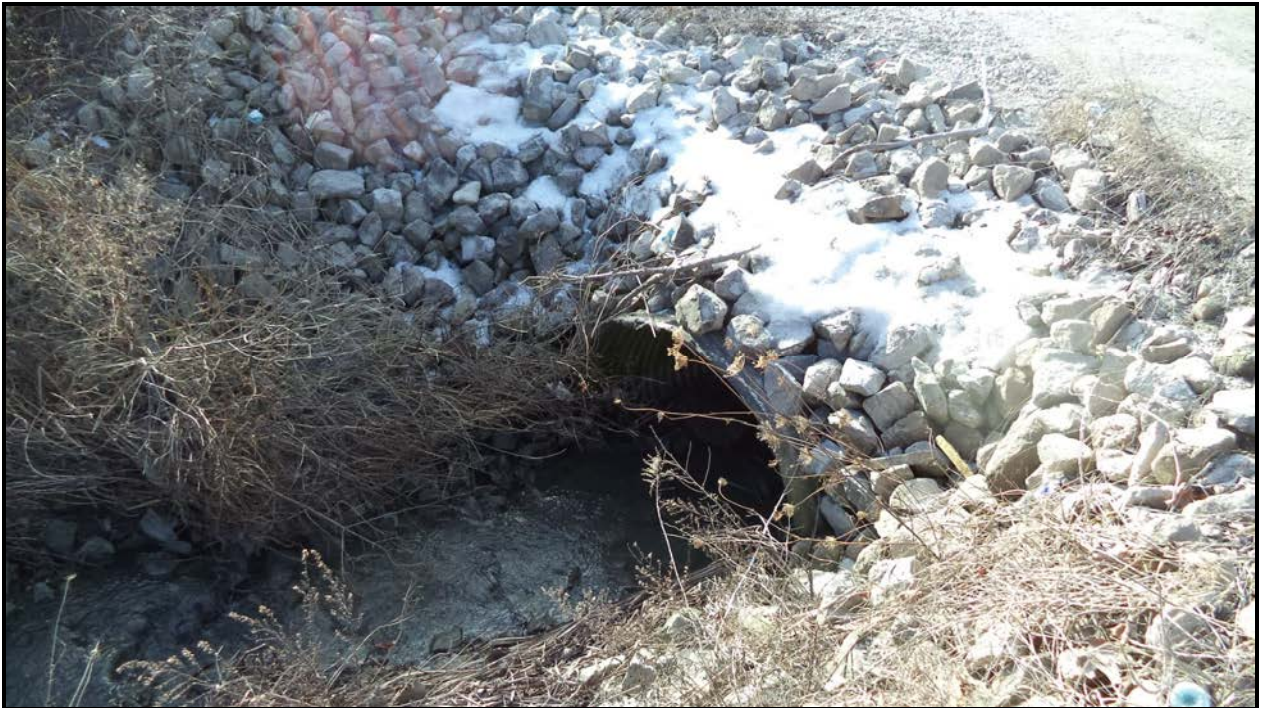
Photograph 3 – North Elevation

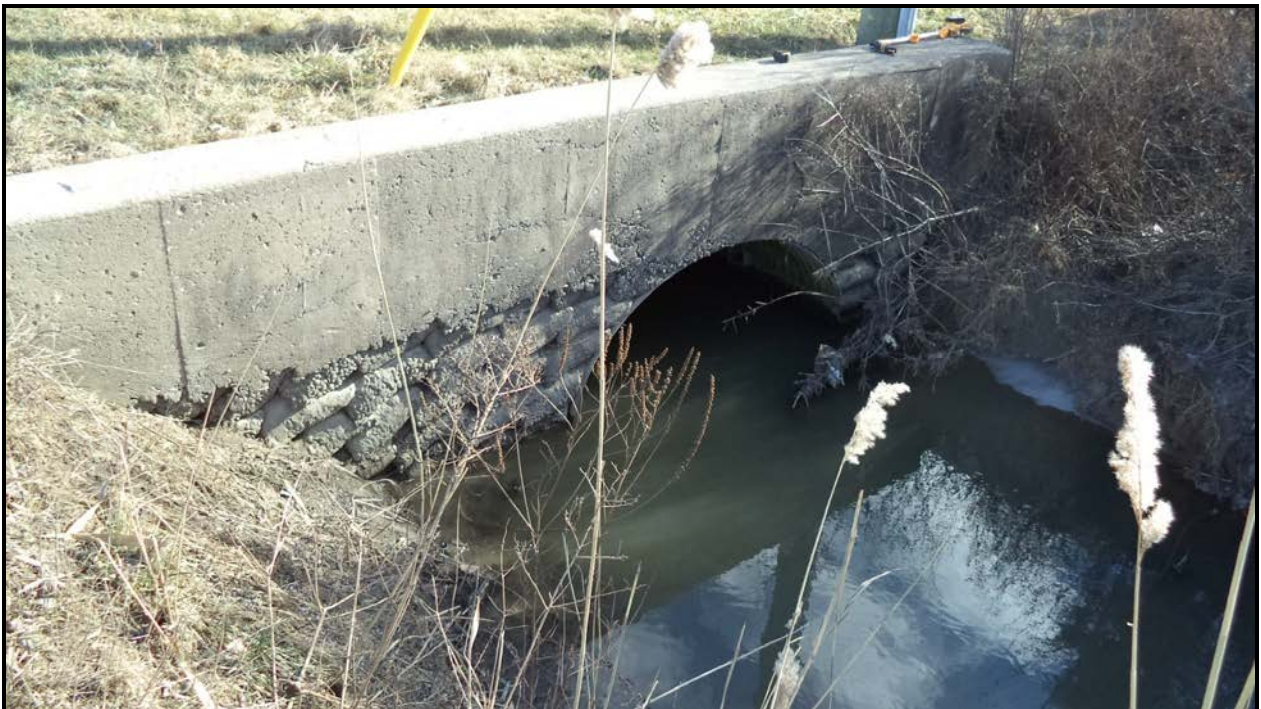
Photograph 4 – South Elevation

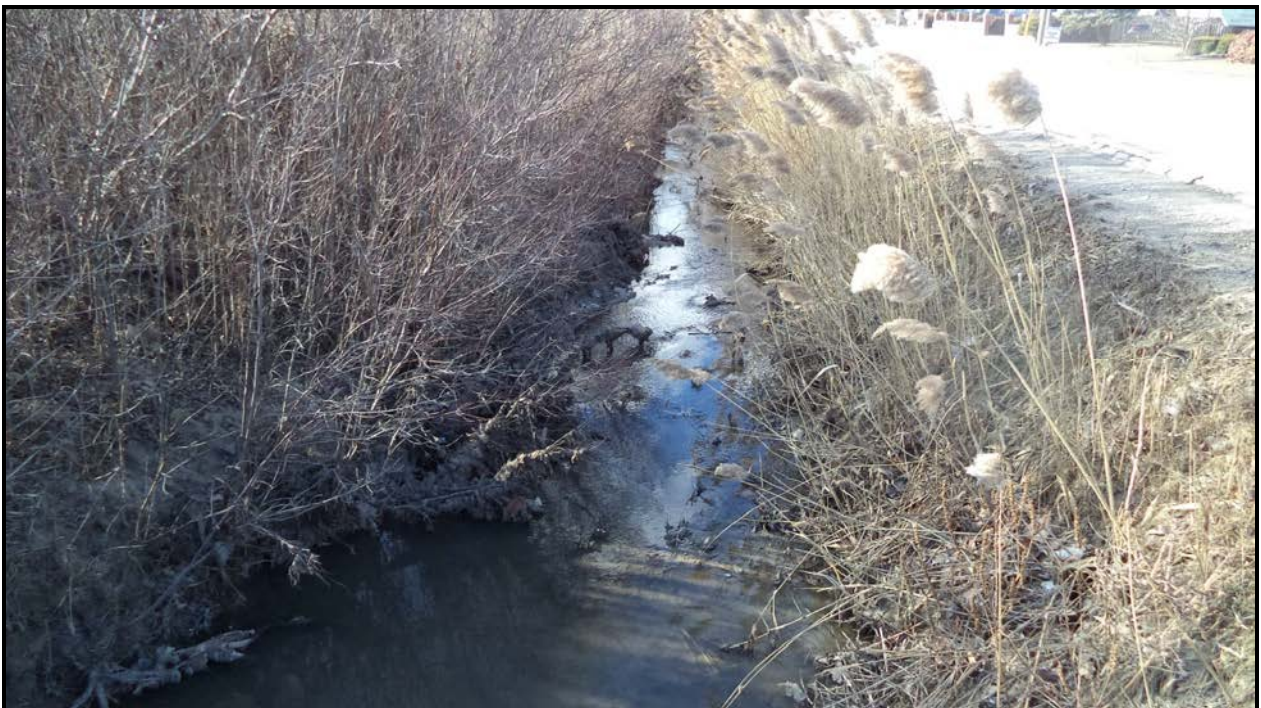
Photograph 6 – Water Stream (Blackacre Drive South Side - Looking South)

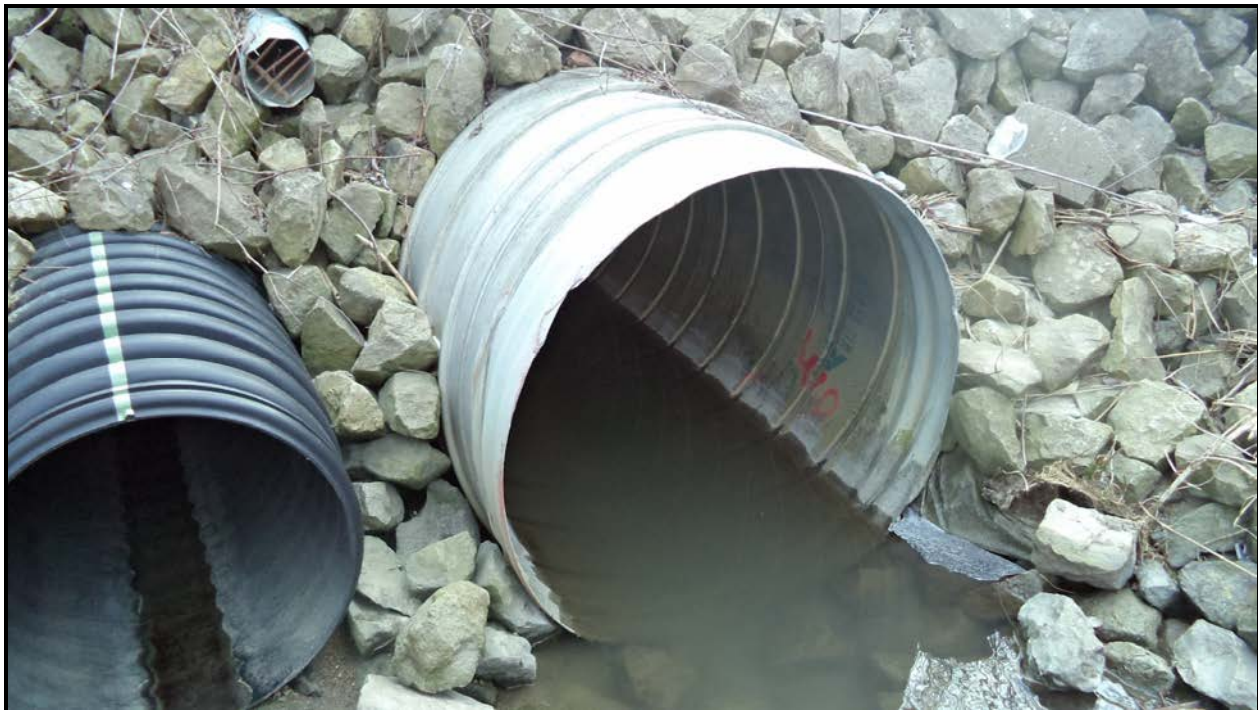
Photograph 2 – Culvert Barrel
