CORPORATE OF THE TOWN OF TECUMSEH
2016 Culvert Needs Study

Structures with Spans $\leq 3.0\text{m}$ – Final Report

Our File: 15-2977

October 28, 2016

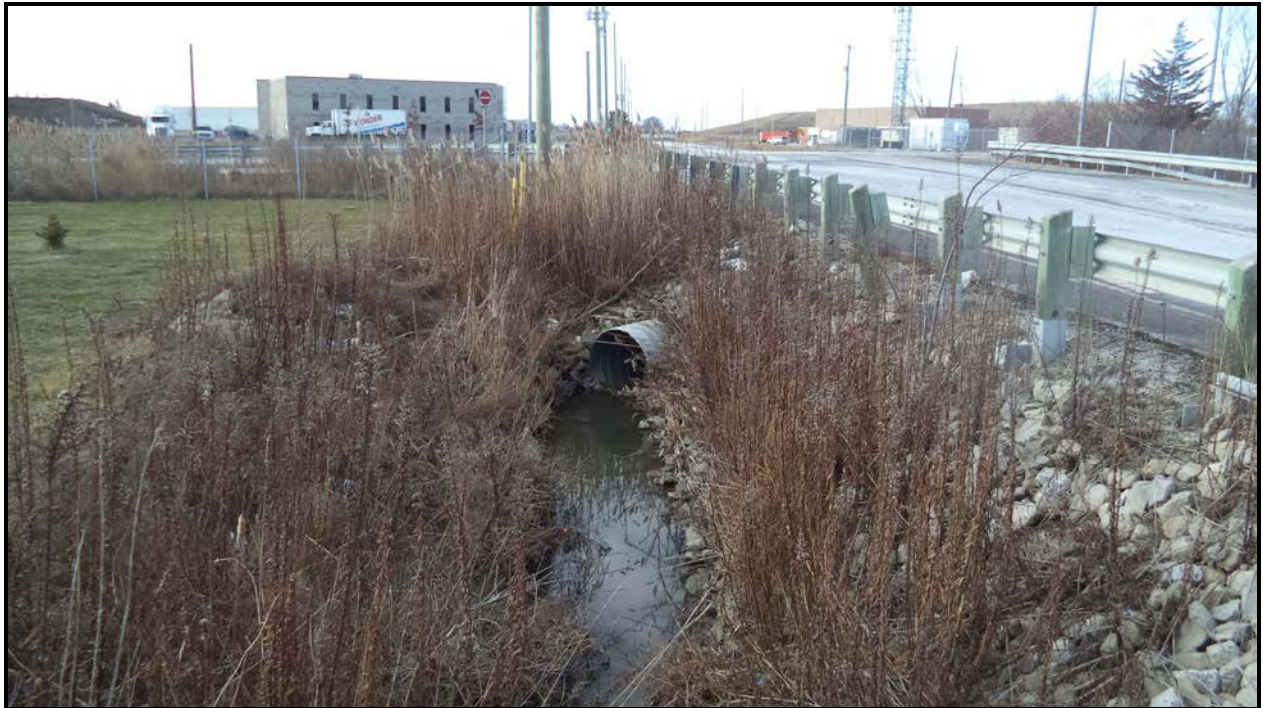
Photograph 3 – East Elevation

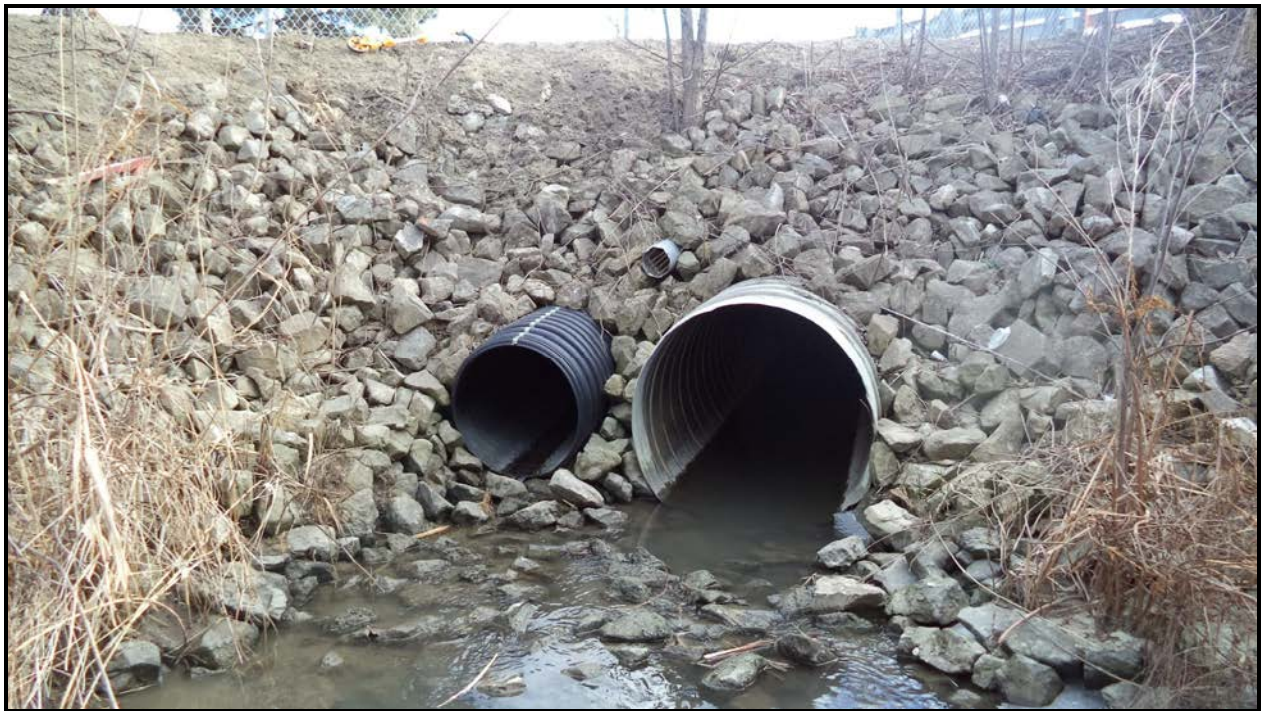
Photograph 4 – West Elevation

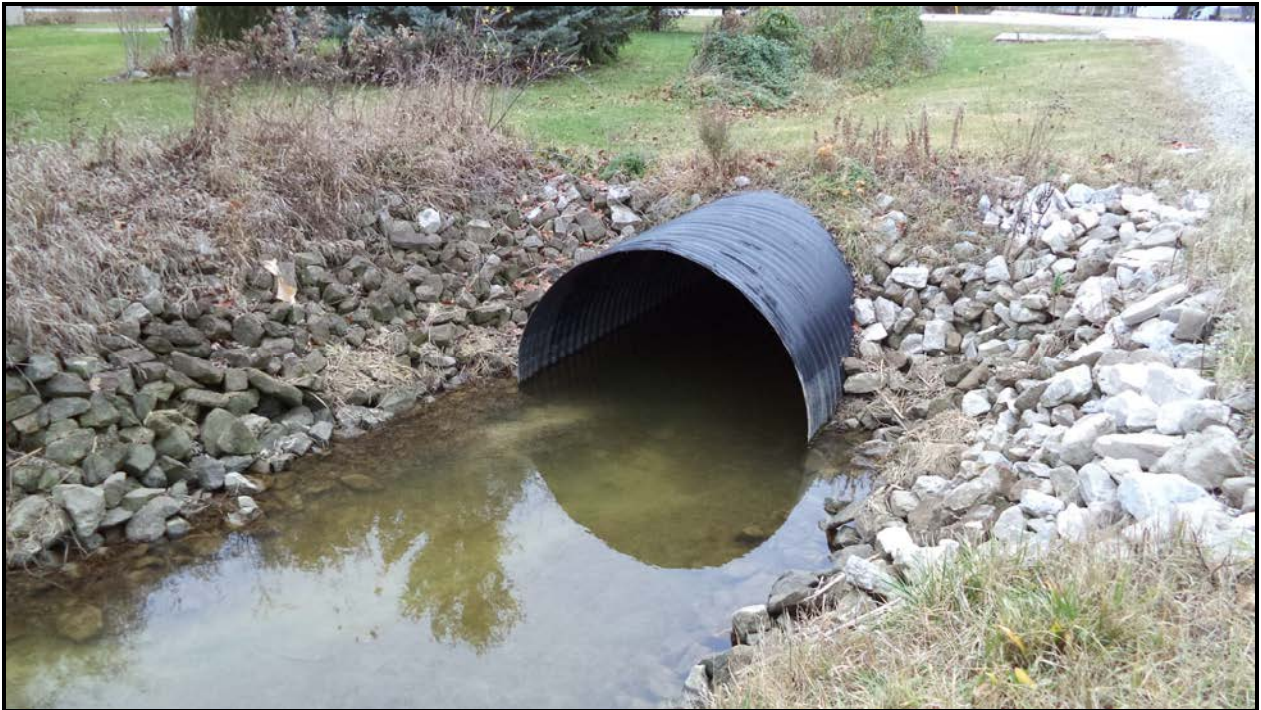
Photograph 3 – East Elevation

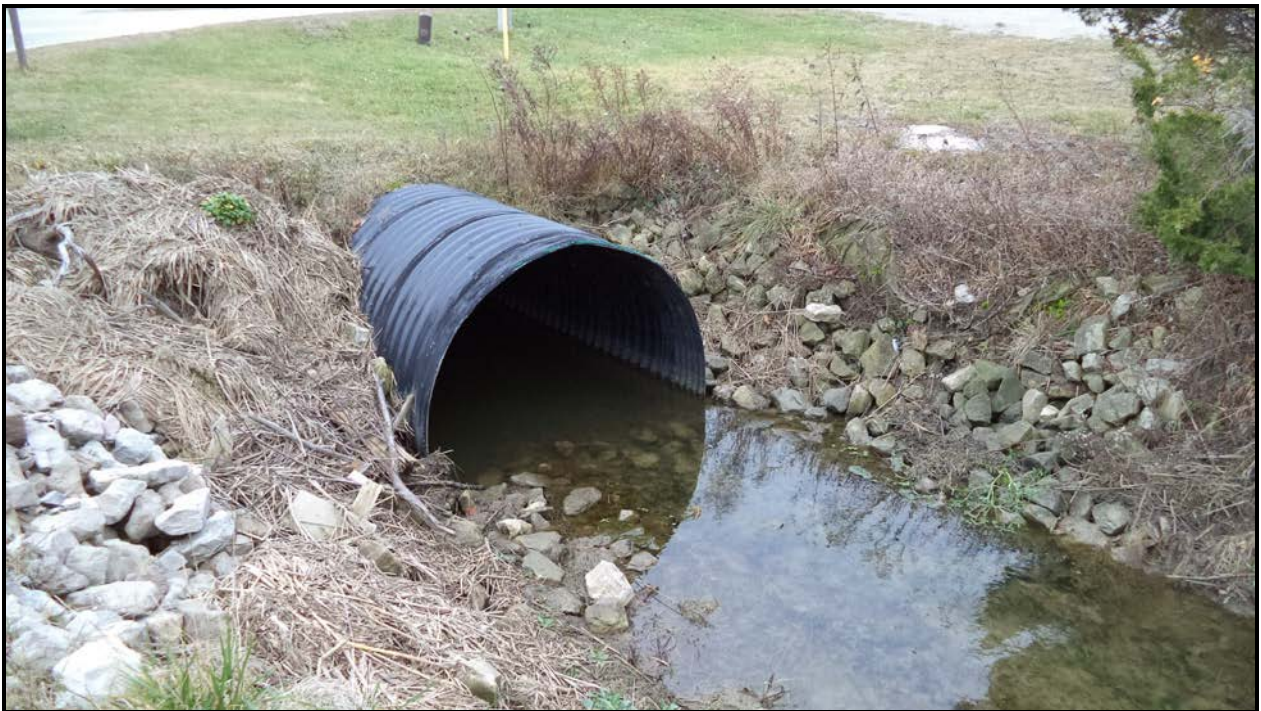
Photograph 4 – West Elevation

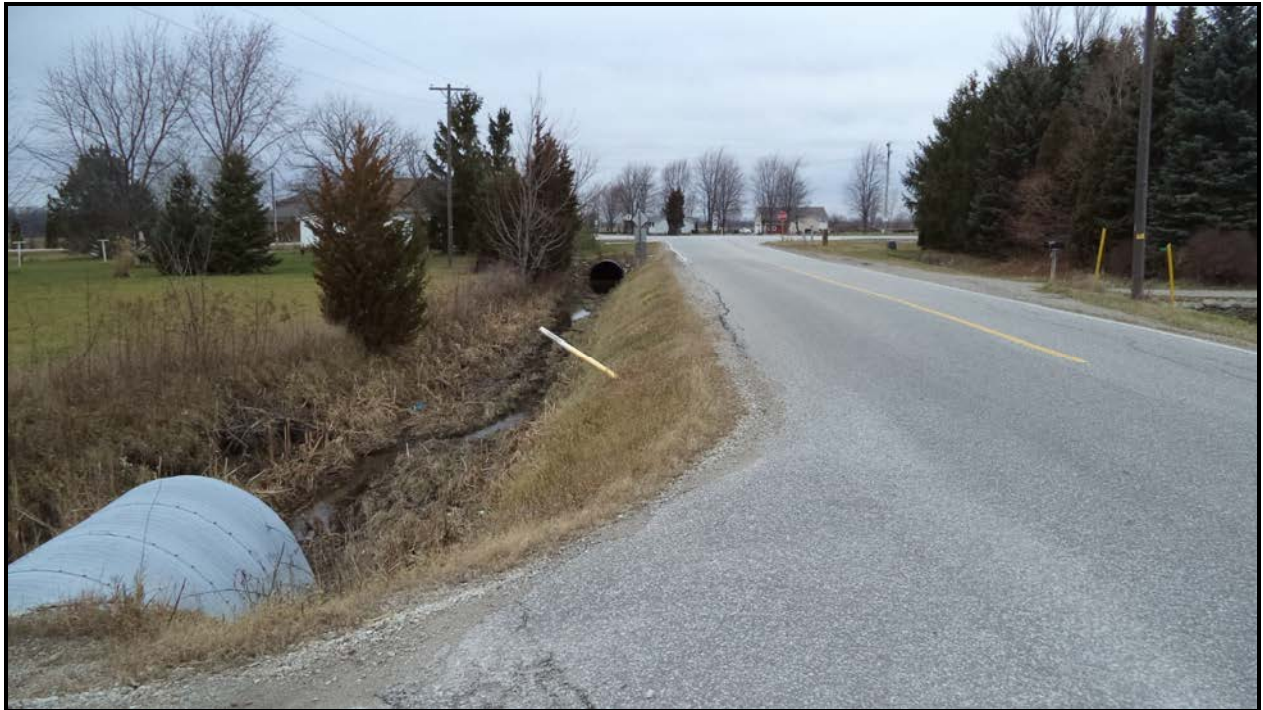
Photograph 9 – Water Stream (Malden Road West Side – Looking West)

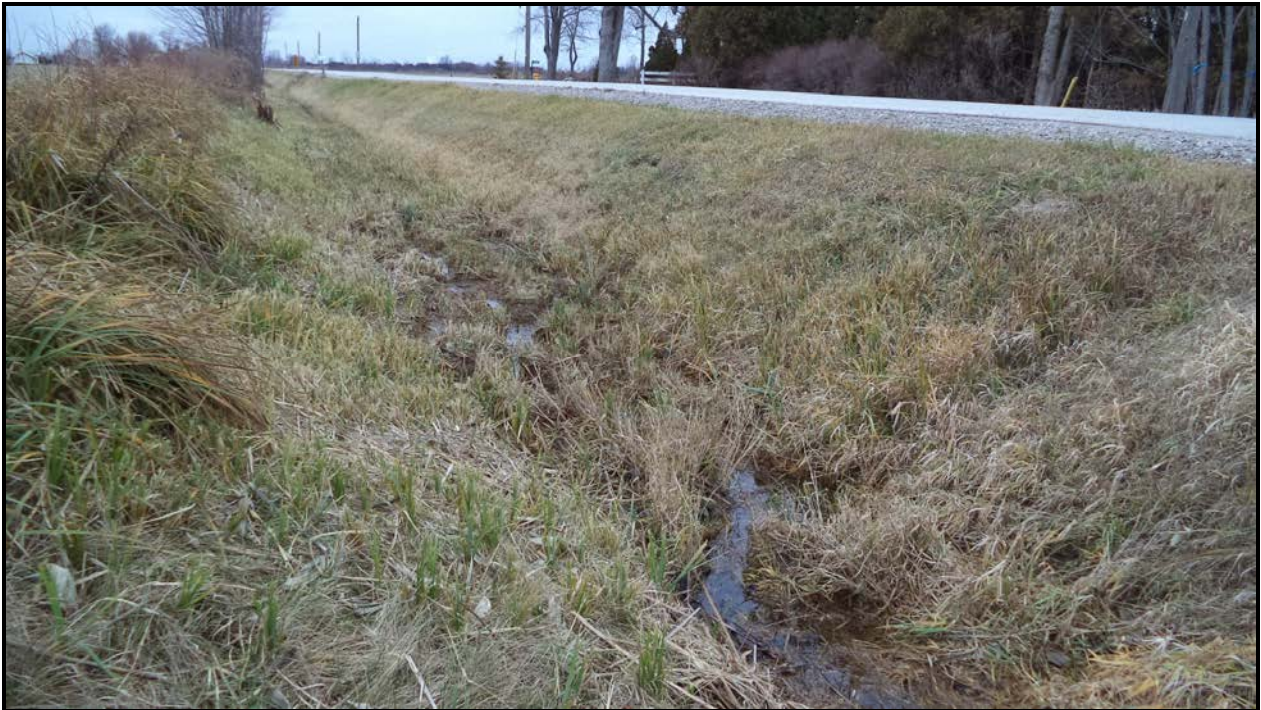
Photograph 7 – Water Stream (Concession Road 10 West Side – Looking West)

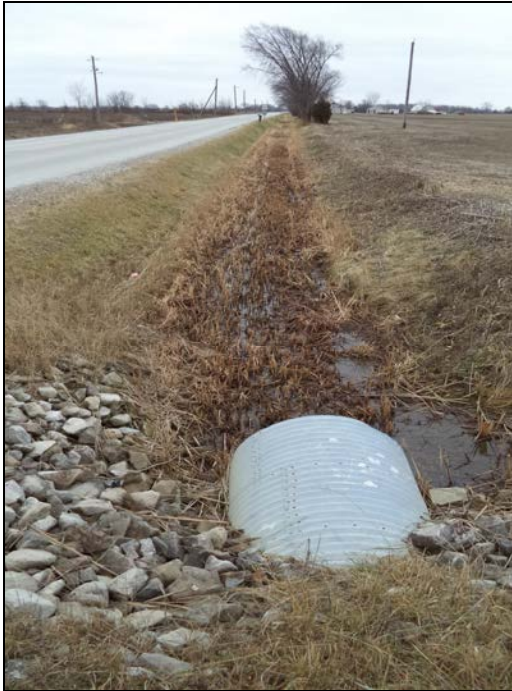
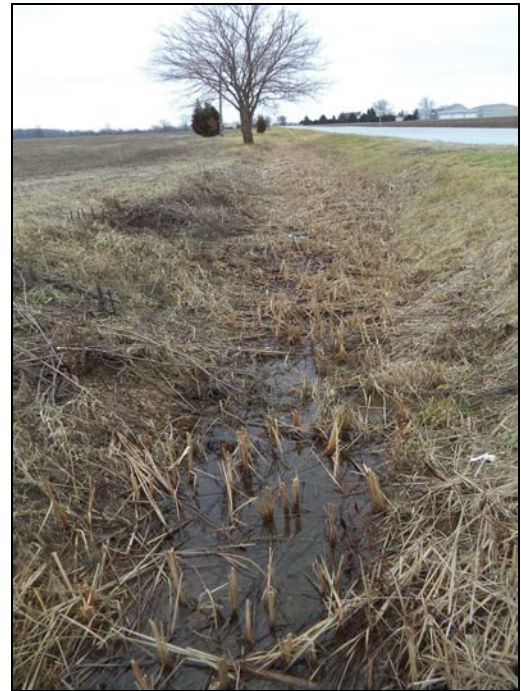
Photograph 7 – Water Stream (Concession Road 9 East Side – Looking East / South)

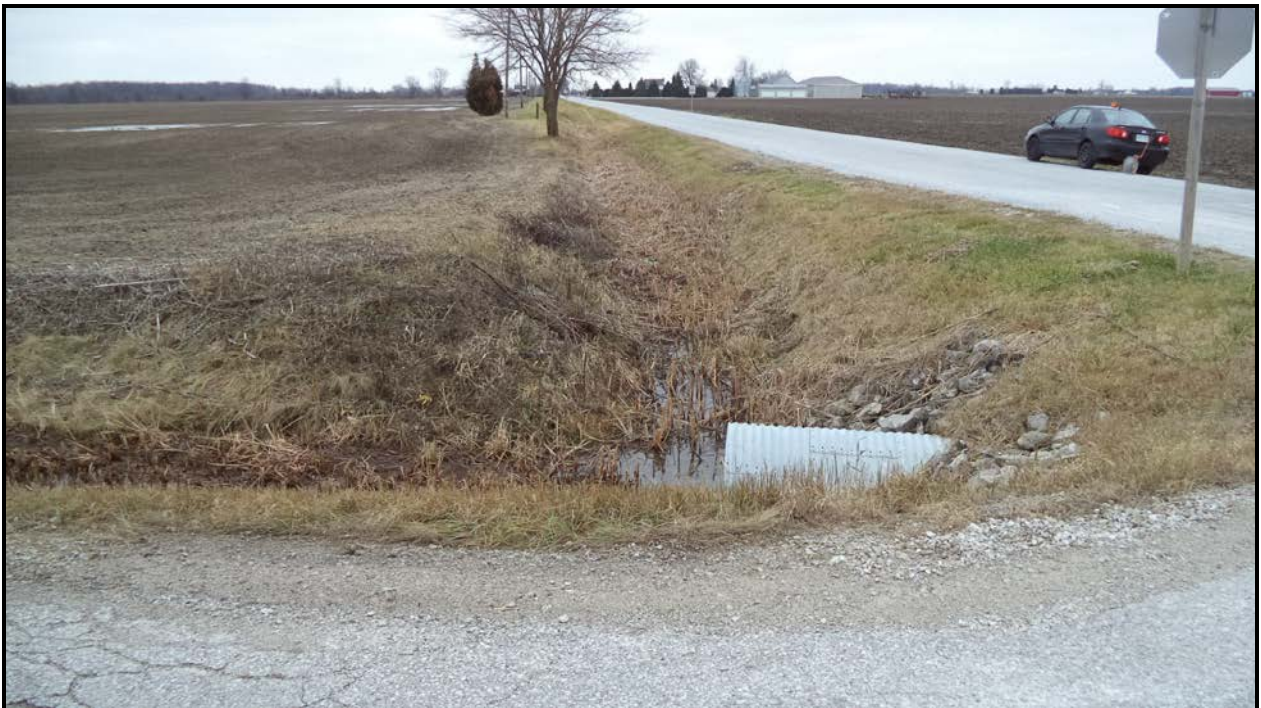
Photograph 8 – Water Stream (Concession Road 9 West Side – Looking West)

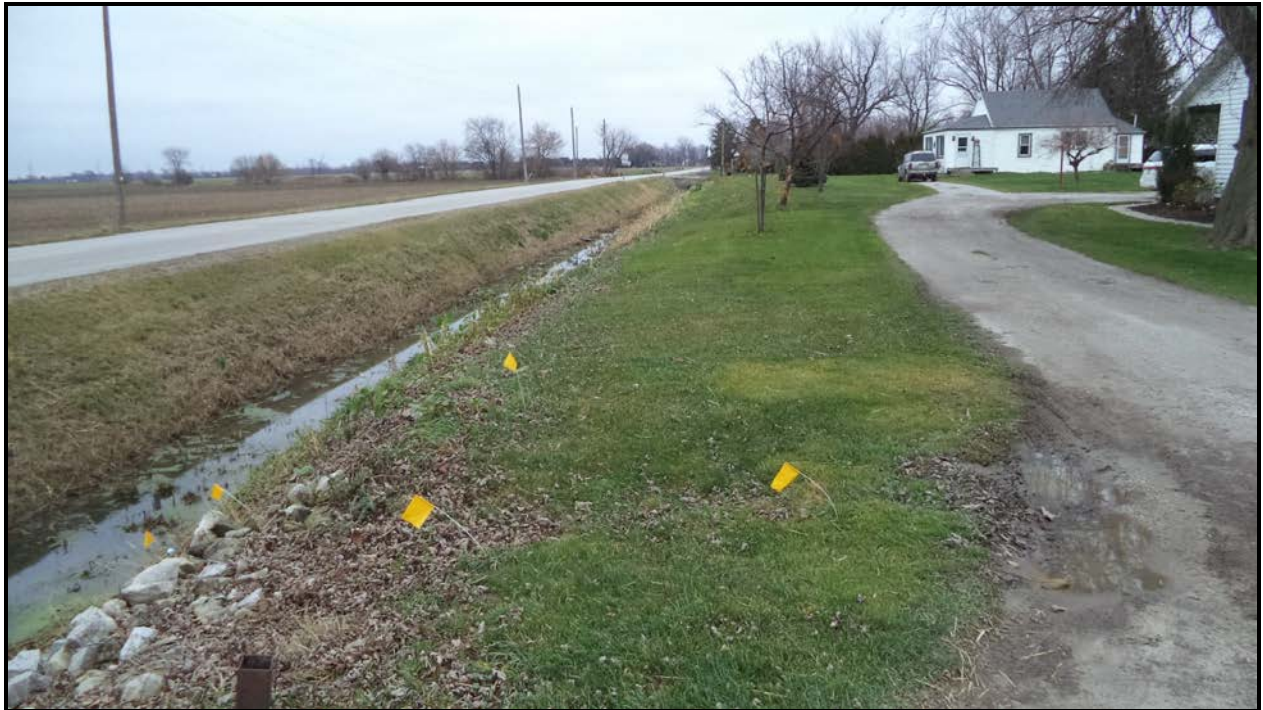
Photograph 11 – Water Stream (South Talbot Road South Side - Looking East)

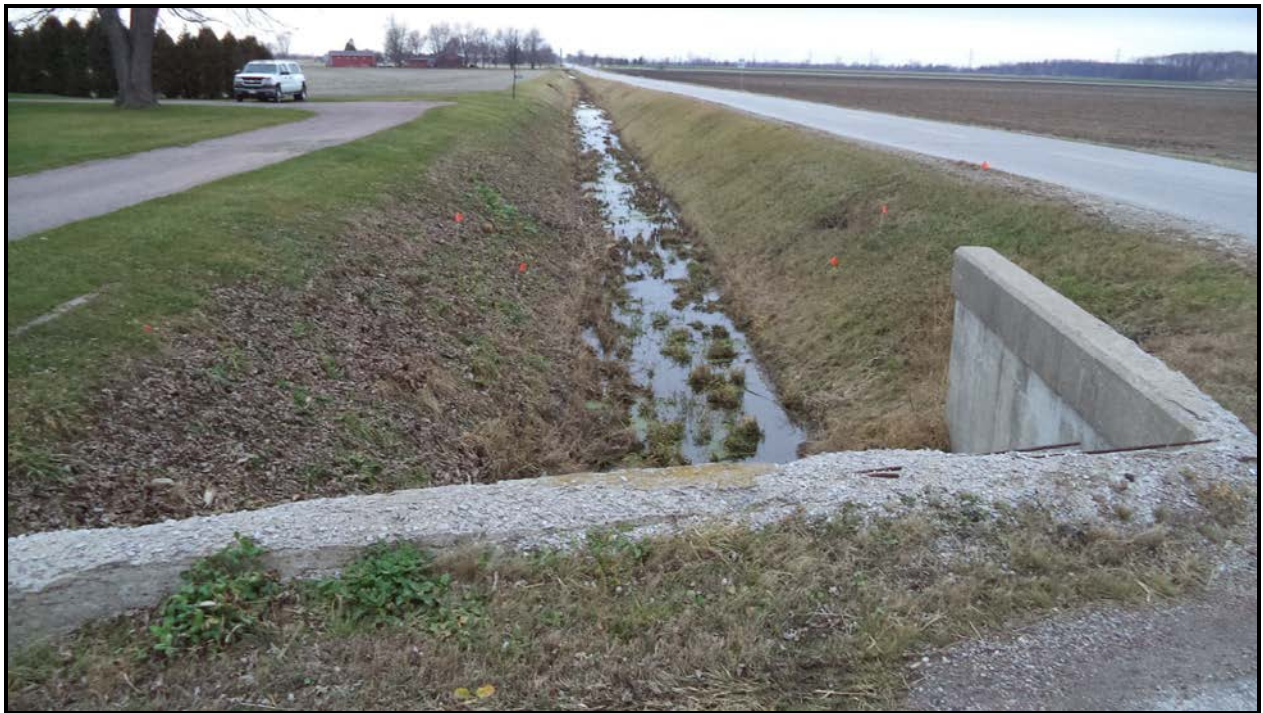
Photograph 12 – Water Stream (South Talbot Road South Side - Looking West)

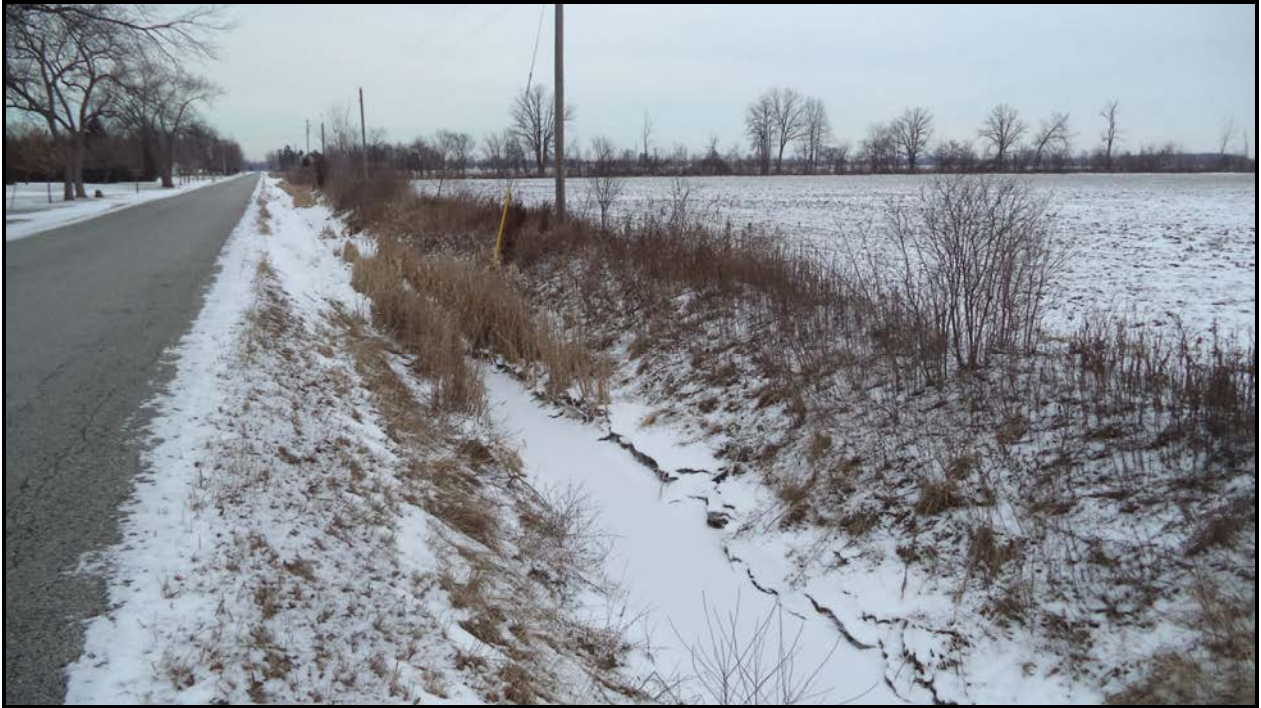
Photograph 9 – Water Stream (Holden Road Wes Side – Looking North)

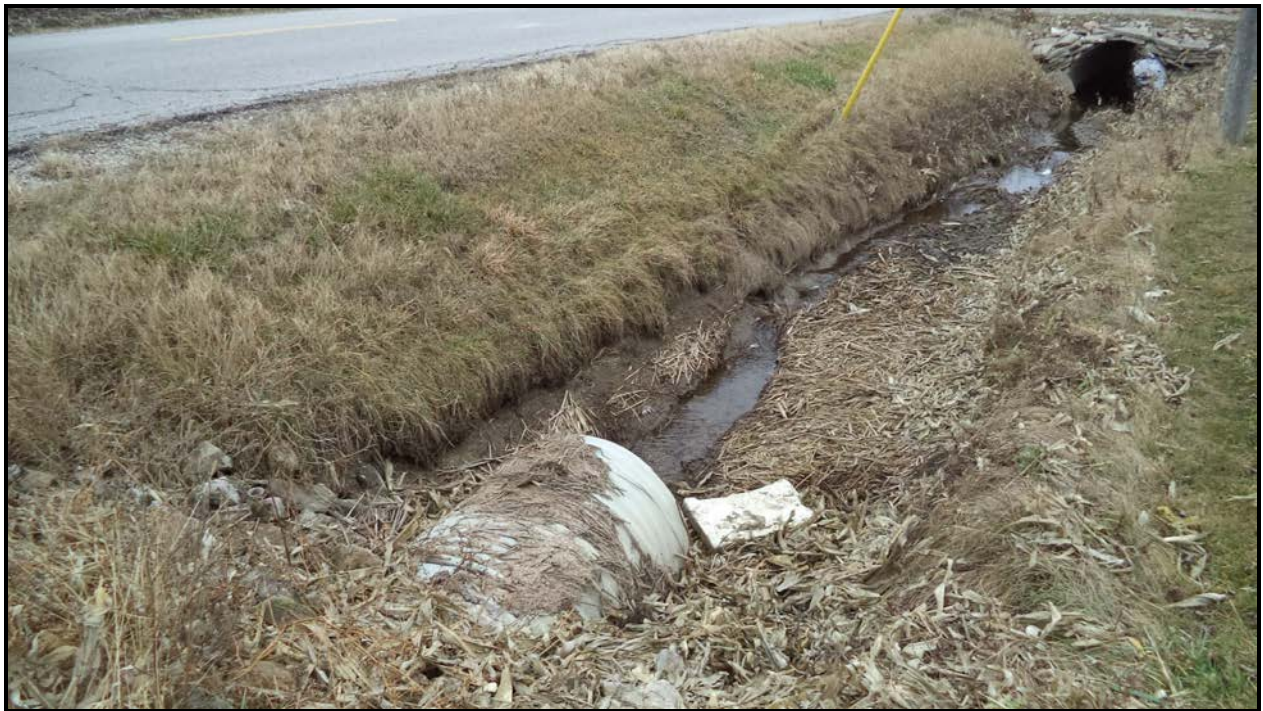
Photograph 6 – Water Stream (South Talbot Road South Side – Looking East)

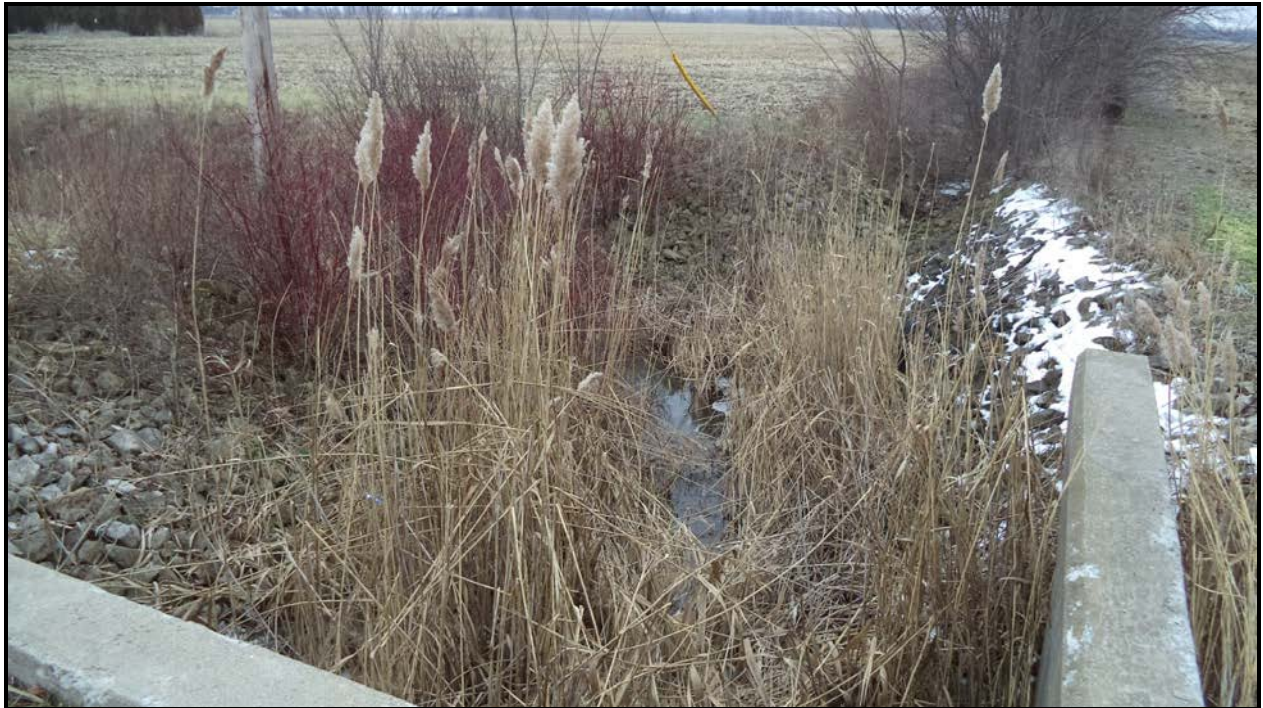
Photograph 7 – Water Stream (Concession Road 8 East Side - Looking East)

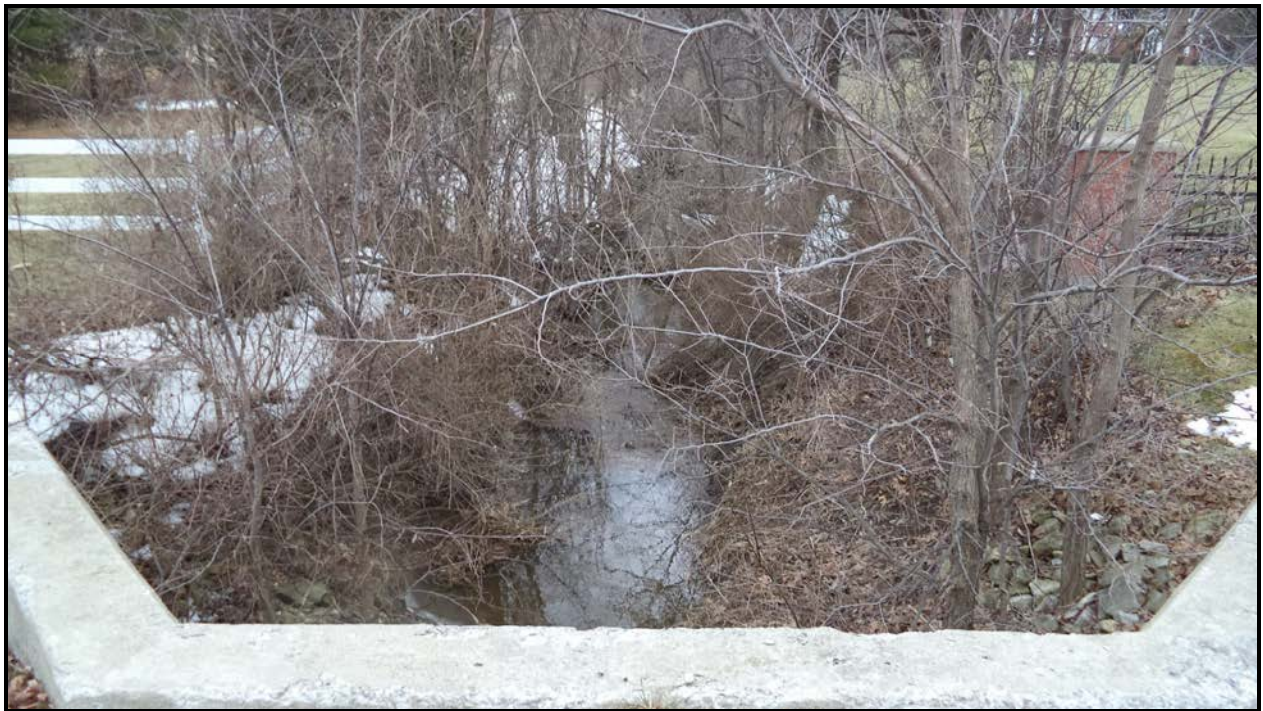
Photograph 8 – Water Stream (Concession Road 8 West Side - Looking West)

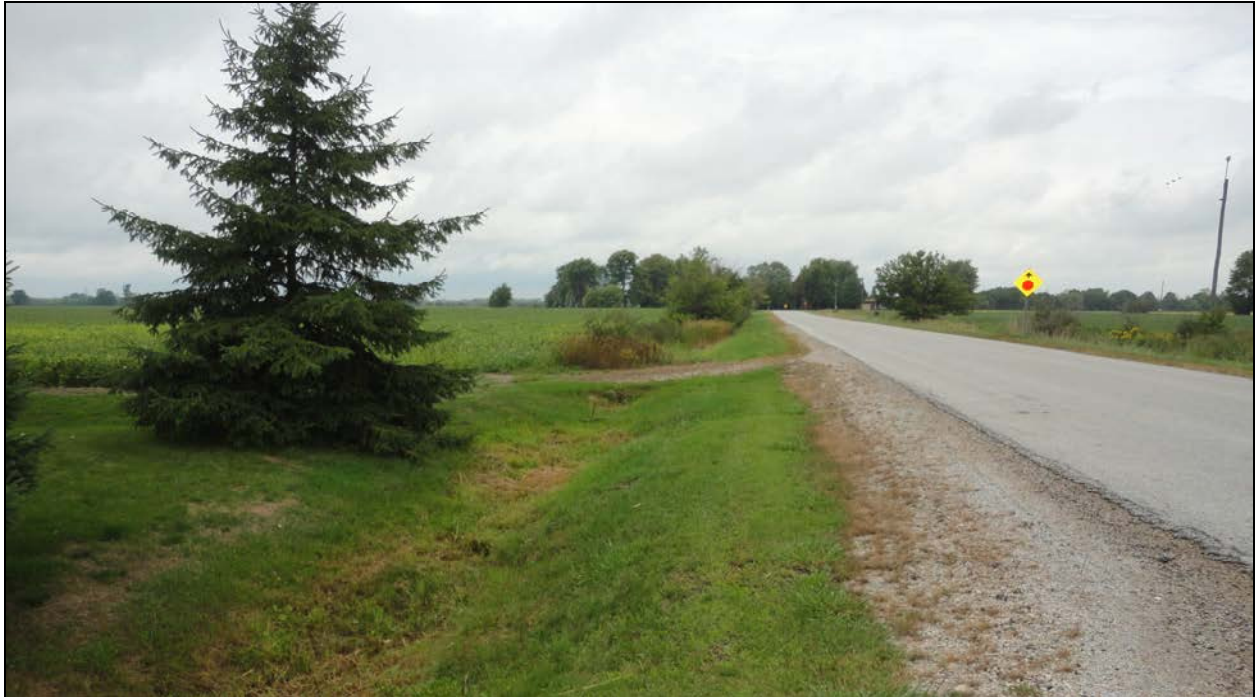
Photograph 2 – West Embankments & Waterway (Looking North)

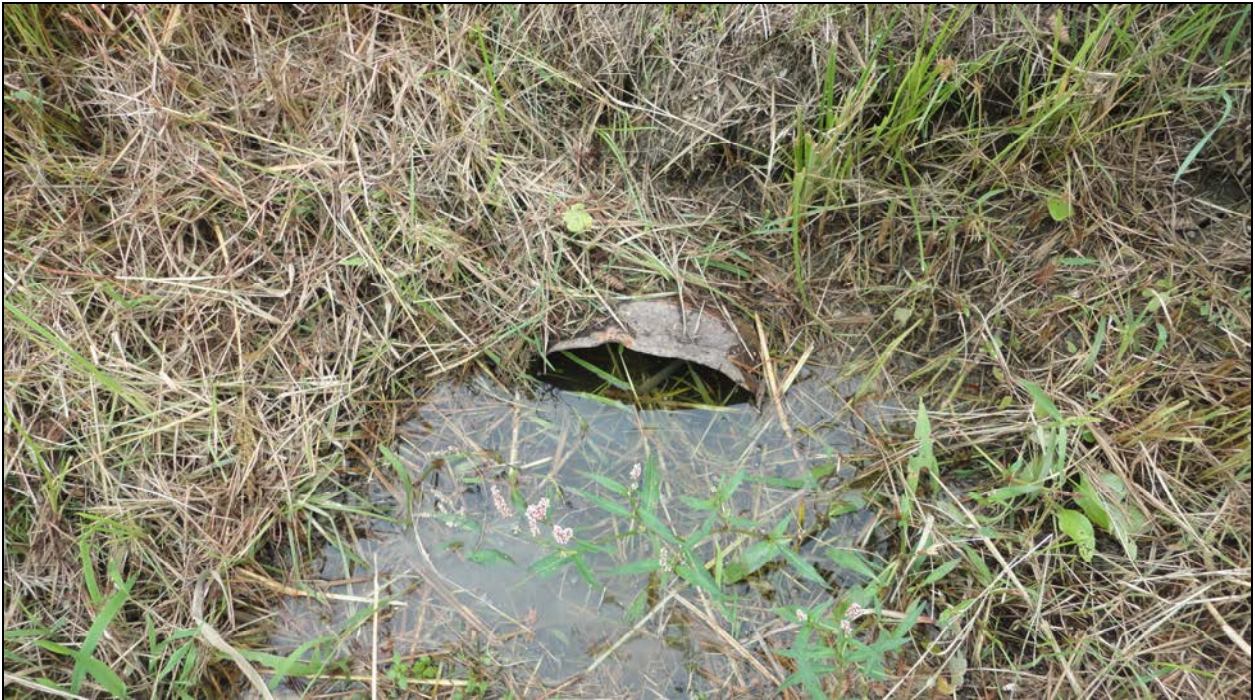
Photograph 3 – West Elevation

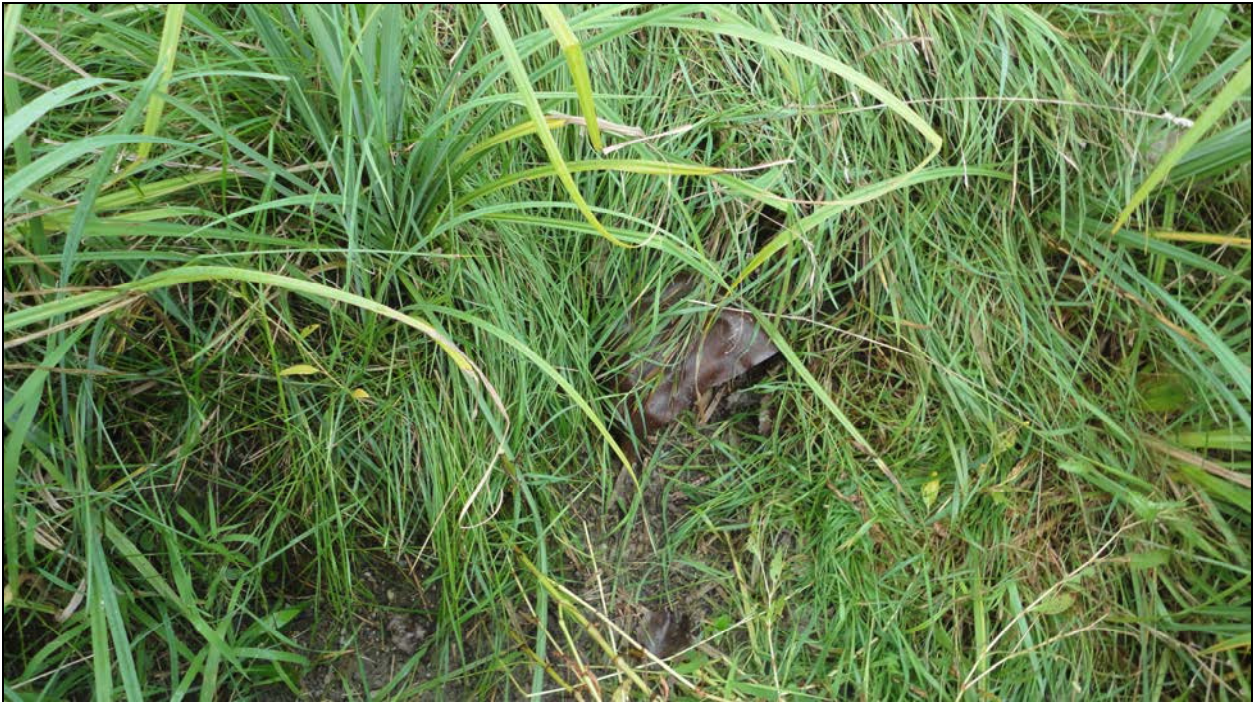
Photograph 5 – East Elevation

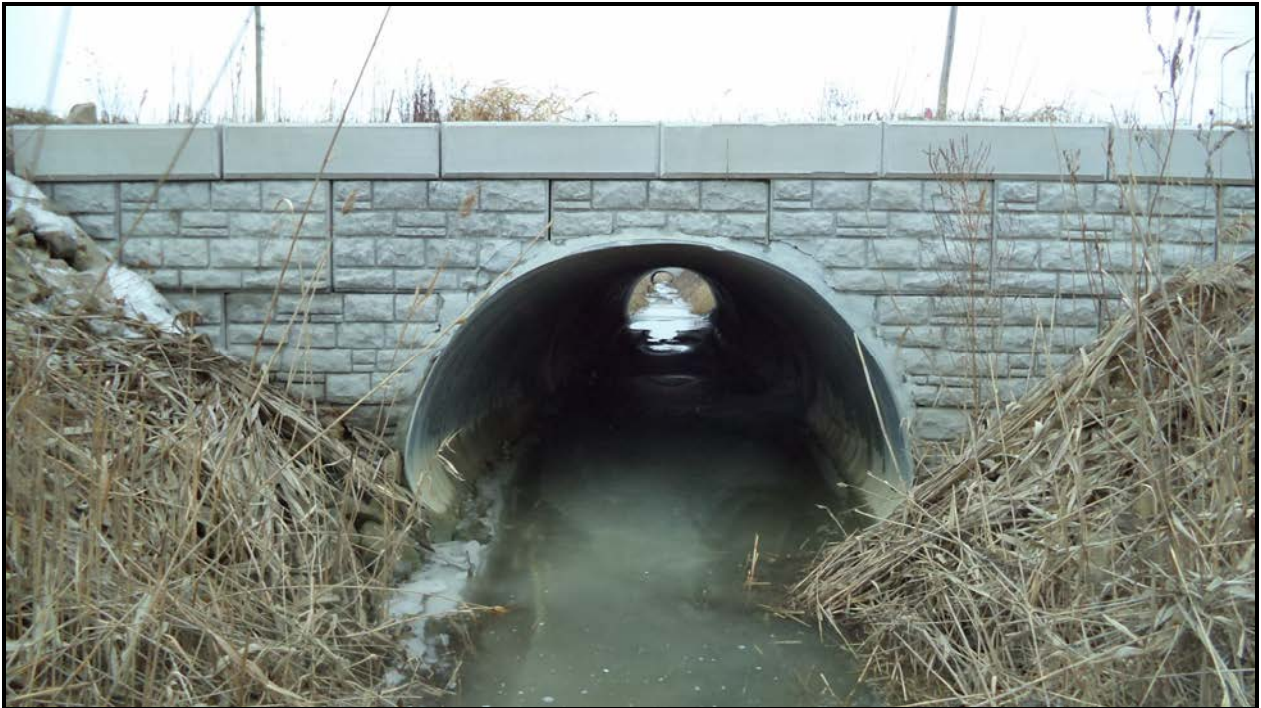
Photograph 3 – East Elevation

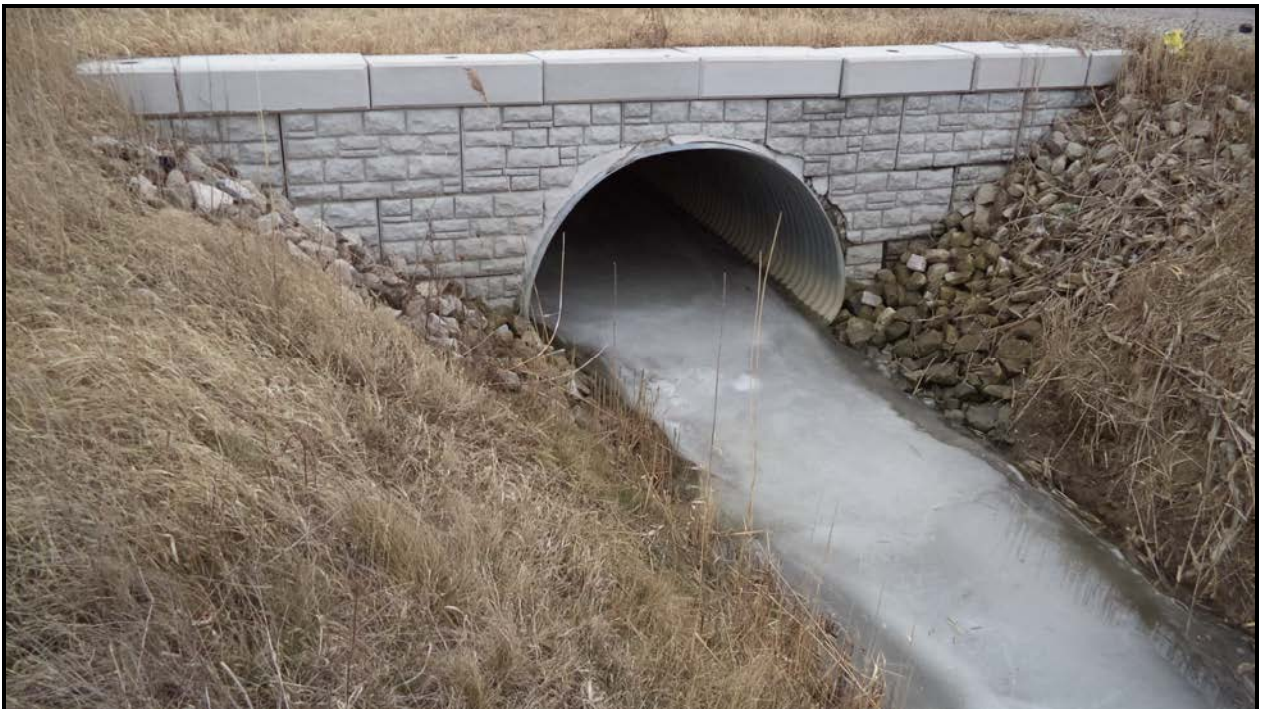
Photograph 4 – West Elevation

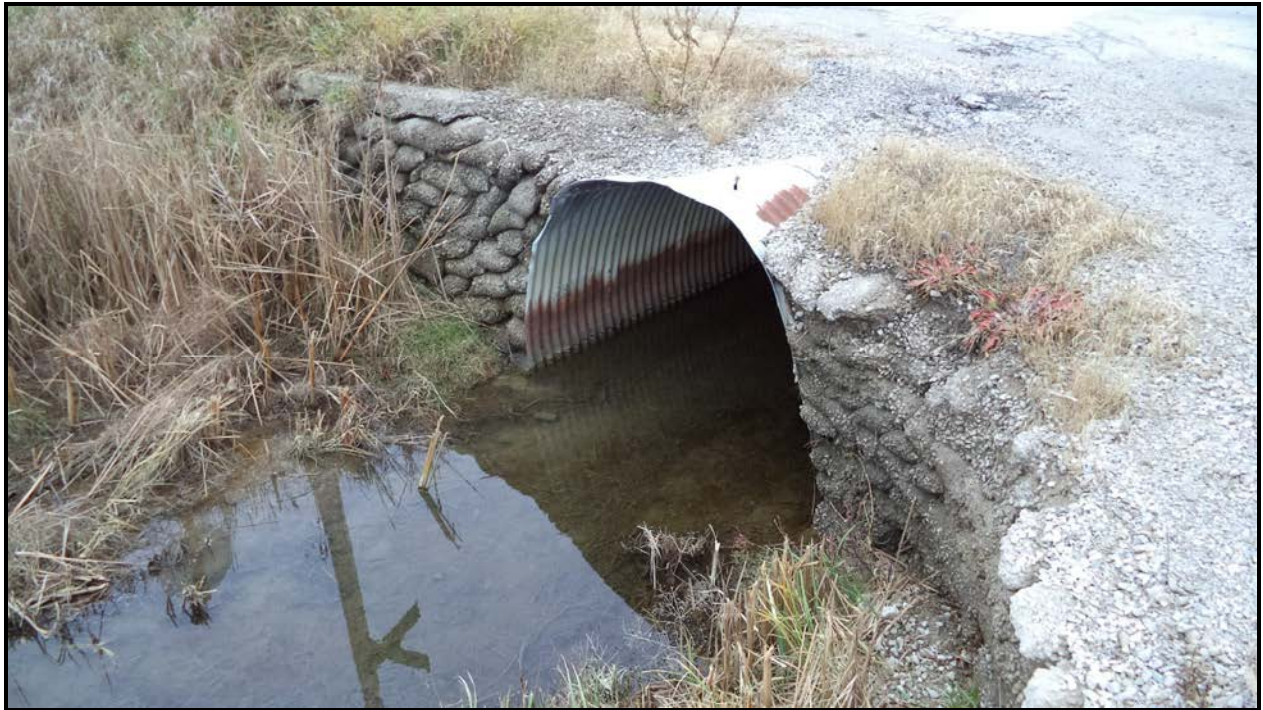
Photograph 5 – East Elevation

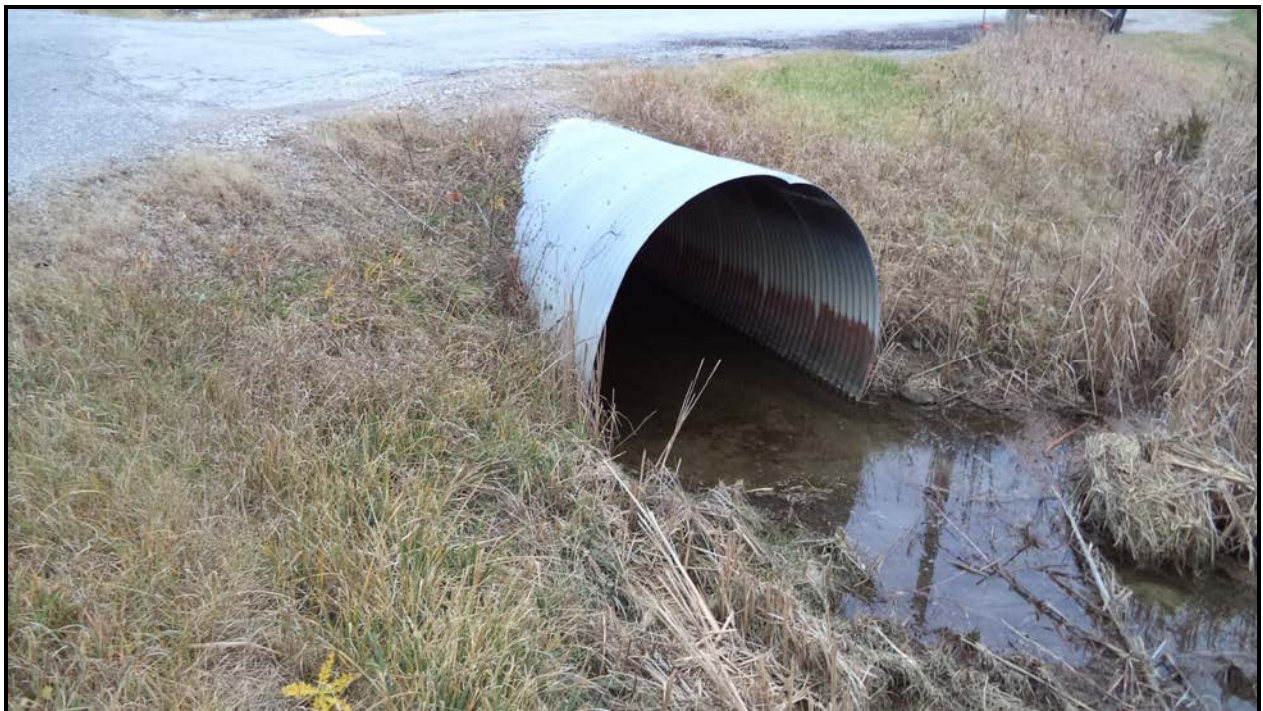
Photograph 6 – West Elevation

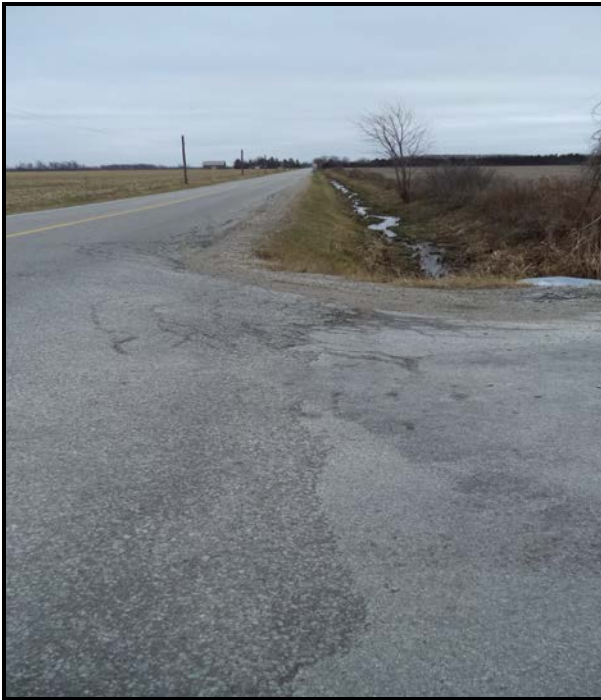
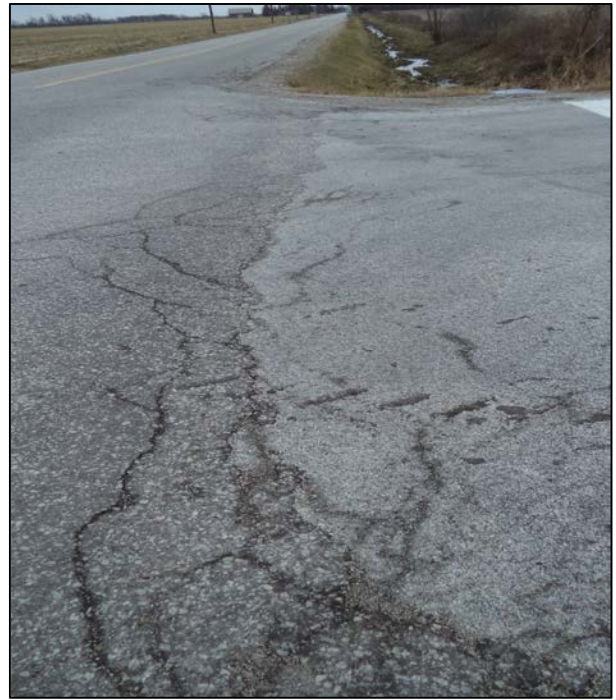
Photograph 7 – Wearing Surface at North Approach

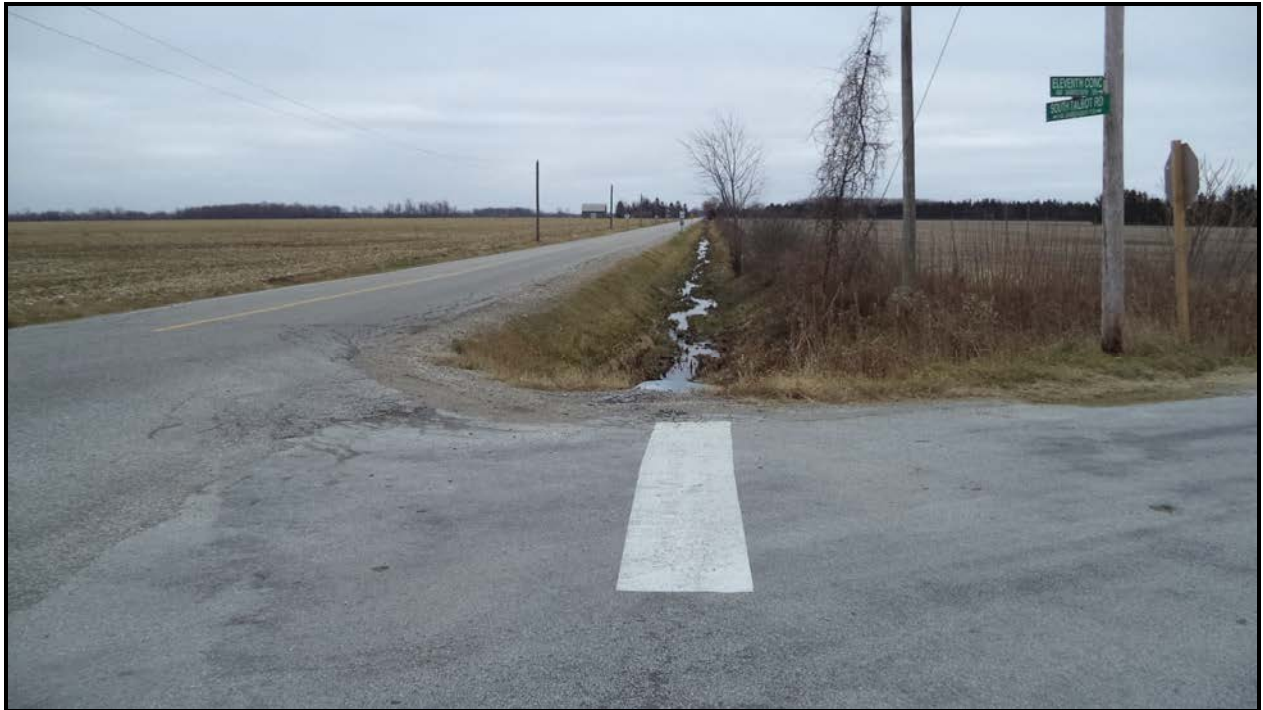
Photograph 9 – Water Stream (Concession Road 11 East Side – Looking East)

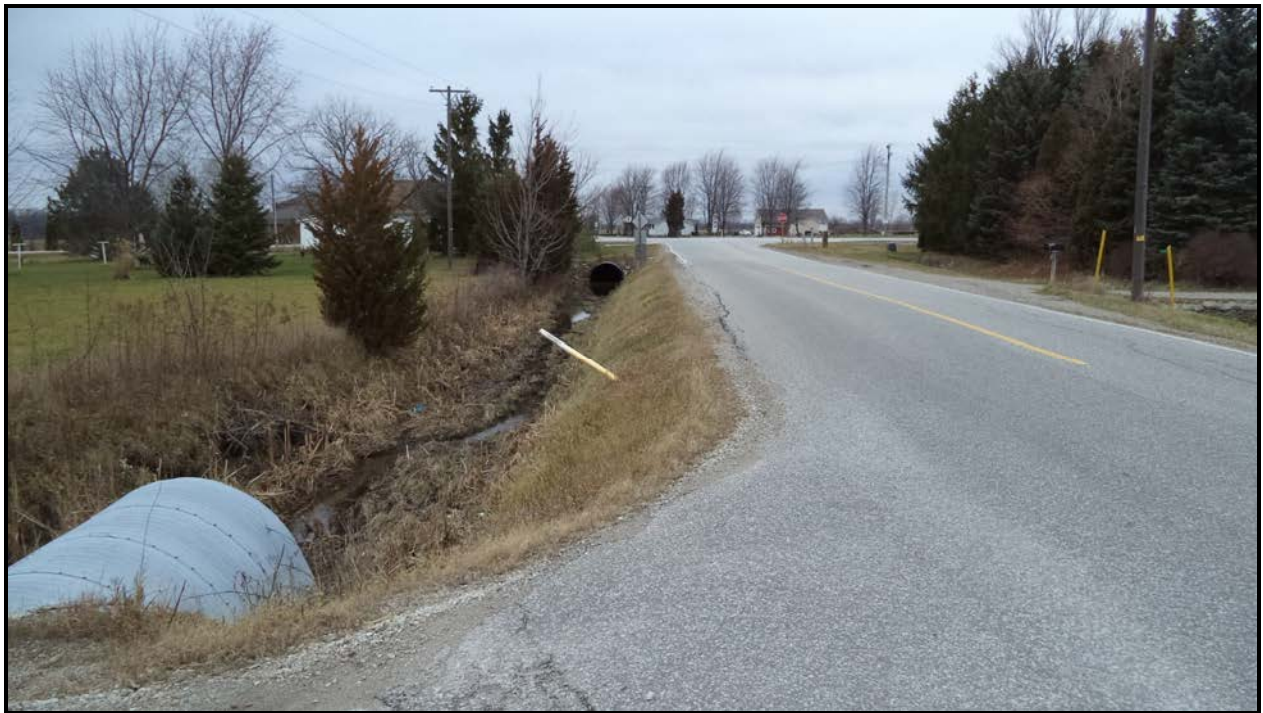
Photograph 10 – Water Stream (Concession Road 11 West Side – Looking West)

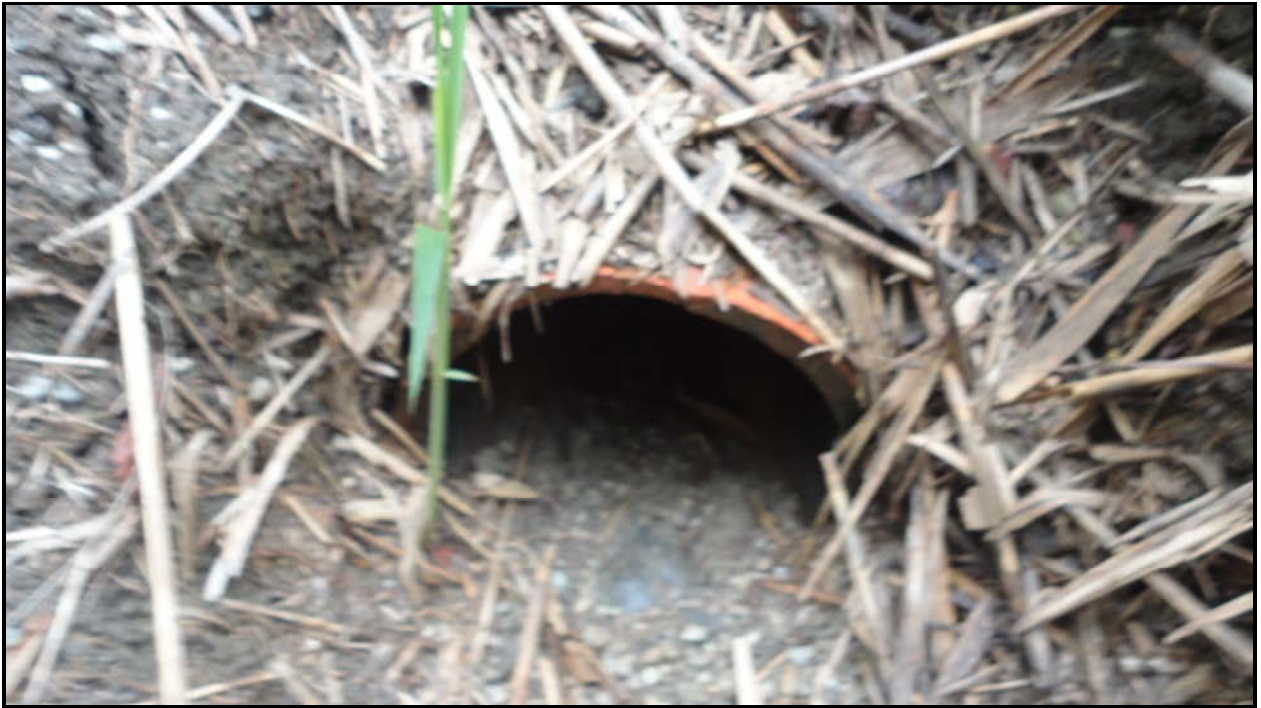
Photograph 3 – West Elevation

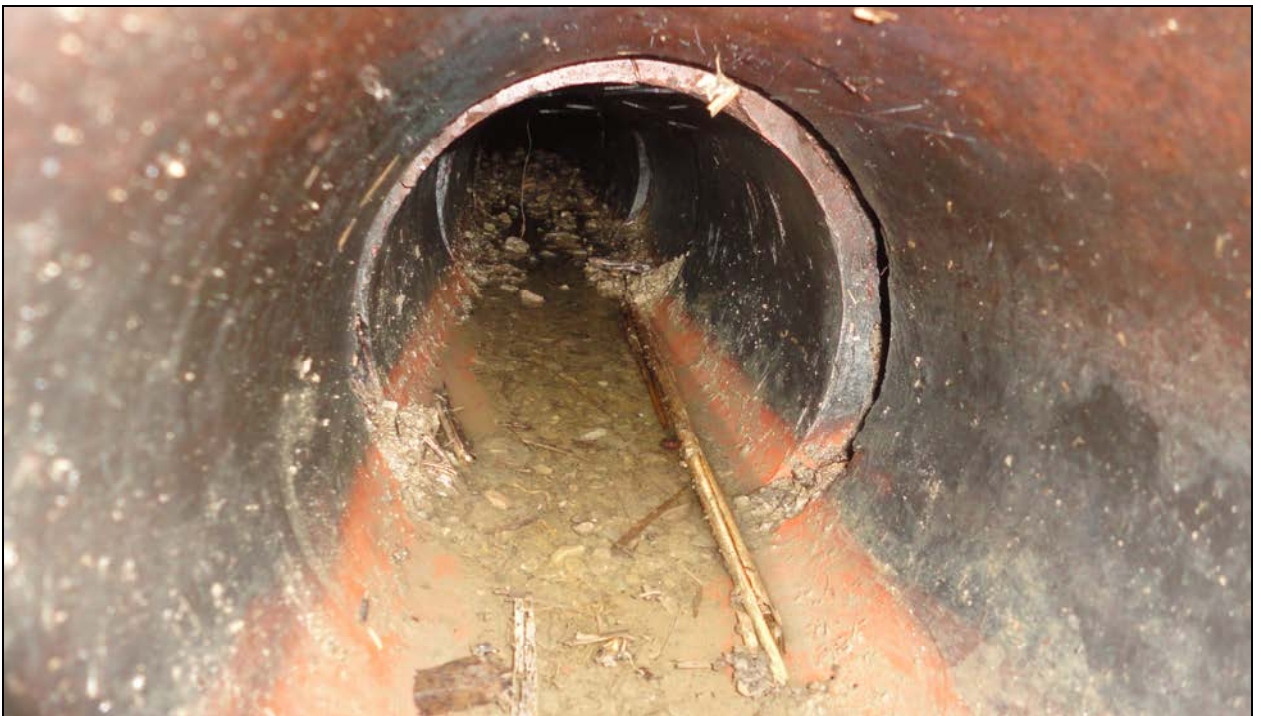
Photograph 4 – Culvert Barrel
