CORPORATE OF THE TOWN OF TECUMSEH
2016 Culvert Needs Study

Structures with Spans $\leq 3.0\text{m}$ – Final Report

Our File: 15-2977

October 28, 2016

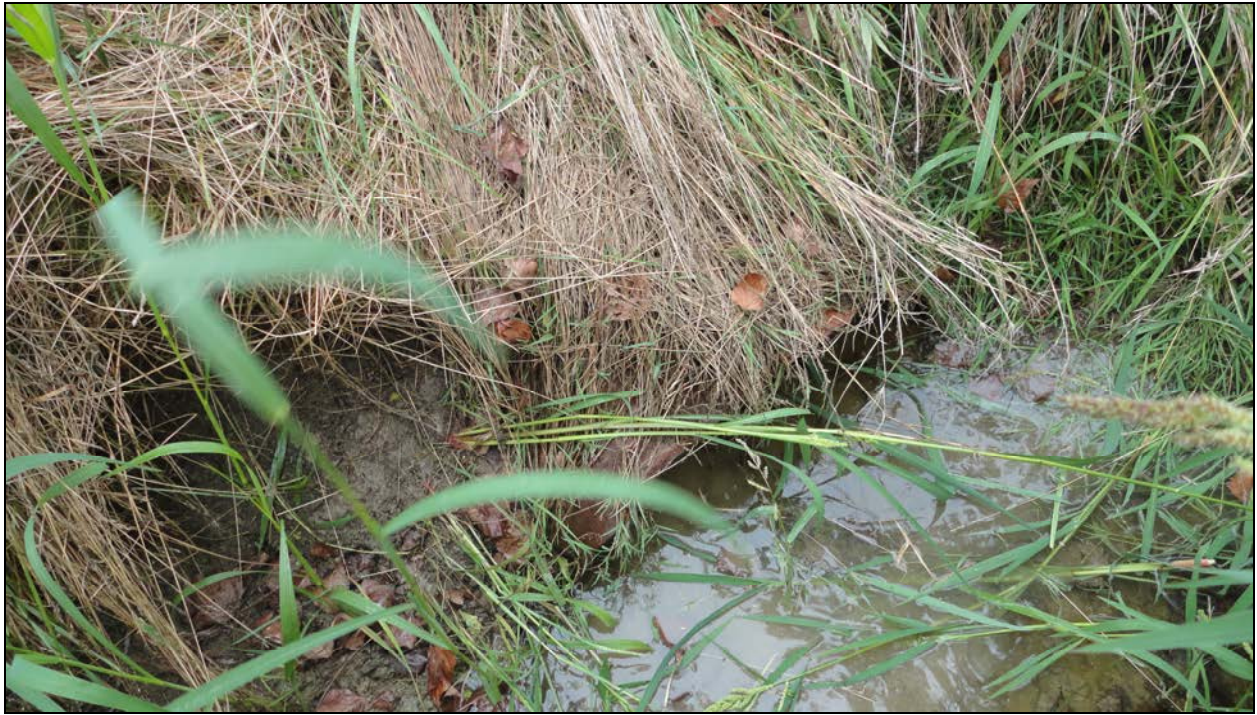
Photograph 3 – East Elevation

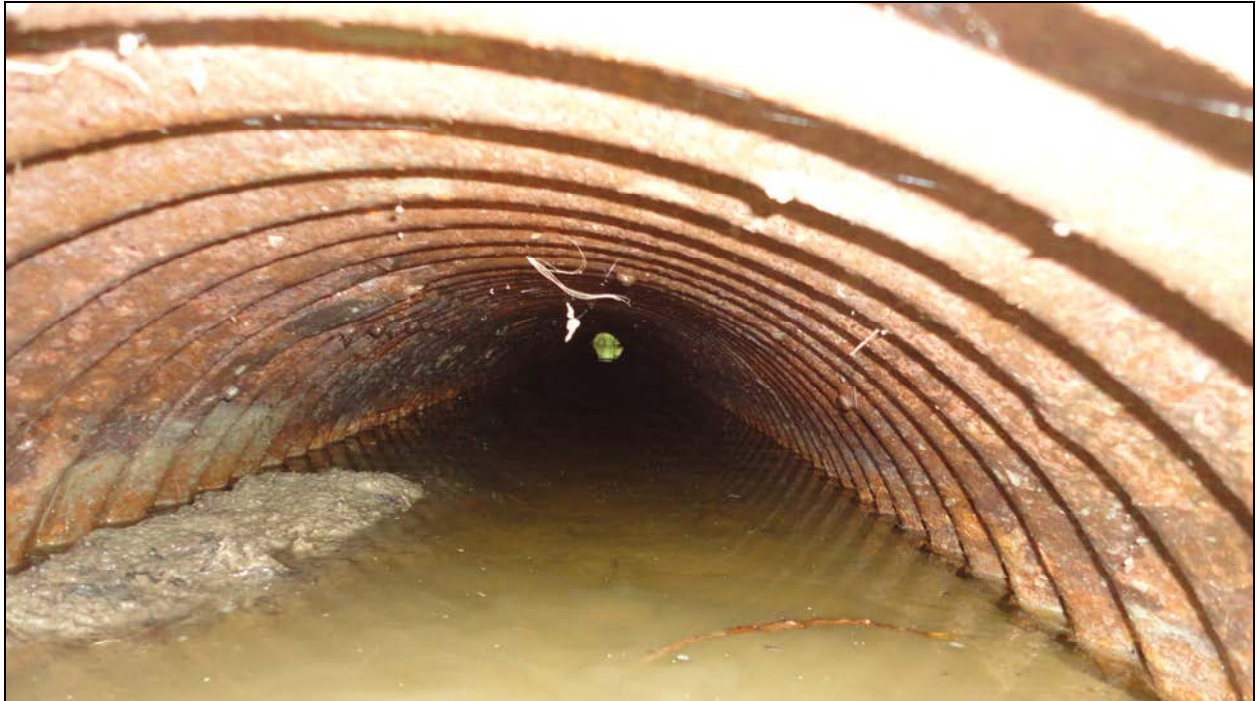
Photograph 4 – Culvert Barrel

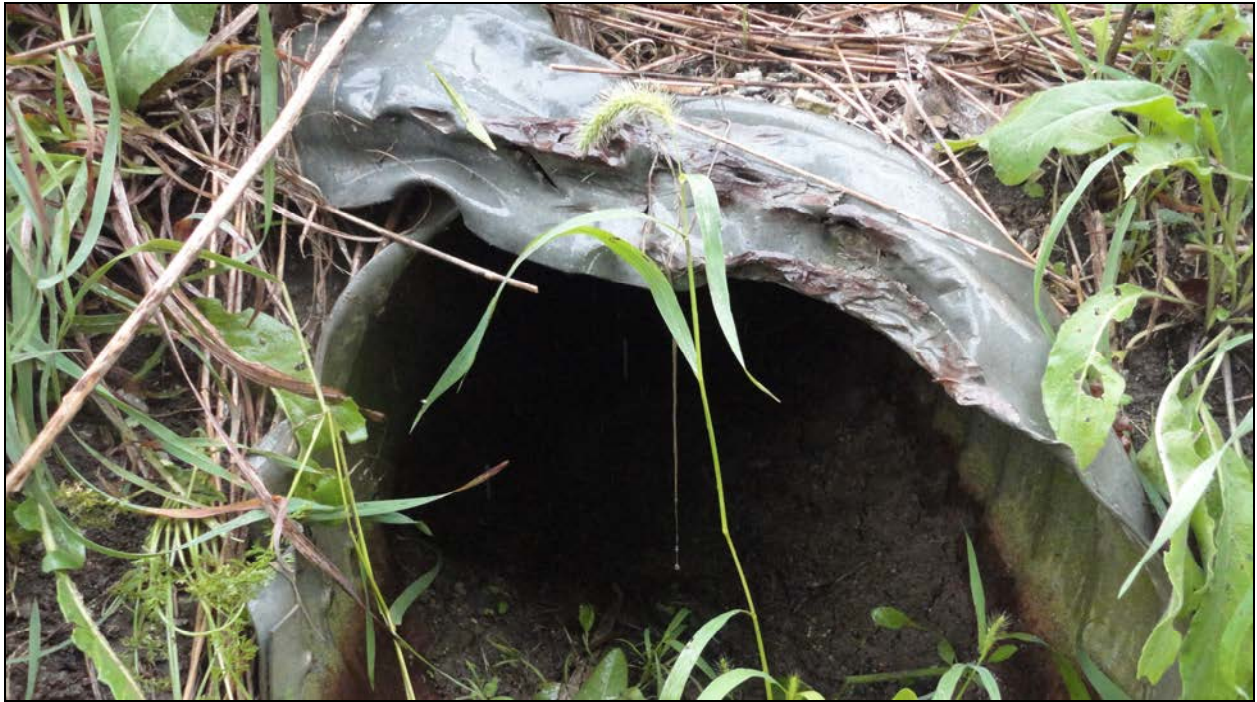
Photograph 5 – West Elevation

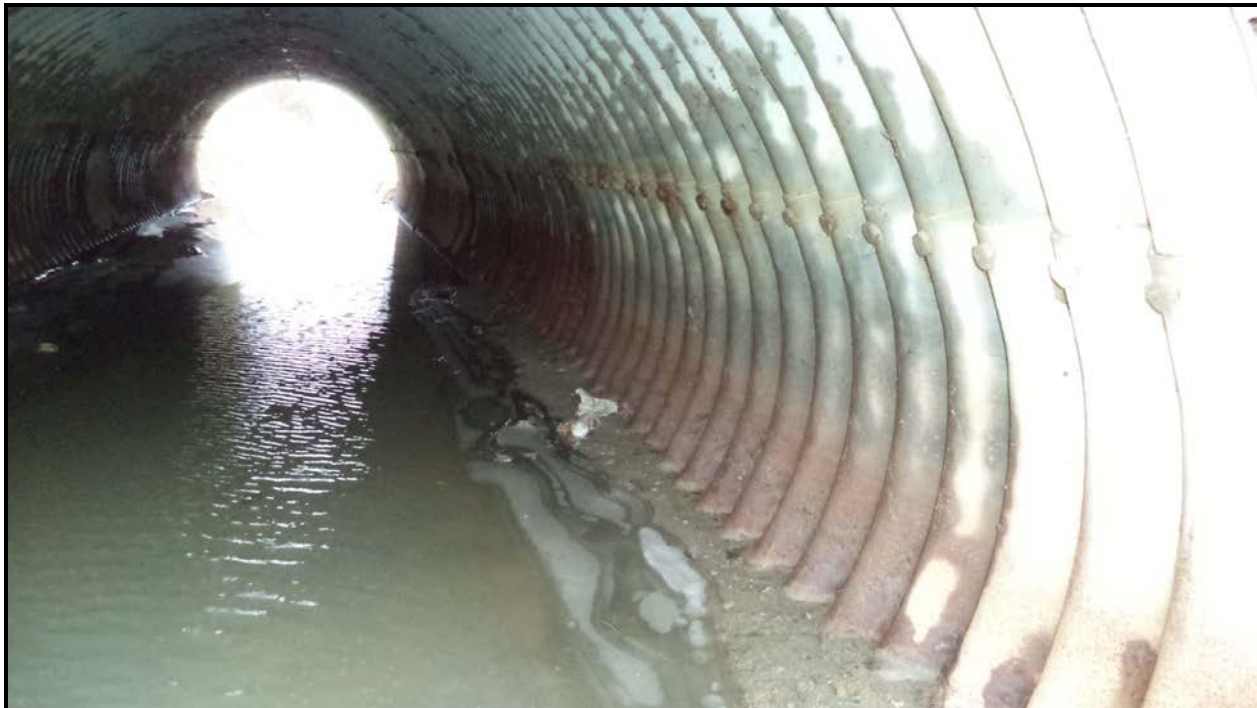
Photograph 2 – Culvert Barrel

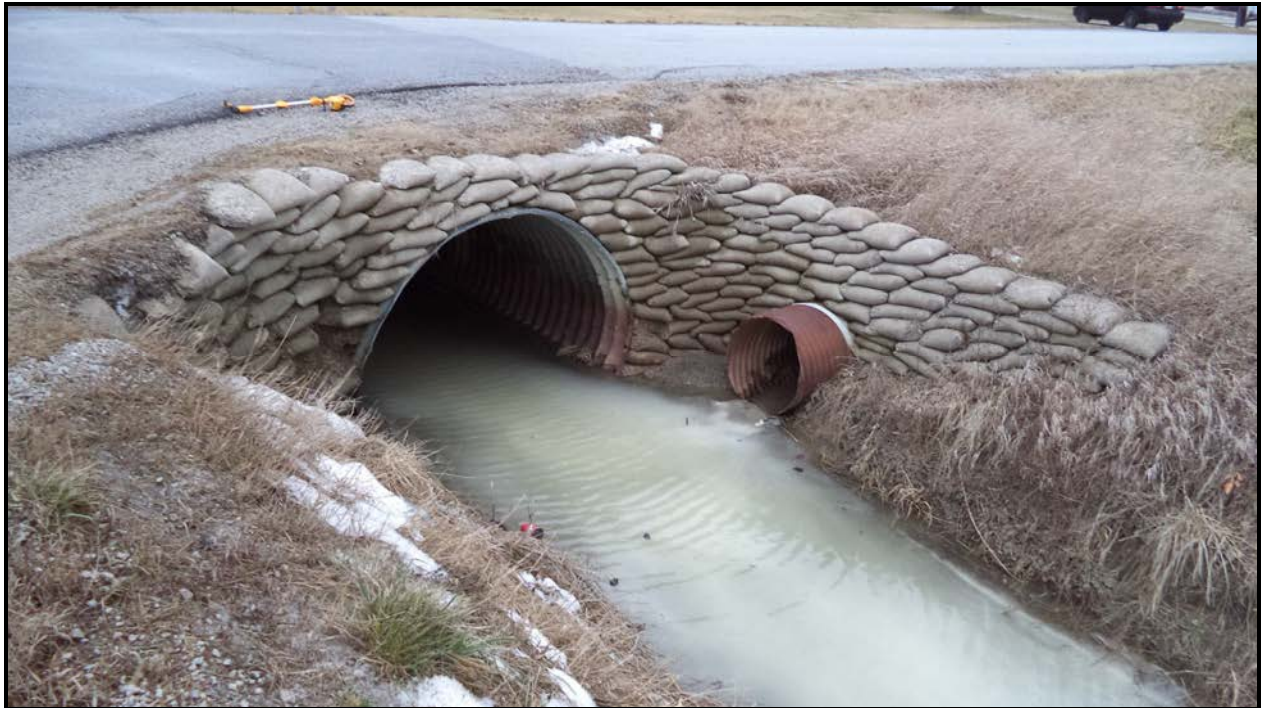
Photograph 5 – East Elevation

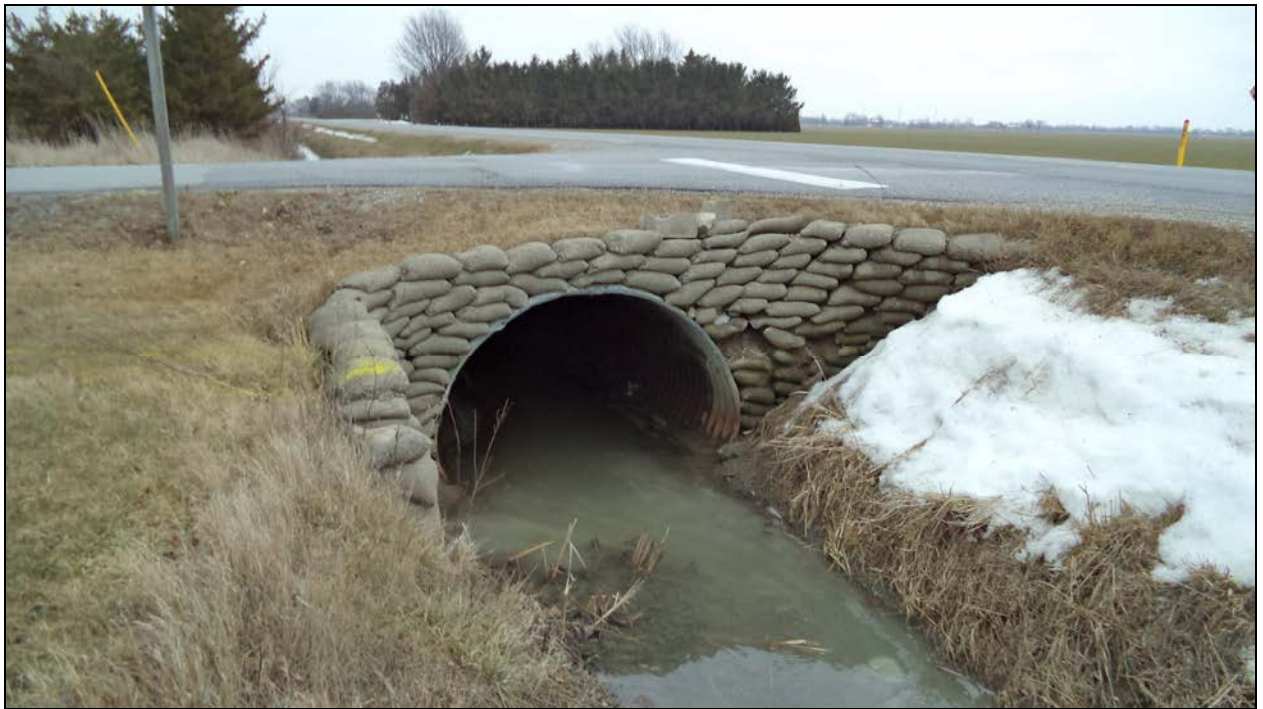
Photograph 6 – West Elevation

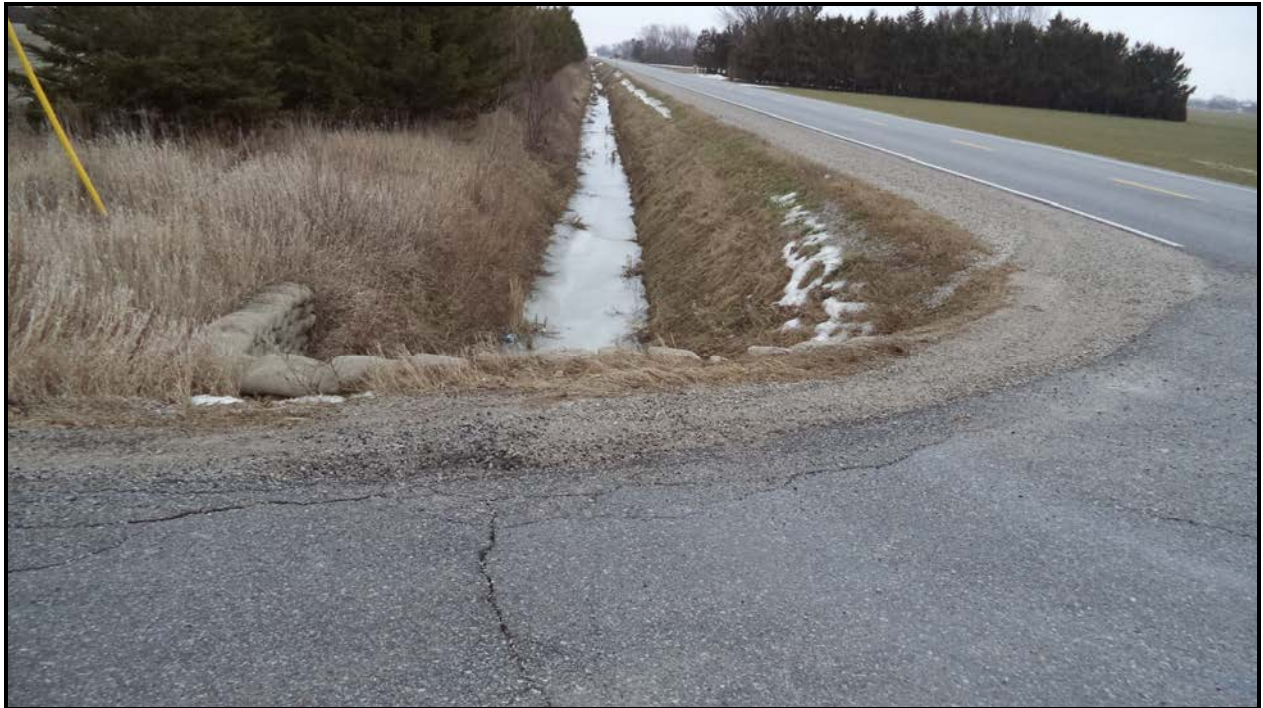
Photograph 9 – Water Stream (Concession Road 11 East Side - Looking East)

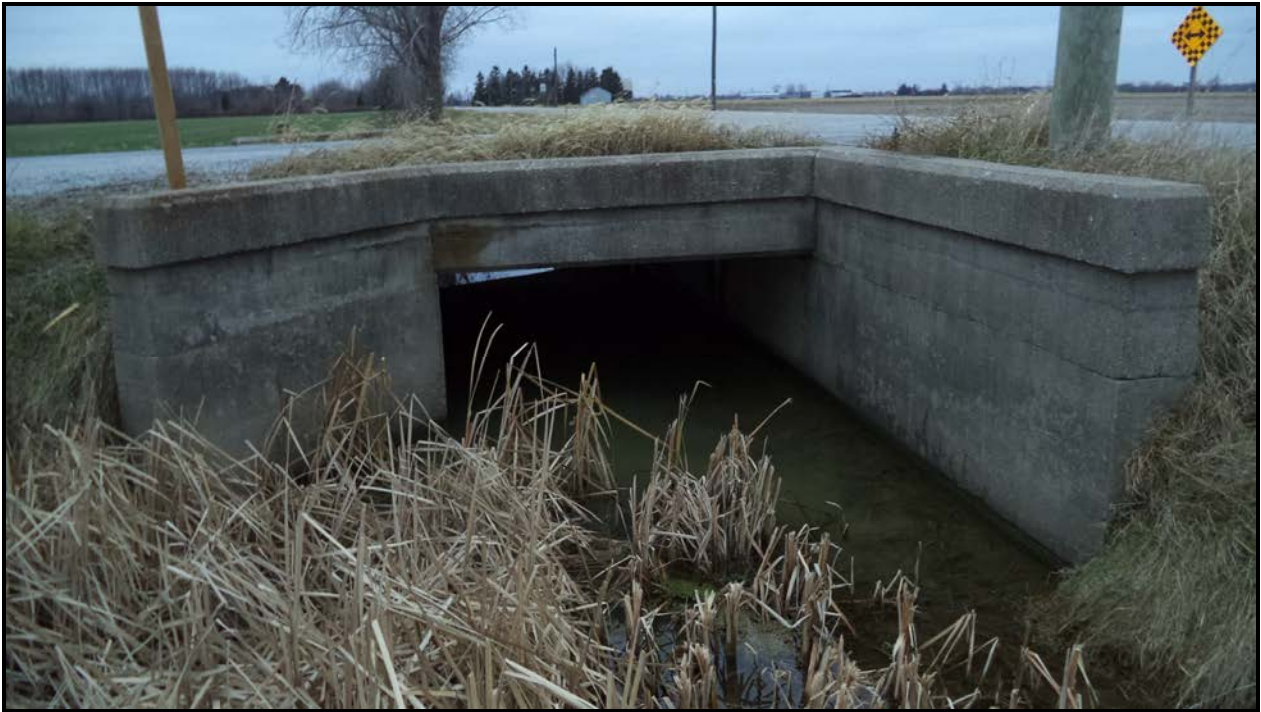
Photograph 2 – Culvert Soffit (Looking South)

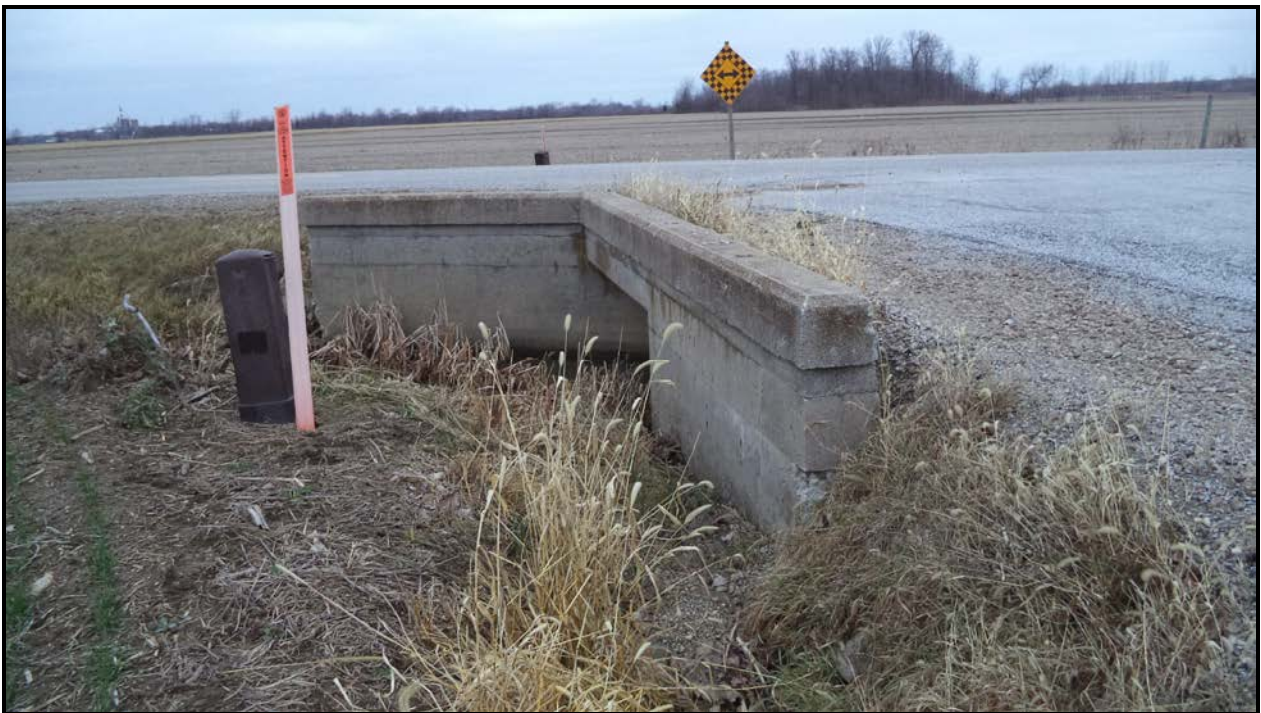
Photograph 3 – East Elevation

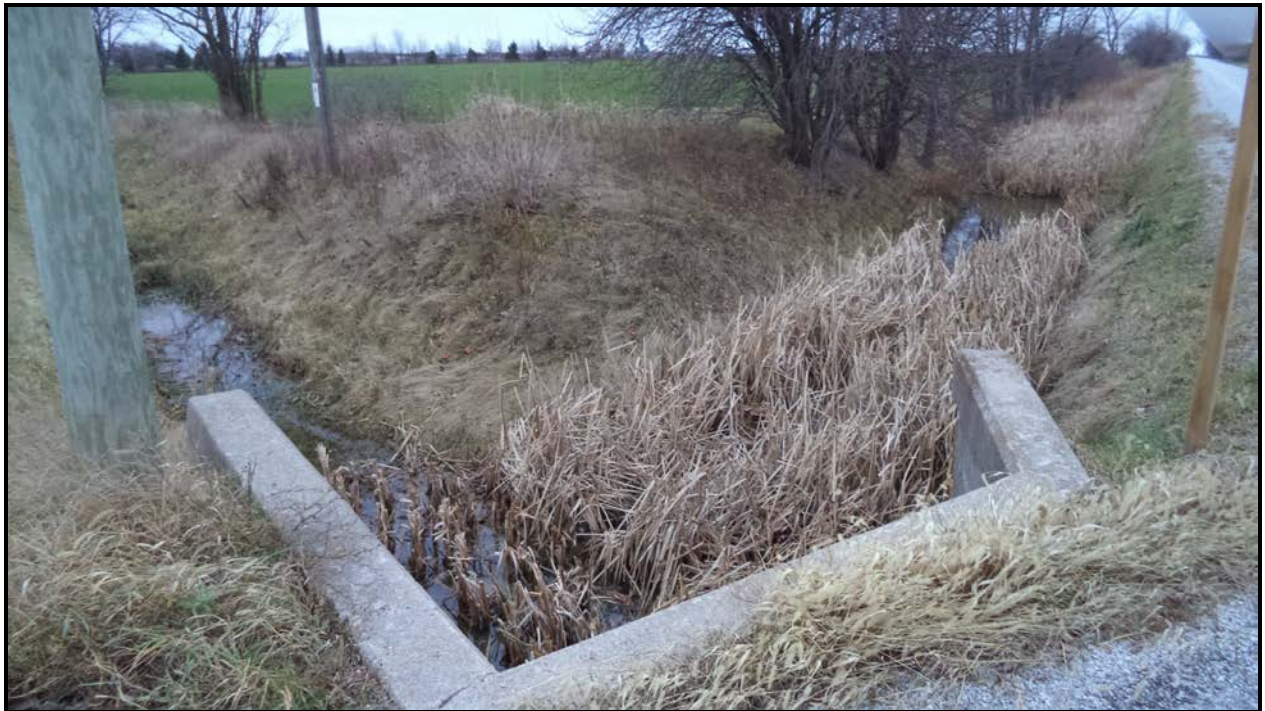
Photograph 7 – Wearing Surface over Culvert Deck

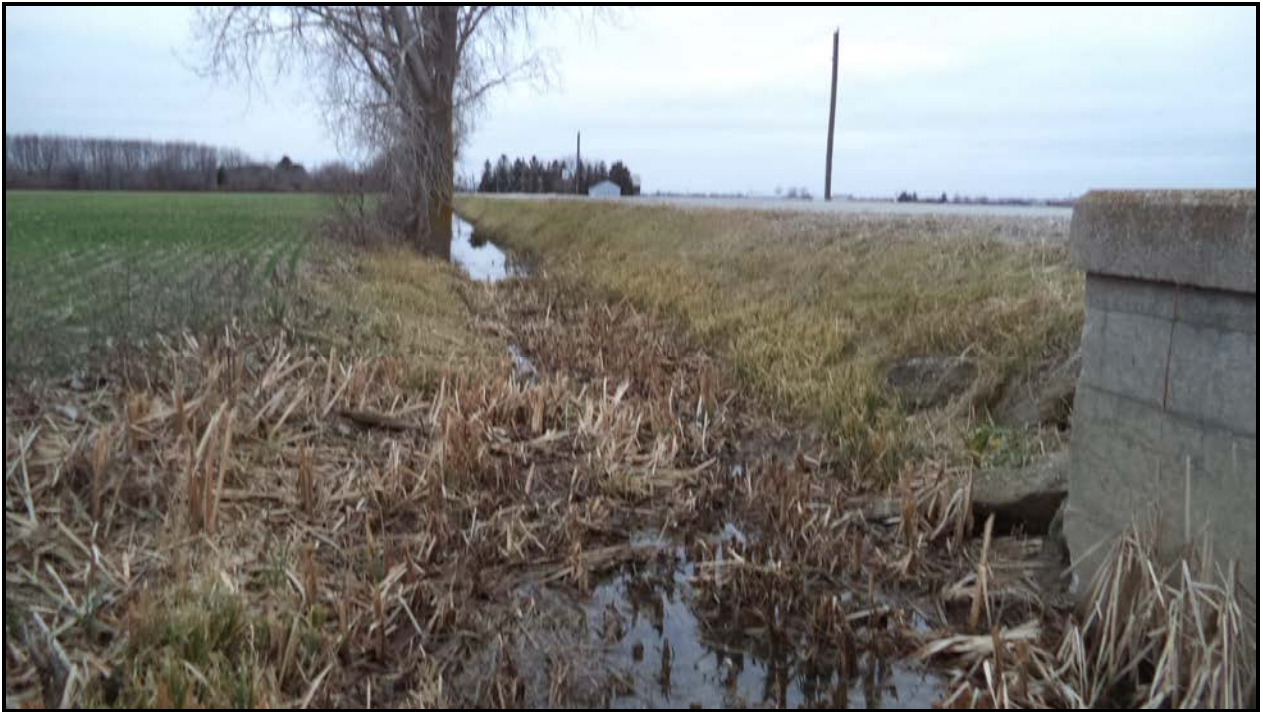
Photograph 8 – Water Stream (Concession Road 12 West Side – Looking West)

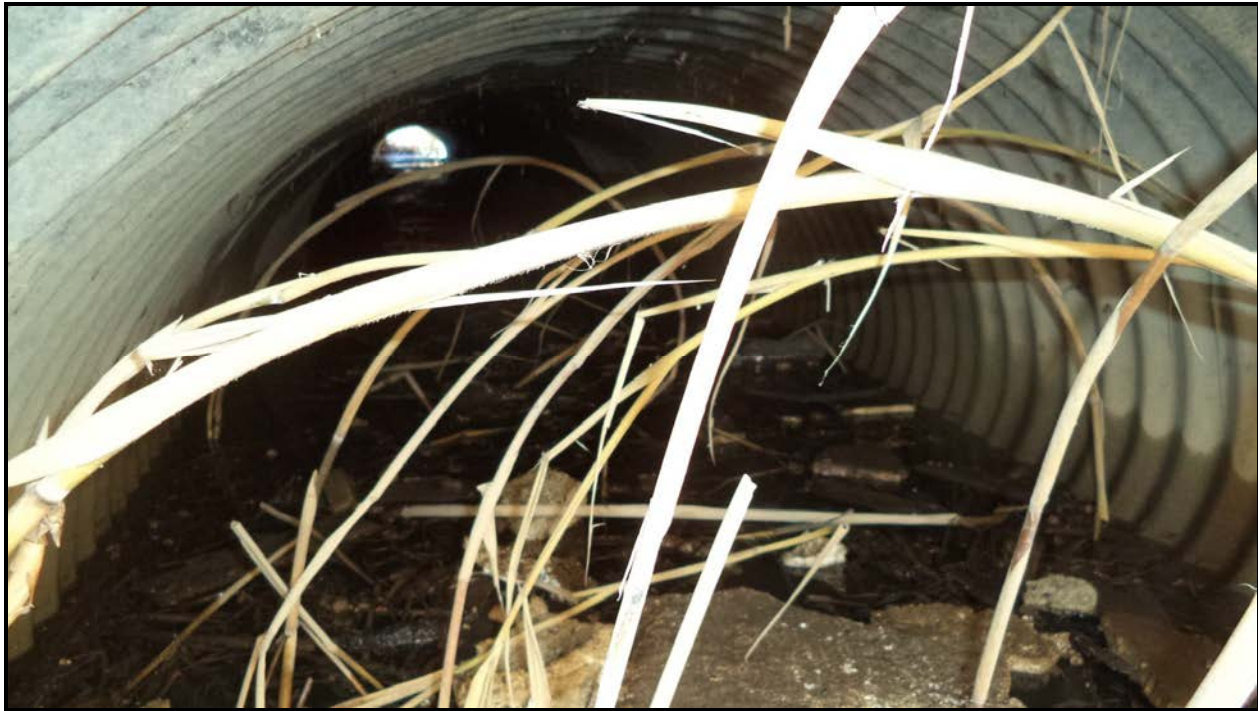
Photograph 2 – Culvert Barrel

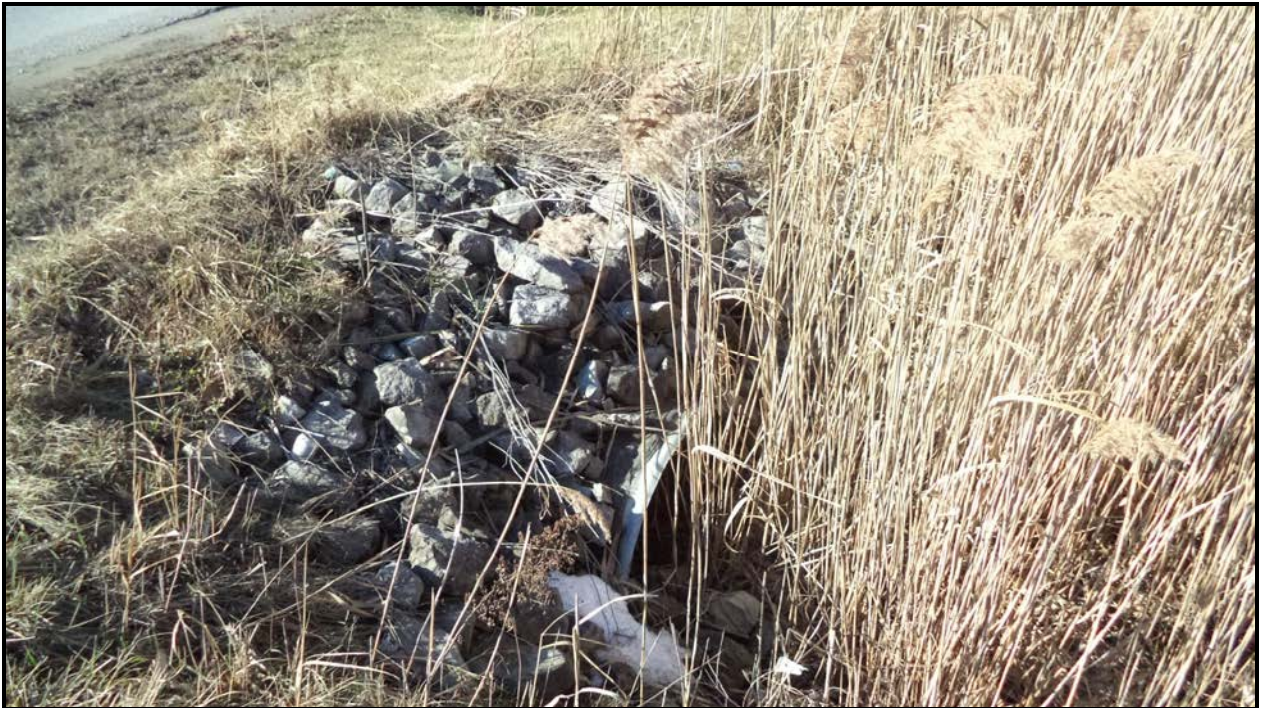
Photograph 3 – East Elevation

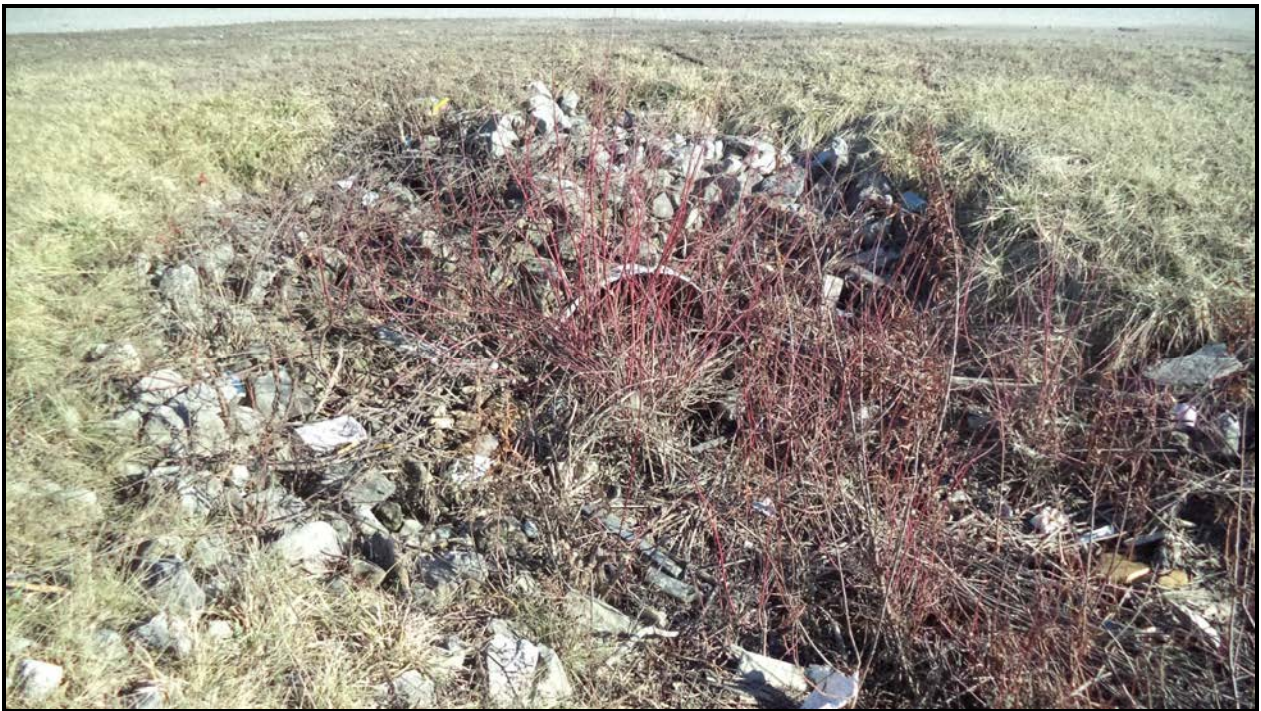
Photograph 4 – West Elevation

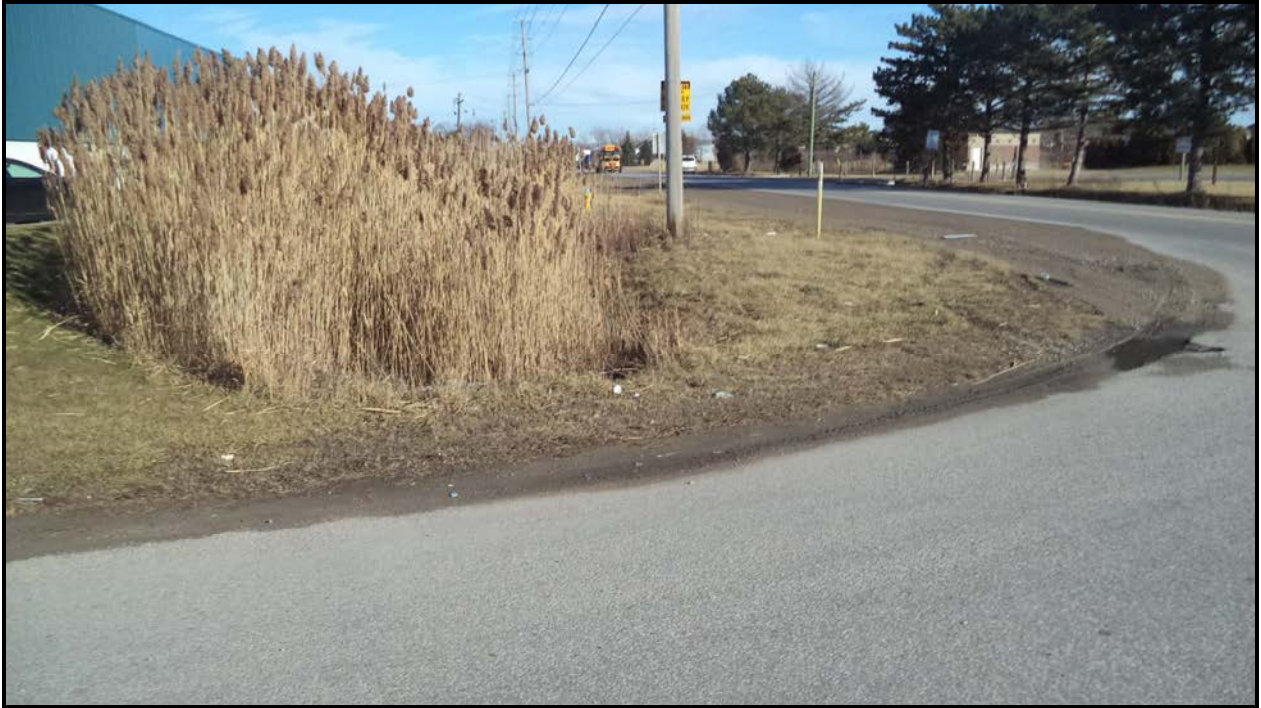
Photograph 7 – Water Stream (County Road 42 North Side - Looking East)
