CORPORATION OF THE TOWN OF TECUMSEH
2020 Bridge and Culvert Needs Study
Structures with Spans > 3.0 m

March 30, 2021

Town of Tecumseh
2020 Bridge and Culvert Needs Study
Structures with Spans > 3.0 m

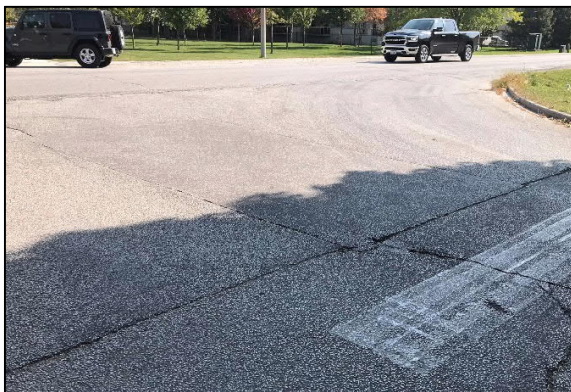
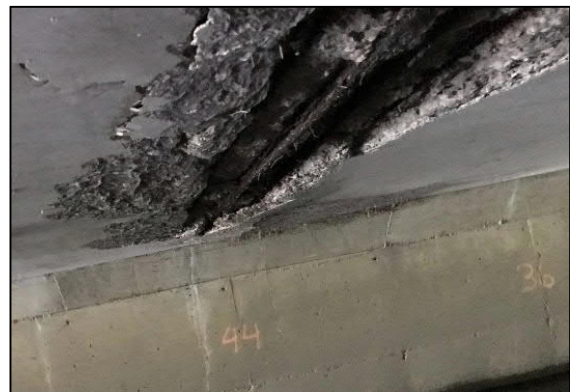
Figure 1: Asphalt over steel plate repair on deck top (left), typ. soffit deterioration (right)

This structure was built in 1975, and is a 4.8 m span cast-in-place concrete rigid frame culvert with open footings. To our knowledge, there have not been any major rehabilitations completed to this structure. The current BCI for this structure is 57.6.

Narrow to wide cracks with efflorescence staining were observed throughout the culvert barrel. Approximately seven (7) locations of very severe delamination and very severe spalling with exposed and severely corroded reinforcing steel were observed in the culvert barrel soffit.

In July 2016, temporary repairs were completed by removing the asphalt wearing surface and placing a steel plate on the top of deck over the deteriorated soffit sections and re-paving the repaired areas.

Until the structure is replaced, Dillon recommends a monitoring program that consists of biannual inspections (two-times per year). The program should monitor the extents of the soffit deterioration to ensure the temporary repairs remain satisfactory. Additional temporary works may be warranted based on the results of the inspections and will be recommended to the Town upon the completion of each biannual investigation.

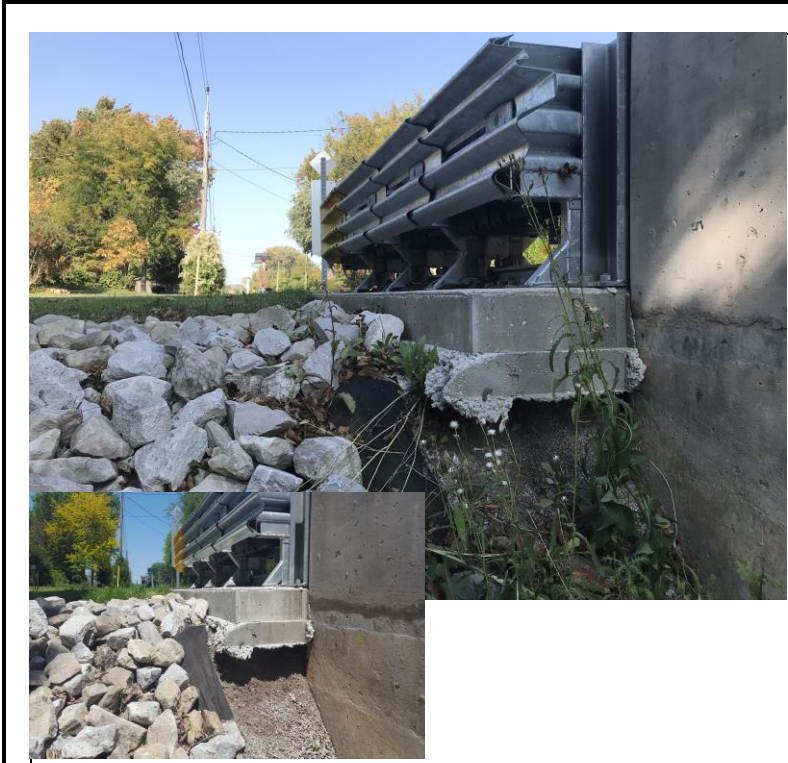
Description
Erosion below curb slab at northwest wingwall

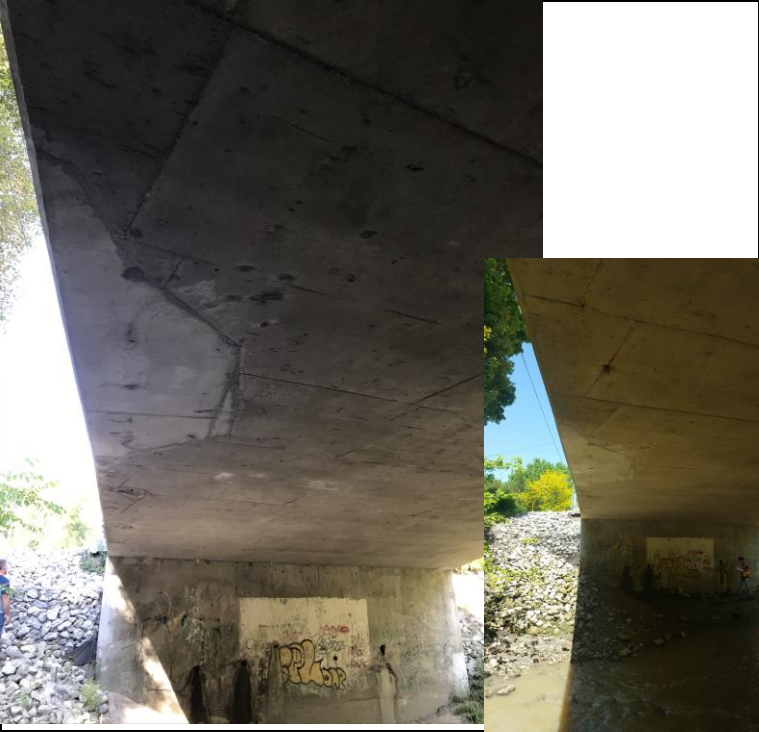
<p>Description</p> <p>Wet staining and efflorescence on west edge of soffit.</p>
--	---

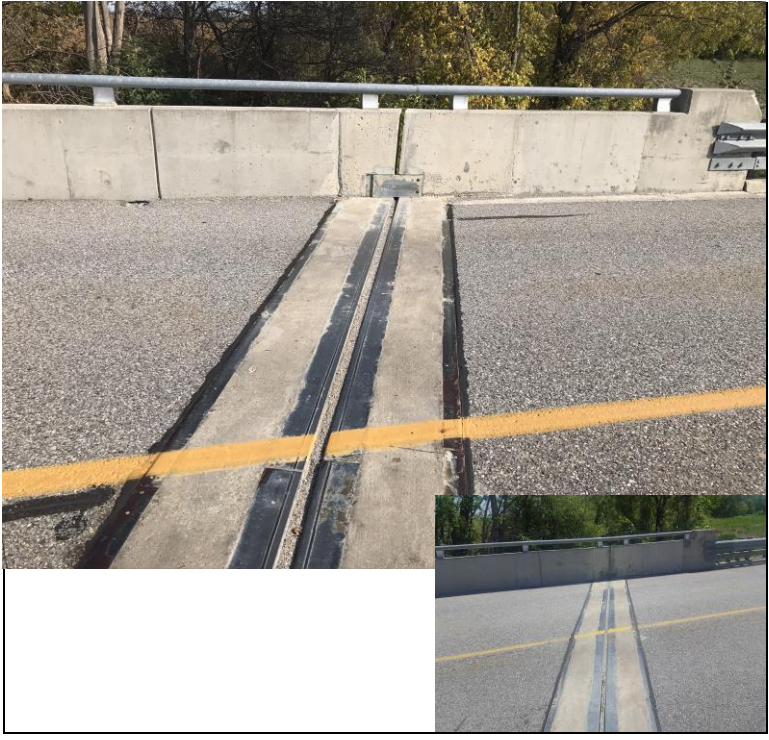
<p>Description</p> <p>Expansion joint at the south bridge approach. (Looking East)</p>
--	---

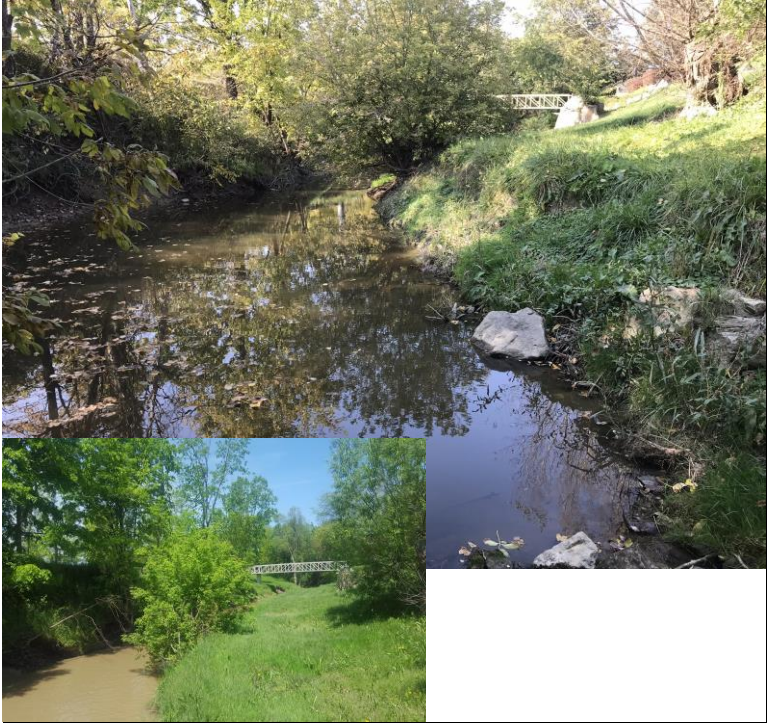
<p>Description</p> <p>Waterway at west side. (Looking West)</p>
--	--

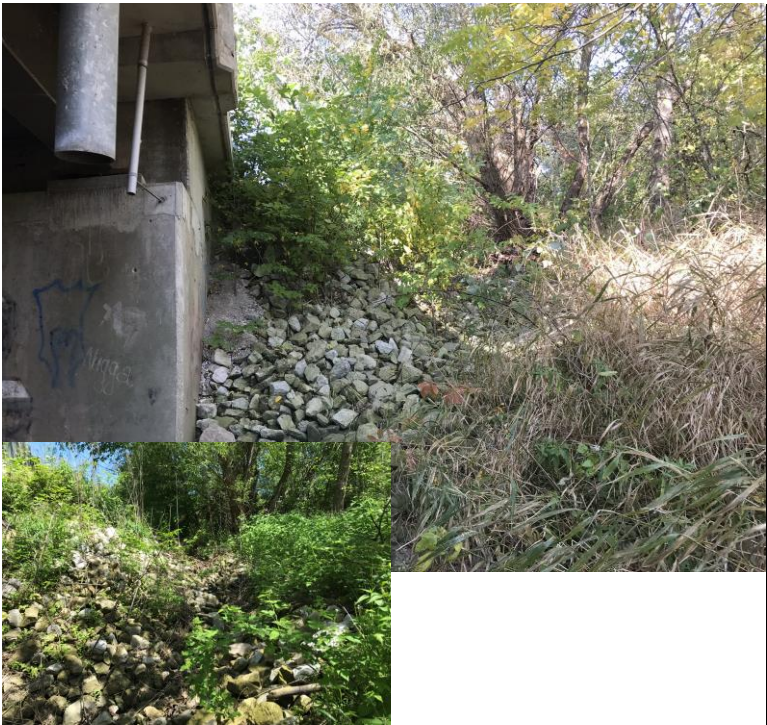
<p>Description</p> <p>Northeast embankments. (Looking North)</p>
---	---

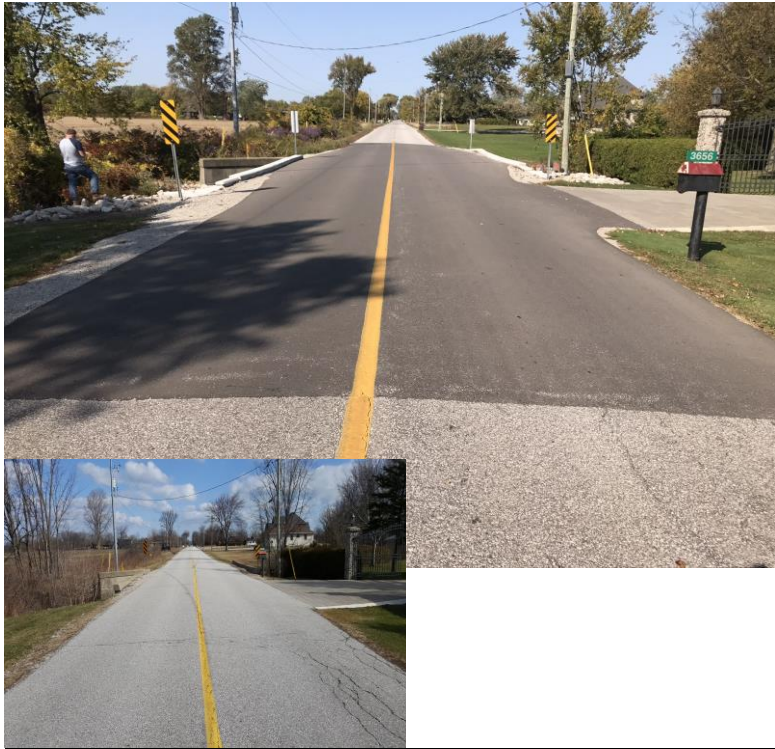
Description
Road over the bridge. (Looking North)

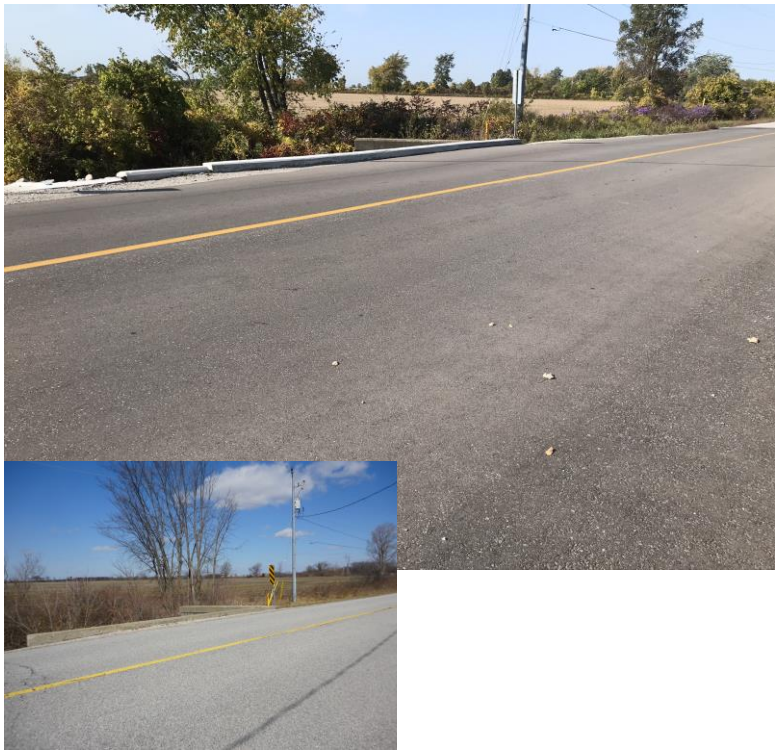
Description
Wearing surface over the bridge. (Looking North)

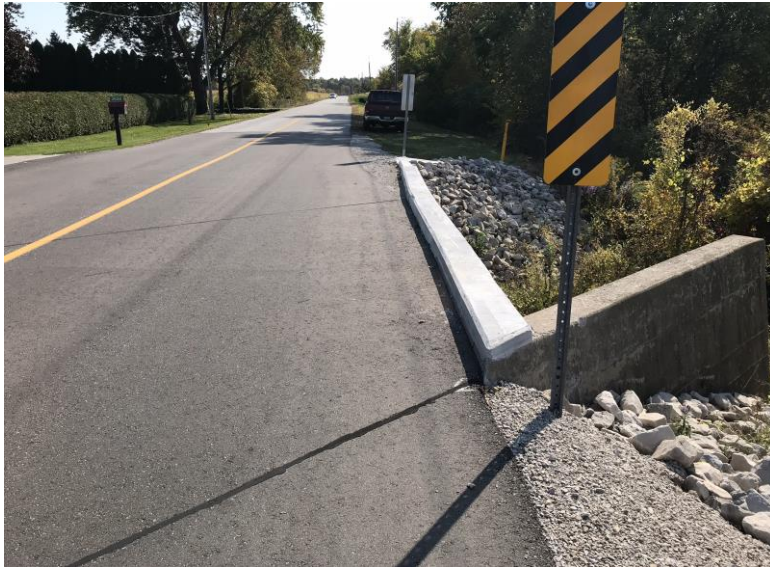
Object marker and new raised curbs on West side (Looking South).

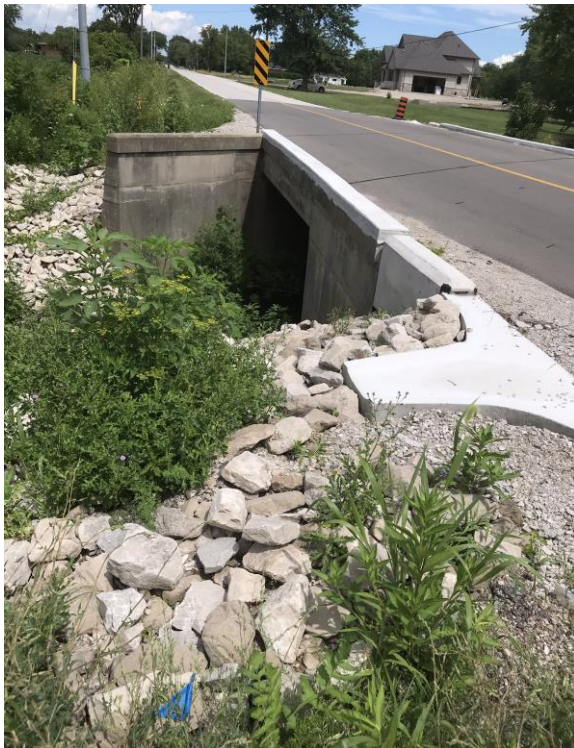
Concrete spillway, precast block retaining wall and raised curb at southwest structure corner. (Looking North).

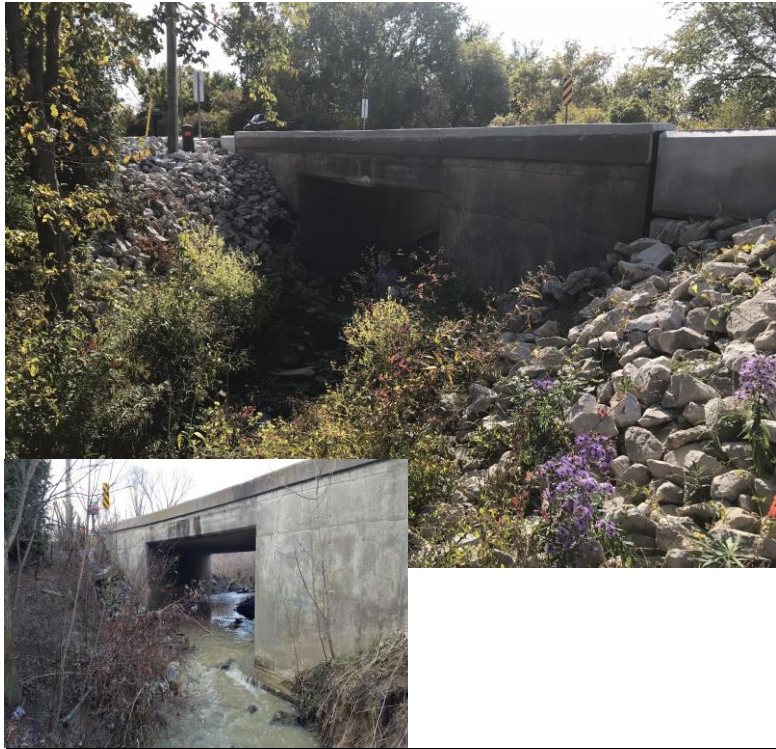
Description
East elevation. (Looking West)

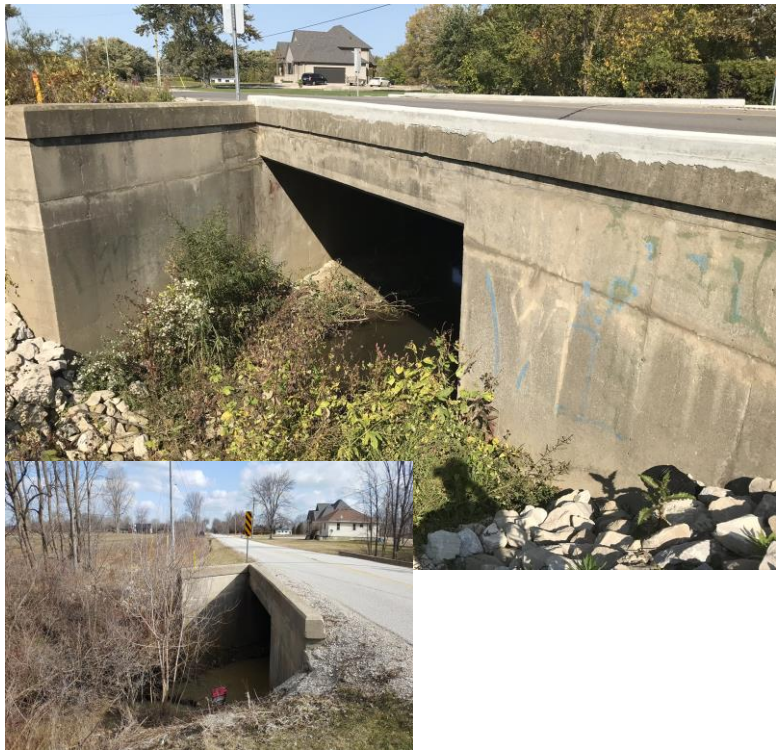
Description
West elevation. (Looking North)

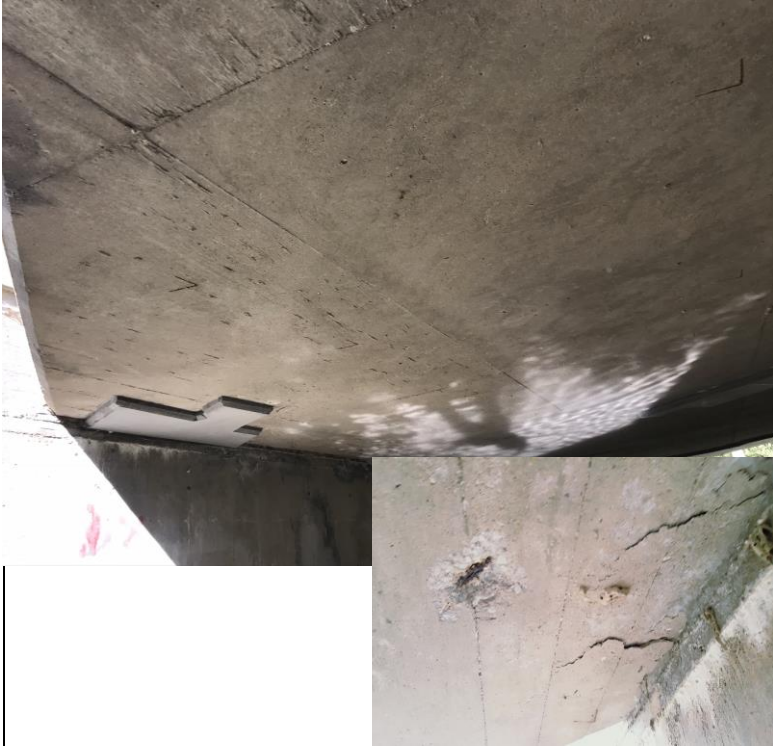
<table border="1"><tr><td>Description</td></tr><tr><td>Concrete soffit patch at near West end of soffit.</td></tr></table>	Description	Concrete soffit patch at near West end of soffit.
Description			
Concrete soffit patch at near West end of soffit.

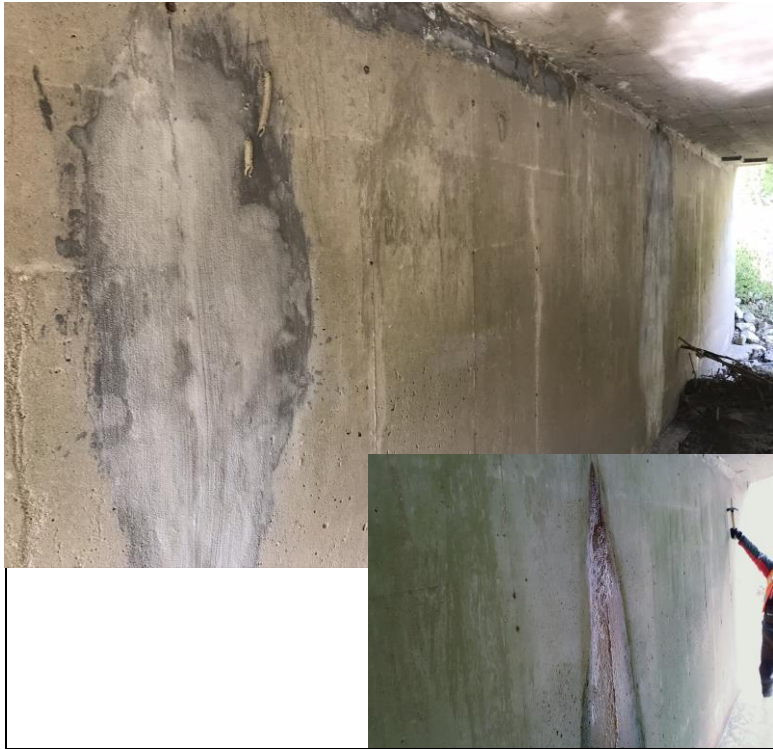
Crack repairs at North abutment.

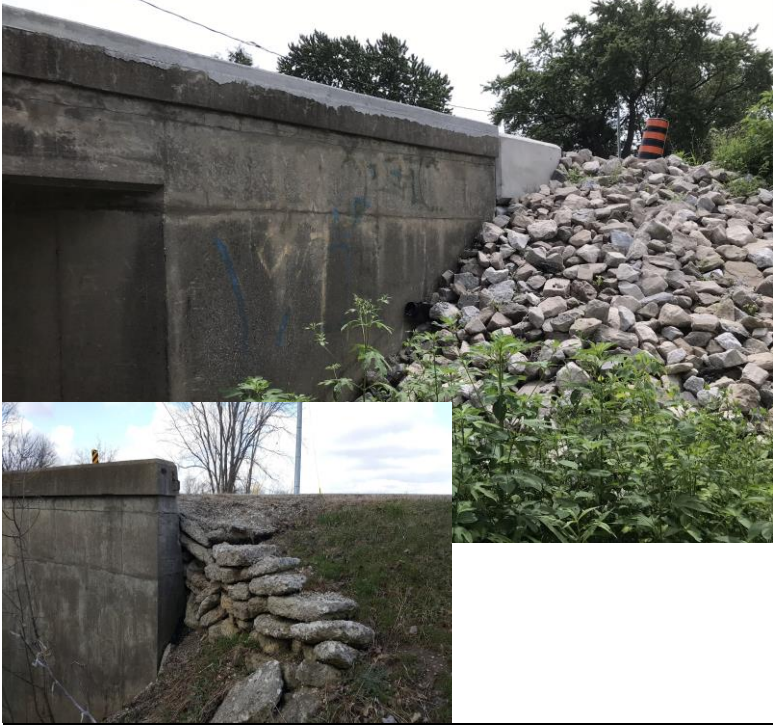
<p>Description</p> <p>New precast block retaining wall and slope protection at northeast embankment. (Looking West)</p>
--	--

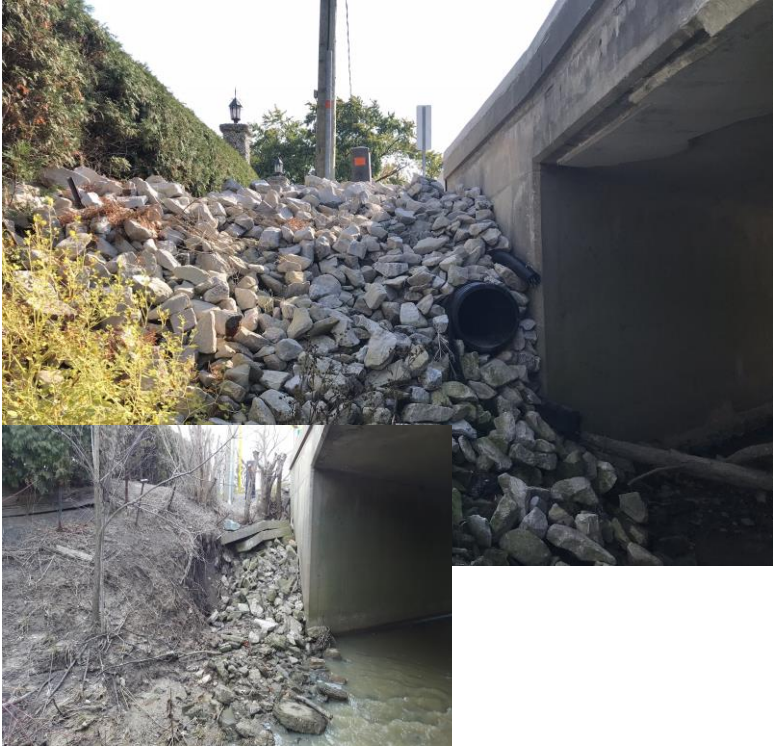
<p>Description</p> <p>New slope protection at southeast embankment. (Looking South)</p>
---	--

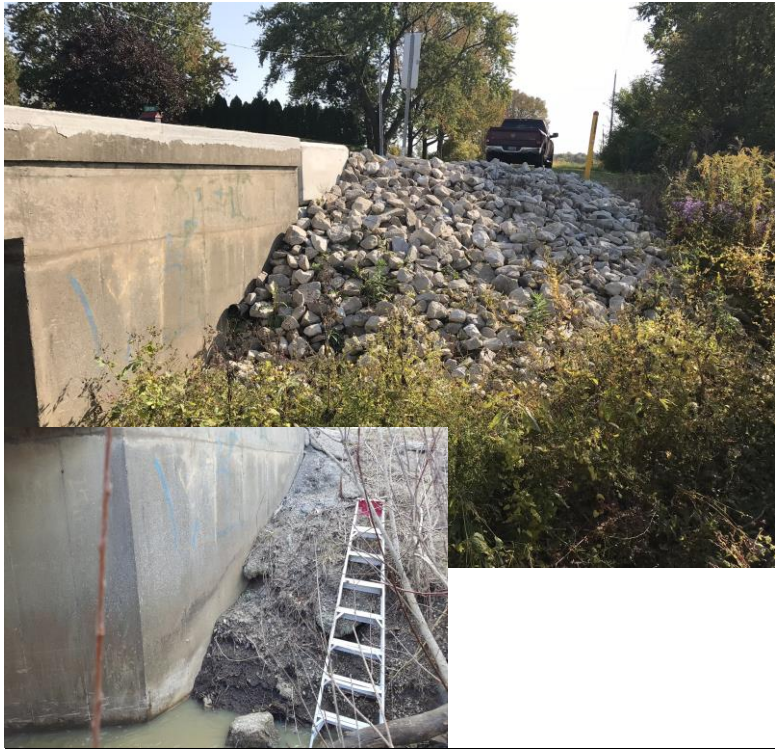
Description
New precast block retaining wall and slope protection at southwest embankment. (Looking South)

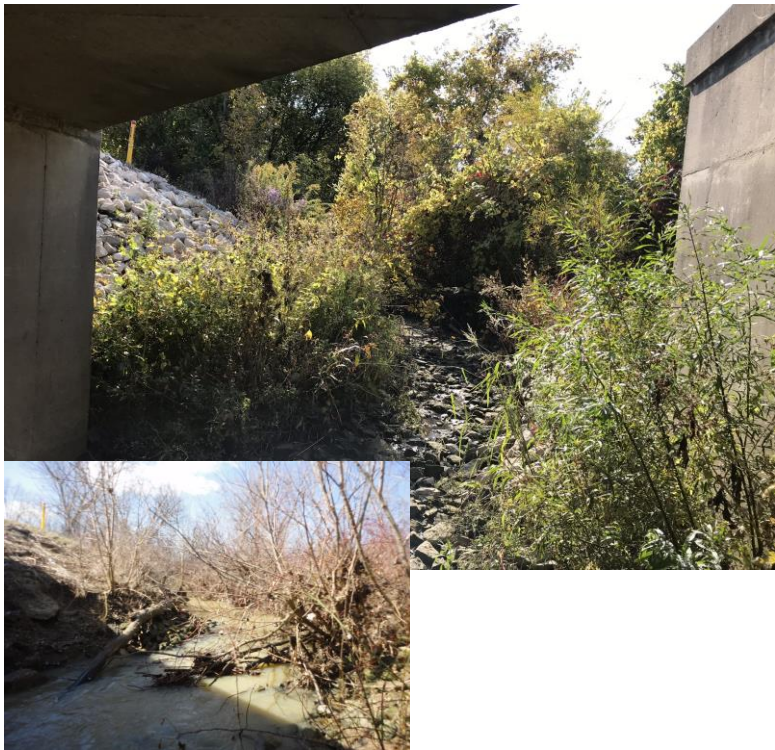
Description
Waterway at west side. (Looking West)

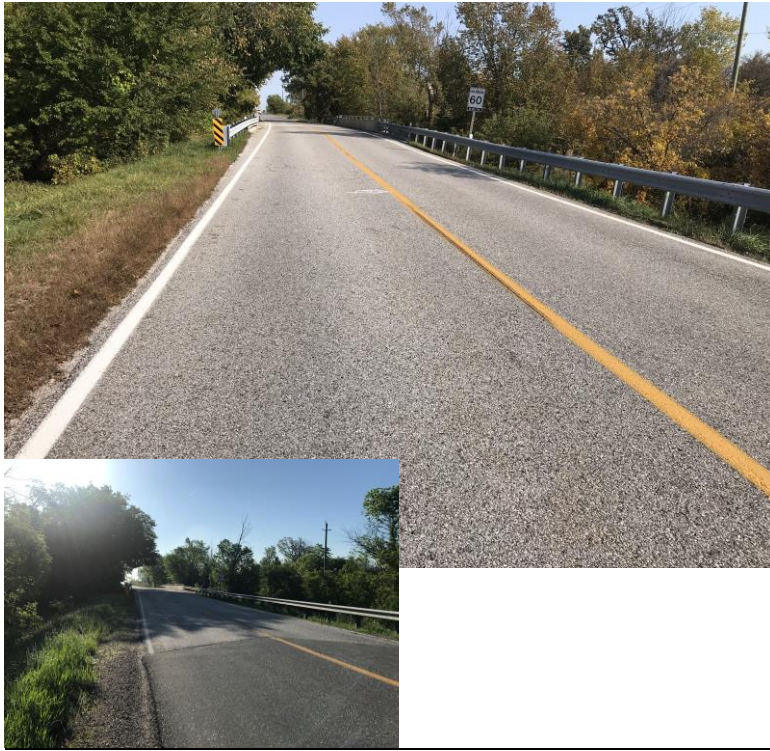
Description
Road over the bridge. (Looking East)

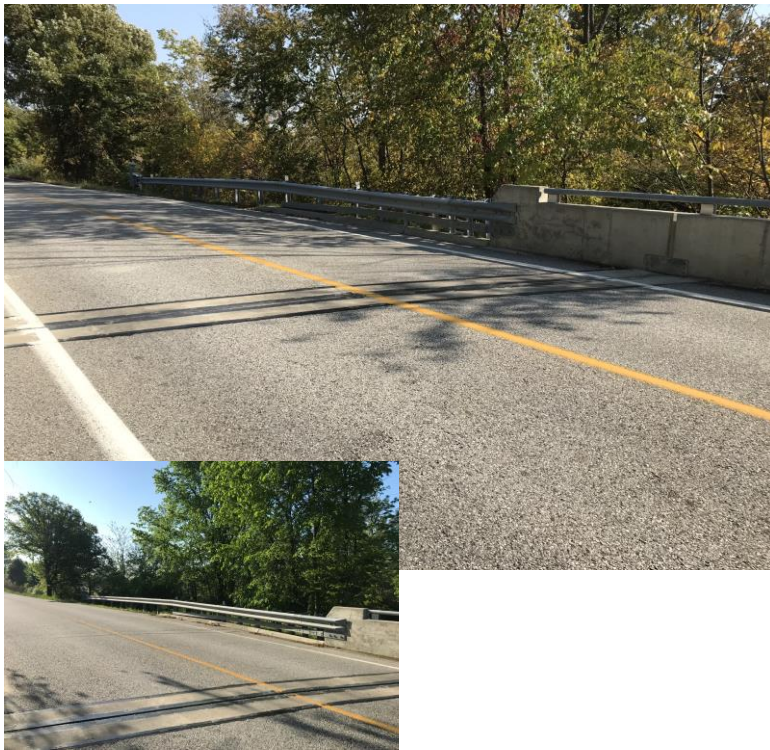
Description
Wearing surface over the bridge, curbs, railing system, and barriers at south edge

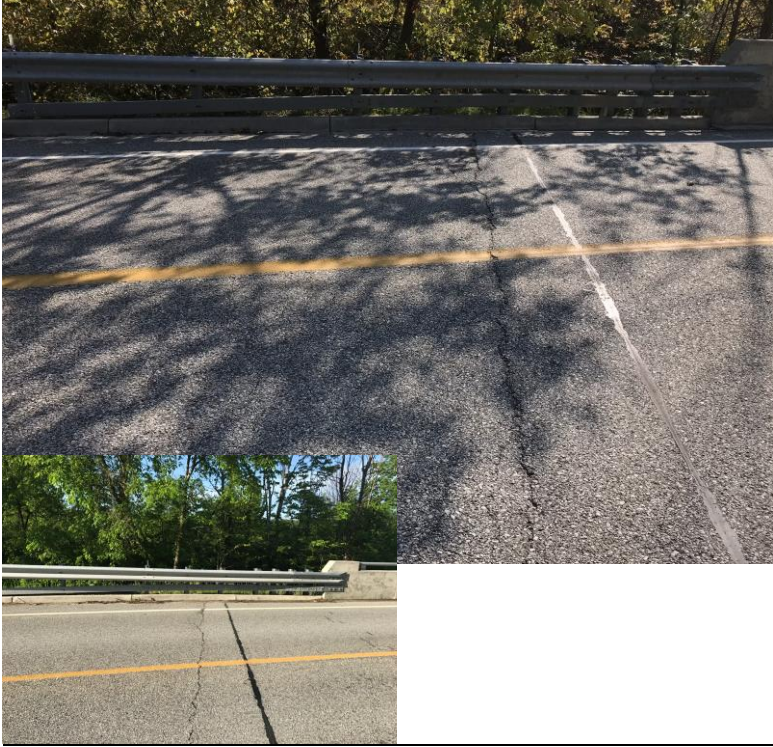
<p>Description</p> <p>Railing system at southeast curb.</p>
--	--

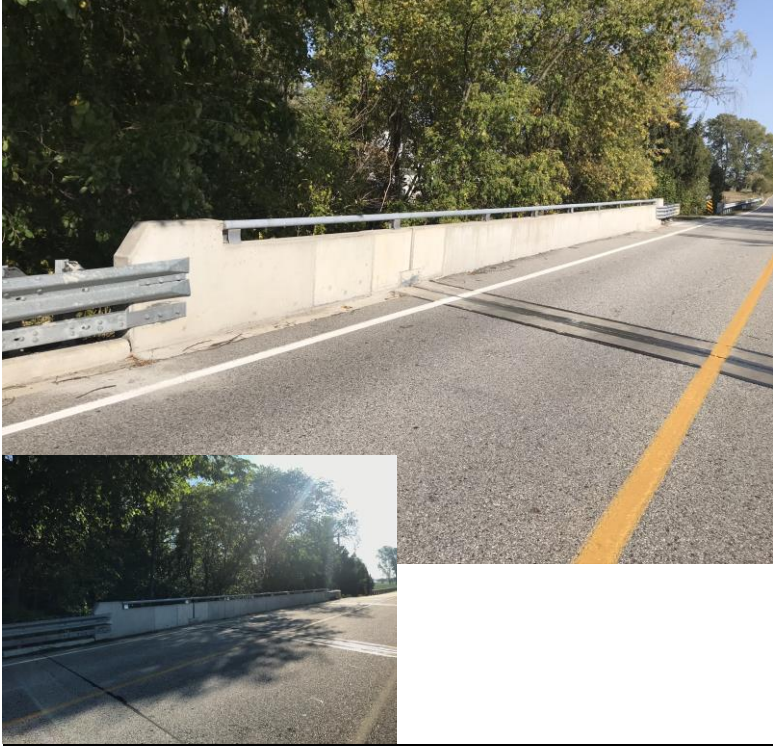
<p>Description</p> <p>Barrier wall at bridge north edge. (Looking West)</p>
---	--

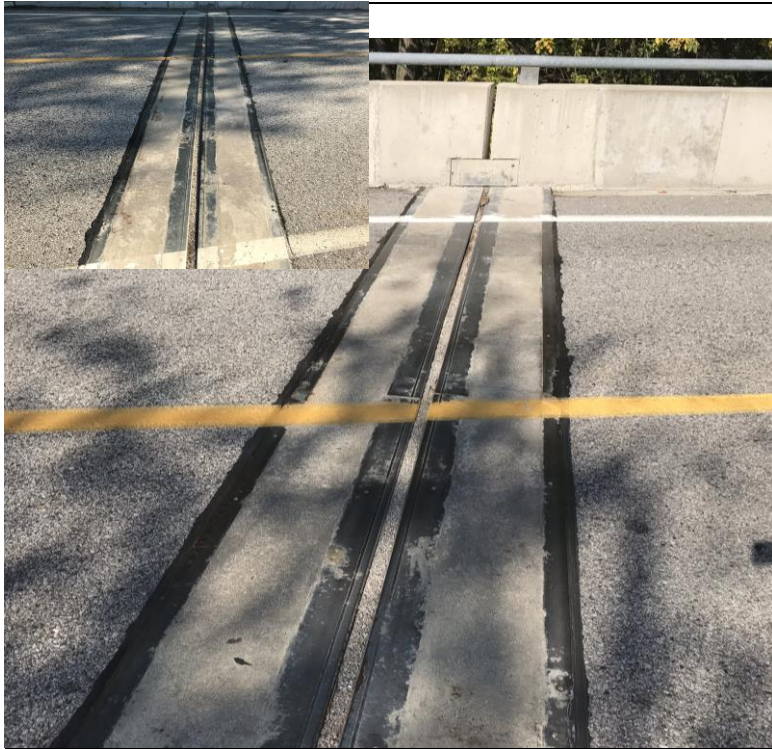
Description
Expansion joint at east of the bridge. (Looking South)

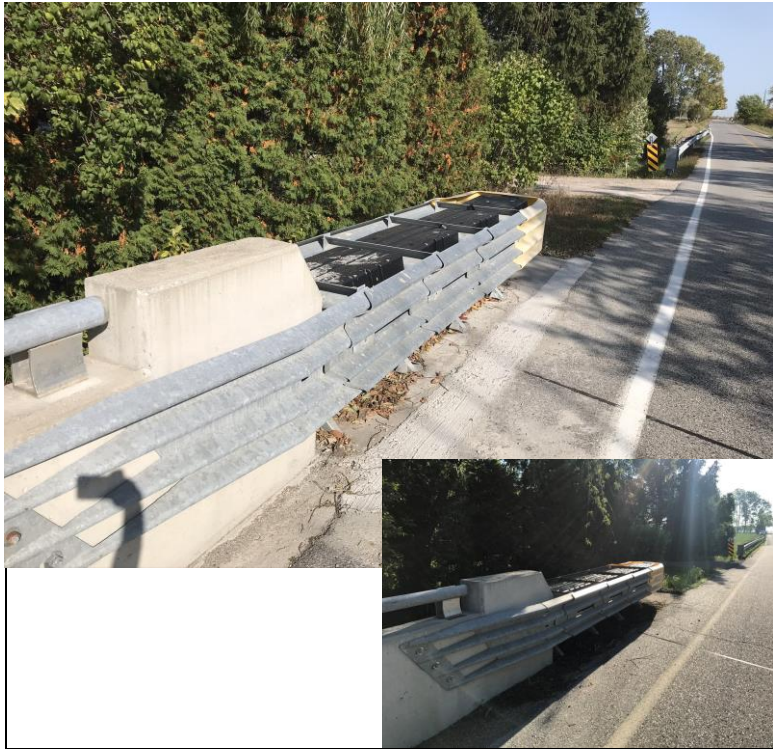
SBEAT at east approach.
(Looking East)

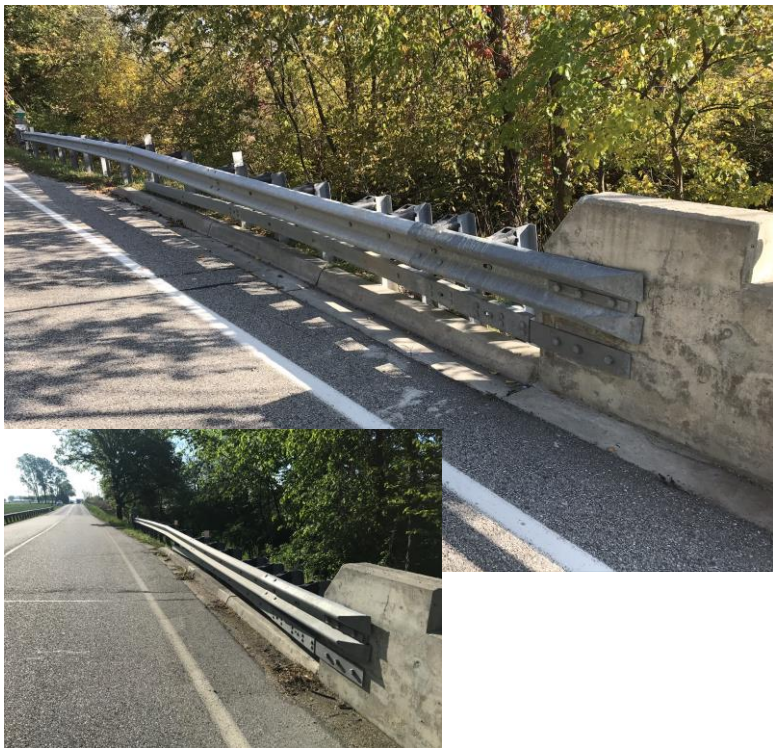
Railing system at southeast curb.

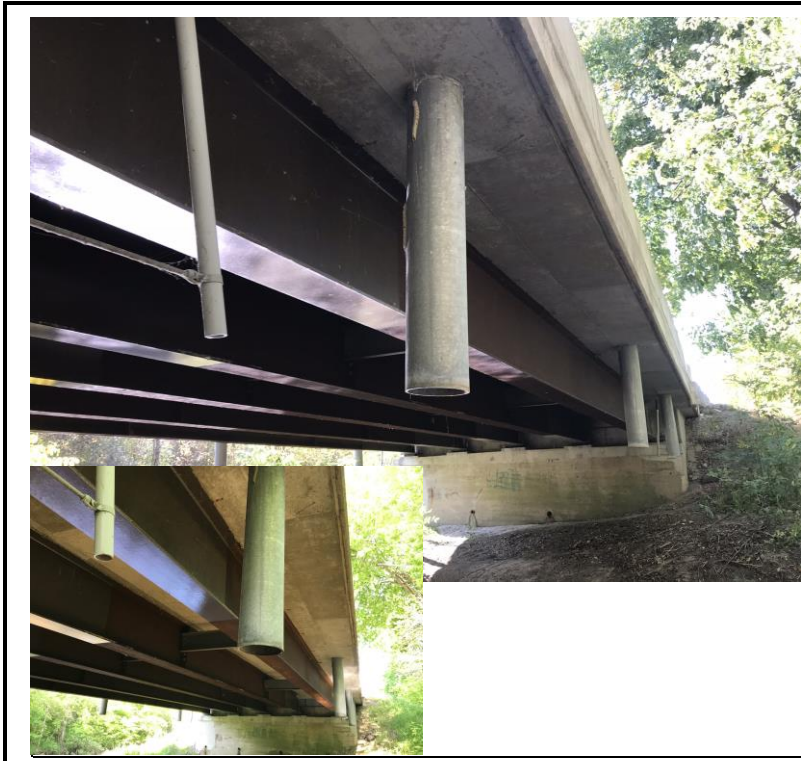
Description
Deck soffit, main girders, diaphragms, and deck drainage. (Looking West)

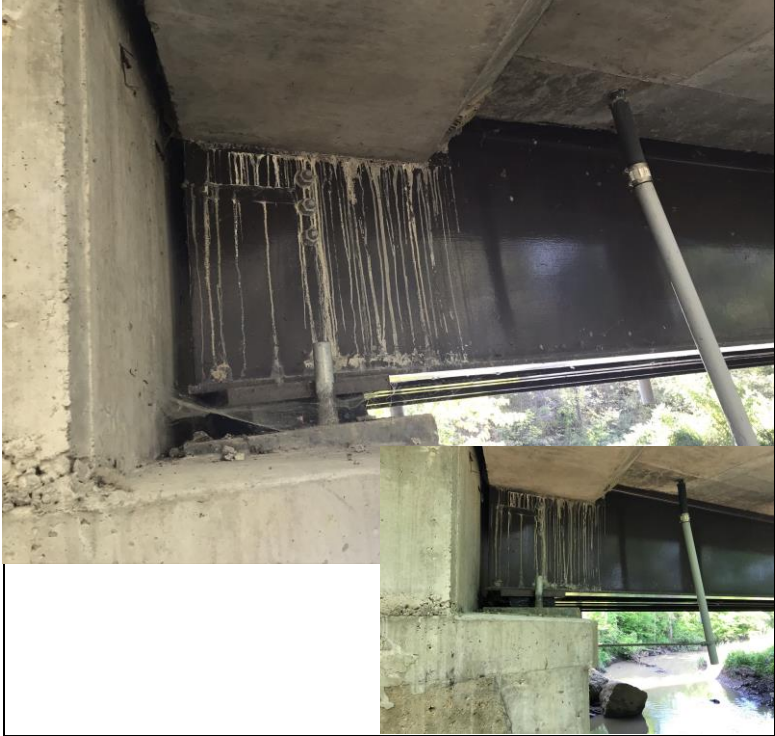
<p>Description Bearing seat at east abutment wall with typical bent anchor bolt. (Looking South)</p>
--	---

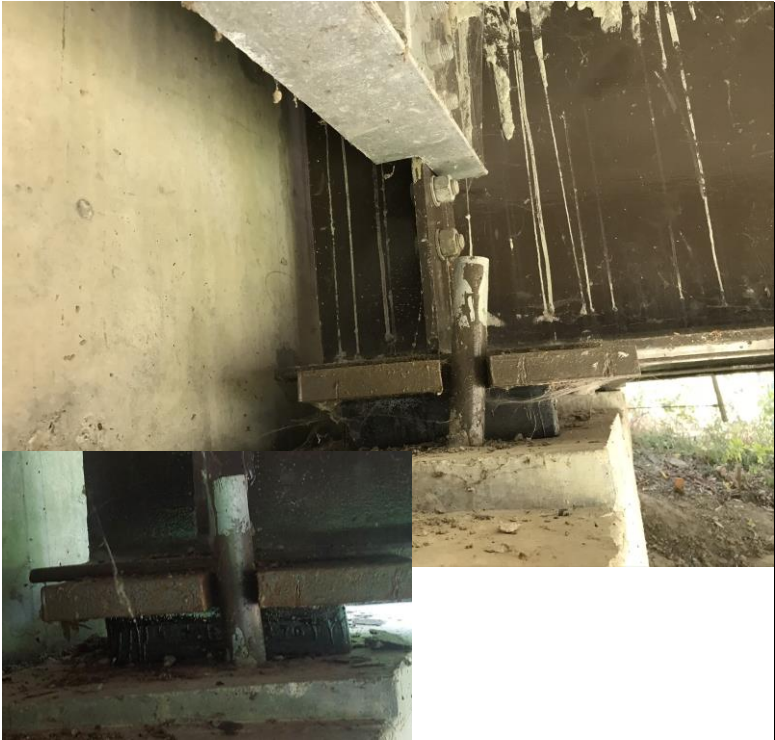
<p>Description Misaligned anchor rod at abutment bearings (typ.)</p>
---	---

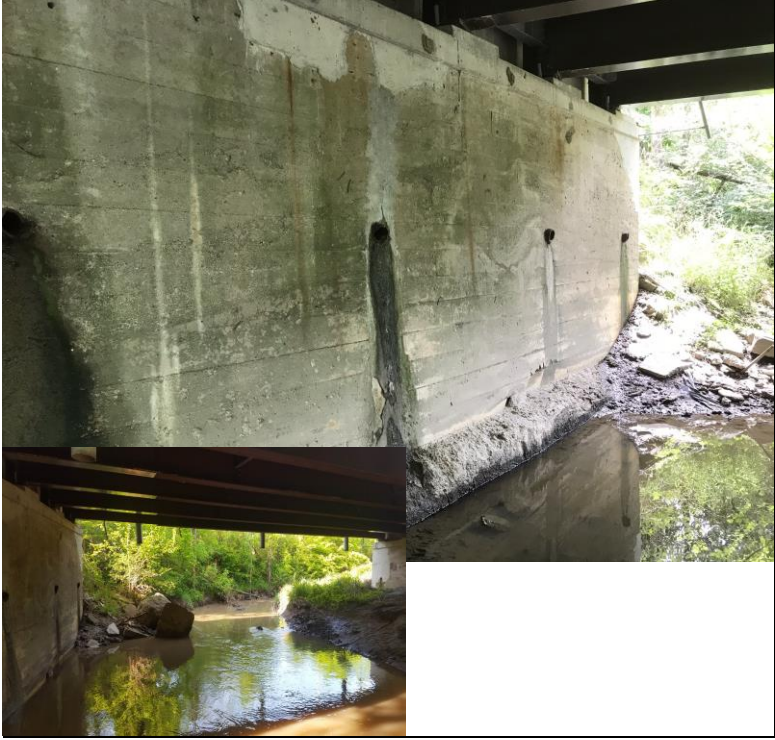
<p>Description Wall drains at East abutment. (Looking South)</p>
--	---

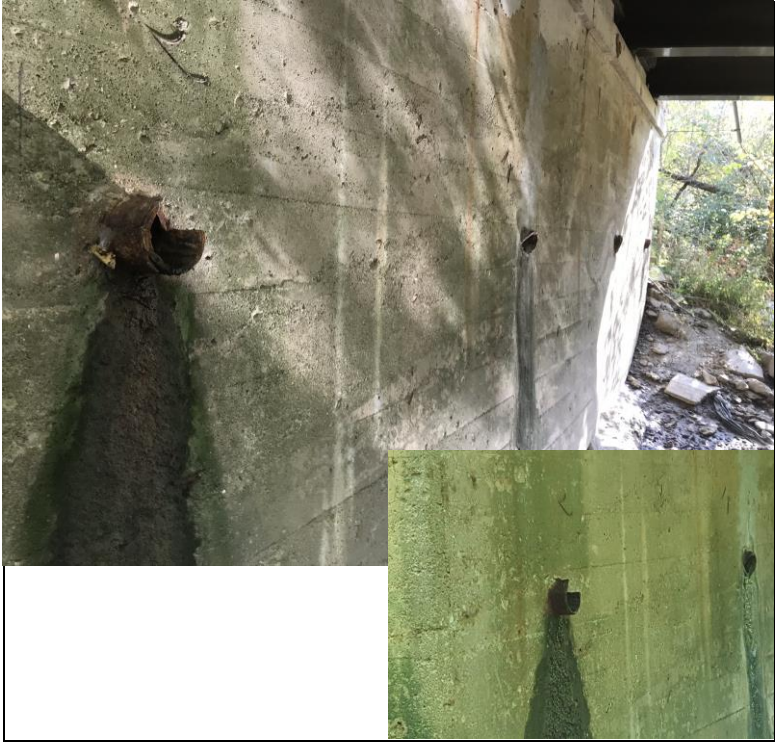
<p>Description East abutment wall drains</p>
---	---

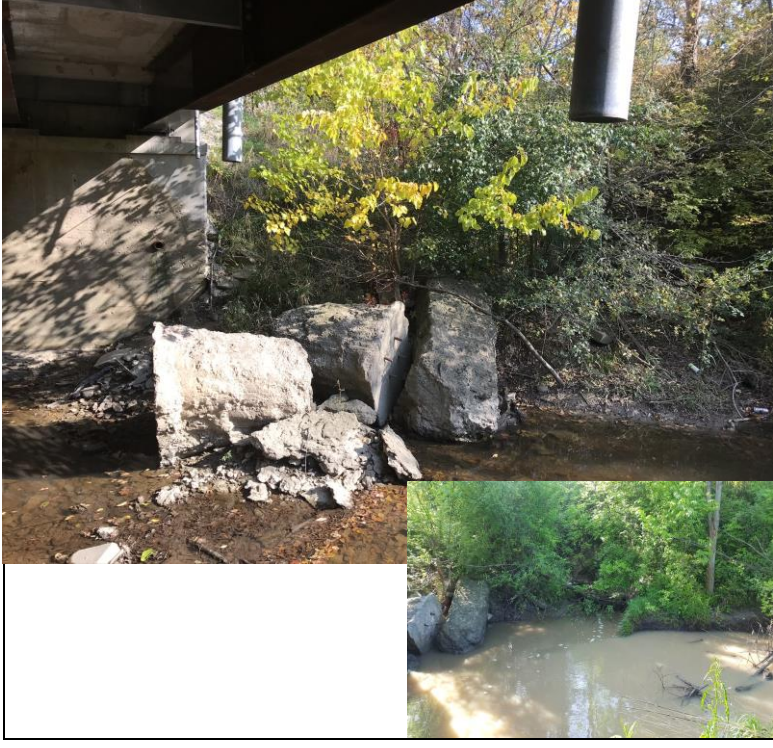
<p>Description Embankments and waterway at south side. (Looking South)</p>
---	---

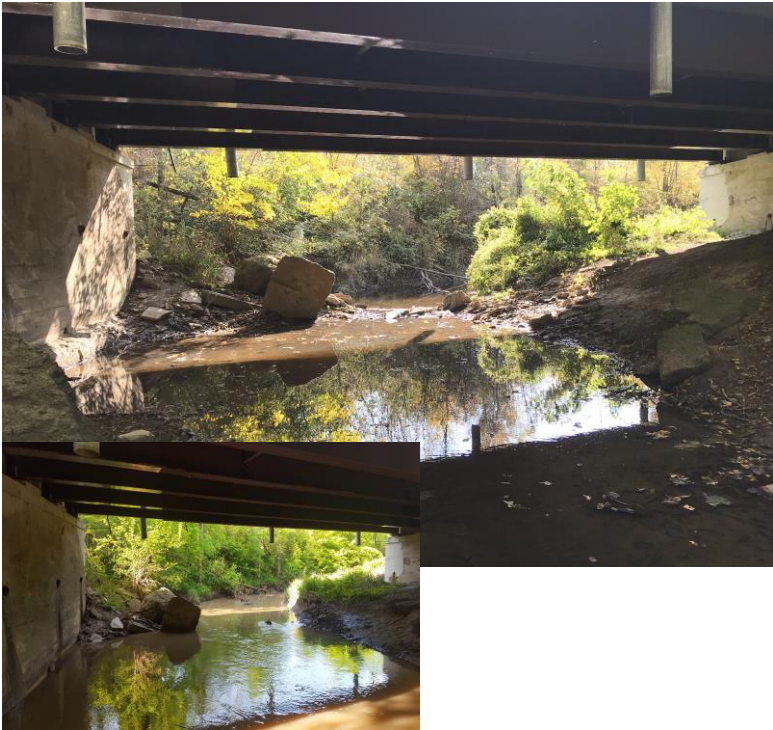
<p>Description Waterway. (Looking South)</p>
--	---

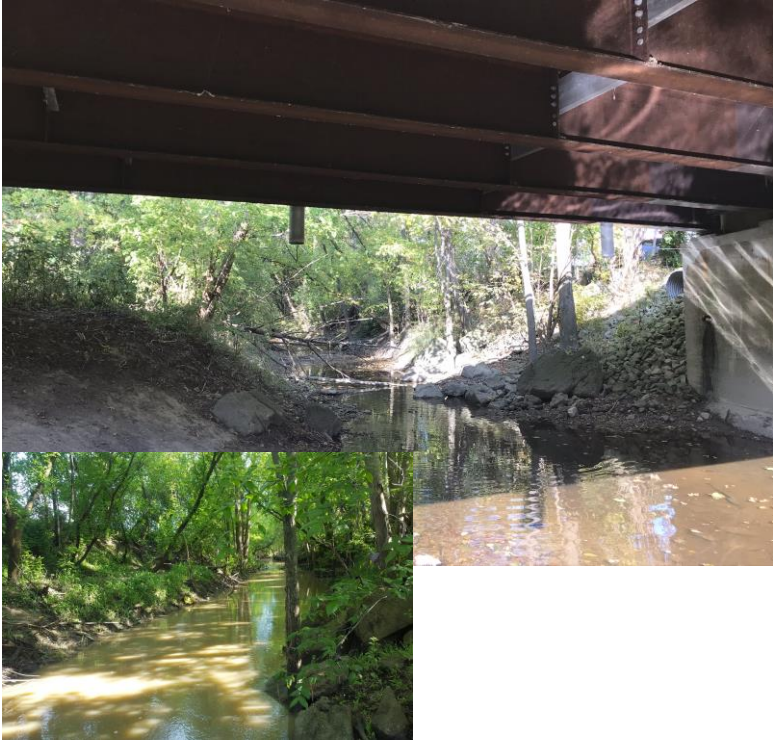
<p>Description Embankments and waterway. (Looking North)</p>
---	---

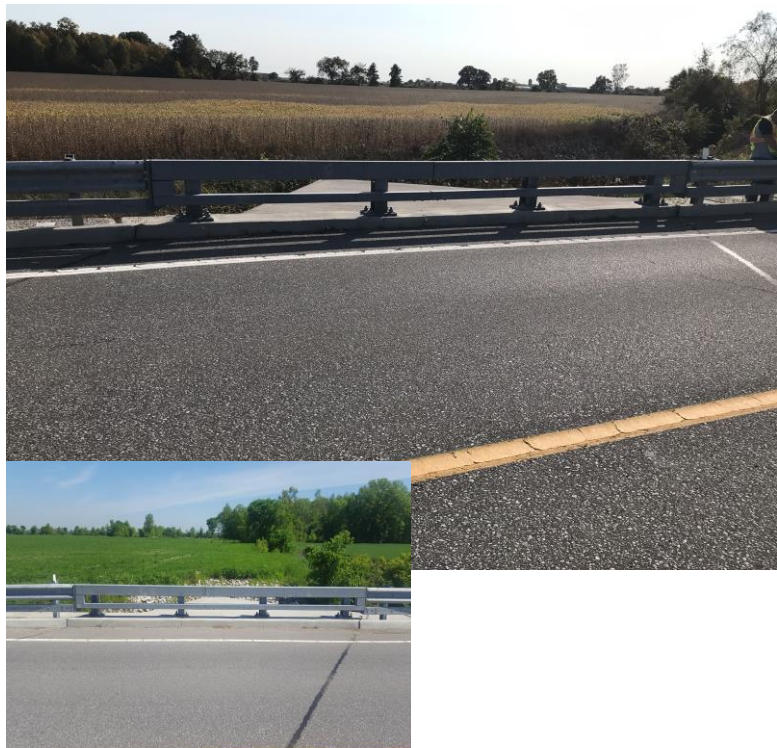
<p>Description</p> <p>Wearing surface over the bridge. (Looking South)</p>
---	---

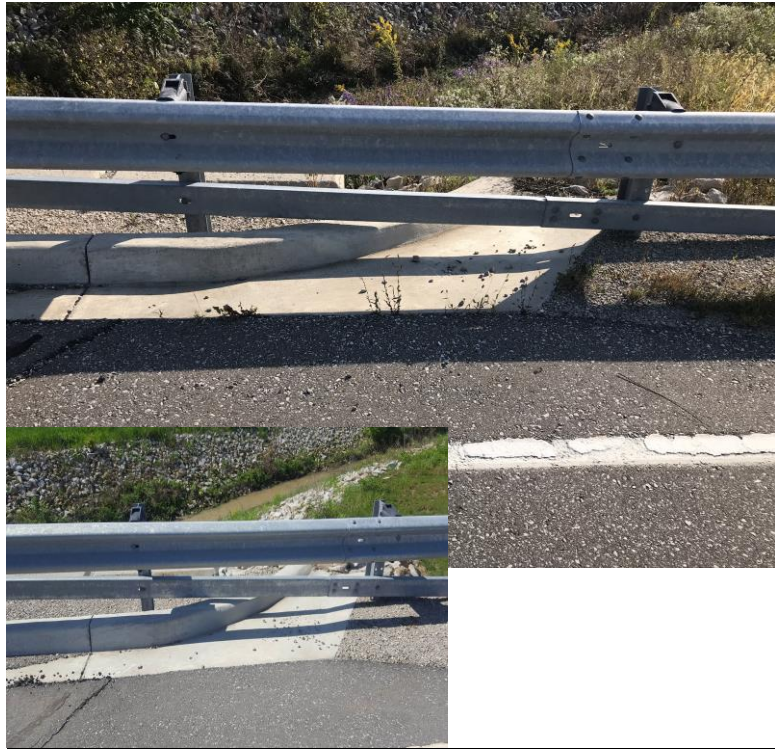
Description
Spillway at SW corner. (Looking South)

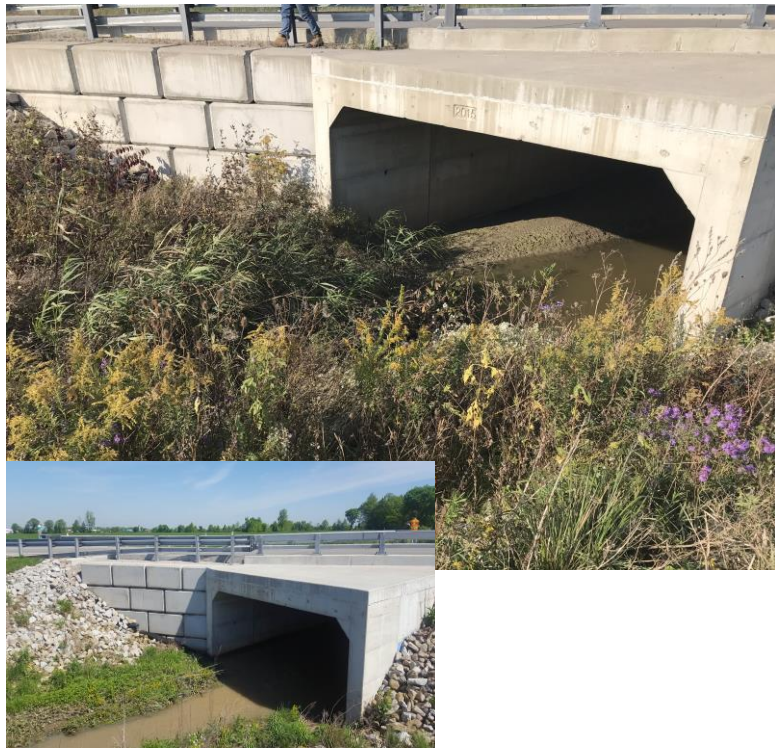
Description
South elevation. (Looking North)

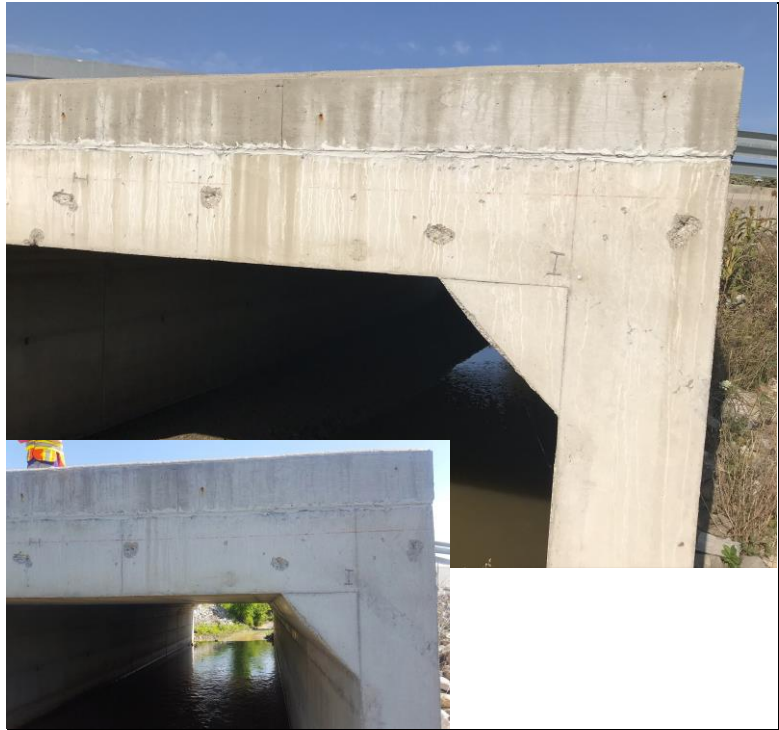
<p>Description</p> <p>Discrete locations of light spalling at the south headwall.</p>
--	--

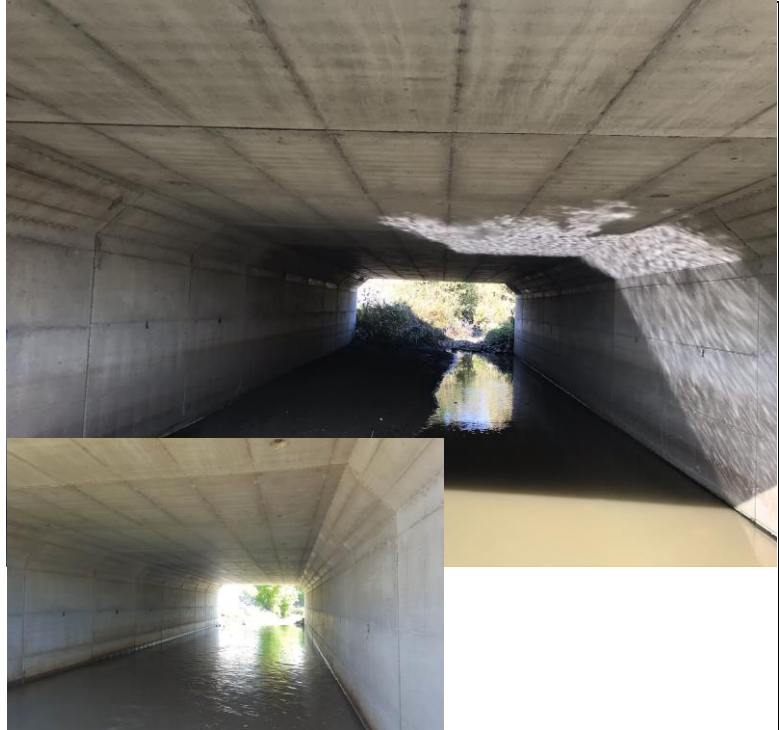
<p>Description</p> <p>Structure barrel (Looking North).</p>
---	--

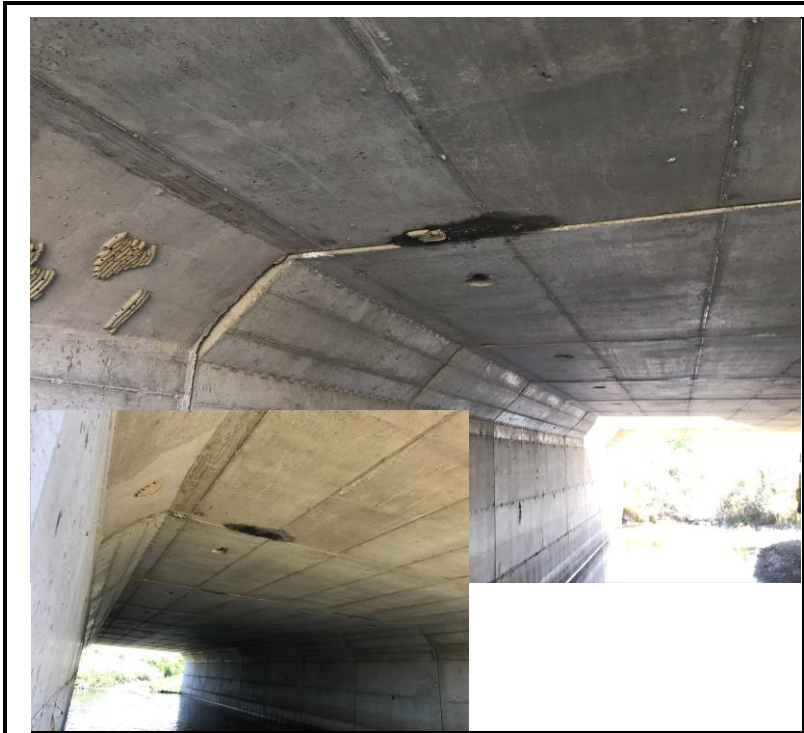
Description
Existing concrete parging at precast unit joint.
