CORPORATION OF THE TOWN OF TECUMSEH
2020 Bridge and Culvert Needs Study
Structures with Spans > 3.0 m

March 30, 2021

Town of Tecumseh
2020 Bridge and Culvert Needs Study
Structures with Spans > 3.0 m

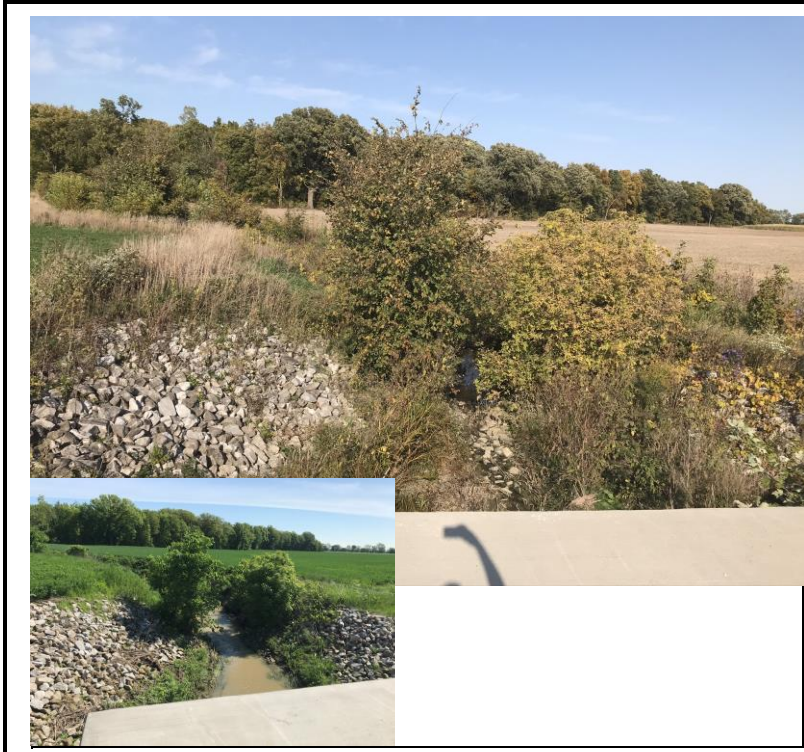
Description
North embankments and waterway. (Looking North)

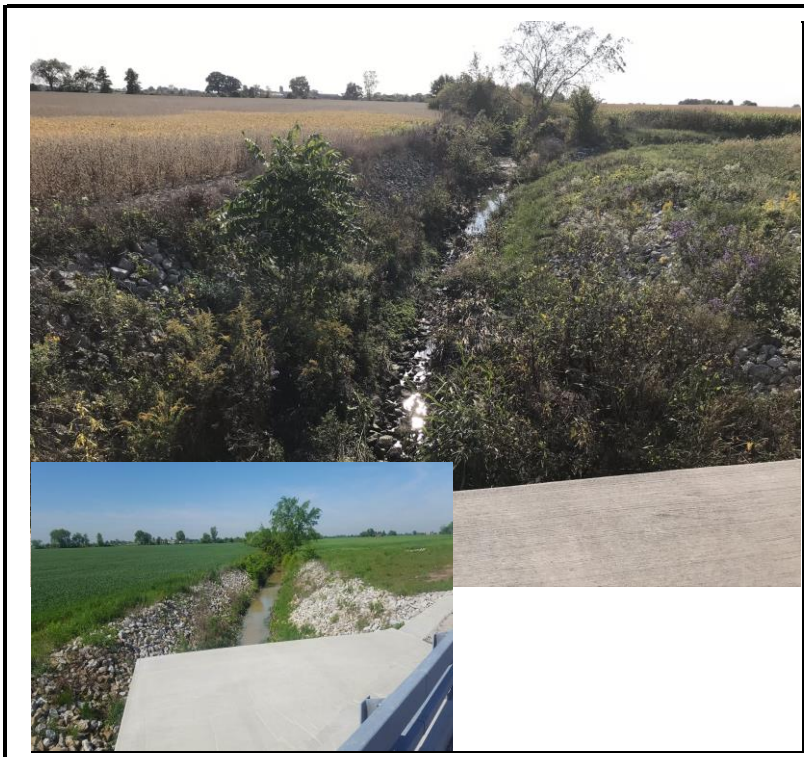
Description
Embankments and waterway. (Looking South)

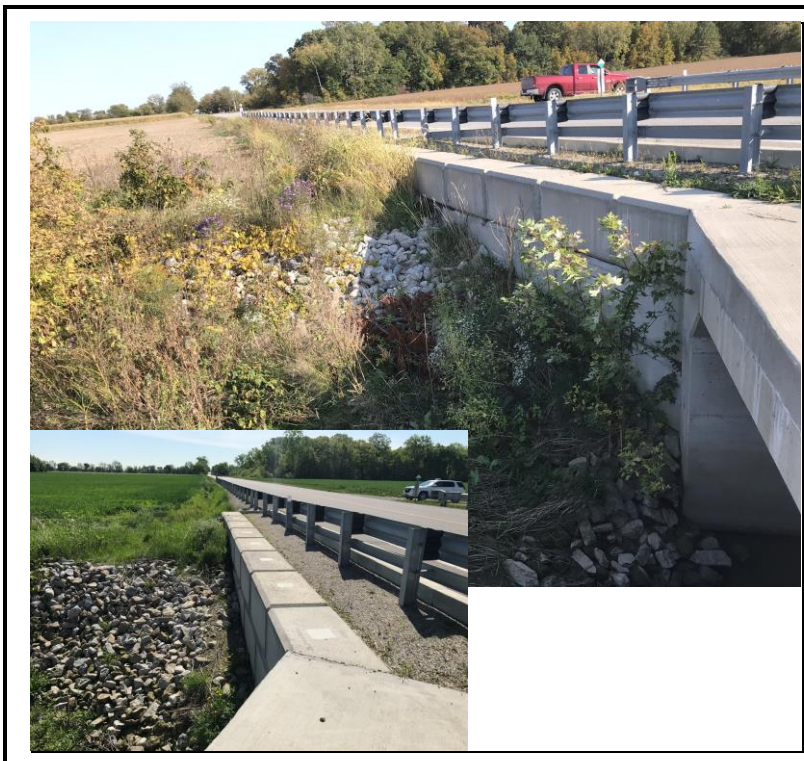
Description
Embankments and retaining walls at north elevation. (Looking East)

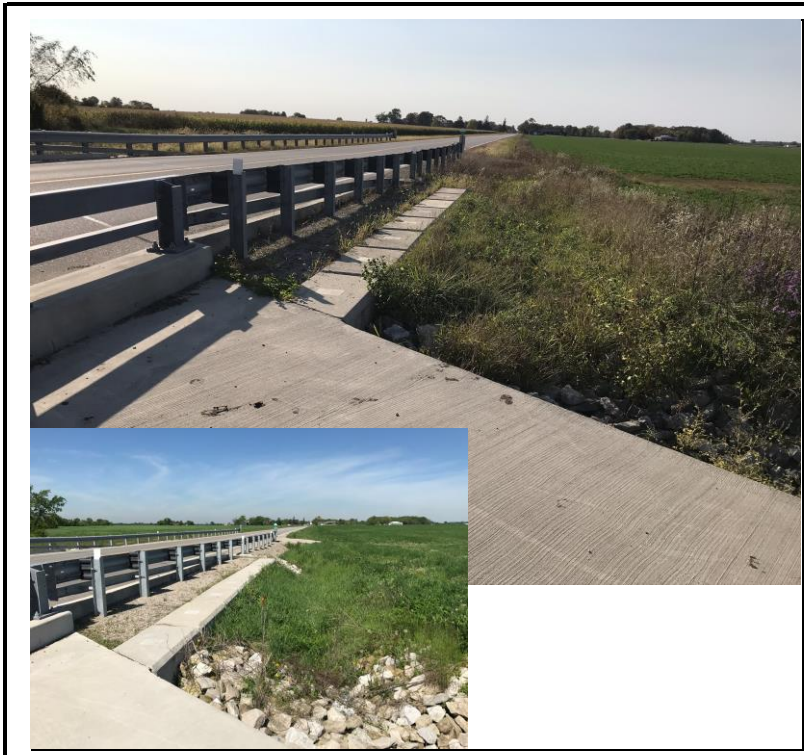
Description
Embankments and retaining walls at north elevation. (Looking West)

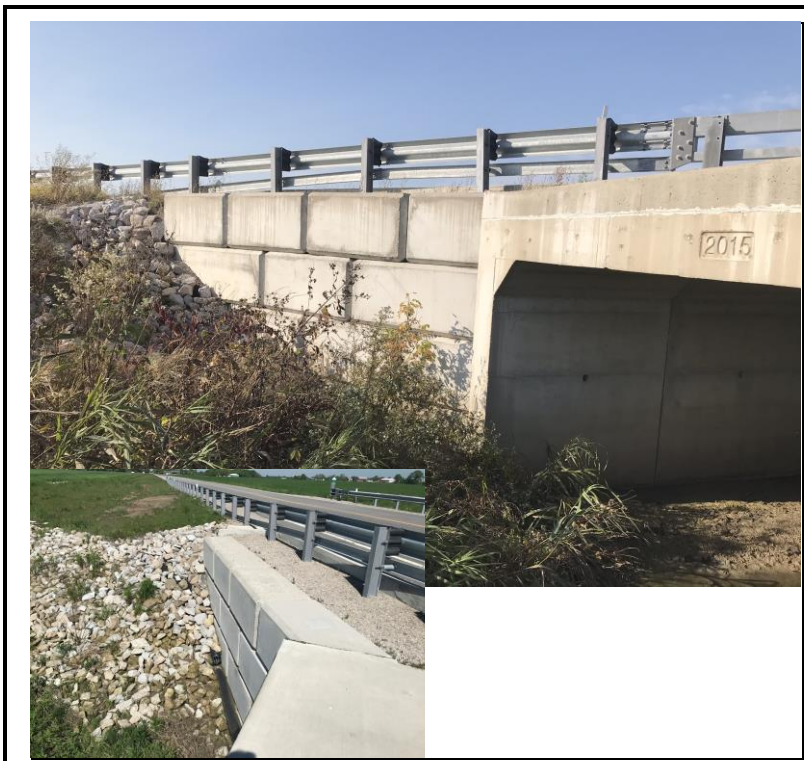
Description
Embankments and retaining walls at south elevation. (Looking West)

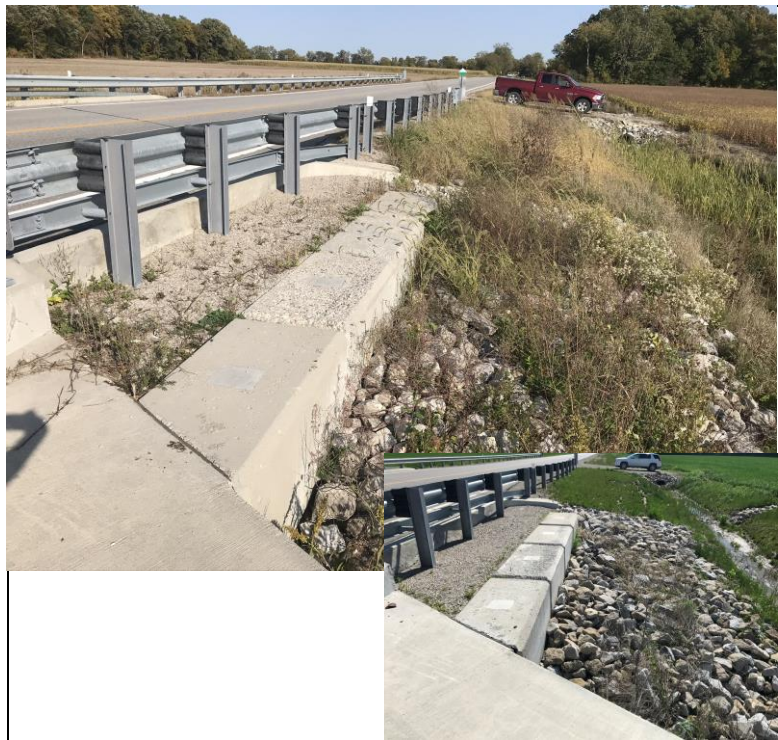
Description
Embankments and retaining walls at south elevation. (Looking East)

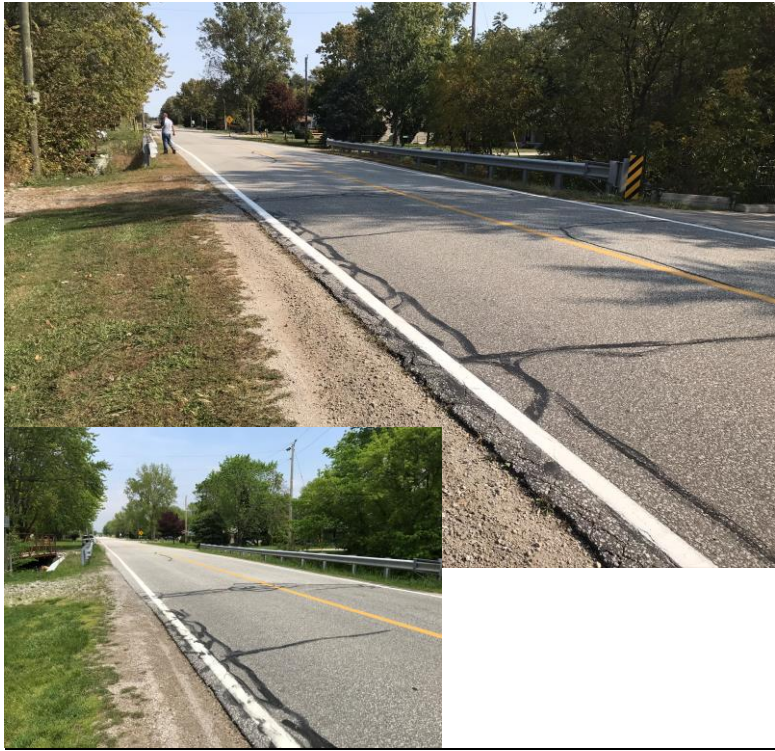
Description
Road over the bridge. (Looking North)

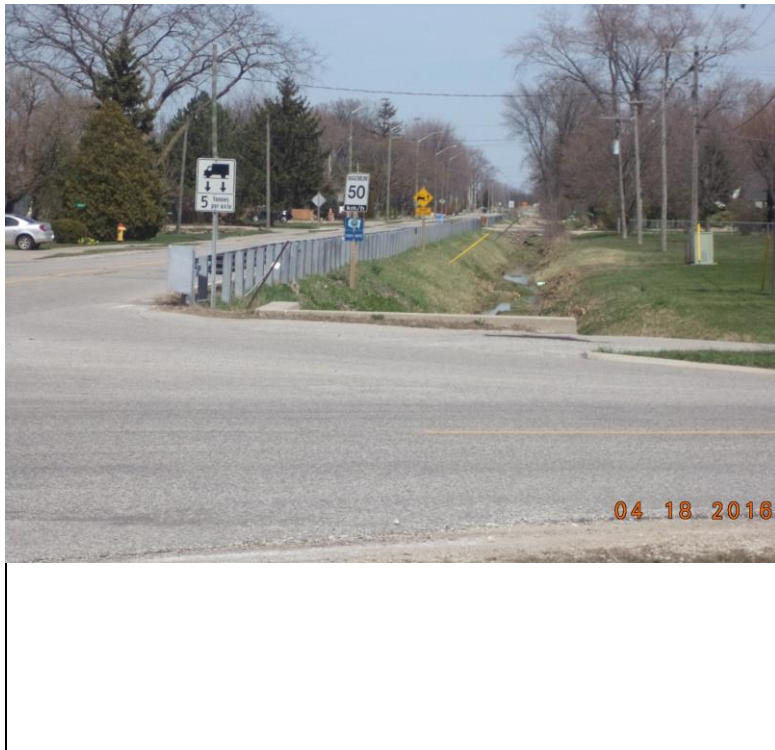
Description
Load limit and speed limit signs.

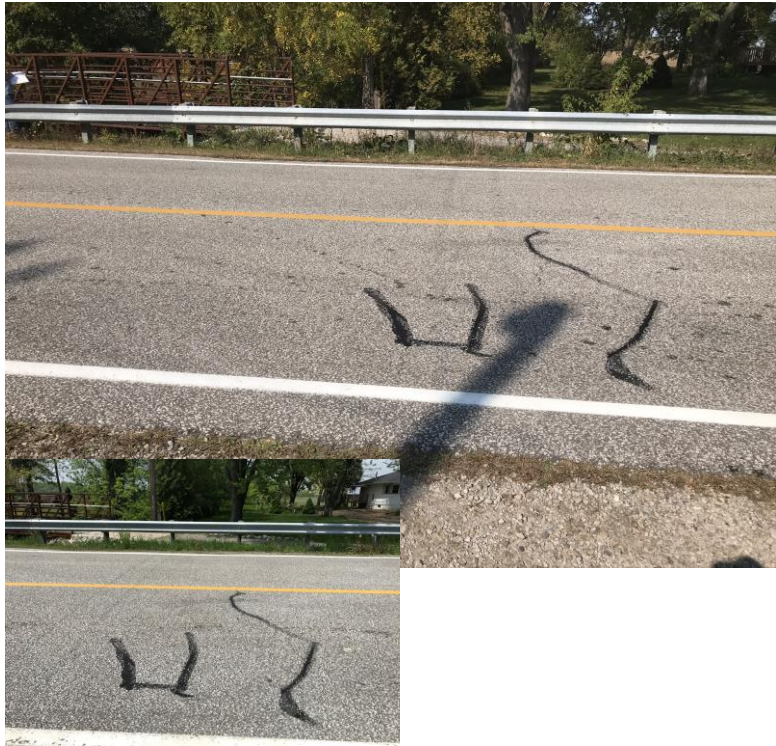
Description
Road at the north approach. (Looking West)

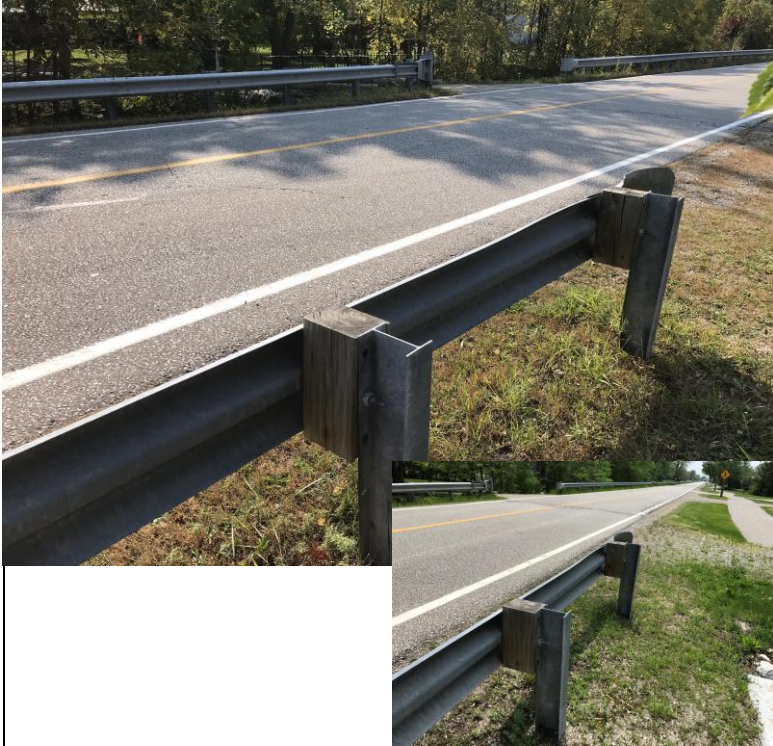
<p>Description</p> <p>Guide rail end treatment at the south-west corner.</p>
---	---

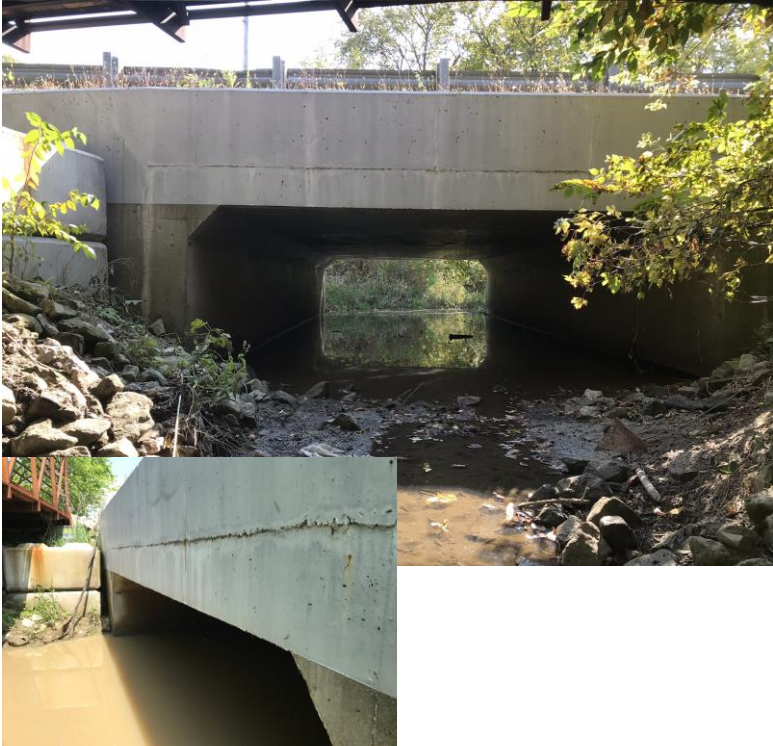
<p>Description</p> <p>West elevation.</p>
---	--

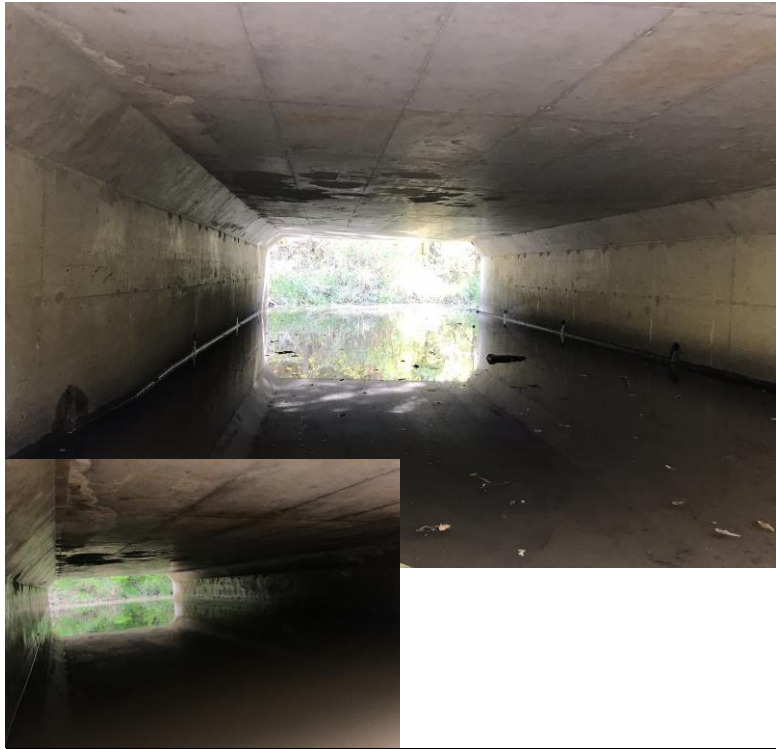
Description
Inside box. (Looking West)

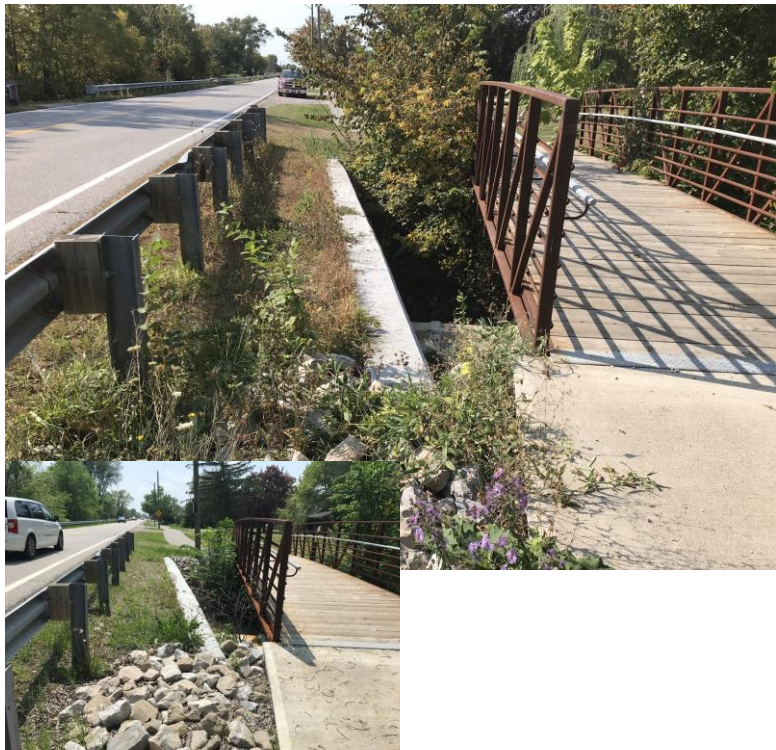
Description
Pedestrian bridge at east elevation. (Looking South)

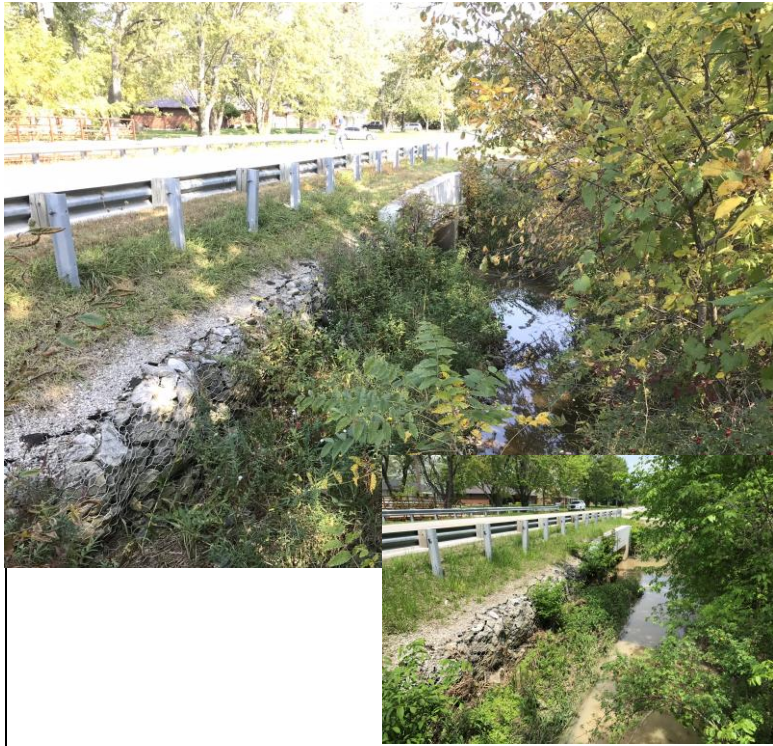
Embankments, retaining elements at west elevation. (Looking North)

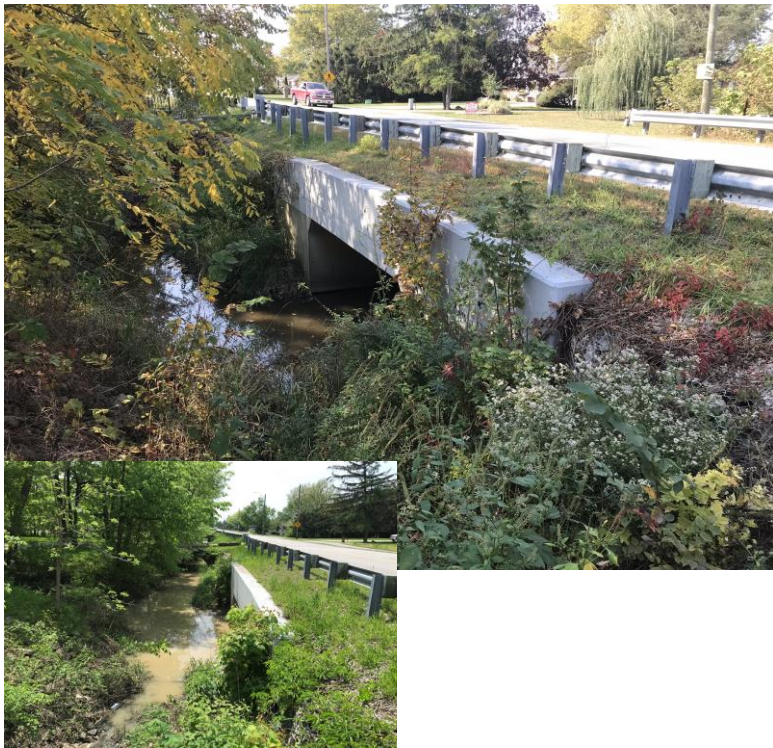
Embankments, retaining elements at west elevation. (Looking South)

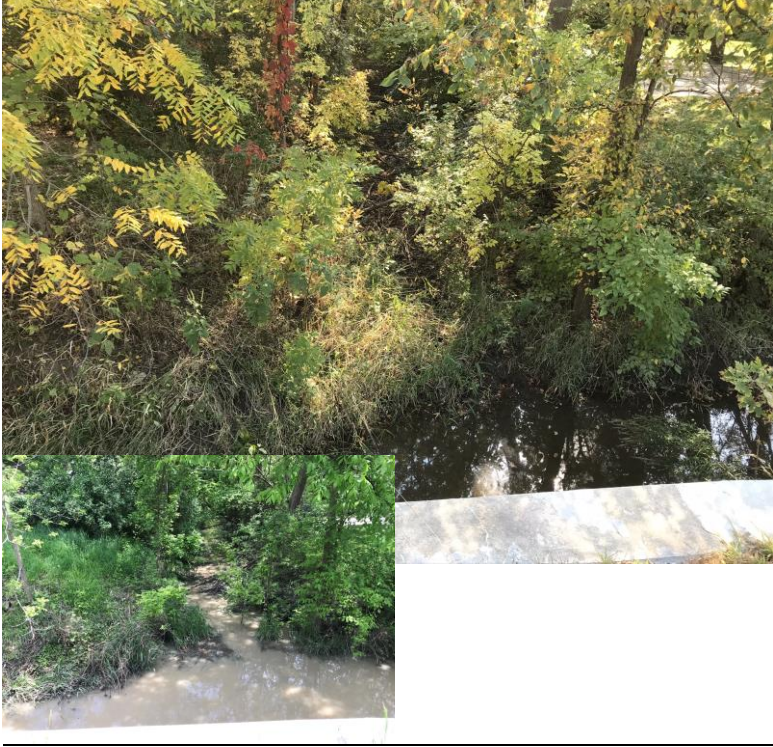
<p>Description</p> <p>Waterway at the east inlet. (Looking East)</p>
--	---

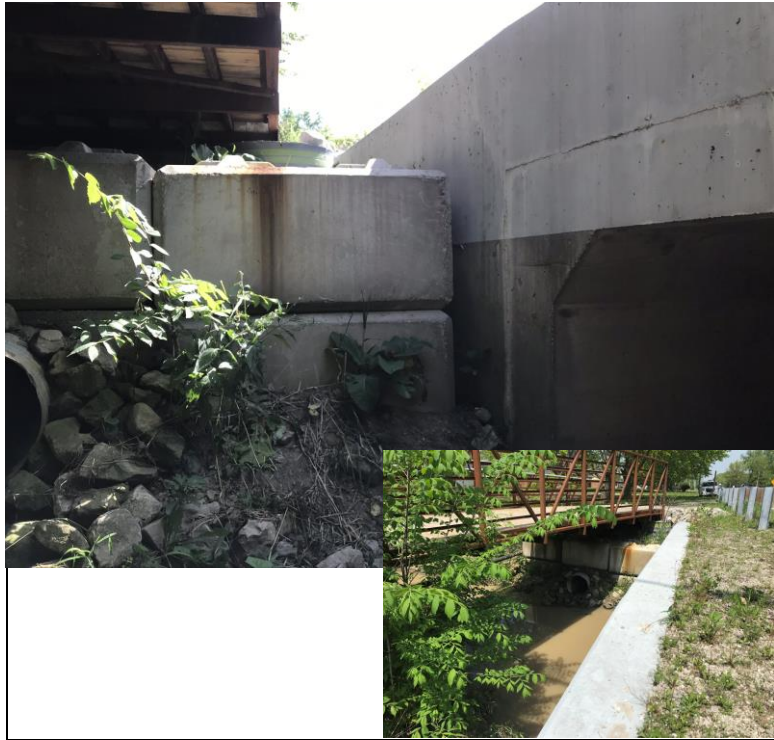
Description
C.S.P outlet, retaining structure, and pedestrian bridge and support, at west elevation. (Looking North)

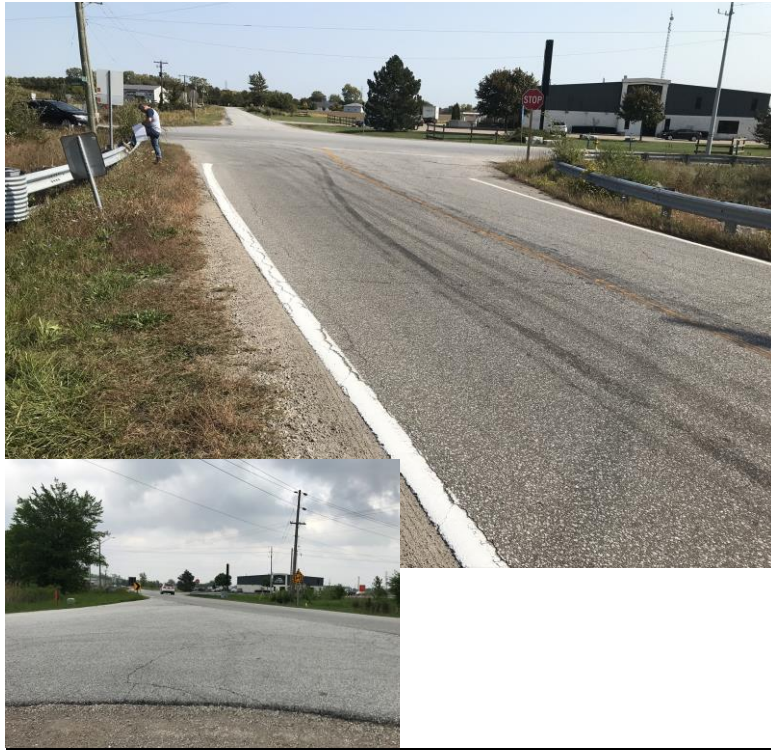
Description
Road over the culvert (Looking East)

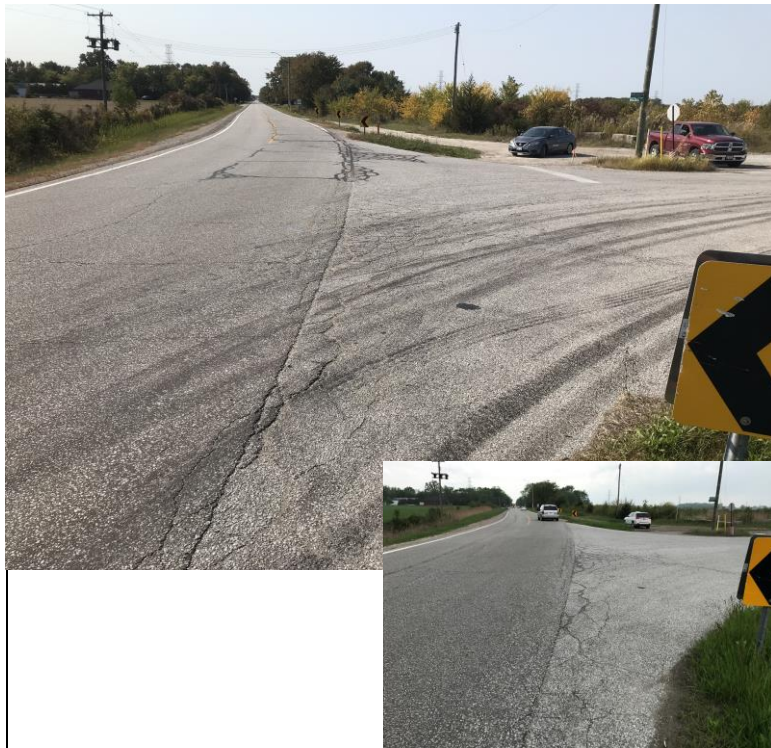
Wearing surface at west approach.

Element Group:	Approaches		Length:	6.0 m		
Element Name:	Wearing Surface		Width:	9.6 m		
Location:	East/West Approach		Height:			
Material:	Asphalt		Count:	2		
Element Type:			Total Quantity:	115.2 sq.m		
Environment:	Moderate		Limited Inspection			
Protection System:						Perform. Deficiencies
Condition	Units	Exc.	Good	Fair	Poor	
Data:	Sq.m / m / each / % / all	0.0	65.2	50.0	0.0	
Comments: Medium to severe map cracking at both approaches. Settlement noted at SE structure corner.						
Recommended Work:	Rehab	Replace	Maintenance Needs:			
	1-5 years	6-10 years	Urgent	x	1 year	2 year
			Crack sealing or repave.

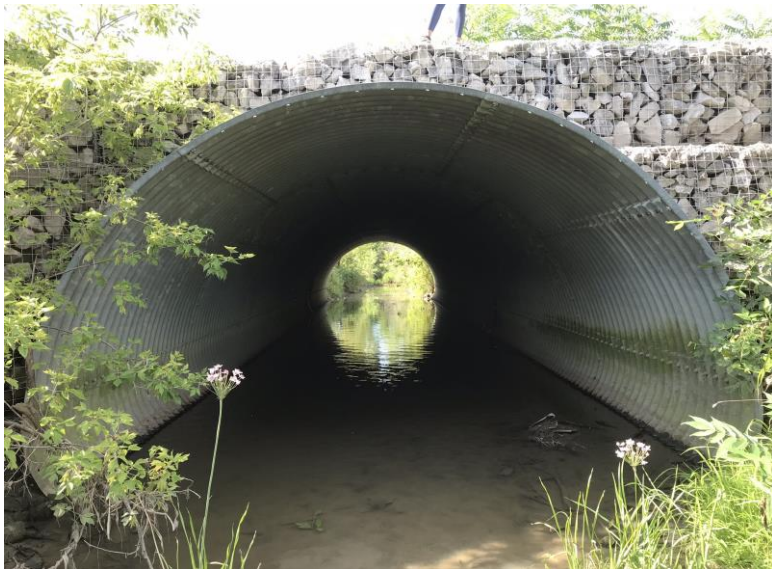
North culvert barrel and gabion headwalls.

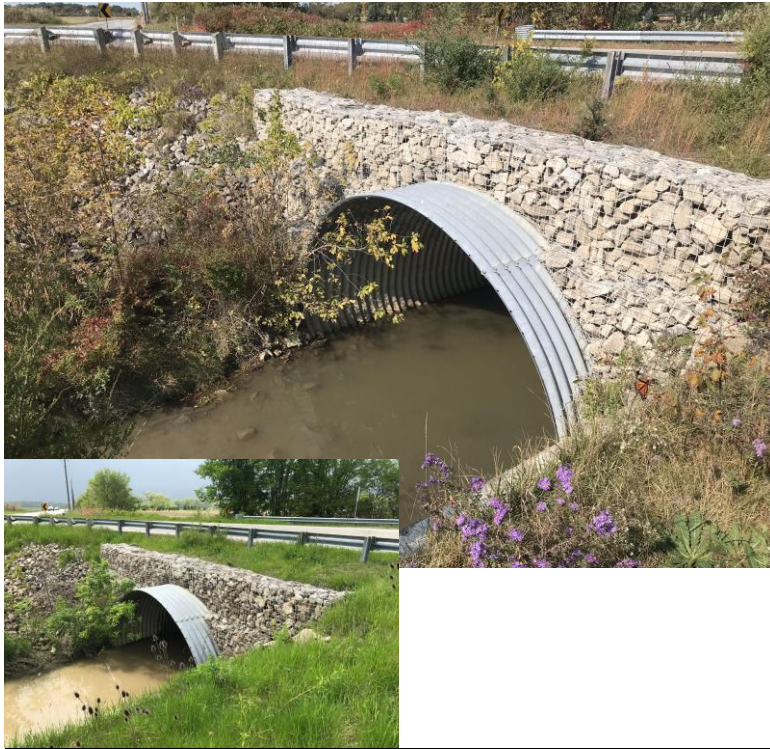
Description
Rip-rap slope protection, and gabion basket wingwalls at south elevation. (Looking North)

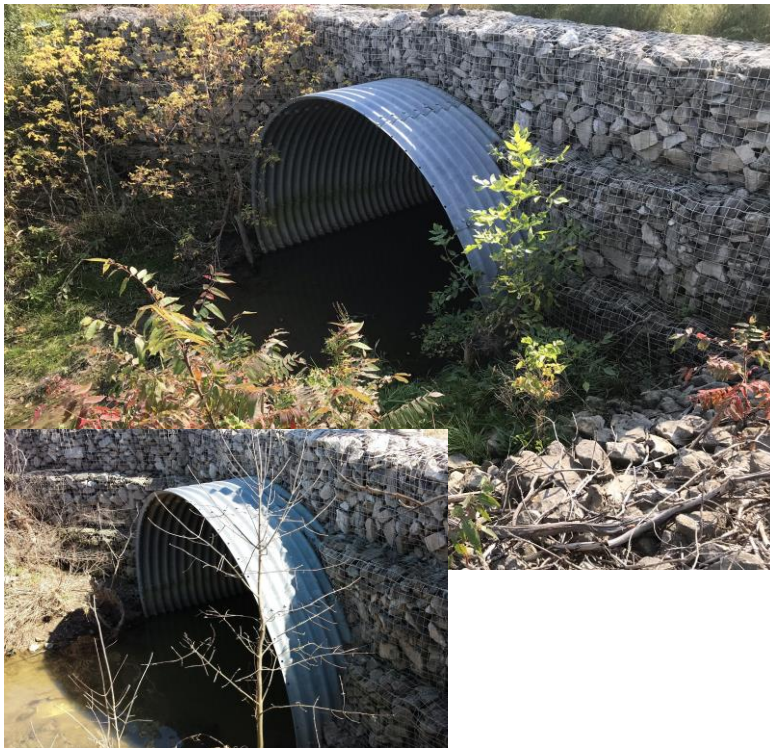
Description
Gabion basket wingwalls at north elevation, (Looking South) (Picture from 2016)

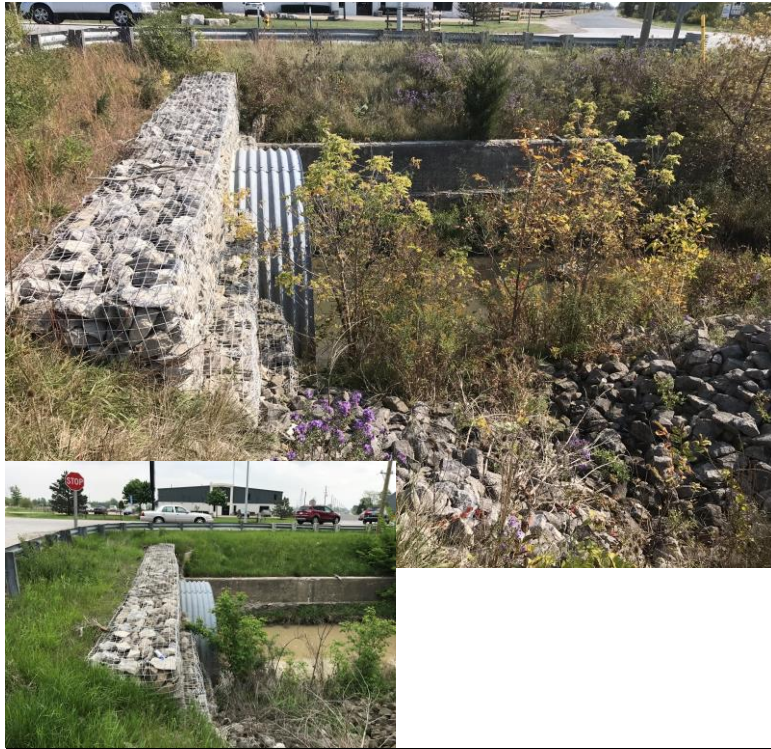
Retaining wall, gabion baskets, and culvert end at south elevation. (Looking East)

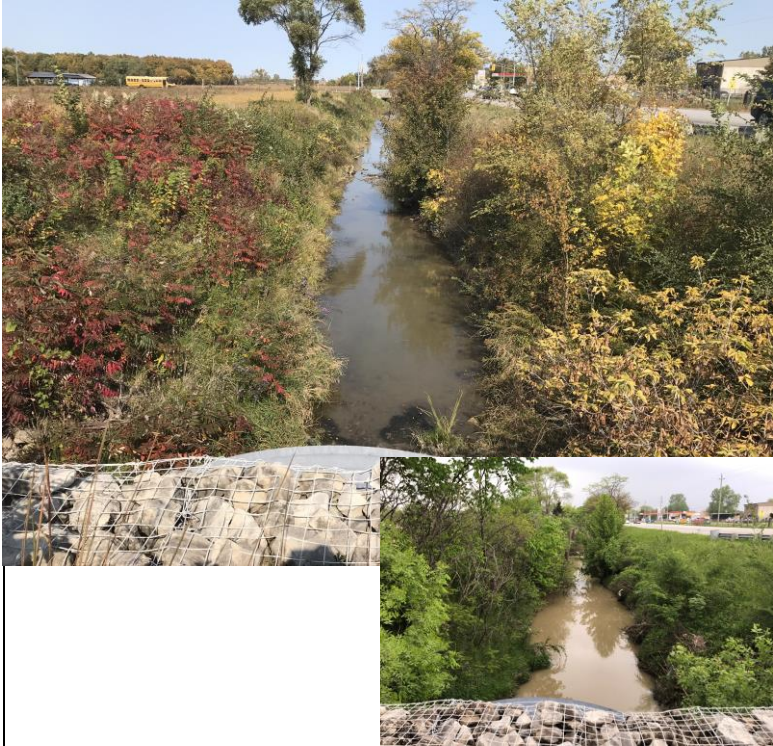
<p>Description</p> <p>Waterway. (Looking North)</p>
---	--

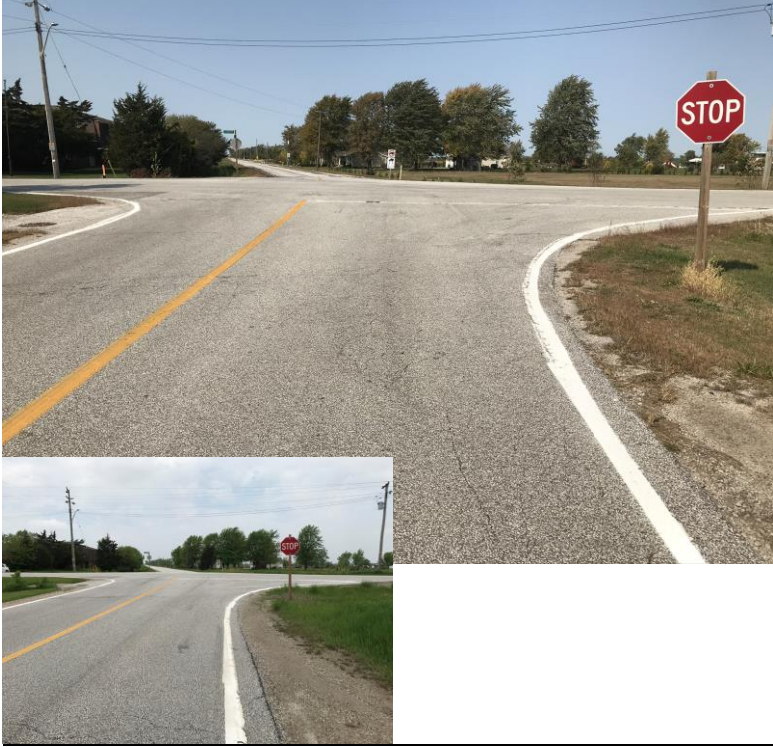
<p>Description</p> <p>Road over the bridge. (Looking West)</p>
--	---

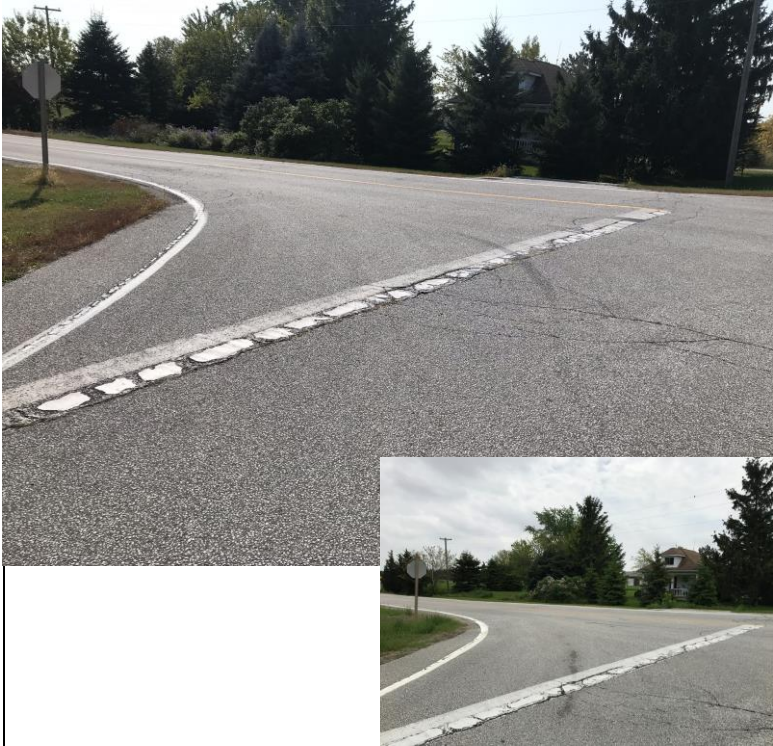
<p>Description</p> <p>Road over bridge deck. (Looking East)</p>
---	--

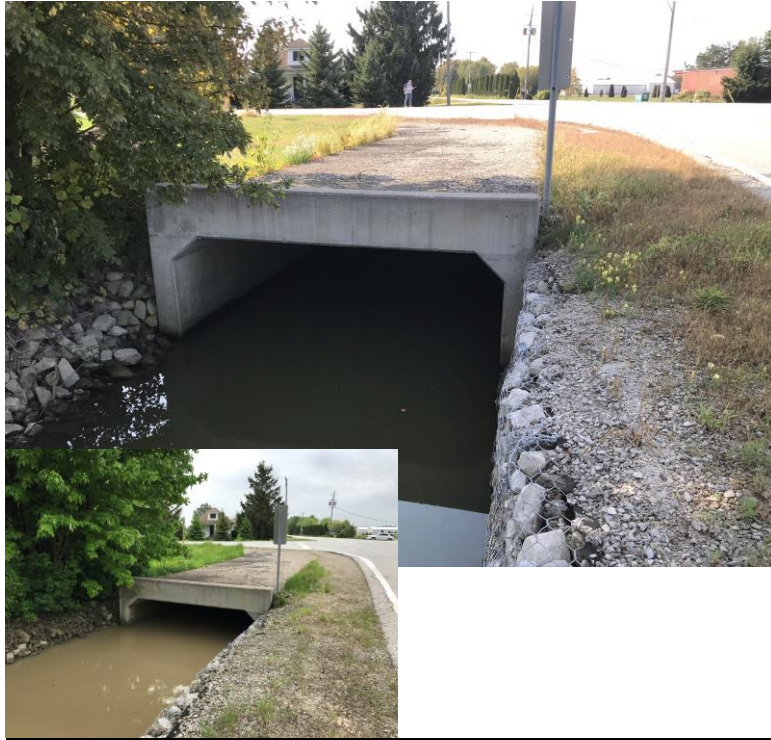
Description
North Inlet of the bridge section with exposed waterproofing at the decktop. (Looking South)

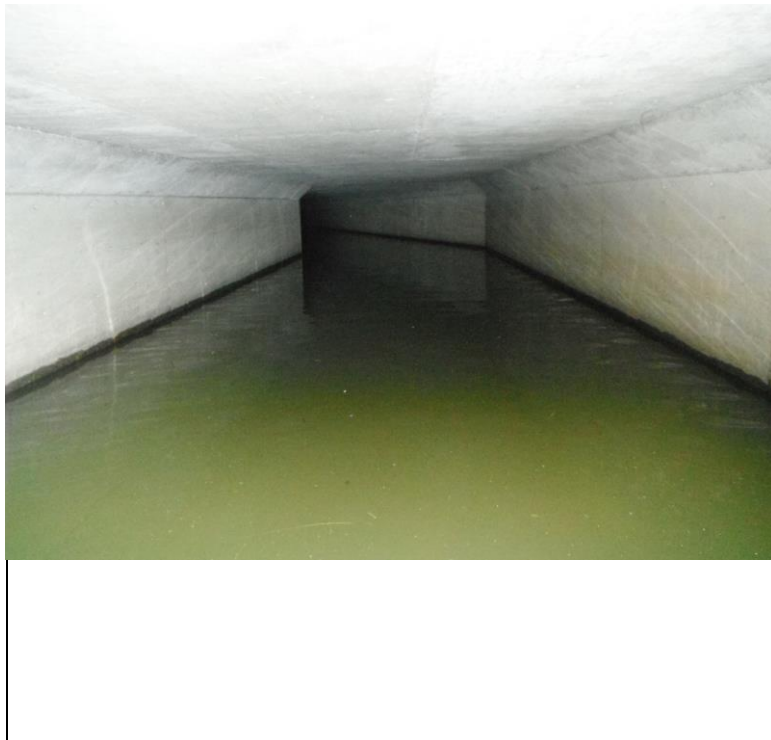
Description
North end of box section of the bridge, looking south. Bend in box section located approximately below the road edge. (Picture from 2016)
Structure barrel access is deemed Confined Space Entry.

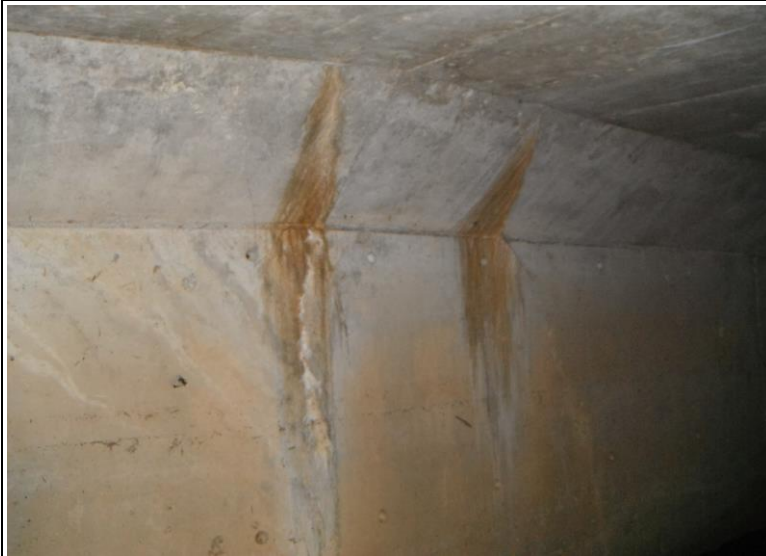
Description
Two vertical cracks at the east abutment wall (Picture from 2016).

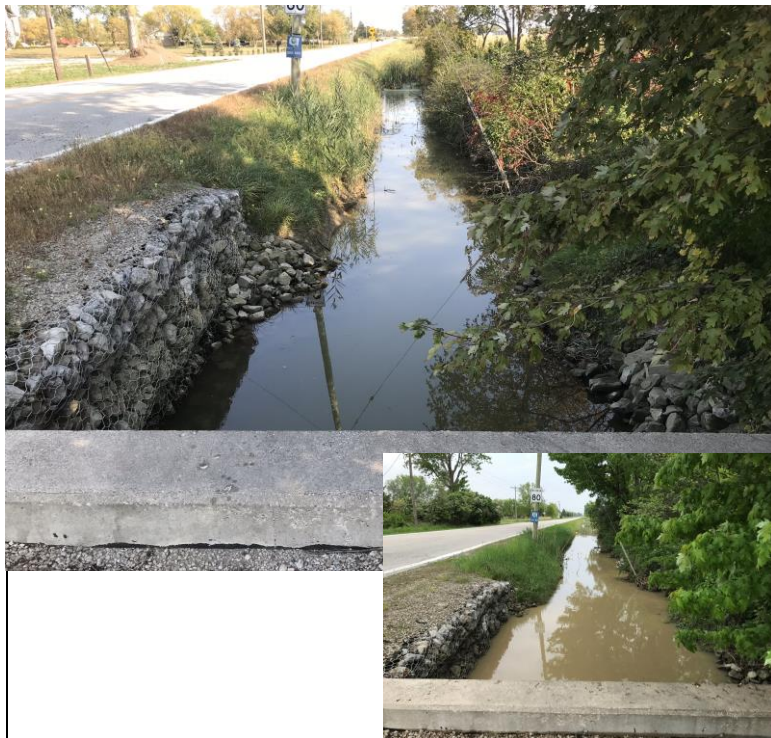
Description
North waterway, embankments and slope protection at the north inlet of the bridge section (Looking North)

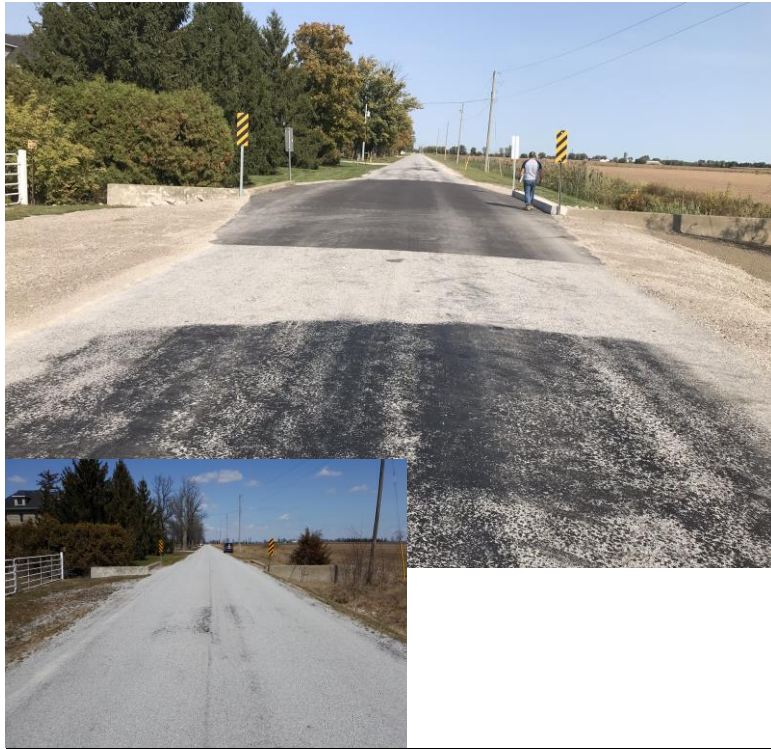
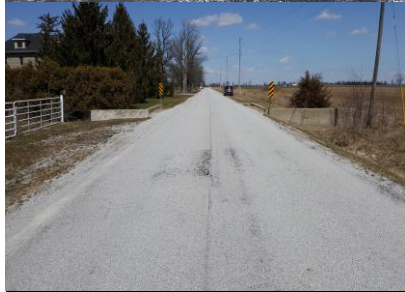
Road over structure. (Looking North)

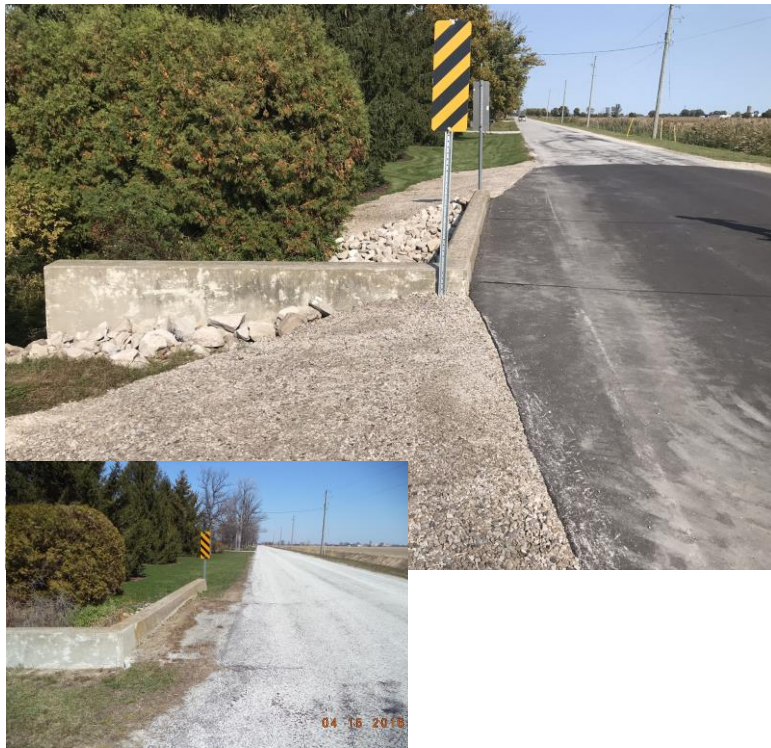
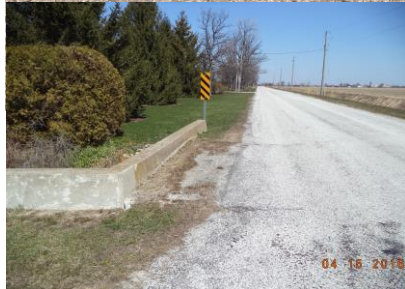
Curb, wingwall, shoulder and object marker at SW corner of structure. (Looking North)

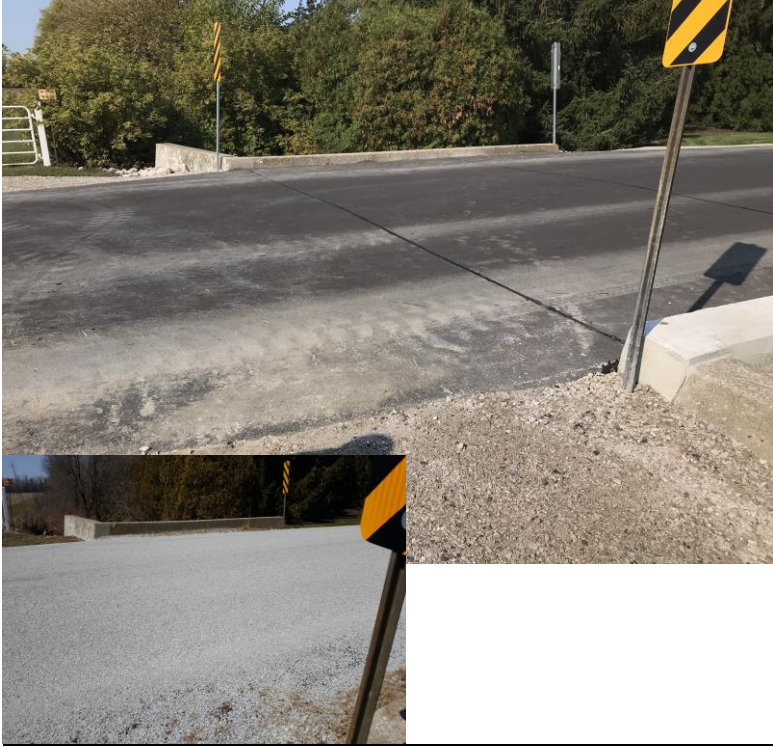
<p>Description</p> <p>Wearing surface over the bridge. (Looking West)</p>
--	--

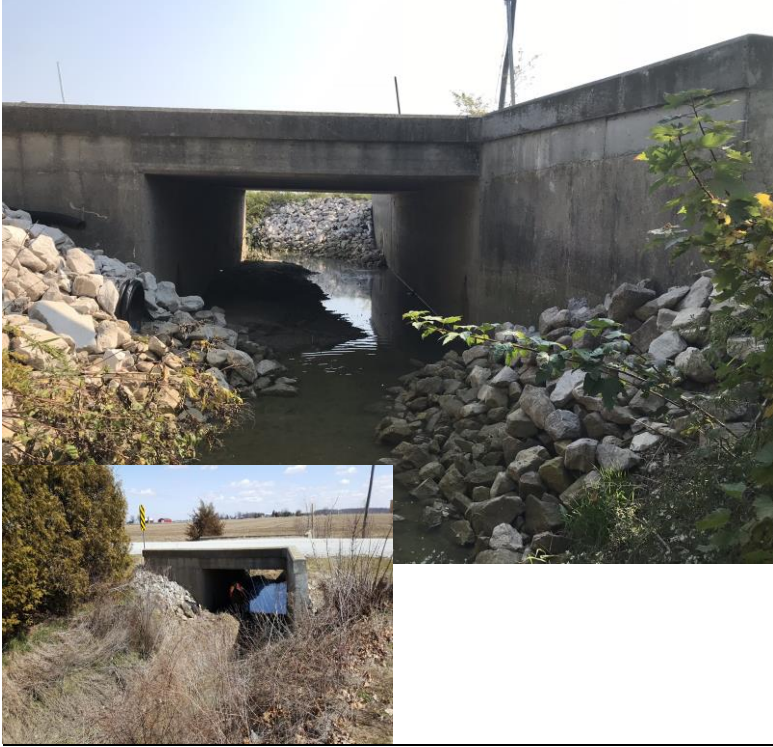
<table border="1"><tr><th data-bbox="971 289 1432 327">Description</th></tr><tr><td data-bbox="971 327 1432 1031">West elevation. (Looking East)</td></tr></table>	Description	West elevation. (Looking East)
Description			
West elevation. (Looking East)

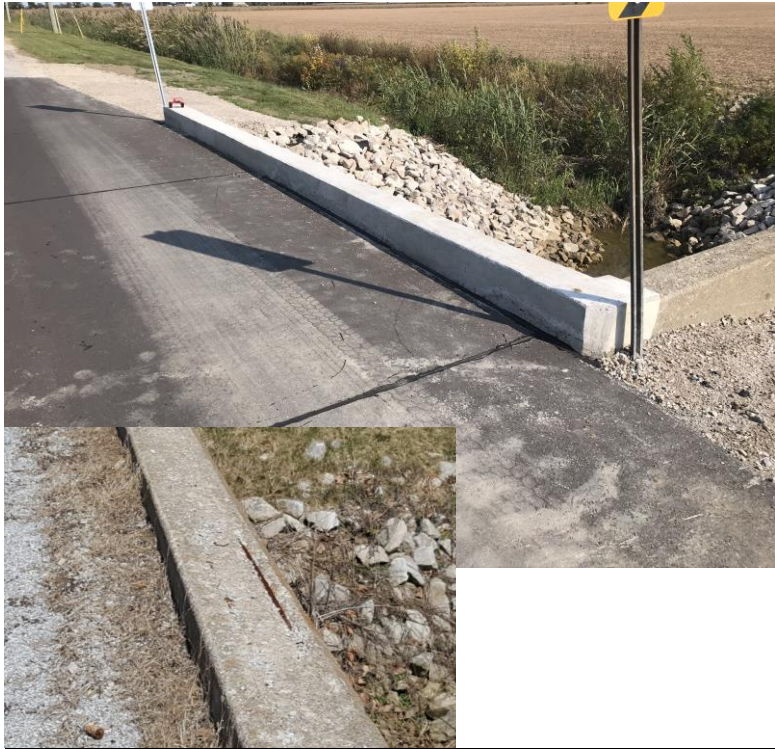
Description
Reconstructed curb at East side

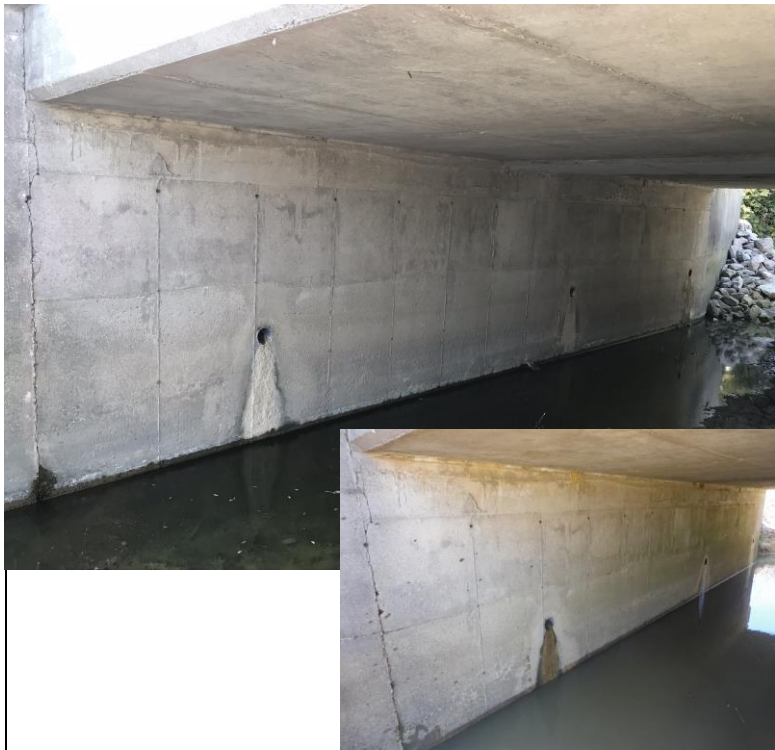
Description
South abutment wall and wall drains.

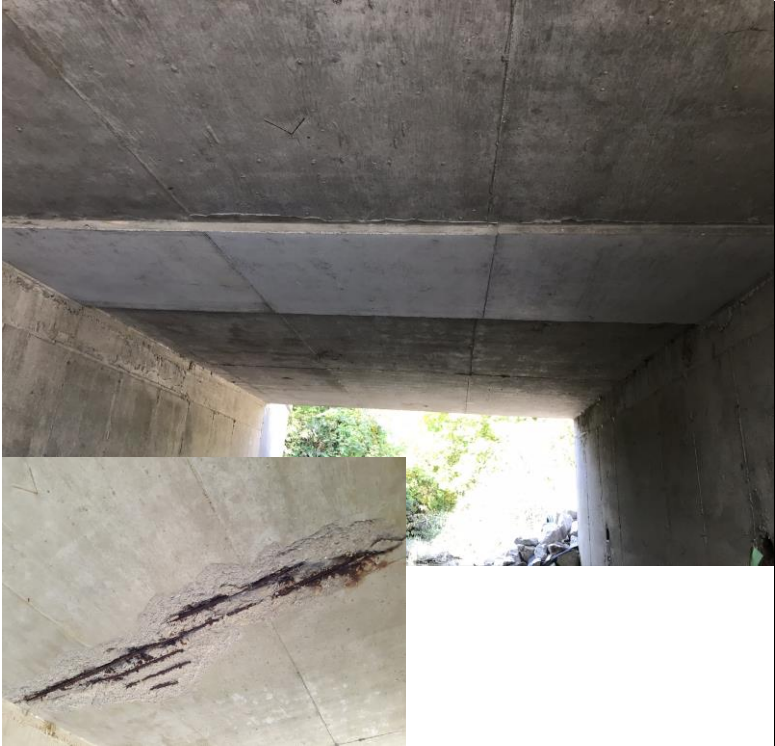
<p>Description</p> <p>Full depth deck repair at soffit. Looking West.</p>
---	--

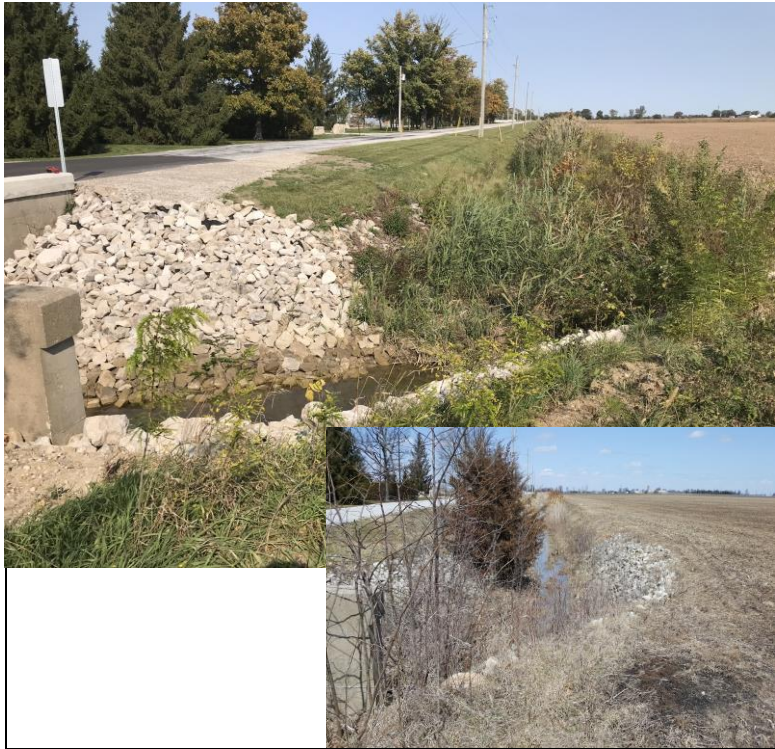
East waterway, and slope protection rip-rap. Looking North.
