CORPORATION OF THE TOWN OF TECUMSEH
2020 Bridge and Culvert Needs Study
Structures with Spans > 3.0 m

March 30, 2021

Town of Tecumseh
2020 Bridge and Culvert Needs Study
Structures with Spans > 3.0 m

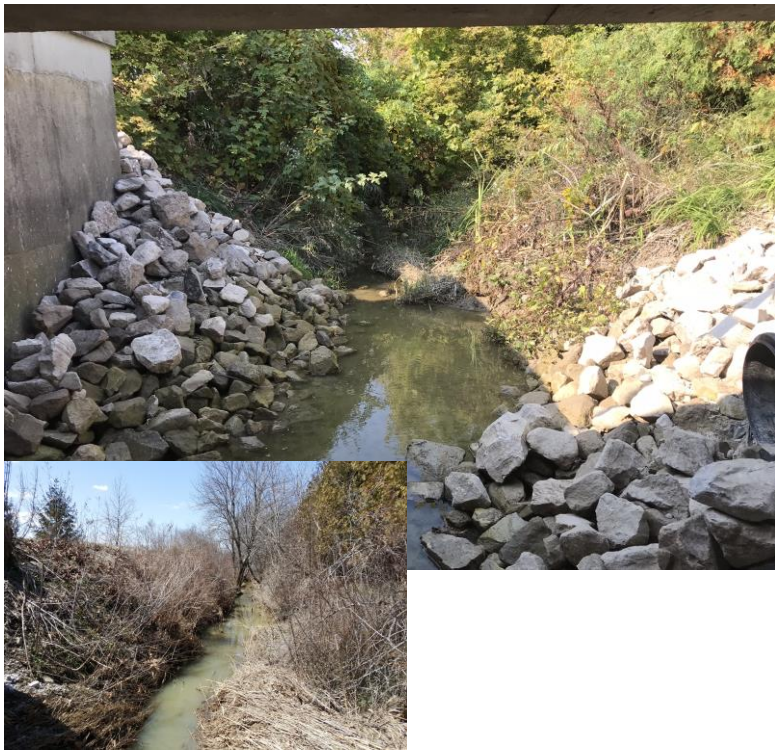
West watercourse (Looking West).

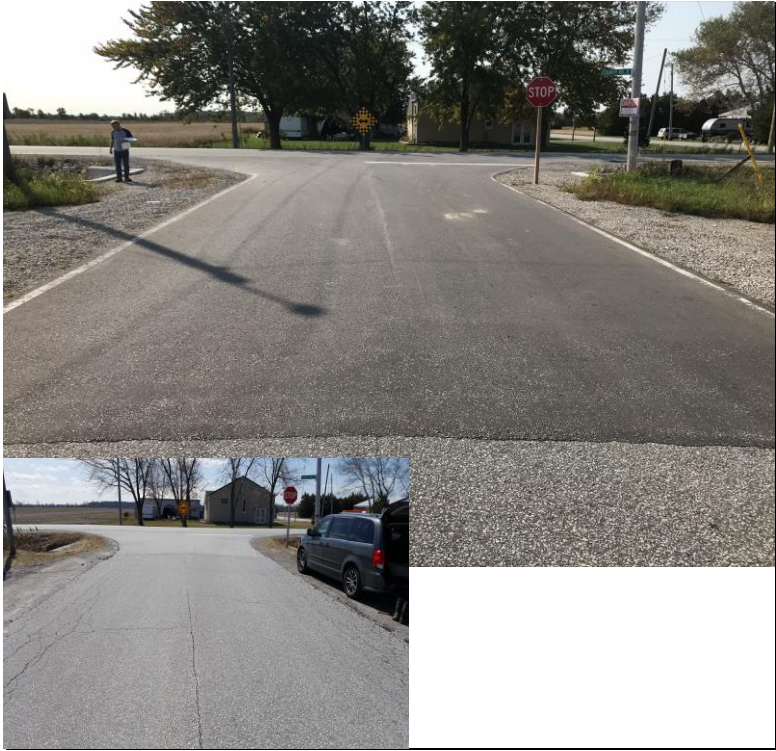
<p>Description</p> <p>Road over the bridge. (Looking South)</p>
--	--

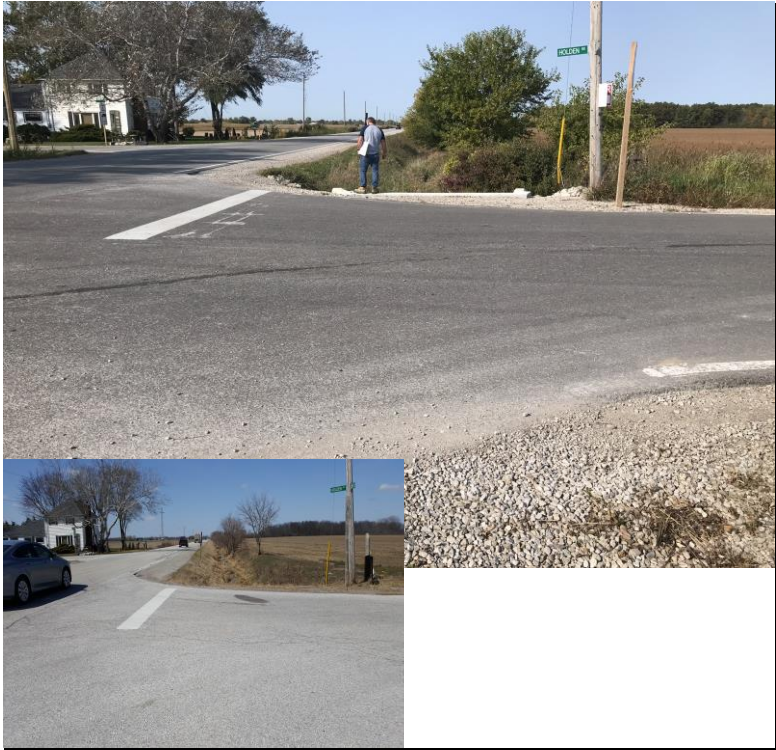
<p>Description</p> <p>Wearing surface at south approach. (Looking West)</p>
---	--

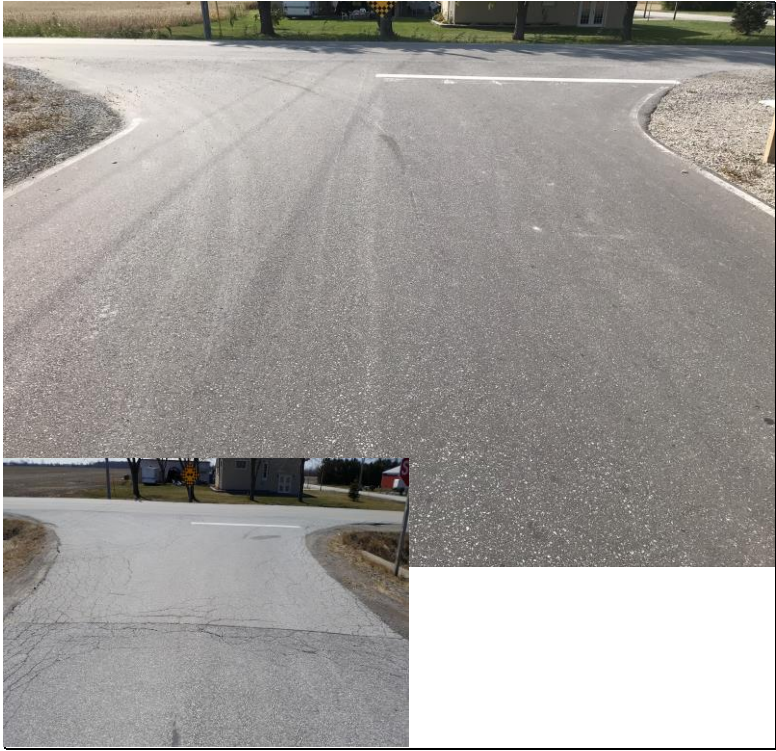
<p>Description</p> <p>Wearing surface at north approach. (Looking South)</p>
--	---

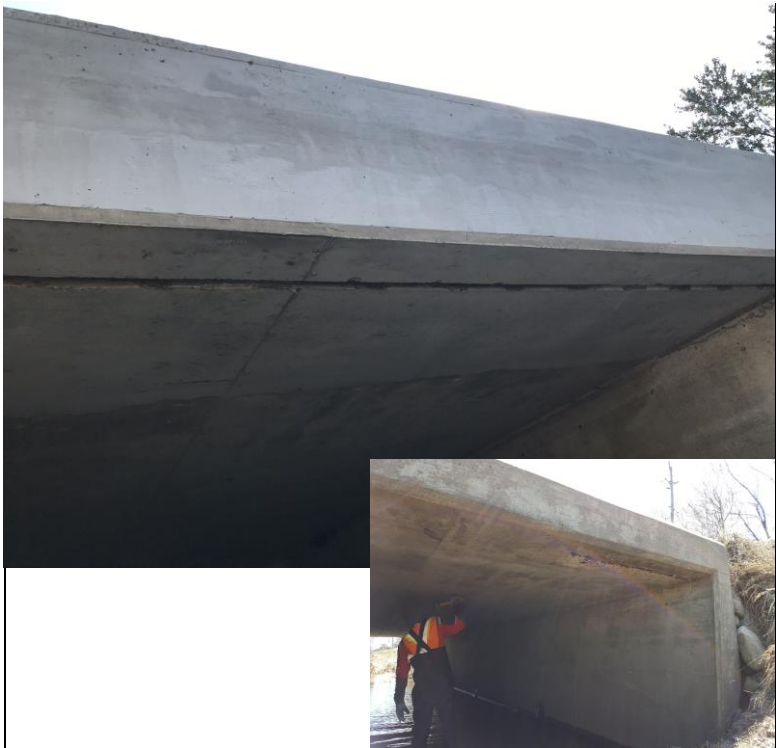
<p>Description</p> <p>Deck soffit at the west end.</p>
---	---

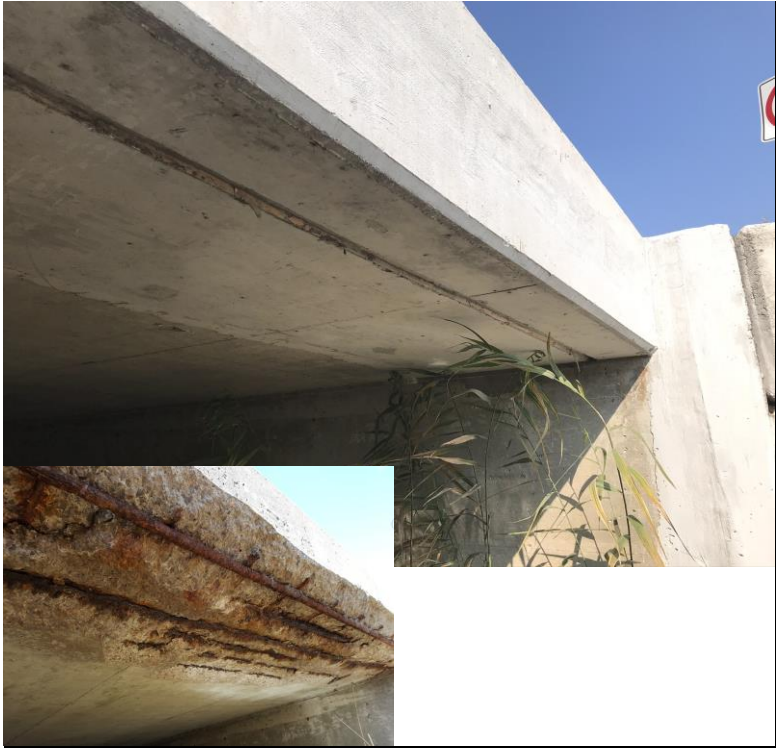
<p>Description</p> <p>Deck soffit at the east end.</p>
---	---

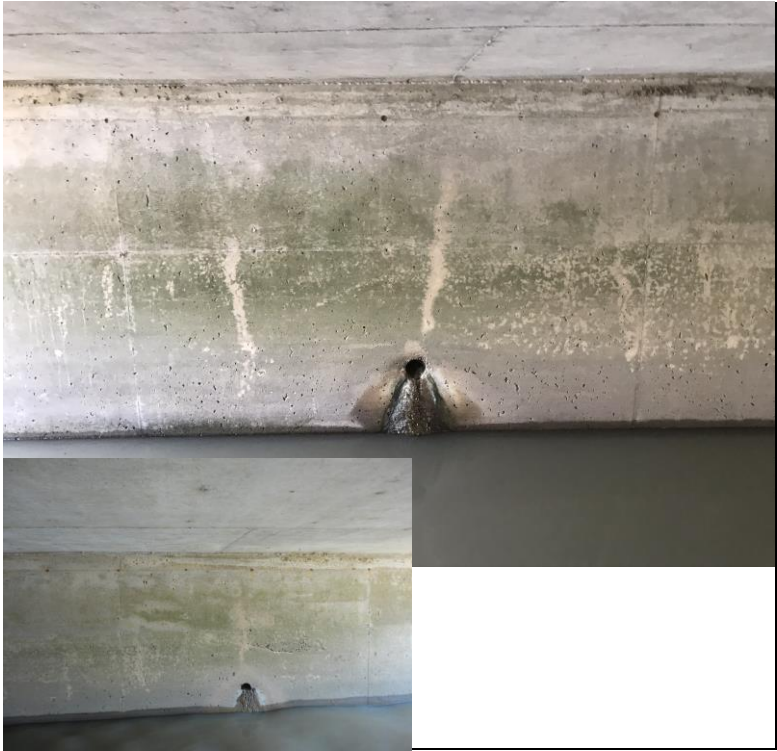
<p>Description</p> <p>Abutment wall and deck soffit inside the culvert section. (Looking North)</p>
--	--

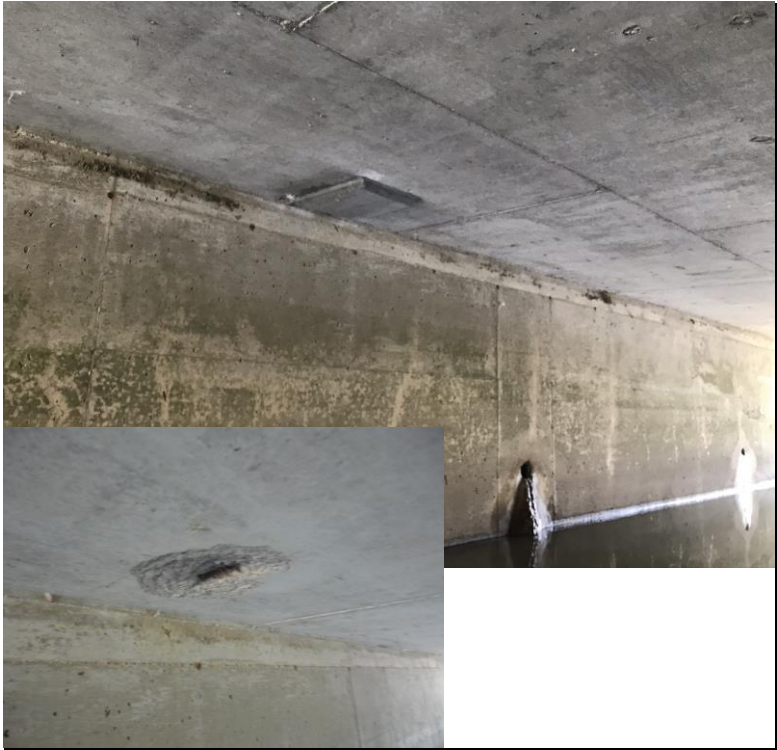
<p>Description</p> <p>Concrete patch near North abutment of soffit.</p>
---	--

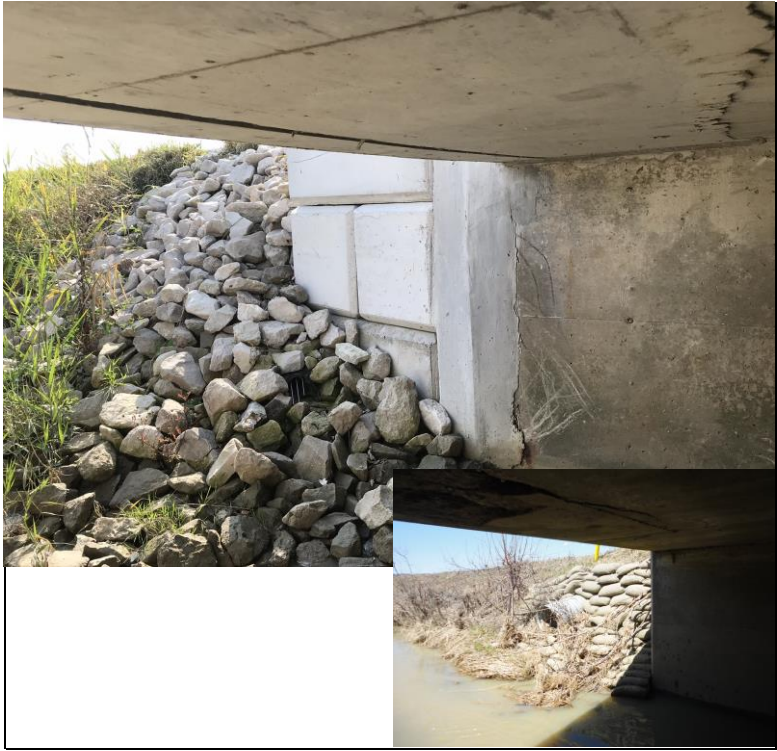
<p>Description</p> <p>New precast block retaining walls, rip rap and subdrains at embankments. (Typ.)</p>
--	--

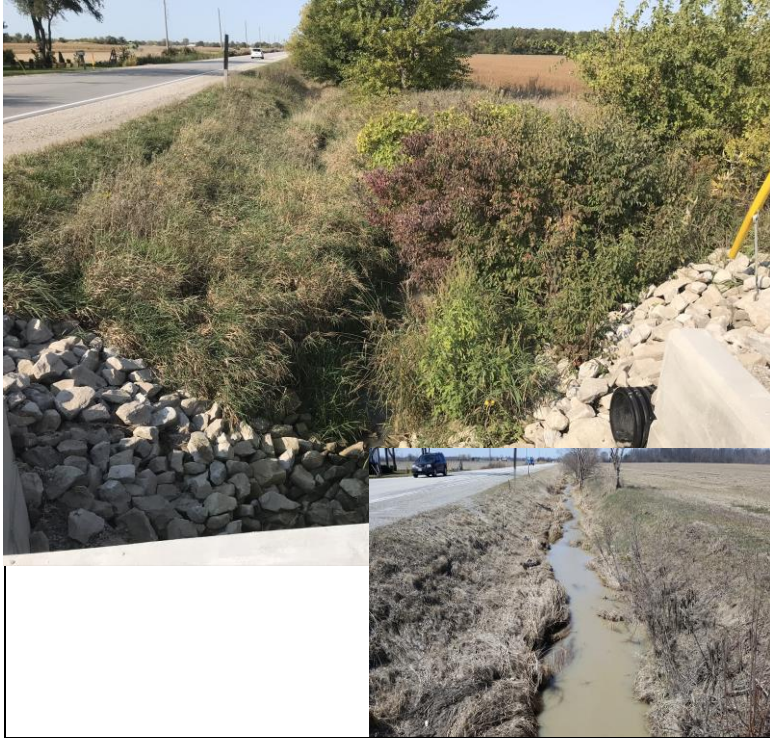
Description
Waterway west from the culvert.

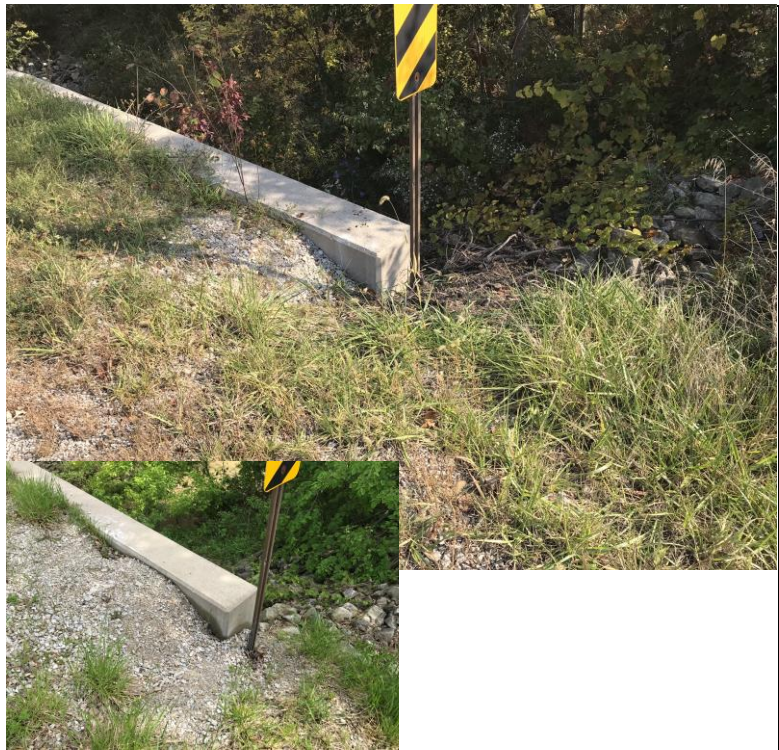
Overall Structure Notes:	
Recommended Work on Structure:	<input type="checkbox"/> None <input checked="" type="checkbox"/> Maintenance <input type="checkbox"/> Minor Rehab. <input type="checkbox"/> Replace <input type="checkbox"/> Major Rehab.
Timing of Recommended Work:	<input checked="" type="checkbox"/> 1 to 5 years <input type="checkbox"/> 6 to 10 years
Overall Comments:	Maintenance is recommended for numerous cracks in the wearing surfaces of the deck top and approaches (or repavement program). Severe erosion was observed at SE shoulder.
Date of Next Inspection:	June 2022

<p>Description</p> <p>Severe erosion of the shoulder at the south-east embankment.</p>
---	---

Element Group:	Embankments & Streams		Length:			
Element Name:	Embankments		Width:			
Location:			Height:			
Material:			Count:	6		
Element Type:			Total Quantity:	6 each		
Environment:			Limited Inspection			
Protection System:						Perform.
Condition	Units	Exc.	Good	Fair	Poor	Deficiencies
Data:	Sq.m / m / each / % / all	0.0	0.0	4.0	2.0	
Comments: Additional embankments located at NE and SW corners. SE: Severe erosion of the shoulder at structure corner. NE: Steep slope with filtercloth exposed.						
Recommended Work:	Rehab	Replace	Maintenance Needs:			
	1-5 years	6-10 years	Urgent	1 year	x 2 year	
			Repair embankments.

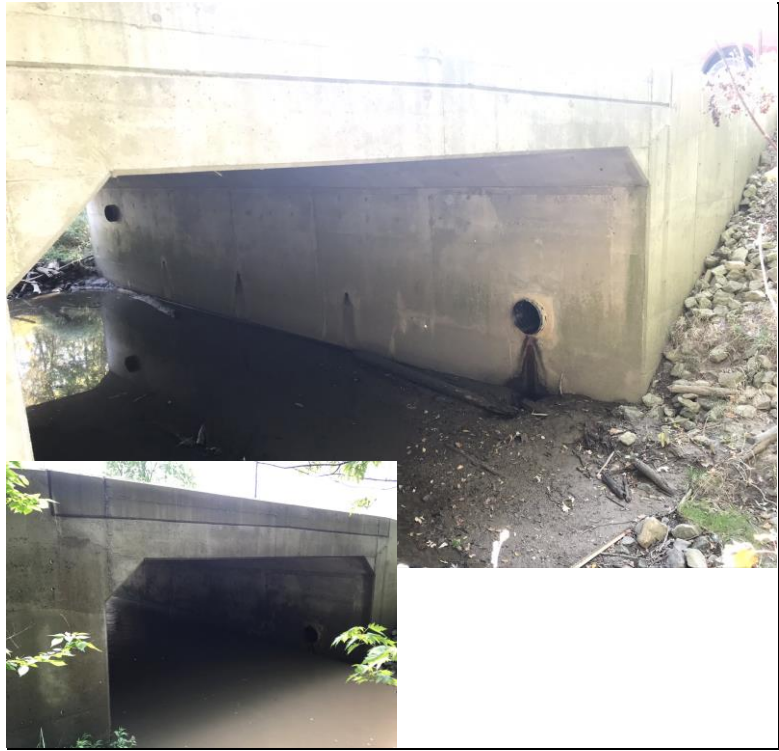
<p>Description</p> <p>West elevation, wingwalls, abutment walls, and HDPE outlet. (Looking East)</p>
--	---

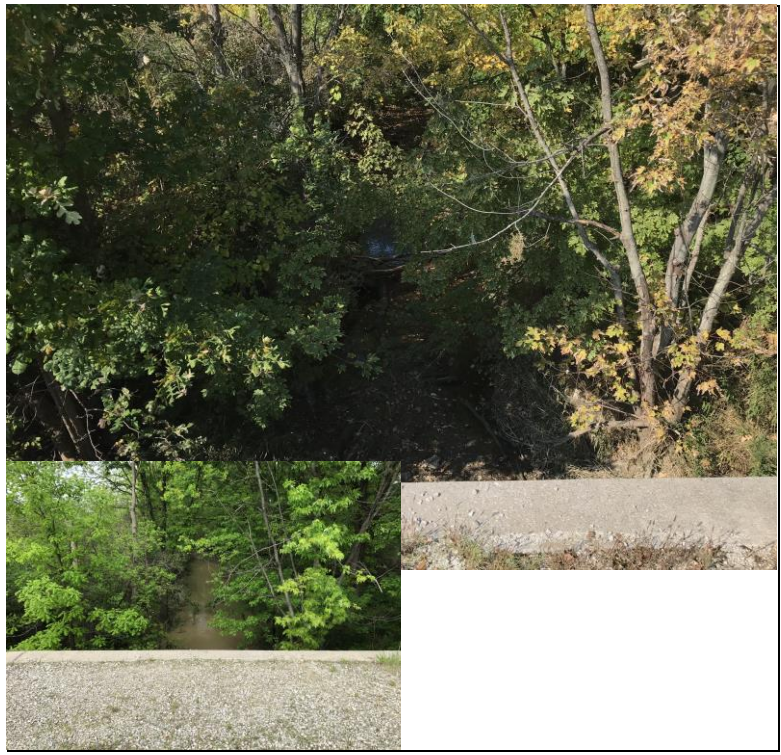
<p>Description</p> <p>Waterway west from the bridge. (Looking West)</p>
---	--

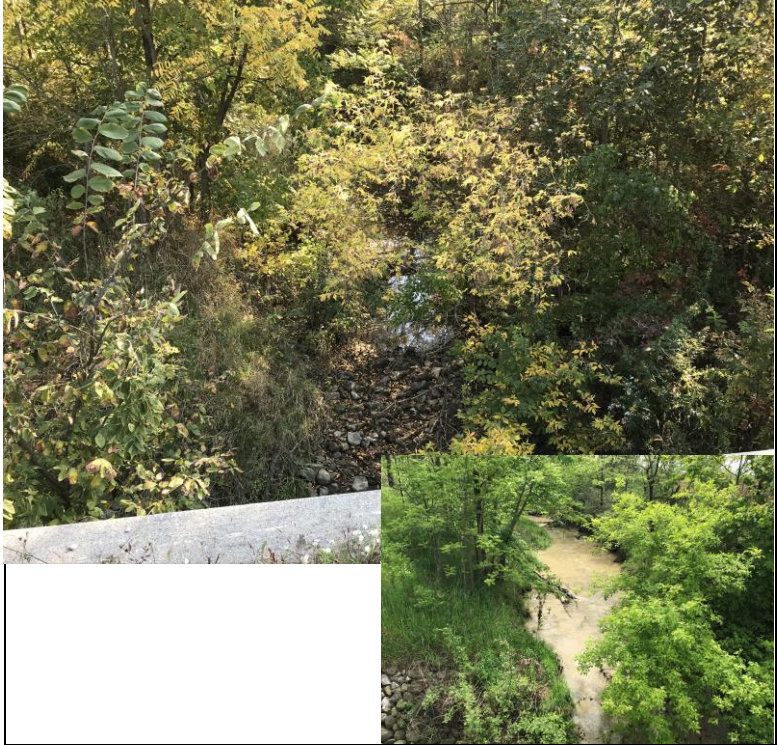
<p>Description</p> <p>Waterway east from the bridge. (Looking East)</p>
--	--

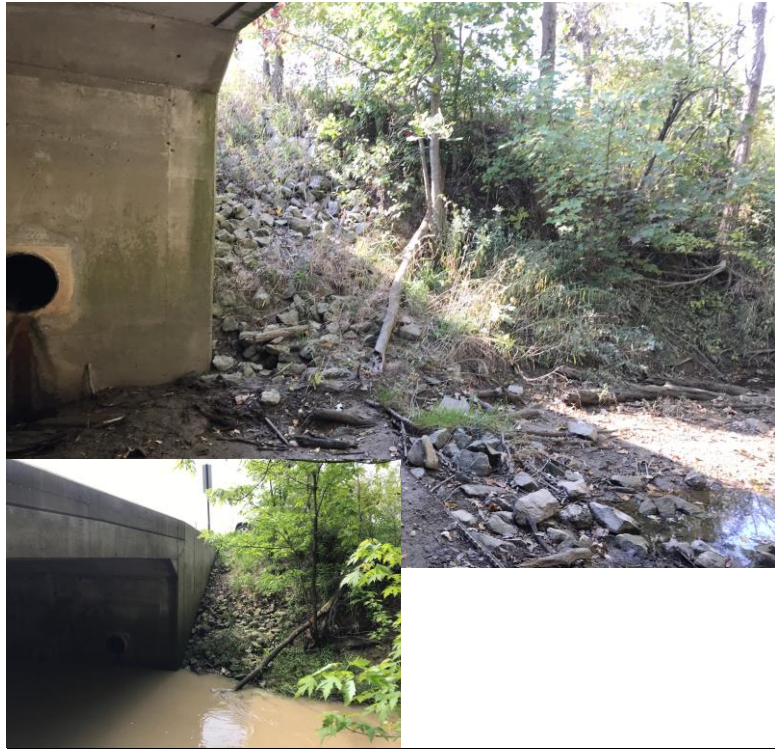
Description
Waterway and south-west embankment with some debris blocking the flow.

Element Group:	Embankments & Streams		Length:			
Element Name:	Streams and Waterways		Width:			
Location:			Height:			
Material:			Count:	2		
Element Type:			Total Quantity:	2 all		
Environment:			Limited Inspection			
Protection System:						Perform.
Condition	Units	Exc.	Good	Fair	Poor	Deficiencies
Data:	Sq.m / m / each / % / all	0	0	1	1	
Comments:						
Debris build up in the waterway. Large trees and other vegetation at inlet end.						
Recommended Work:	Rehab	Replace	Maintenance Needs:			
	1-5 years	6-10 years	Urgent	1 year	x 2 year	
Remove debris.

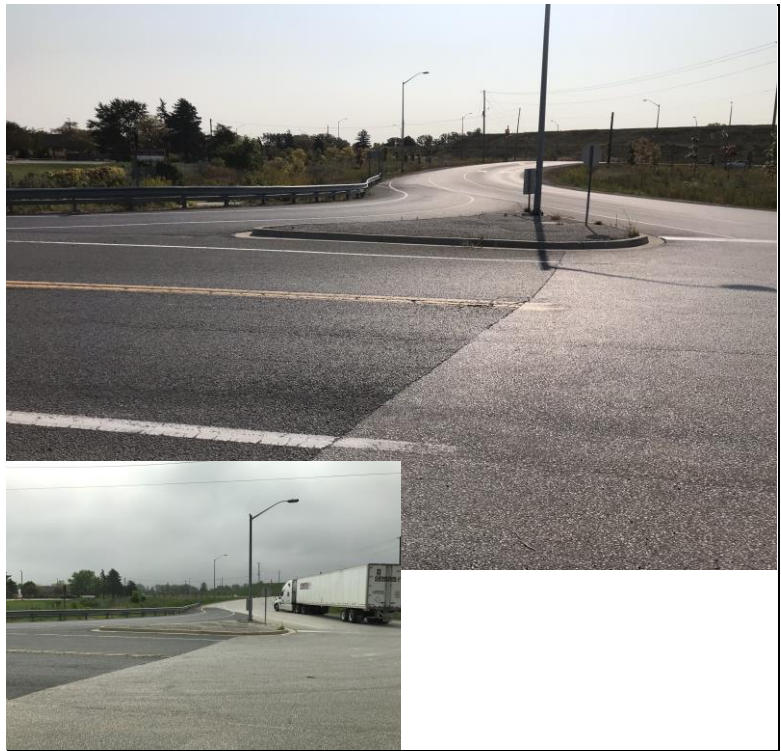
<p>Description</p> <p>South approach. (Looking East)</p>
--	---

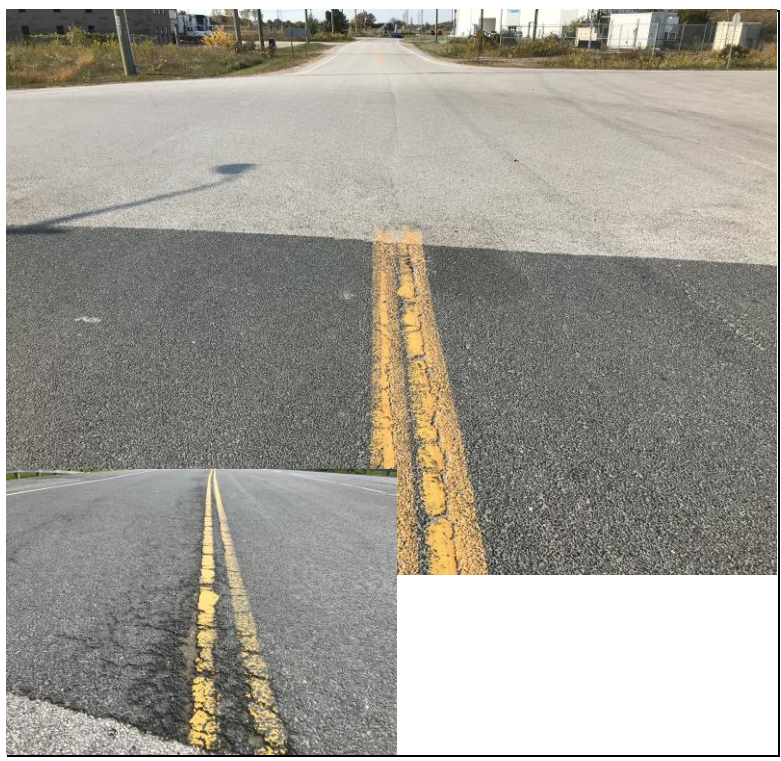
<p>Description</p> <p>Centreline of the road wearing surface approximately at midspan of the culvert.</p>
---	--

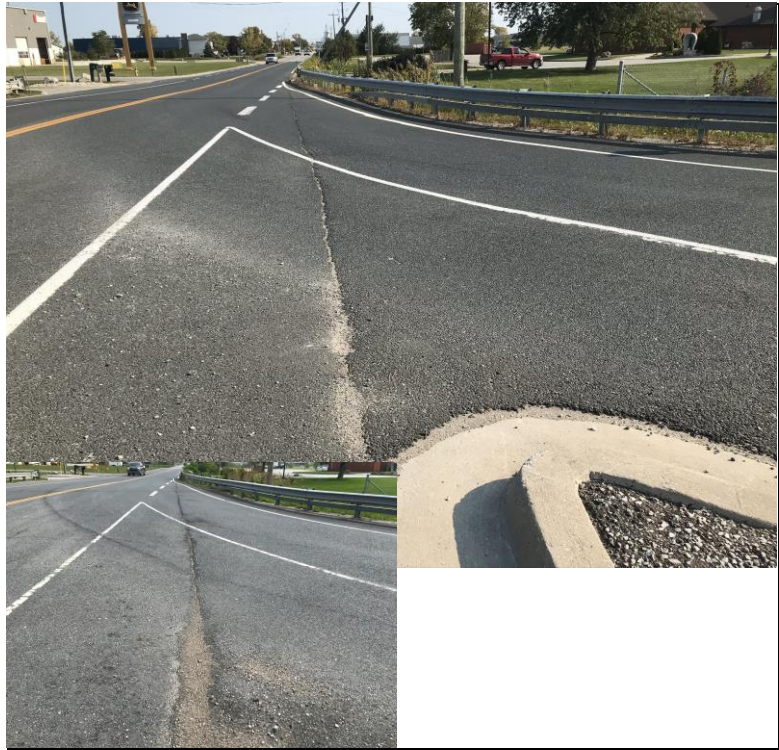
<p>Description</p> <p>Pavement joint on the deck and approach wearing surfaces. (Looking NE)</p>
---	---

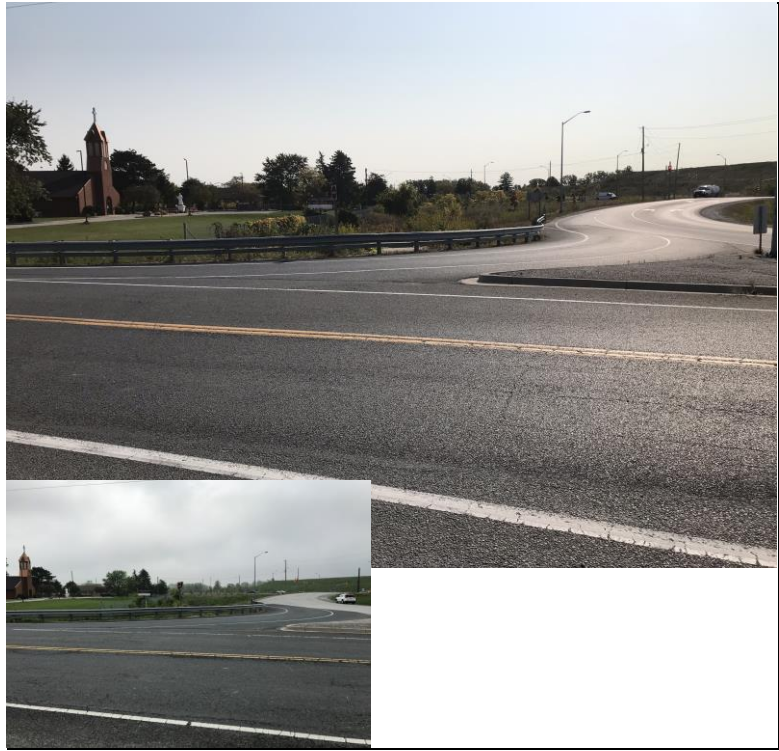
<p>Description</p> <p>Wearing surface over the structure deck (Looking SE)</p>
--	---

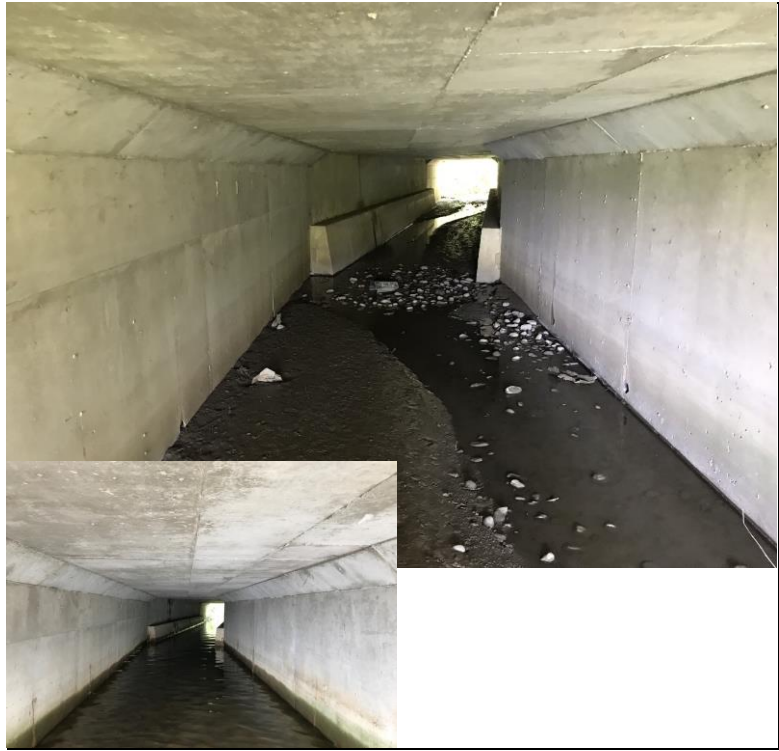
<p>Description</p> <p>Inside the bridge, showing the non-rigid original section of the bridge with jacketed footings, as well as the new rigid frame section extension. (Looking Northwest)</p>
--	--

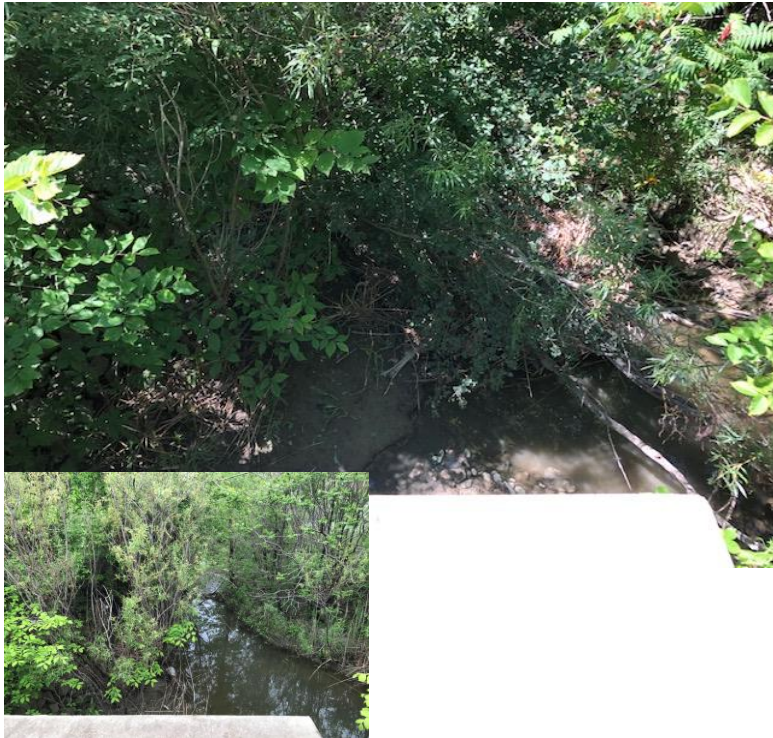
Description
Waterway at west extent. (Looking West)

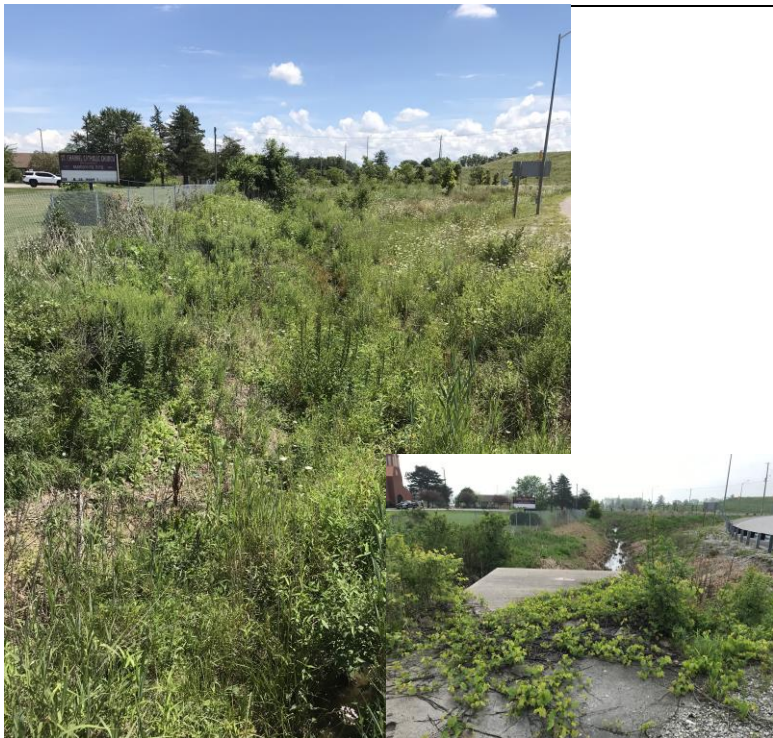
Description
Waterway at east extent. (Looking Southeast)

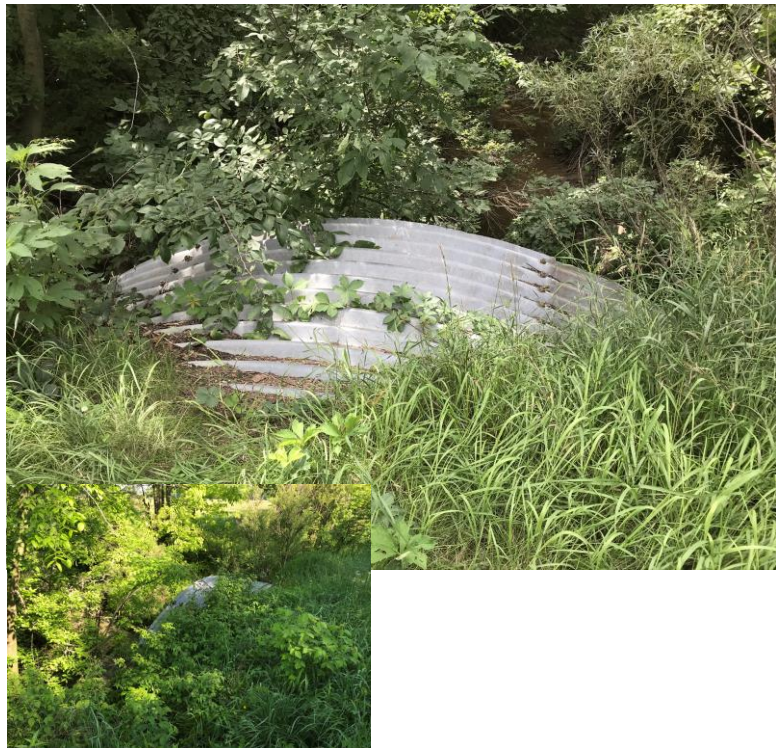
Description
West elevation. (Looking West)

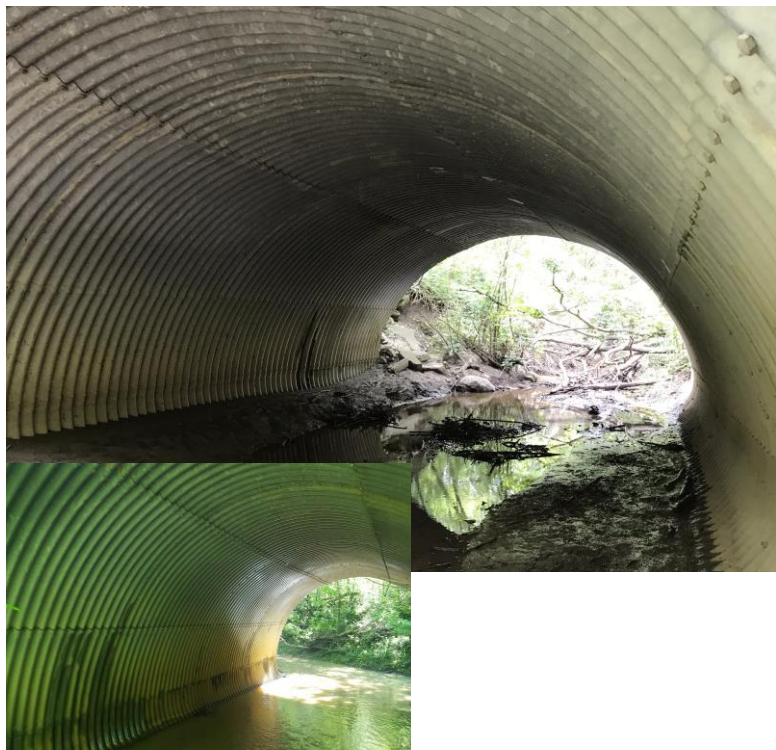
Description
Bridge barrel. (Looking West)

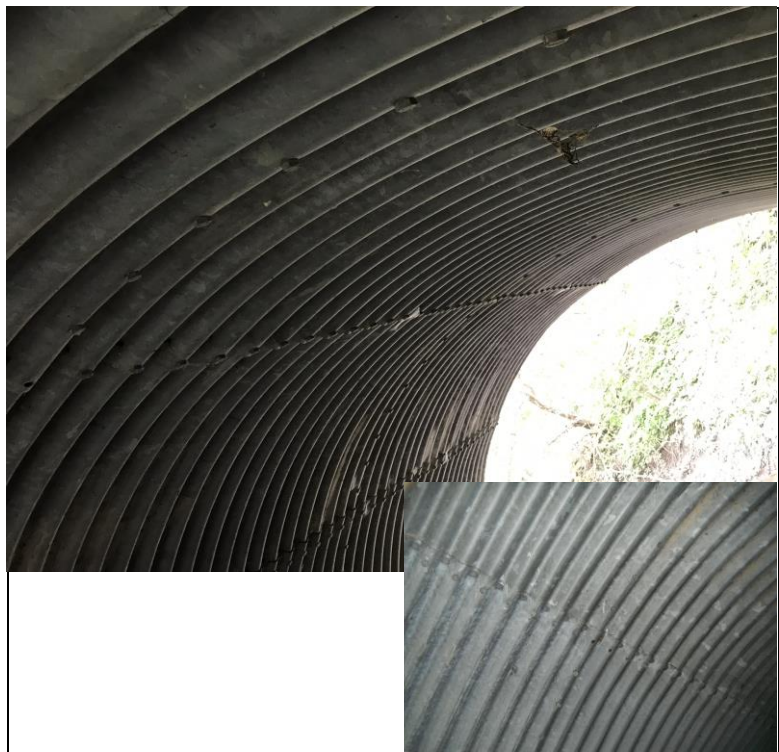
<table border="1"><tr><th data-bbox="976 1117 1437 1159">Description</th></tr><tr><td data-bbox="976 1159 1437 1864">Minor deformation in structure barrel.</td></tr></table>	Description	Minor deformation in structure barrel.
Description			
Minor deformation in structure barrel.

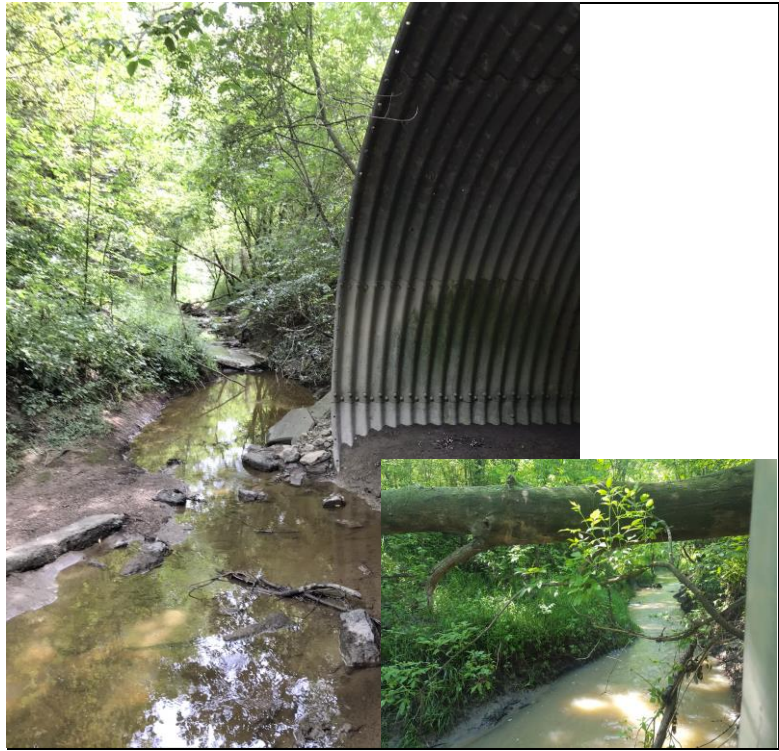
<p>Description</p> <p>Water flowing from south at east end. (Looking South)</p>
--	--

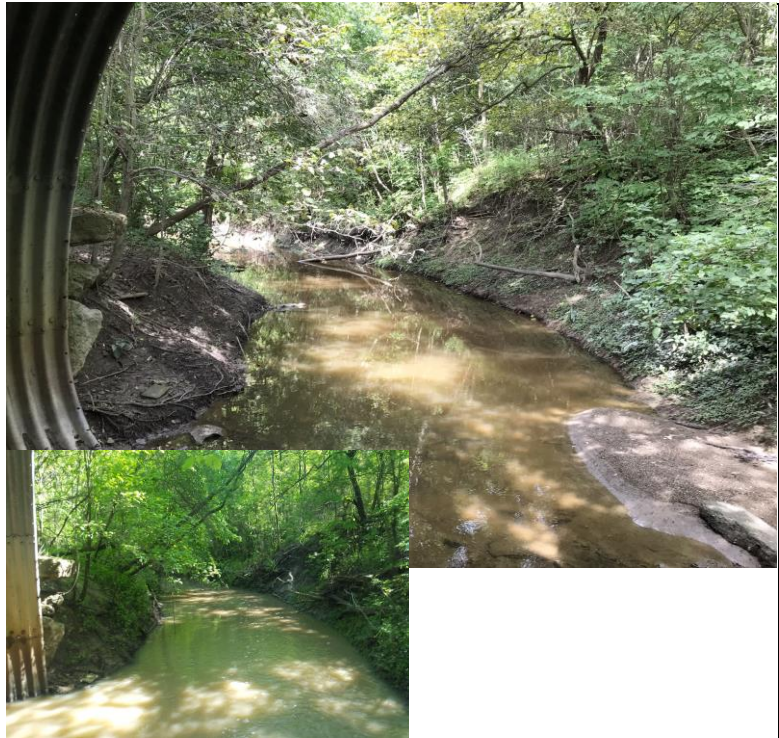
<p>Description</p> <p>Water flowing towards north at east end. (Looking North)</p>
---	---

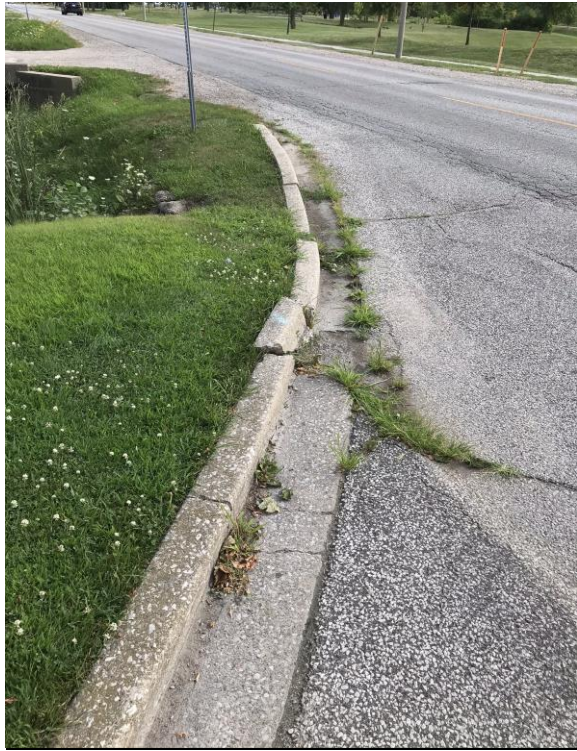
<p>Description</p> <p>Settlement of curb & gutter and asphalt at NE corner of the bridge, (Looking NE)</p>
--	--	---

Element Group:	Approaches		Length:	31.0 m		
Element Name:	Curb and Gutters		Width:	0.45 m		
Location:	East/West Approaches		Height:	0.15 m		
Material:	Cast-in-place concrete		Count:			
Element Type:			Total Quantity:	31.0 m		
Environment:	Moderate		Limited Inspection			
Protection System:						Perform. Deficiencies
Condition Data:	Units	Exc.	Good	Fair	Poor	
	Sq.m / m / each / % / all	0.0	14.0	5.0	12.0	
Comments:						
Cracked curbs and settlement located along Manning Road. Curbs at SE have failed.						
Recommended Work:	<input checked="" type="checkbox"/>	Rehab	<input type="checkbox"/>	Replace	Maintenance Needs:	
	<input checked="" type="checkbox"/>	1-5 years	<input type="checkbox"/>	6-10 years	<input type="checkbox"/>	Urgent
					<input type="checkbox"/>	1 year
					<input type="checkbox"/>	2 year
Repair curbs for roadside safety.

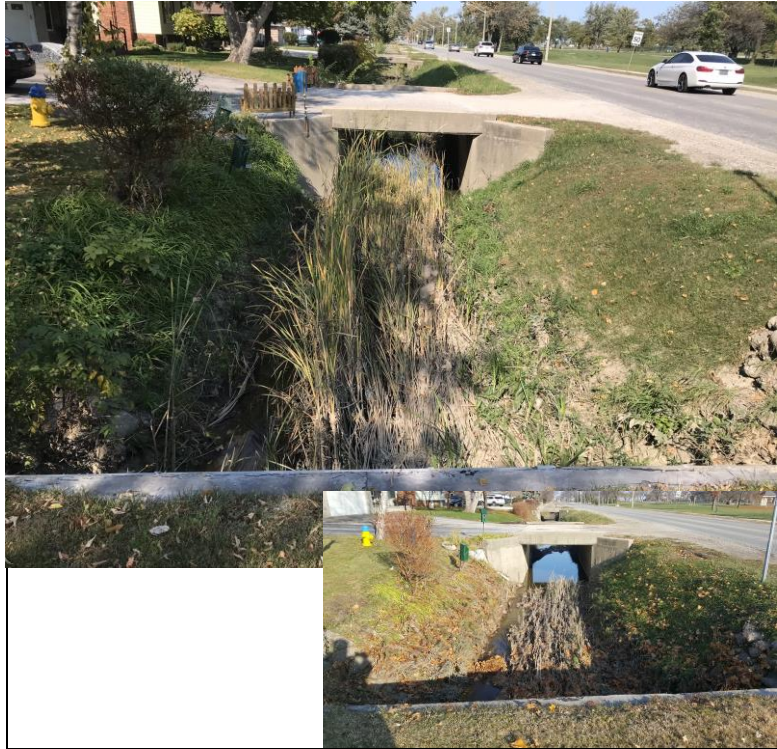
<p>Description</p> <p>Embankments and waterway at north side.</p>
--	--

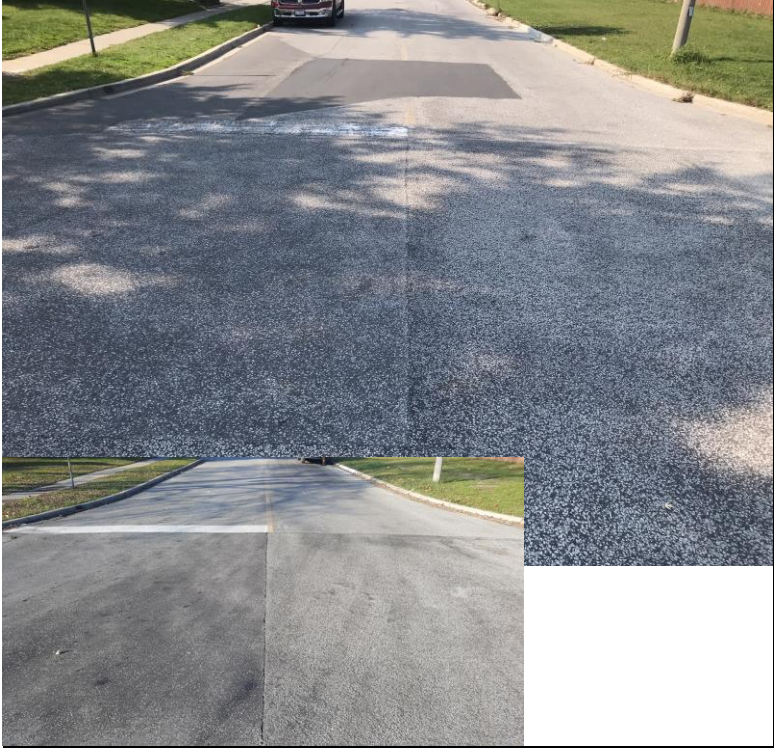
<p>Description</p> <p>Wearing at west approach. (Looking West)</p> <p>New asphalt patch on south side of road from steel plate install in July 2016.</p>
--	--

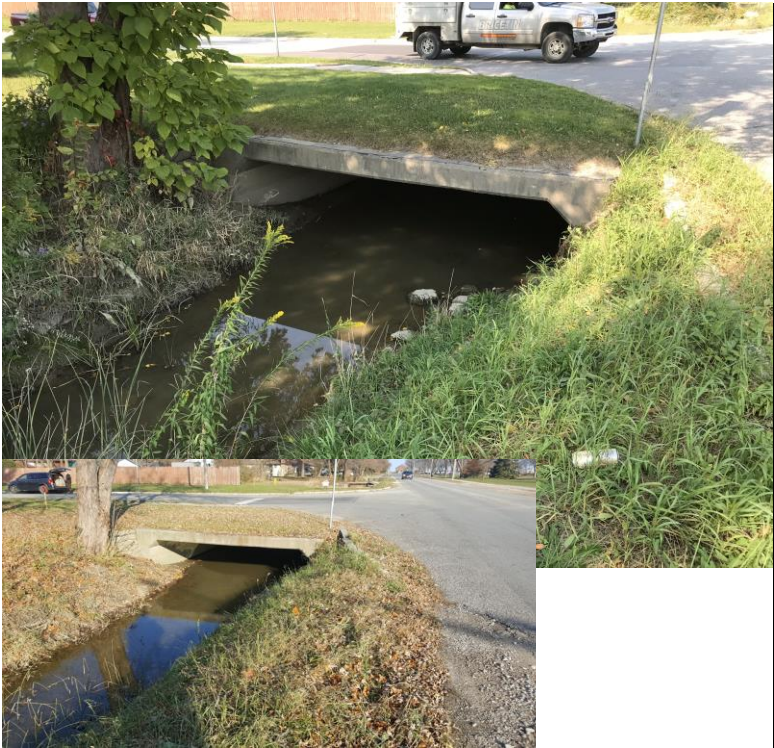
A photograph showing the south elevation of a concrete bridge structure. The bridge is surrounded by dense, tall grasses and weeds. In the background, a paved road with a white pickup truck and a grassy area are visible. An inset photo in the bottom left shows a different angle of the bridge structure.	<table border="1"><tr><td>Description</td></tr><tr><td>South elevation.</td></tr></table>	Description	South elevation.
Description			
South elevation.

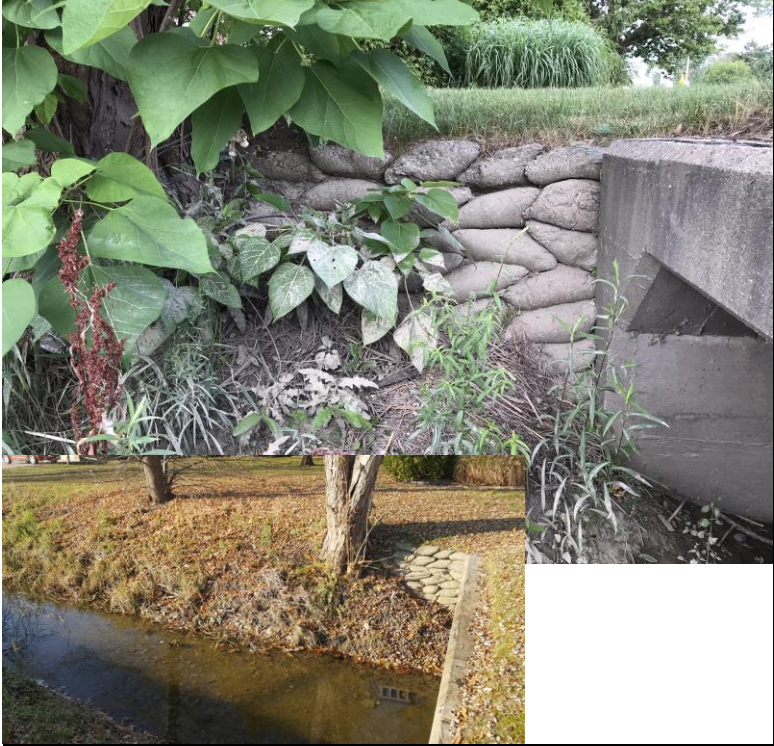
<p>Description</p> <p>South-west embankment and retaining walls.</p>
---	---

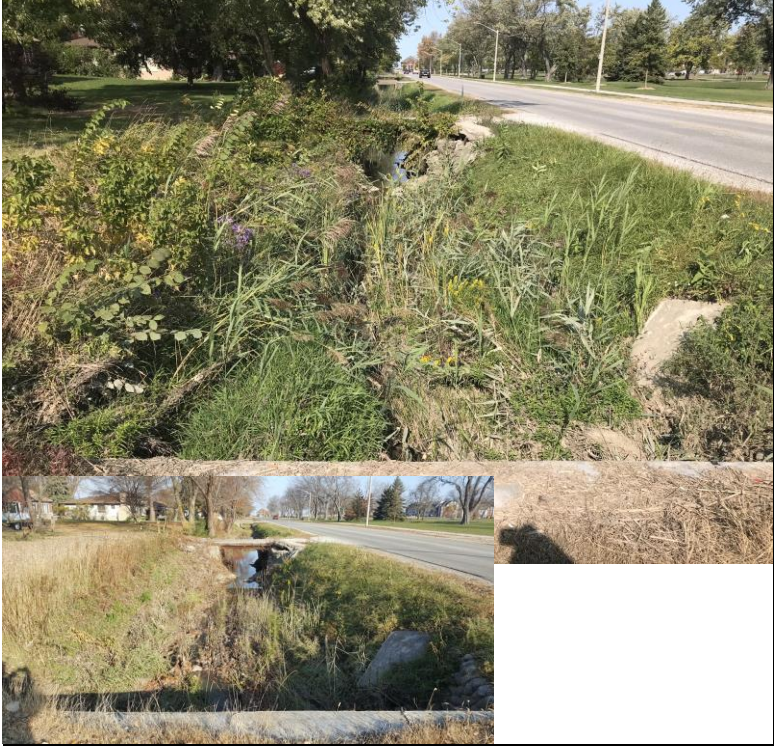
<p>Description</p> <p>Embankments and waterways at north side. Excessive vegetation.</p>
--	---

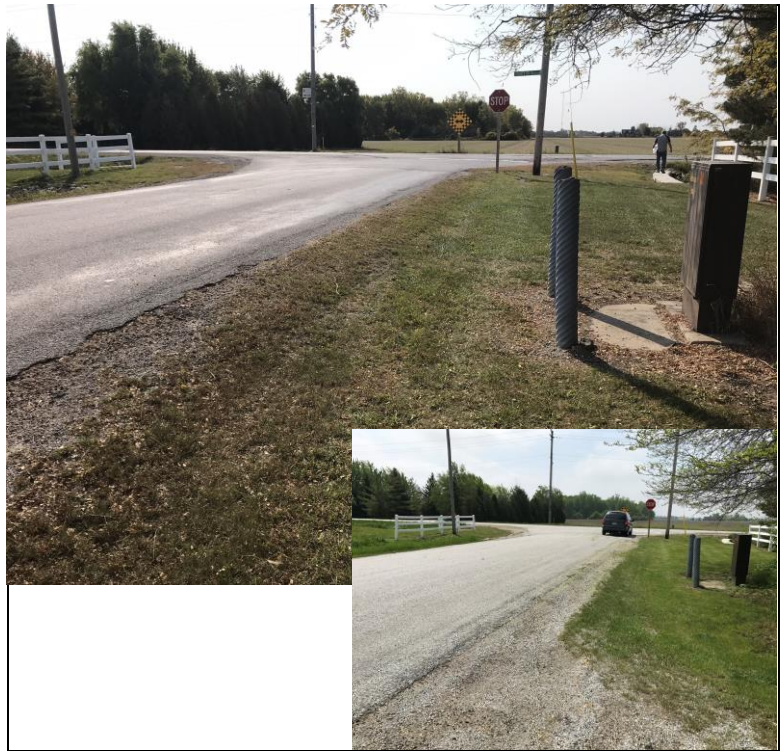
<p>Description</p> <p>Road over the bridge. (Looking South)</p>
--	--

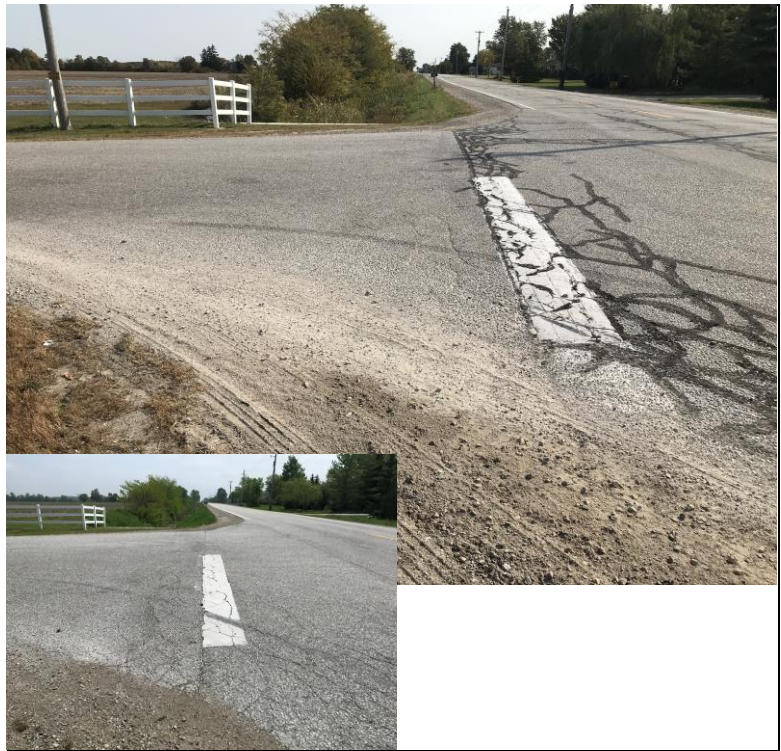
<p>Description</p> <p>Wearing surface at south approach. (Looking East)</p>
--	--

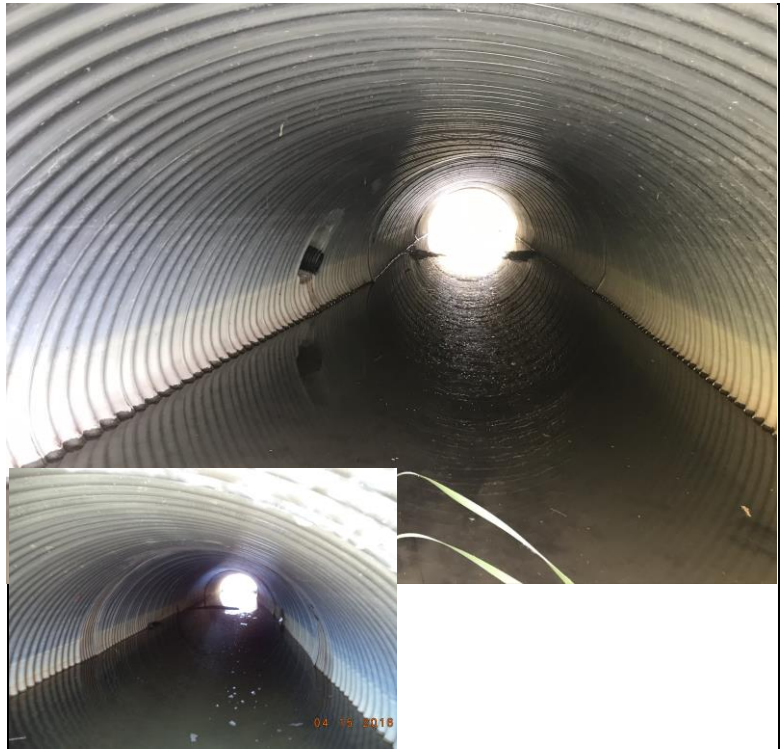
Description
Culvert barrel

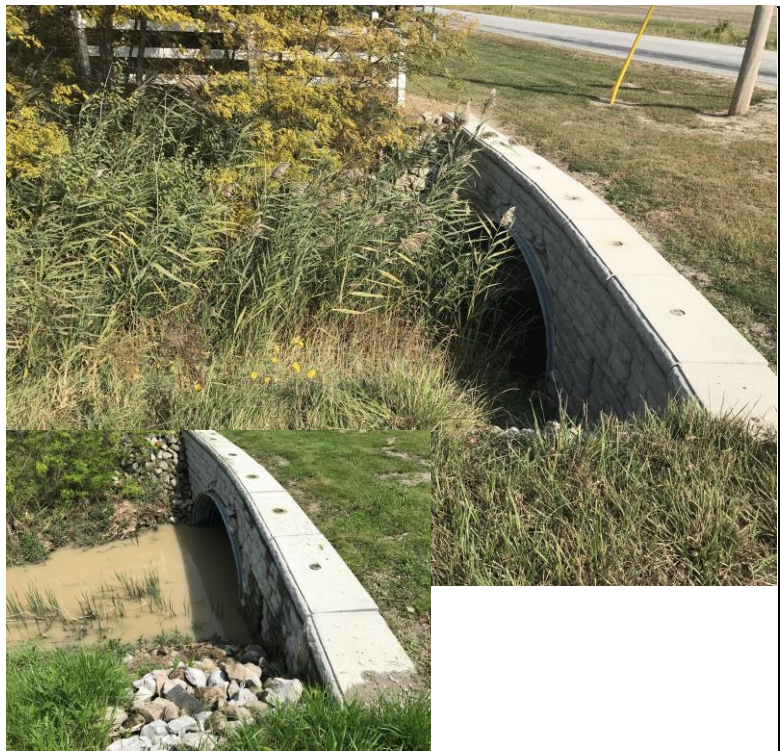
Description
West Elevation (Looking North) Excessive vegetation
