CORPORATION OF THE TOWN OF TECUMSEH
2020 Bridge and Culvert Needs Study
Structures with Spans > 3.0 m

March 30, 2021

Town of Tecumseh
2020 Bridge and Culvert Needs Study
Structures with Spans > 3.0 m

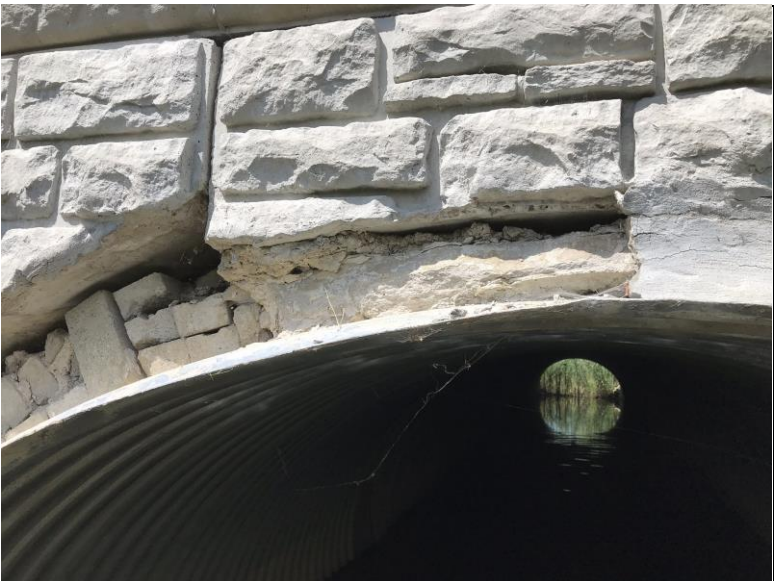
<p>Description</p> <p>Headwall joint at East elevation. Signs of precast block movement.</p>
---	---

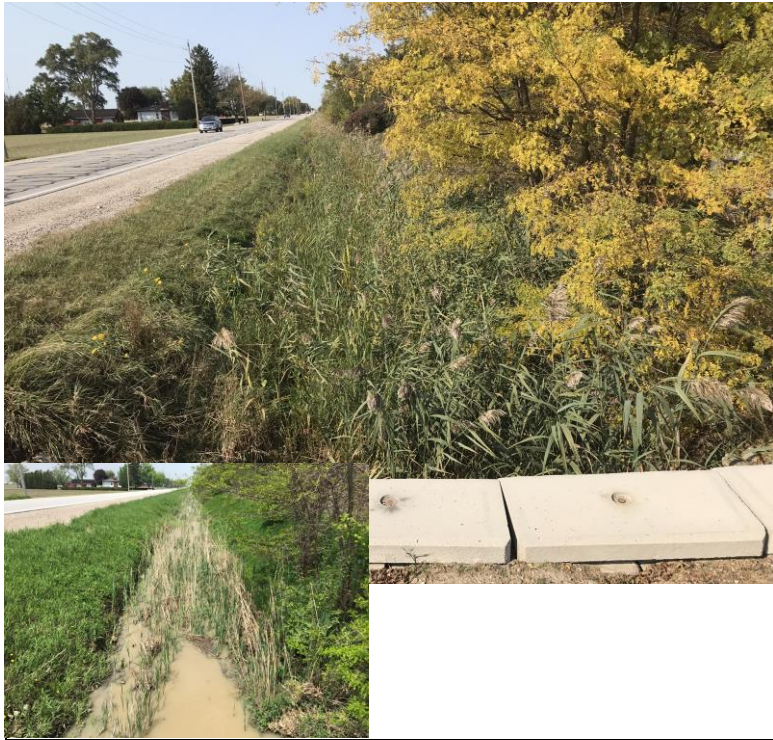
Description
Waterway, embankments and vegetation (Looking West).

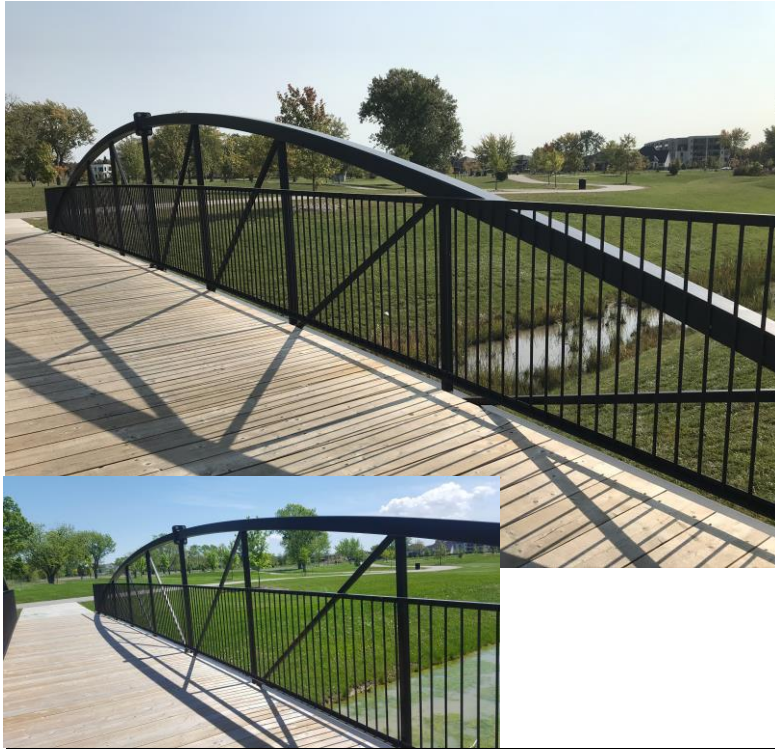
Description
Top chord, railing system, truss verticals and diagonals (Looking Southeast)

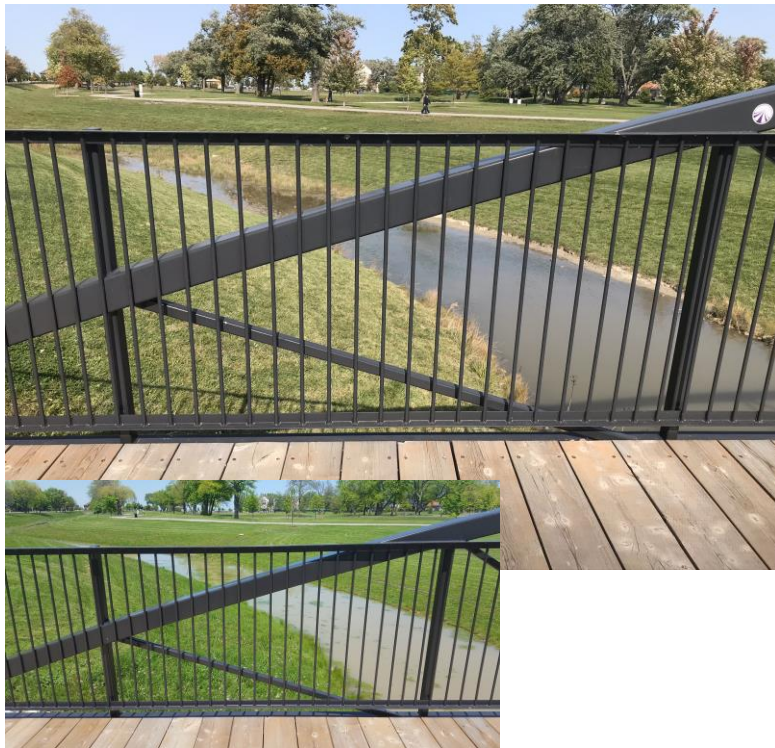
Description
Typical railing (Looking North)

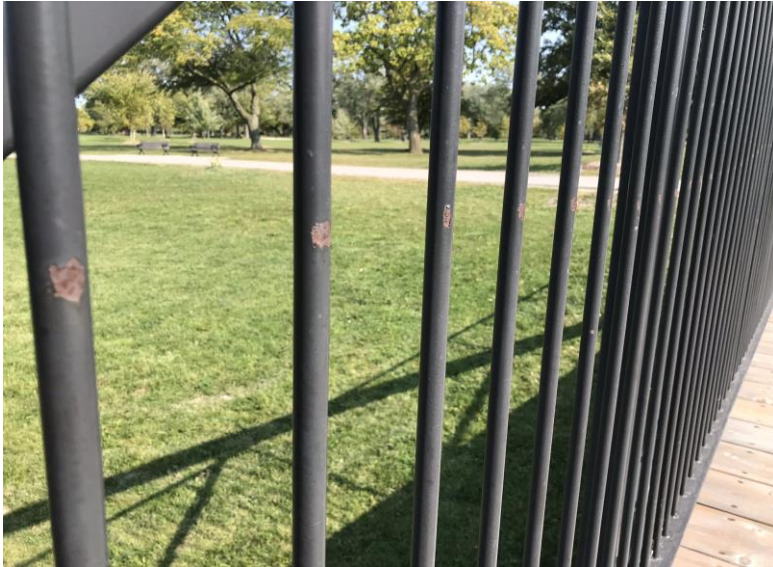
Description
Coating damage to North railing.

Overall Structure Notes:	
Recommended Work on Structure:	<input checked="" type="checkbox"/> None <input type="checkbox"/> Minor Rehab. <input type="checkbox"/> Major Rehab. <input type="checkbox"/> Replace
Timing of Recommended Work:	<input type="checkbox"/> 1 to 5 years <input type="checkbox"/> 6 to 10 years
Overall Comments:	Maintenance: Wire brush and coat corroded welded connections and coating damage on North railing.
Date of Next Inspection:	June 2022

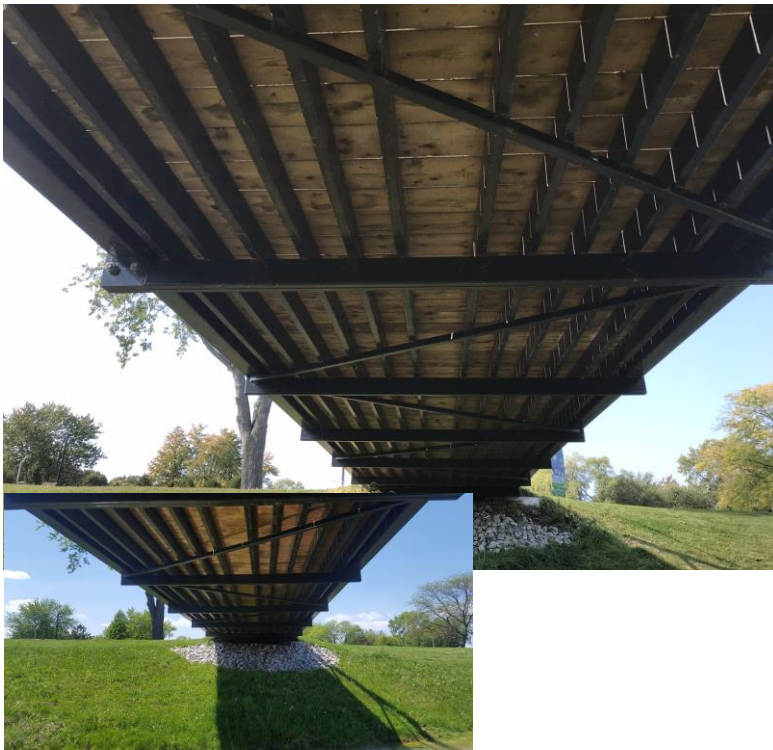
Description
Underside of deck (Looking West)

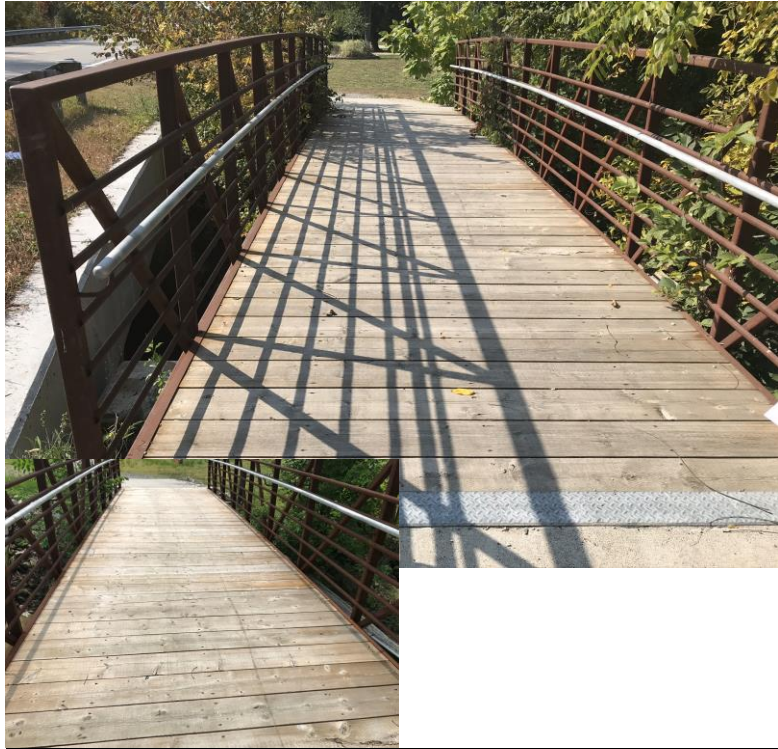
Description
Deck top (Looking South)

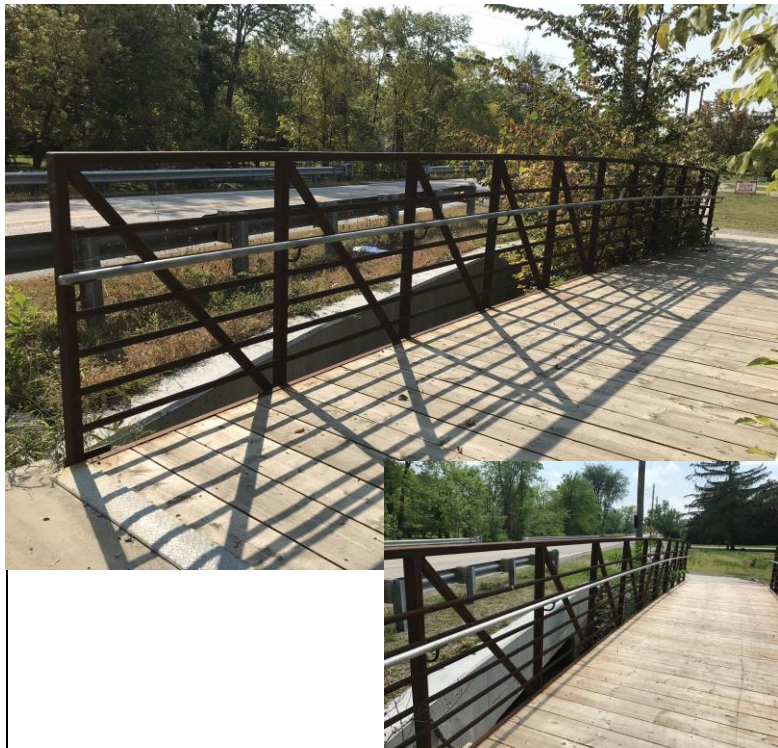
Description
Top chord, railing system, truss verticals and diagonals (Looking Southeast)

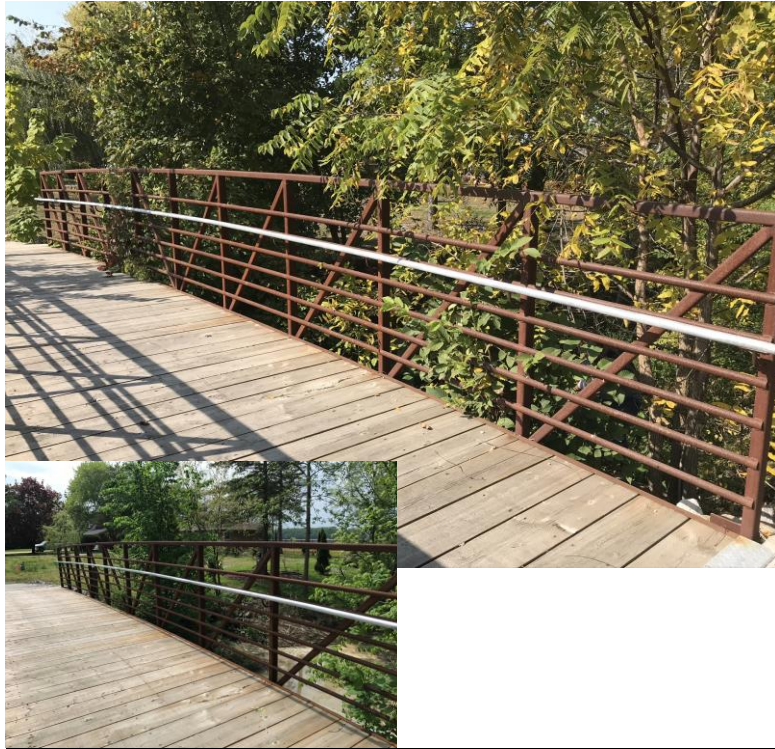
Description
Top chord, railing system, truss verticals and diagonals (Looking Southwest)

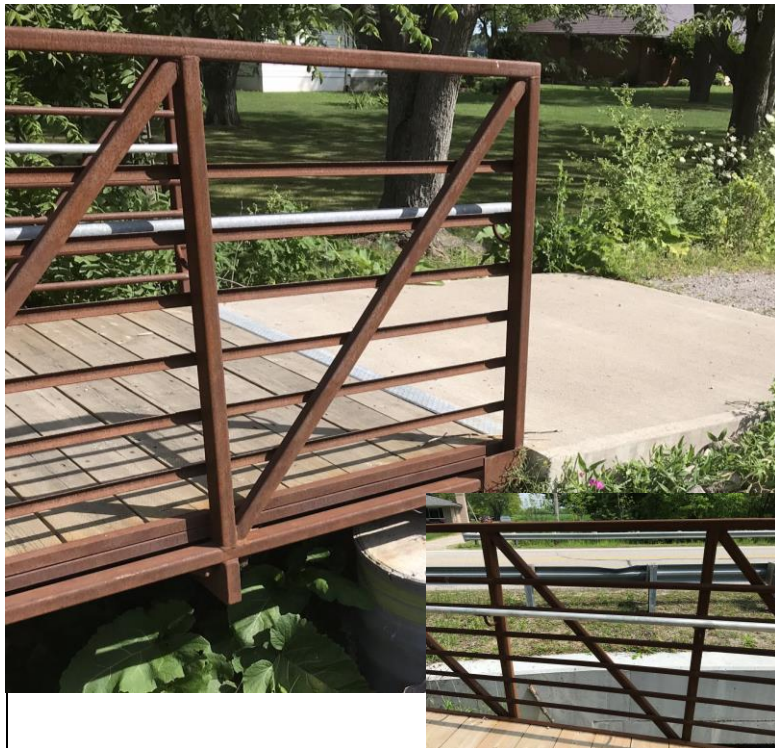
Description
Typical top chord, railing system, truss verticals and diagonals

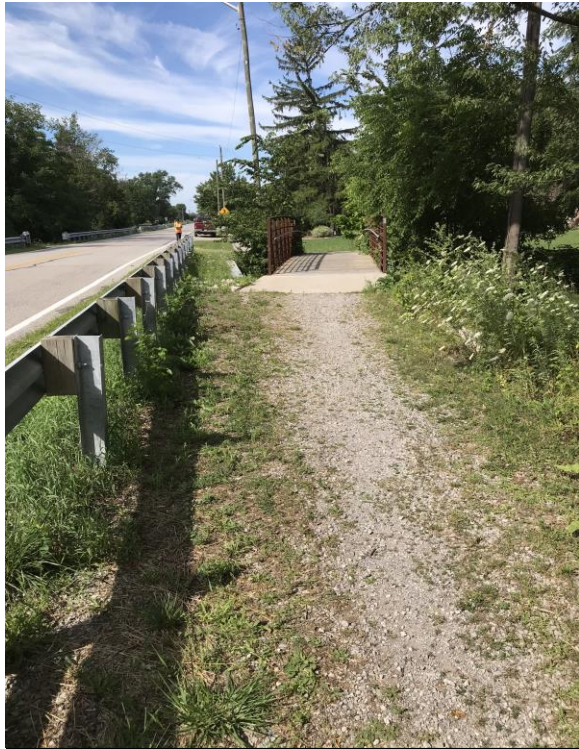
Description
North approach (Looking SW)

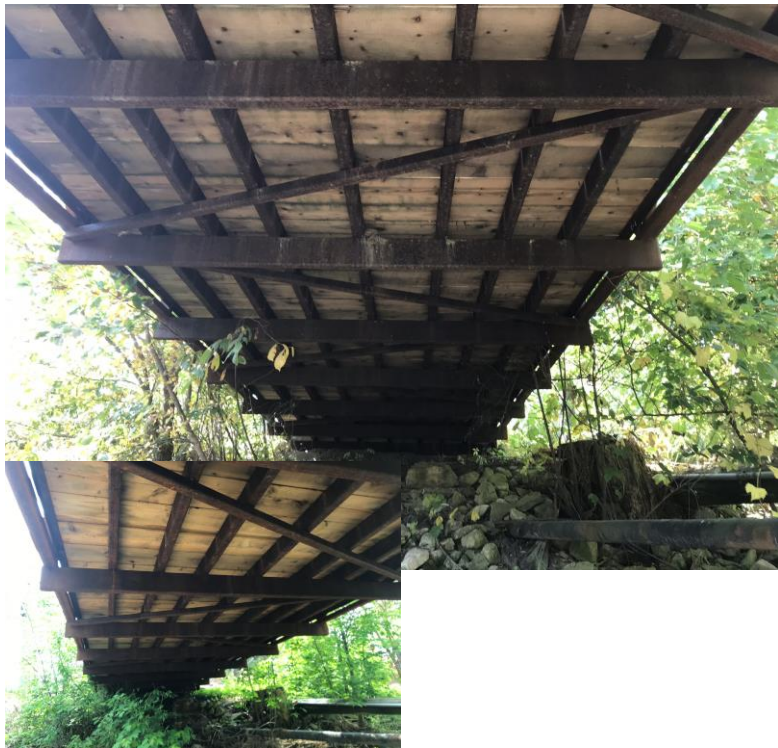
Description
Underside of the deck (Looking South)

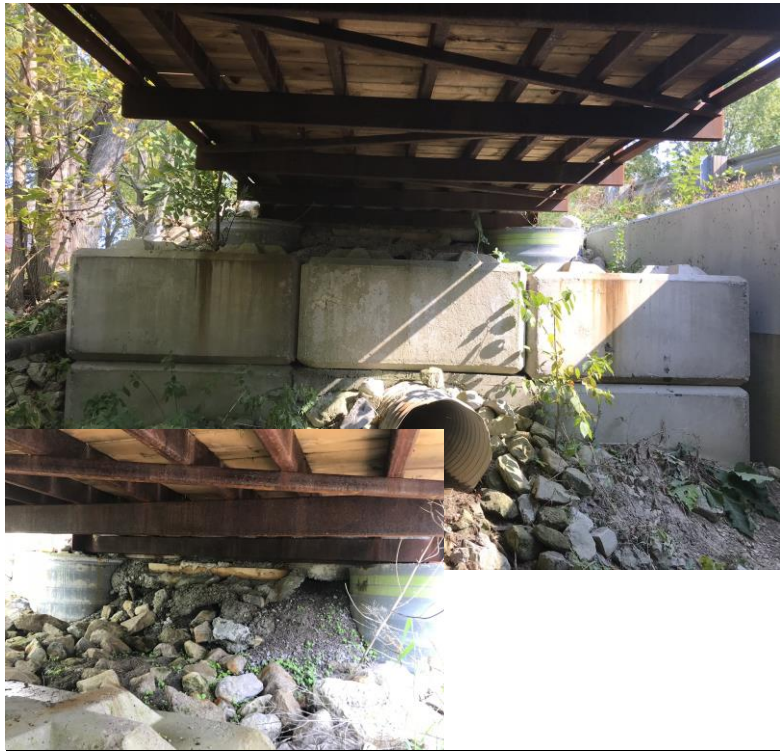
Description
Concrete caissons at North end

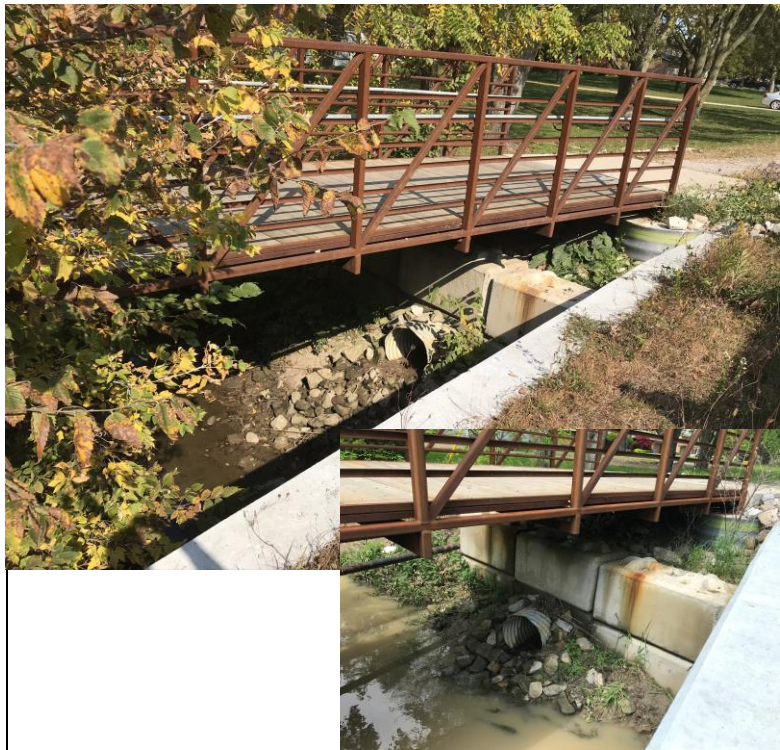
Description
CSP outlet (Looking North)

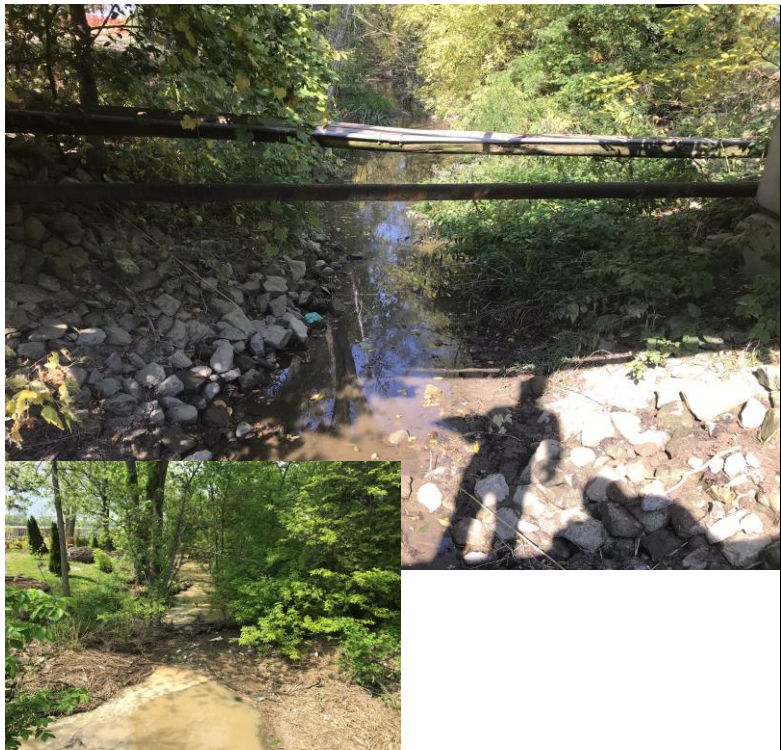
<table border="1"><tr><th>Description</th></tr><tr><td>Waterway downstream (Looking West)</td></tr></table>	Description	Waterway downstream (Looking West)
Description			
Waterway downstream (Looking West)
